**ALBERTA TRANSPORTATION  
GEOHAZARD ASSESSMENT PROGRAM  
PEACE REGION (PEACE RIVER DISTRICT)  
2021 INSPECTION**

Site Number	Location	Name	Hwy	km
SH010-1	Little Smoky River	Little Smoky River Valley, South Hill – Site #1	744:02	14.4-14.7
Legal Description		UTM Co-ordinates		
NE-13-76-23-W5		11U E 473,759	N	6,160,016

**SH010: HWY 744:02 LITTLE SMOKY RIVER VALLEY (SITE #1)  
2021 SITE INSPECTION PLAN**

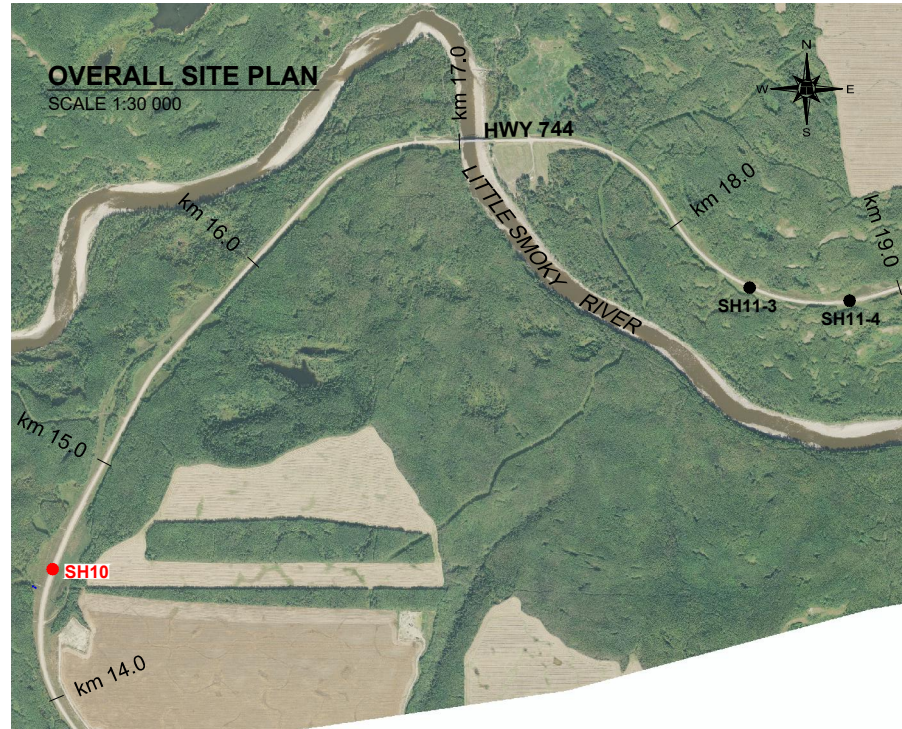
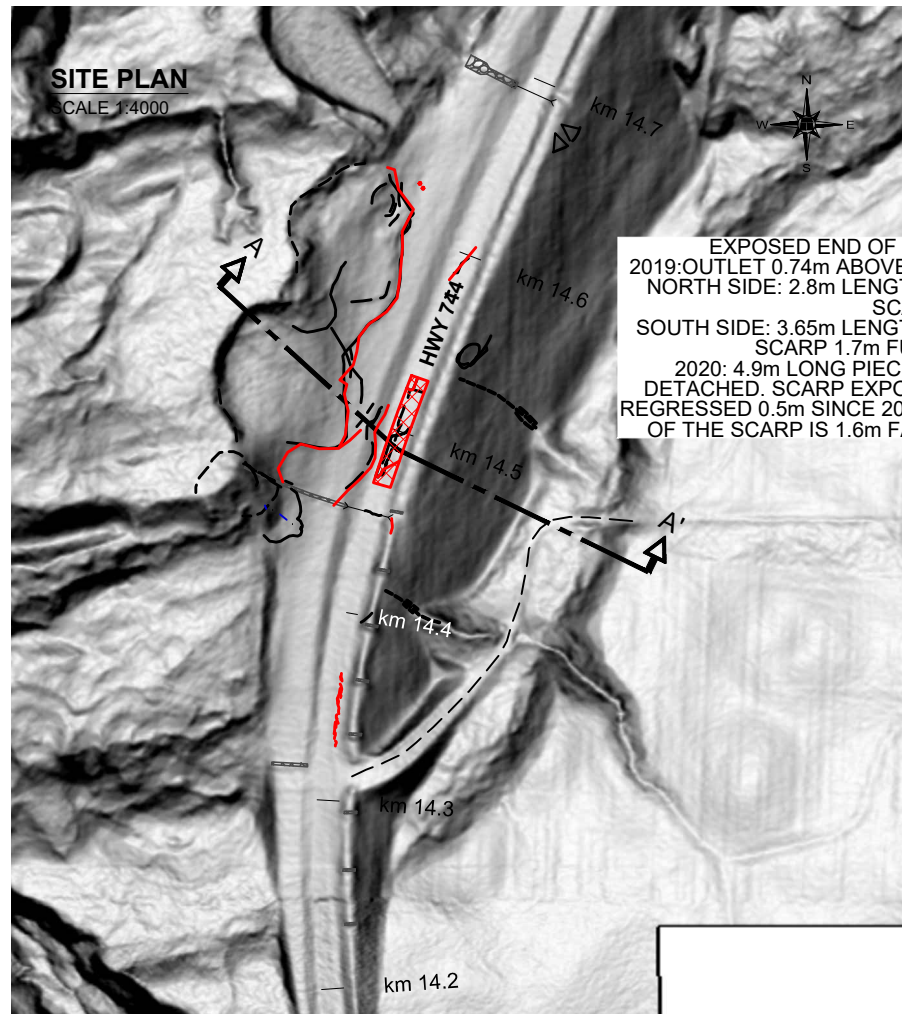
EXPOSED END OF OLD CULVERT:  
2019: OUTLET 0.74m ABOVE SCARP BOWL  
NORTH SIDE: 2.8m LENGTH EXPOSED &  
SCARP 1.5m HIGH  
SOUTH SIDE: 3.65m LENGTH EXPOSED &  
SCARP 1.7m FURTHER BACK;  
2020: 4.9m LONG PIECE OF CULVERT  
DETACHED. SCARP EXPOSING 0.9m SO  
REGRESSED 0.5m SINCE 2019. A PORTION  
OF THE SCARP IS 1.6m FARTHER BACK.

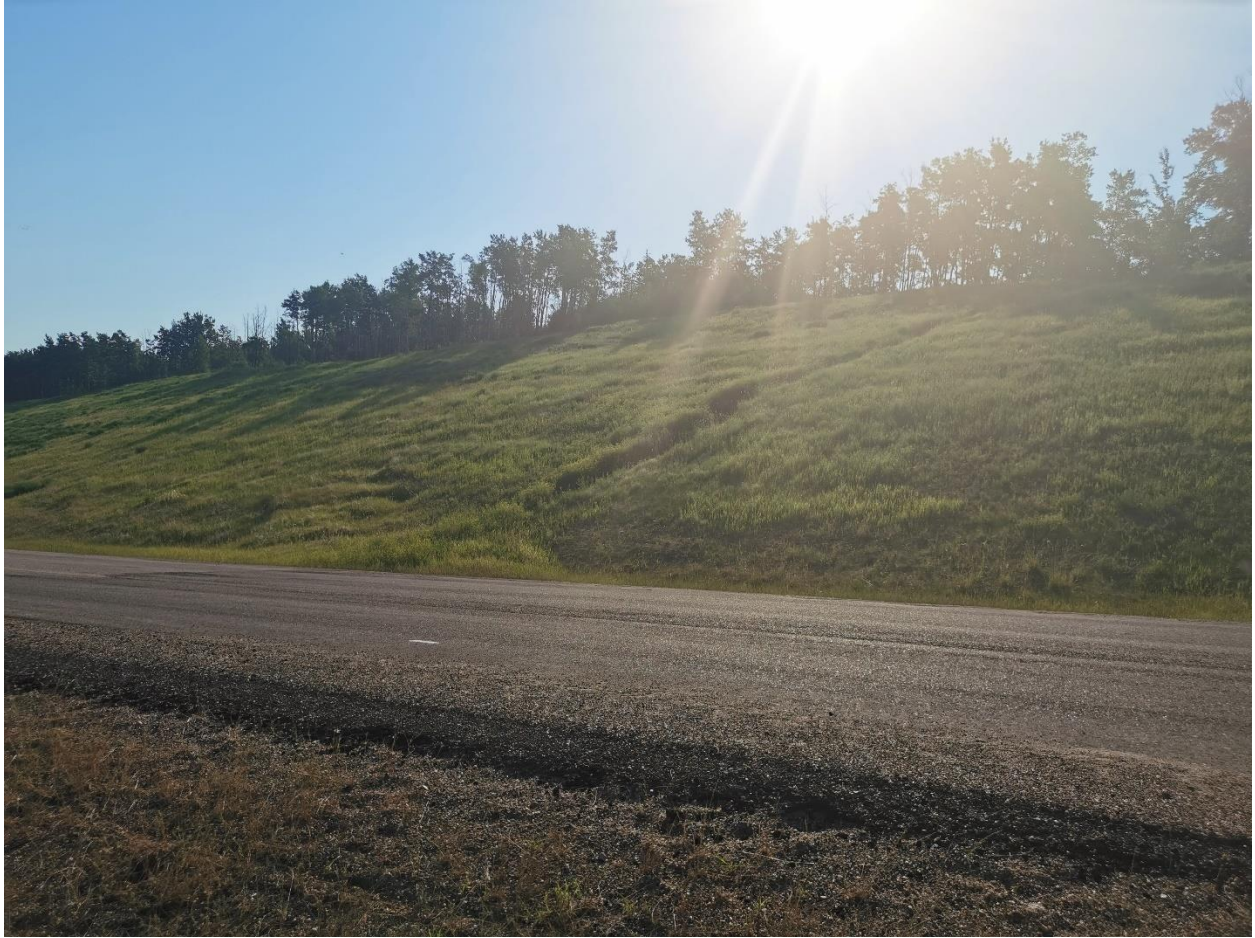
Photo 1 – North gully; note slump to left of gully on lower part of slope.

<b>Recommendations:</b>
<p><b>Short-Term:</b> The backslope erosion gullies should be repaired by installing engineered riprap-lined swales extending down to the highway ditch. This work should be undertaken as soon as possible to reduce further erosion.</p> <p><b>Medium-Term:</b> Due to the reactivation of the larger slide mass between km 14.48 and km 14.62, it is recommended that a geotechnical investigation be undertaken to understand the stratigraphy and install slope inclinometers to determine the depth and rate of movement. Continued development of this large scarp commensurate with new tension crack formation indicates that the movement is active and regressing toward the highway. It is recommended that two inclinometers be installed within this slide mass and a third placed upslope of the km 14.45 slump.</p> <p><b>Long-Term:</b> Overall, the south hill portion of the highway is relatively stable and low maintenance compared to the north hill. However, the new slide is progressing toward the highway, and it is recommended that preliminary engineering be initiated as repair may be required within 5 years. A potential longer term solution might be to construct a large toe berm on the terrace to buttress the moving slope</p>

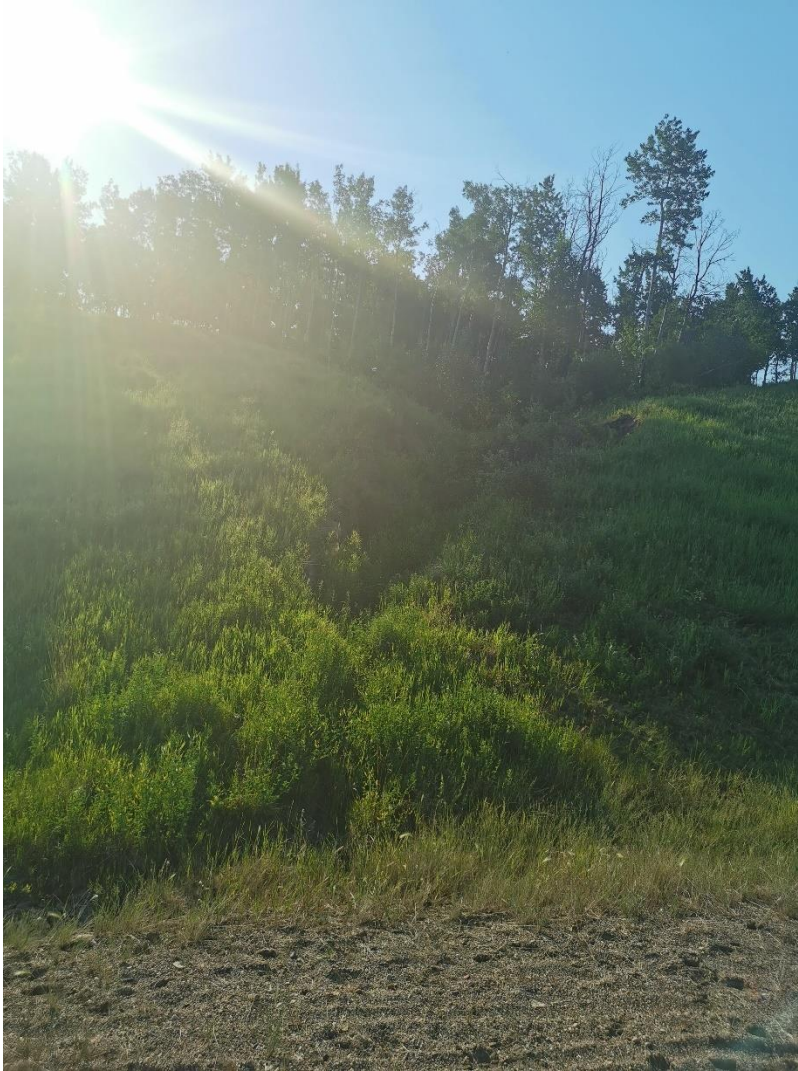
Photo 2 – South gully; note fan of material at toe.

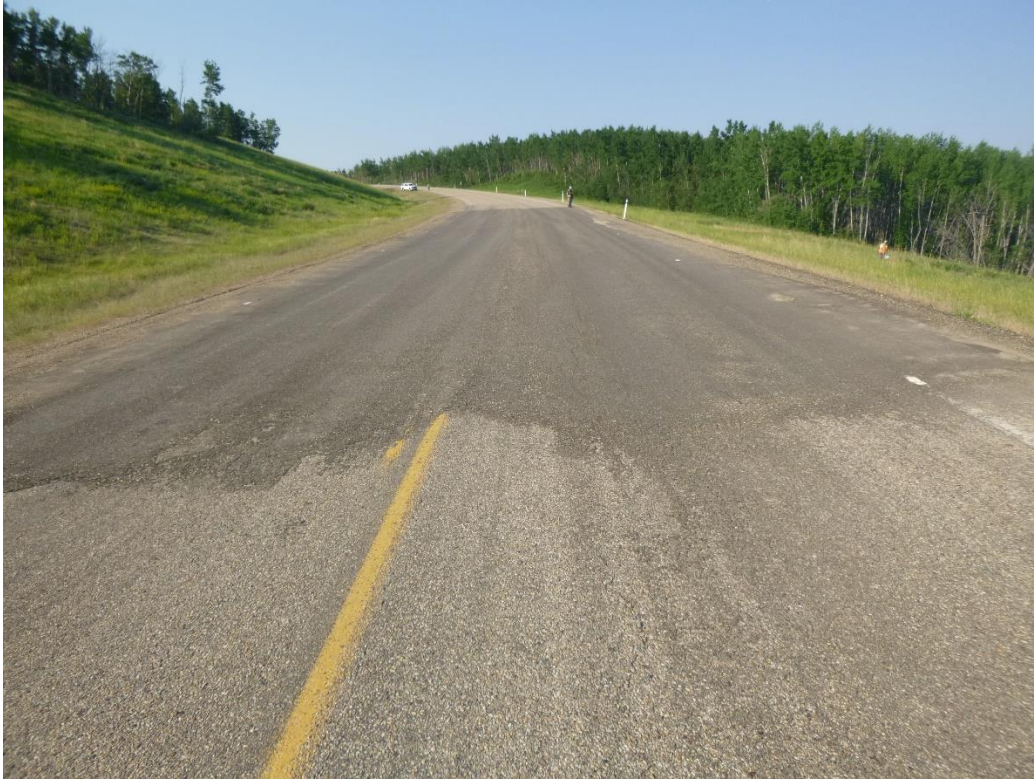
Photo 3 – Looking south at patched pavement area.

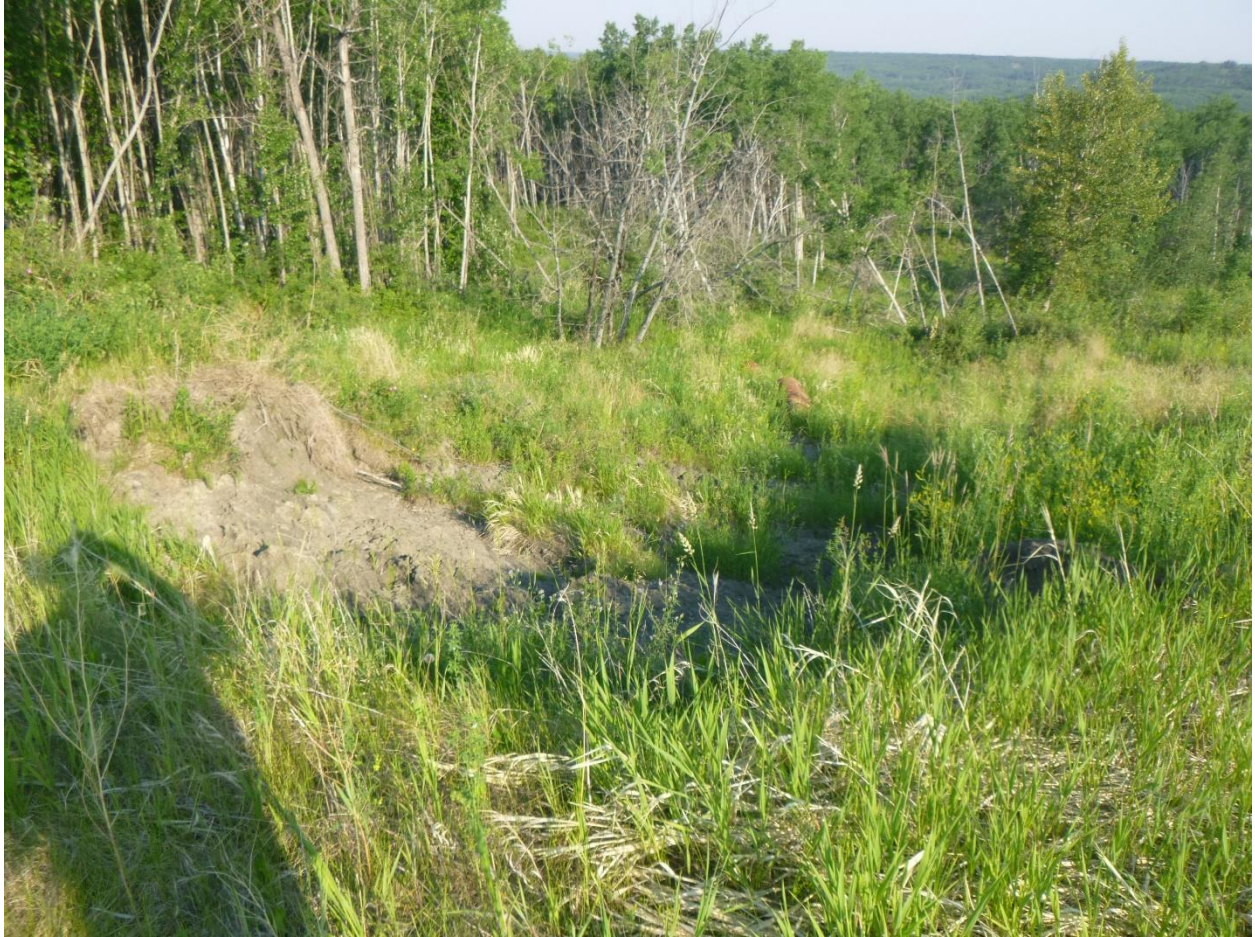
Photo 4 – Looking west at slide at km 14.45 located adjacent to south gabion basket swale.

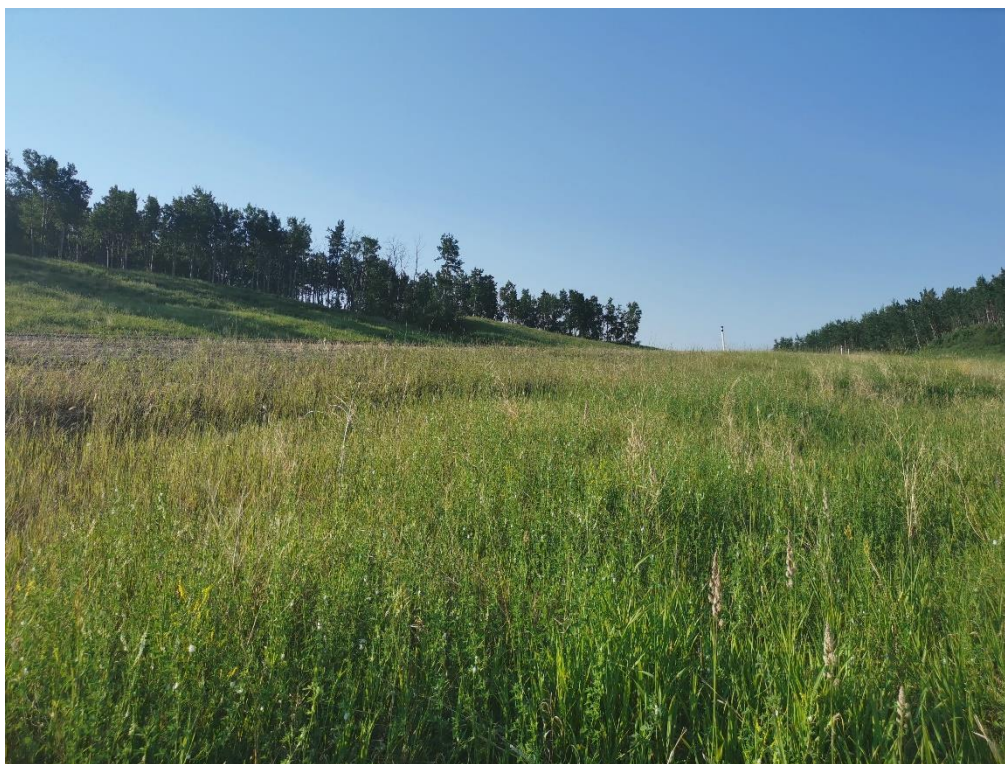
Photo 5 – Looking southeast at scarps forming close to the highway at about km 14.48

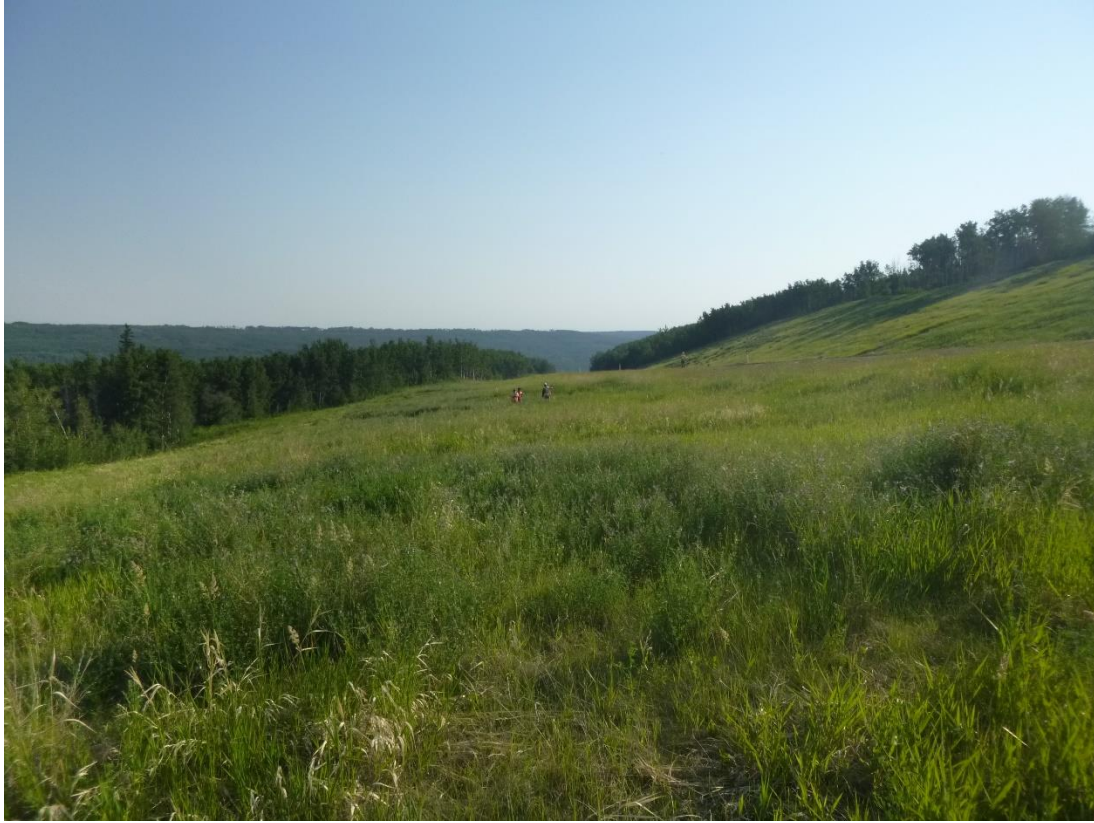
Photo 6 – Looking north over the lower scarp, just north of the gabion basket swale. The vegetation was quite high during the site inspection.
