**ALBERTA TRANSPORTATION  
GEOHAZARD ASSESSMENT PROGRAM  
PEACE REGION (PEACE RIVER DISTRICT)  
2022 INSPECTION**

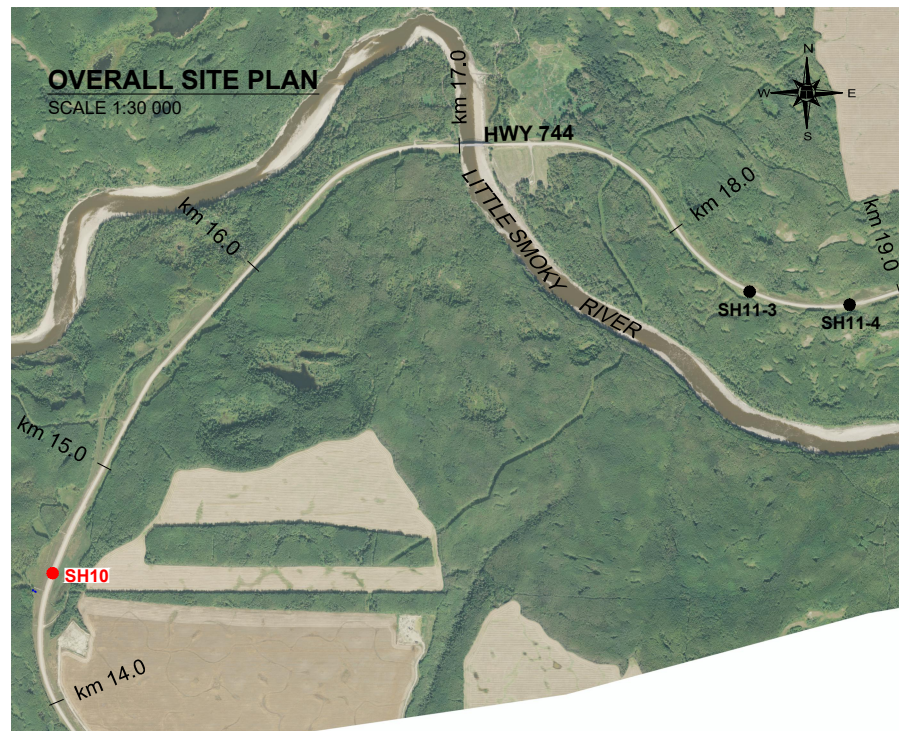
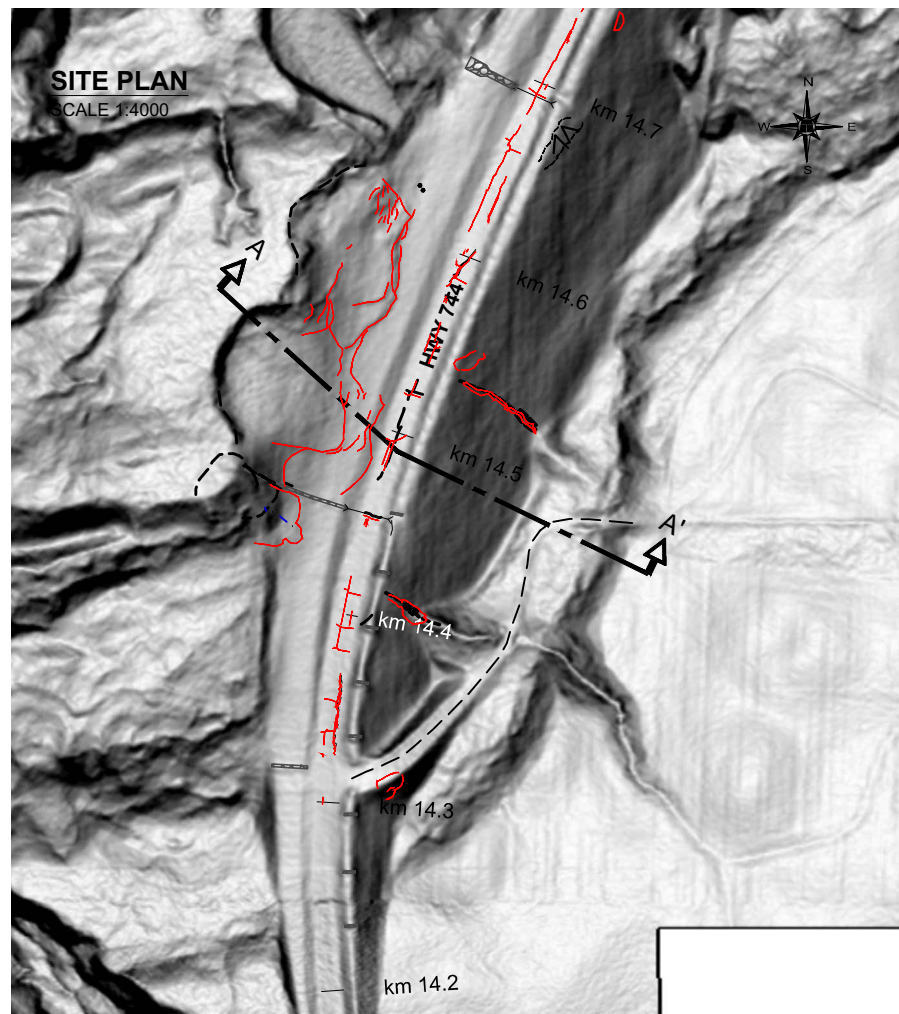
**DETAILED SITE PLAN**  
SCALE 1:2000

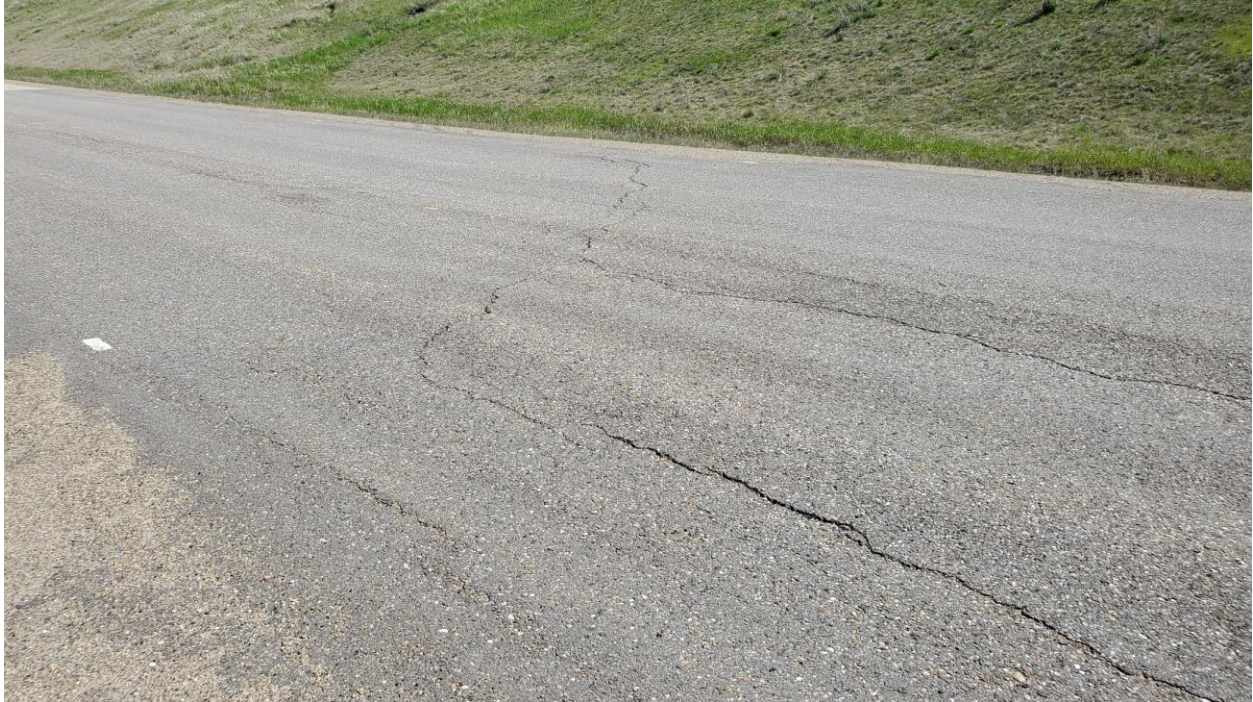
Photo 3 – Looking northeast at crack pattern reflecting through recent patch on highway above scarps shown in Photo 7.

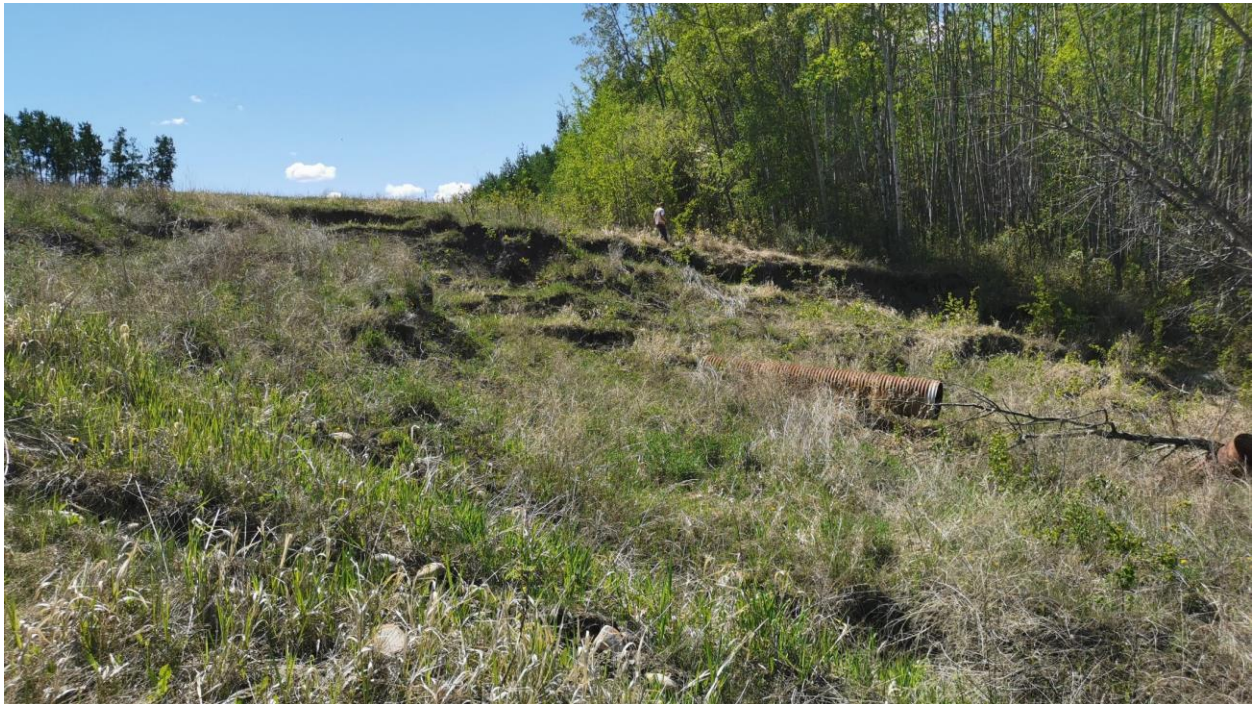
Photo 4 – Looking south at fresh slide at km 14.45 located adjacent to south gabion basket swale. The culvert may be from the previous highway alignment.

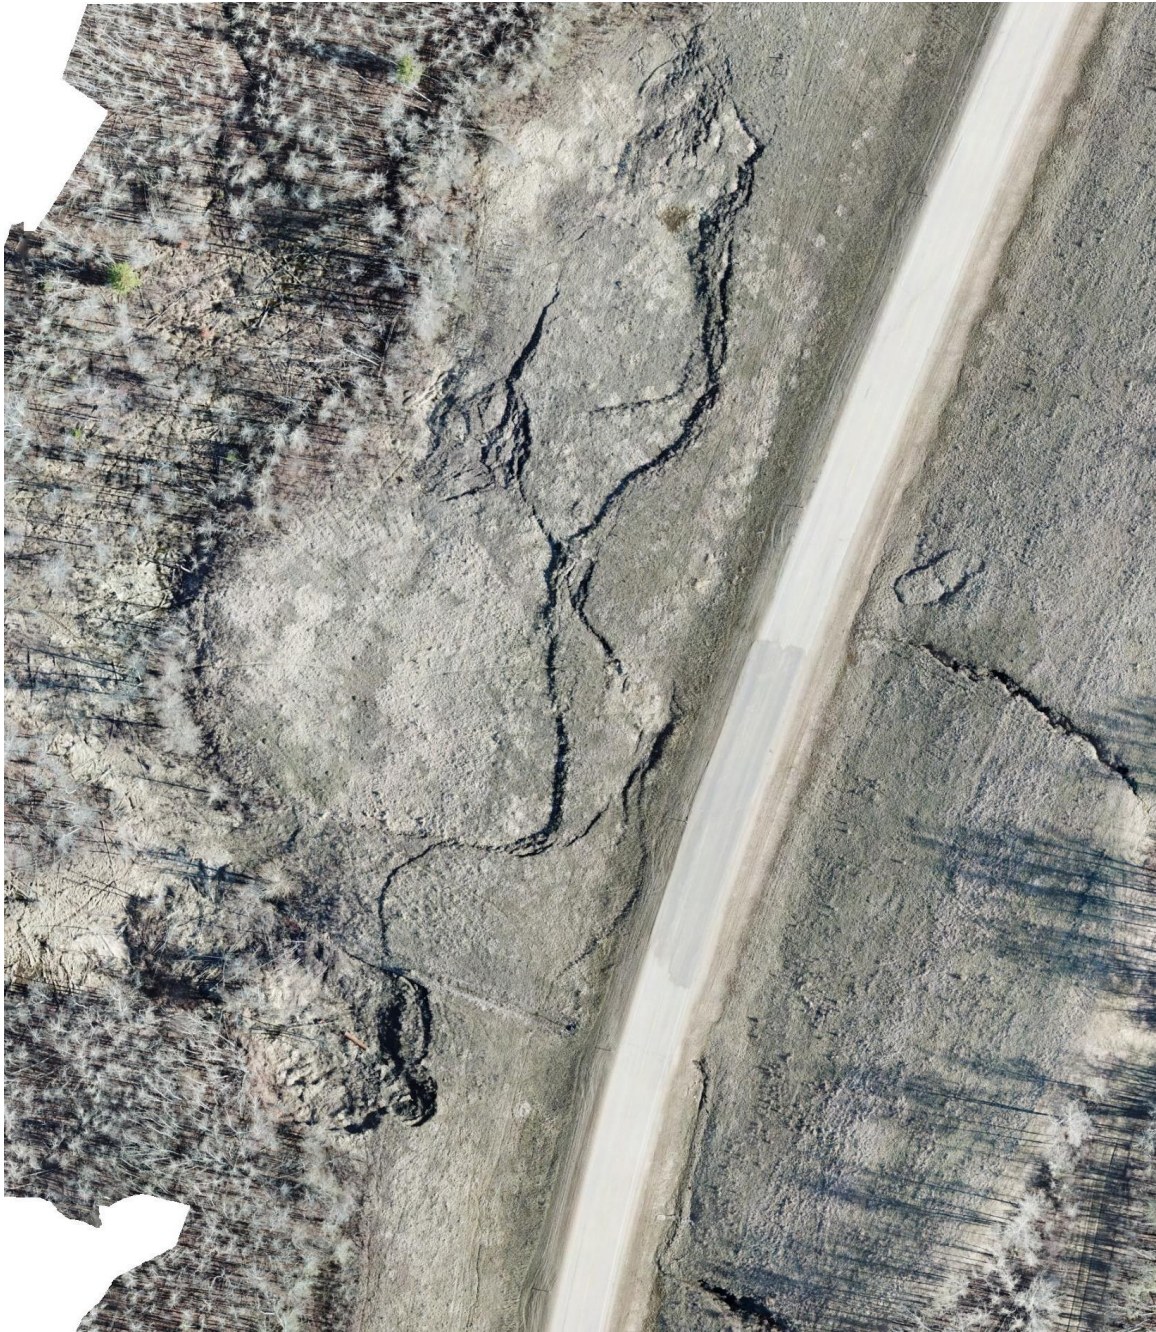
2022 UAV orthomosaic showing the developing landslides that have damaged the south gabion basket swale and are encroaching towards the highway.
