**ALBERTA TRANSPORTATION
GEOHAZARD ASSESSMENT PROGRAM
PEACE REGION – SWAN HILLS
2020 INSPECTION**

Site Number	Location	Name	Hwy	km
SH011-3 SH011-4	Little Smoky River	Little Smoky River Valley, North Hill – Sites #3 and #4	744:02	18.26-18.52 18.62-18.90
Legal Description		UTM Co-ordinates		
Site 3: SE20-76-22-W5M		11U E 476,536	N	6,161,182
Site 4: SE20-76-22-W5M		11U E 476,872	N	6,161,121

**SH011-4: HWY 744:02 LITTLE SMOKY RIVER VALLEY
2020 SITE INSPECTION PLAN**

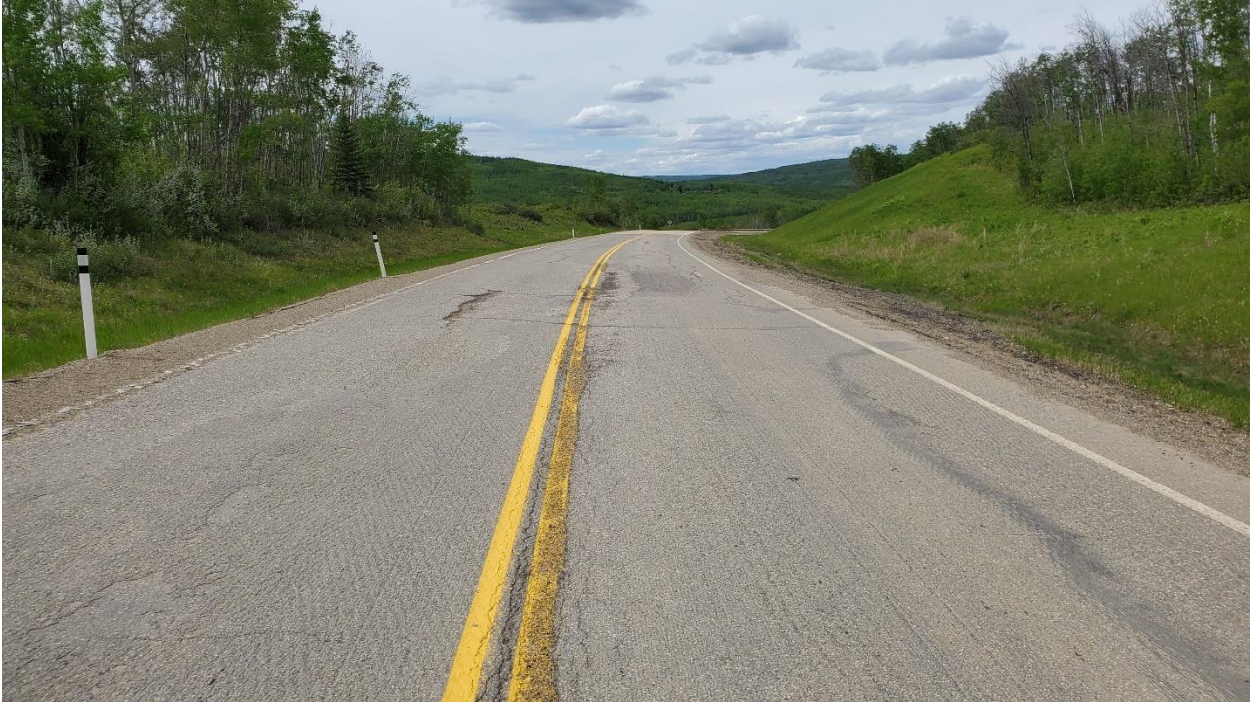
Photo 5, Site 4 – Looking west at patch at ~km 18.750.

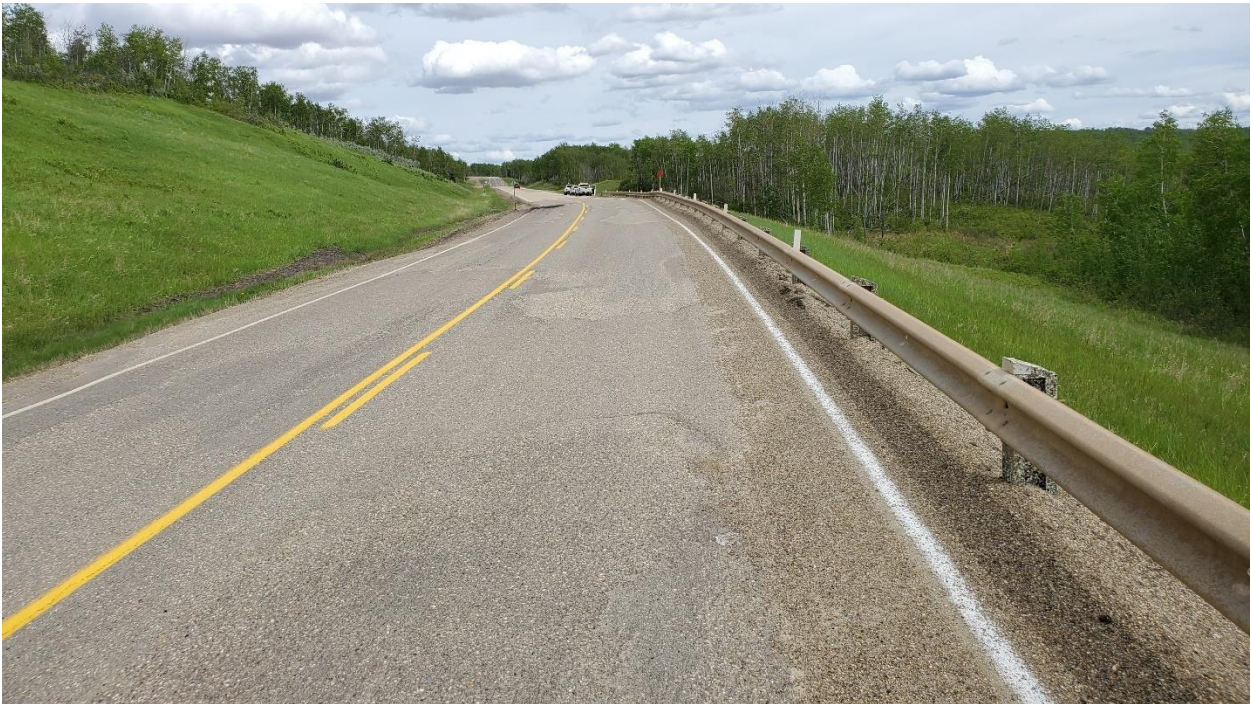
Photo 6, Site 4 – Looking east at transverse crack and patch at ~km 18.820.

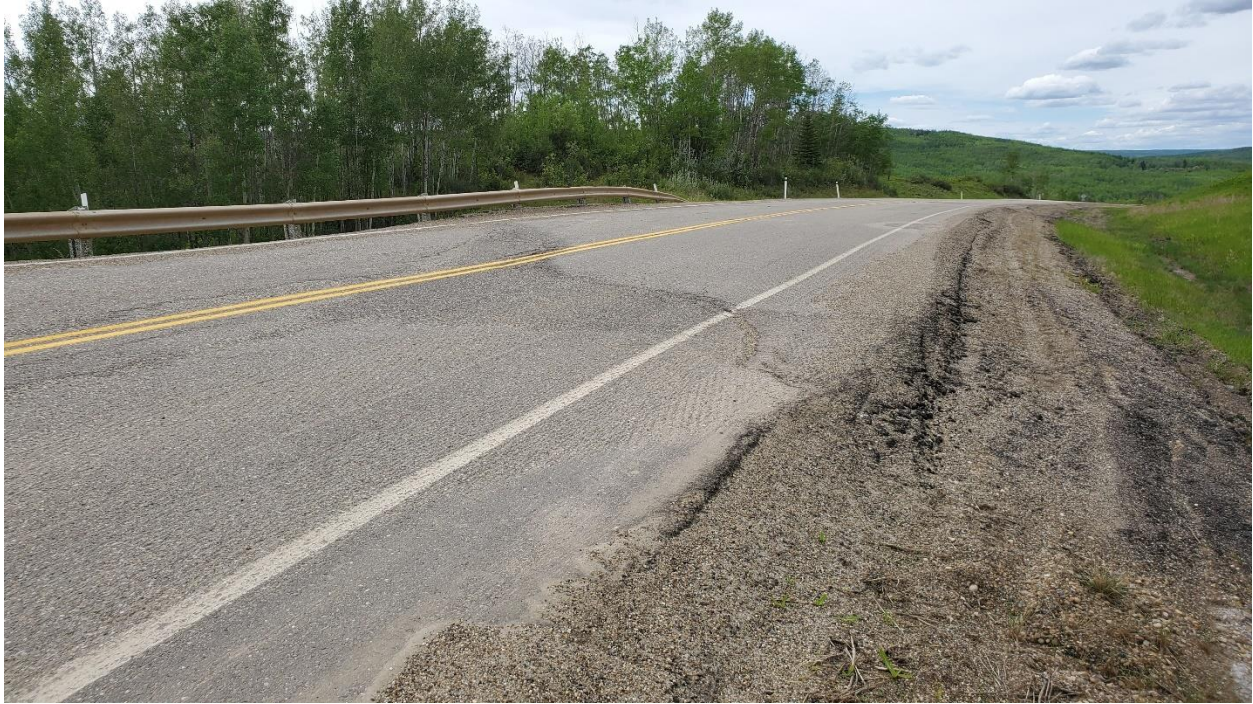
In general, the site has deteriorated steadily over the last two or three years. There were noticeable changes in crack widths and lengths despite the milling undertaken across the entire site in 2019. Although the differential heights measured across the cracks was mostly eliminated, the cracks are still present and there is still overall unevenness of the driving surface. Recent patching had been undertaken at km 18.84 where vertical deformation has continued to occur.

Photo 7, Site 4 – Looking southwest at dip in highway surface at ~km 18.840.

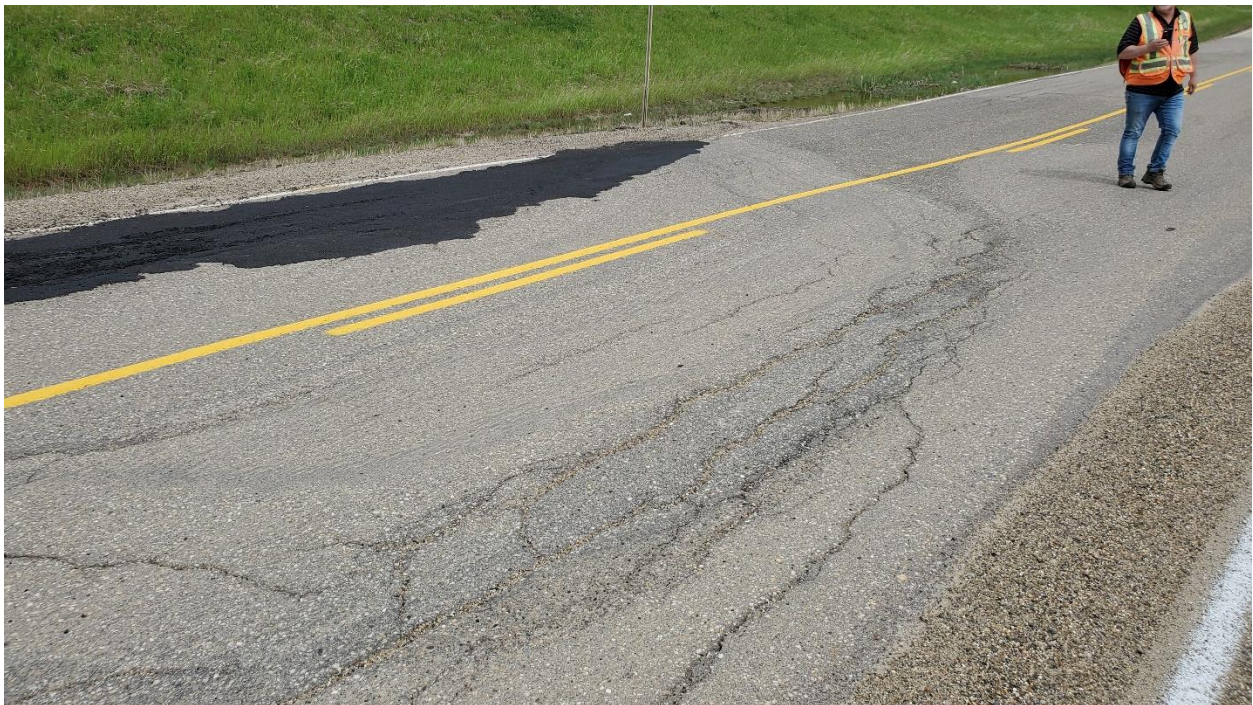
Photo 8 – Looking northeast of a portion of the patch at km 18.84.
