**ALBERTA TRANSPORTATION  
GEOHAZARD ASSESSMENT PROGRAM  
PEACE REGION – SWAN HILLS  
2020 INSPECTION**

| Site Number | Location | Name | Hwy | km |
|---|---|--|---|---|
| SH012-8<br>SH012-9 | Little Smoky River | Little Smoky River Valley,<br>North Hill – Sites #8 and #9 | 744:02 | 19.70-19.83<br>19.83-20.0* |

**SH012-8: HWY 744:02 LITTLE SMOKY RIVER VALLEY  
2020 SITE INSPECTION PLAN**

**SH012-9: HWY 744:02 LITTLE SMOKY RIVER VALLEY  
2020 SITE INSPECTION PLAN**

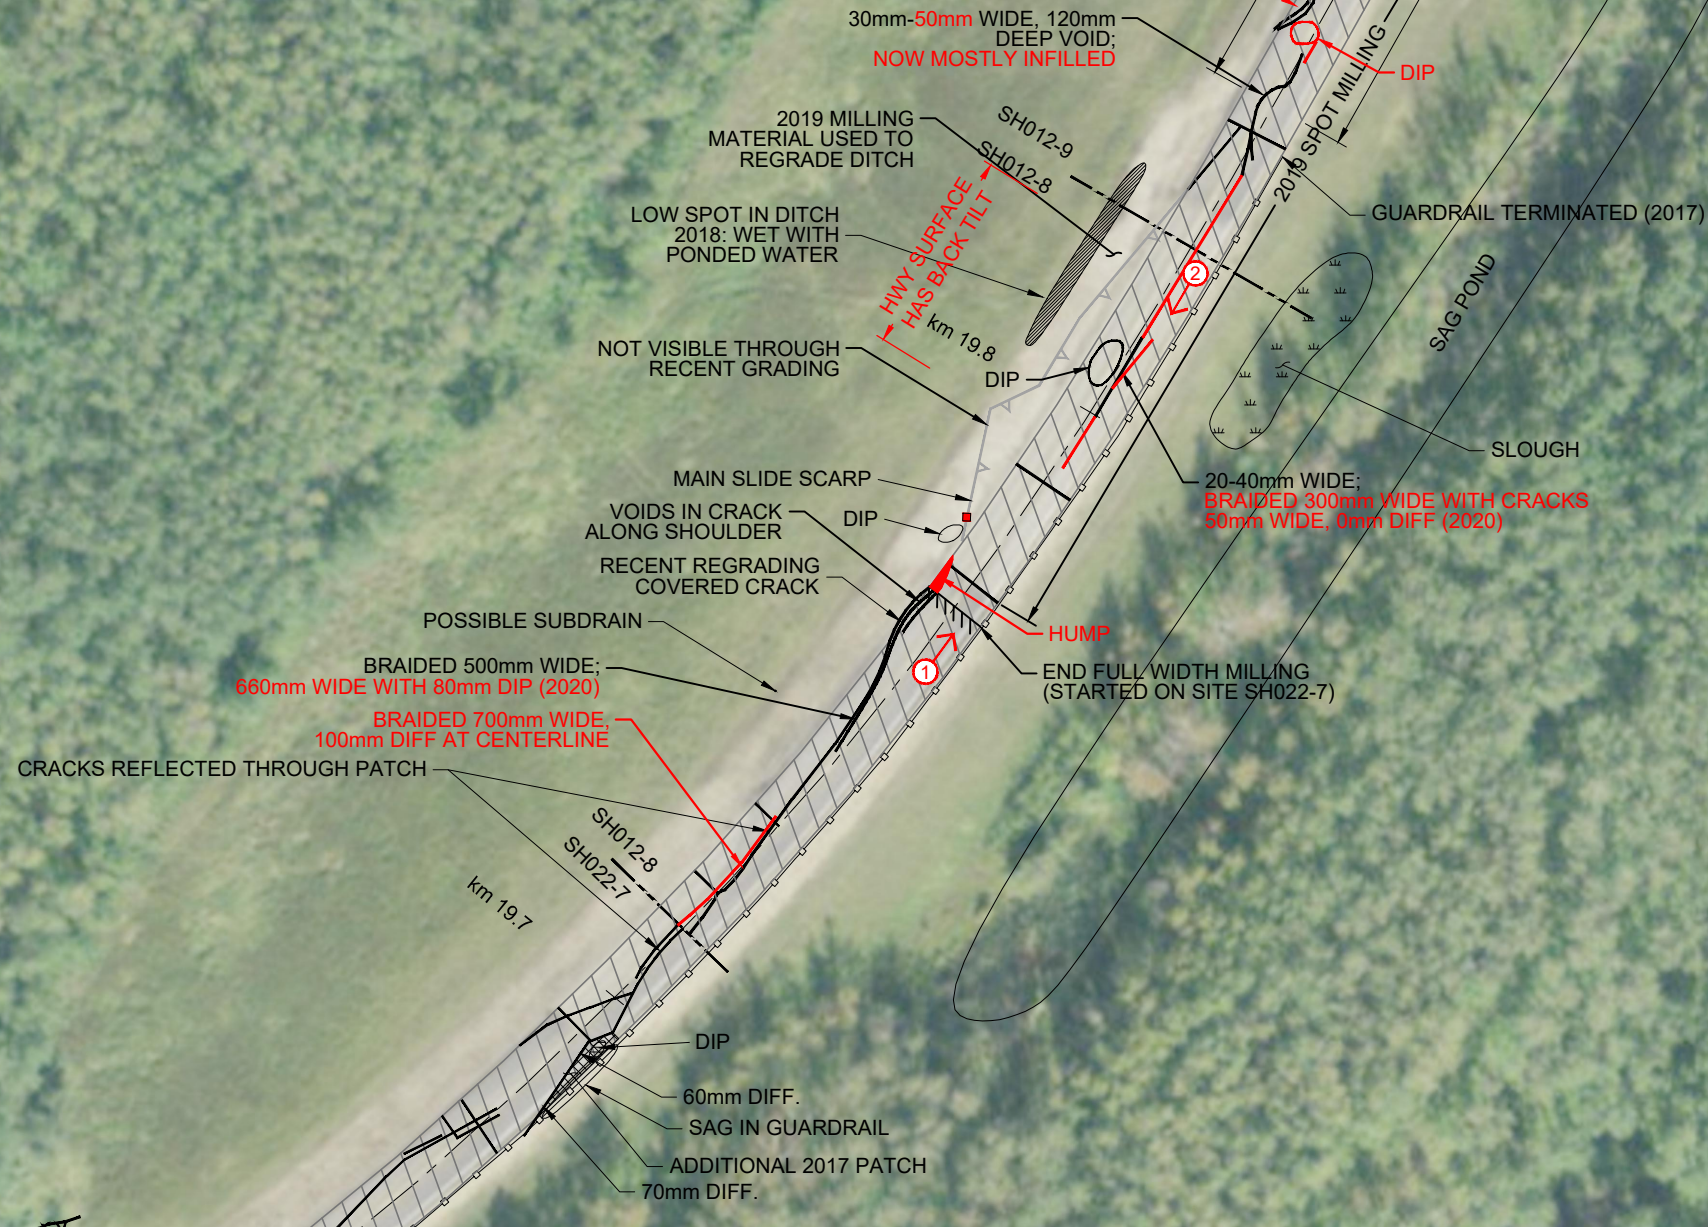
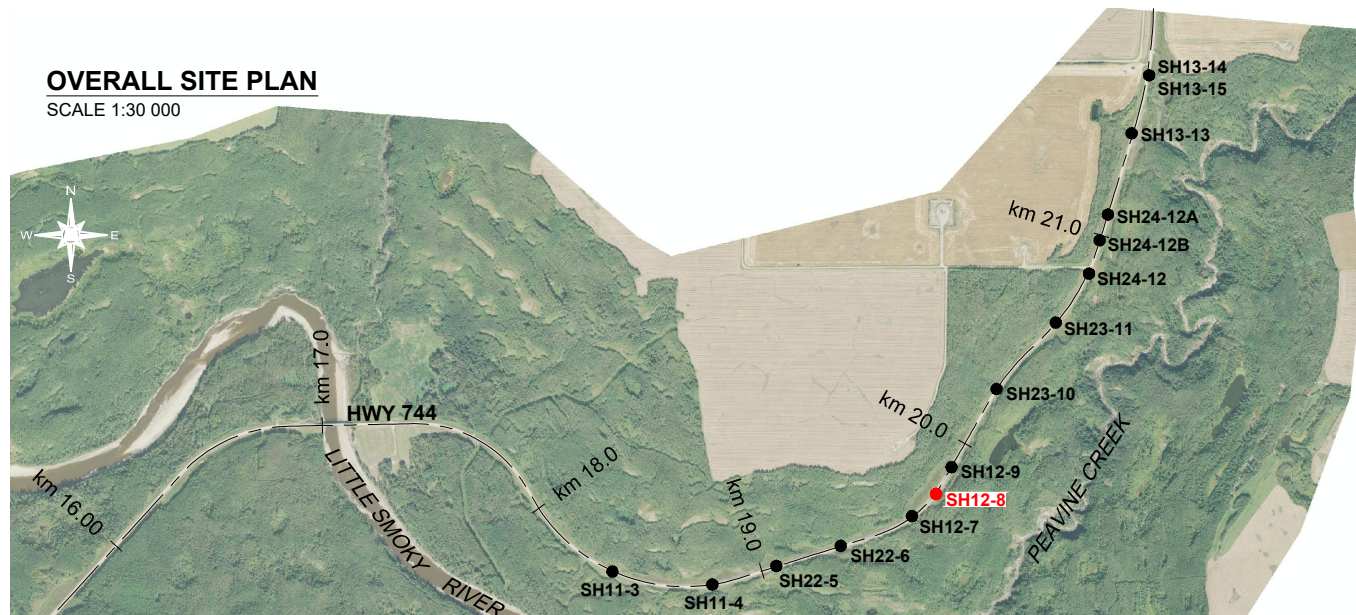
| <input checked="" type="checkbox"/> Pavement Distress | Numerous longitudinal and traverse cracks have reflected through 2017 patches and been exposed by 2019 milling. There is moderate surface distortion. | <input checked="" type="checkbox"/> | |
| <input checked="" type="checkbox"/> Slope Movement | Site is located on an active deep-seated landslide moving toward the Peavine Creek. Cracks are reflecting through recent patch. | <input checked="" type="checkbox"/> | |

- Road maintenance should continue as necessary to maintain a safe roadway surface and may consist of ACP milling, patching, and crack sealing.

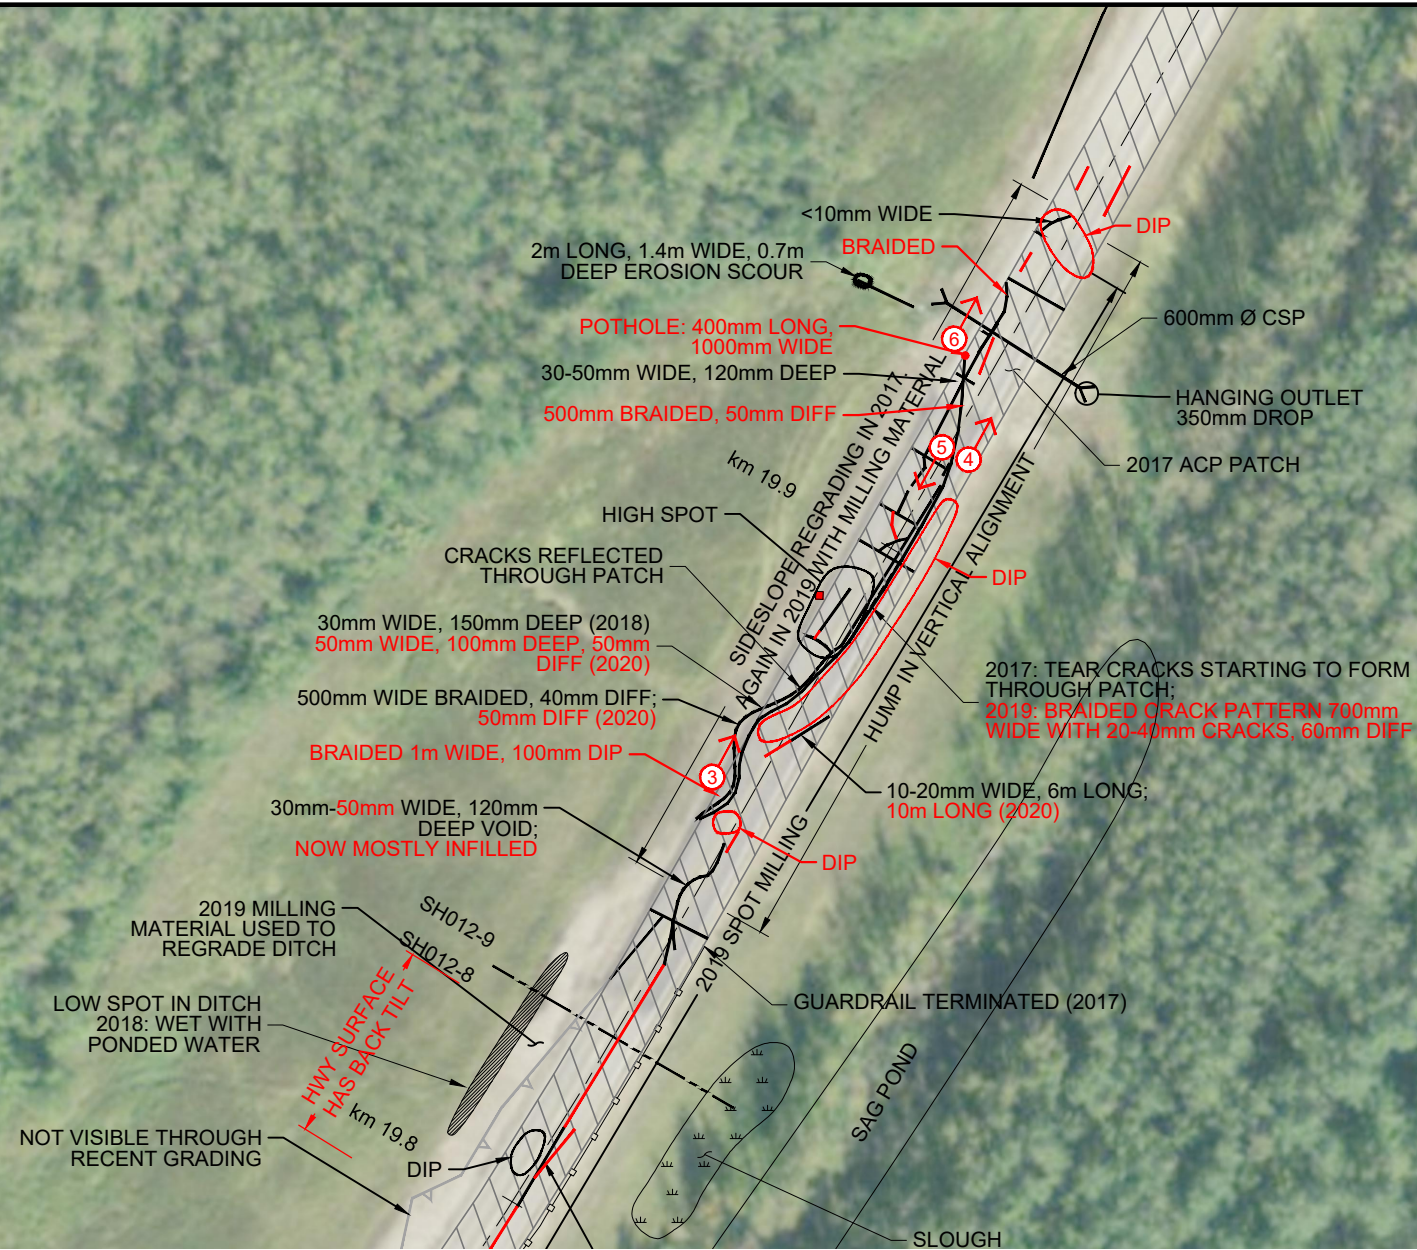
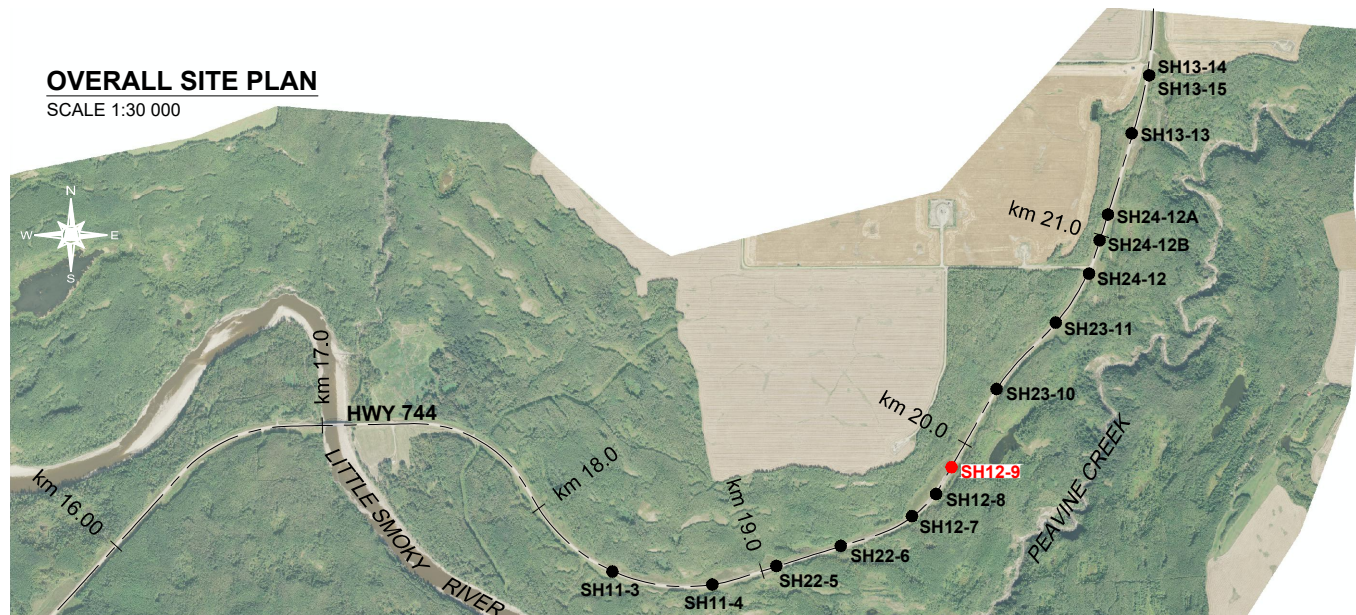
| <input checked="" type="checkbox"/> Pavement Distress | Numerous longitudinal and traverse cracks have reflected through 2017 patches and been exposed by 2019 milling. There is significant surface distortion particularly near the northeast end of the Site. | <input checked="" type="checkbox"/> |
| <input checked="" type="checkbox"/> Slope Movement | Site is located on an active deep-seated landslide moving toward the Peavine Creek. This site crosses over a sag pond/graben. Cracks are reflecting through recent patch. | <input checked="" type="checkbox"/> |
| <input checked="" type="checkbox"/> Bridge/Culvert Distress | Culvert at km 19.93: hanging outlet repaired with sideslope regrading in 2017 but is starting to scour again. | <input checked="" type="checkbox"/> |

- Culvert outlet at km 19.93 (Site 9): consideration should be given to placing some riprap at the outlet (there is none currently) to minimize downcutting through recently-regraded slope.

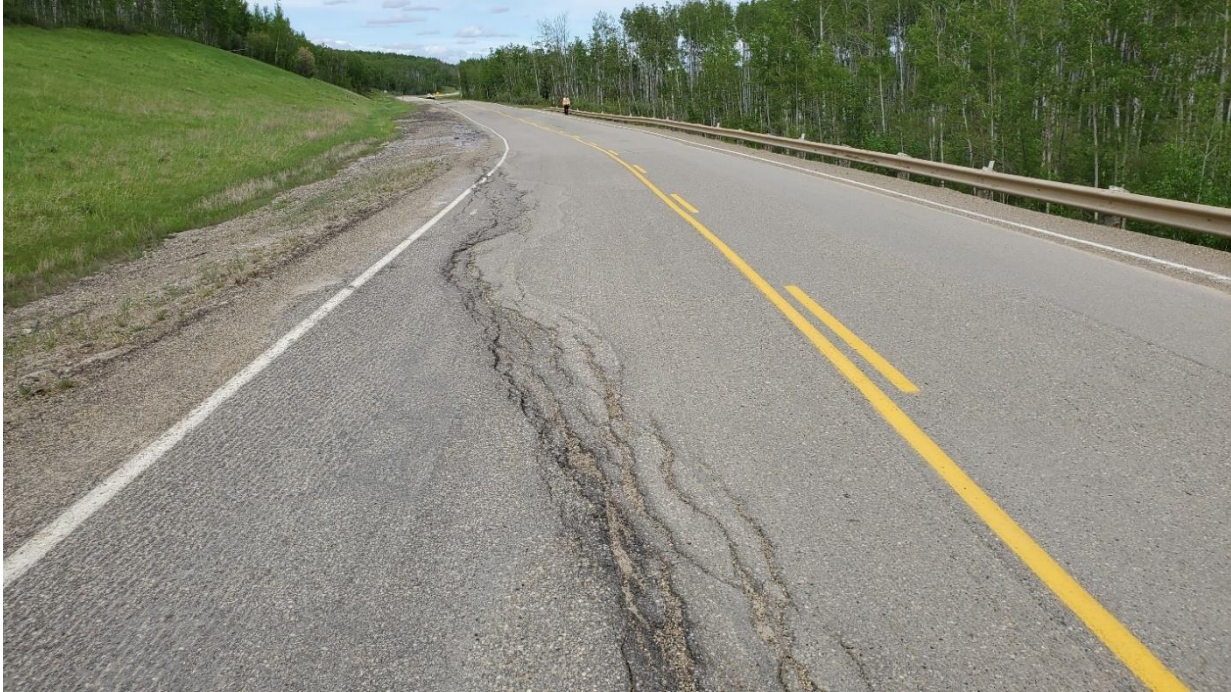
Photo 1, Site 8 – Looking northeast from the southwest end of the Site along a major scarp crack.

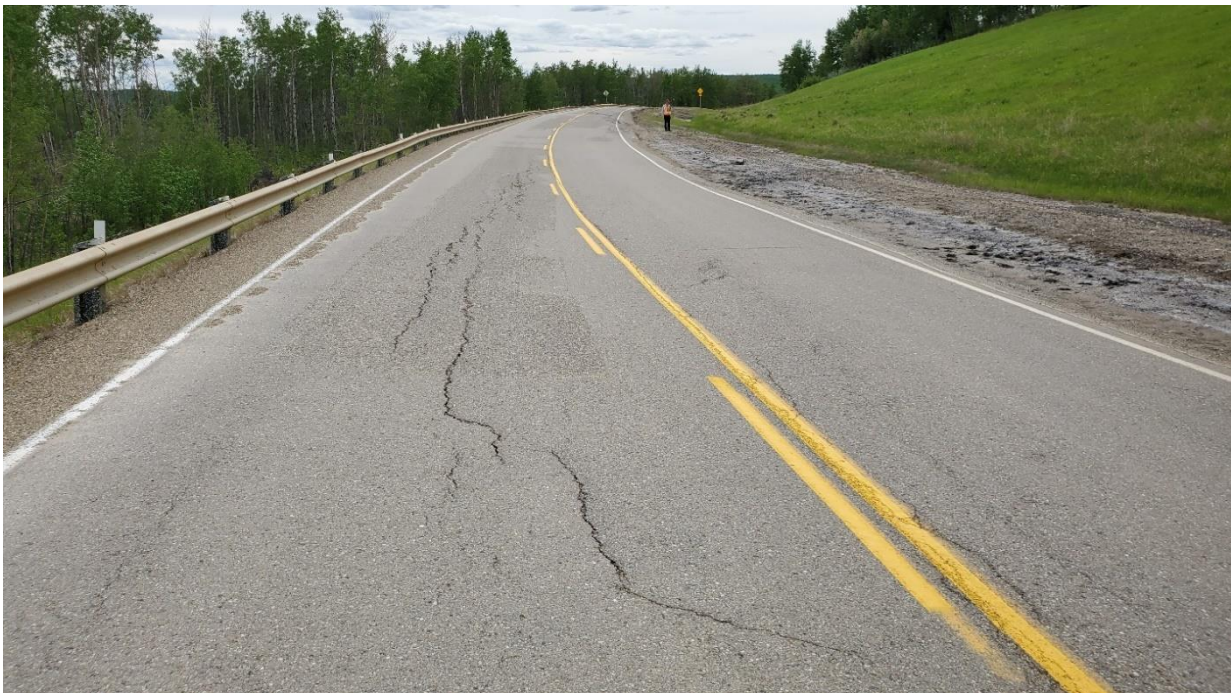
Photo 2, Site 8 – Looking southwest from the northeast end of Site SH012-8. Note main scarp crack has reflected through the new patch.

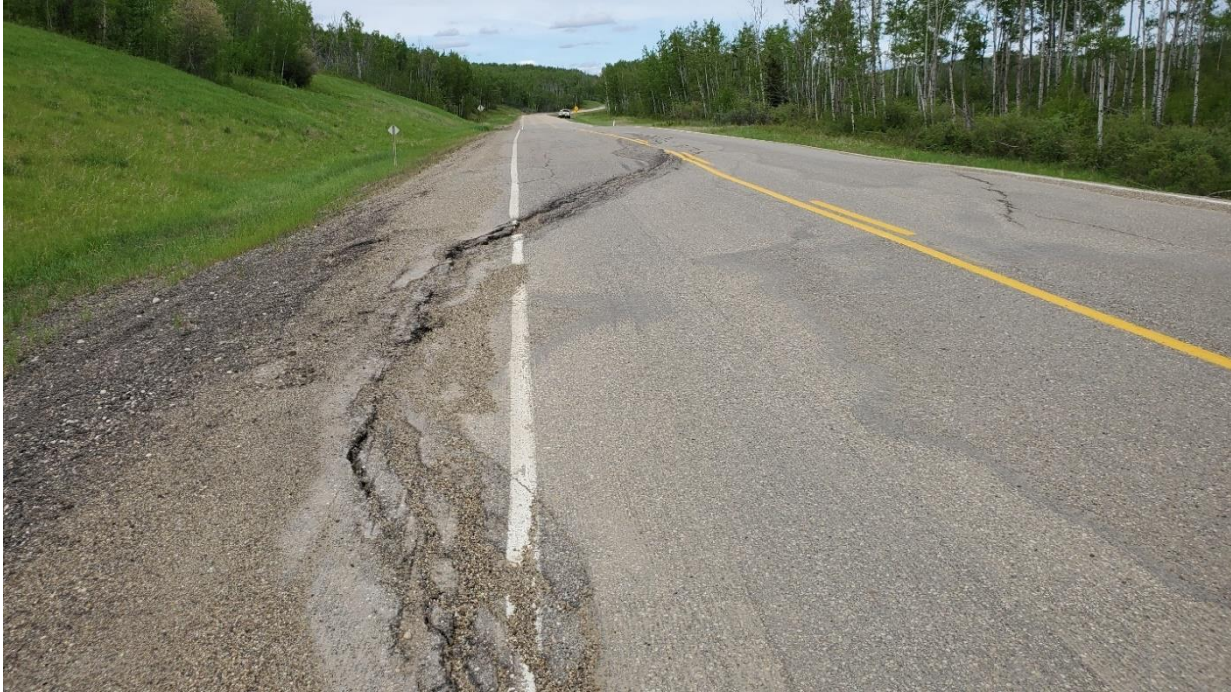
Photo 3, Site 9: Looking northeast at braided crack in highway surface over main slide scarp.

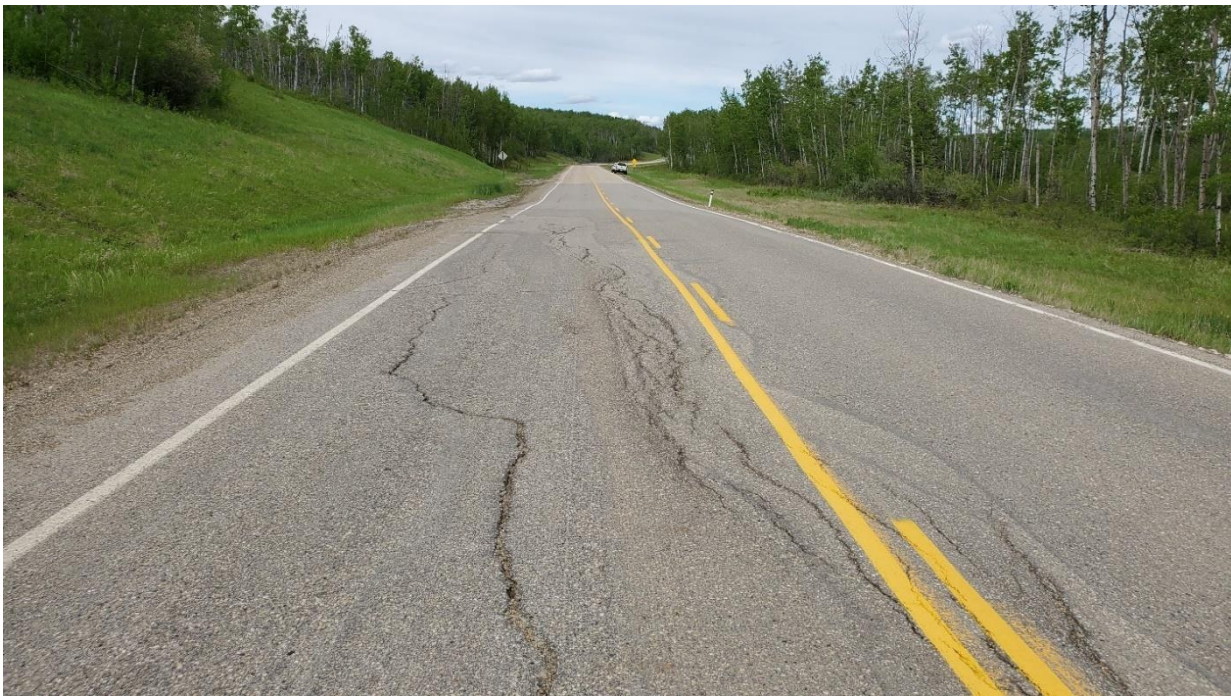
Photo 4, Site 9: Looking northeast at cracking and milling near northeast end of site.

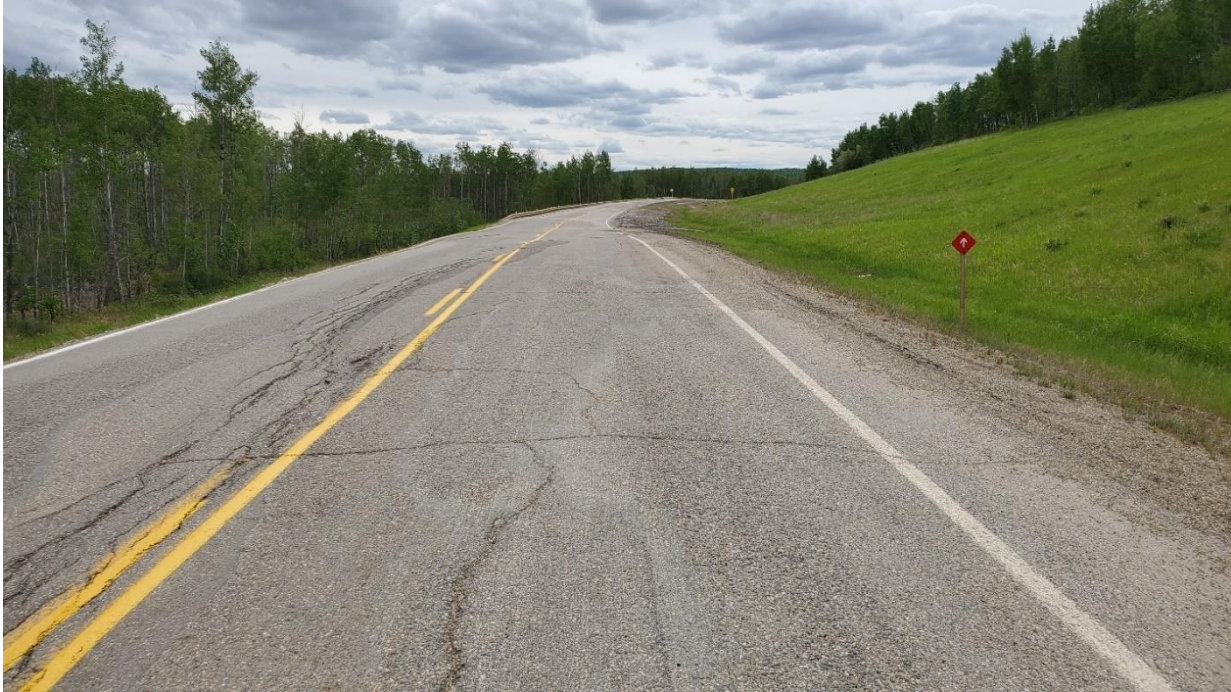
Photo 5, Site 9: Looking southwest at braided crack along main slide scarp. Note milling material used to regrade sideslope and ditch.

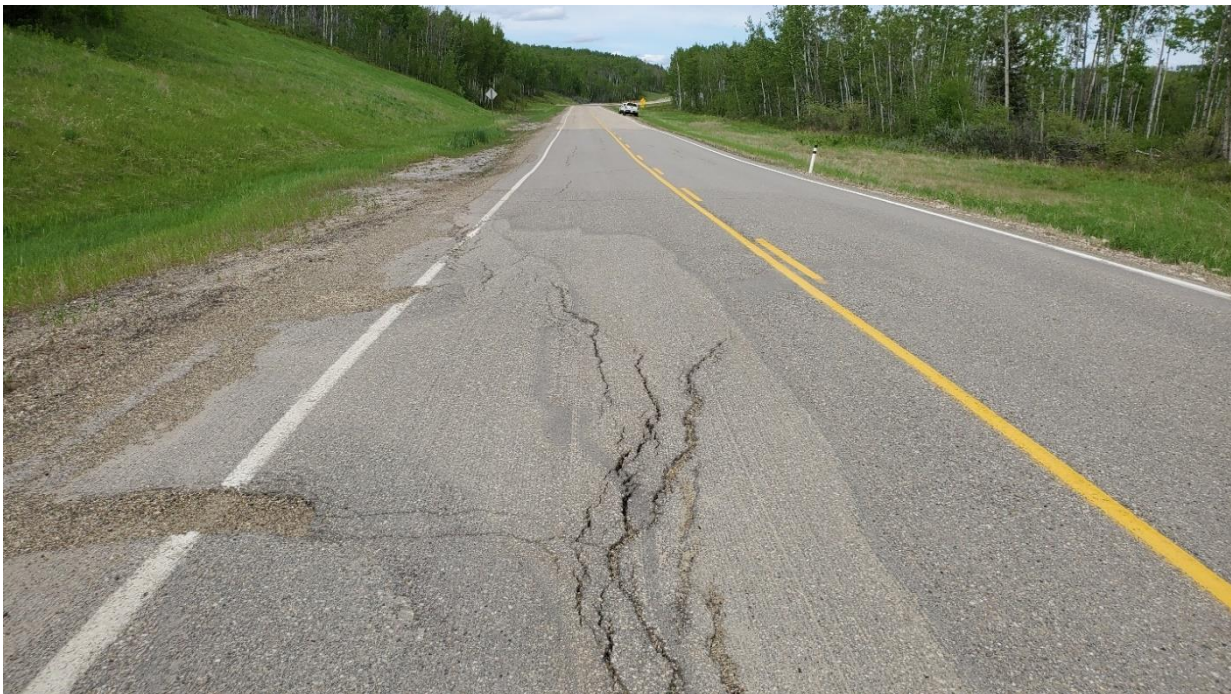
Photo 6, Site 9: Looking northeast near northeast end of site where main slide scarp moves north of highway.
