**ALBERTA TRANSPORTATION  
GEOHAZARD ASSESSMENT PROGRAM  
PEACE REGION – SWAN HILLS  
2022 INSPECTION**

Site Number	Location	Name	Hwy	km
SH012-8 SH012-9	Little Smoky River	Little Smoky River Valley, North Hill – Sites #8 and #9	744:02	19.70-19.83 19.83-20.0*
<b>Legal Description</b>		<b>UTM Co-ordinates</b>		
Site 8: SW21-76-22-W5M		11U E 477,815	N	6,161,486
Site 9: 21-76-22-W5		11U E 477,887	N	6,161,592

**SH012-8: HWY 744:02 LITTLE SMOKY RIVER VALLEY  
2022 SITE INSPECTION PLAN**

**SH012-9: HWY 744:02 LITTLE SMOKY RIVER VALLEY  
2022 SITE INSPECTION PLAN**

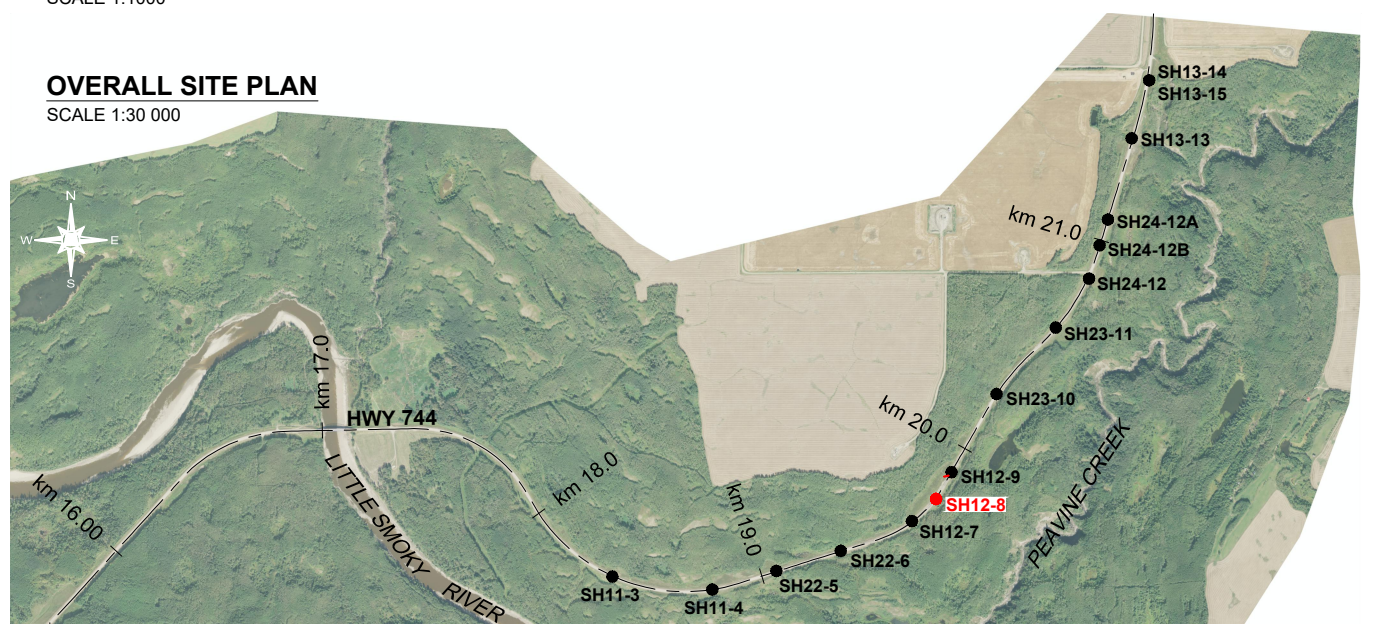
MAIN SLIDE SCARP NOT VISIBLE THROUGH RECENT GRADING

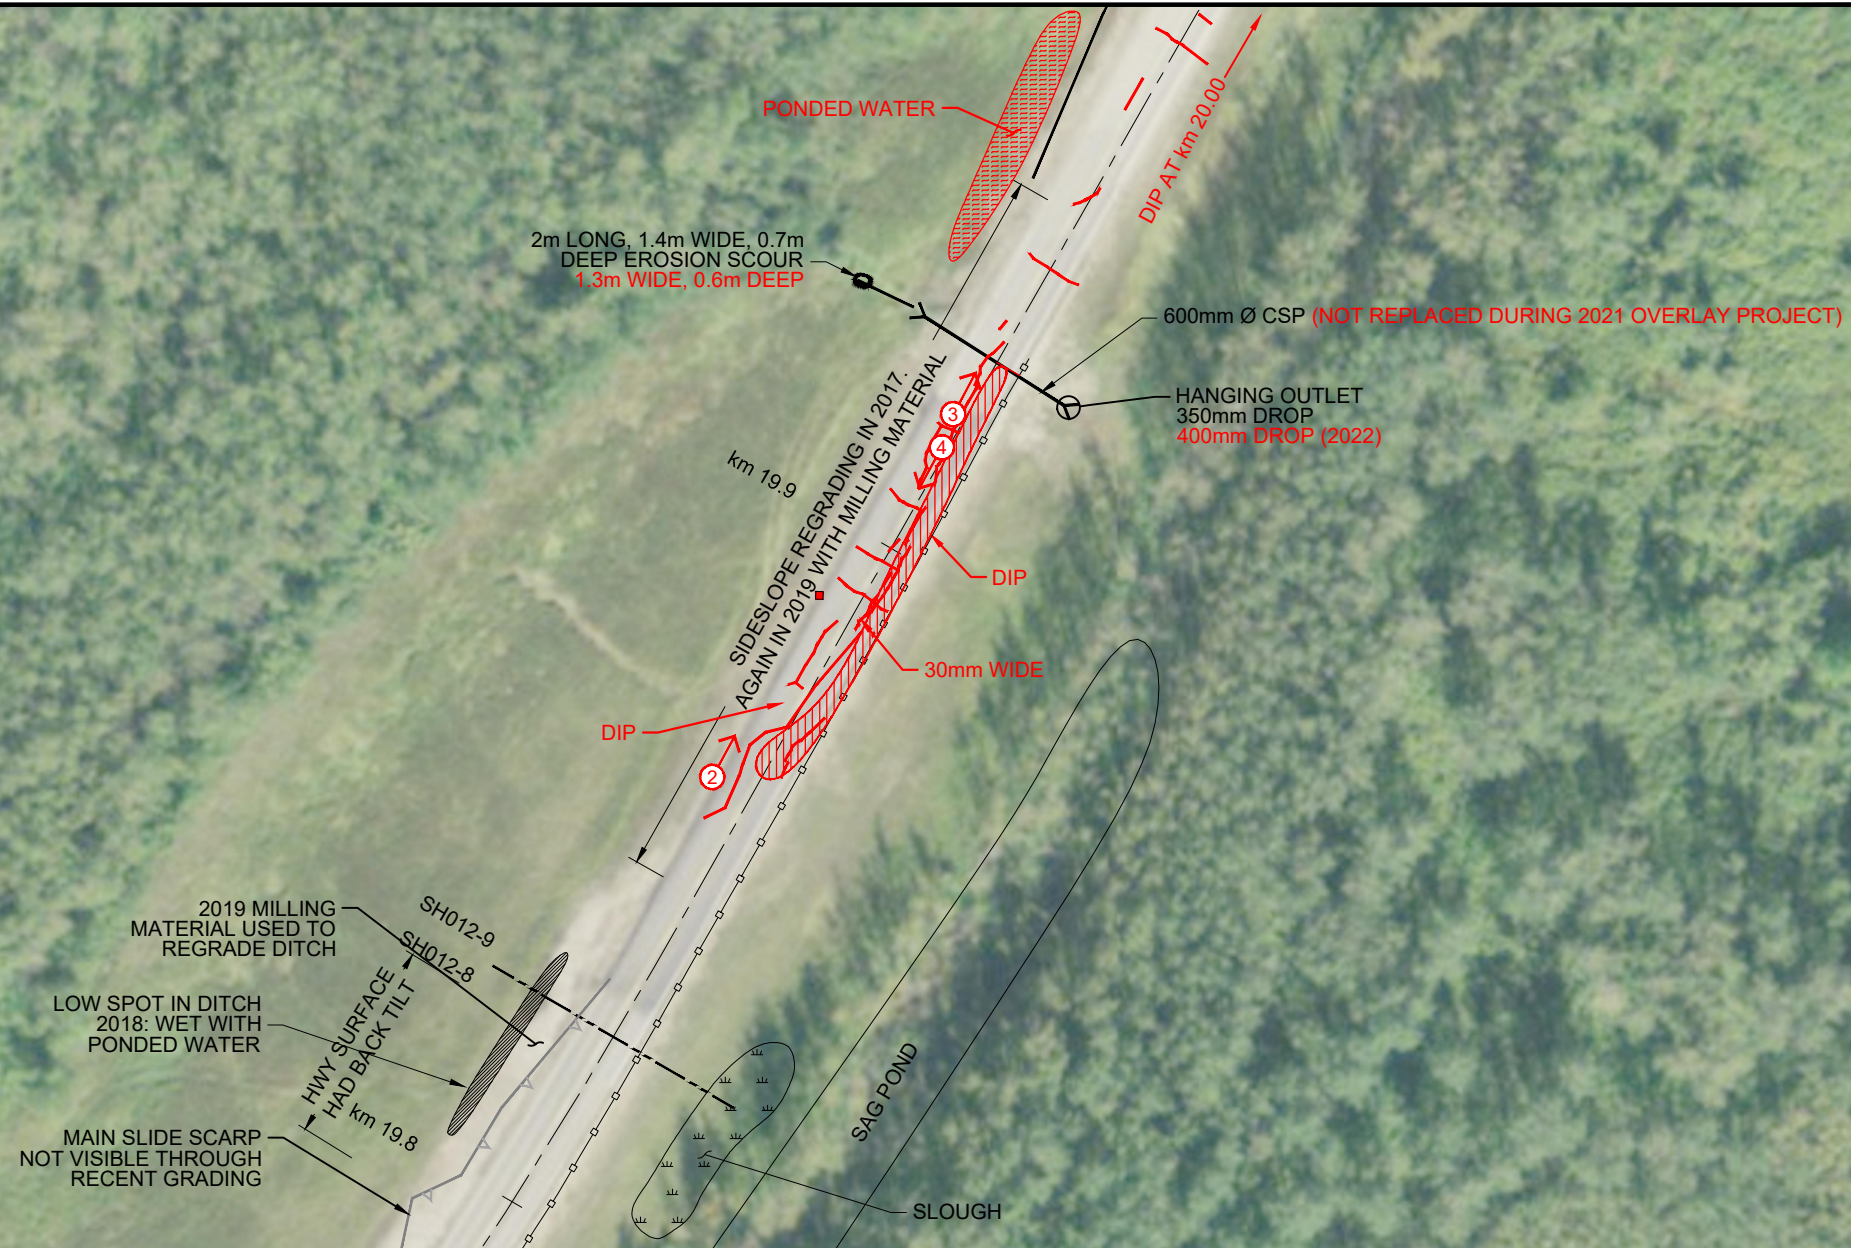
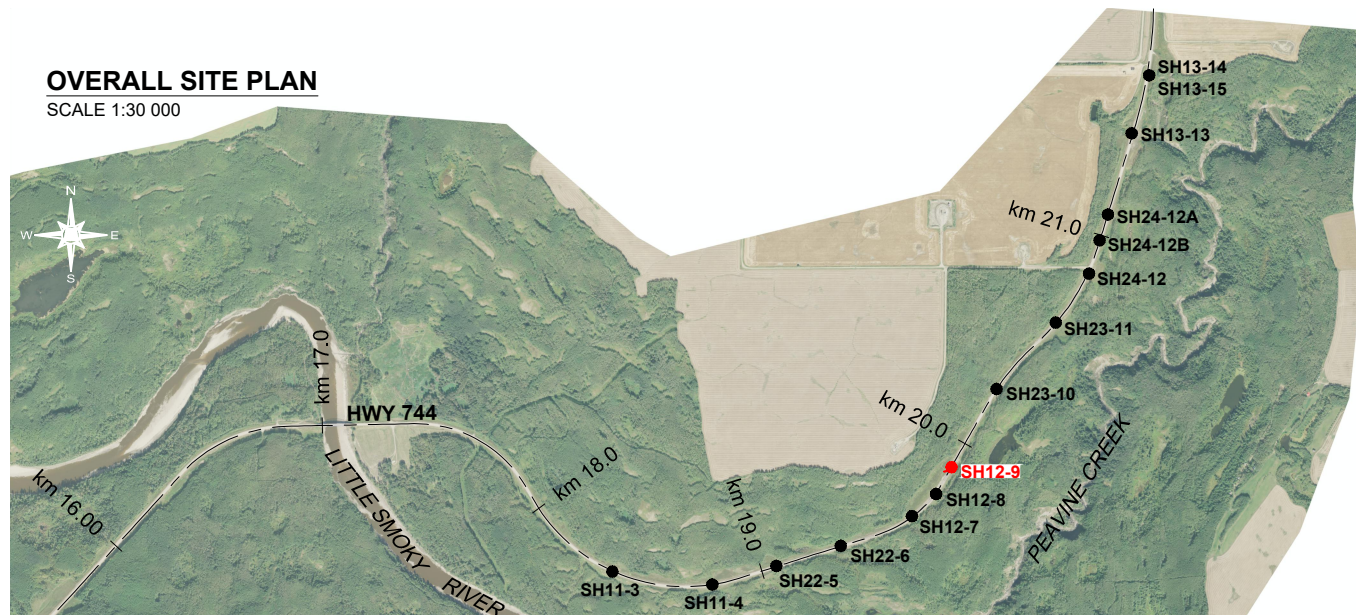
LOW SPOT IN DITCH 2018: WET WITH PONDED WATER

HWY SURFACE HAD BACK TILT

- Consideration should be given to regrading the ditches at the north end of Site 9 to allow the ponded water to drain.

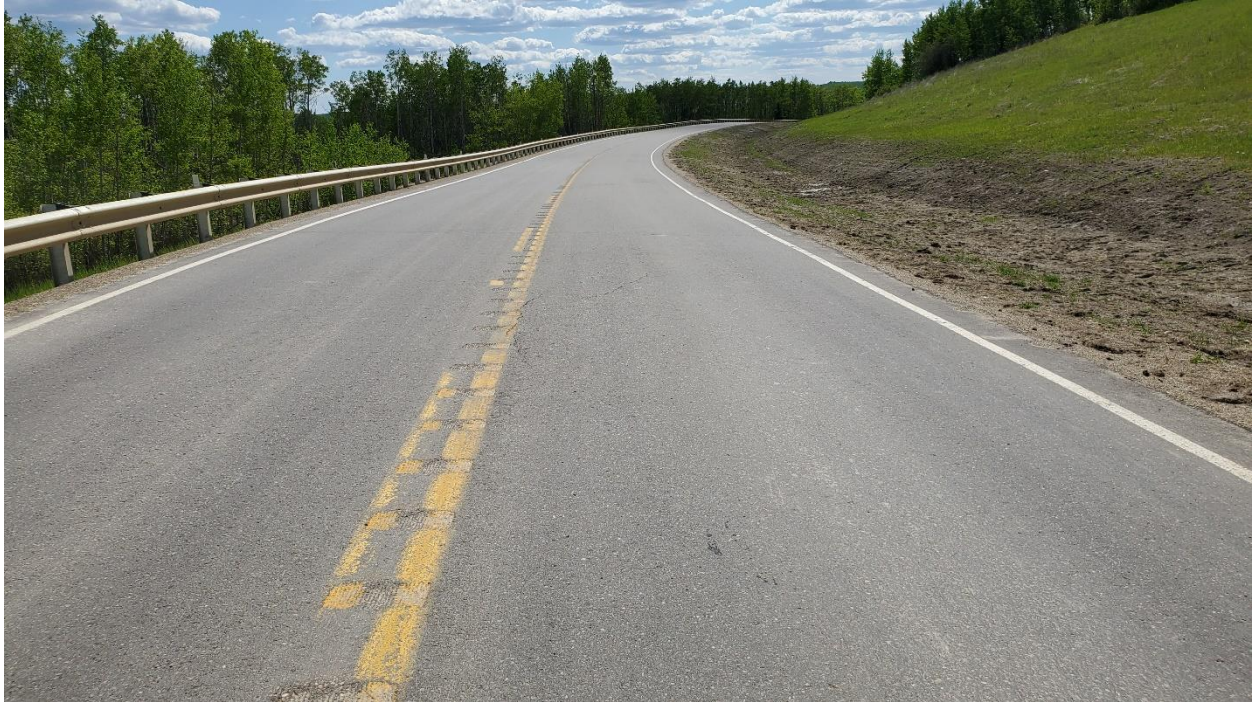
<b>Observations (Site 8):</b>	<b>Description</b>	<b>Worsened?</b>
<input checked="" type="checkbox"/> Pavement Distress	Site was recently overlaid. Some of the previous longitudinal and traverse cracks have reflected through.	<input type="checkbox"/>
<input checked="" type="checkbox"/> Slope Movement	Site is located on an active deep-seated landslide moving toward the Peavine Creek.	<input type="checkbox"/>

Photo 1, Site 8 – Looking southwest from the northeast end of Site SH012-8. Previous main scarp crack not clearly visible during inspection.

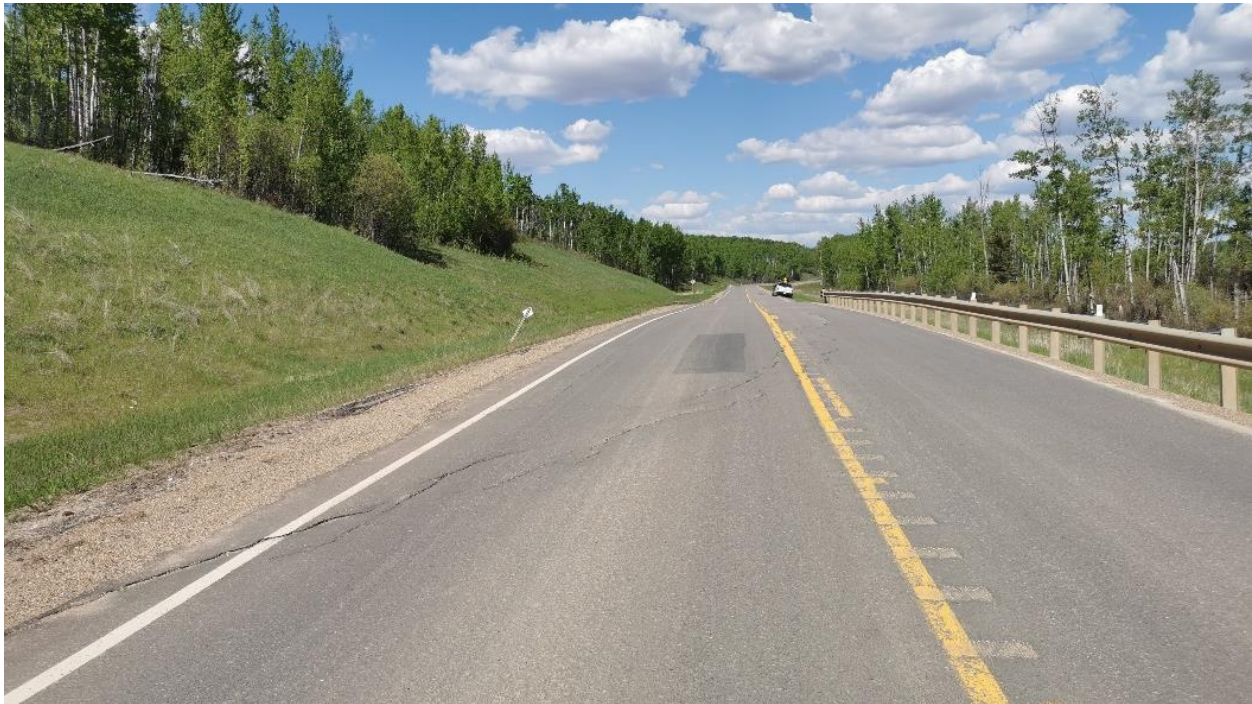
Photo 2, Site 9: Looking northeast at crack in highway surface over main slide scarp that is reflecting through the recent highway overlay.

<b>Recommendations:</b>		
<p>Short-Term:</p> <ul style="list-style-type: none"> <li>▪ Road maintenance should continue as necessary to maintain a safe roadway surface and may consist of ACP milling, patching, and crack sealing.</li> </ul> <p>Medium-Term:</p> <ul style="list-style-type: none"> <li>▪ Culvert outlet at km 19.93 (Site 9): consideration should be given to placing some riprap at the outlet (there is none currently) to minimize downcutting through recently regraded slope.</li> </ul>

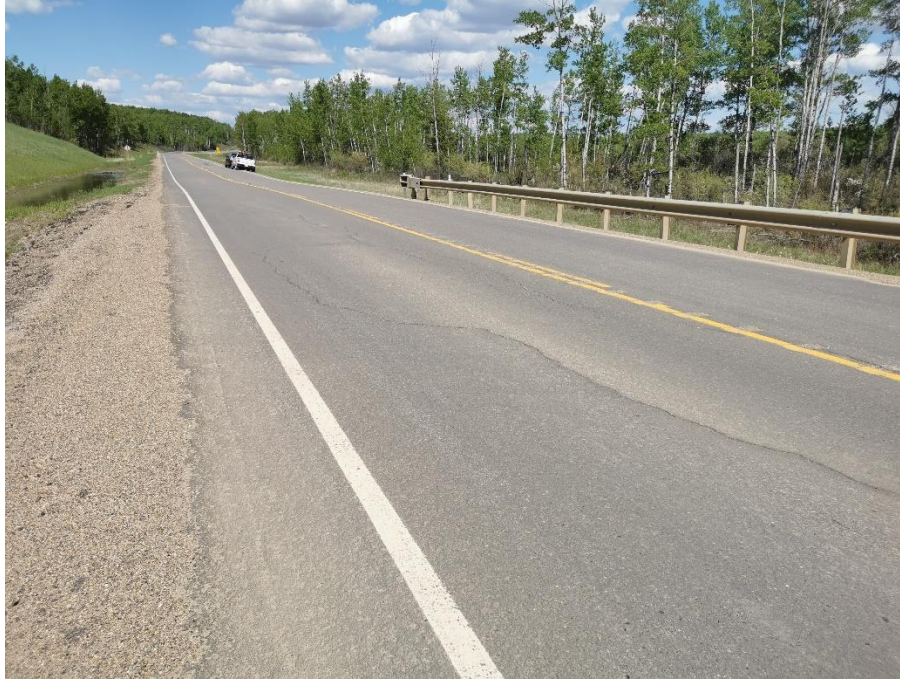
Photo 3, Site 9: Looking northeast at cracking near northeast end of site.

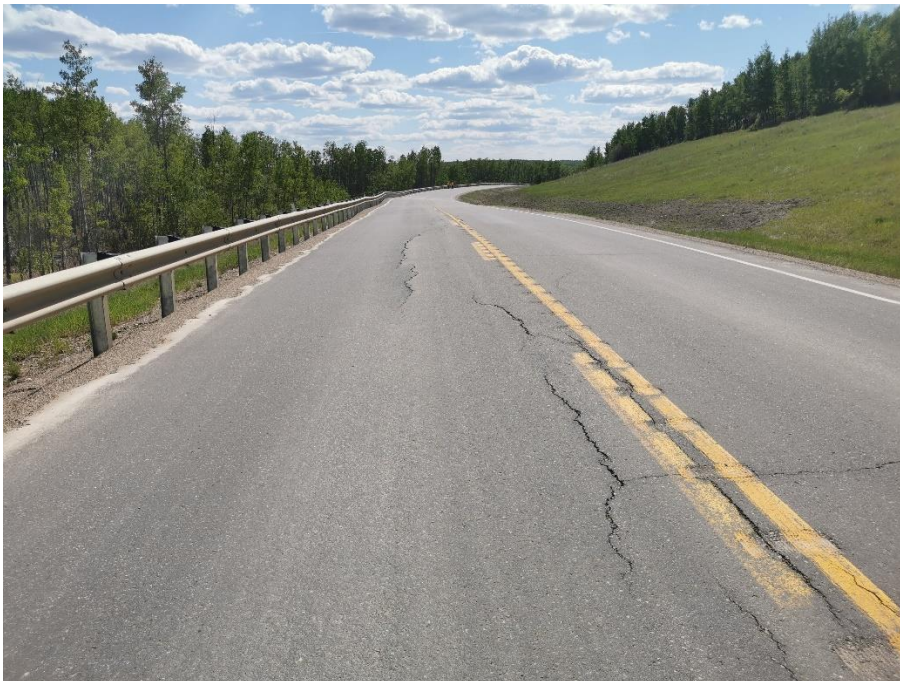
Photo 4, Site 9: Looking southwest at crack along main slide scarp.
