THURBER ENGINEERING LTD.

December 19, 2019

File: 13355

**GEOHAZARD ASSESSMENT PROGRAM
CALL-OUT INSPECTION
SH013-13 HWY 744:02 LITTLE SMOKY RIVER VALLEY**

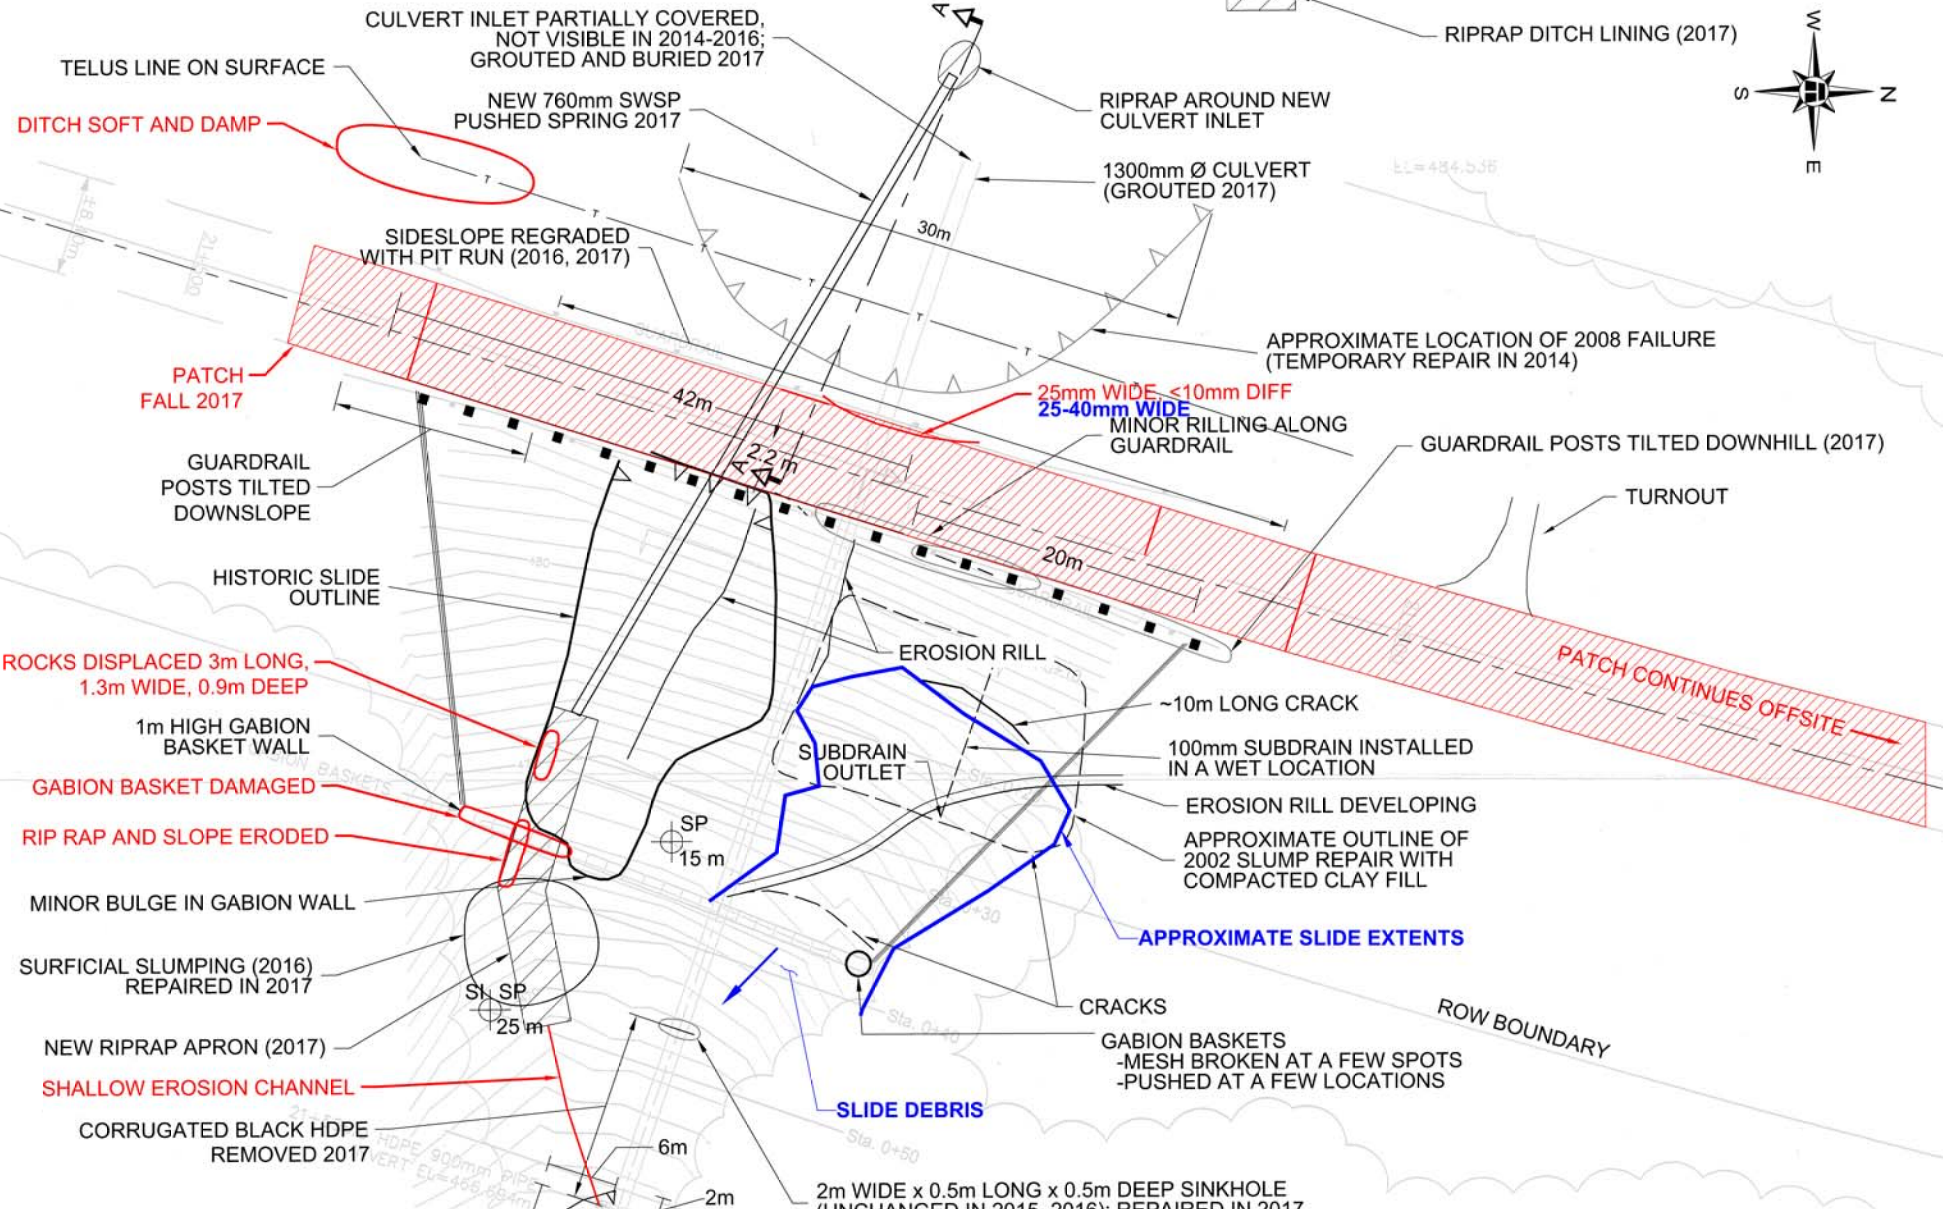
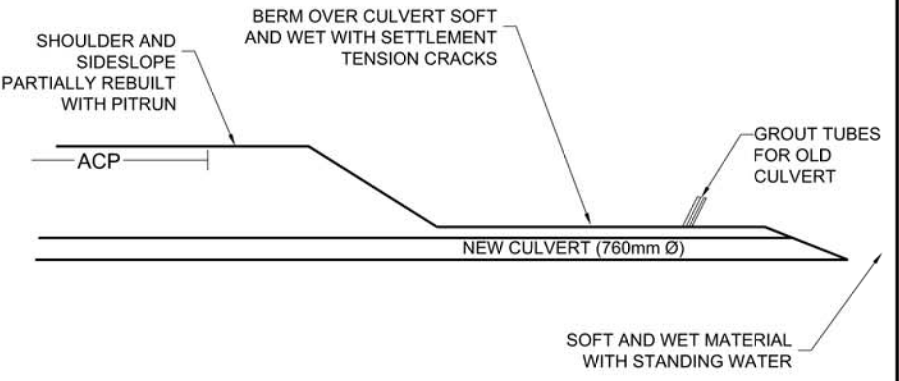
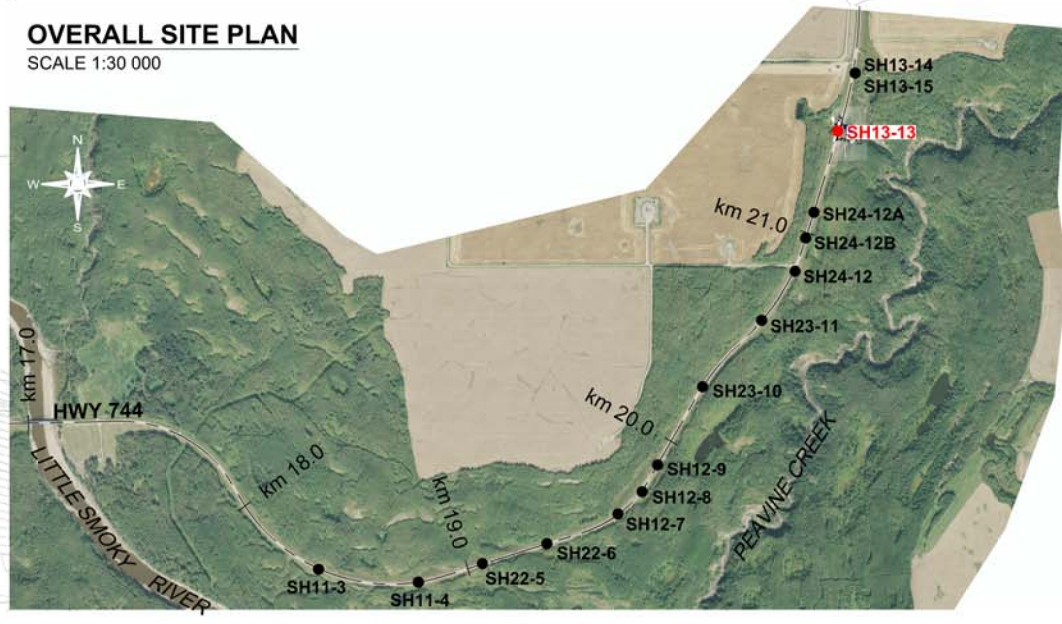
DWG No. 13355-SH013-13

The site (SH013-13) is located on the east side of Hwy 744:02 (the highway is oriented approximately north-south) at about km 21.5 within the Little Smoky River valley approximately 12 km south of the junction with Highway 2. Site features and observations are shown on the attached Drawing 13355-1. At this location, the highway is constructed in fill over a drainage course approximately 8 m deep (as measured along the upslope ditch). There is a dugout in the upland field above that drains into this course. Below the site, erosion is creating a significant oversteepened gully that leads down to a drainage channel that is a tributary to the Peavine Creek. This site has been repaired on at least three separate occasions: the repair associated with the gabion basket wall (east sideslope), and the 2002 (east sideslope) and 2017 (west sideslope) repairs discussed further below.

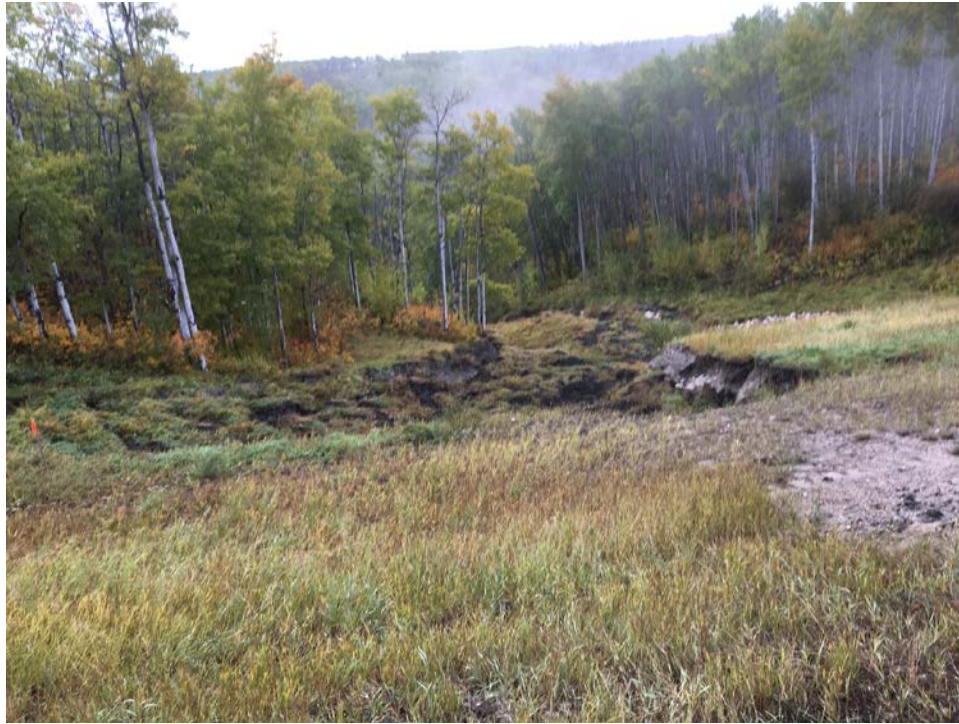
Photo 1: Looking east from the edge of the highway.

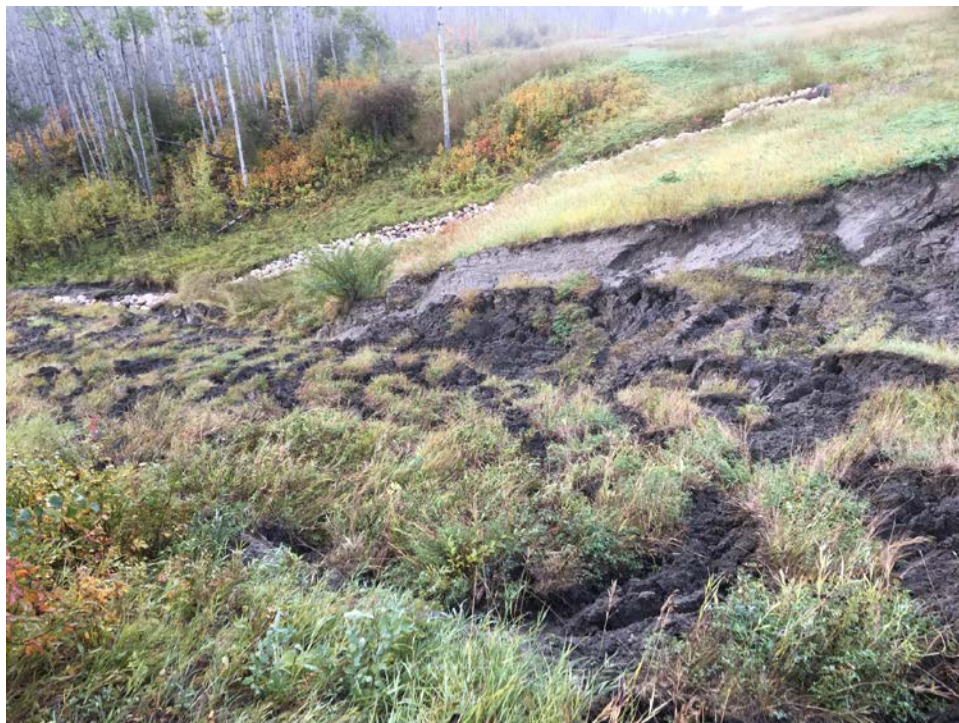
Photo 2: Looking south at upper portion of the slide.

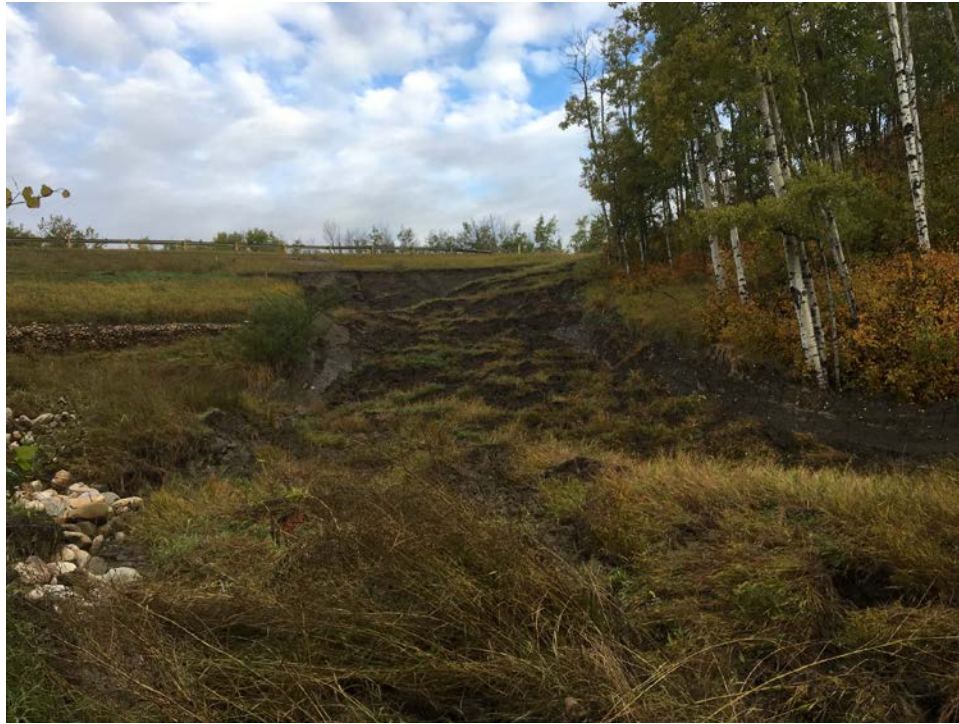
Photo 3: Looking northwest up at slide mass.

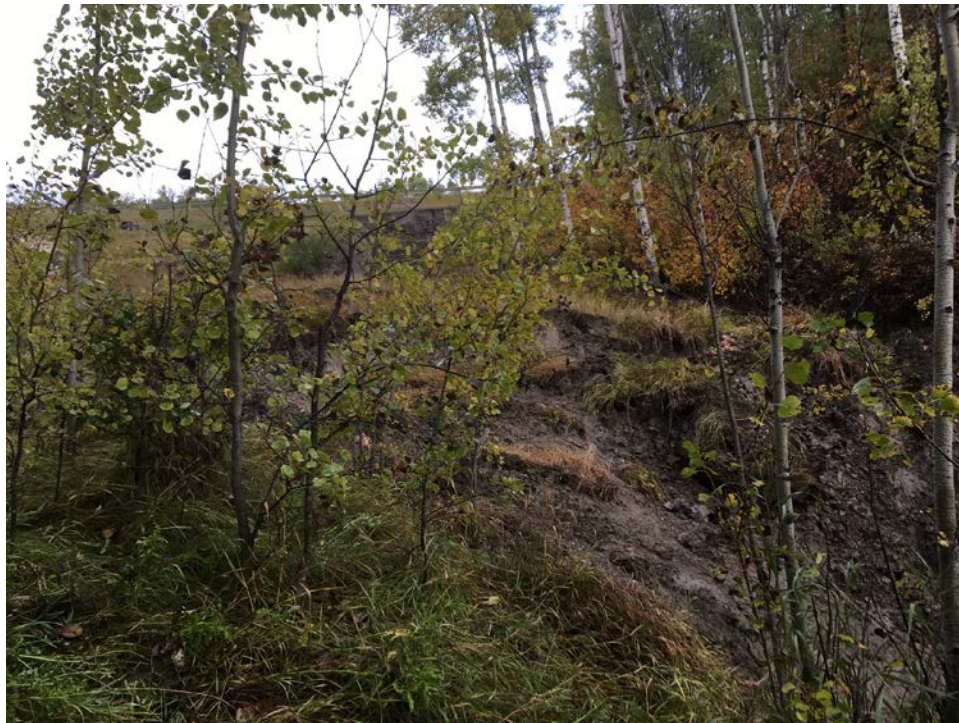
Photo 4: Looking north where slide mass went over the gully crest.

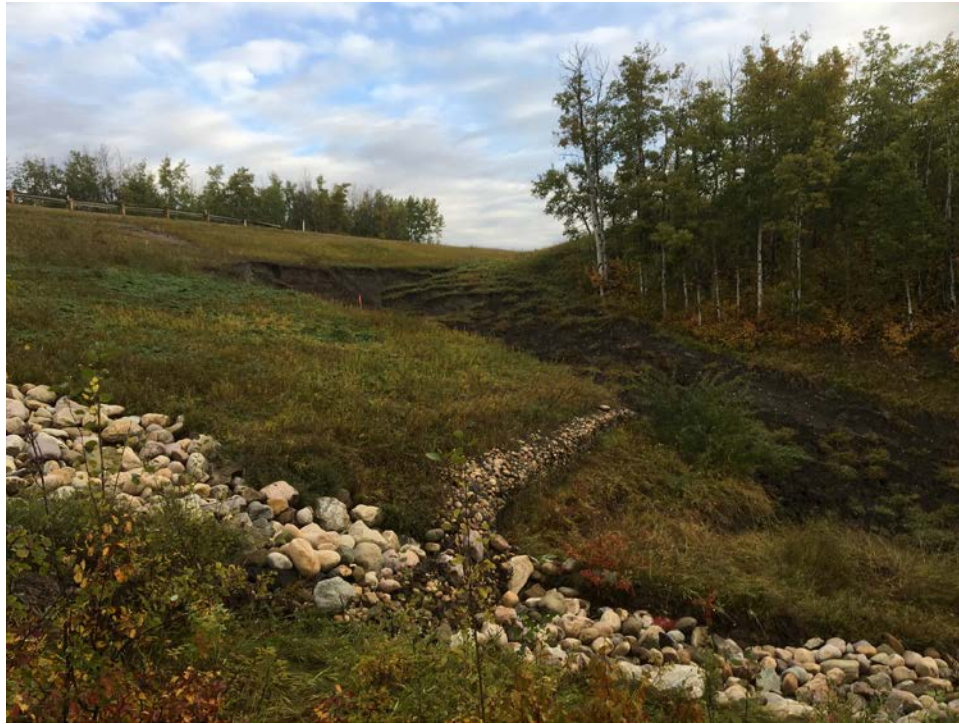
Photo 5: Looking north along existing gabion basket wall.

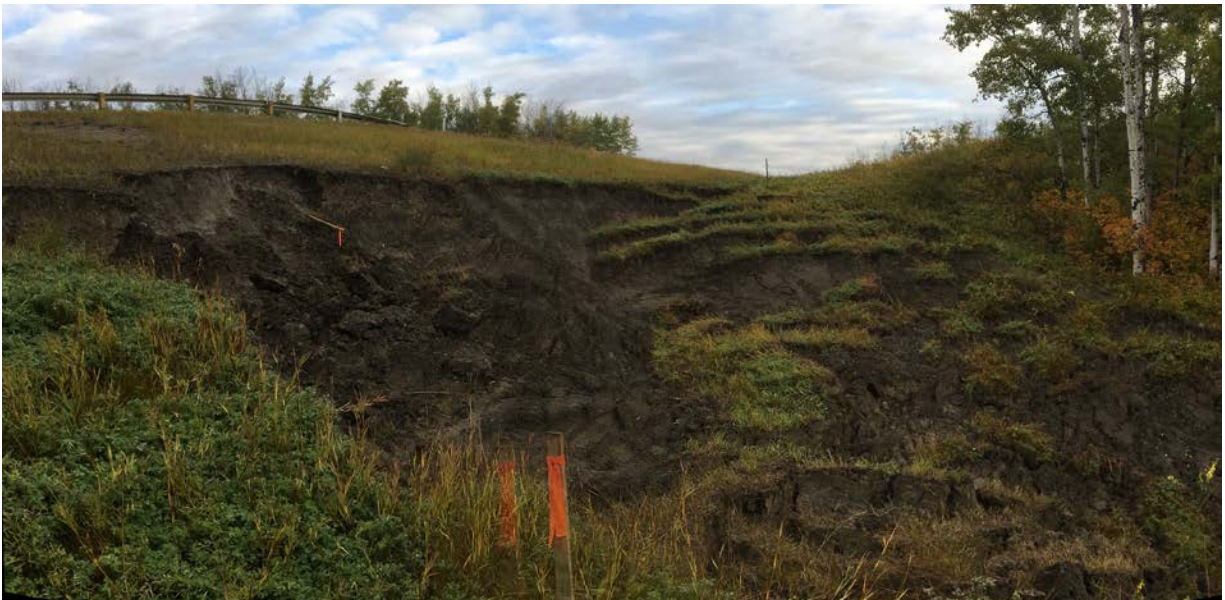
Photo 6: Looking northwest at top scarp of slide.
