**ALBERTA TRANSPORTATION
GEOHAZARD ASSESSMENT PROGRAM
PEACE REGION – SWAN HILLS
2020 INSPECTION**

Site Number	Location	Name	Hwy	km
SH013-13	Little Smoky River	Little Smoky River Valley, North Hill – Site #13	744:02	21.36-21.49
Legal Description		UTM Co-ordinates		
SE28/SW27-76-22-W5M		11U E 478,608	N	6,162,922

**SH013-13: HWY 744:02 LITTLE SMOKY RIVER VALLEY
2020 SITE INSPECTION PLAN**

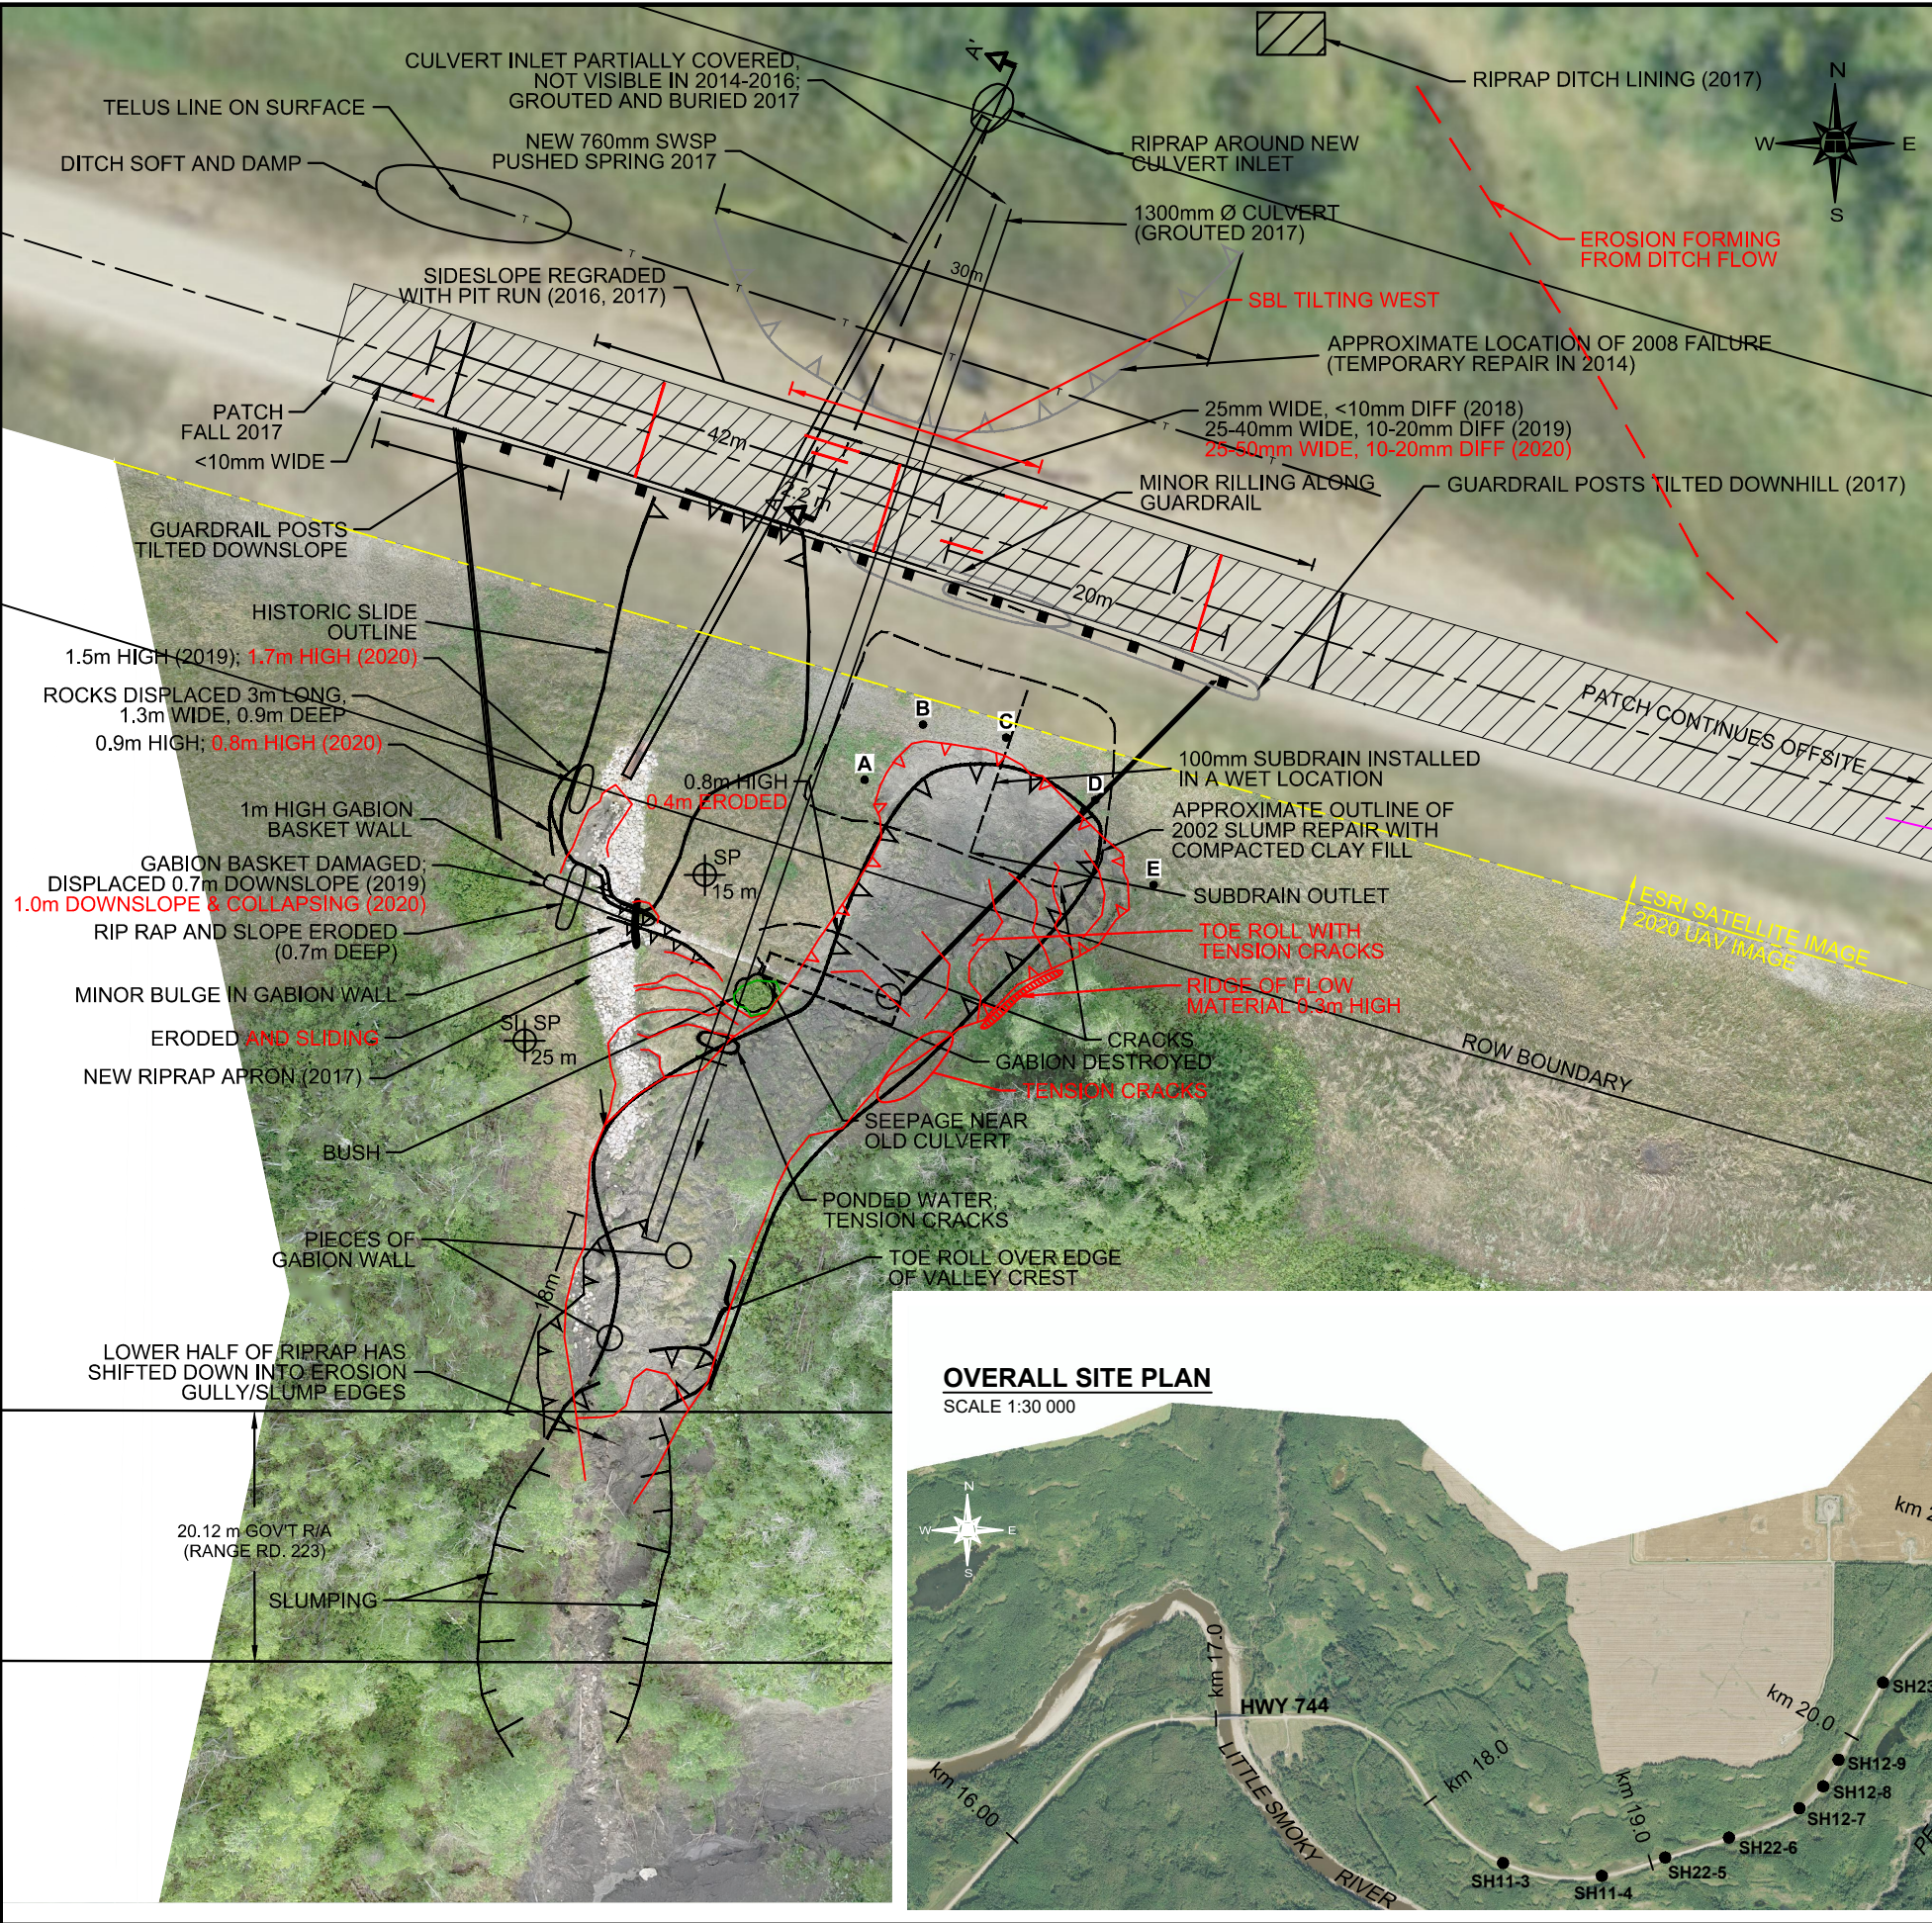
STAKE	SCARP (HEIGHT)	
	2019	2020
A	3.1m (1.5m HIGH)	? (1.8m HIGH)*
B	1.5m DOWNSLOPE 1.7m LATERAL	0.3m / 2.0m** (0.5m HIGH)
C	1.3m 11.6m TO GUARDRAIL	0m / 2.0m**
D	0.6m	FELL / 2.0m**
E	0.6m TO CRACK 1.9m TO SCARP (0.5m HIGH)	0.6m TO CRACK 1.9m TO SCARP (0.5m HIGH)

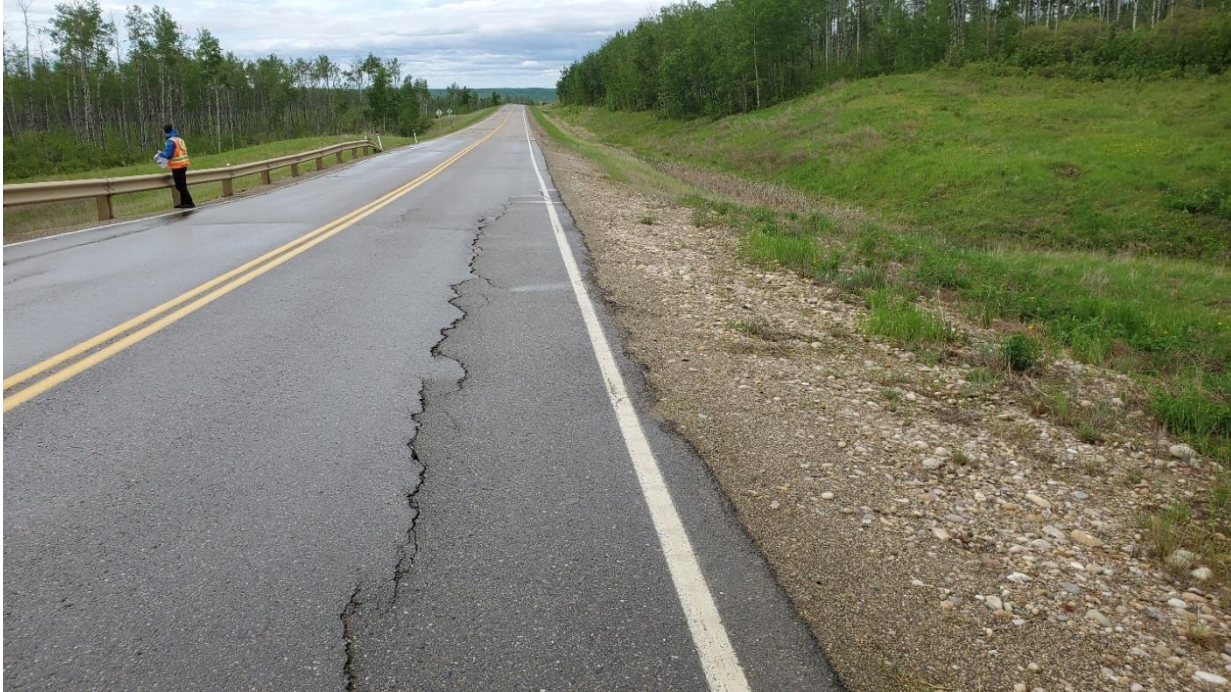
Photo 1 – Looking south at reconstructed upslope shoulder - note tension crack forming in roadway with differential settlement.

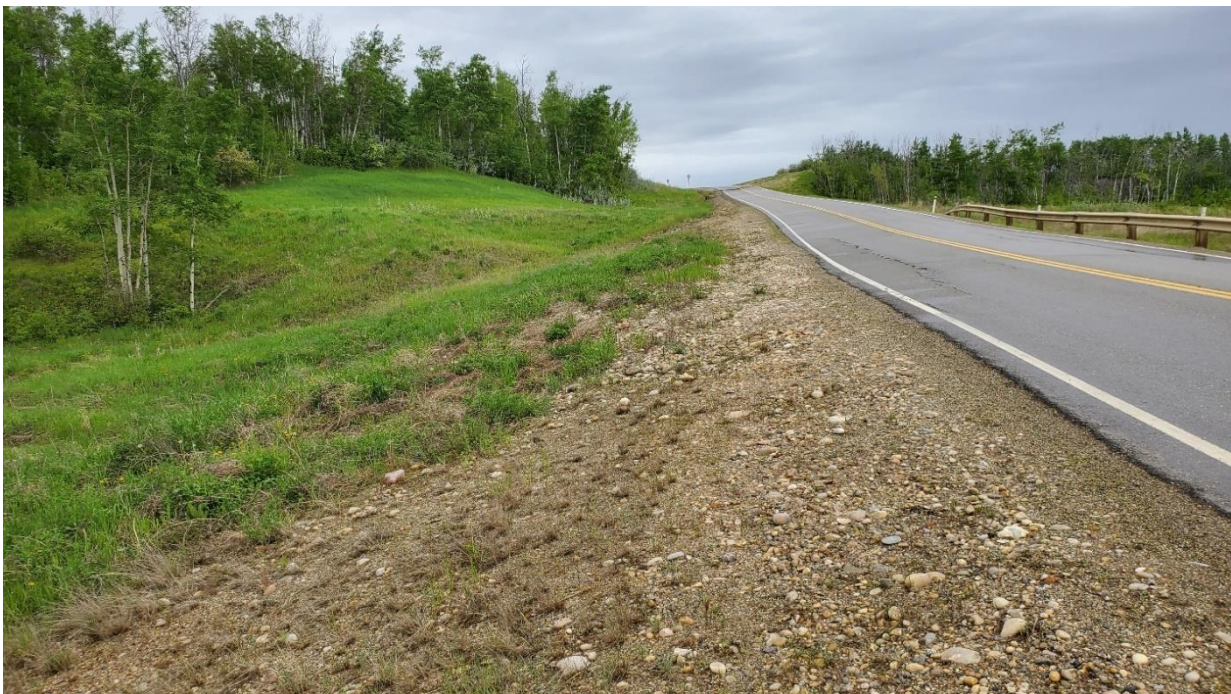
Photo 2 – Looking north at reconstructed sideslope above culvert inlet.

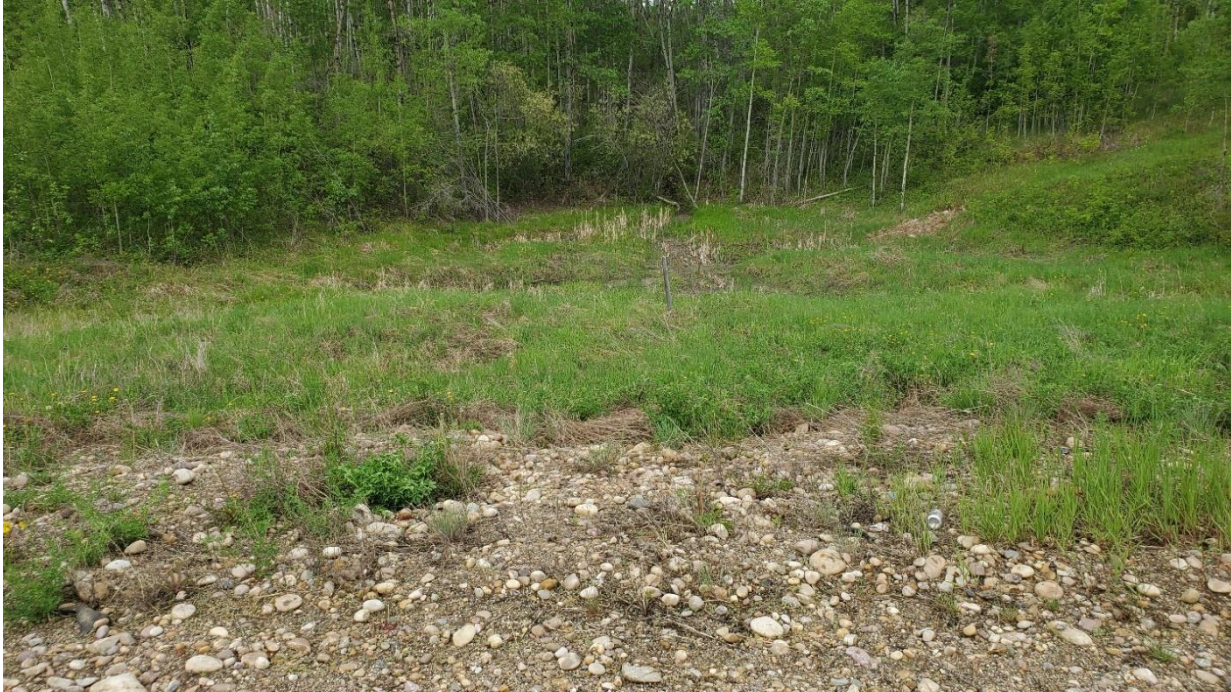
Photo 3: Looking northwest at new culvert inlet.

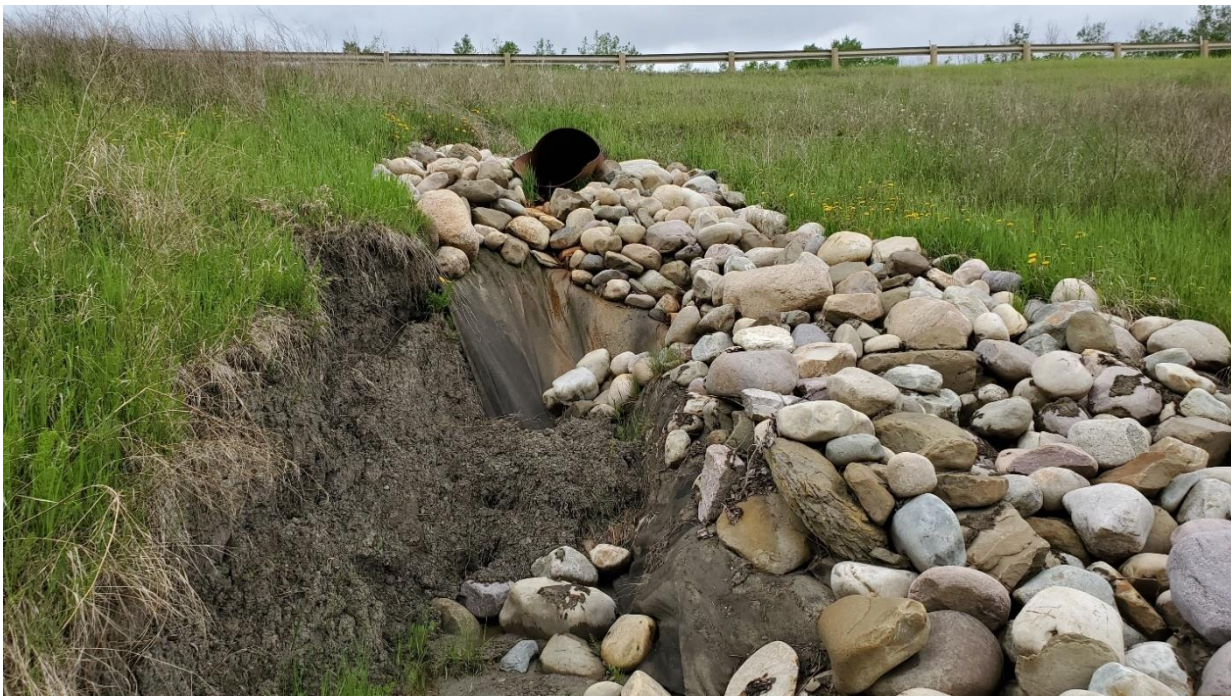
Photo 4: Looking northwest at new culvert outlet. Erosion on left-hand side (south) is significantly worse and may be part of a retrogressive tension crack from the slide further down the slope.

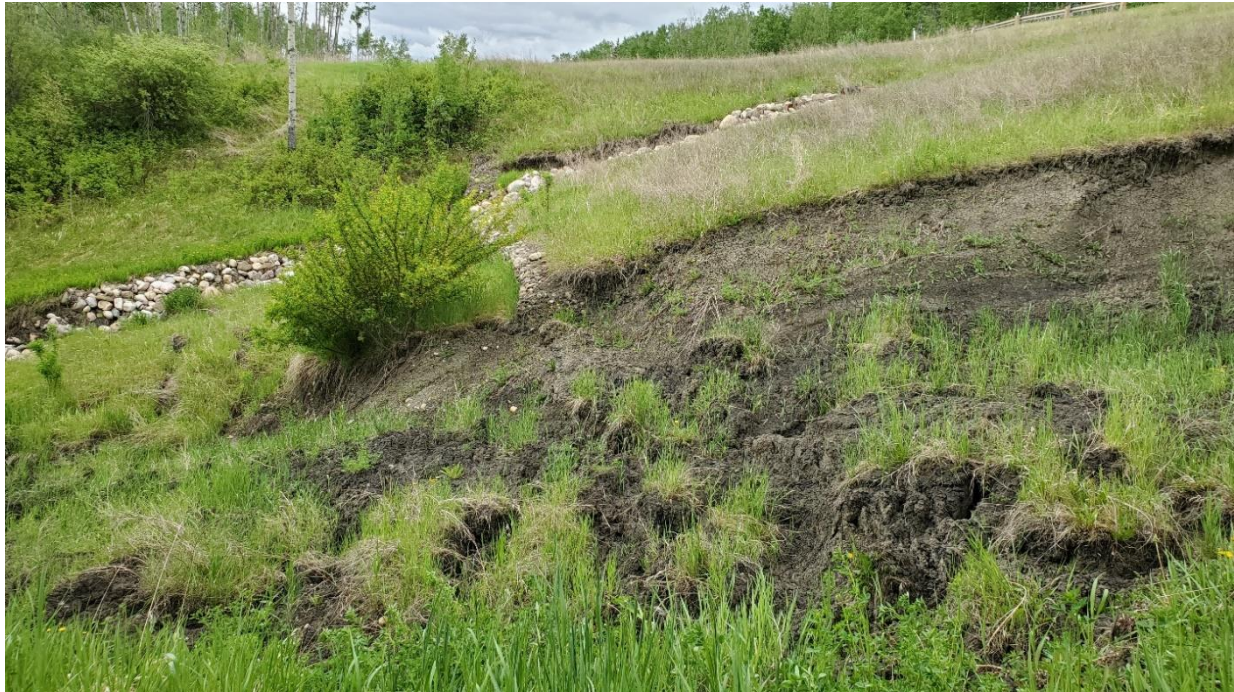
Photo 5 – Looking south at gabion wall on downslope side of embankment. Note eroded south face of new riprap apron from culvert outlet. September 2018 slide has removed about half of the gabion wall.

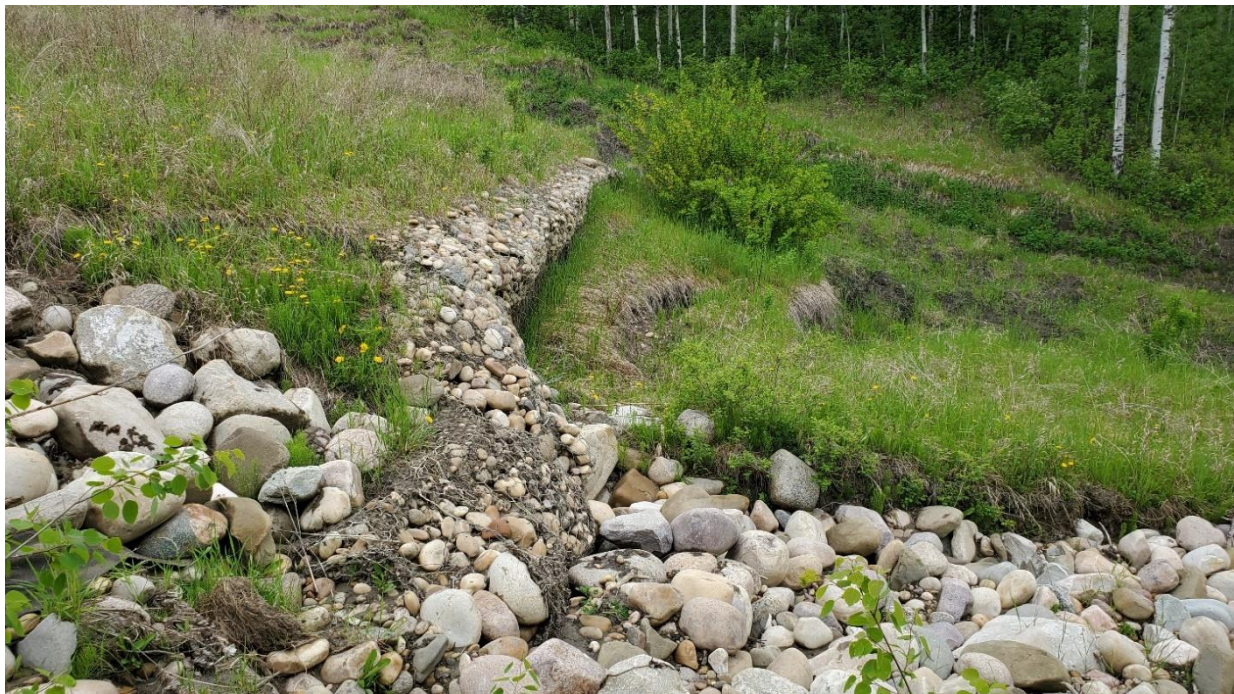
Photo 6 – Scarps above and below the gabion wall at the riprap apron.

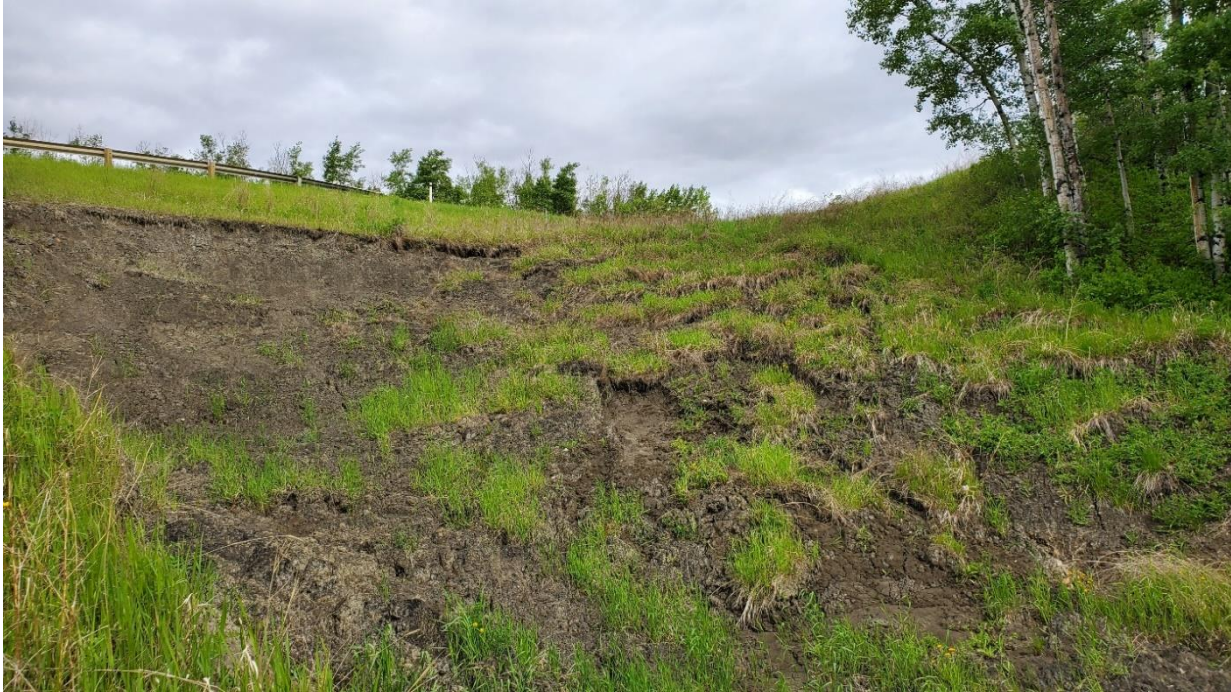
Photo 7 – Looking north at top of September 2019 slide block.

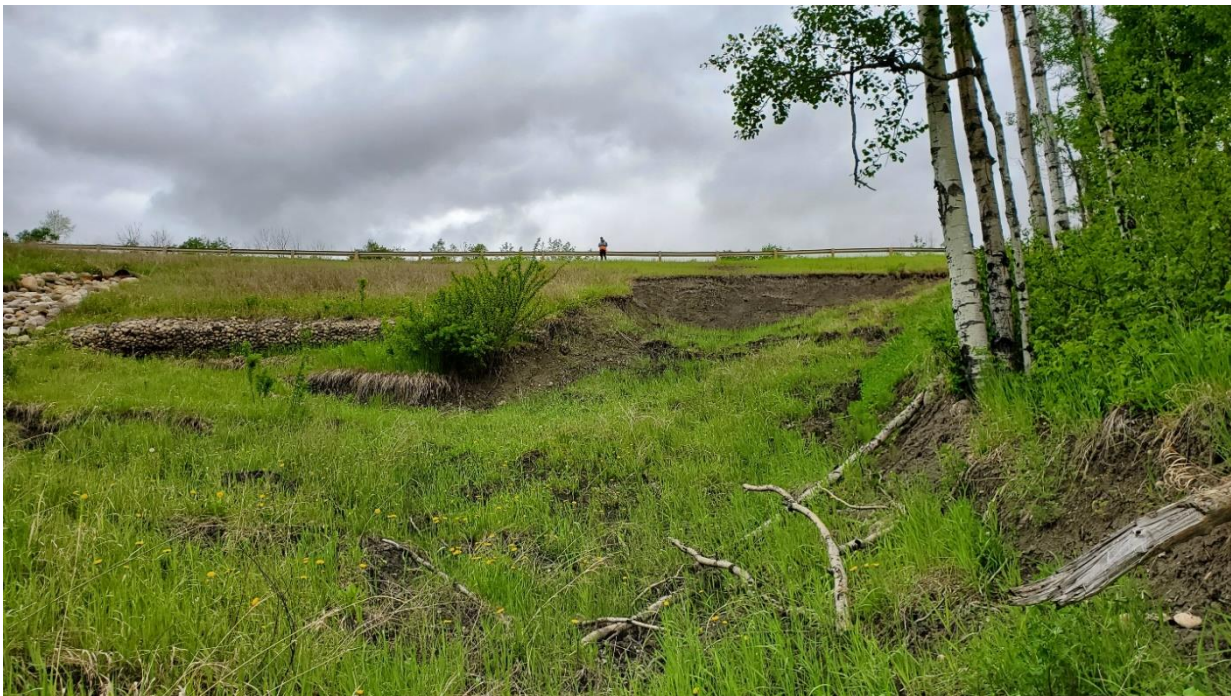
Photo 8 – Looking west at slide in the north half of the embankment with tension cracks extending into the south half at and below the gabion wall.

- A pile wall could be constructed across the narrower downslope end of the sideslope near the outlet of the old culvert to buttress the slope. The slump in the east embankment could then be reconstructed with geogrid-reinforced fill after over-excavating the slide material.
- A surface pipe should be installed from the new culvert extending further down the gully to where it meets the tributary coming down from Site #14.
- The ditches coming down the east embankment (once the north portion has been rebuilt) should be lined with riprap or other erosion protection and the flow directed to the gully where it should be discharged in a controlled manner.

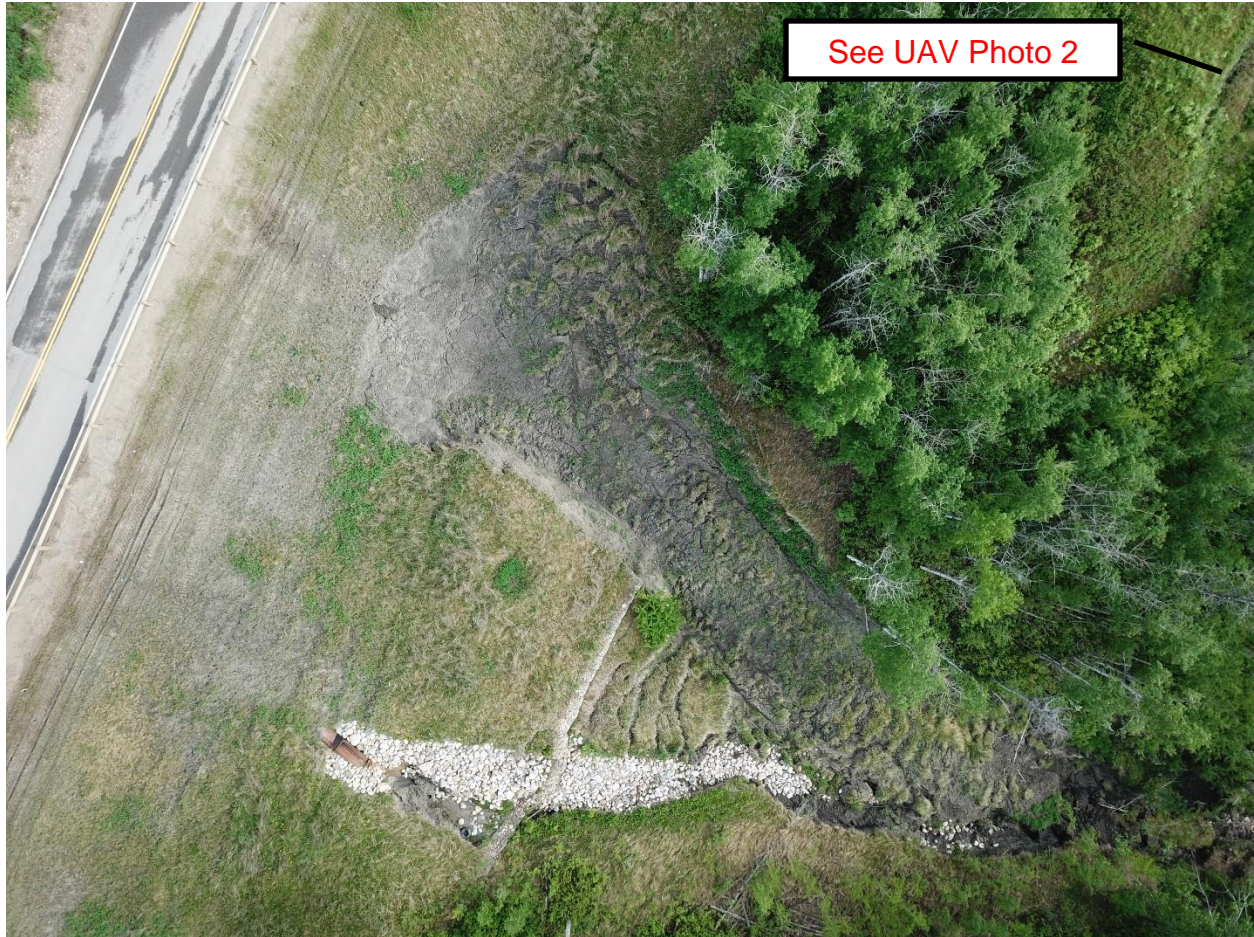
UAV Photo 1: Landslide on east side of highway embankment

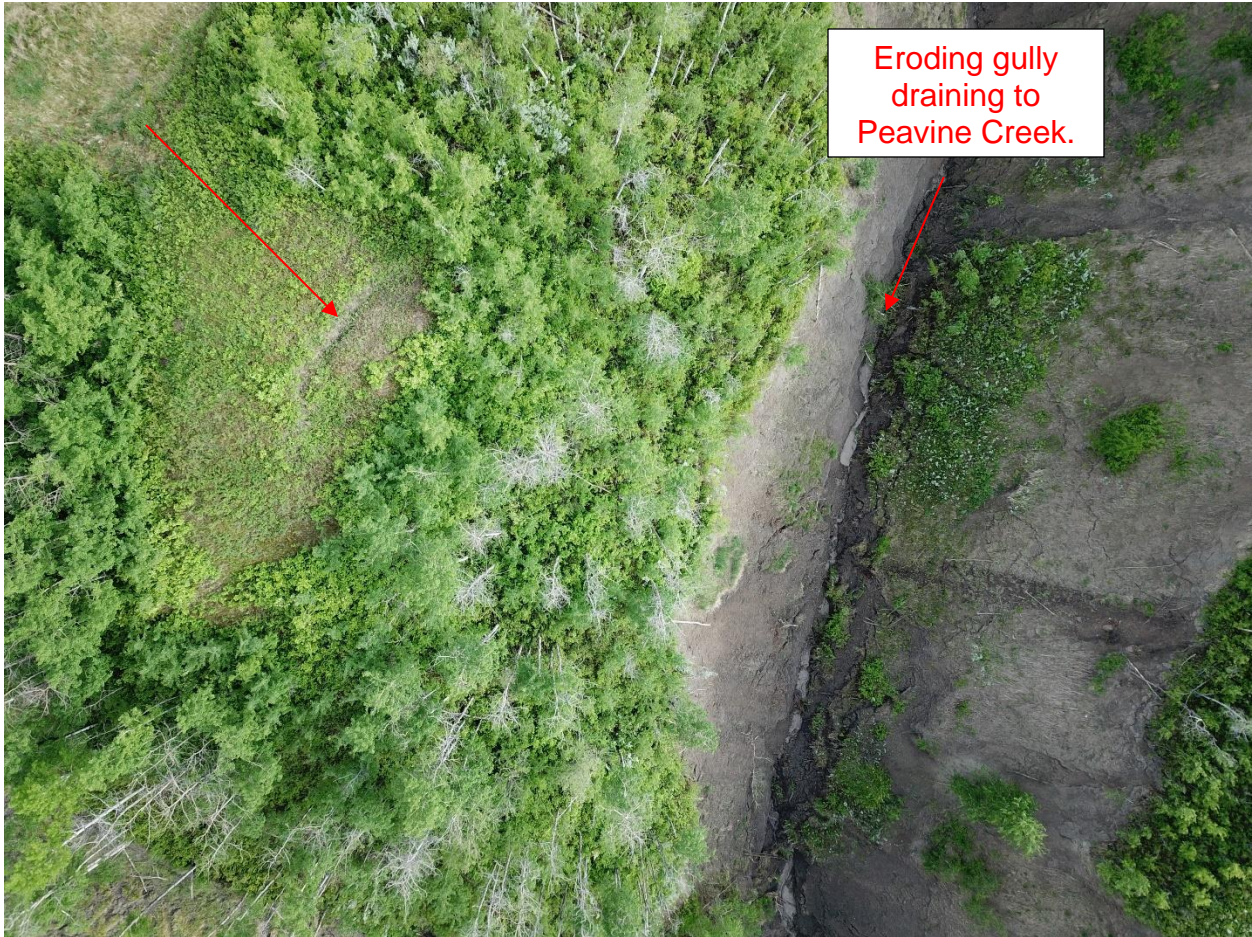
UAV Photo 2: Potential scarp forming north of the main slide
