**ALBERTA TRANSPORTATION
GEOHAZARD ASSESSMENT PROGRAM
PEACE REGION – SWAN HILLS
2020 INSPECTION**

Site Number	Location	Name	Hwy	km
SH013-14 SH013-15	Little Smoky River	Little Smoky River Valley, North Hill – Sites #14 & #15	744:02	21.55-21.61 21.61-21.80
Legal Description		UTM Co-ordinates		
Site 14: SE28/SW27-76-22-W5M		11U E 478,675	N	6,163,221
Site 15: SE28/SW27-76-22-W5M		11U E 478,647	N	6,163,070

**SH013-14 & -15: HWY 744:02
LITTLE SMOKY RIVER VALLEY
2020 SITE INSPECTION PLAN**

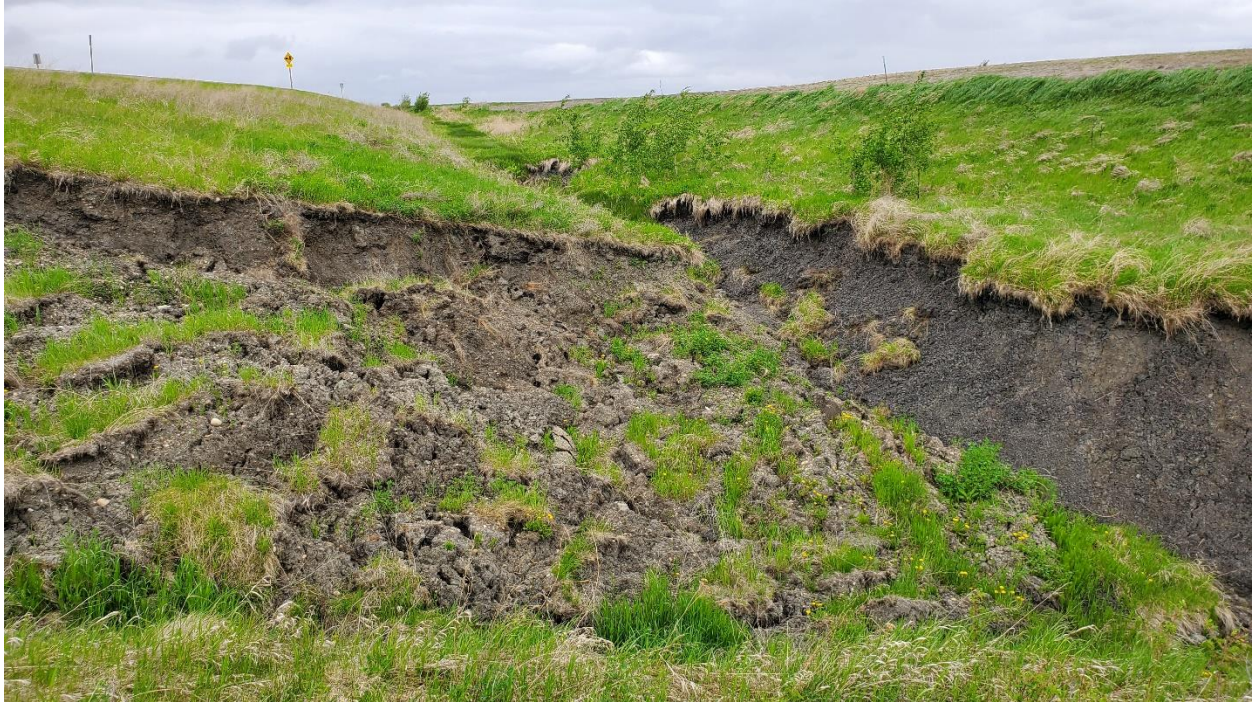
Observations (Site 14):	Description	Worsened?	
<input type="checkbox"/> Pavement Distress	Cracking with minor pavement surface distortion (dip)	<input type="checkbox"/>	
<input checked="" type="checkbox"/> Slope Movement	Slumps have developed along the creek valley and are retrogressing as creek continues to erode.	<input checked="" type="checkbox"/>	
<input checked="" type="checkbox"/> Erosion	Significant erosion along channel of tributary to Peavine Creek.	<input checked="" type="checkbox"/>	
<input type="checkbox"/> Seepage		<input type="checkbox"/>

Photo 1, Site 14 – Looking north through east at increasing depth of erosion along the tributary.

- If the highway is not re-aligned, consideration should be given to remediating the erosion in the tributary channel at Site 14 by installing a series of rock check dams or armouring most of the channel bottom.
- Consideration could also be given to the installation of steel sheet piles along the highway at Site 14 as an interim measure if the gully regresses close enough to the highway that there is concern for the safety of the traveling public. A guardrail would also be required in this scenario. Preliminary engineering should be undertaken so that this remediation can be implemented quickly when required.

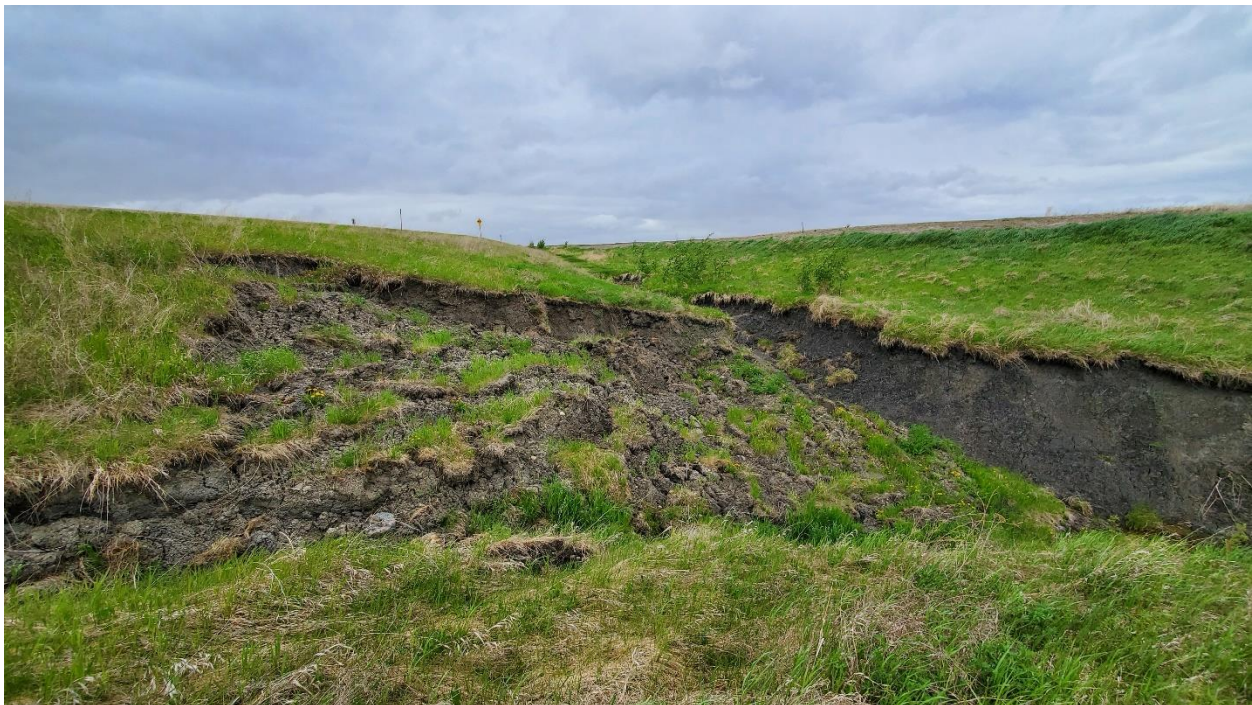
Photo 2, Site 14 – Looking north along the ditch where the erosion gully begins.

- Road maintenance should continue as necessary to maintain a safe roadway surface and may consist of milling, patching, and crack sealing of the ACP.
- Riprap could be placed at the headscarp of the erosion ravine to slow retrogression of the erosion up-gradient.

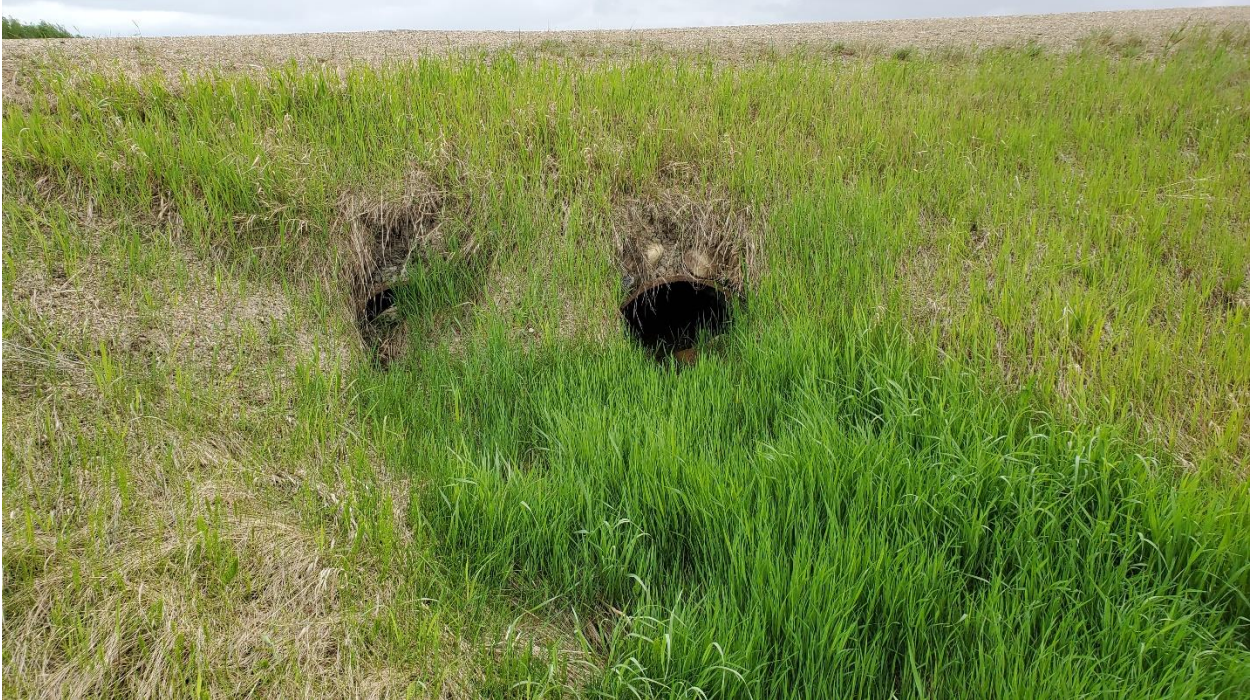
<input checked="" type="checkbox"/> Bridge/Culvert Distress	Twin culverts at km 21.77 have partially obstructed inlets and outlets	<input type="checkbox"/>
<input type="checkbox"/> Other		<input type="checkbox"/>
Observations (Site 15):	Description	Worsened?
<input checked="" type="checkbox"/> Pavement Distress	Cracking reflected through recent patch with minor pavement surface distortion (dip)	<input checked="" type="checkbox"/>
<input checked="" type="checkbox"/> Slope Movement	Site is located on an active deep-seated landslide moving toward the Peavine Creek. There is also a slump at the top of the backslope.	<input checked="" type="checkbox"/>
<input checked="" type="checkbox"/> Erosion	Gully in the west ditch approx. 73 m in length	<input type="checkbox"/>
<input type="checkbox"/> Seepage		<input type="checkbox"/>
<input type="checkbox"/> Bridge/Culvert Distress		<input type="checkbox"/>
<input type="checkbox"/> Other		<input type="checkbox"/>

Photo 3, Site 14 – Looking at twin culverts outlets which convey west ditch flow to the east.

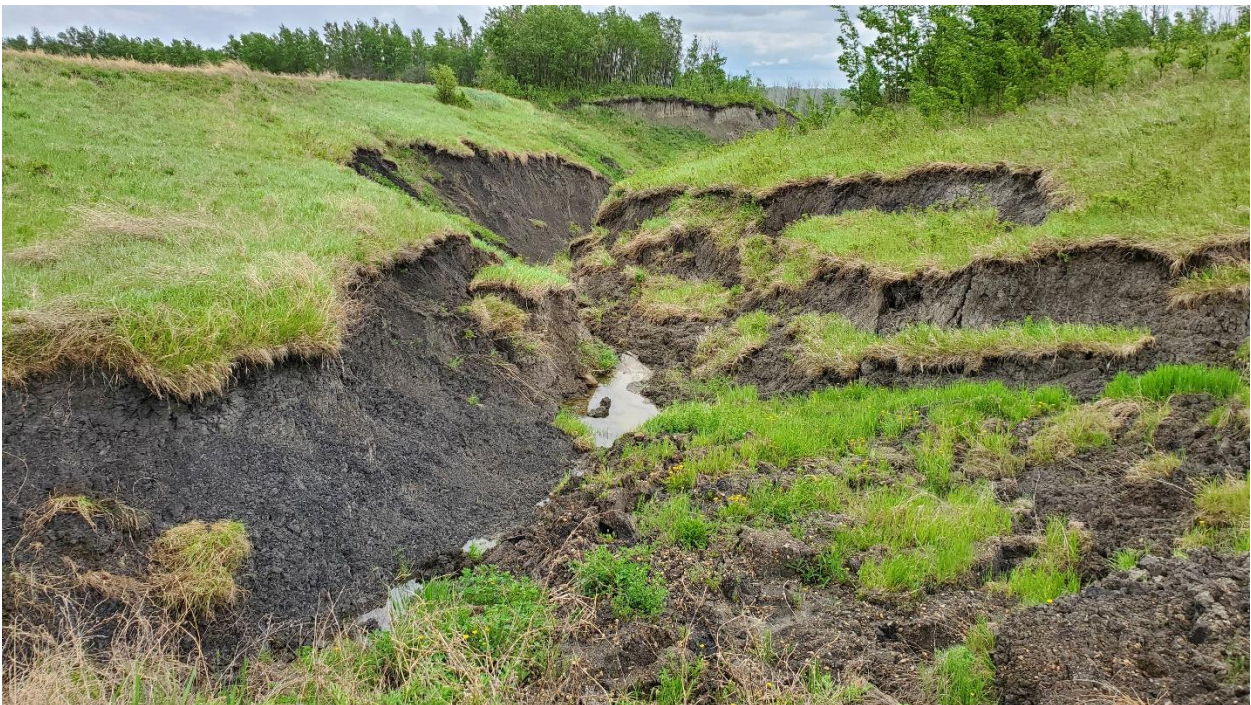
Photo 4, Site 14 – Looking south at slumping along tributary channel.

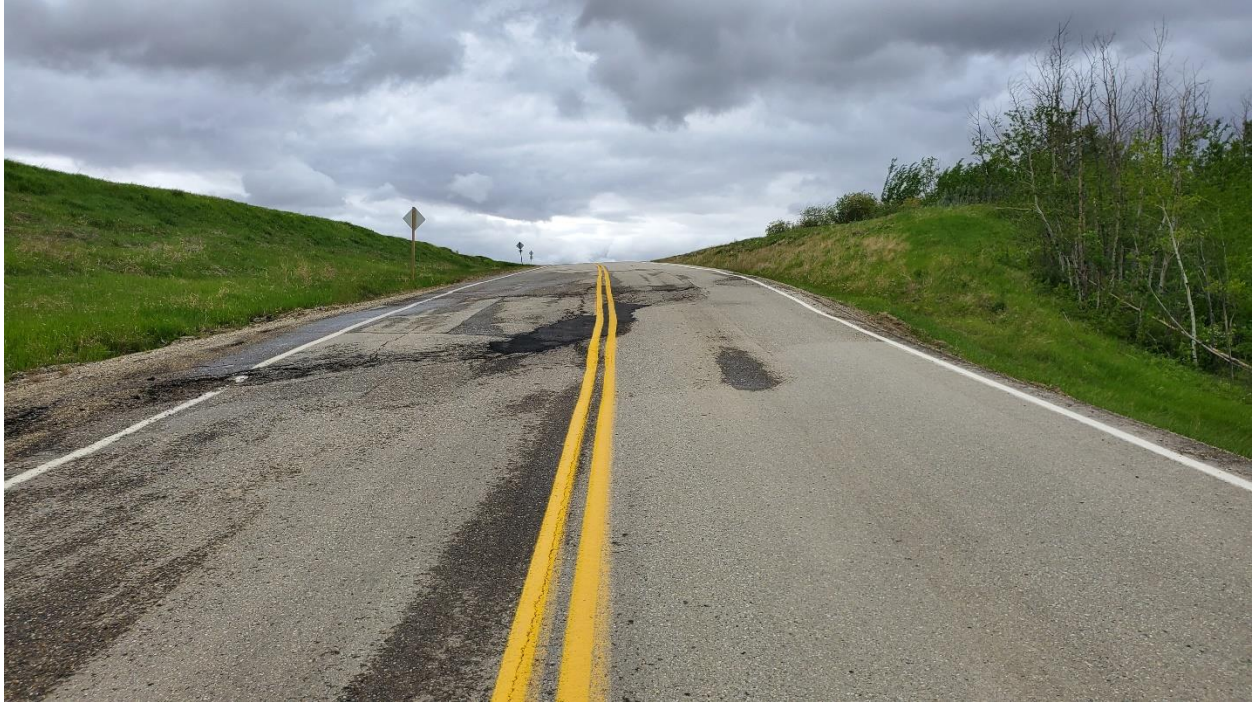
Photo 5, Site 15 – Looking north at diagonal crack intersecting the highway. There is a slight dip in the east lane on the south side (downslope) of the crack.

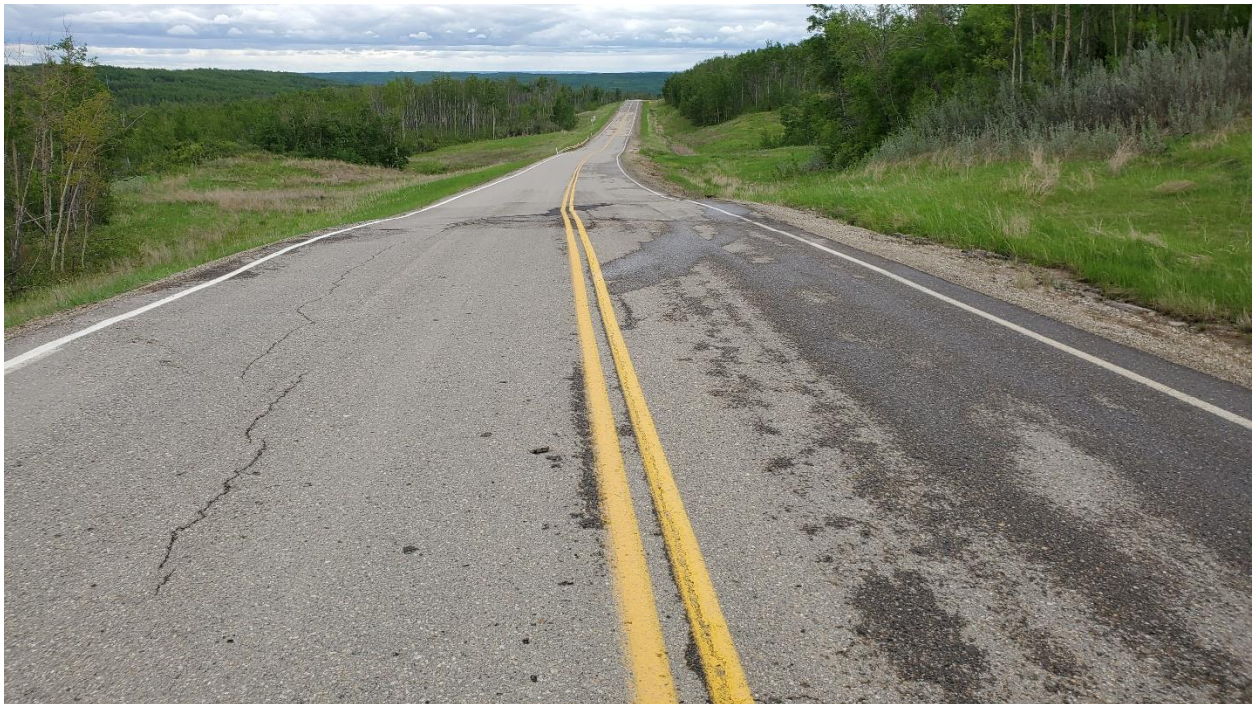
Photo 6, Site 15 – Looking south at the main crack.

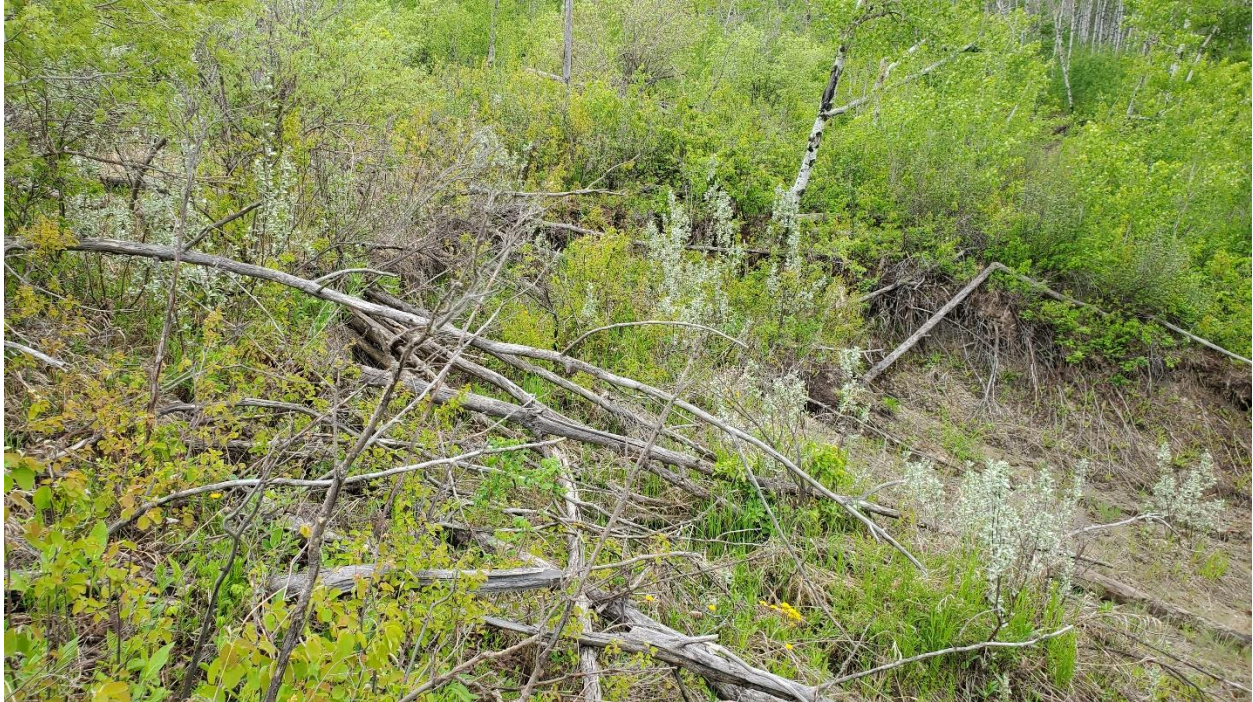
Photo 7, Site 15 – Looking north at head of shallow slump downslope of the highway.

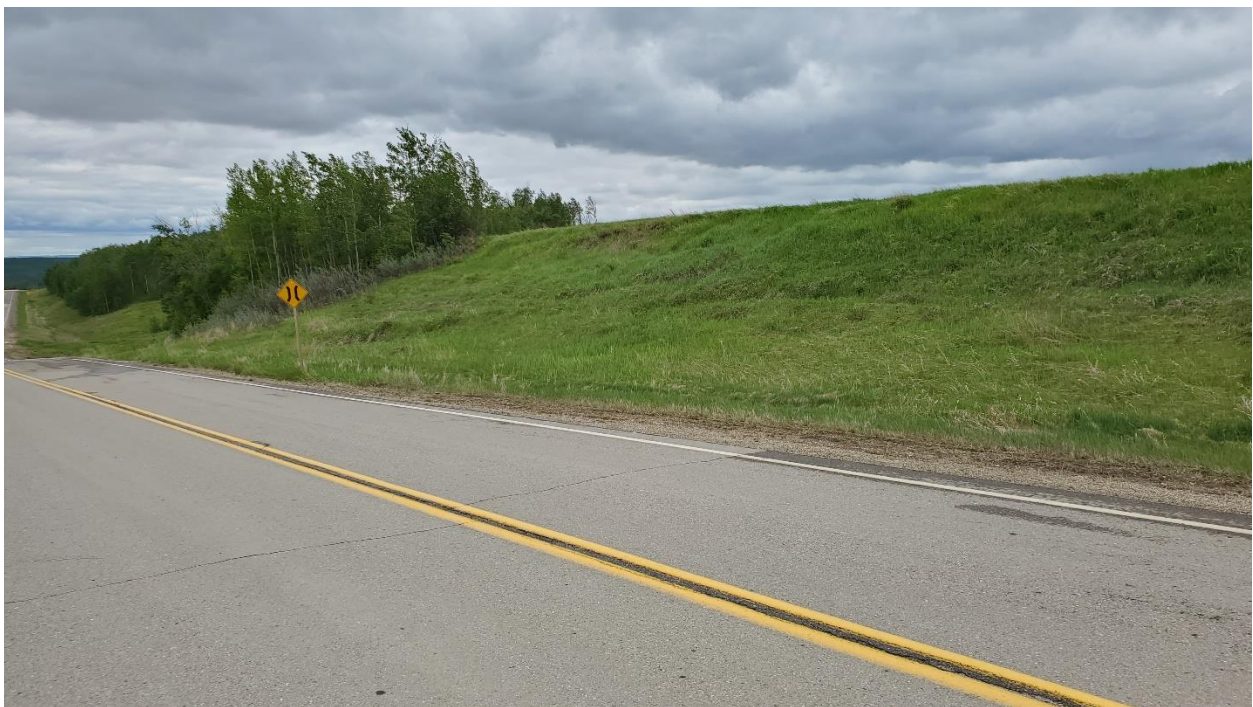
Photo 8, Site 15 – Looking southwest at backslope slump at valley crest.

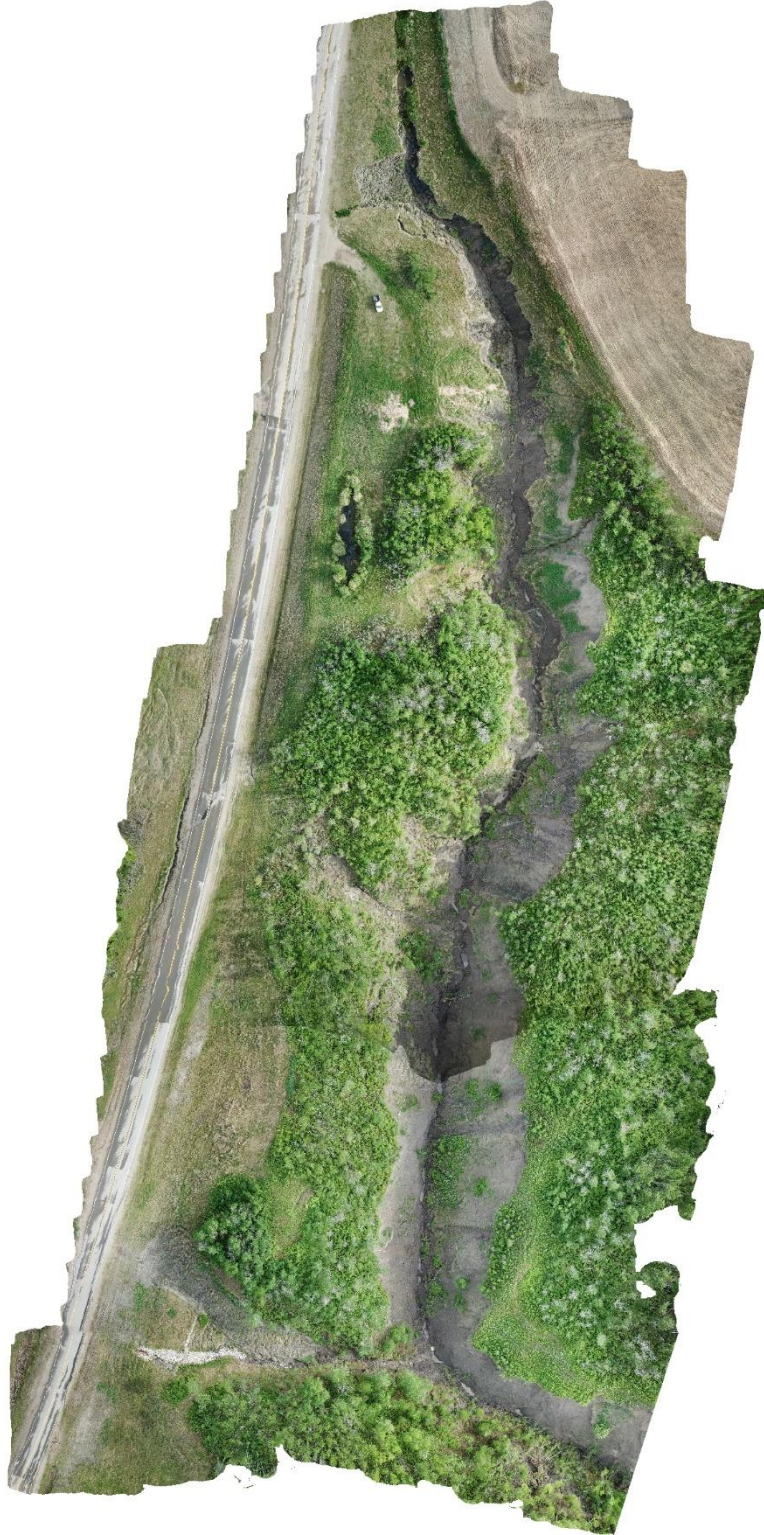
2020 UAV composite image of the erosion gully.
