**ALBERTA TRANSPORTATION
GEOHAZARD ASSESSMENT PROGRAM
PEACE REGION (PEACE RIVER DISTRICT)
2022 INSPECTION**

Site Number	Location	Name	Hwy	km
SH013-13	Little Smoky River	Little Smoky River Valley, North Hill – Site #13	744:02	21.36-21.49
Legal Description		UTM Co-ordinates		
SE28/SW27-76-22-W5M		11U E 478,608	N	6,162,922

**SH013-13: HWY 744:02 LITTLE SMOKY RIVER VALLEY
2022 SITE INSPECTION PLAN**

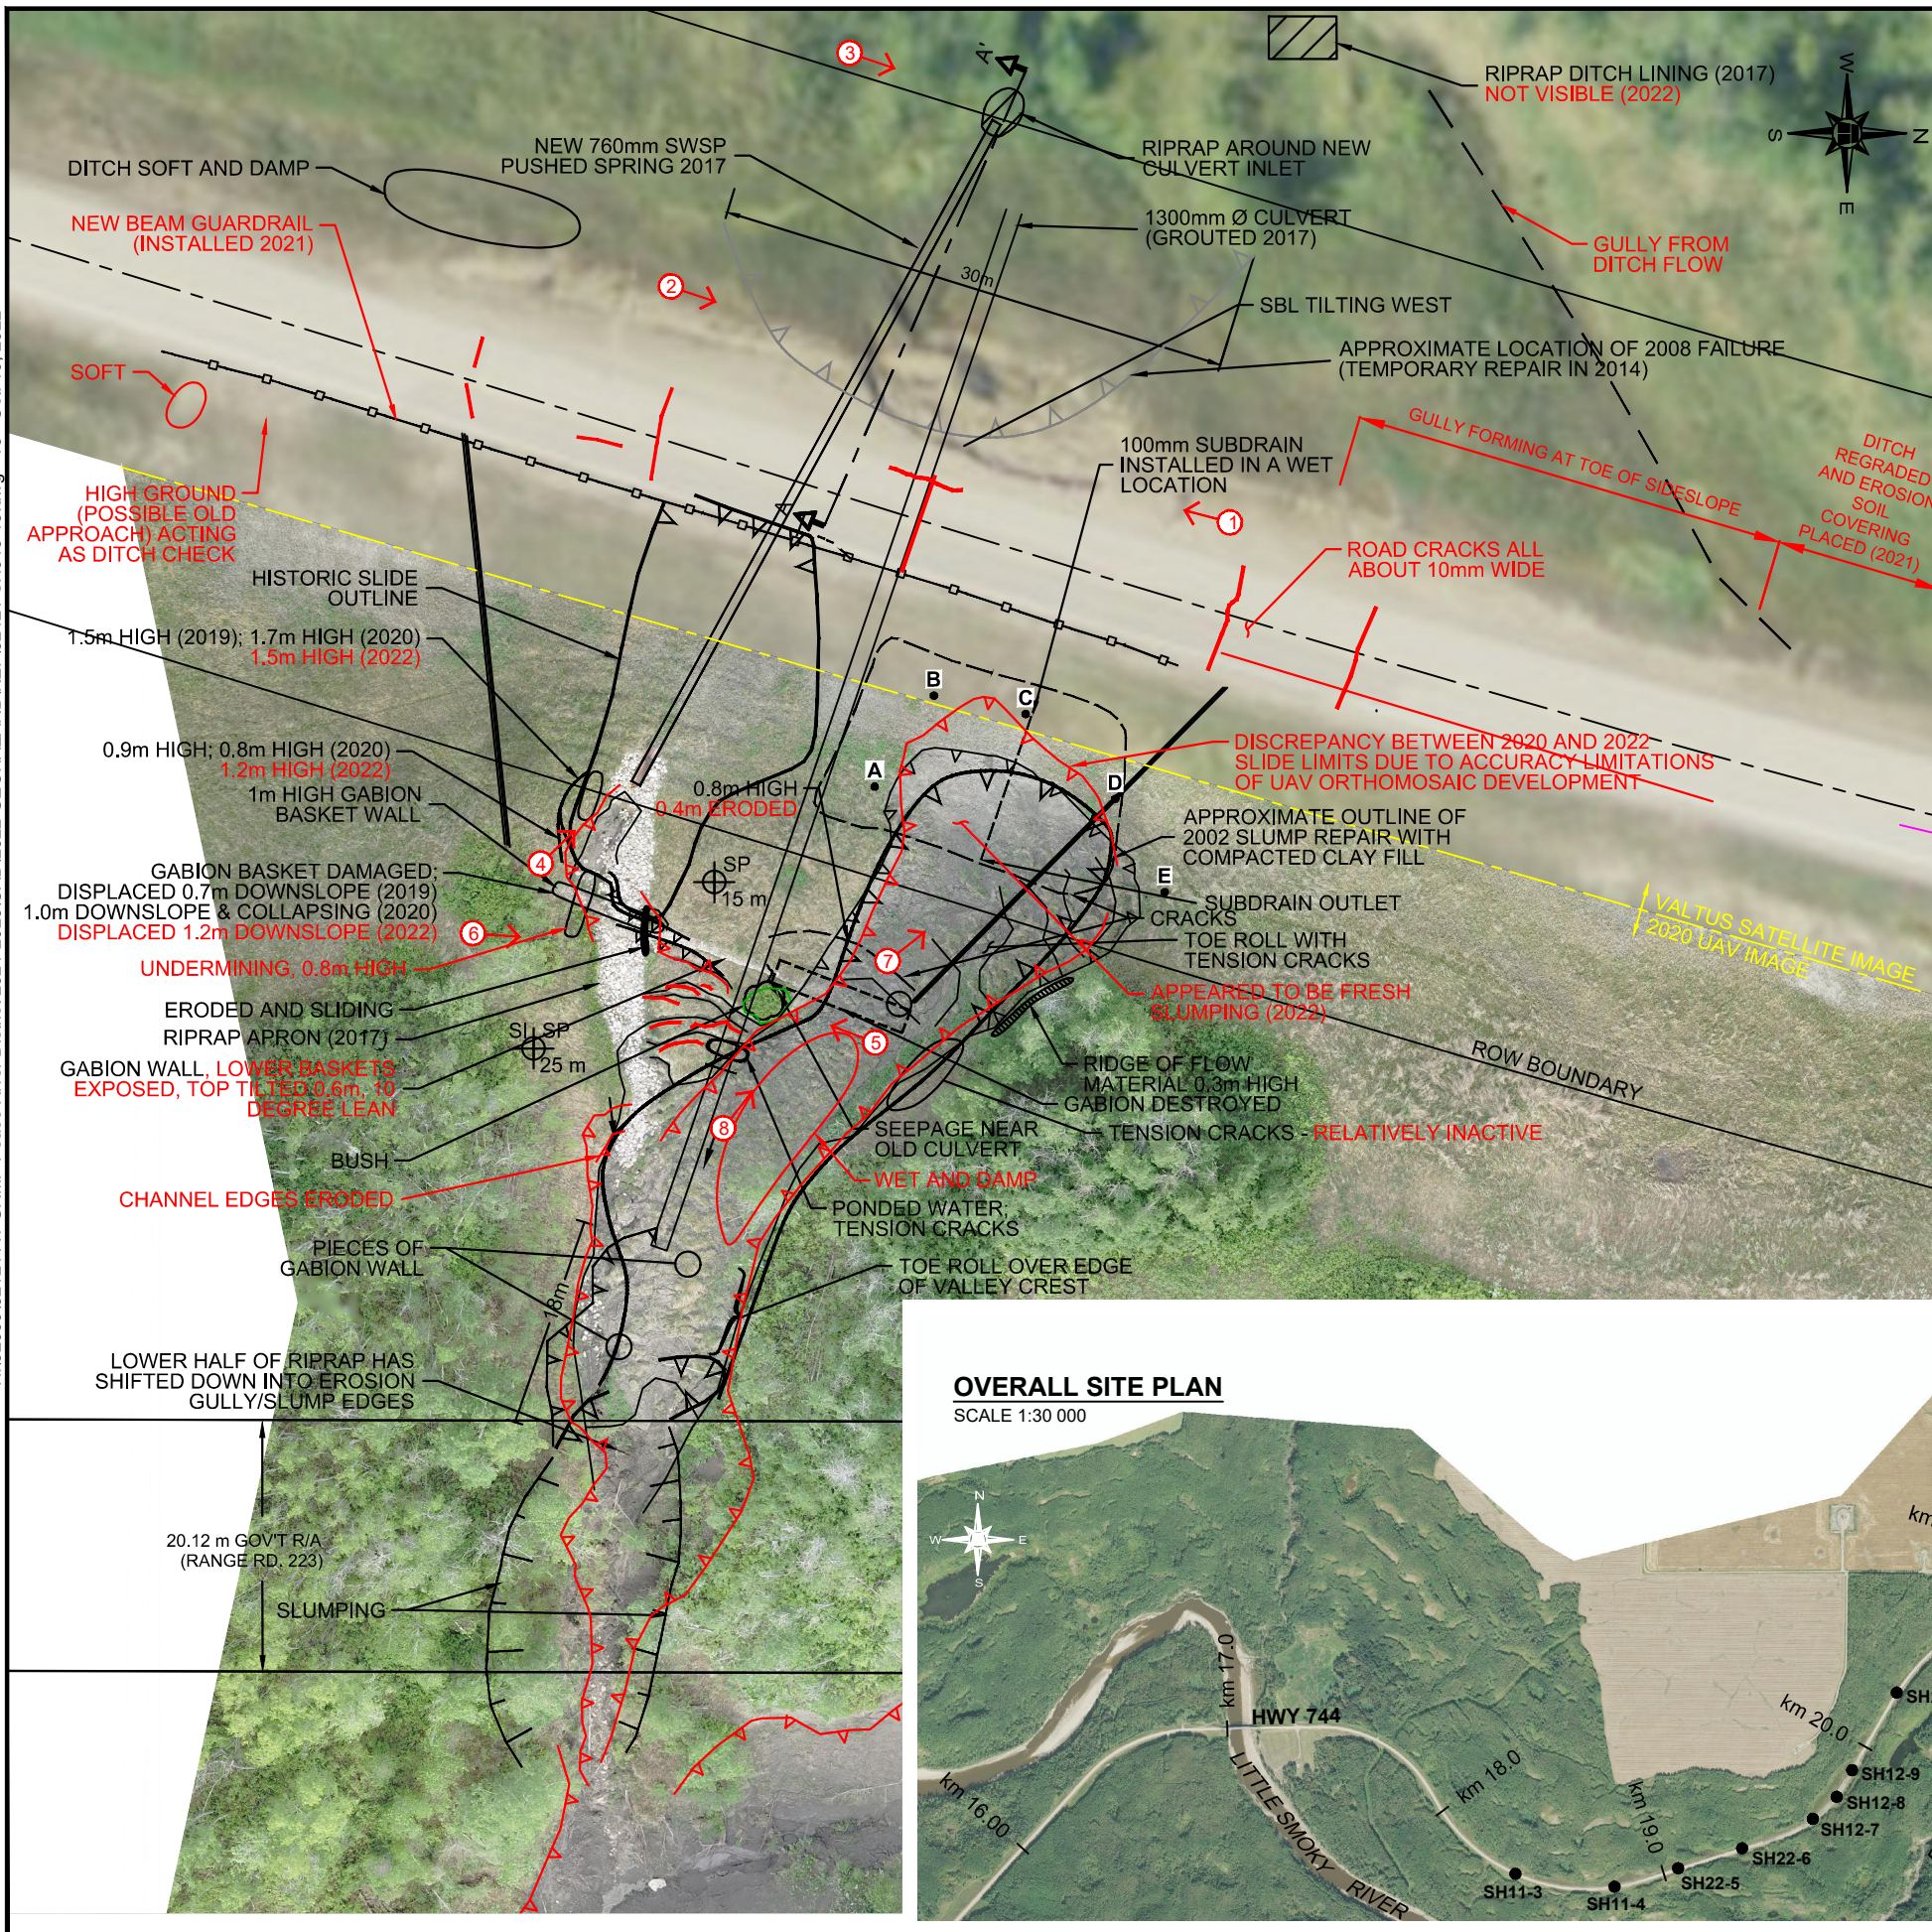
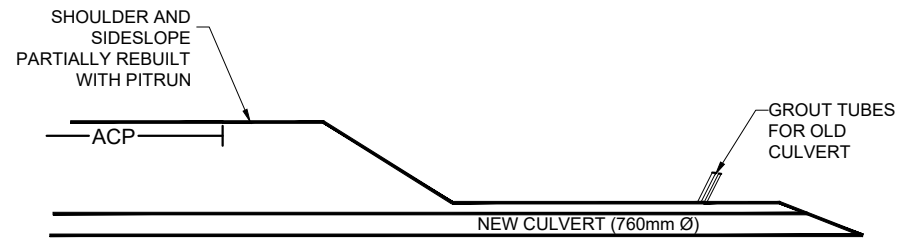
CROSS - SECTION A - A'
APPROX. SCALE: 1:300 (HAND MEASURED)

STAKE	SCARP (HEIGHT)		
	2019	2020	2022
A	3.1m (1.5m HIGH)	? (1.8m HIGH)*	1.8m (0.6m HIGH)
B	1.5m DOWNSLOPE 1.7m LATERAL	0.3m / 2.0m** (0.5m HIGH)	2.0m (0.2m HIGH)
C	1.3m	0m / 2.0m**	2.0m (0.6m HIGH) 5.1m TO BACK SIDE OF W-BEAM GUARDRAIL AND 5.7m TO EGG LINE
D	11.6m TO GUARDRAIL	FELL / 2.0m**	1.3m (0.6m HIGH)
E	0.6m TO CRACK 1.9m TO SCARP (0.5m HIGH)	0.6m TO CRACK 1.9m TO SCARP (0.5m HIGH)	0.6m TO CRACK 1.9m TO SCARP (0.5m HIGH)

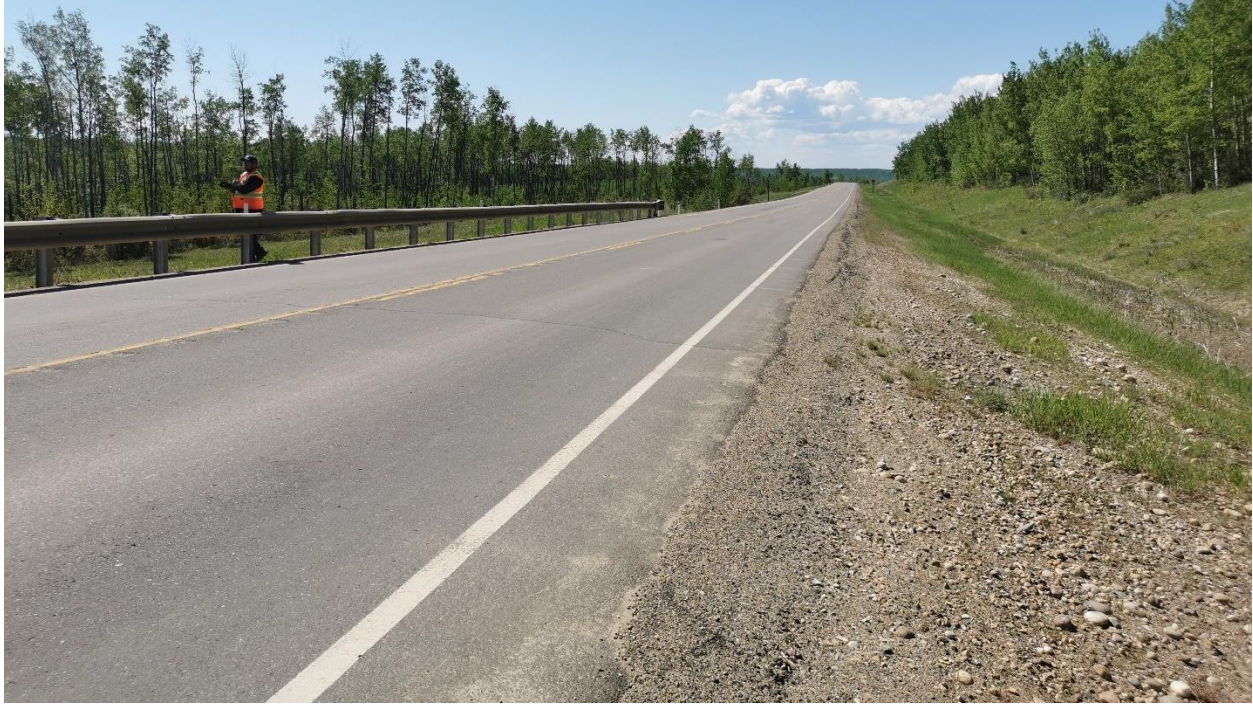
Photo 1 – Looking south at upslope shoulder – the highway was overlaid the previous year and the crack pattern is not yet fully re-established.

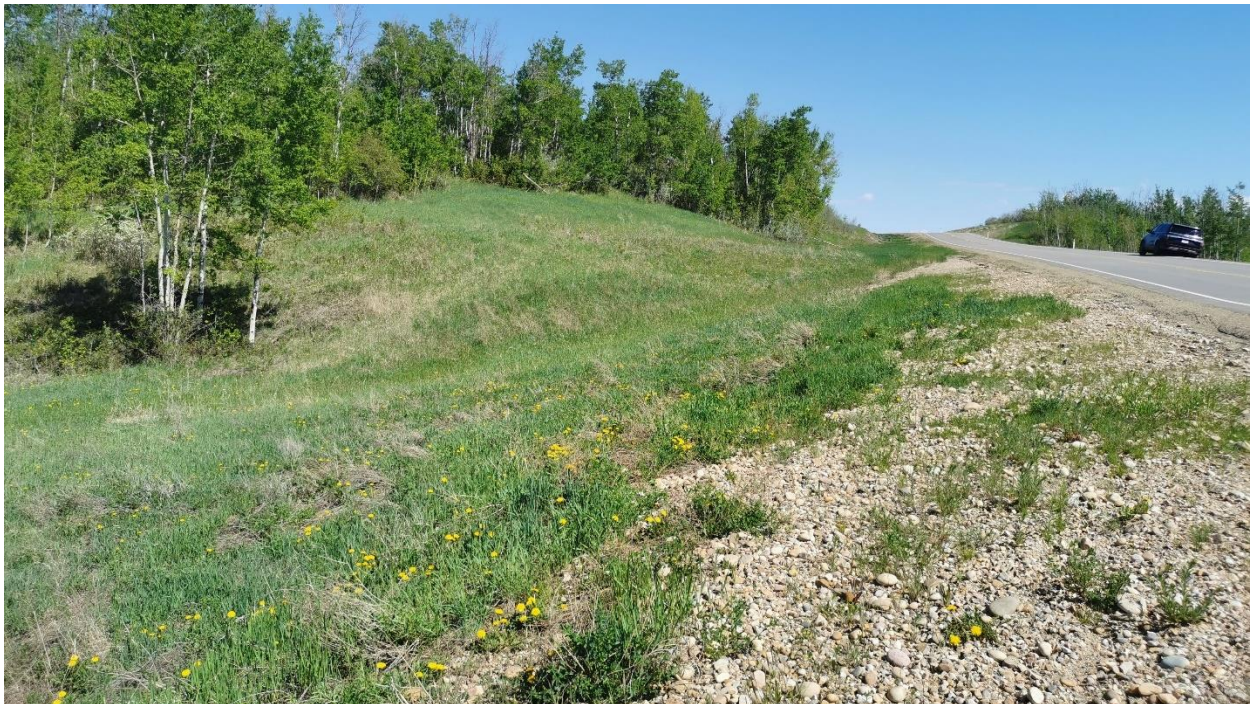
Photo 2 – Looking north at sideslope above culvert inlet.

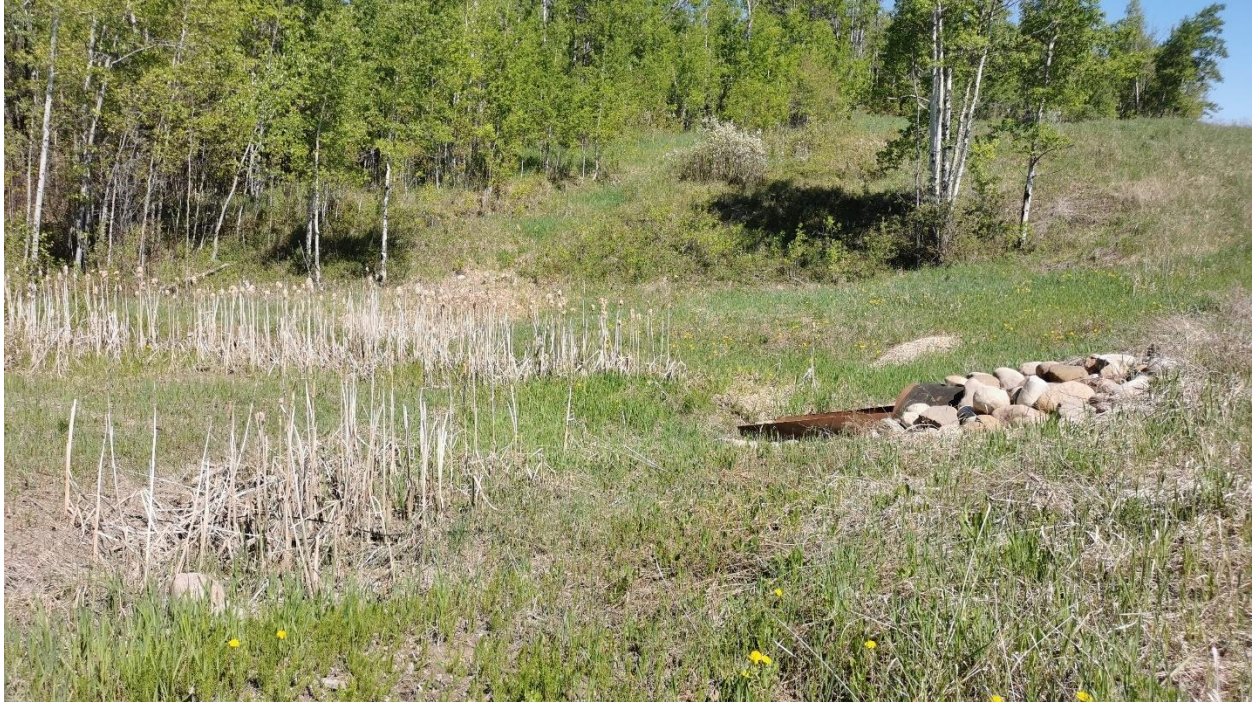
Photo 3: Looking north at new culvert inlet.

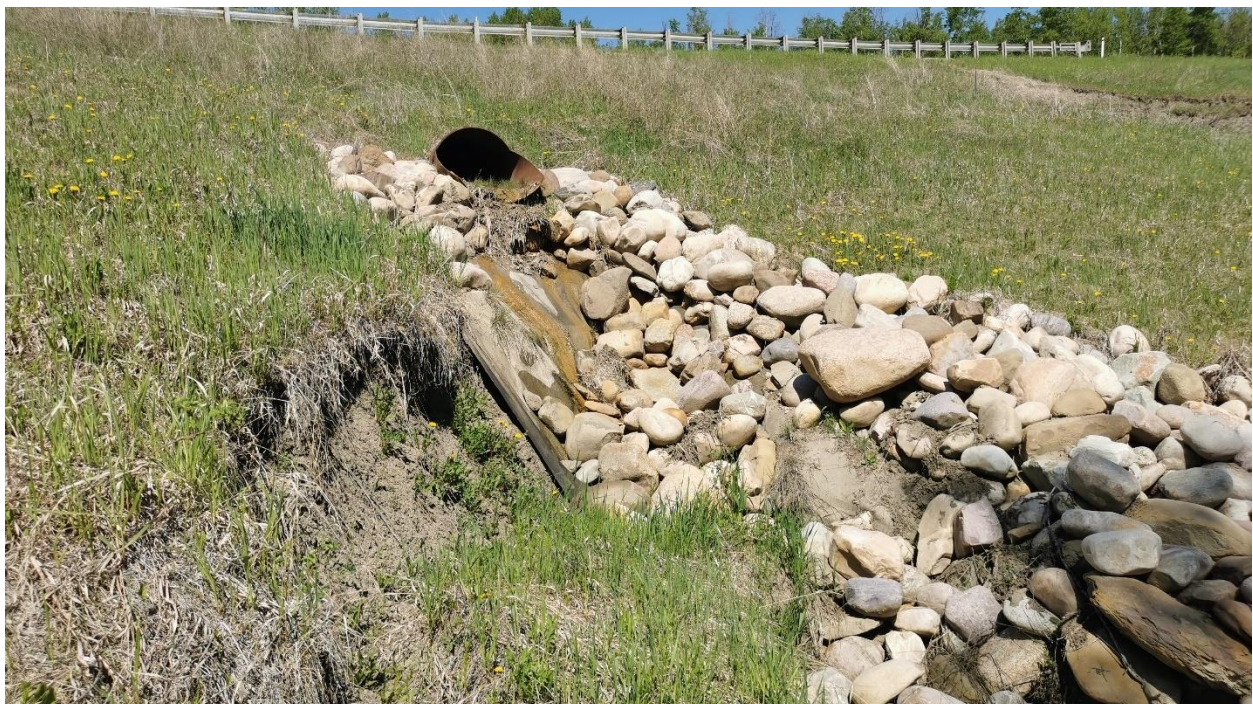
Heavy spring runoff in 2018 has led to erosion and undermining of the riprap apron below the culvert outlet particularly immediately below the outlet where the discharge flow impacted the top of the apron. There was also erosion, displacement of riprap, and damage to the gabion basket wall further down-channel. In Fall 2018, the north portion of the east embankment slope failed at the approximate location of the 2002 slump. By 2019, the scarp was approximately 20 m in width up to the north tree line and extended through the gabion wall removing the north half of it. The scarp was approximately 12 m from the highway at the closest point. In 2020, the scarp had widened to 22 m and about 11 m from the highway. Three of the five stakes placed in 2019 had to be relocated away from the encroaching scarp and may need to be relocated again in 2023. There was a slower rate of deterioration of the north side between the 2020 and 2022 inspections; nonetheless, this slump is now about 5.1 m from the back of the new guardrail. The remaining south half of the gabion wall has displaced further and the retrogressive slumping below it is affecting the riprap apron including the erosion bowl forming below the culvert outlet. The inspection in 2022 observed deeper and wider slumps at and downstream of the culvert outlet. UAV flights taken over the site in 2020 and 2022 were used to refine the site drawing.

Photo 4: Looking northwest at new culvert outlet. Erosion on left-hand side (south) is significantly worse and may be part of a retrogressive tension crack from the slide further down the slope.

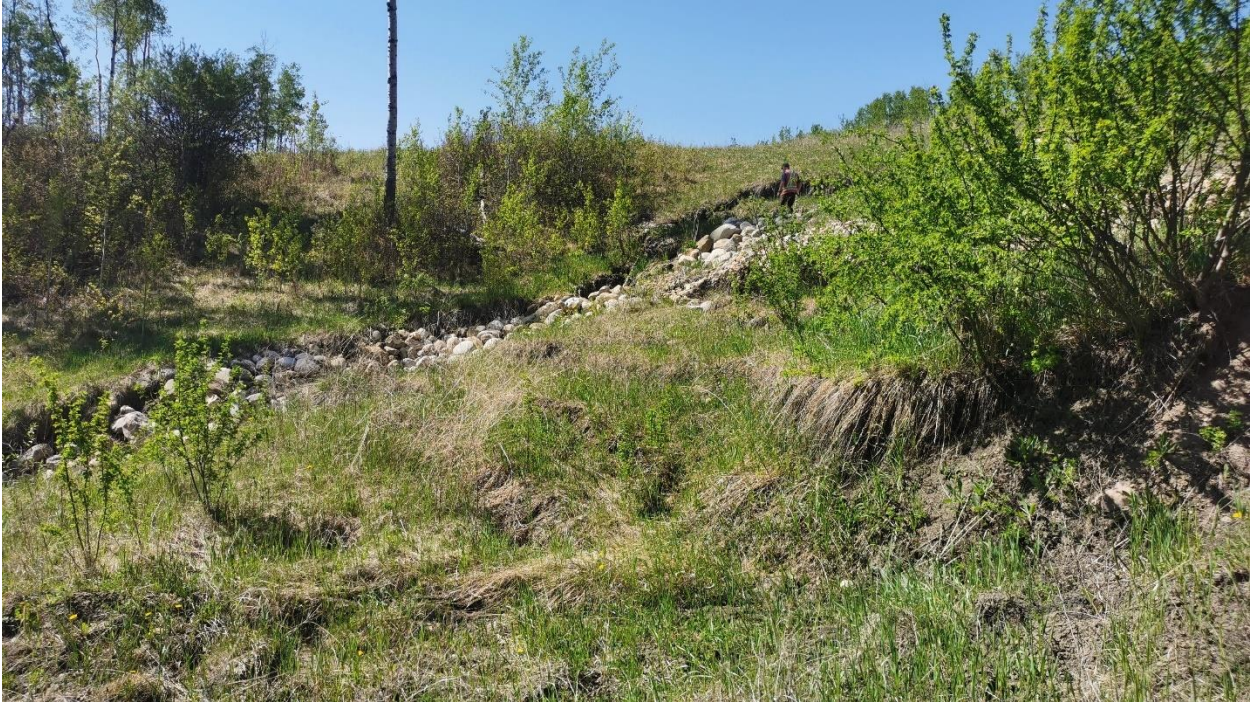
Photo 5 – Looking south at gabion wall on downslope side of embankment. Note eroded south face of new riprap apron from culvert outlet. September 2018 slide has removed about half of the gabion wall.

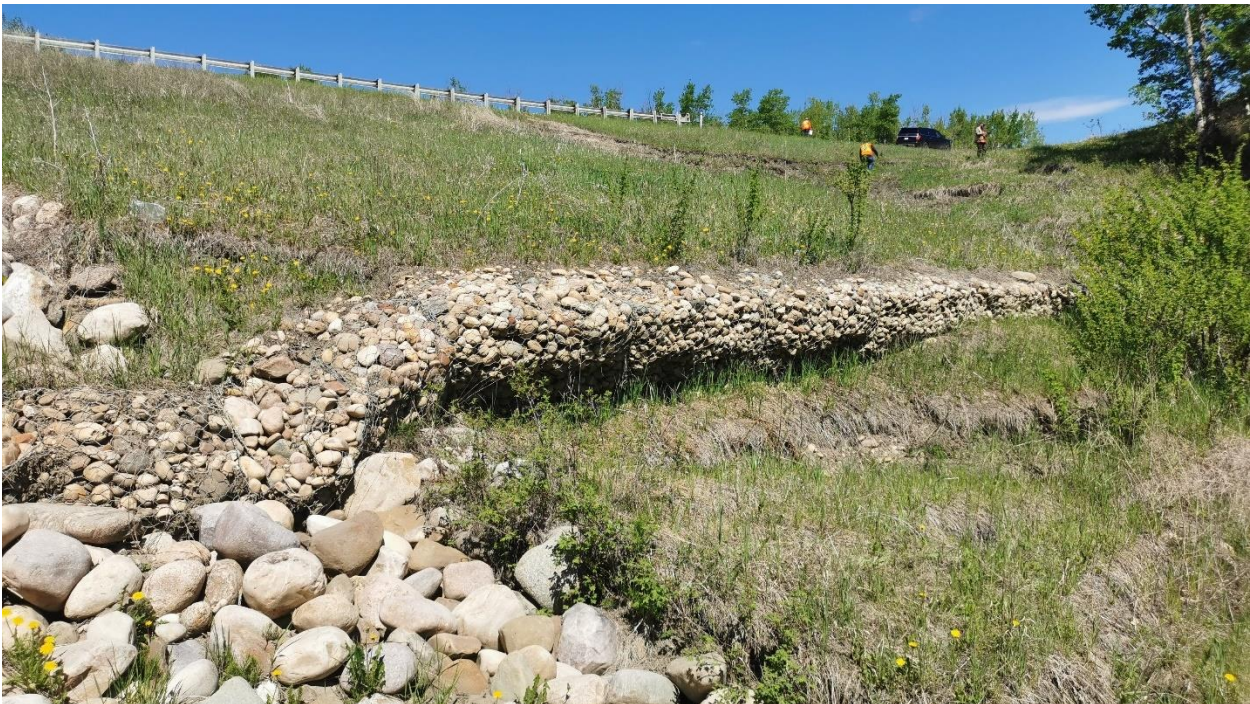
Photo 6 – Looking north at scarps above and below the gabion wall at the riprap apron.

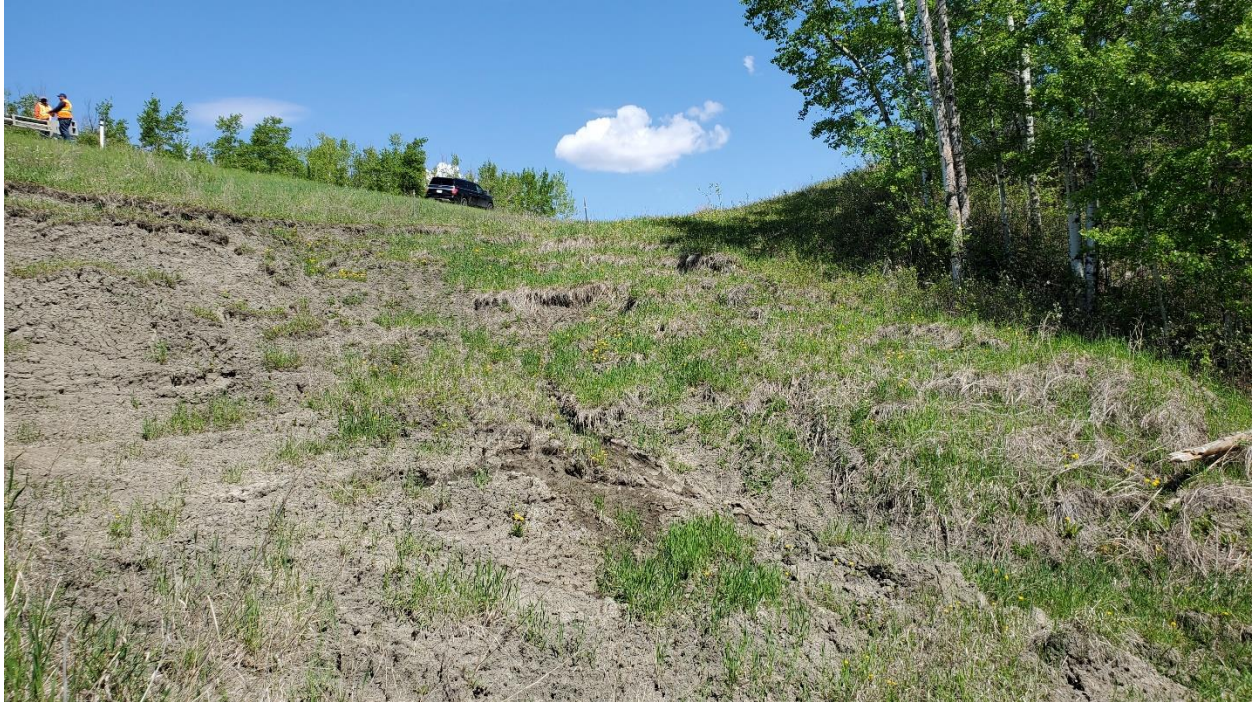
Photo 7 – Looking northwest at top of September 2019 slide block.

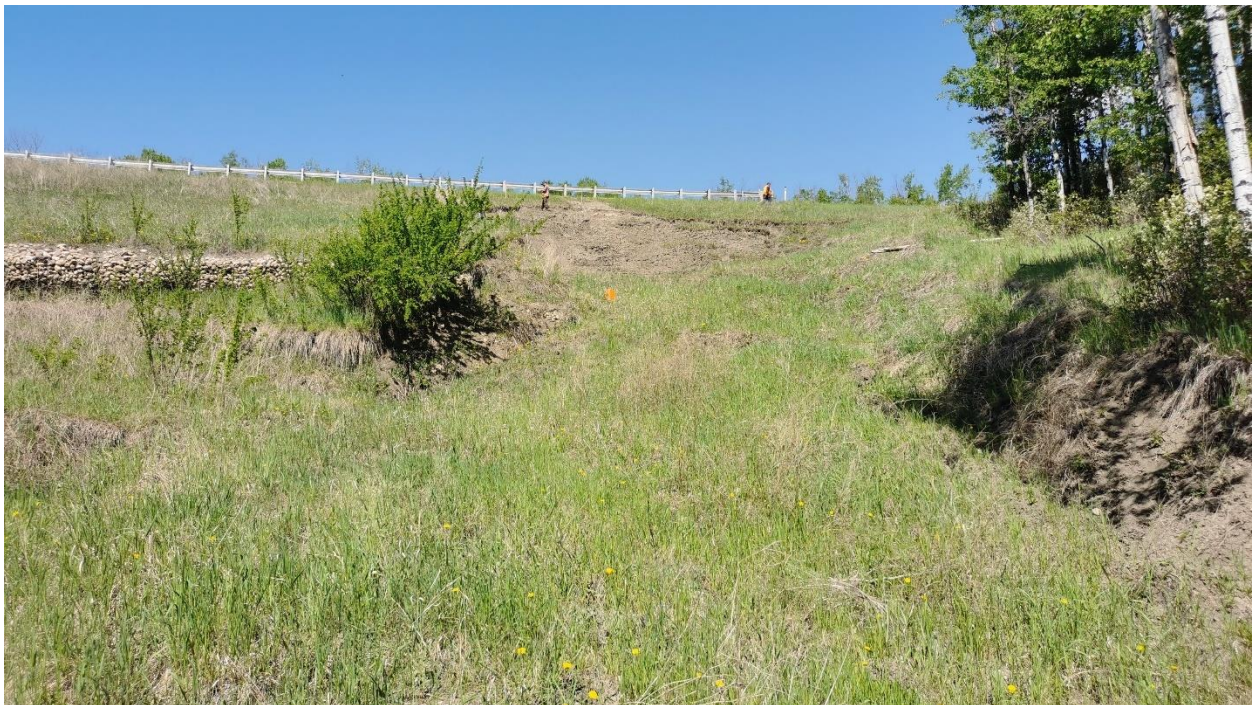
Photo 8 – Looking northwest at slide in the north half of the embankment with tension cracks extending into the south half at and below the gabion wall.

- A pile wall could be constructed across the narrower downslope end of the sideslope near the outlet of the old culvert to buttress the slope. The slump in the east embankment could then be reconstructed with geogrid-reinforced fill after over-excavating the slide material.
- A surface pipe should be installed from the new culvert extending further down the gully to where it meets the tributary coming down from Site #14.
- Although the upslope ditches were regraded and protected from erosion during the 2021 overlay, the gully from the ditch down toward the culvert inlet should also be shaped and protected from erosion to minimize eventual downcutting of the ditch and sediment accumulating at the culvert inlet.

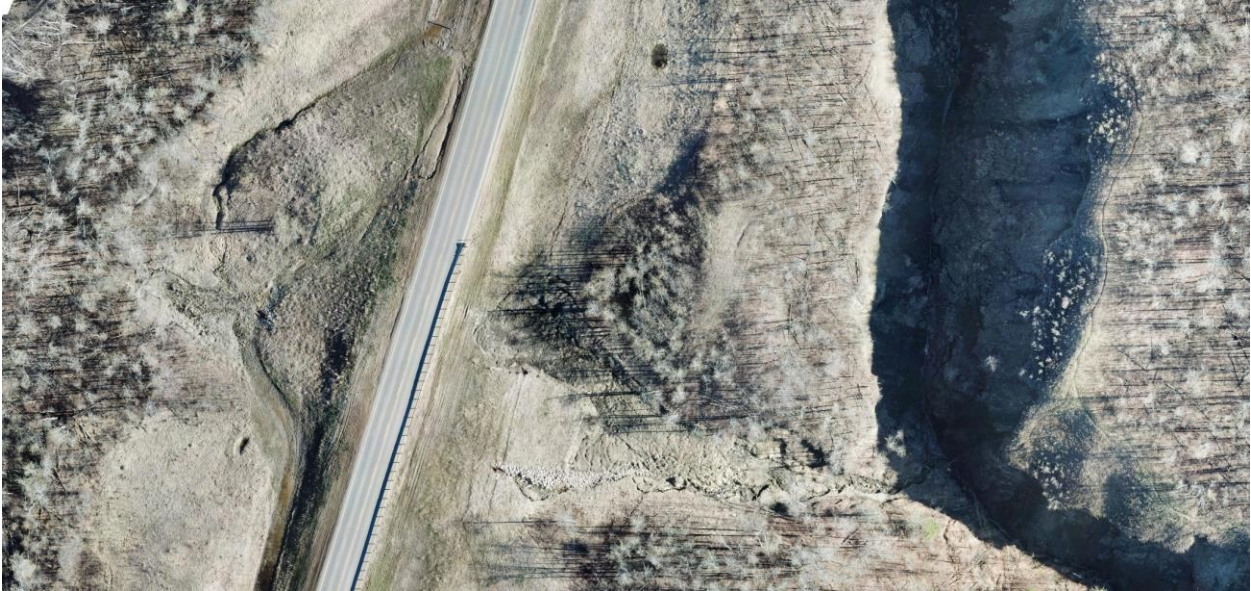
UAV Photo 2 (May 2022): Overall site including tributary gully on the right (south).

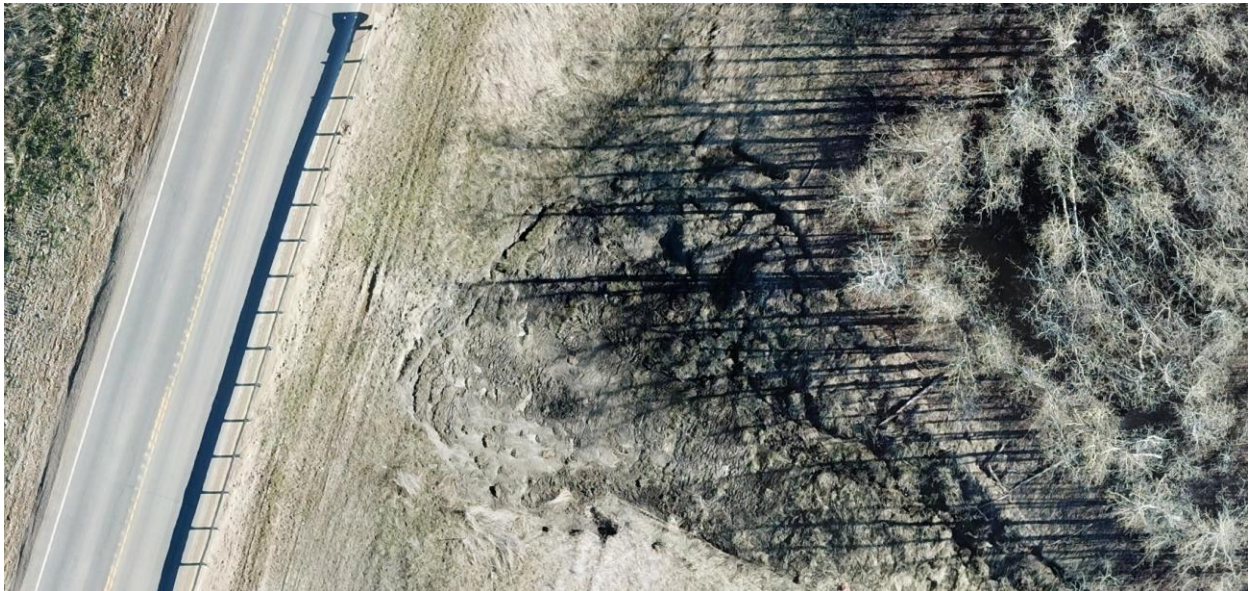
There is significant risk of undermining of the east embankment due to the continued erosion of the slide mass and retrogression of the gully.

UAV Photo 2 (May 2022): Closer view of the east slump encroaching towards the highway (5.1 m from back of W-Beam guardrail).
