**ALBERTA TRANSPORTATION AND
ECONOMIC CORRIDORS
GEOHAZARD RISK MANAGEMENT PROGRAM
PEACE REGION (PEACE RIVER DISTRICT)
2025 INSPECTION**

| Site Number | Location | Name | Hwy | km |
|---|---|--|---|---|
| SH013-14 SH013-15 | Little Smoky River - East Valley Slope | Little Smoky River Valley, North Hill – Sites #14 & #15 | 744:02 | 21.61-21.80 21.55-21.61 |

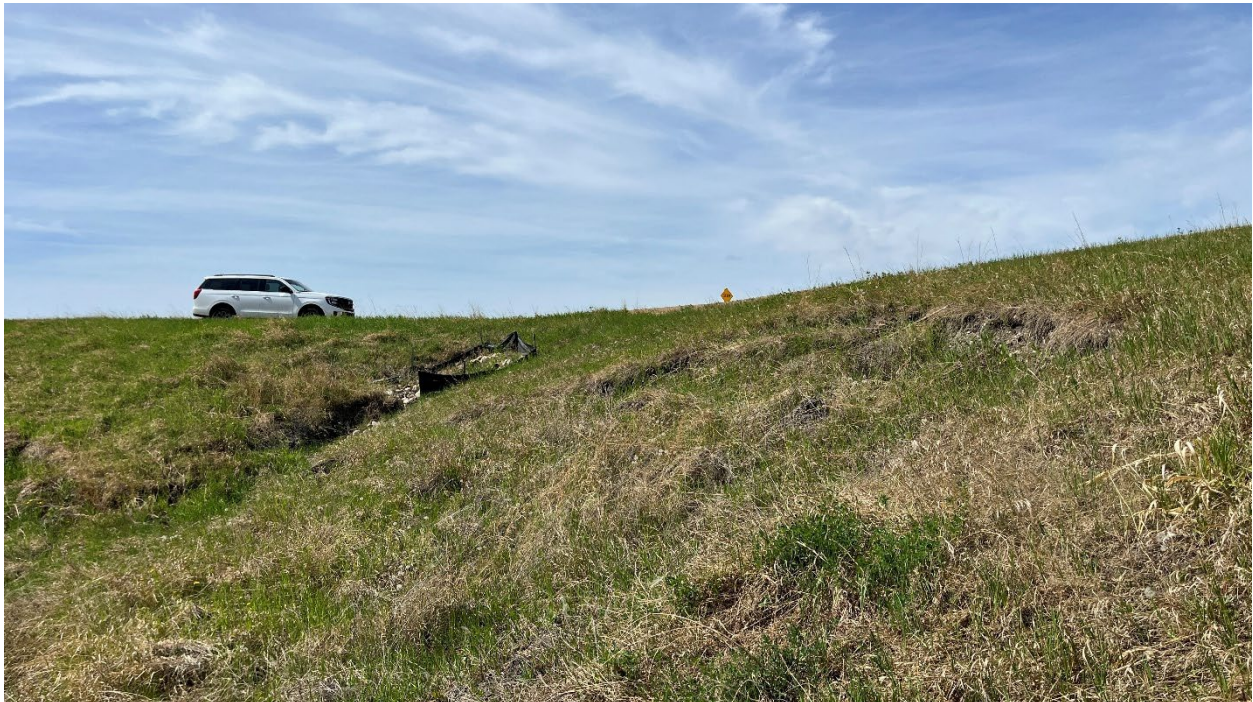
| <input checked="" type="checkbox"/> Slope Movement | Slumps have developed along the tributary gully and are retrogressing as it continues to downcut. Scarp adjacent to highway did not appear to retrogress further towards the highway during the 2025 inspection. | <input checked="" type="checkbox"/> |

Photo 1, Site 14 – Looking southwest at slide scarp north of twin culverts that is retrogressing towards the highway.

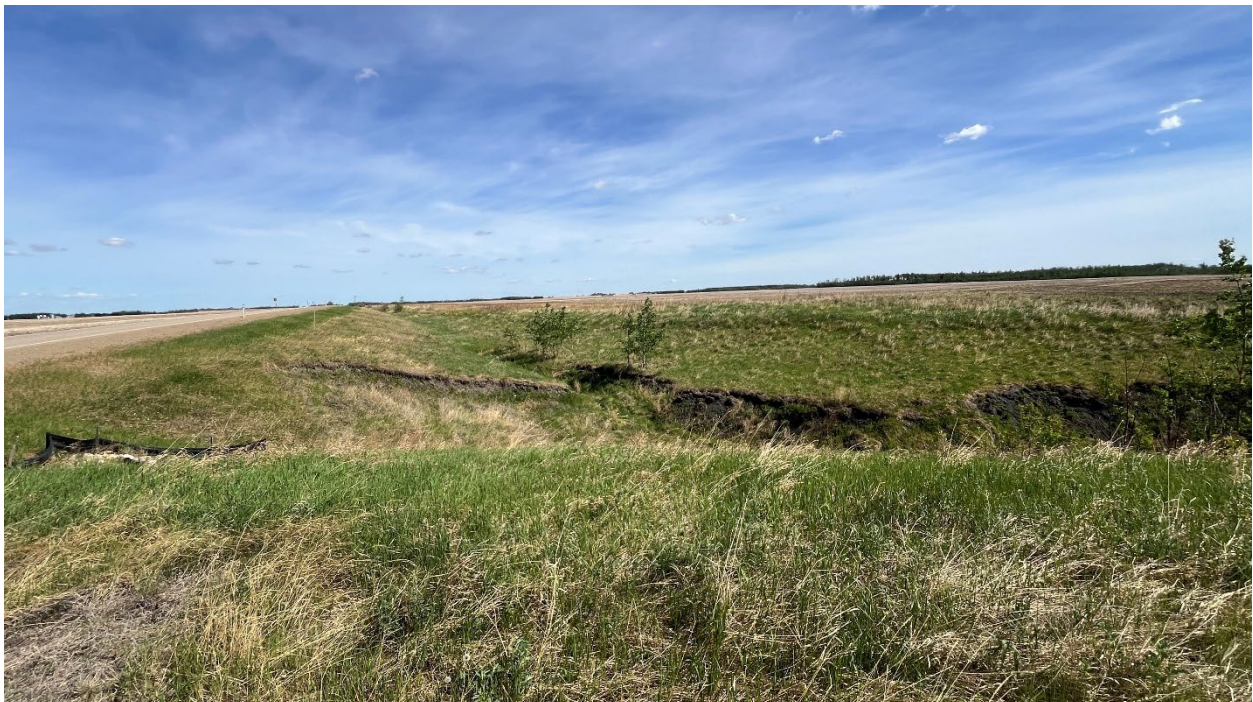
| <input checked="" type="checkbox"/> Erosion | Significant erosion along the east highway ditch and ravine leading to Peavine Creek. | <input checked="" type="checkbox"/> |
| <input checked="" type="checkbox"/> Seepage | Ponded water observed in the east ditch. | <input checked="" type="checkbox"/> |

Photo 2, Site 14 – Looking north towards the east ditch.

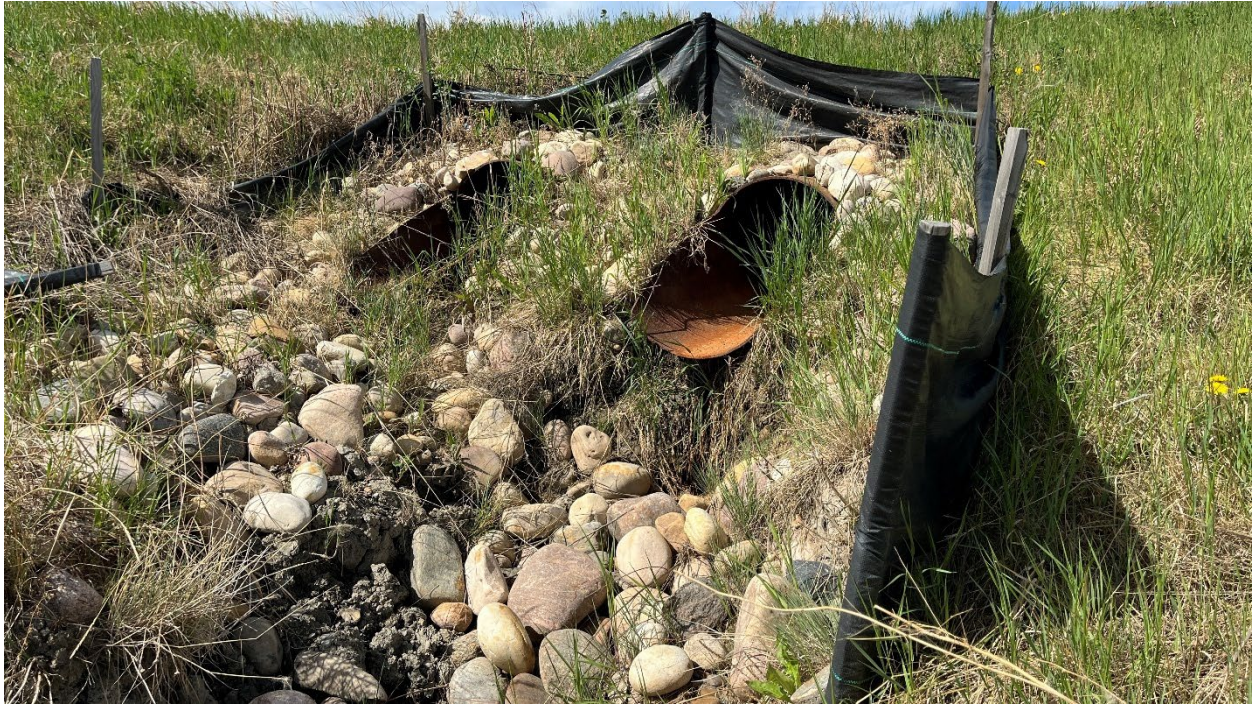
| <input checked="" type="checkbox"/> Bridge/Culvert | Riprap apron at north pipe outlet collapsed with the riprap accumulating in the channel. | <input type="checkbox"/> |

Photo 3, Site 14 – Looking at outlets of SWSP twin culverts outlets. The riprap apron at the north SWSP had collapsed.

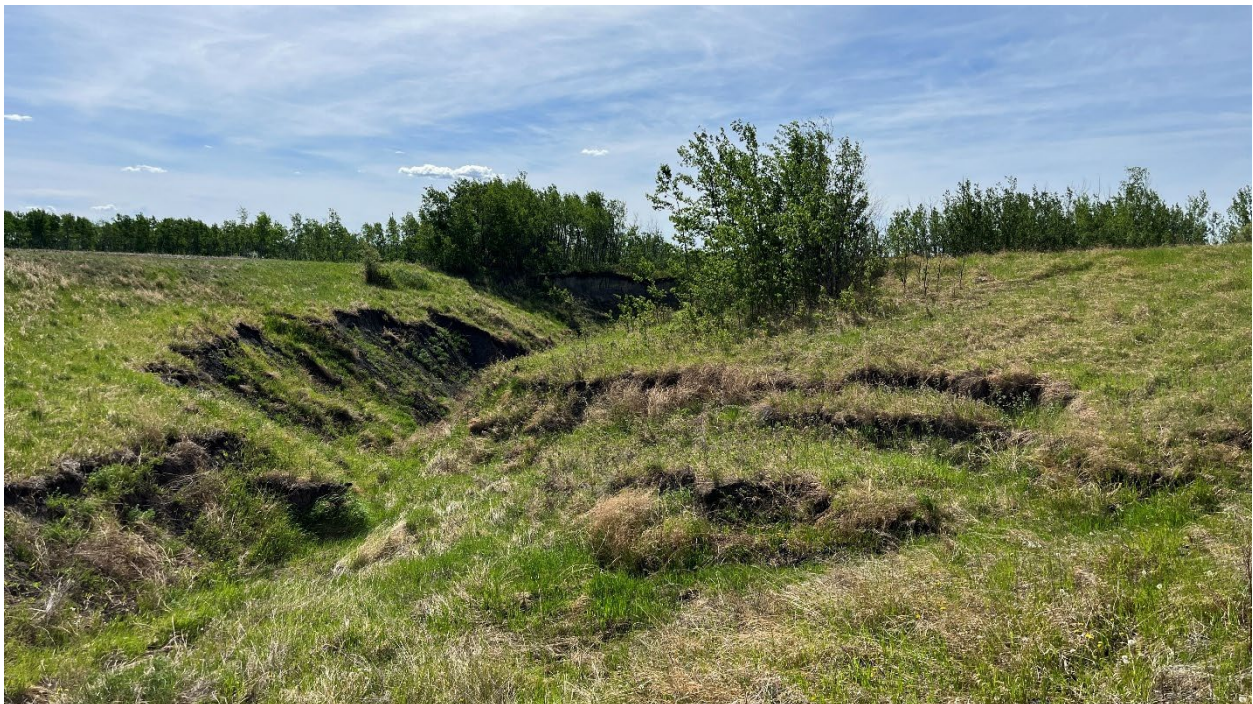
Photo 4, Site 14 – Looking south at slumping along the tributary channel.

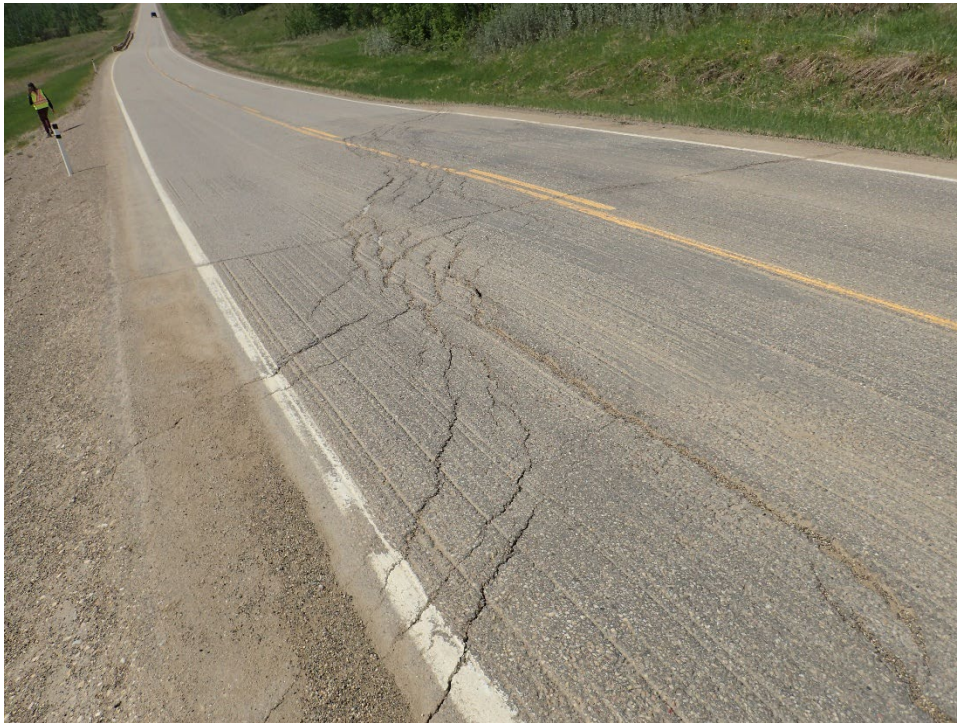
| <input checked="" type="checkbox"/> Pavement Distress | Previous longitudinal and traverse cracks have reflected through and extended. Main crack area had multiple coalescing and parallel cracks with vertical displacement. | <input checked="" type="checkbox"/> |

Large scale valley movements produce a diagonal crack across the highway at this location. The crack likely represents the northern flank of the uppermost scarp of deep-seated, retrogressive movements in the valley. The dip in the highway surface on the downslope side of the crack was removed with the highway overlay in 2021. The main crack pattern has re-established after the overlay. Increased crack width was observed in 2023; however, the vertical difference was reduced as the main crack area had been recently milled. During the 2024 inspection, the main crack area had multiple coalescing cracks, and the cracks continued to widen. The cracks were infilled with sand and gravel. Additional parallel cracks were observed during the 2025 inspection. There is some erosion located downslope (east) of the highway and shallower scarp which may both be contributing to the movement at the highway. During the 2024 inspection, the scarp on the roadway was observed to extend southwest into the treeline. Additional scarp movement in the treeline was observed during the 2025 inspection. There is also a backslope slump that has formed about 1 m from the valley crest which may be the result of cut slope angle rather than the overall valley movement. There were no observed changes to the backslope slump during the 2025 inspection.

Photo 5, Site 15 – Looking southwest at diagonal crack intersecting the highway.

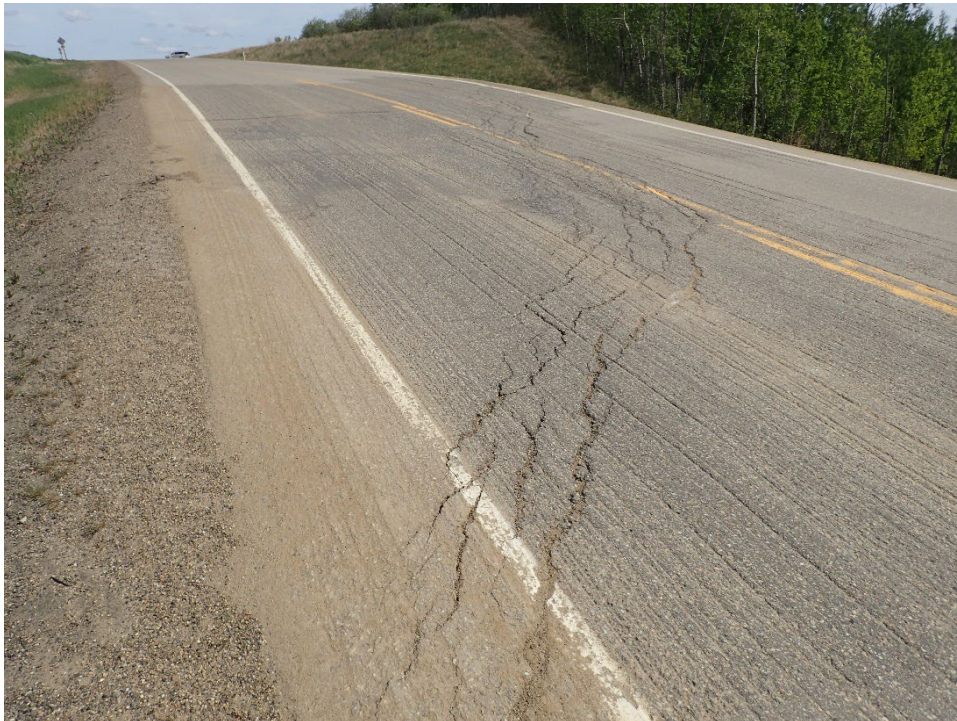
Photo 6, Site 15 – Looking northeast at the main crack. Scarp from road extends southwest into the treeline.

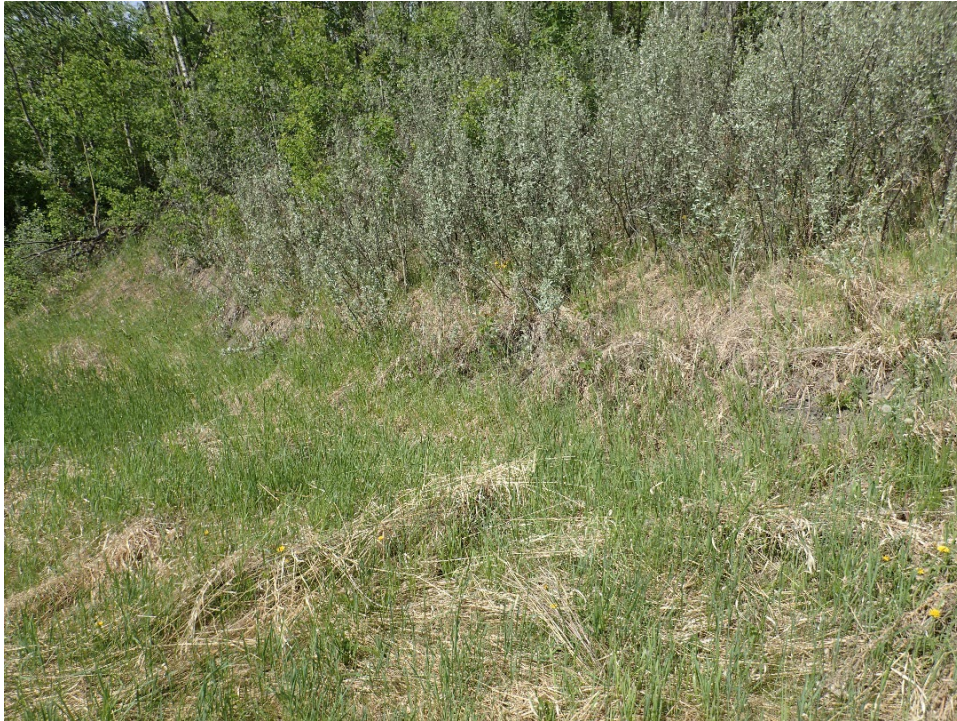
| Dimensions: | <p><u>Site 14:</u> 55 m length of highway parallels active erosion area.</p> <p><u>Site 15:</u> 40 m length of highway with distortion and cracking. The cracking at this site likely represents the northern flank of a much larger instability. The main scarp can be observed extending +75m into the treeline along the west side of the highway.</p> | |

Photo 7, Site 15 – Looking southwest where scarp extends into the treeline.

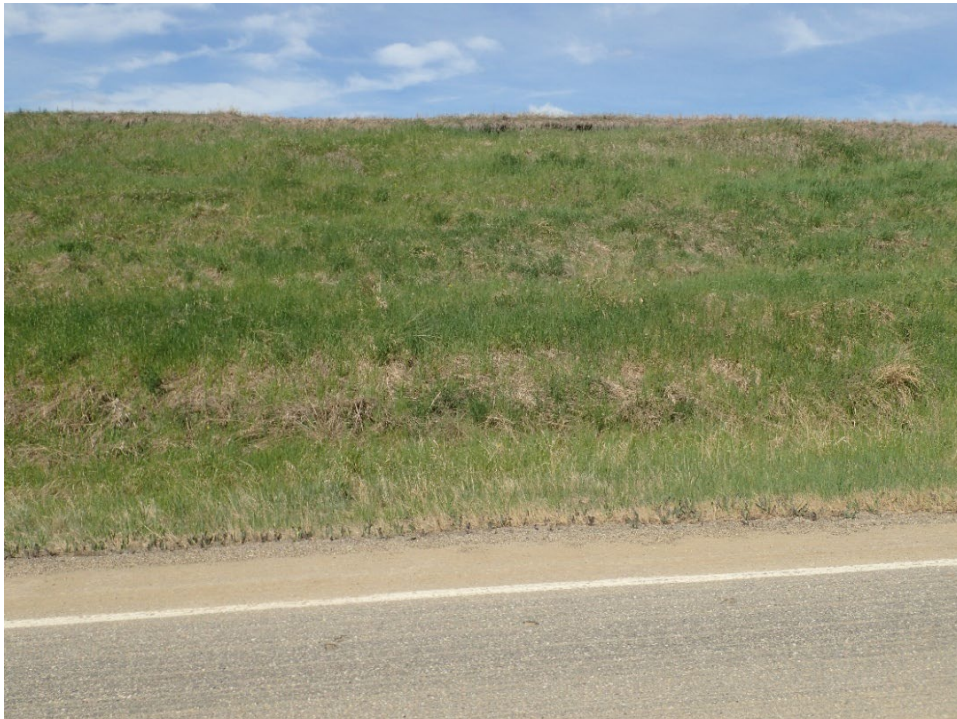
Photo 8, Site 15 – Looking west at backslope slump. No changes observed in 2025 inspection.

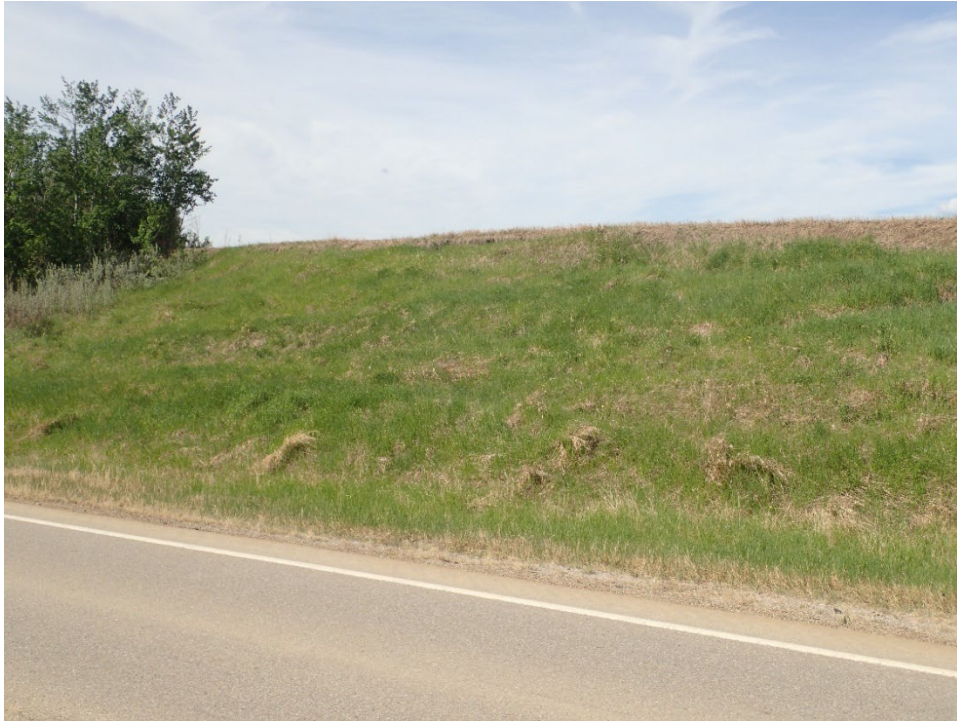
Photo 9, Site 15 – Looking southwest at backslope slump at valley crest.

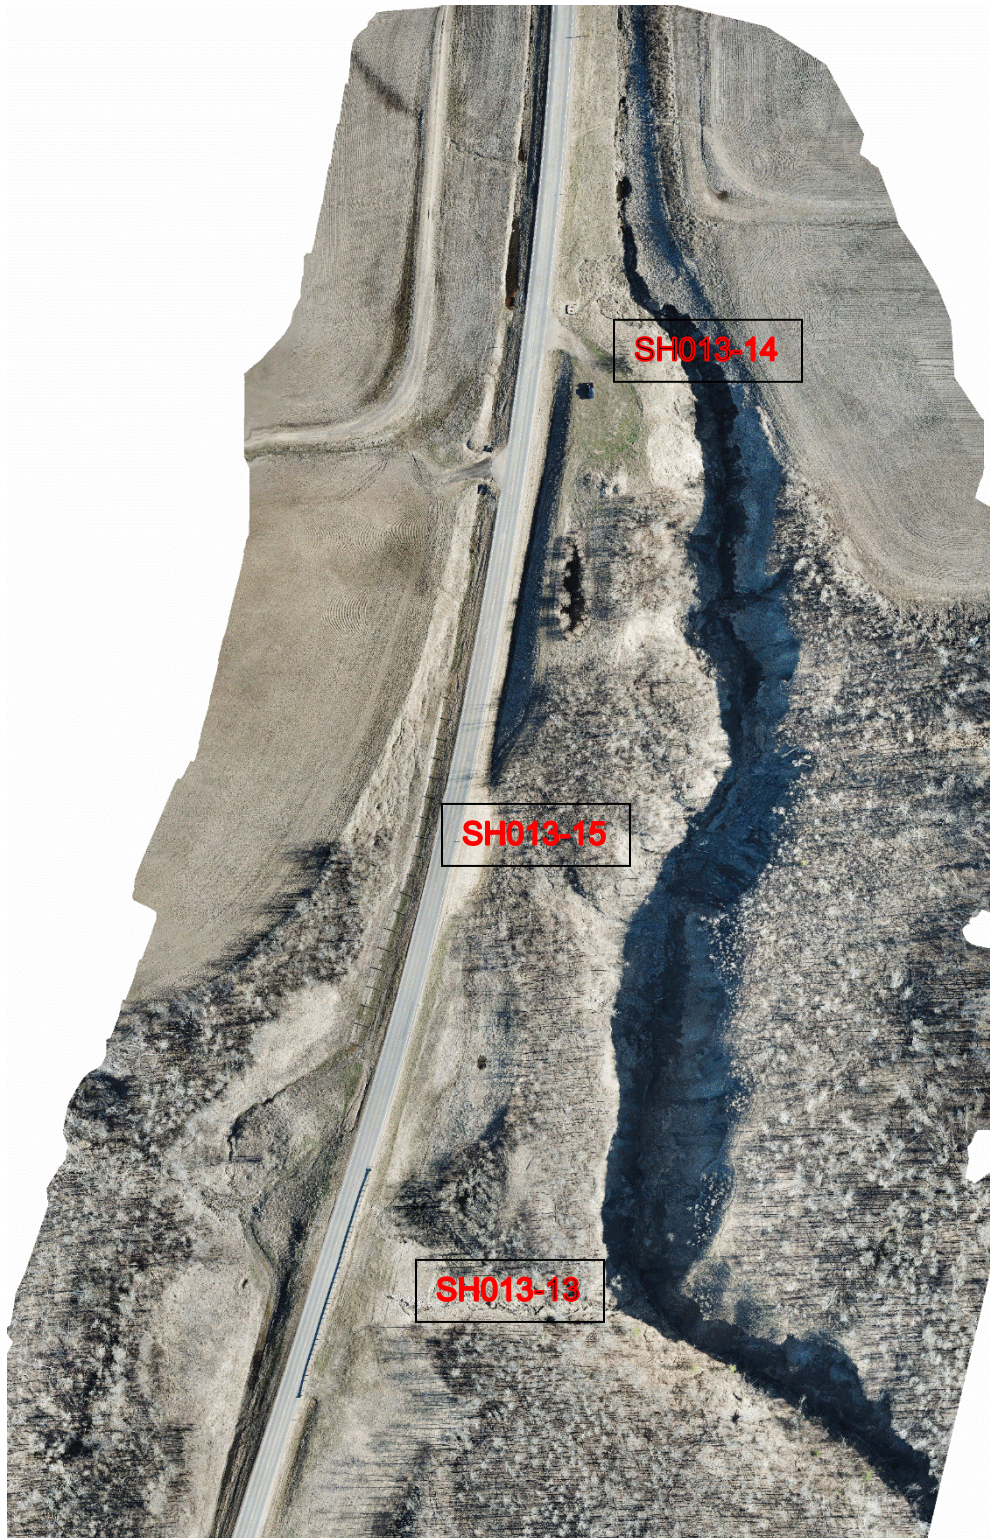
2022 UAV orthomosaic of the erosion gully at SH013-13, SH013-14, and SH013-15 locations.
