**ALBERTA TRANSPORTATION
GEOHAZARD ASSESSMENT PROGRAM
PEACE REGION – SWAN HILLS
2019 INSPECTION**

Site Number	Location	Name	Hwy	km
SH023-10	Little Smoky River	Little Smoky River Valley, North Hill – Site #10	744:02	20.20-20.40
Legal Description		UTM Co-ordinates		
NE21-76-22-W5M		11U E 478,074	N	6,161,918

SH023-10: HWY 744:02 LITTLE SMOKY RIVER VALLEY 2019 SITE INSPECTION PLAN

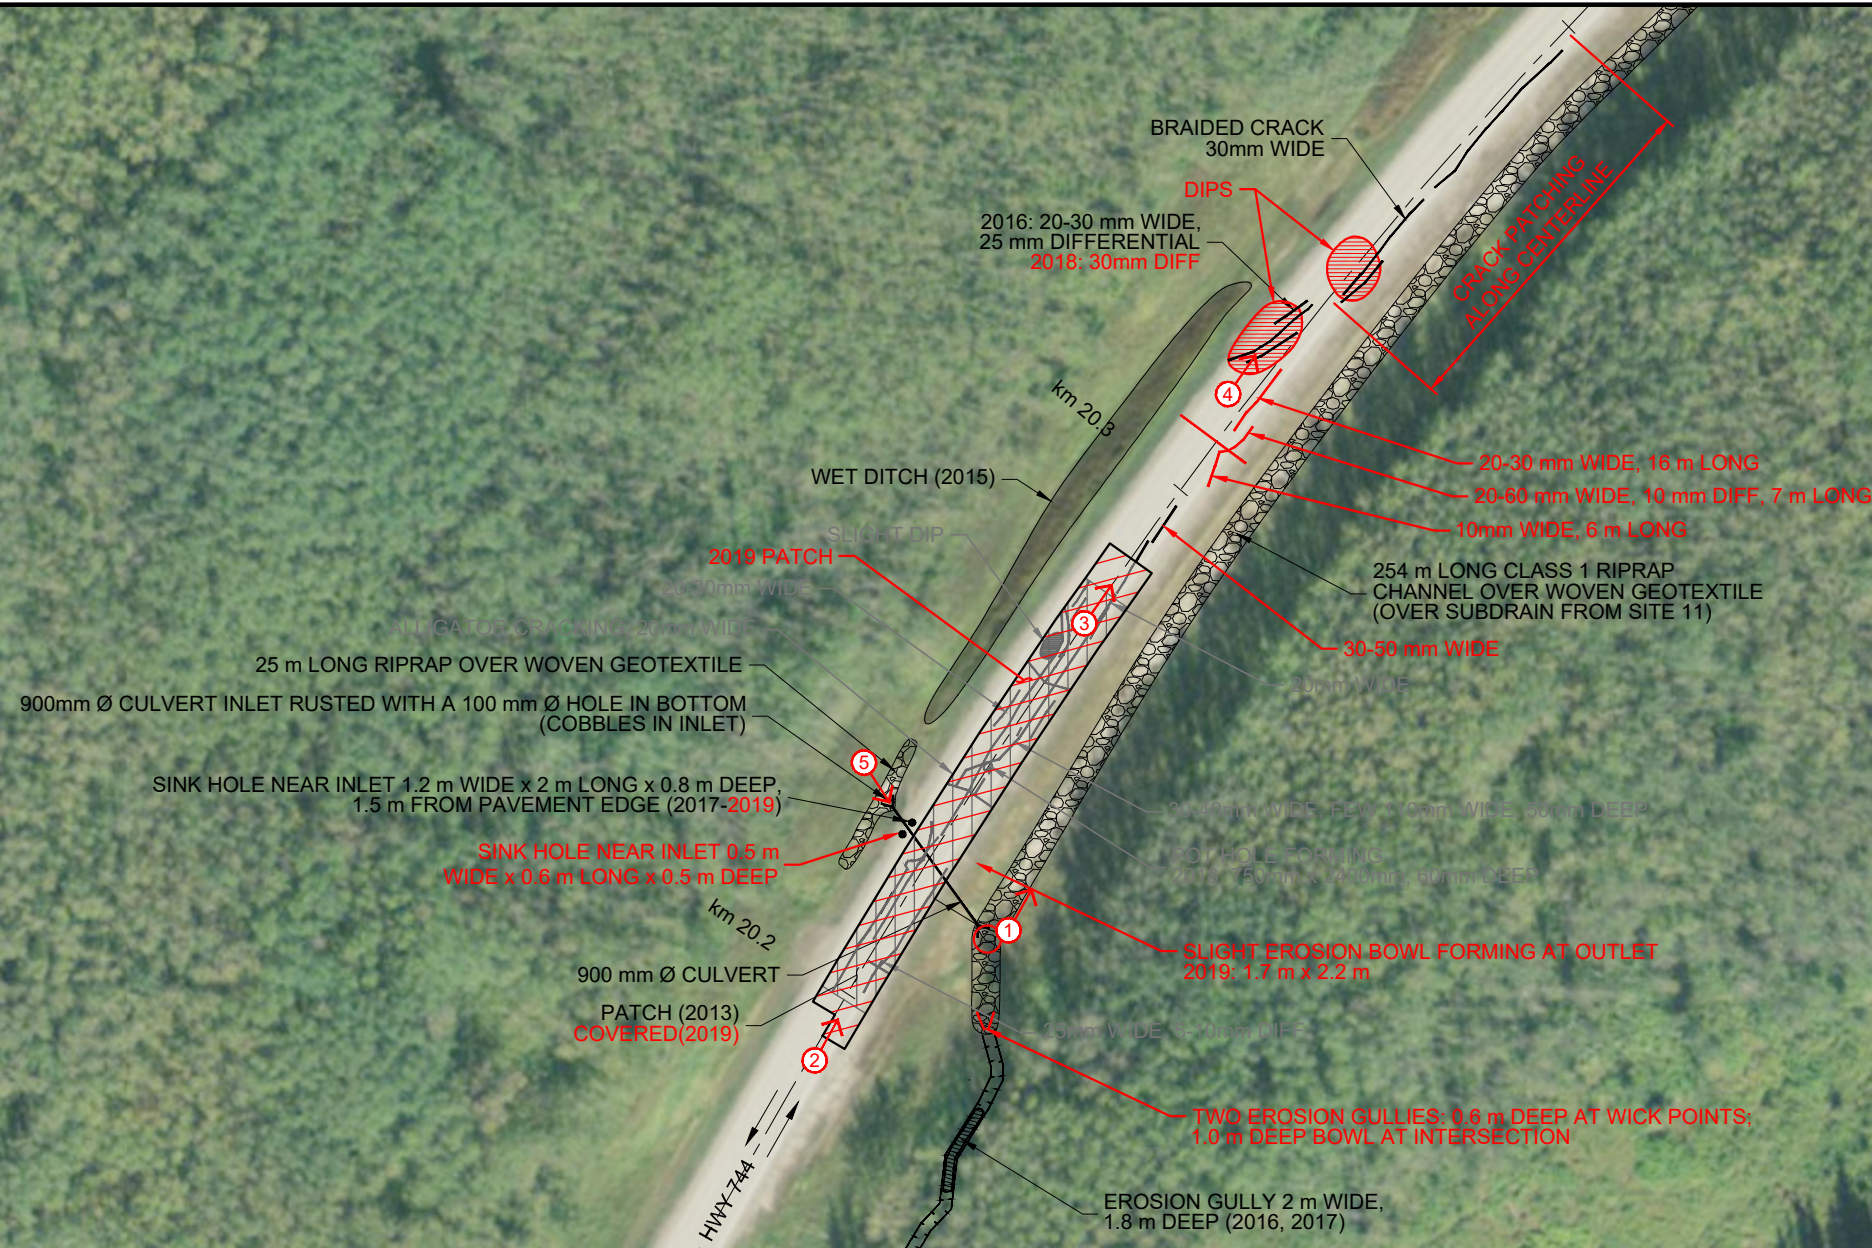
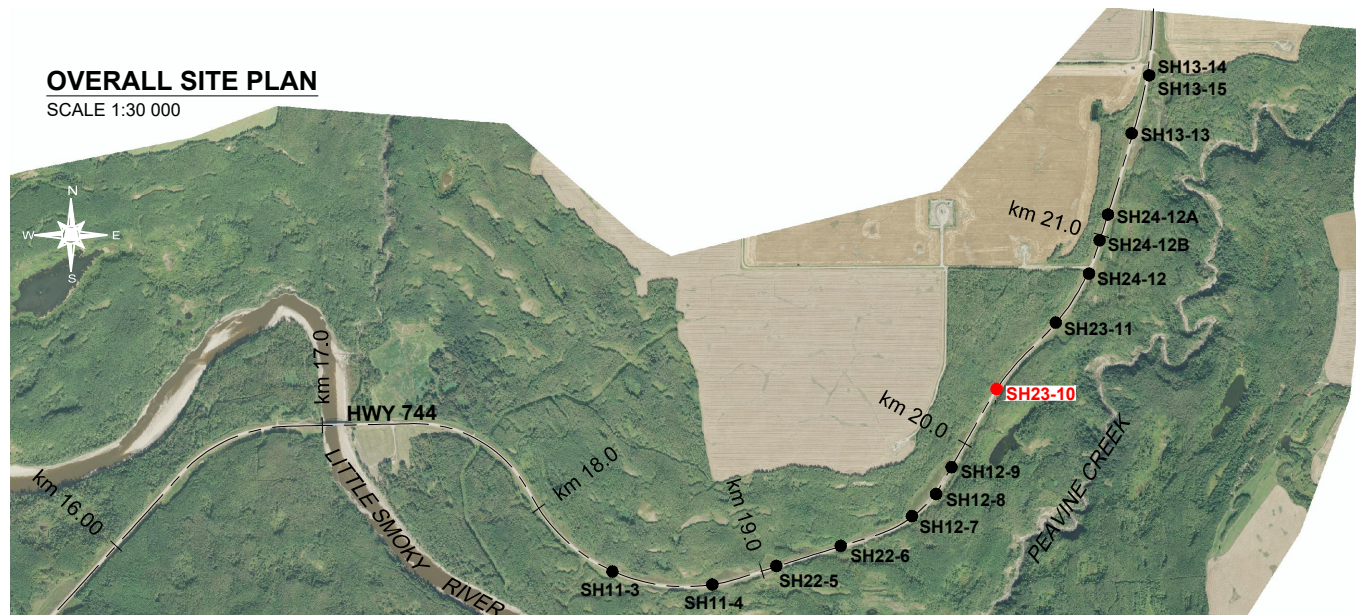
1. FEATURE LOCATIONS ARE APPROXIMATE.
2. PREVIOUS OBSERVATIONS SHOWN IN BLACK (2013-2015 FROM AMEC FIGURE 1, PROJECT EG10030, PROVIDED BY ALBERTA TRANSPORTATION).
3. JUNE 2019 OBSERVATIONS SHOWN IN RED.
4. CRACKS IN AREA OF 2019 PATCH WERE NOT VISIBLE AT TIME OF SITE INSPECTION

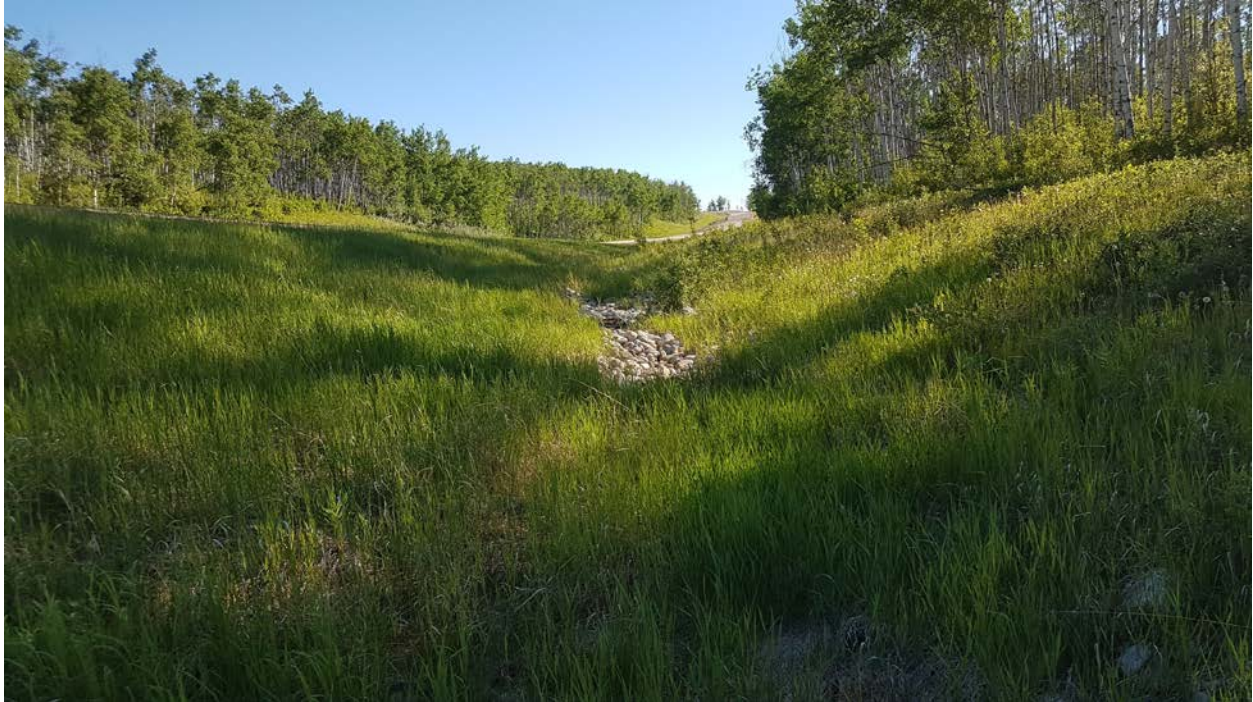
Photo 1 – Looking northeast along downslope ditch.

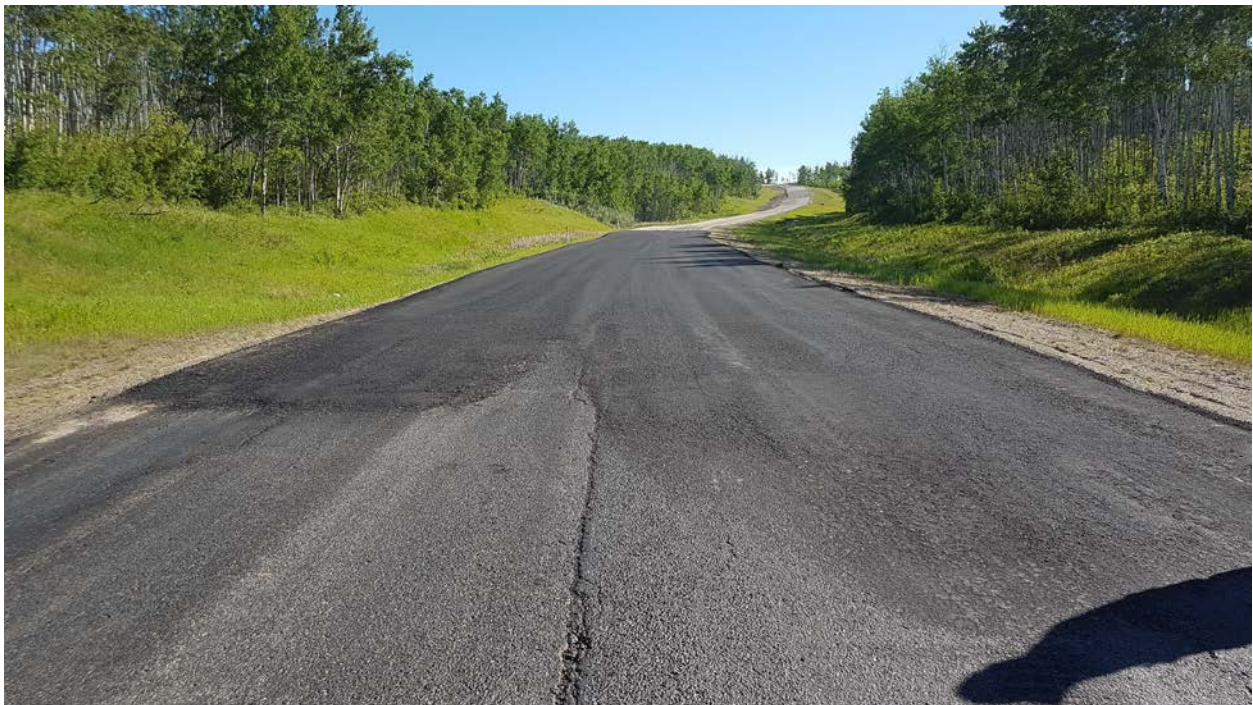
Photo 2 – Looking northeast from southwest end of recent patch and Site. Note longitudinal cracking.

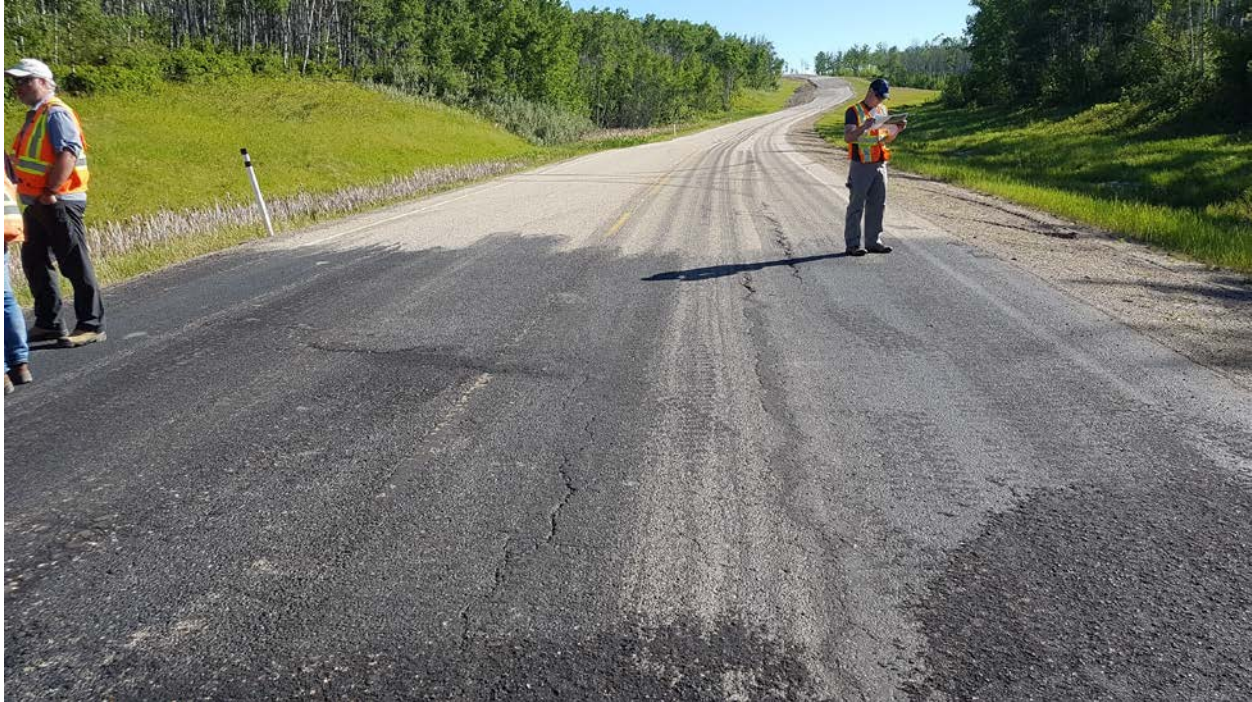
Photo 3 – Looking northeast at longitudinal cracking near northeast end of recent patch and Site.

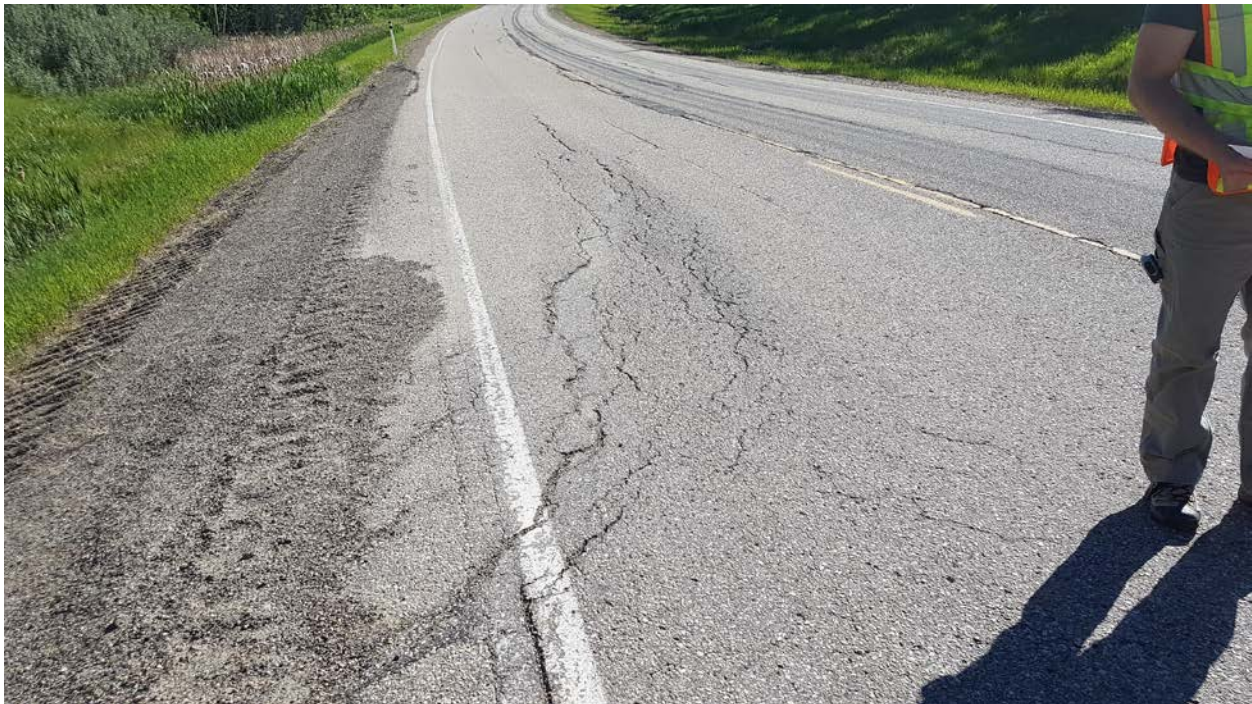
Photo 4 – Looking northeast at scarp crack northeast of patched section.

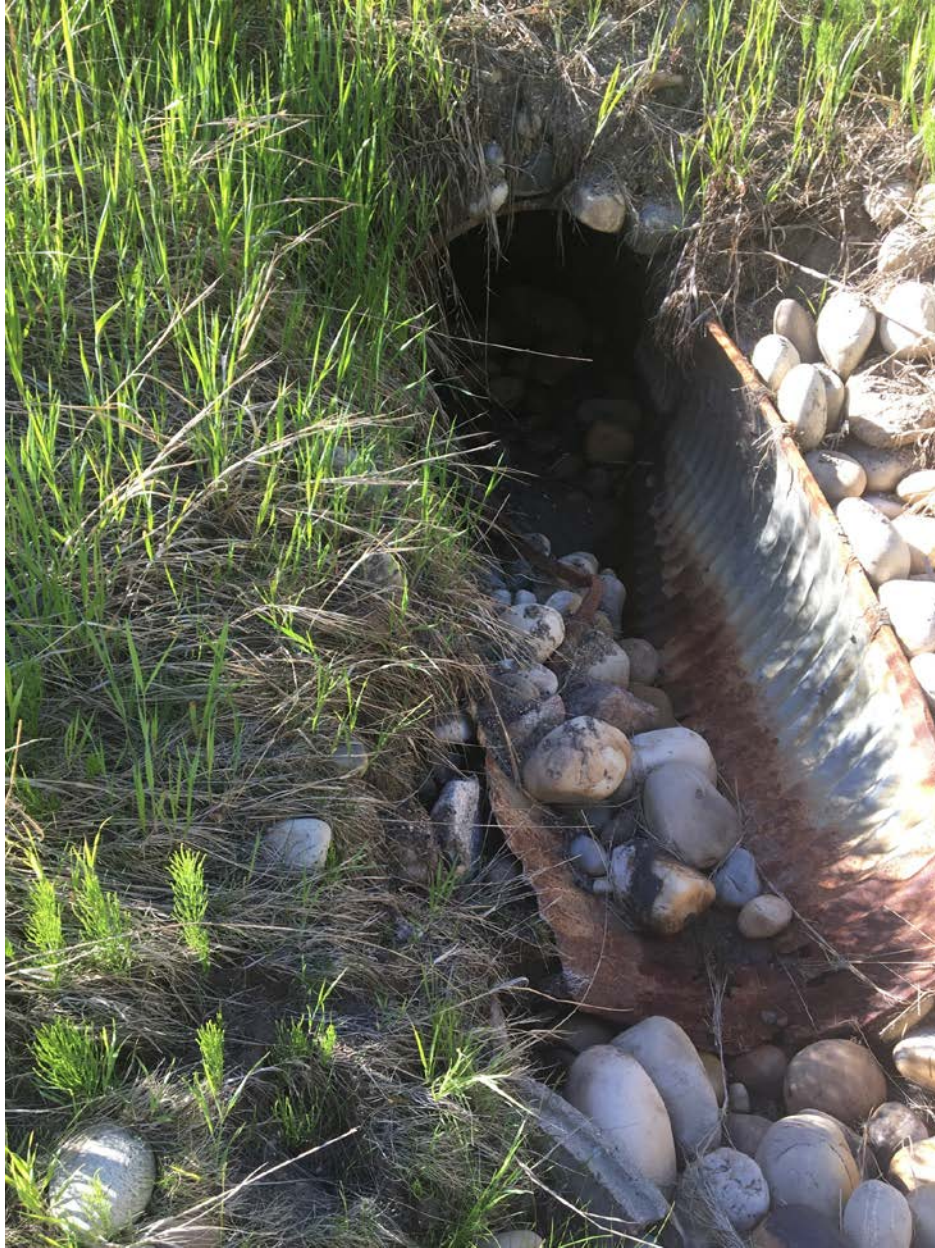
Although this Site #10 is located on the unstable valley slope with a significant sag pond located below the site, landslide movements have not been consistently observable at this site with most cracking being transverse or longitudinal. However, the minor vertical distortion at the northeast end of the Site appears to be collapsing into a definable pattern though it may also be related to soft subgrade soils given the historically wet upslope ditch. The angled crack noted about 35 m northeast of the northeast end of the patch may be scarp-related. Portions of the 2013 ACP patch had been breaking out at the centerline and was recently patched. Historically, there has also been problems with erosion of the ditches following high precipitation events. The erosion gully forming away from the highway below the riprap apron had noticeable deteriorated since 2018. There is now a second sinkhole forming near the culvert inlet but the size of the initial sinkhole appears relatively unchanged since 2018.

Photo 5 – Looking at culvert inlet distress: partial obstruction with cobbles from ditch lining and sinkhole (not visible in photo) forming near edge of the highway shoulder.

- The culvert inlet at km 20.22 should be repaired to prevent subsurface infiltration and/or piping.
- An asphalt overlay could be applied throughout the length of the valley crossing to “reset” the road surface, although cracks and distortions will re-appear over time.
