**ALBERTA TRANSPORTATION
GEOHAZARD ASSESSMENT PROGRAM
PEACE REGION – SWAN HILLS
2019 INSPECTION**

| Site Number | Location | Name | Hwy | km |
|---|---|---|---|---|
| SH023-11 | Little Smoky River | Little Smoky River Valley, North Hill – Site #11 | 744:02 | 20.46-20.79 |

**SH023-11: HWY 744:02 LITTLE SMOKY RIVER VALLEY
2019 SITE INSPECTION PLAN**

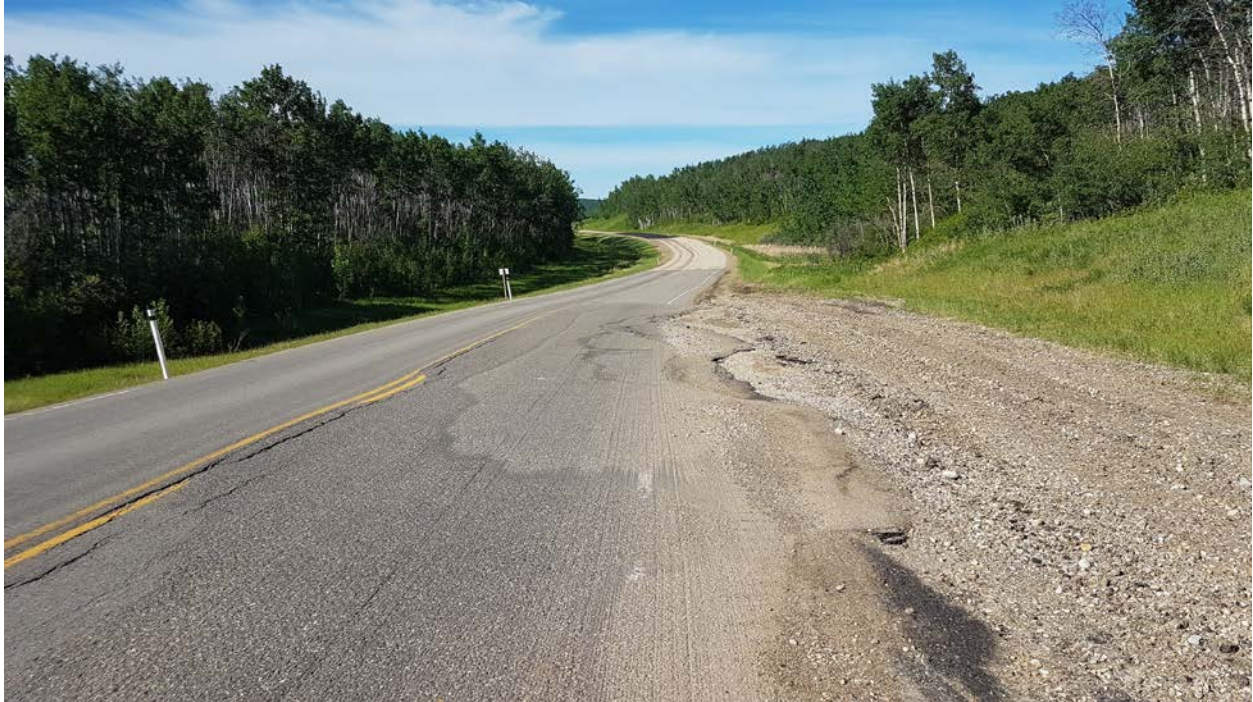
Photo 1 – Looking southwest at the southwest end of the main scarp crack through Site 11.

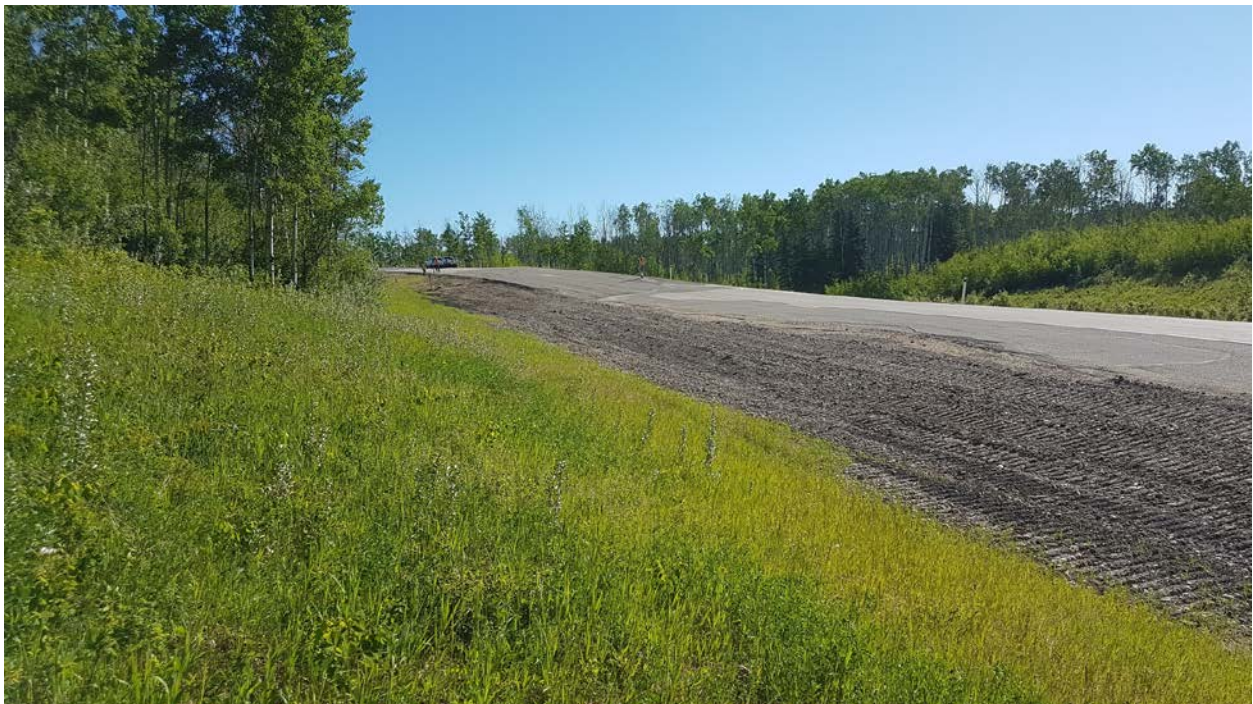
| <input checked="" type="checkbox"/> Erosion | 95 m-long gully formed in upslope ditch exposing erosion control fabrics near the west end was regraded in 2019 using milled material. | <input type="checkbox"/> | |

Photo 2 – Looking east at vertical distortion of highway at south end of site and regraded sideslope where there had been a significant gully.

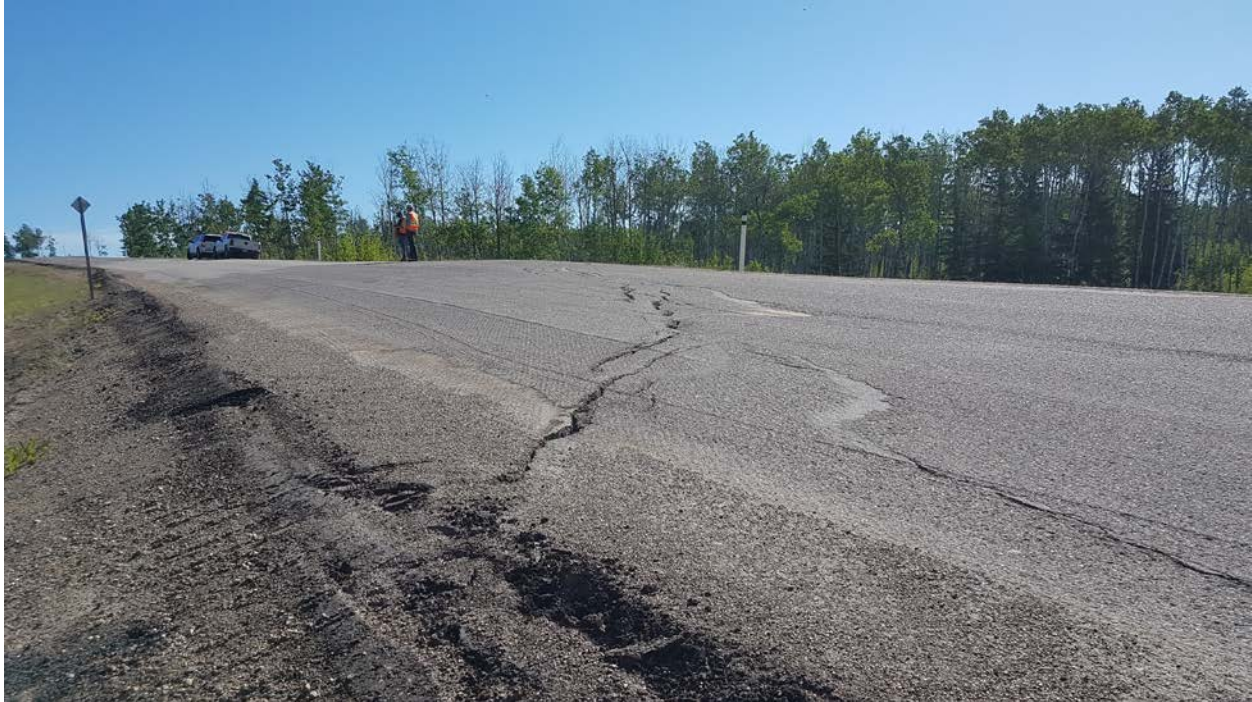
Photo 3 – Looking east at main scarp crack crossing highway (see Photo #4).

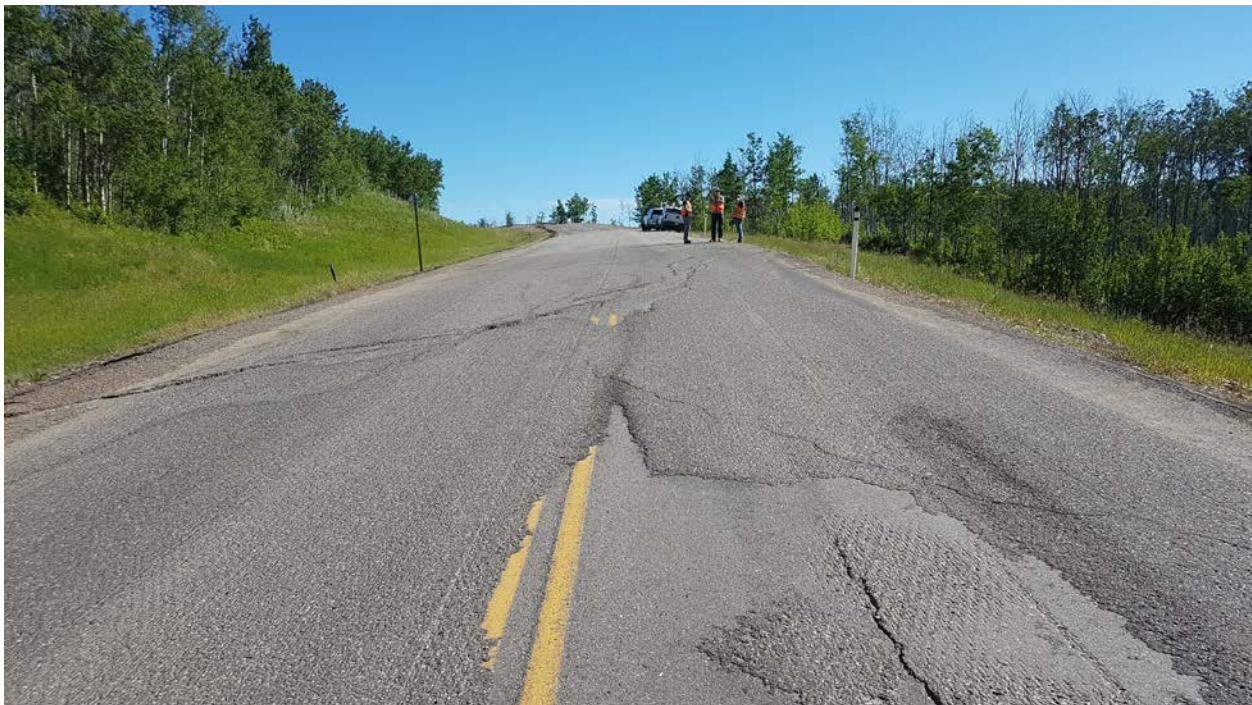
Photo 4: Looking northeast where main scarp crack crosses the highway at the central portion of Site 11.

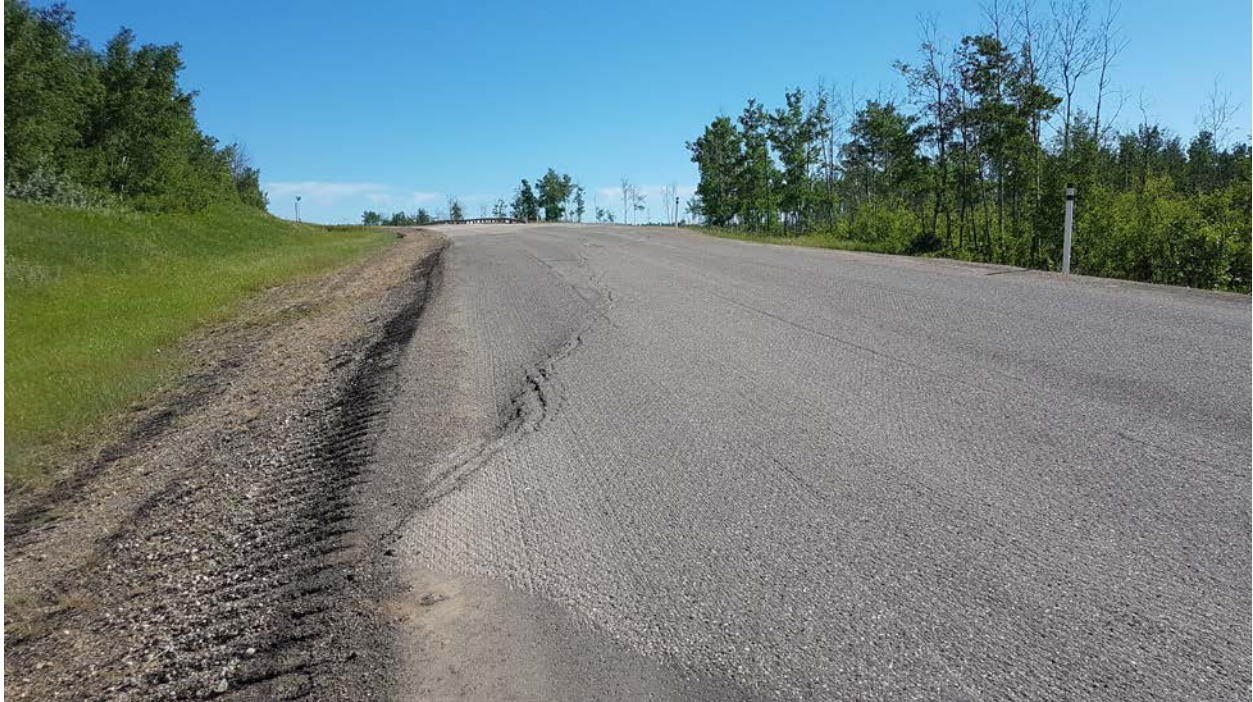
Photo 5 – Looking northeast at north scarp crack.

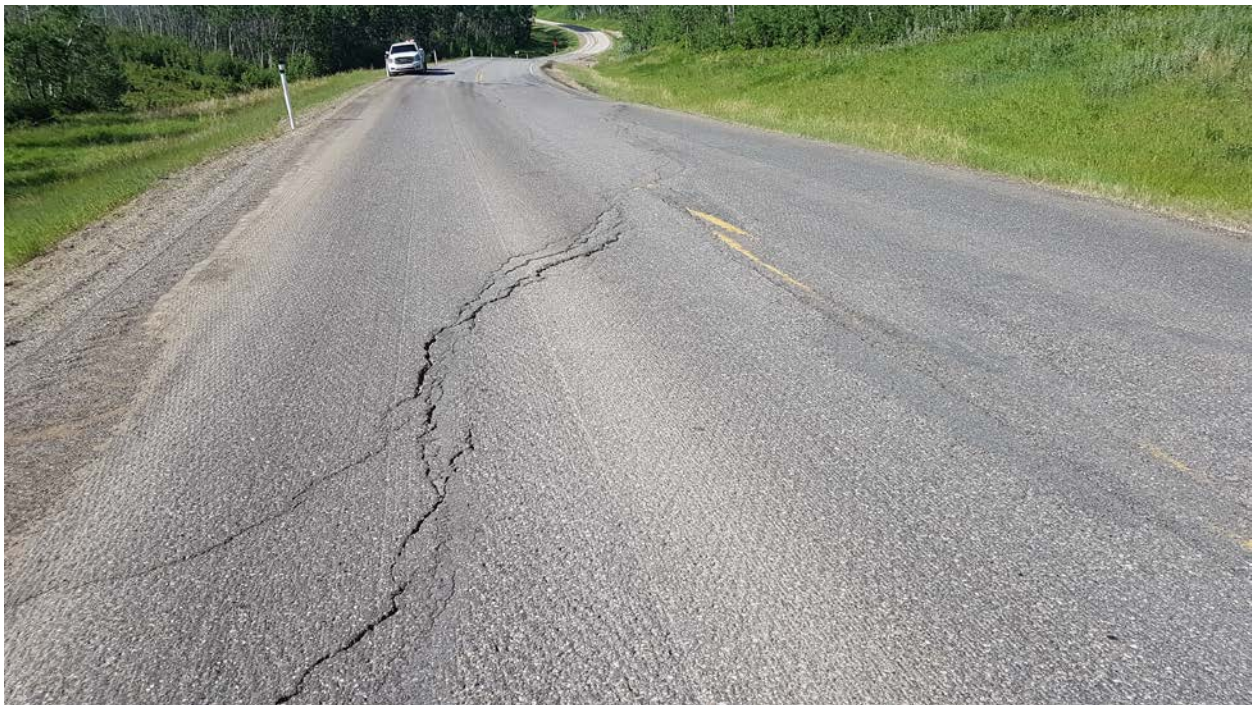
Photo 6 – Looking southwest at north scarp crack.
