**ALBERTA TRANSPORTATION
GEOHAZARD ASSESSMENT PROGRAM
PEACE REGION – SWAN HILLS
2022 INSPECTION**

Site Number	Location	Name	Hwy	km
SH023-10	Little Smoky River	Little Smoky River Valley, North Hill – Site #10	744:02	20.20-20.40
Legal Description		UTM Co-ordinates		
NE21-76-22-W5M		11U E 478,074	N	6,161,918

**SH023-10: HWY 744:02 LITTLE SMOKY RIVER VALLEY
2022 SITE INSPECTION PLAN**

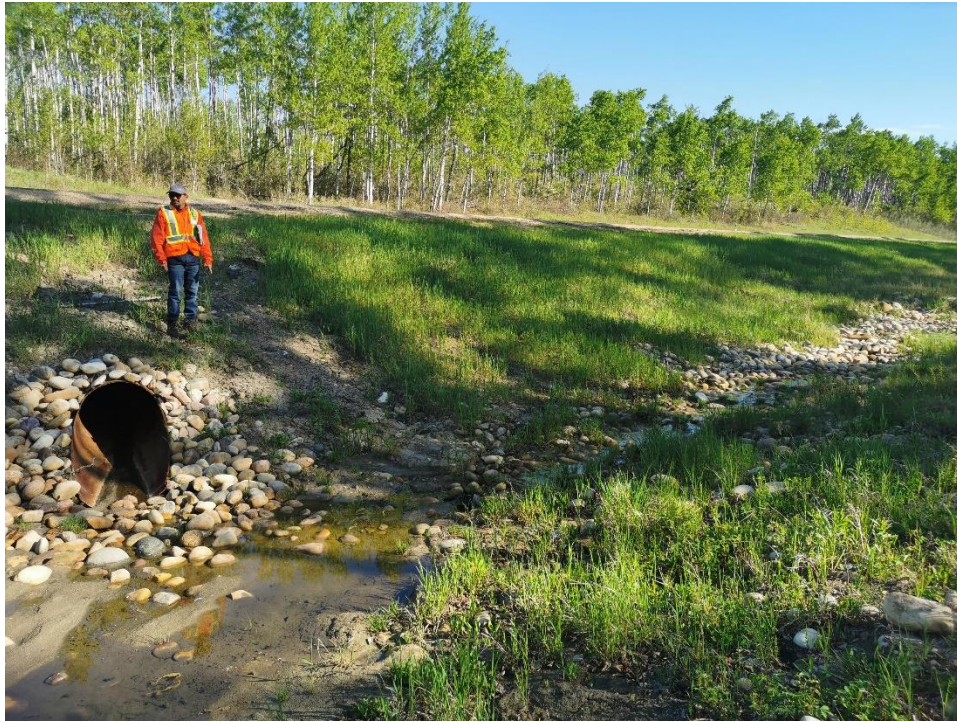
Photo 1 – Looking northeast along downslope ditch.

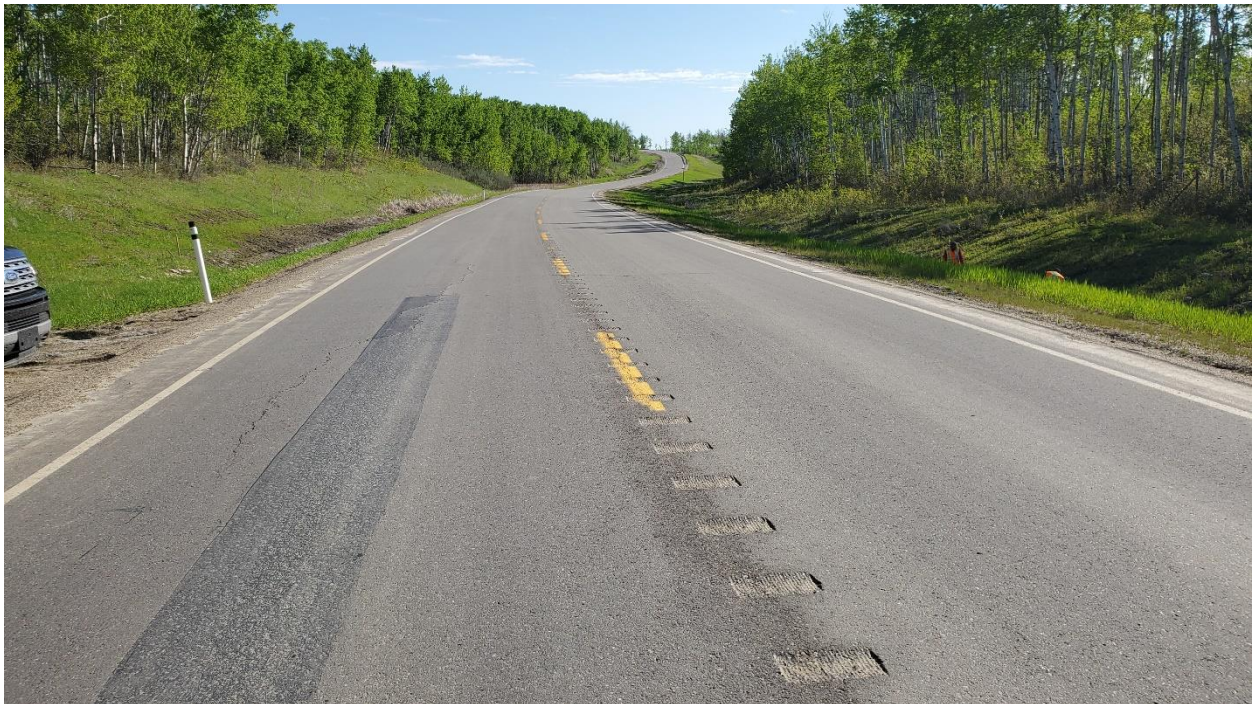
Photo 2 – Looking northeast from southwest end of Site.

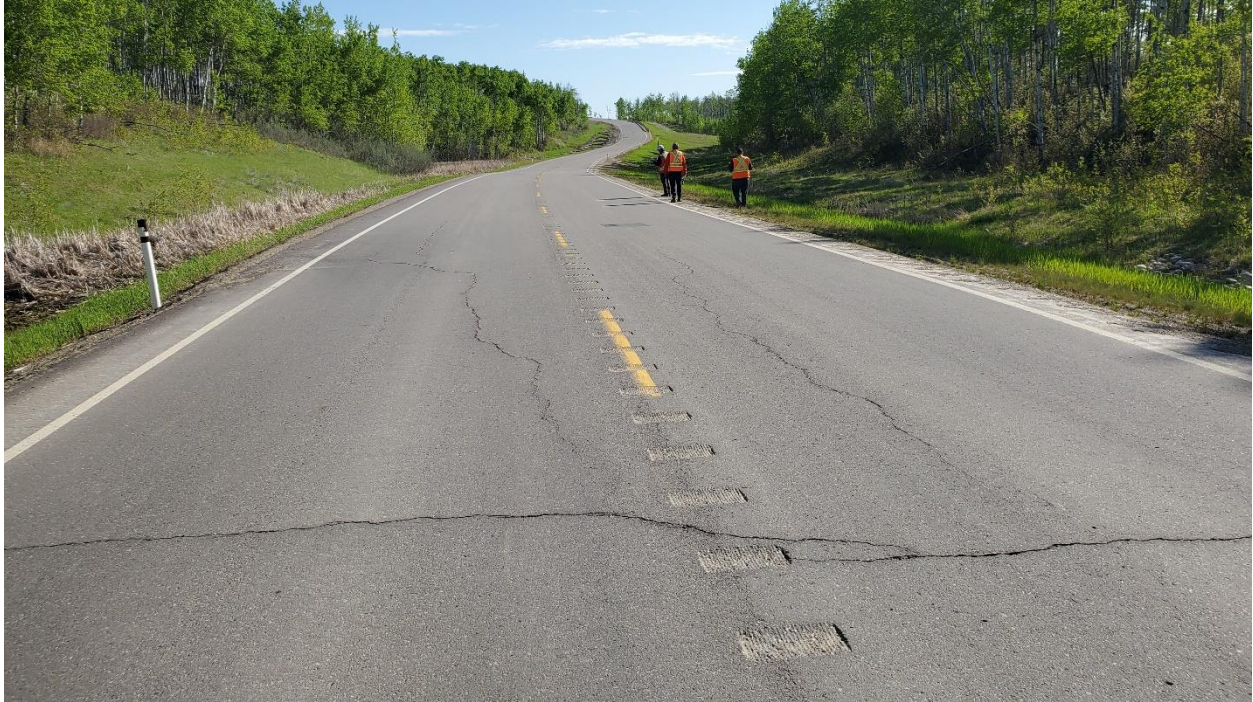
Although this Site #10 is located on the unstable valley slope with a significant sag pond located below the site, landslide movements have not been consistently observable at this site with most cracking being transverse or longitudinal. There is a noticeable dip in the highway profile which could also be related to soft subgrade soils given the historically wet upslope ditch. Previously observed vertical distortions and angled cracks were not present during the 2022 inspection since the highway was overlaid in 2021. However, a few longitudinal and transverse cracks have started to reflect.

Photo 3 – Looking northeast at cracking that is starting to surface around km 20.26 (just northeast of the culvert).

- Road maintenance should continue as necessary to maintain a safe roadway surface and may consist of ACP milling, patching, and crack sealing.

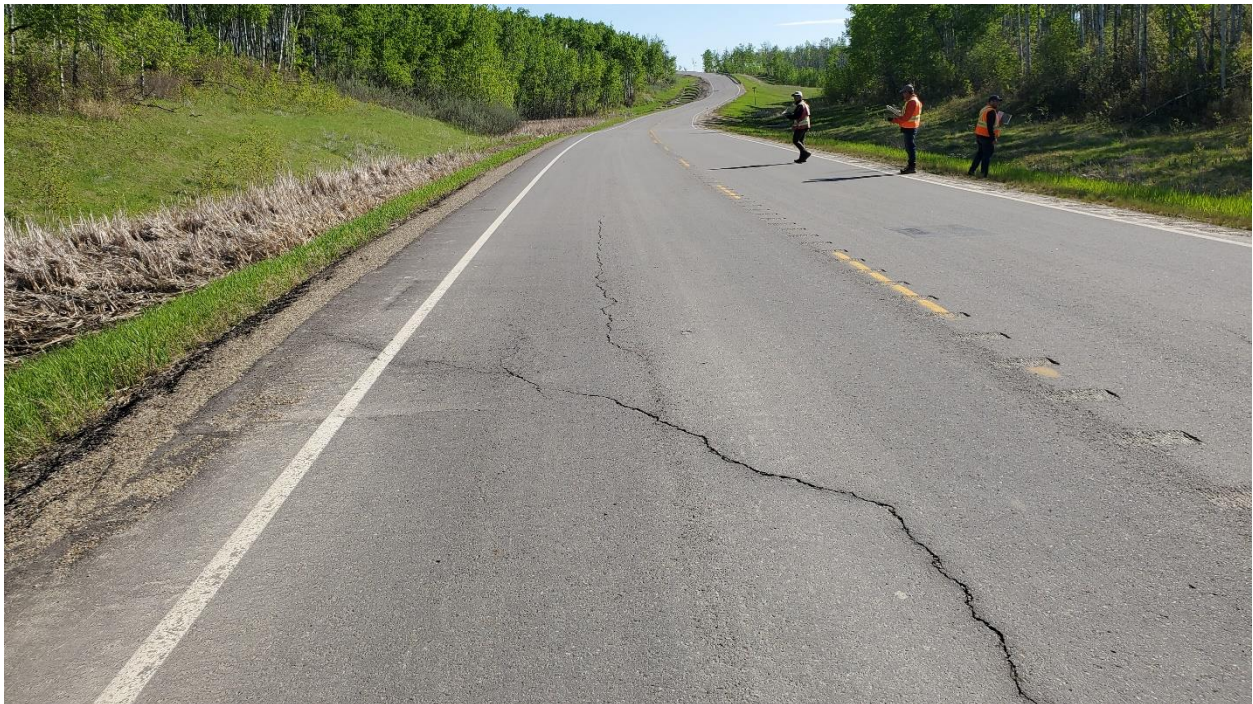
Photo 4 – Looking northeast at potential scarp crack northeast of Photo 3.

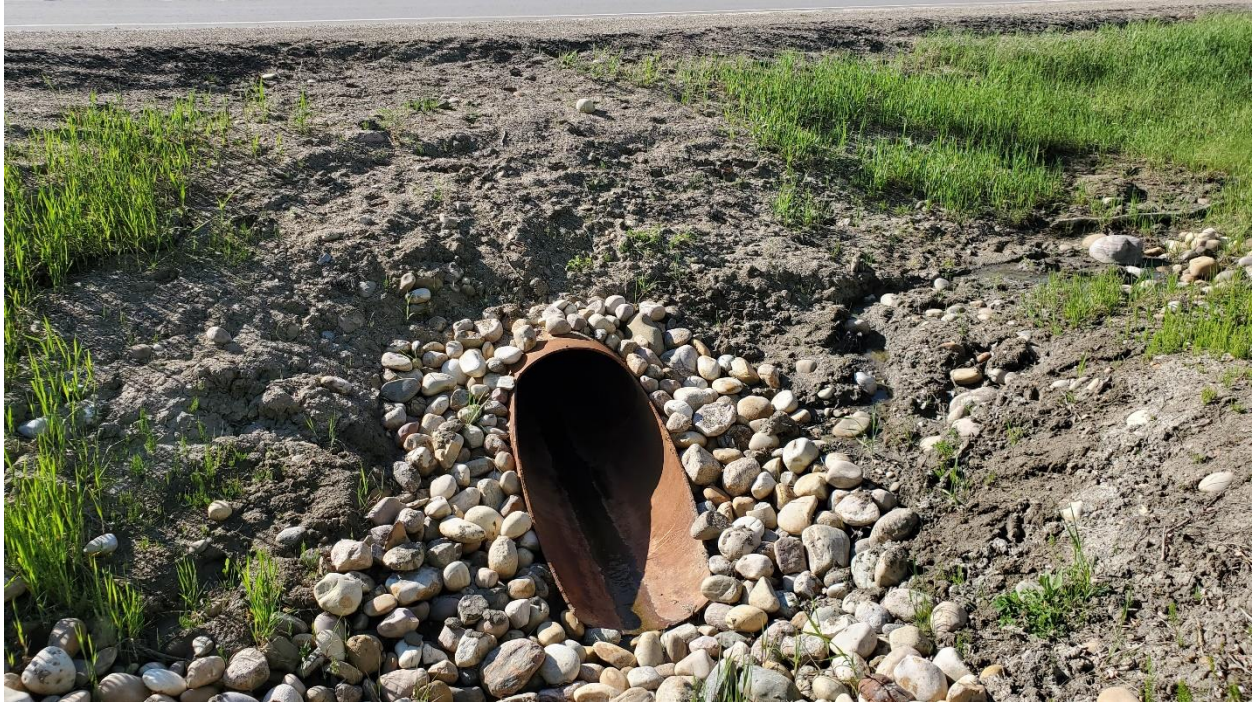
Photo 5 – Looking at inlet of new culvert at km 20.22. Note minor rill forming on the right-hand side of the photo.

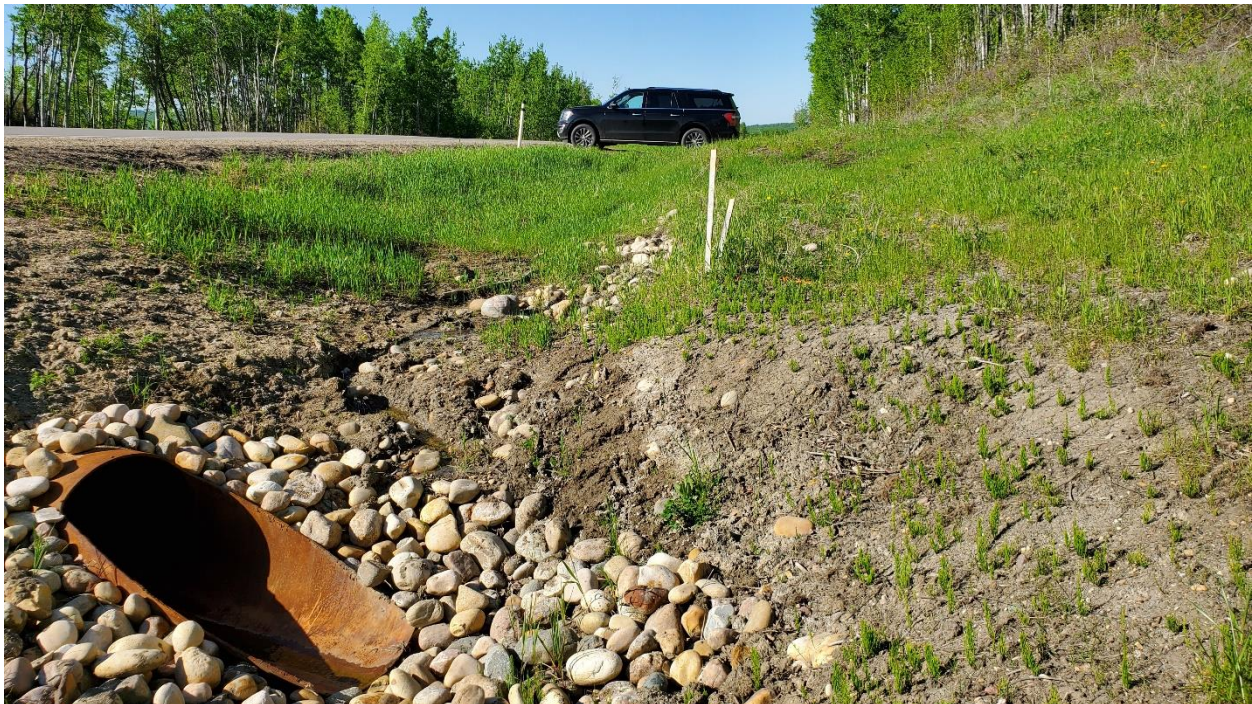
Photo 6: Erosion adjacent to km 20.22 culvert inlet (right side of Photo 5).

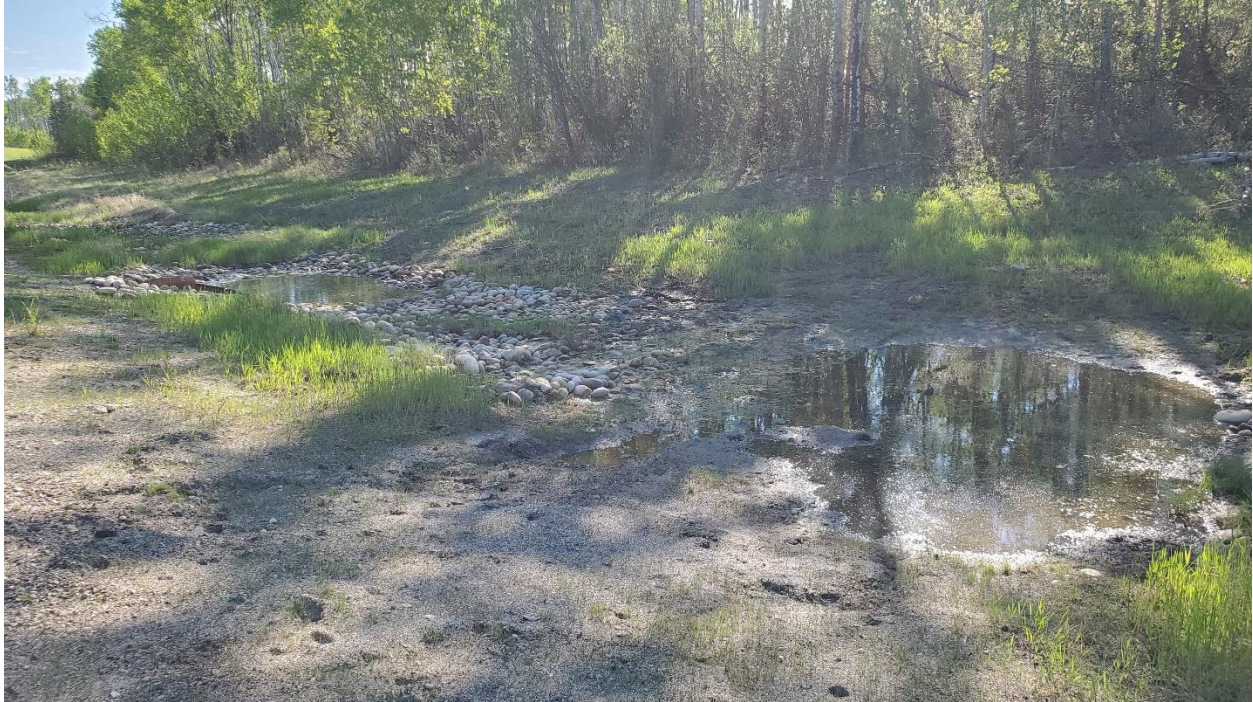
Historically, there has also been problems with erosion of the ditches following high precipitation events. The erosion gully forming away from the highway below the riprap apron had noticeably deteriorated since 2018. New SWSP culverts were installed at km 20.22 and at km 20.38. Culvert at km 20.38 is 50 percent full and ponded water was observed at the outlet. Standing water was observed in the east ditch which is an indication of poor drainage at the site.

Photo 7: Ponding water in reggraded downslope ditch at the km 20.38 culvert outlet.

- Minor regrading could be carried out to allow drainage of the ponded water at the north culvert and standing water observed in the east ditch.

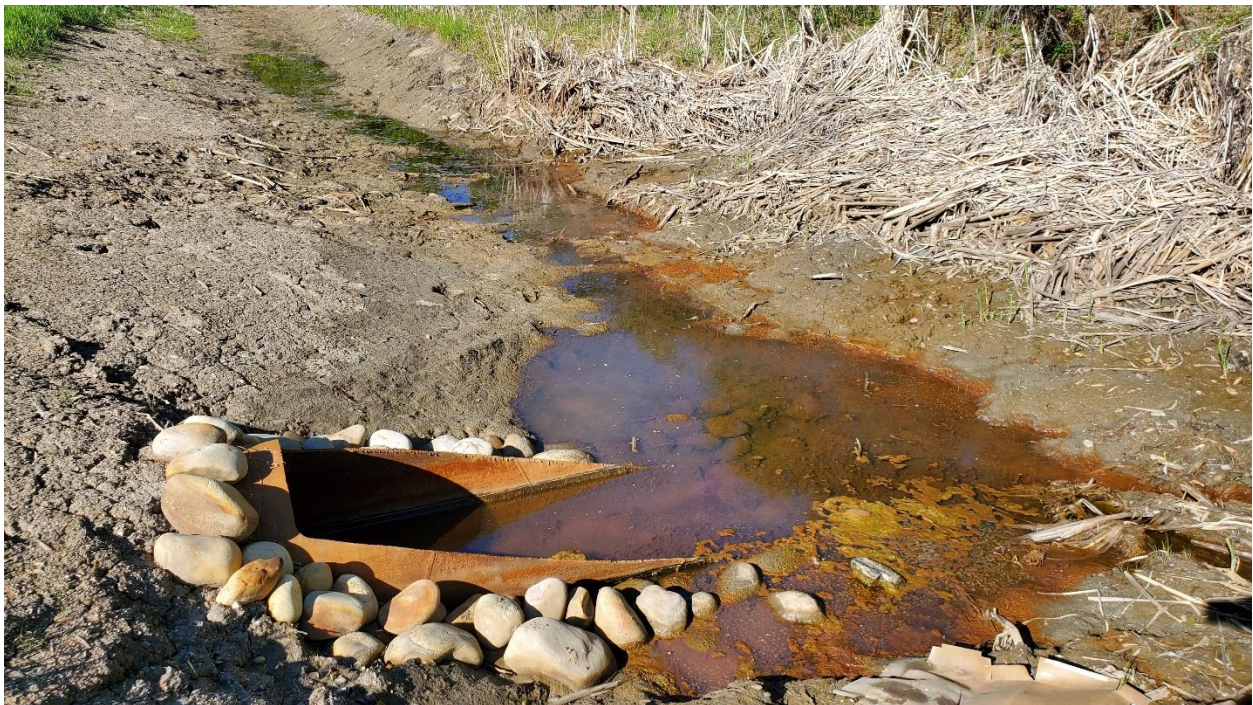
Photo 8: Poor drainage and ponding water at the km 20.38 culvert inlet.
