**ALBERTA TRANSPORTATION
GEOHAZARD ASSESSMENT PROGRAM
PEACE REGION – SWAN HILLS
2020 INSPECTION**

Site Number	Location	Name	Hwy	km
SH024-12 SH024-12B* SH024-12A* SH024-12D**	Little Smoky River	Little Smoky River Valley, North Hill – Sites #12, #12B, #12A, and #12D	744:02	20.80-20.90 20.94-21.03 21.03-21.12 21.17-21.30
Legal Description		UTM Co-ordinates		
Site 12: NE21-76-22-W5M		11U E 478,432	N	6,162,375
Site 12B: NE21-76-22-W5M		11U E 478,472	N	6,162,492
Site 12A: NE21-76-22-W5M		11U E 478,504	N	6,162,588
Site 12D: NE21- and SE28-76-22-W5M		11U E 478,550	N	6,162,737

**SH024-12: HWY 744:02 LITTLE SMOKY RIVER VALLEY
2020 SITE INSPECTION PLAN**

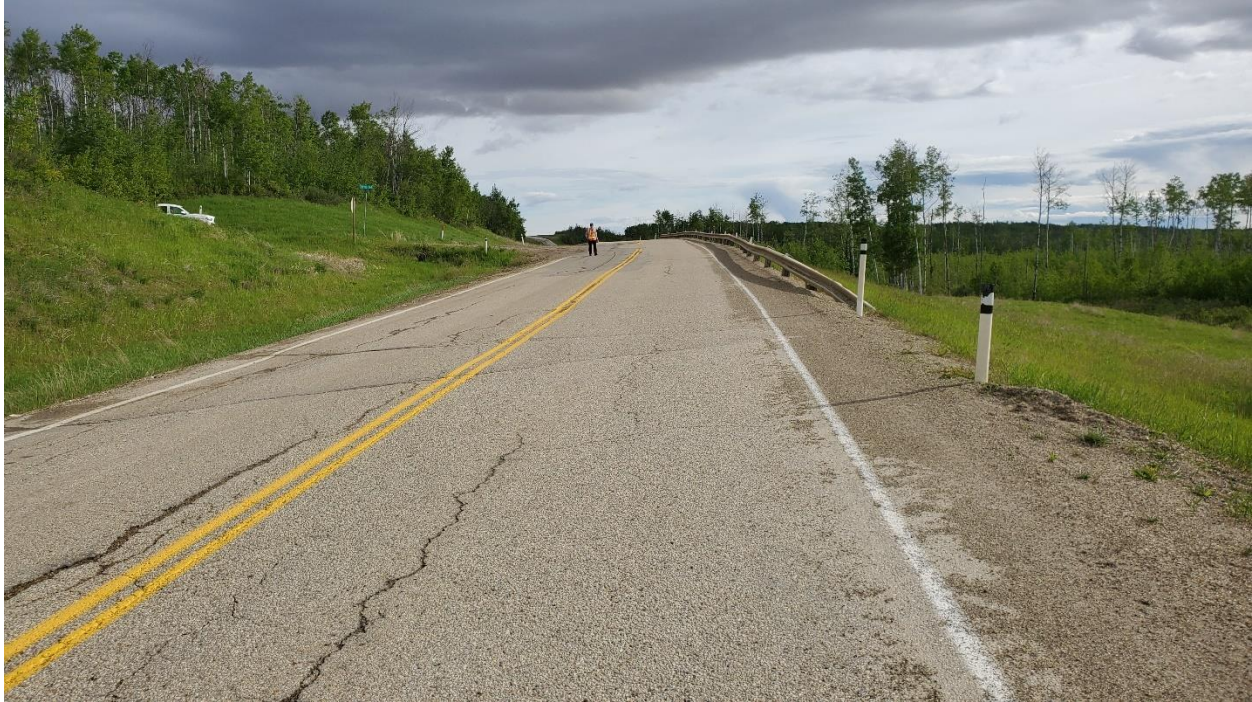
Maintenance:	Routine ACP crack sealing, milling, and patching, when required. 2019: Milling over most of the sites 2020: Line painting		
Observations (Site 12):	Description	Worsened?	
<input checked="" type="checkbox"/> Pavement Distress	Vertical distortion over historical scarp crack and associated cracking.	<input checked="" type="checkbox"/>	
<input checked="" type="checkbox"/> Slope Movement	Site is located on an active deep-seated landslide moving toward the Peavine Creek. There is vertical and horizontal distortion of the guardrail.	<input checked="" type="checkbox"/>

Photo 1, Site 12 – Looking northeast over toe berm. Note vertical and horizontal deformation of the guardrail.

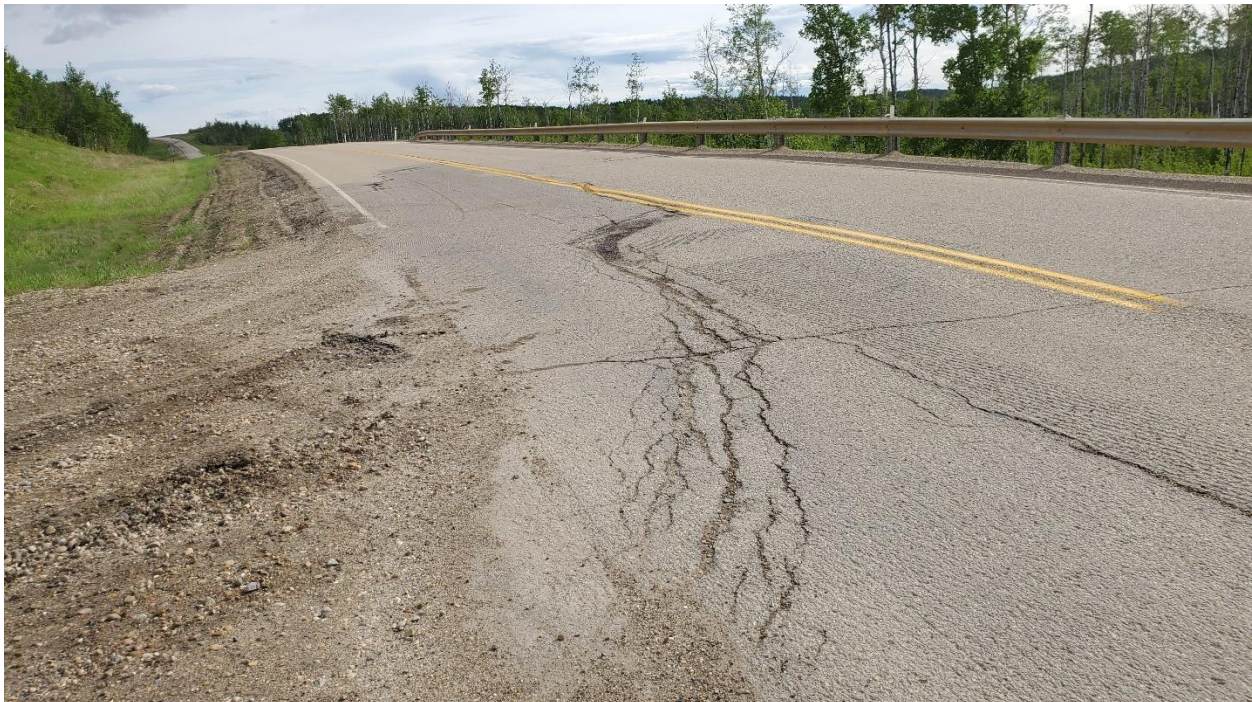
Photo 2, Site 12 – Looking north from TR764 intersection at main scarp crack.

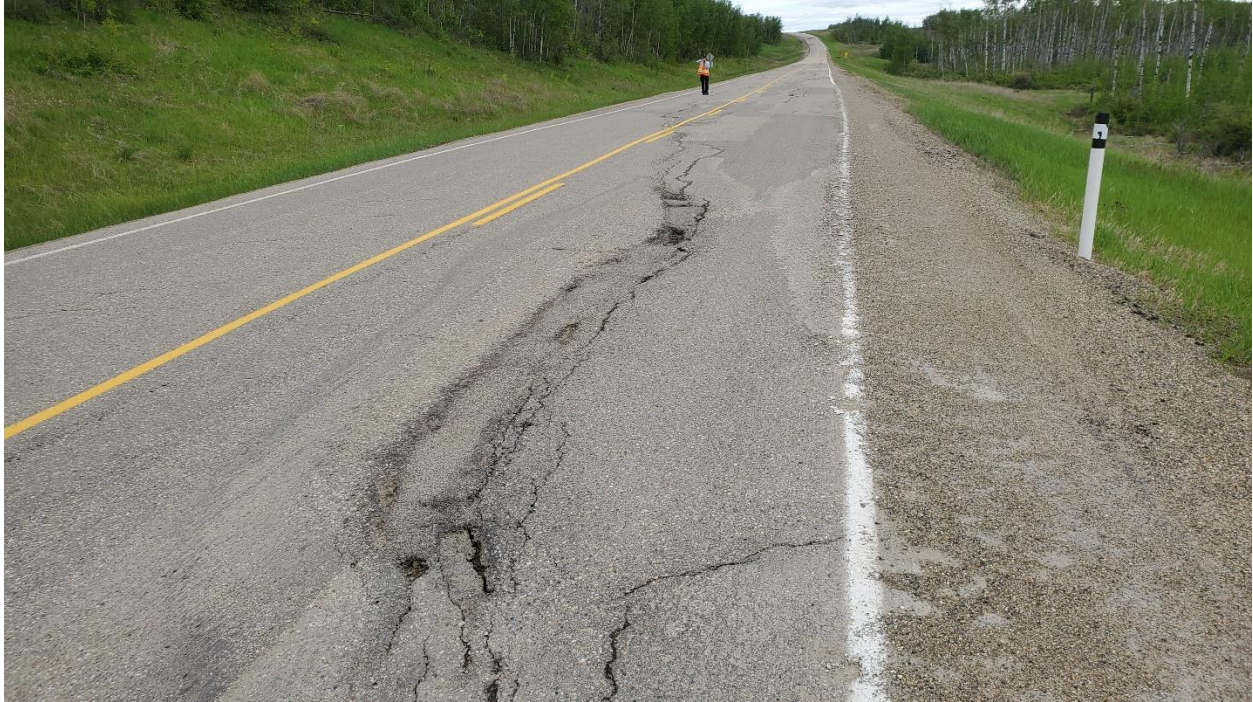
Photo 3, Site 12B: Looking north at deteriorating patch over crack at south end of site.

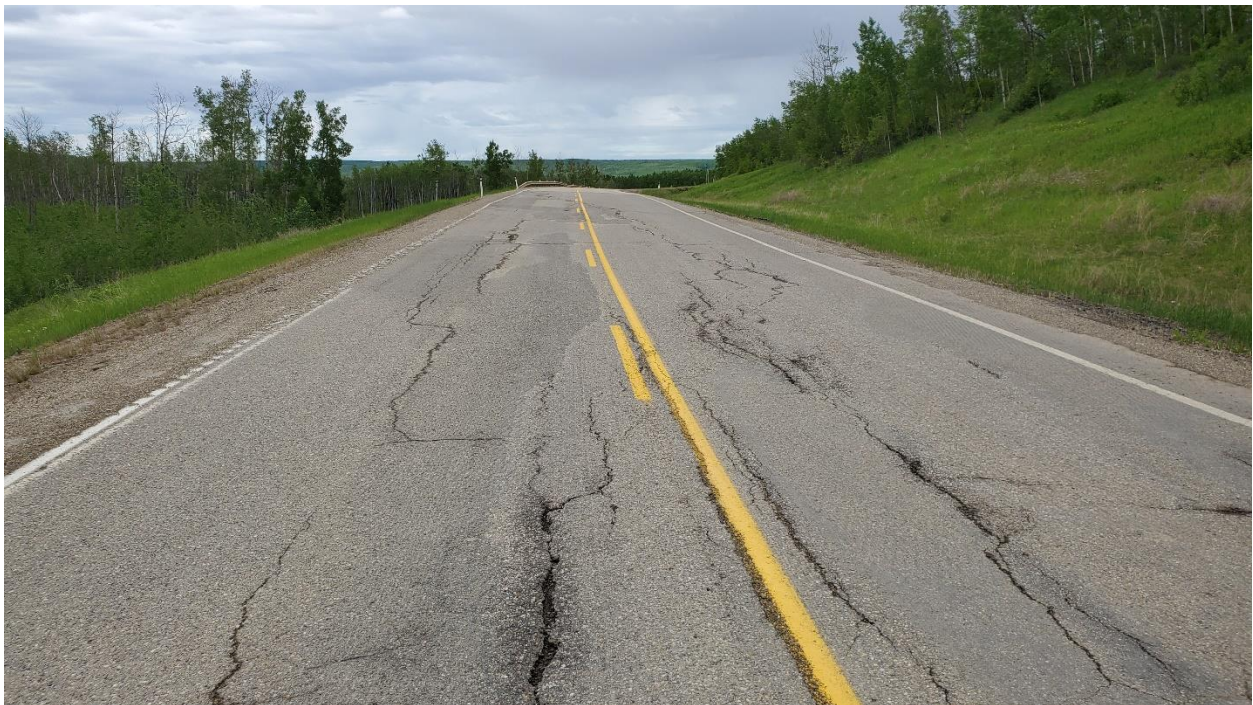
This site, an area of additional cracking between the two toe berms at Site #12 and Site #12A, was discontinued from the GeoHazard Assessment program in 2007. At the time of the 2016 inspection, there appeared to be a long crack roughly parallel to the highway that may be associated with slope movement and the width and extents of cracking have increased slightly each year following. The recent milling appears to have exposed previously-covered cracks and there does appear to be an arc-shape to the pattern. The crack widths are on the order of 10 mm to 20 mm with some areas up to 30 mm. Some of the cracks are braided with overall widths up to 500 mm and at least had a slight dip over the width of the braided cracks.

Photo 4, Site 12B – Looking south at main crack.

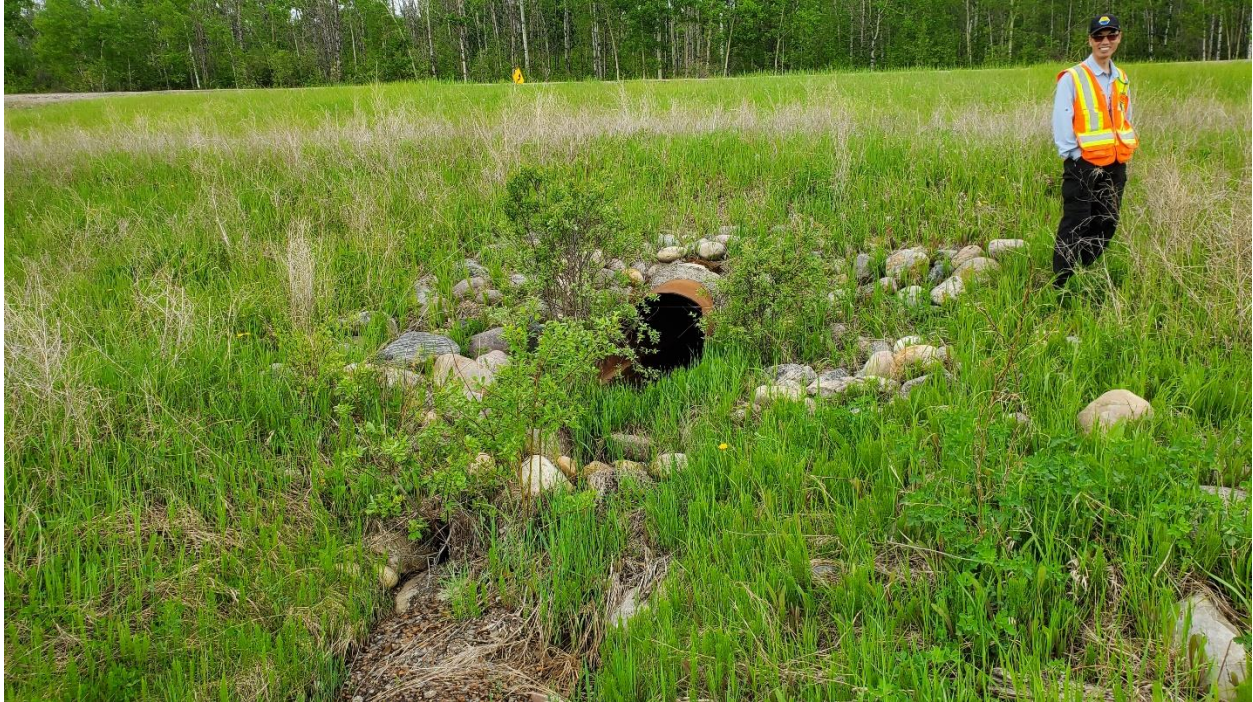
Photo 5, Site 12A – Rusting culvert liner outlet.

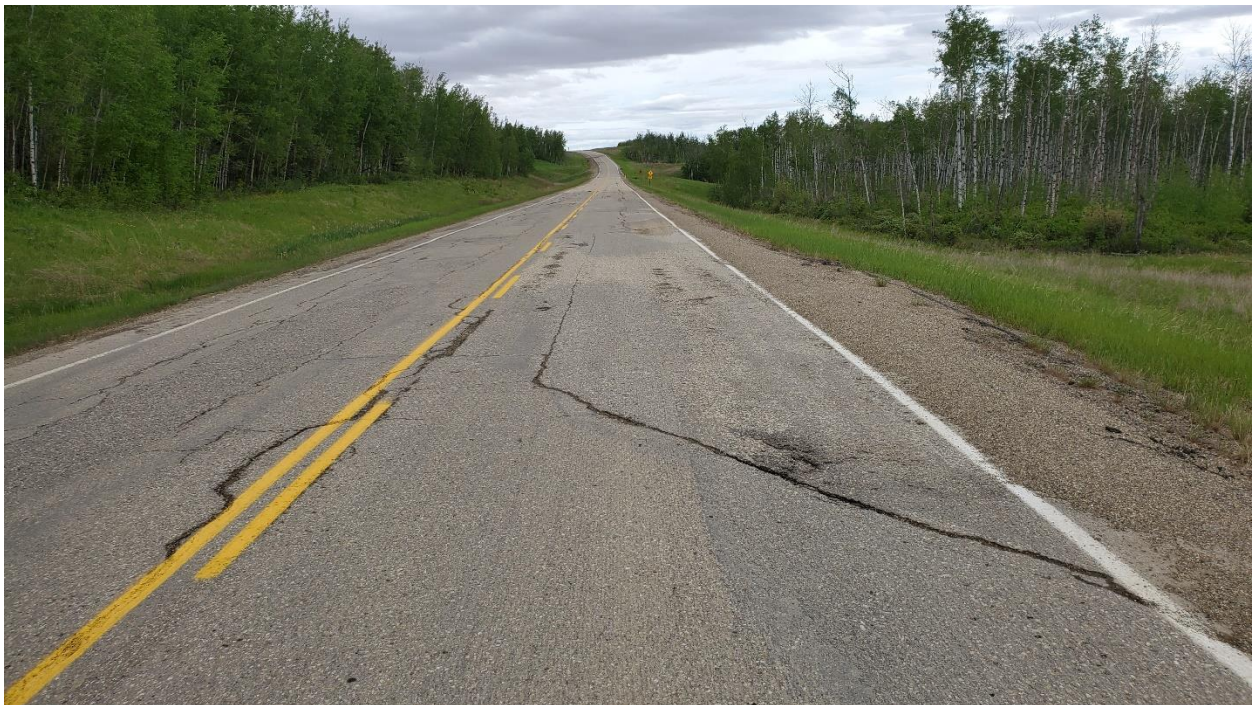
There is some longitudinal and transverse cracking along the highway above the toe berm; however, it was not apparent if this was related to subgrade issues or slope movement. The site was milled in 2019 which has exposed additional cracks. There was continued deterioration observed in 2020. Two zones of seepage were noted in the downslope ditch which may be subdrain outlets. It appears that the toe berm has been successful in stabilizing the local highway embankment at this location.

Photo 6, Site 12A – Looking north at crack forming along edge of toe berm excavation.
