**ALBERTA TRANSPORTATION
GEOHAZARD ASSESSMENT PROGRAM
PEACE REGION (PEACE RIVER DISTRICT)
2022 INSPECTION**

Site Number	Location	Name	Hwy	km
SH024-12 SH024-12B* SH024-12A* SH024-12D**	Little Smoky River	Little Smoky River Valley, North Hill – Sites #12, #12B, #12A, and #12D	744:02	20.80-20.90 20.94-21.03 21.03-21.12 21.17-21.30
Legal Description		UTM Co-ordinates		
Site 12: NE21-76-22-W5M		11U E 478,432	N	6,162,375
Site 12B: NE21-76-22-W5M		11U E 478,472	N	6,162,492
Site 12A: NE21-76-22-W5M		11U E 478,504	N	6,162,588
Site 12D: NE21- and SE28-76-22-W5M		11U E 478,550	N	6,162,737

**SH024-12: HWY 744:02 LITTLE SMOKY RIVER VALLEY
2022 SITE INSPECTION PLAN**

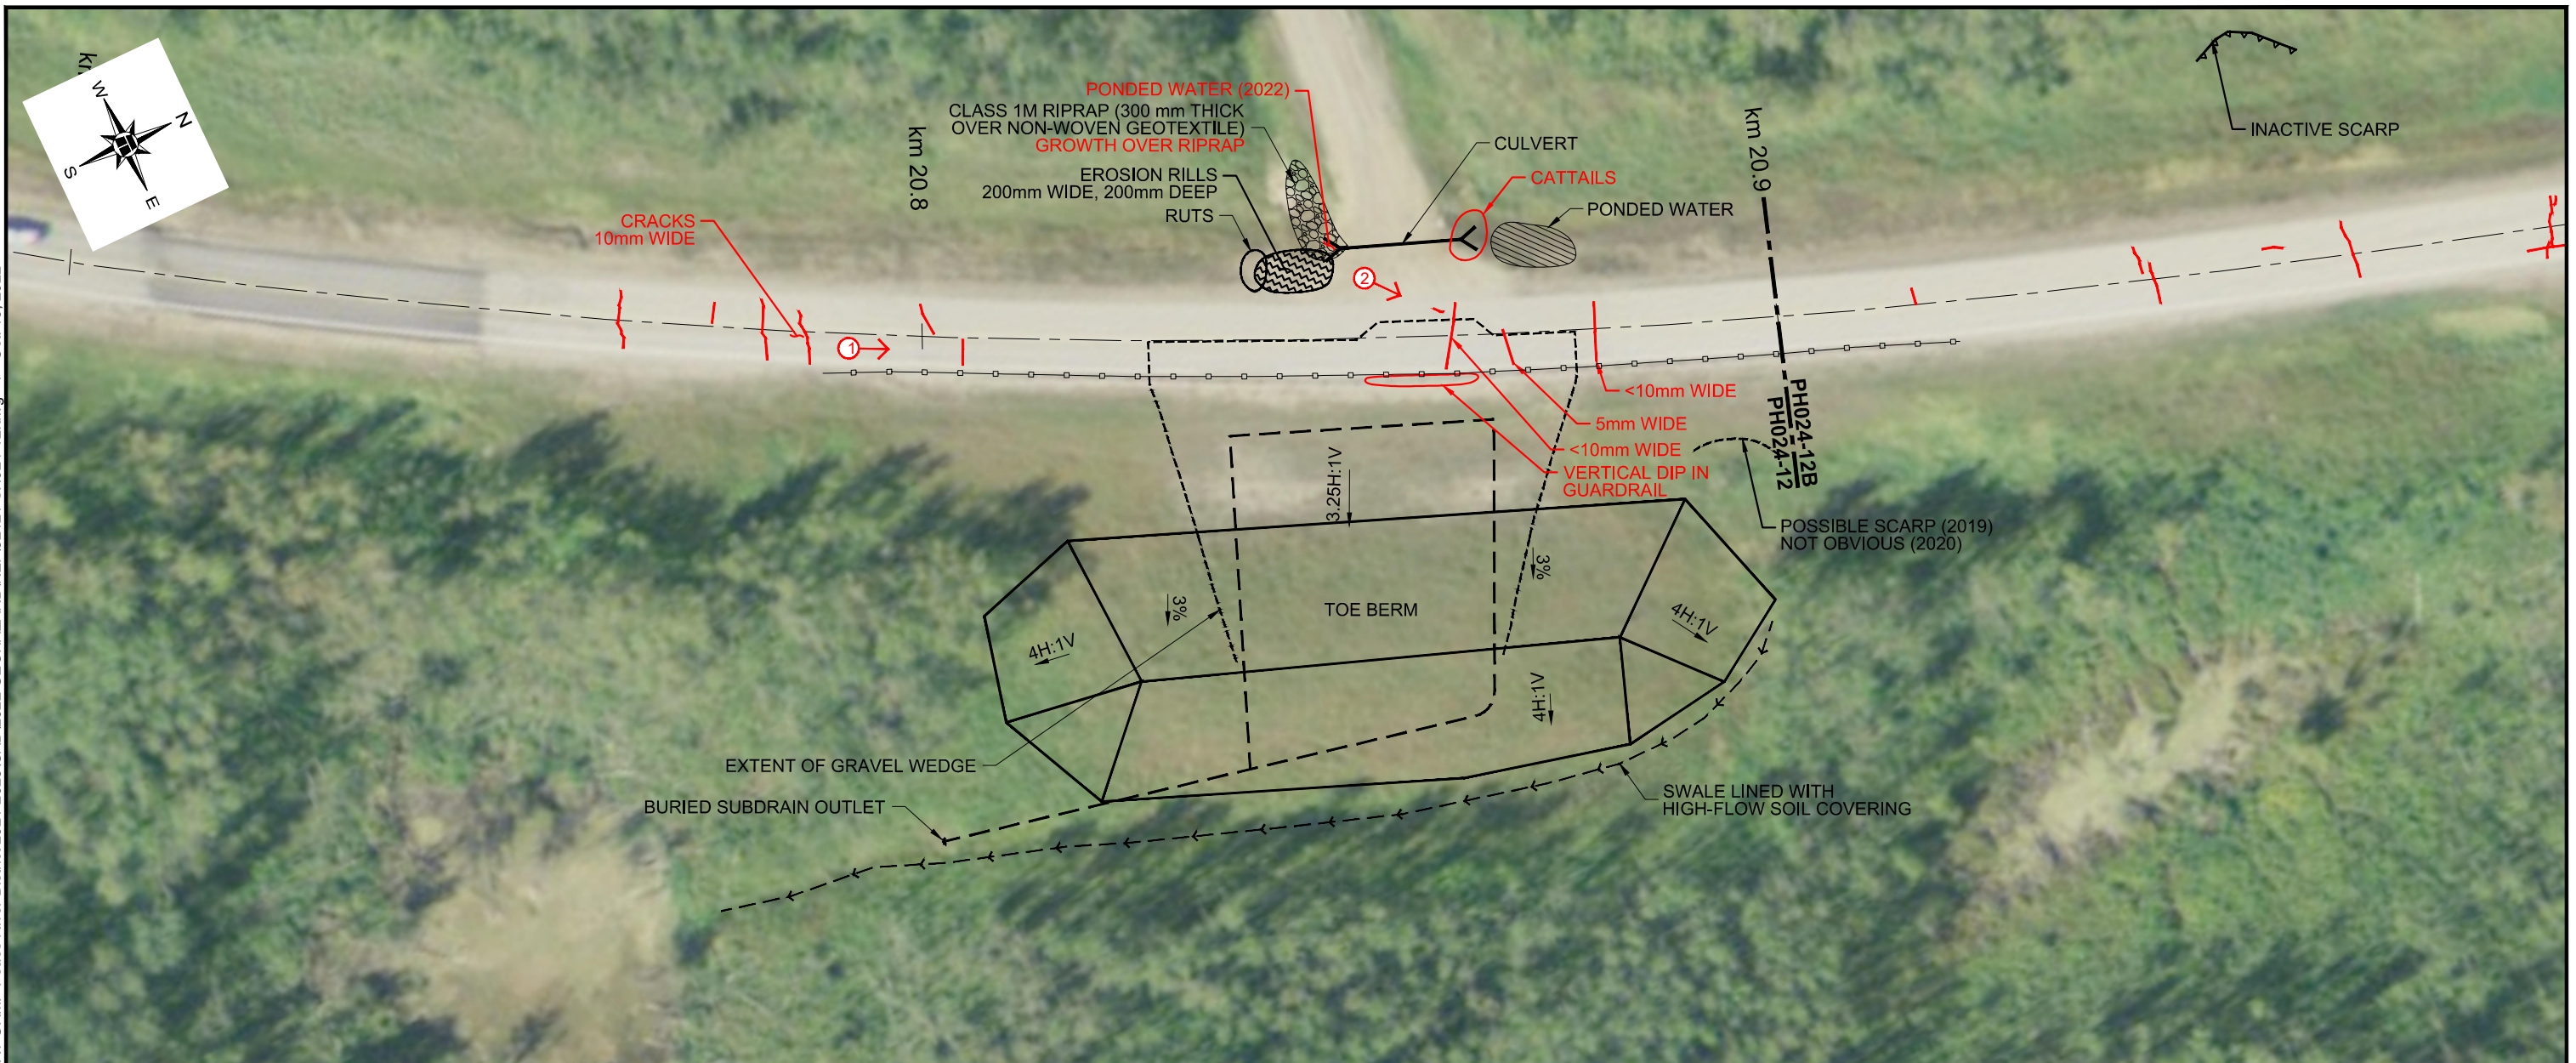
DWG No. 32121-SH024-12

Primary Site Issue:	Highway traverses deep-seated, retrogressive landslides with ongoing creep movements due partly to erosion at toe by the Little Smoky River and Peavine Creek resulting in cracking and sagging of the pavement surface at numerous locations. Approx. 4 km of the highway crosses this unstable north valley slope. These Sites are 55 m to 60 m above and 375 m to 475 m away from the Peavine Creek.		
Dimensions:	Site 12: 85 m length of highway affected by cracking and guardrail distortion. Site 12B: 50 m length of highway with cracking. Site 12A: 90 m length of highway with cracking and slumping. * In 2016, a review of historical documentation for this Site determined that Site #12C should be #12B (south portion) and #12A (north portion). ** Site #12D not assessed since 2015.		
Date of Remediation:	2002: Site #12A subexcavated and reconstructed with pitrun gravel with 2 m high toe berm, subdrain installation, and culvert extension. 2003: Site #12A: culvert lined with 762 mm smooth-wall steel 2004: Site #12 subexcavated and replaced with pitrun gravel with clay toe berm and subdrain; west ditch erosion also repaired.

<input type="checkbox"/> Other		<input type="checkbox"/>
Instrumentation: None		
Assessment:		
<p>The overall valley slope is moving as several separate slide blocks in response to the toe erosion and downcutting of two different rivers resulting in numerous scarps, sag ponds, and differential movement zones going in slightly different directions. The highway intersects the scarps of these blocks at several locations resulting in an uneven highway surface and cracking.</p> <p>Site 12: The main slide scarp crack typically visible at the Township Road 764 (TR764) intersection has not yet reflected through the new overlay; however, some portions of that pattern have become re-established. There appeared to be a slightly vertical sag of the new guardrail (installed in 2021) across from the TR764 intersection in the same location where the previous guardrail was also deformed. Overall, the toe berm appears to be functioning to stabilize the highway fill embankment;</p>

however, it is not conclusive if the pavement cracking and guardrail deformation is related to the local or global slope movements.

- Road maintenance should continue as necessary to maintain a safe roadway surface and may consist of milling, patching, and crack sealing of the ACP.
- The loose gravel fill at Site 12A should be graded and track-packed into a flatter downslope configuration and monitored for any additional movement.

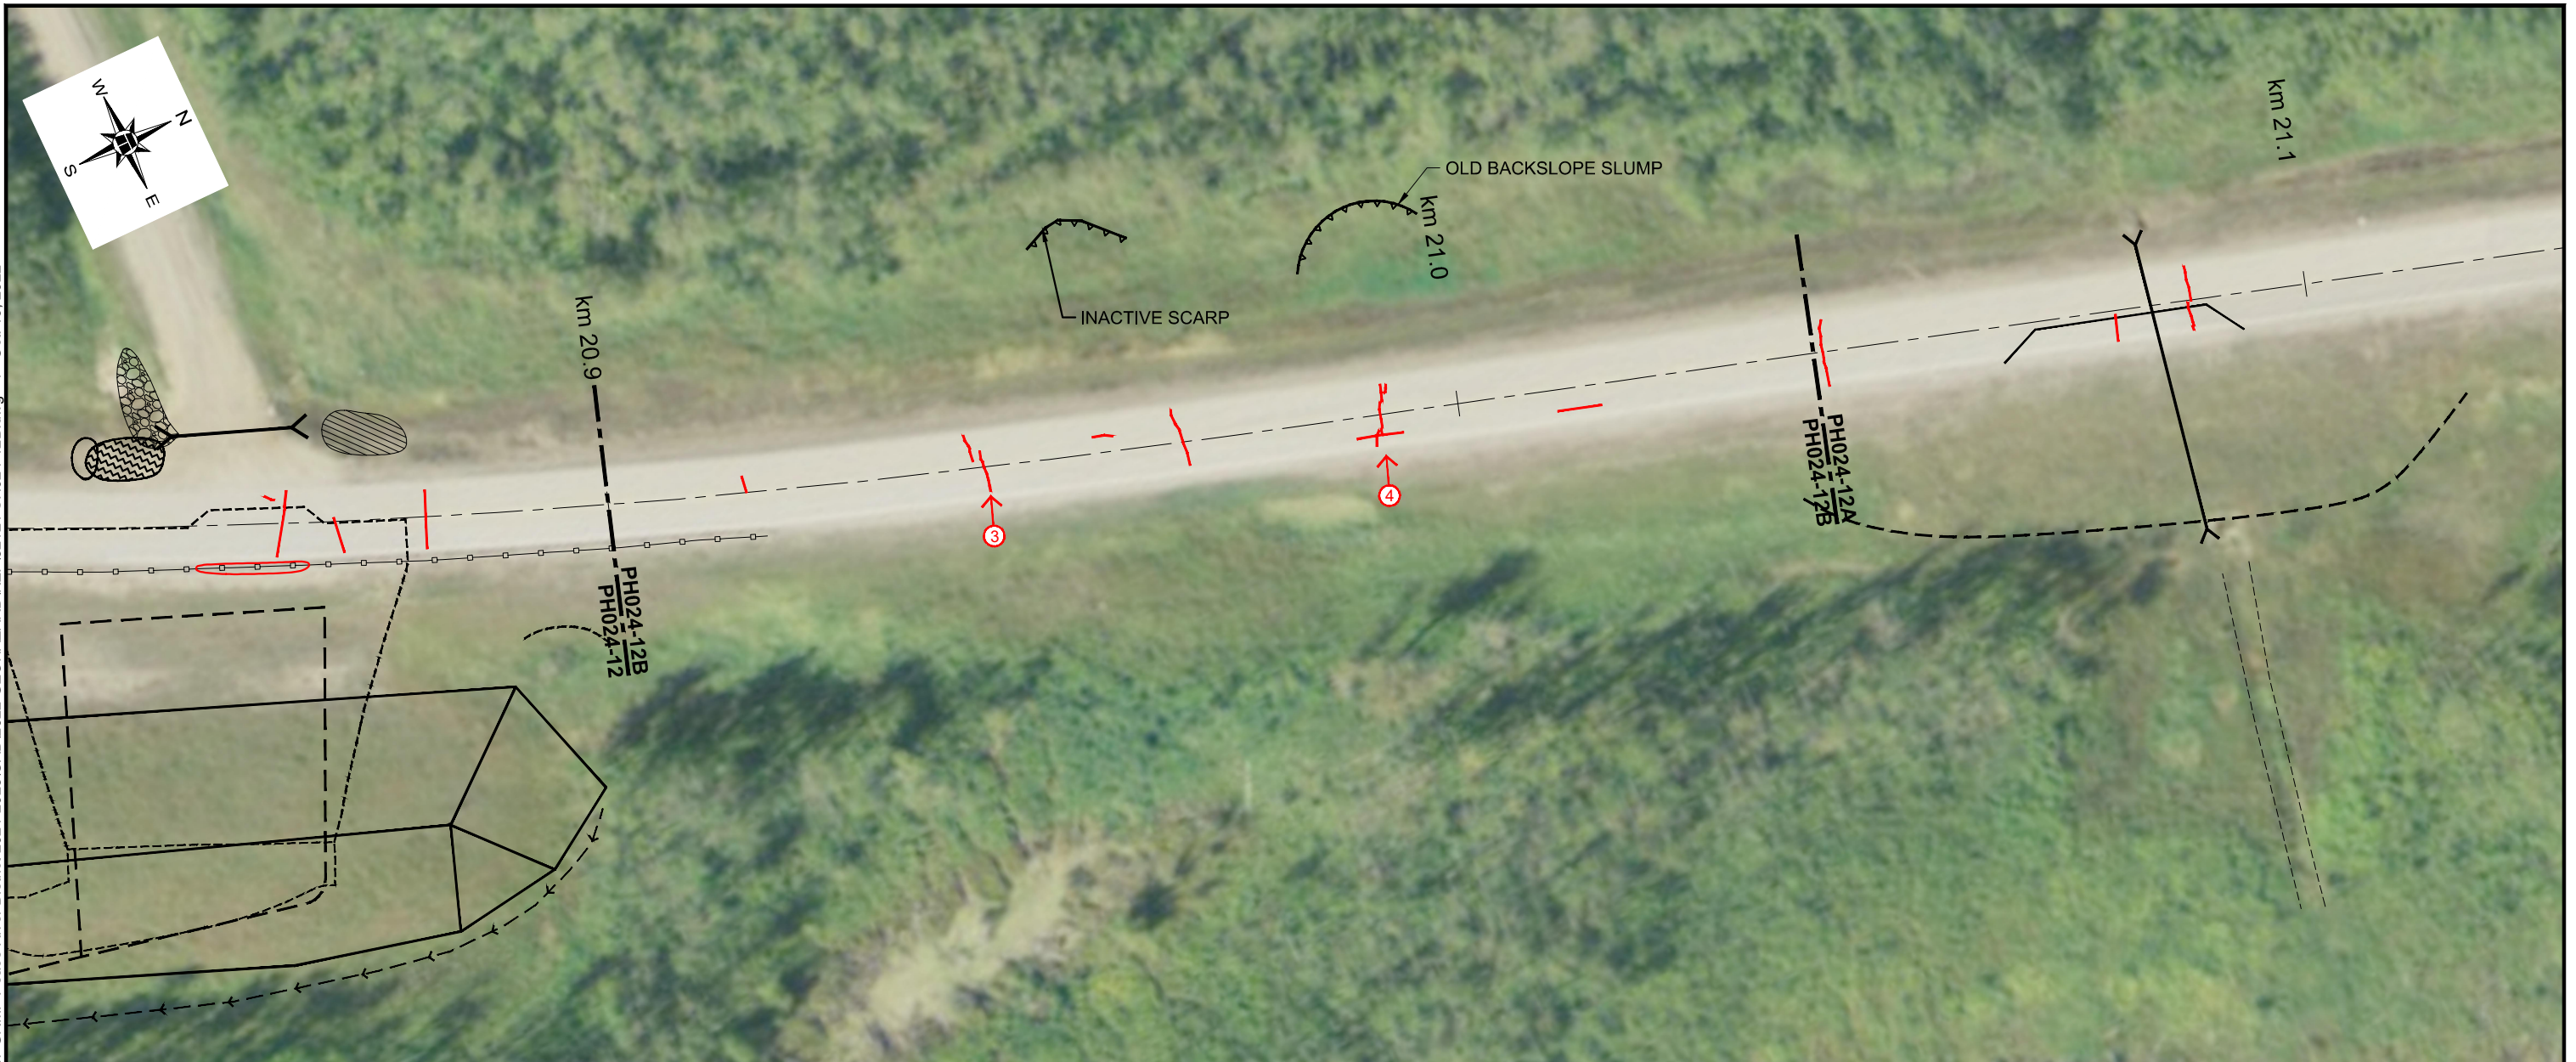
DWG No. 32121-SH024-12B

This site, an area of additional cracking between the two toe berms at Site #12 and Site #12A, was discontinued from the GeoHazard Assessment program in 2007. At the time of the 2016 inspection, there appeared to be a long crack roughly parallel to the highway that may be associated with slope movement and the width and extents of cracking have increased slightly each year following. However, only minor transverse cracks have re-appeared since the 2021 overlay and more time will be required to determine if the full crack pattern will become established. A small, dormant slump was noted this year and has been added to the drawing for completeness.

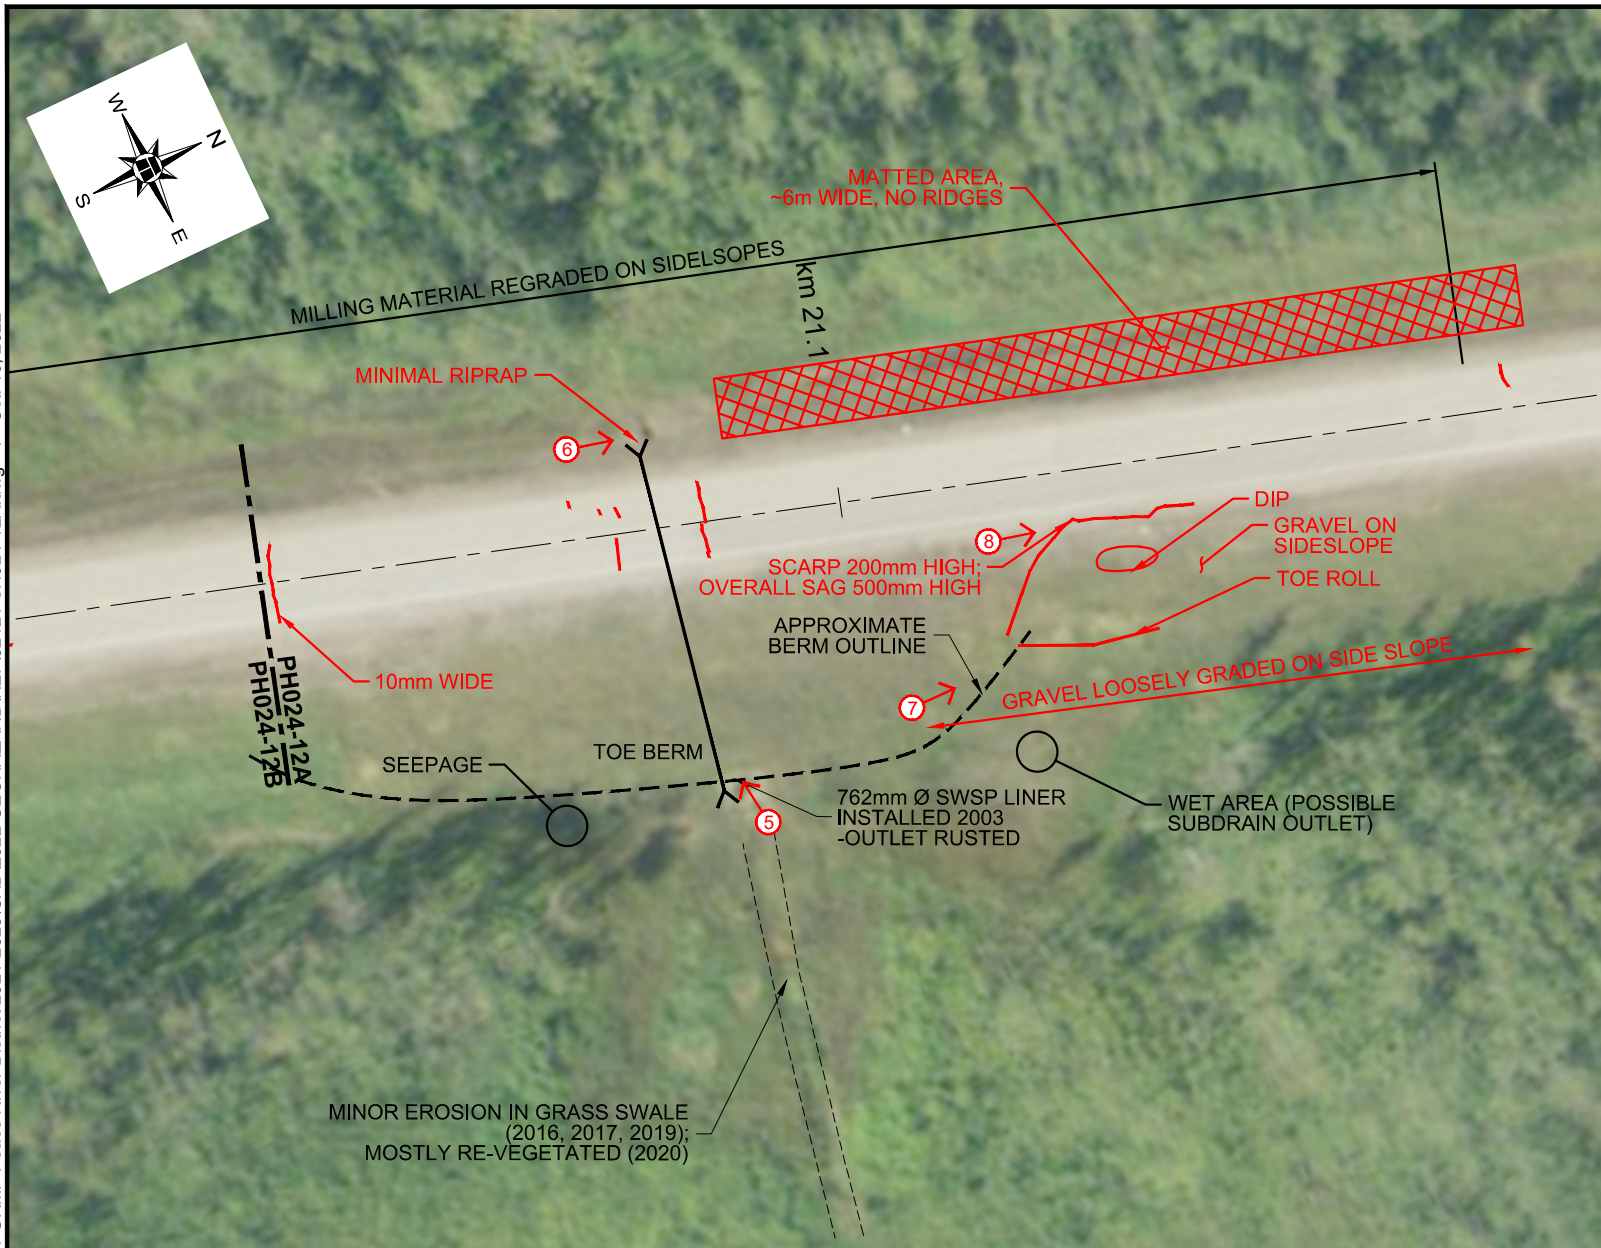
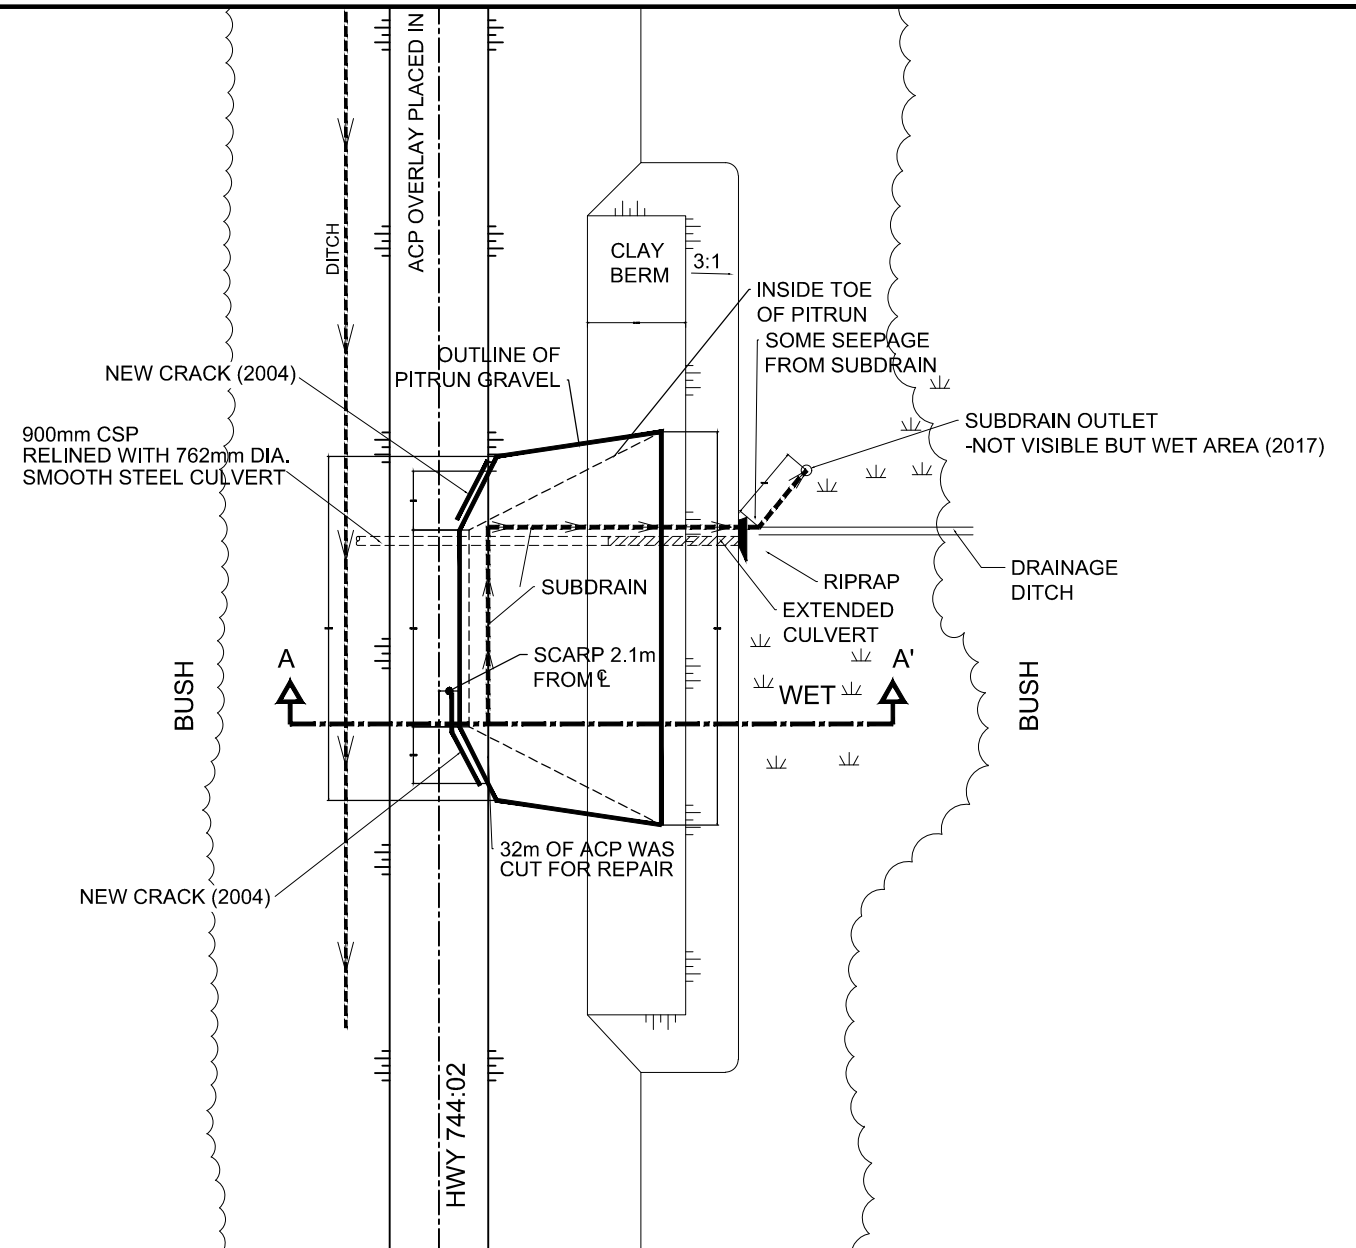
DWG No. 32121-SH024-12A

Some of the longitudinal has reflected through the new overlay; the previous transverse cracking has yet to appear. Although these cracks on the highway are above the toe berm, they do not appear to be related slope movement (at this time). During the grading work, gravel was loosely placed on the east side of the highway embankment just north of the culvert. This material was placed too steeply and is starting to slump. A toe roll was observed at the bottom of the slope. It is possible that the slumping is occurring only within the loose gravel; however, it should be regraded at a flatter slope, spread out along more of the embankment, or removed out of the valley to prevent destabilizing the highway embankment itself.

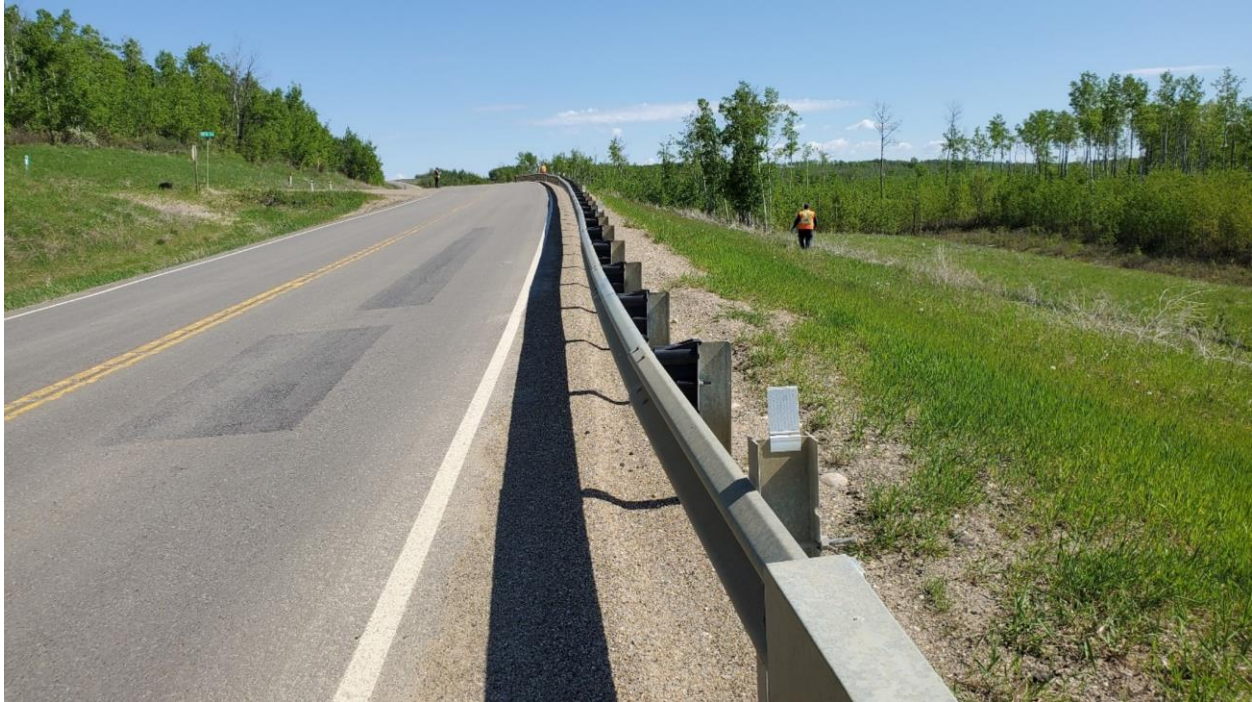
Photo 1, Site 12 – Looking northeast over toe berm. The guardrail was replaced in 2021 during the Highway 744 overlay project.

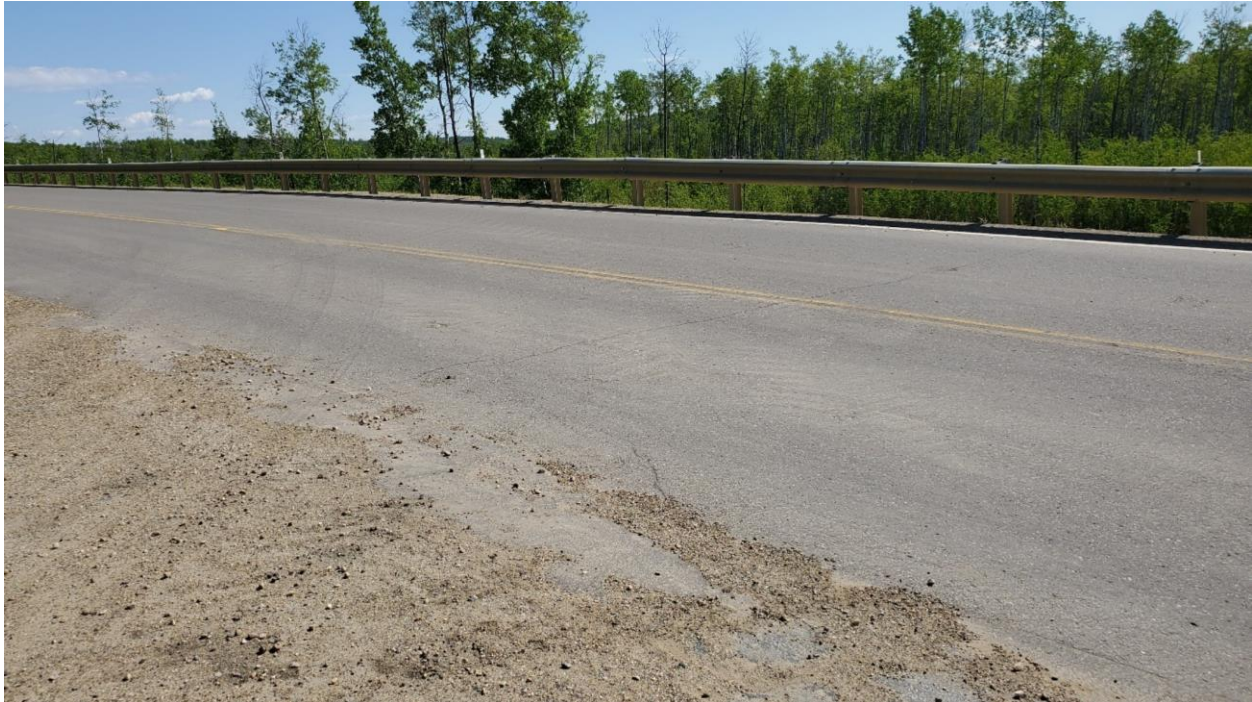
Photo 2, Site 12 – Looking south from north of the TR764 intersection at where the main scarp crack was located. It had just started reflecting through the new overlay.

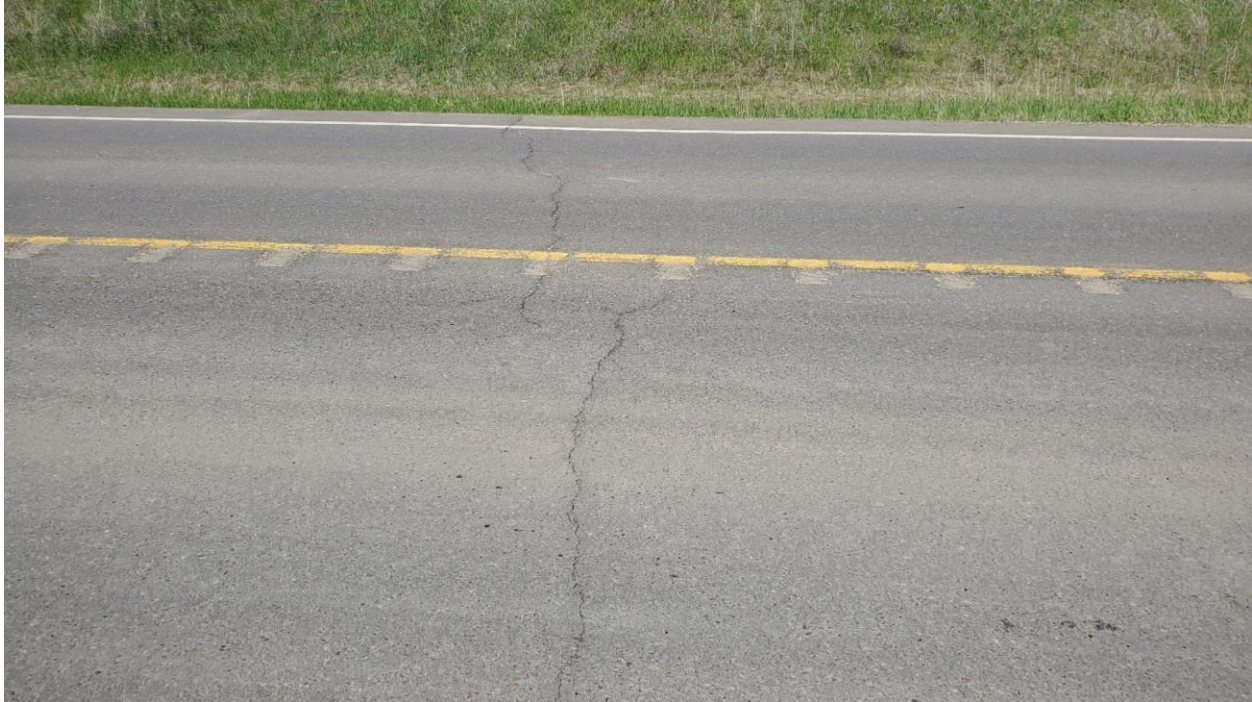
Photo 3, Site 12B: Looking west at one of the transverse cracks that has reflected through the new overlay near the south end of site.

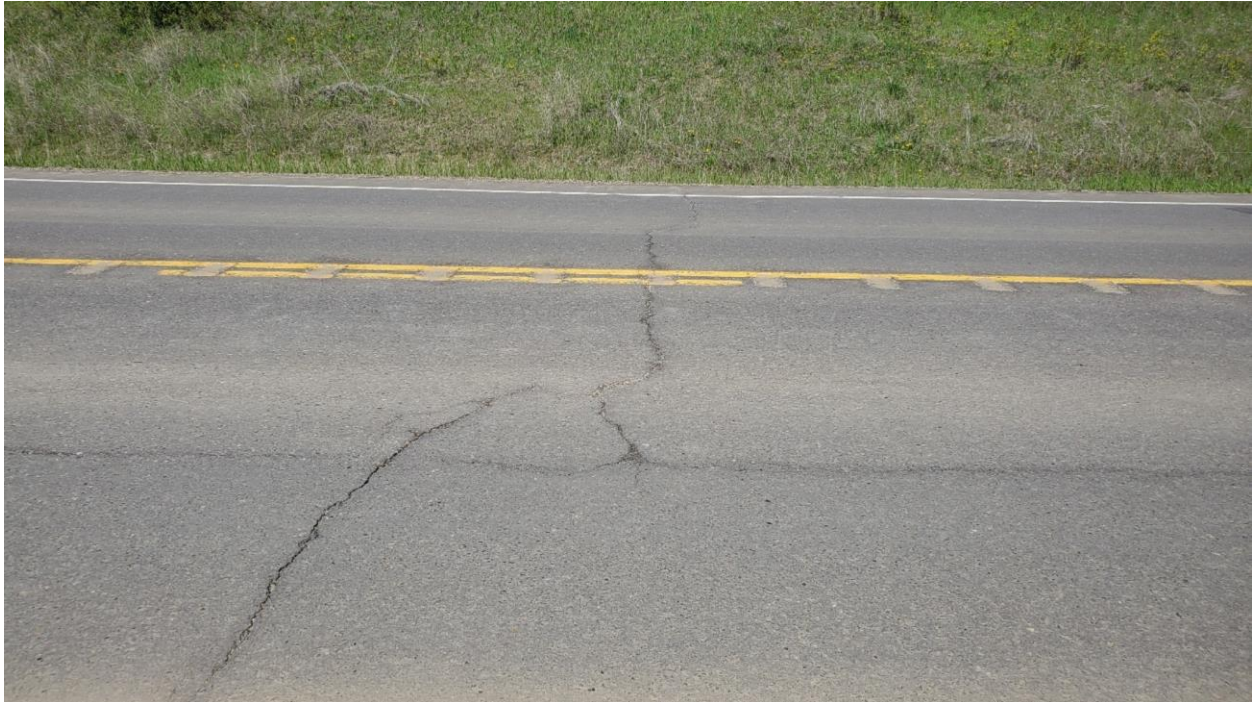
Photo 4, Site 12B – Looking west at the second transverse crack that has started reflecting through the new overlay.

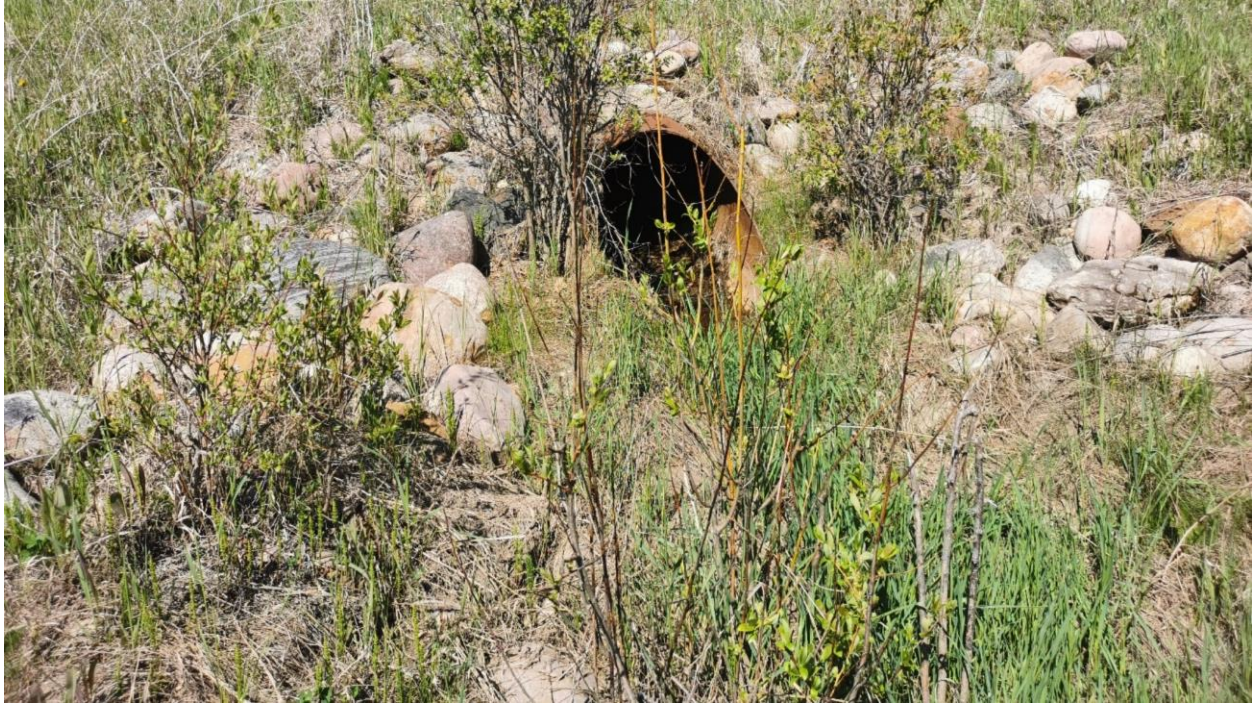
<input type="checkbox"/> Other		<input type="checkbox"/>
Observations (Site 12A):	Description	Worsened?
<input checked="" type="checkbox"/> Pavement Distress	Some traverse cracking was reflected through; may not be related to slope movement.	<input type="checkbox"/>
<input checked="" type="checkbox"/> Slope Movement	Site is located on an active deep-seated landslide moving toward the Peavine Creek. The toe berm appears to be functioning to stabilize the local embankment. New slump noted in 2022 in gravel placed on shoulder north of culvert.	<input checked="" type="checkbox"/>
<input checked="" type="checkbox"/> Erosion	Minor erosion along grassed-lined channel at culvert outlet (km 21.081). Inlet end of ditch has been lined with erosion covering.	<input type="checkbox"/>
<input type="checkbox"/> Seepage		<input type="checkbox"/>
<input checked="" type="checkbox"/> Bridge/Culvert Distress	Culvert at km 21.081: outlet of SWSP liner is rusting.	<input type="checkbox"/>

Photo 5, Site 12A – Looking at culvert liner outlet.

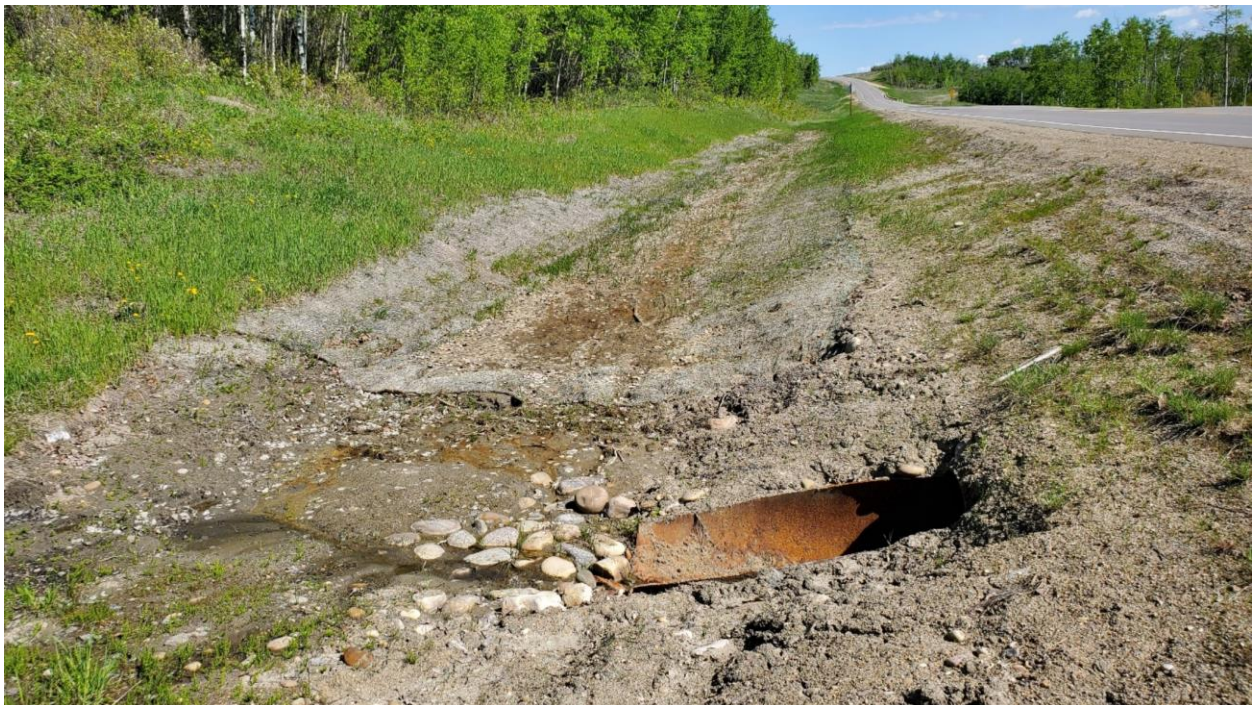
Photo 6, Site 12A – Regraded upslope ditch at culvert liner inlet.

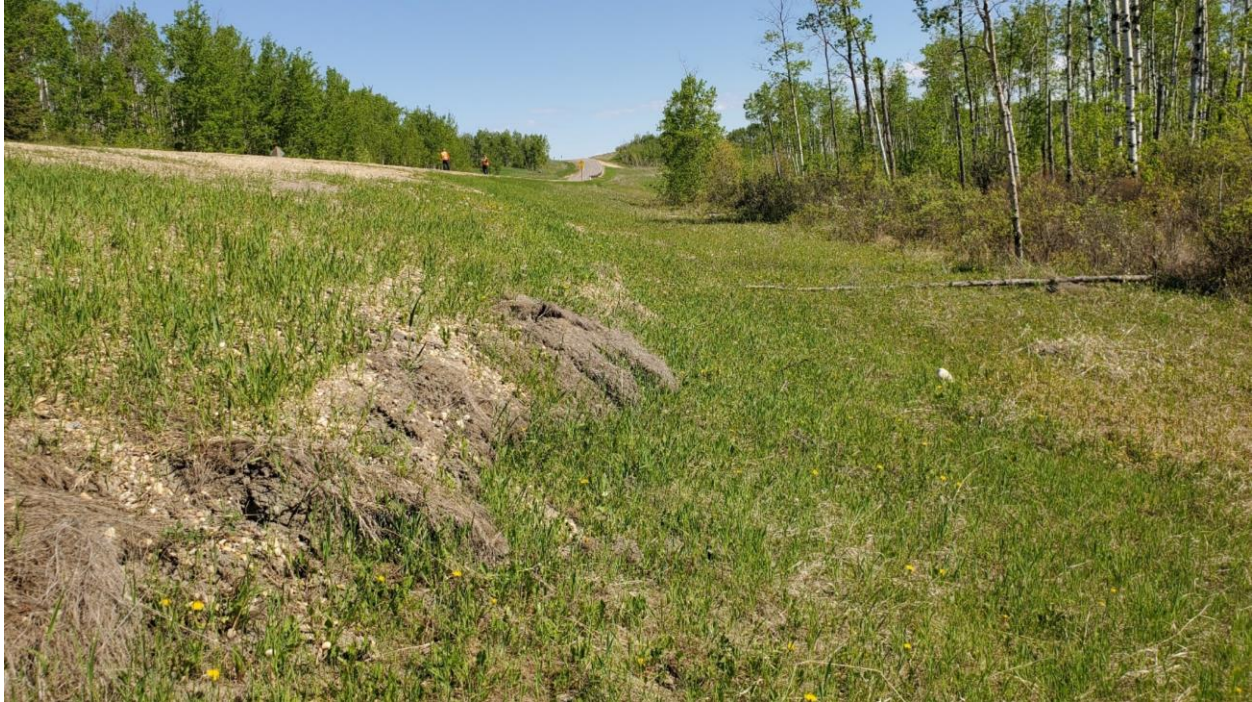
Photo 7, Site 12A – Looking north at potential toe roll on downslope slide where excess gravel appears to have been wasted on the sideslope.

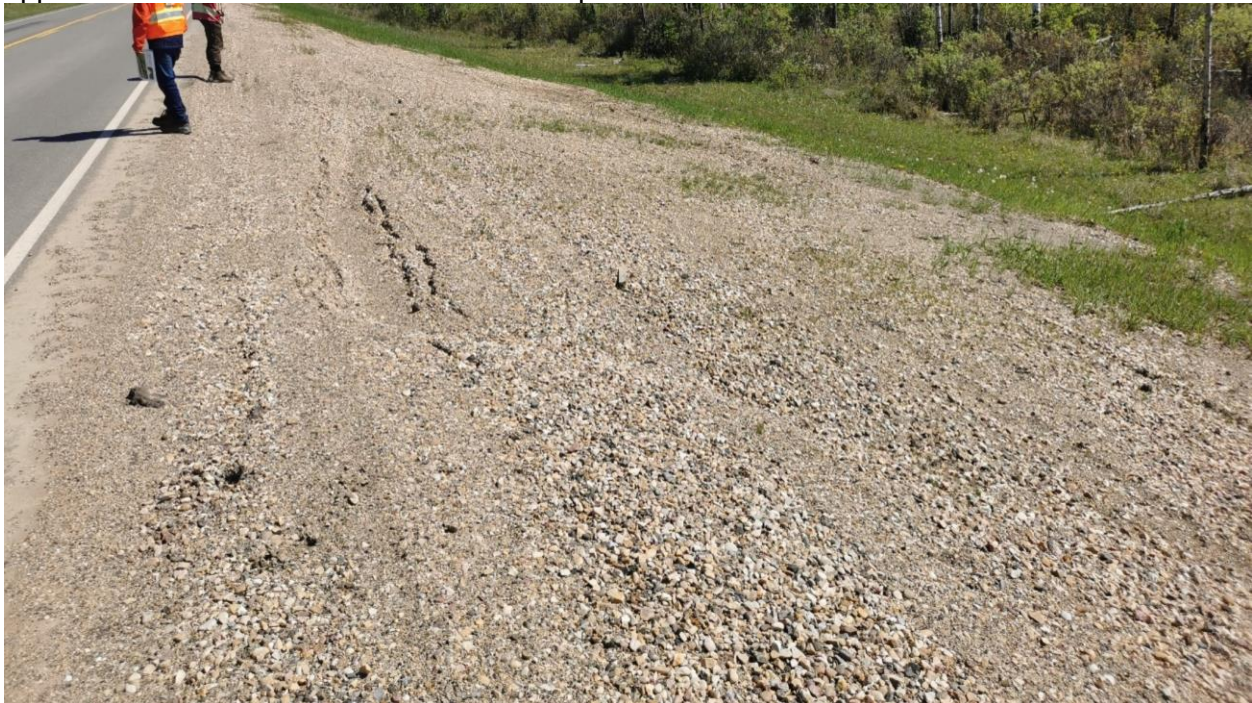
Photo 8, Site 12A – Looking north at top of gravel pile on downslope shoulder where a scarp is forming close to the highway.
