**ALBERTA TRANSPORTATION AND
ECONOMIC CORRIDORS
GEOHAZARD RISK MANAGEMENT PROGRAM
PEACE REGION (PEACE RIVER DISTRICT)
2025 INSPECTION**

Site Number	Location	Name	Hwy	km
SH024-12 SH024-12B* SH024-12A* SH024-12D**	Little Smoky River: East Valley Slope	Little Smoky River Valley, North Hill – Sites #12, #12B, #12A, and #12D	744:02	20.80-20.90 20.94-21.03 21.03-21.12 21.17-21.30
Legal Description		UTM Co-ordinates		
Site 12: NE21-76-22-W5M		11U E 478,432	N	6,162,375
Site 12B: NE21-76-22-W5M		11U E 478,472	N	6,162,492
Site 12A: NE21-76-22-W5M		11U E 478,504	N	6,162,588
Site 12D: NE21- and SE28-76-22-W5M		11U E 478,550	N	6,162,737

**SH024-12: HWY 744:02 LITTLE SMOKY RIVER VALLEY
2025 SITE INSPECTION PLAN**

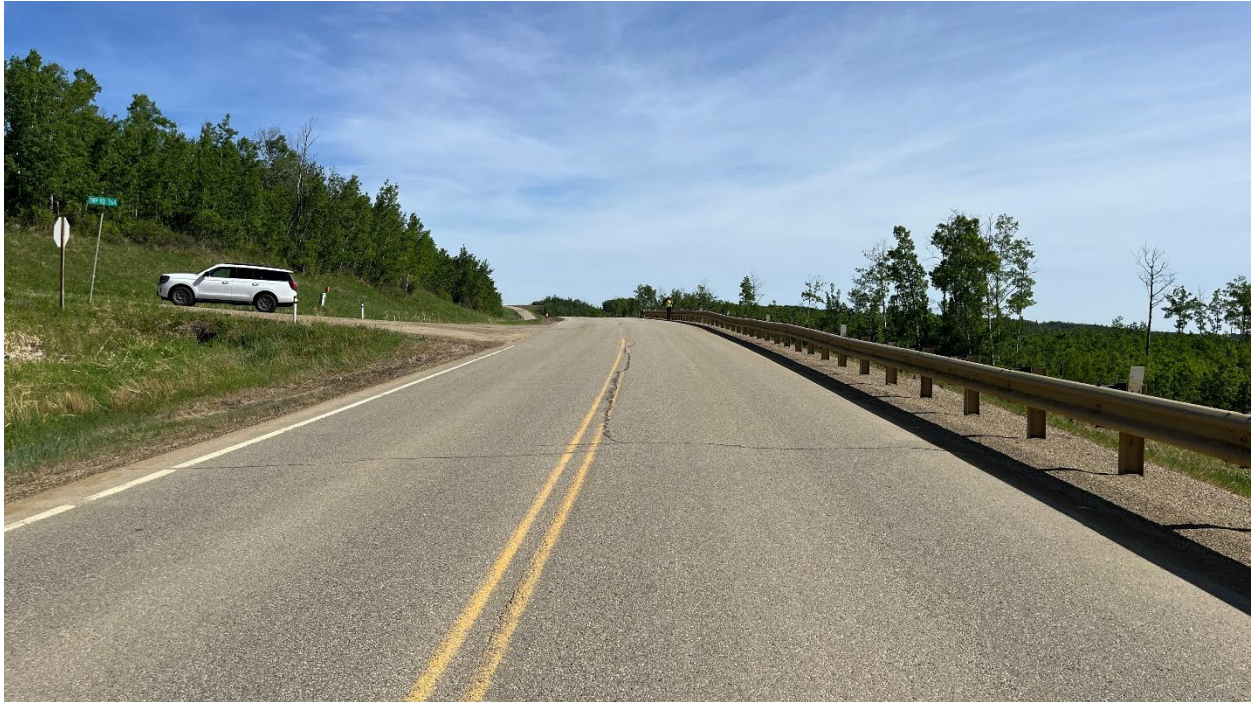
Photo 1, Site 12 – Looking northeast at the highway surface upslope of the toe berm location. There is a noticeable dip in the at the middle section of the guardrail.

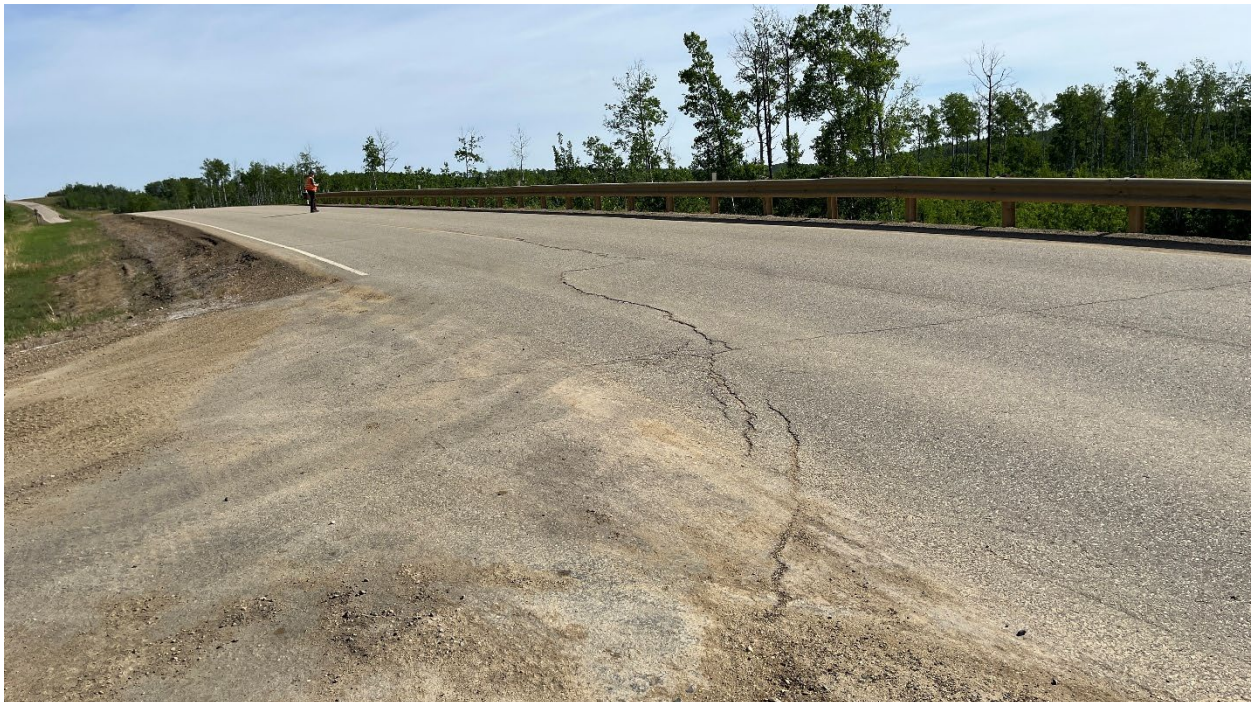
Observations (Site 12):	Description	Worsened?
<input checked="" type="checkbox"/> Pavement Distress	Vertical distortions that develop are periodically removed with each pavement overlay. Cracks are continuing to reflect through since the most recent overlay. Cracks have extended into TR764 intersection towards the southwest ditch.	<input checked="" type="checkbox"/>
<input checked="" type="checkbox"/> Slope Movement	Site is located on an active deep-seated landslide moving toward the Peavine Creek. There is short section of vertical distortion of the new guardrail.	<input checked="" type="checkbox"/>
<input type="checkbox"/> Erosion		<input type="checkbox"/>
<input type="checkbox"/> Seepage		<input type="checkbox"/>
<input checked="" type="checkbox"/> Bridge/Culvert Distress	Minor rill development and ponding of water at both ends of approach culvert under TR764.	<input type="checkbox"/>
<input type="checkbox"/> Other		<input type="checkbox"/>

Photo 2, Site 12 – Looking northeast from the TR764 intersection at where the main scarp crack was located. The previous crack pattern is continuing to reflect through the 2021 overlay.

- Road maintenance should continue as necessary to maintain a safe roadway surface and may consist of milling, patching, and crack sealing of the ACP.
- The loose gravel fill at Site 12A should be graded and track-packed into a flatter downslope configuration and monitored for any additional movement.

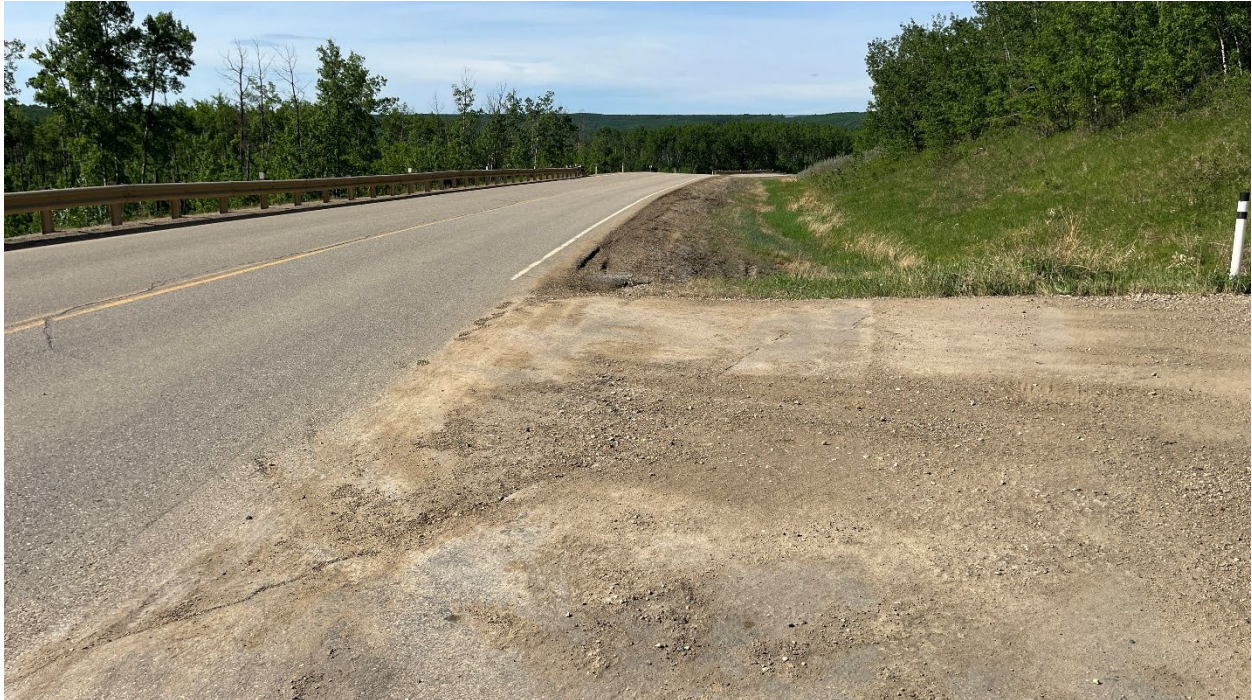
Photo 3, Site 12 – Looking southwest at the TR764 intersection where cracks have extended from the road surface towards the southwest ditch.

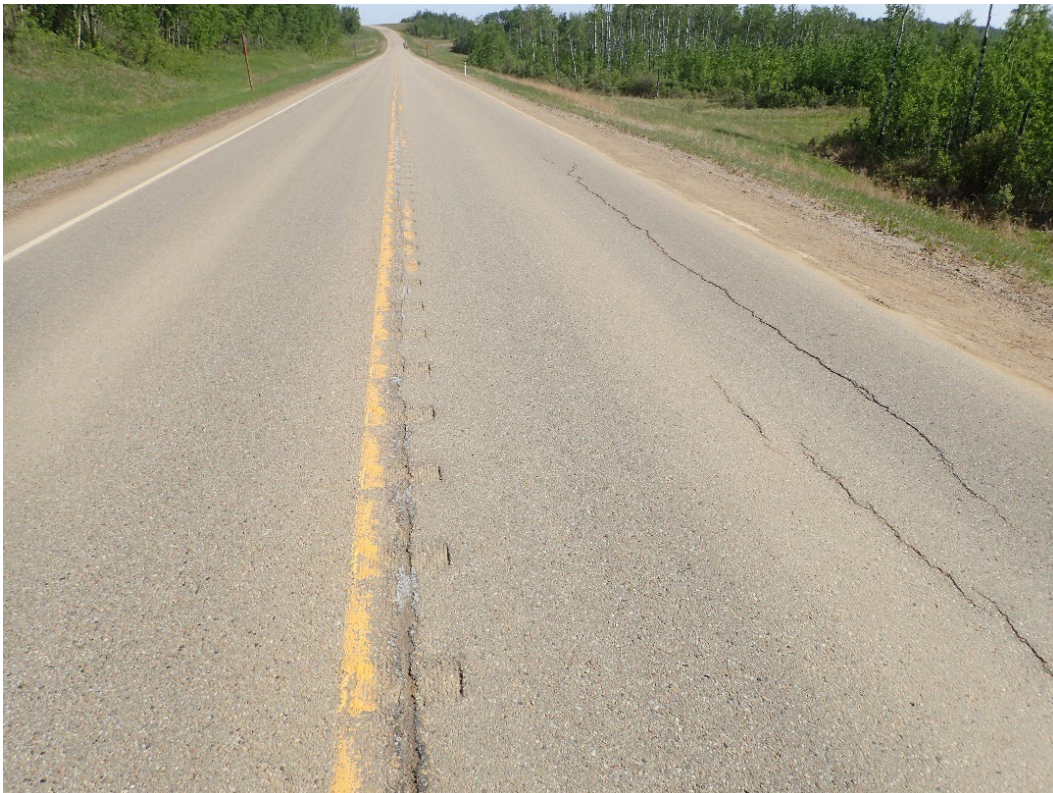
This site, an area of additional cracking between the two toe berms at Site #12 and Site #12A, was discontinued from the Geohazard Assessment program in 2007. At the time of the 2016 inspection, there appeared to be a long crack roughly parallel to the highway that may be associated with slope movement and the width and extents of cracking have increased slightly each year following. In 2022, only minor transverse cracks had re-appeared through the 2021 overlay and a few more cracks were noted in 2023 and 2025. More time will be required to determine if the full crack pattern will become established and if it suggests potential slope instability.

Photo 4, Site 12B: Looking north at cracks extending towards Site 12A.

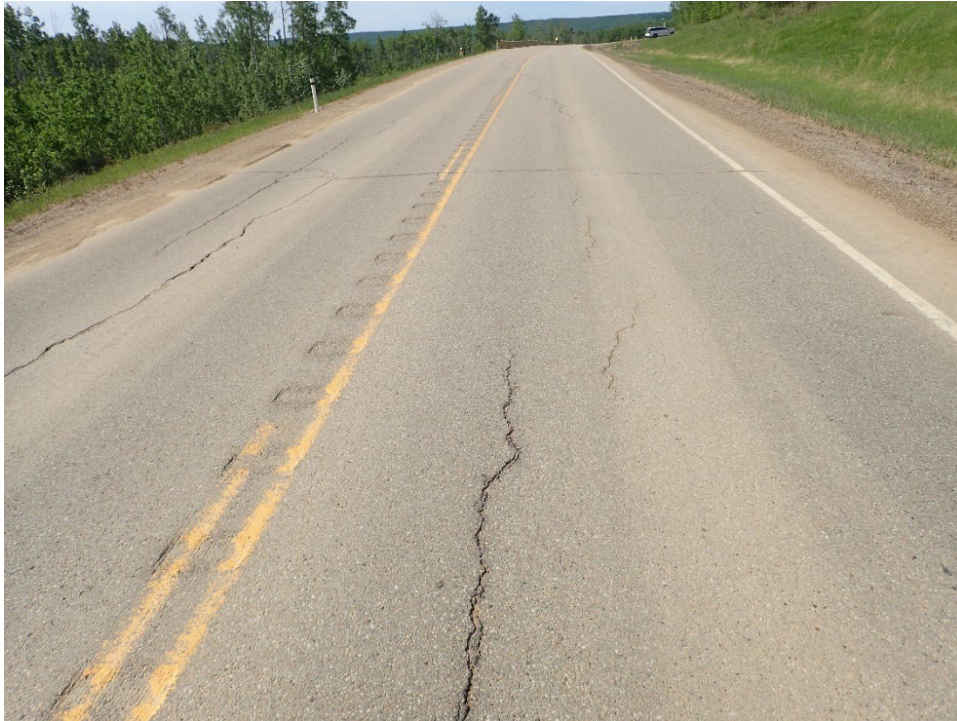
Observations (Site 12B):	Description	Worsened?
<input checked="" type="checkbox"/> Pavement Distress	The scarp crack has not yet reflected through 2021 overlay. Additional cracks continue to reflect through overlay.	<input checked="" type="checkbox"/>
<input checked="" type="checkbox"/> Slope Movement	Site is located on an active deep-seated landslide moving toward the Peavine Creek.	<input type="checkbox"/>
<input type="checkbox"/> Erosion		<input type="checkbox"/>
<input type="checkbox"/> Seepage		<input type="checkbox"/>
<input type="checkbox"/> Bridge/Culvert Distress		<input type="checkbox"/>
<input type="checkbox"/> Other		<input type="checkbox"/>
Observations (Site 12A):	Description	Worsened?
<input checked="" type="checkbox"/> Pavement Distress	Additional longitudinal and transverse cracking was reflected through; may not be related to slope movement.	<input checked="" type="checkbox"/>
<input checked="" type="checkbox"/> Slope Movement	Site is located on an active deep-seated landslide moving toward the Peavine Creek. The toe berm appears to be functioning to stabilize the local embankment. New slump noted in 2022 in gravel placed on shoulder north of culvert. Some movement was observed during 2025 inspection.	<input checked="" type="checkbox"/>

Photo 5, Site 12B – Looking south at cracks continuing to reflect through the 2021 overlay.

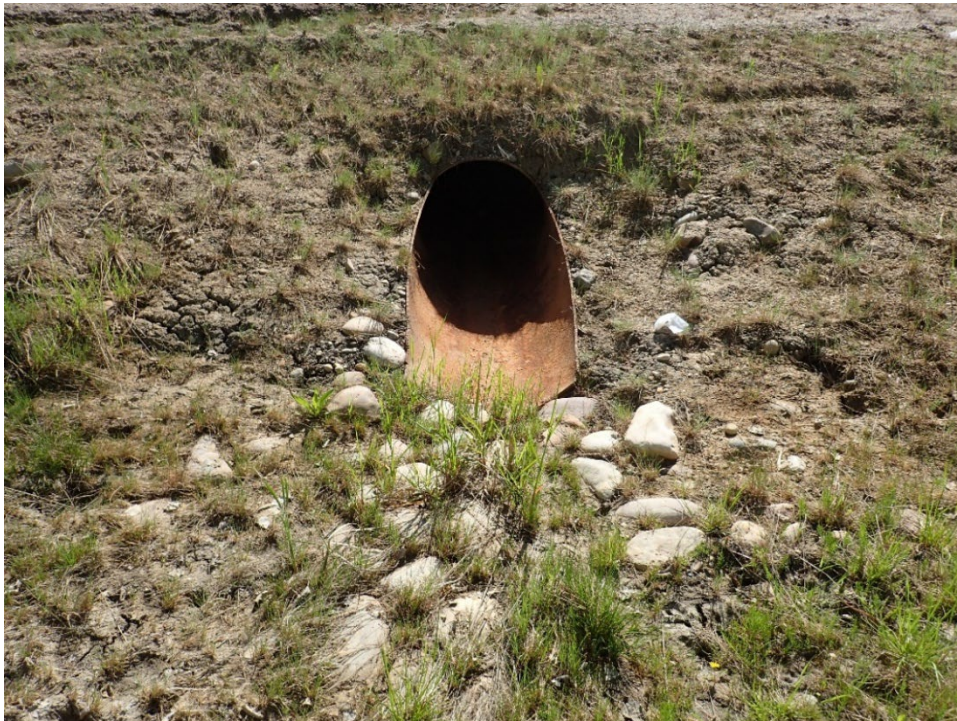
<input checked="" type="checkbox"/> Erosion	Minor erosion along grassed-lined channel at culvert outlet (km 21.081). Inlet end of ditch has been lined with erosion covering.	<input type="checkbox"/>
<input type="checkbox"/> Seepage		<input type="checkbox"/>
<input checked="" type="checkbox"/> Bridge/Culvert Distress	Culvert at km 21.081: inlet of SWSP liner is 1/3 silted in.	<input checked="" type="checkbox"/>
<input type="checkbox"/> Other		<input type="checkbox"/>
Instrumentation: None		
Assessment: <p>The overall valley slope is moving as several separate slide blocks in response to the toe erosion and downcutting of two different rivers resulting in numerous scarps, small to large scale sag ponds, and differential movement zones going in slightly different directions. The highway intersects the scarps of these blocks at several locations resulting in an uneven highway surface and cracking.</p> <p>Site 12:</p> <p>Portions of the main slide scarp crack at the Township Road 764 (TR764) intersection are continuing to reflect through the 2021 overlay. Cracks have extended into TR764 intersection towards the southwest ditch. There is a slight vertical sag observed in the middle section of the guardrail across from the TR764 intersection (installed in 2021) during the 2022, 2023 and 2025 inspections. This appears to be in the same location where the previous guardrail was also deformed. Overall, the toe berm appears to be functioning to stabilize the highway fill embankment; however, it is not conclusive if the pavement cracking and guardrail deformation are related to the local or global slope movements.</p>

Photo 6, Site 12A – Looking east at culvert inlet location.

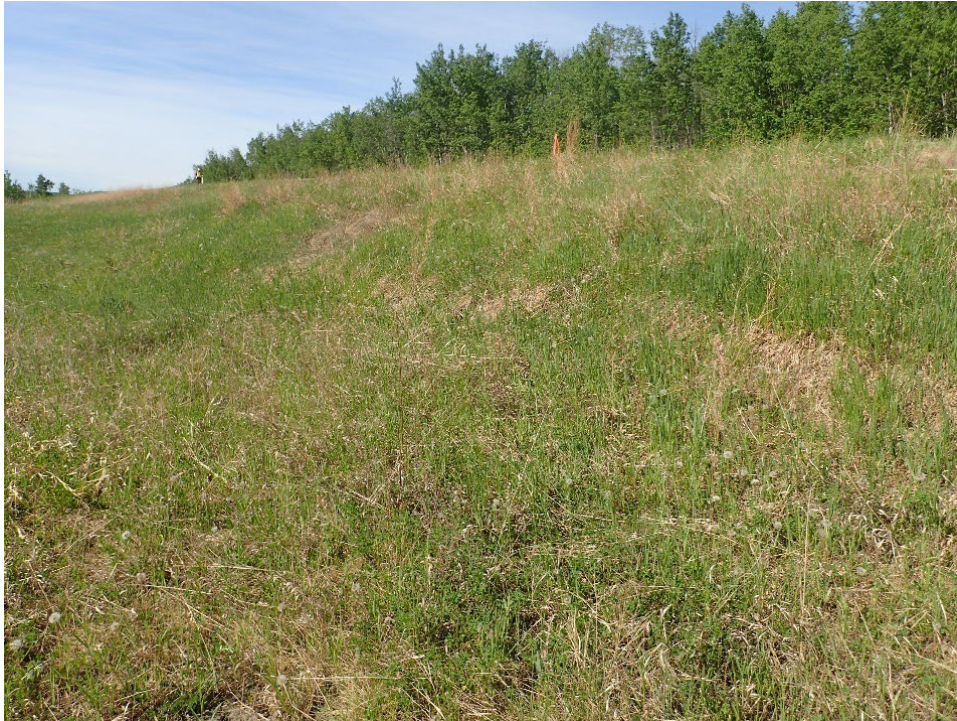
Additional longitudinal cracking has reflected through the 2021 overlay; and some of the previous transverse cracking has appeared. Although these cracks on the highway are above the toe berm, they do not appear to be related slope movement (at this time). During the 2021 grading work, gravel was loosely placed on the east side of the highway embankment just north of the culvert. This material was placed too steeply and had started to slump at the time of the 2022 inspection. Although the scarp at the edge of the highway appeared unchanged, the toe roll observed at the bottom of the slope is more defined. It is possible that the slumping is occurring only within the loose gravel; however, it should be regraded at a flatter slope, spread out along more of the embankment, or removed out of the valley to prevent destabilizing the highway embankment itself. Some movement was observed at the slump and the toe roll during the 2025 inspection.

Photo 7, Site 12A – Looking south at toe roll downslope of where excess gravel appears to have been wasted on the sideslope. There appears to be some movement observed since the last inspection.

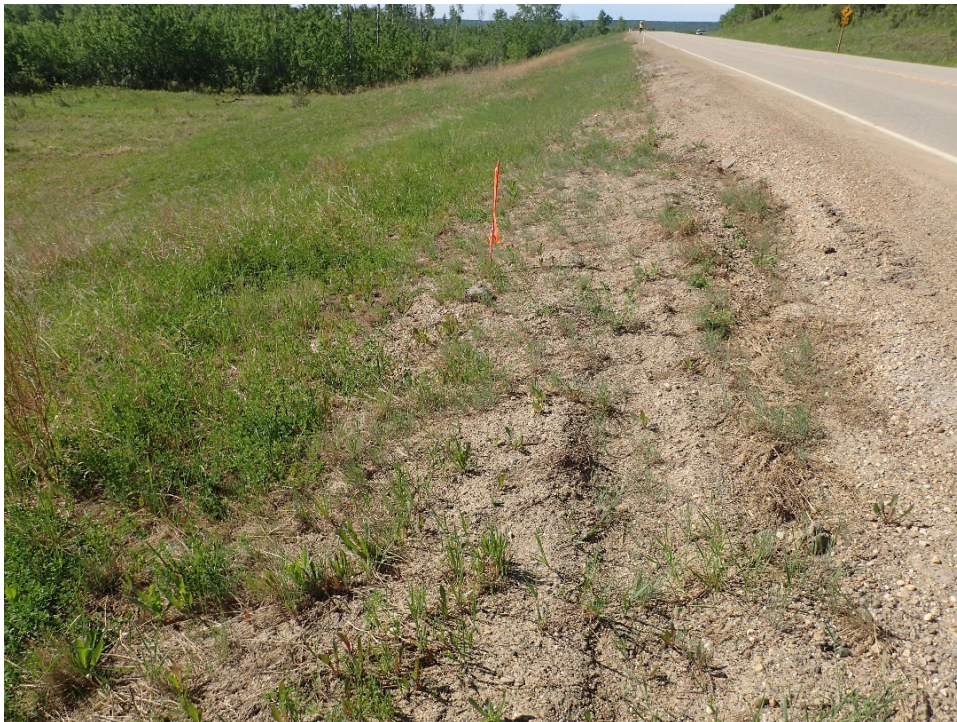
Photo 8, Site 12A – Looking south at the downslope shoulder, where a scarp had previously developed near the highway due to excess gravel placement.
