**PEACE REGION – SWAN HILLS
GEOHAZARD RISK ASSESSMENT
SITE INSPECTION FORM**

SITE NUMBER SH 28	SITE NAME Little Smoky Valley	HIGHWAY & KM HWY 744:02	PREVIOUS INSPECTION DATE June 18, 2013	INSPECTION DATE July 3, 2014
LEGAL DESCRIPTION LSD 13-18-76-22 W5M	NAD 83 COORDINATES N6160721 E474084	PREVIOUS RISK ASSESSMENT		
		PF: 8*	CF: 3	TOTAL: 24
		CURRENT RISK ASSESSMENT		
		PF: 8*	CF: 3	TOTAL: 24
*There are currently no slope movement instruments installed at this site and it is difficult to estimate rates of slope movement.

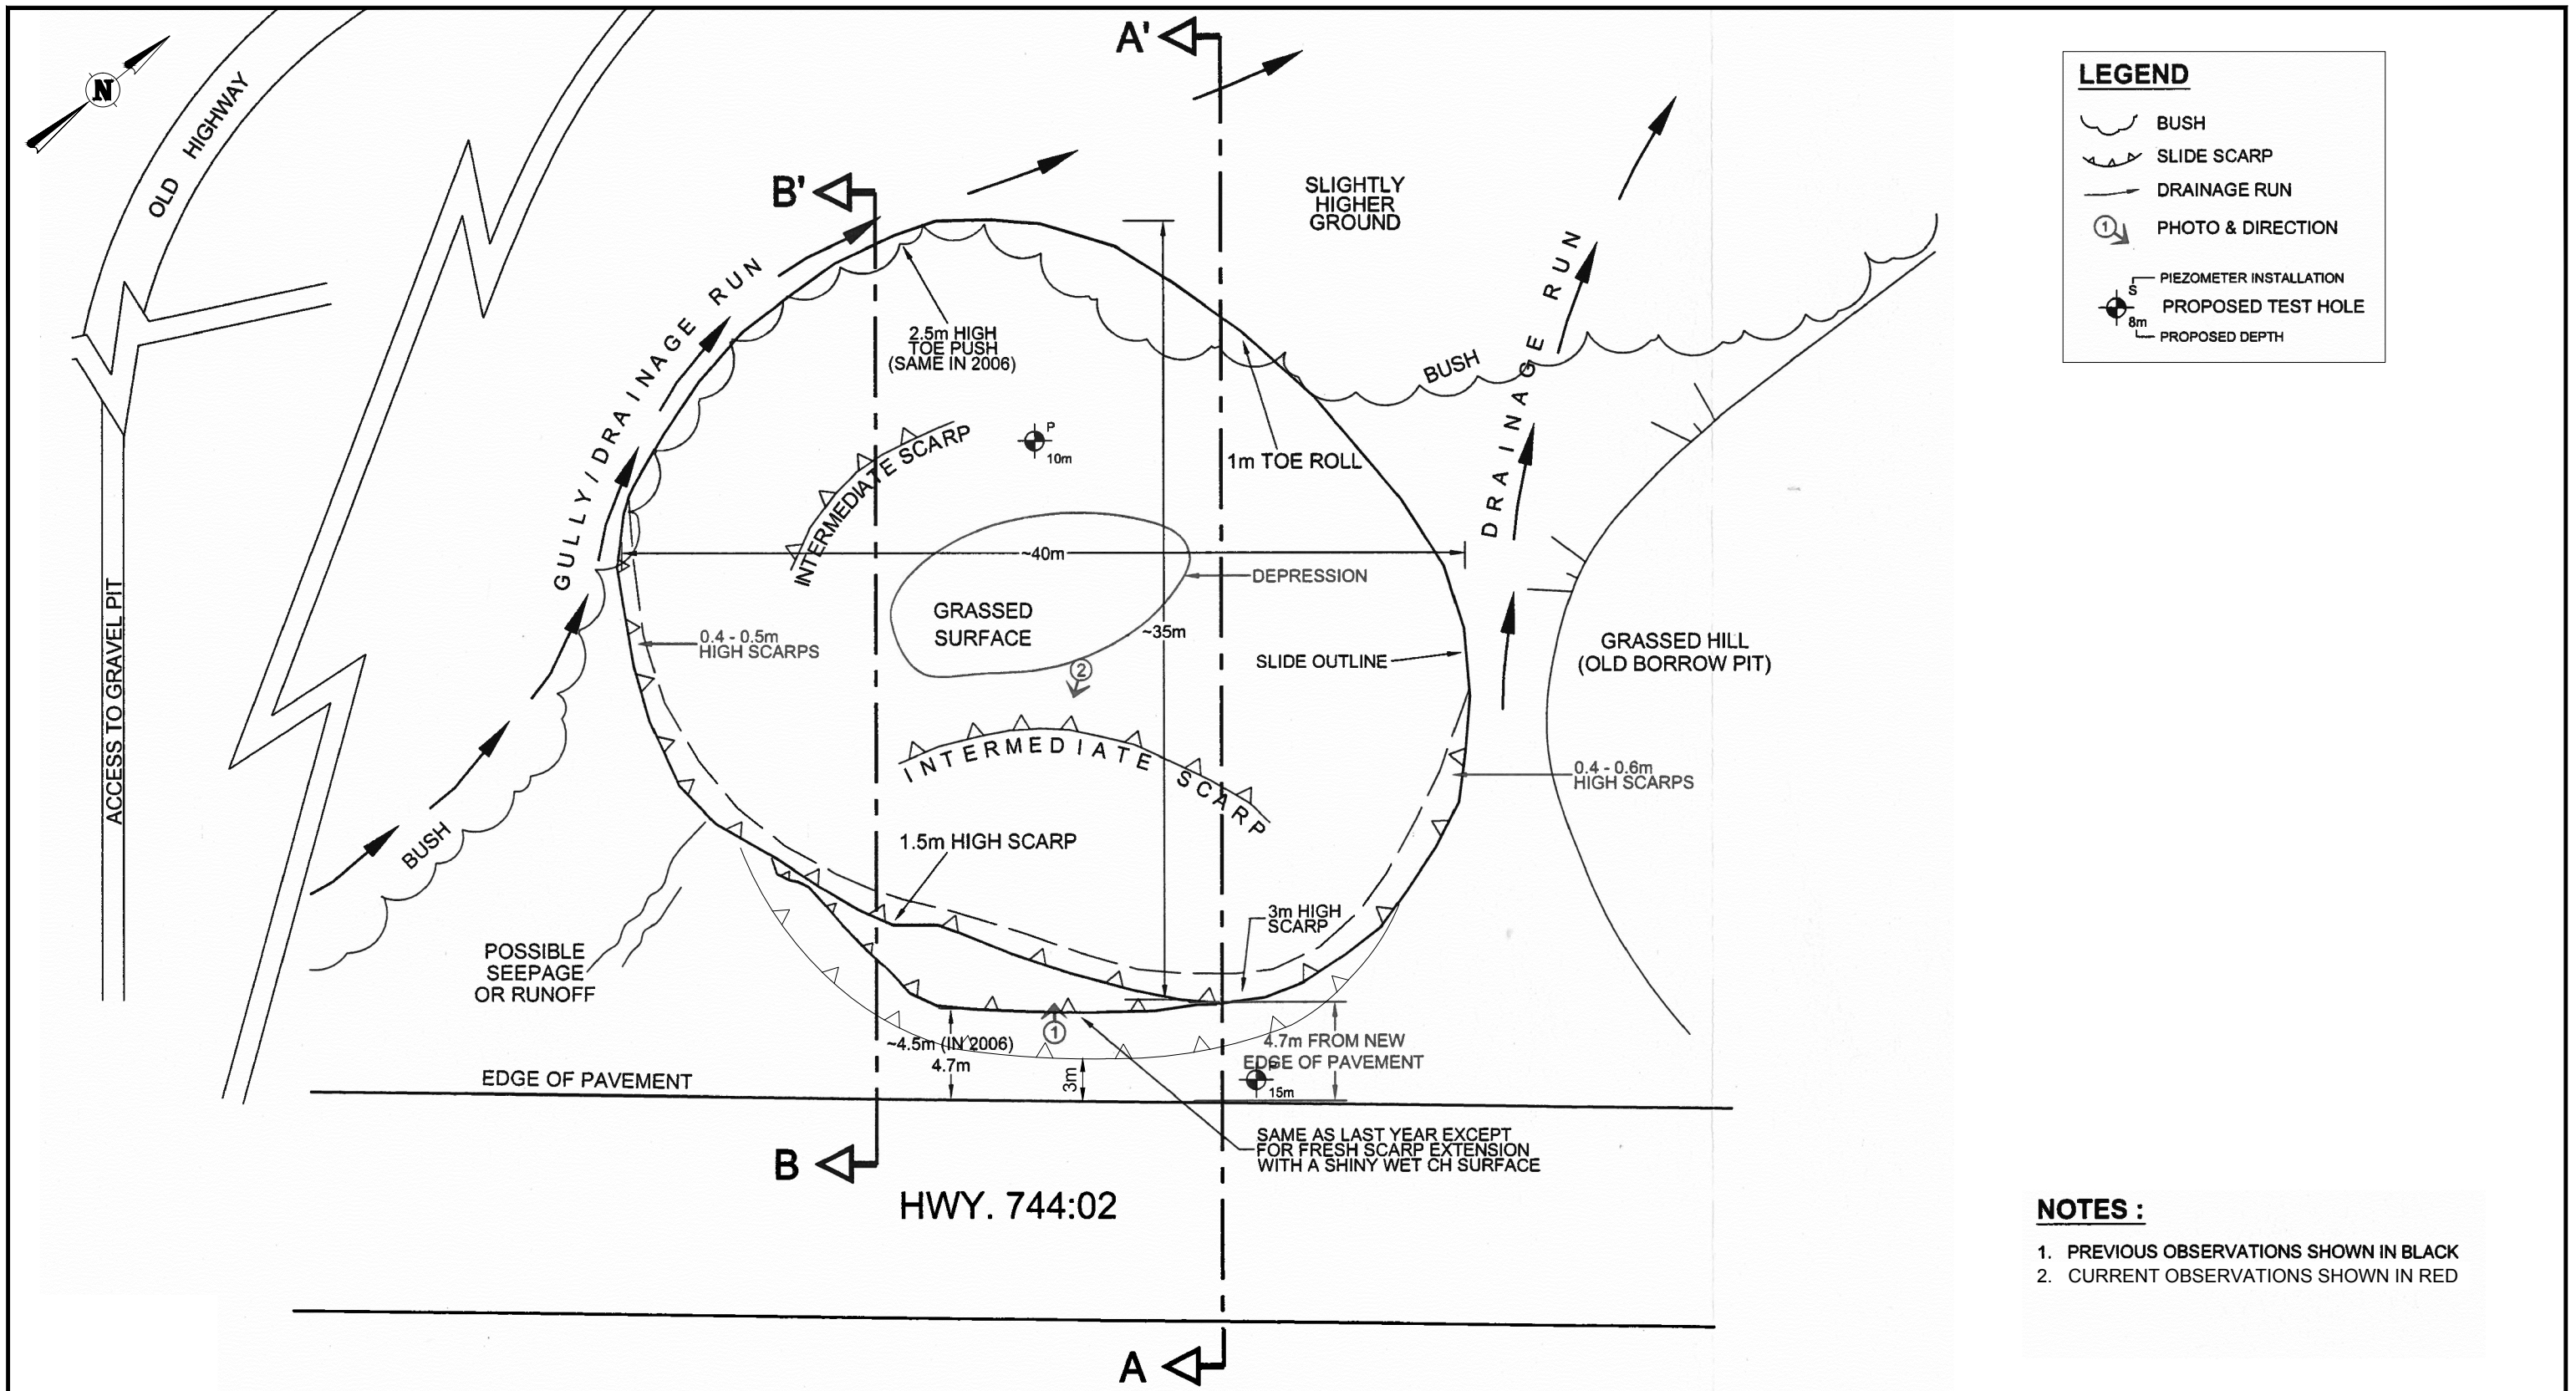
TITLE: SH28, PEACE RIVER (SWAN HILLS) REGION SITE PLAN

Oval shaped failure approximately 45 m wide (along highway) and about 35m in length (perpendicular to highway). The headscarp is up to 3 m in height, and currently 3 m from road (5.1 m from the white line). The failure mass is estimated to be approximately 3 m deep at its deepest. The overall embankment slope is at ~19 degrees from horizontal in the area.

The mechanism of failure is not known with certainty. It is possible that the feature is failed uncontrolled fill that has been saturated and failed on the natural grade.

Annual inspection of the site should be continued. A guard rail would be required along the roadway if the headscarp of the failure is within or retrogresses into the Clear Zone of the roadway. If retrogression is observed in the future, stabilization of the failure would be required to preserve the R/W and to mitigate further retrogression and encroachment towards the highway. Stabilization/remediation may include drainage improvements and slope flattening/buttrressing. An investigation and possibly instrumentation would be required if remedial works were planned.

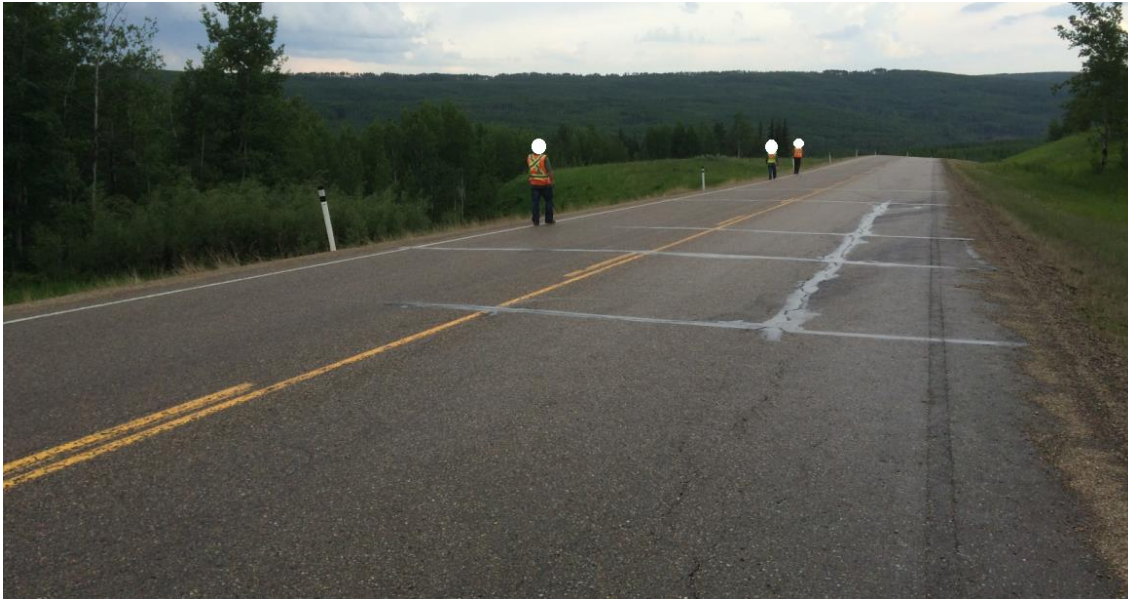
Photo 1 (looking north).
No indications of pavement distress or deformation were observed.

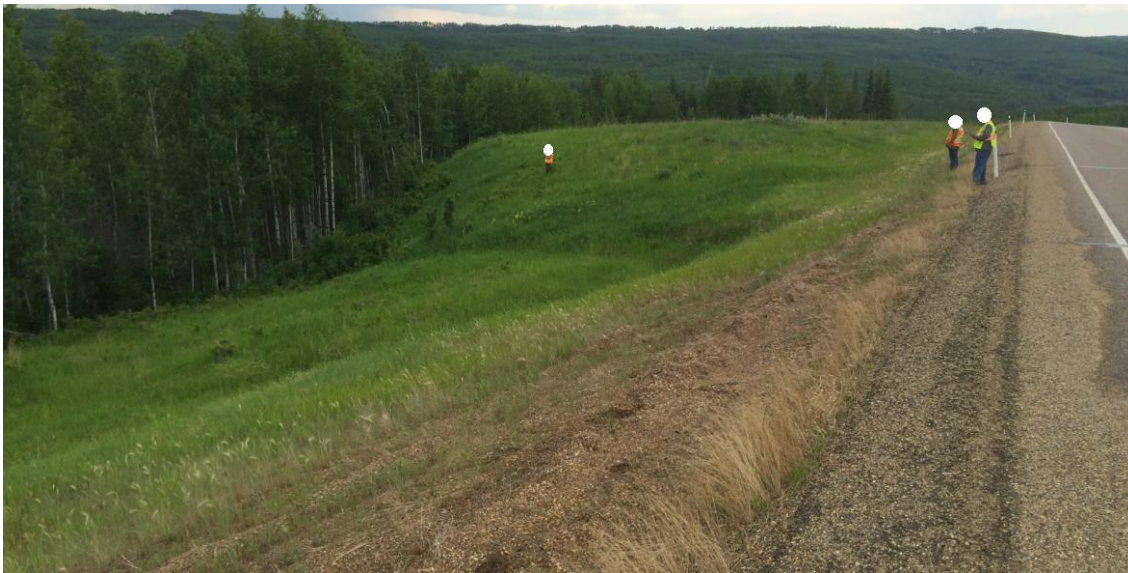
Photo 2 (looking north).
The distance between the edge of the pavement and backscarp was unchanged from June 2013.

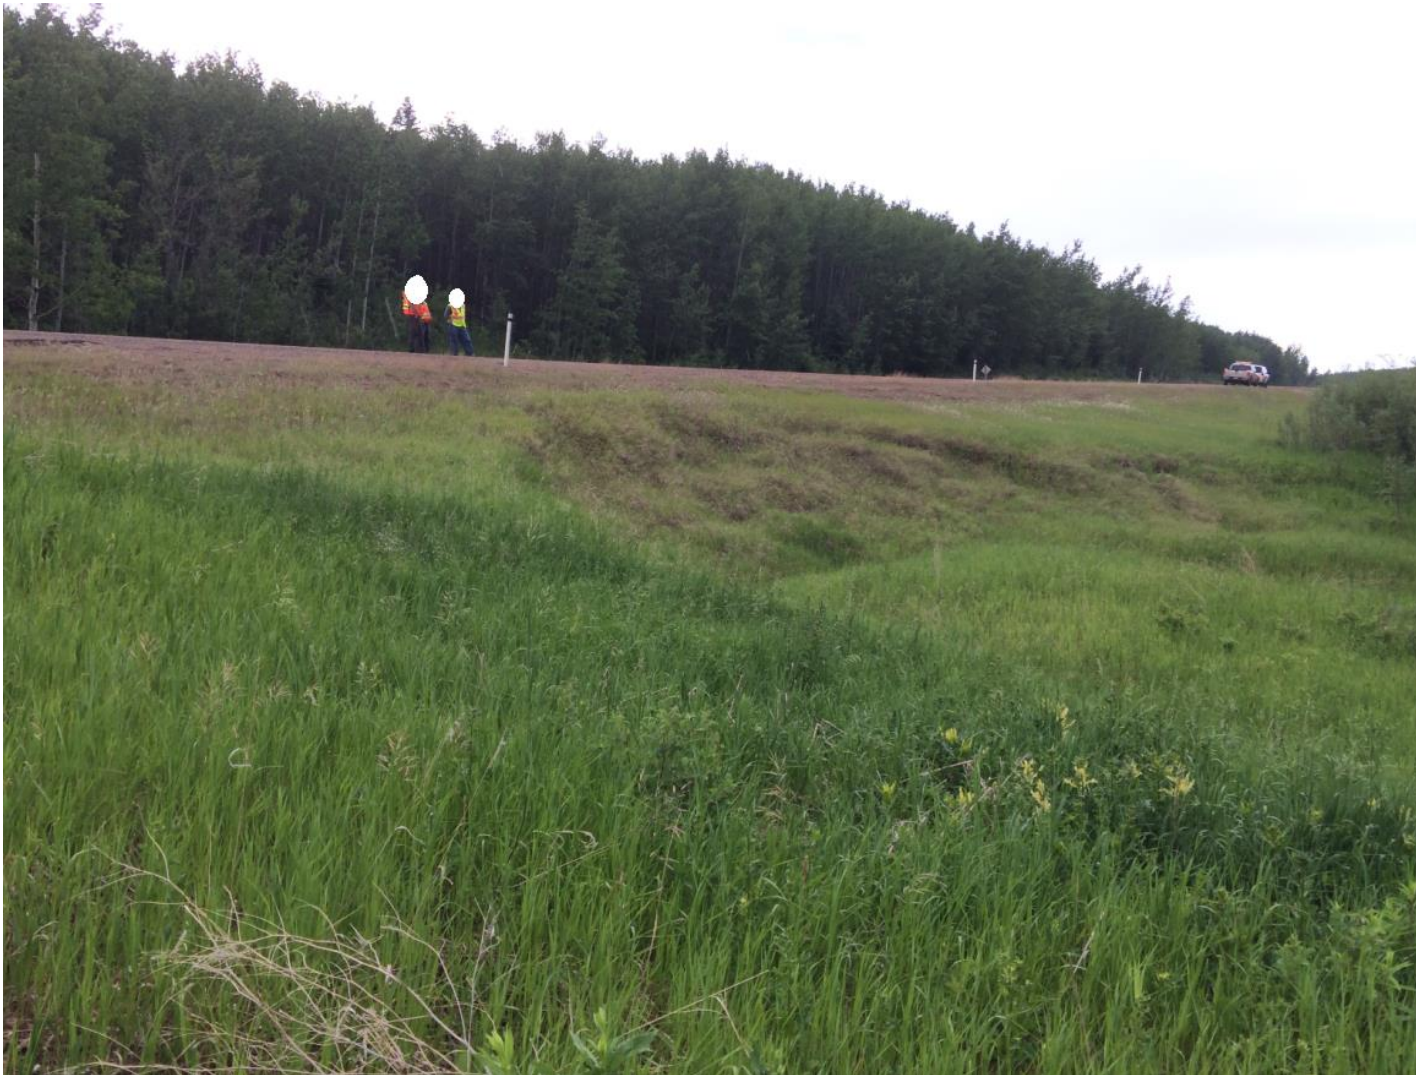
Photo 3: (looking south)

Backscarp is relatively well vegetated and appeared unchanged from June 2013 inspection.
