<b>SITE NUMBER</b> SH 28	<b>SITE NAME</b> Little Smoky Valley	<b>HIGHWAY &amp; KM</b> HWY 744:02	<b>PREVIOUS INSPECTION DATE</b> 03 July 2014	<b>INSPECTION DATE</b> 25 June 2015
<b>LEGAL DESCRIPTION</b> LSD 13-18-76-22 W5M	<b>NAD 83 UTM COORDINATES</b> N6160721 E474084	<b>PREVIOUS RISK ASSESSMENT</b>		
		PF: 8*	CF: 3	<b>TOTAL: 24</b>
		<b>CURRENT RISK ASSESSMENT</b>		
		PF: 8*	CF: 3	<b>TOTAL: 24</b>
*There are currently no slope movement instruments installed at this site and it is difficult to estimate rates of movement.

PROJECT:	GEO HAZARD ASSESSMENT PEACE REGION (SWAN HILLS)
TITLE:	SH28: HWY744:02 - LITTLE SMOKY VALLEY SITE PLAN

DATE:	JULY, 2015
PROJECT No.:	EG10030
REV. No.:	A
FIGURE No.:	FIGURE 1

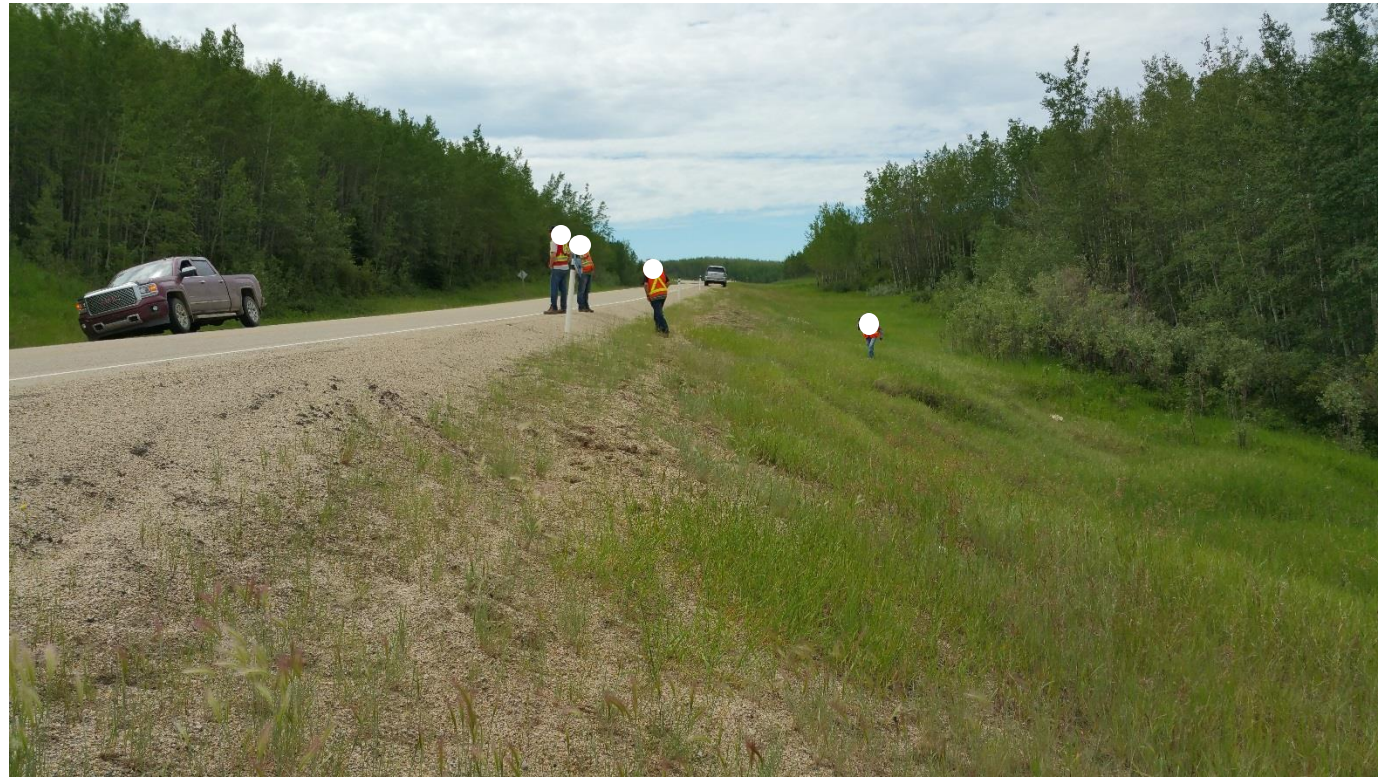
**Photo 1:** (looking south)  
No indications of pavement distress or deformation were observed.

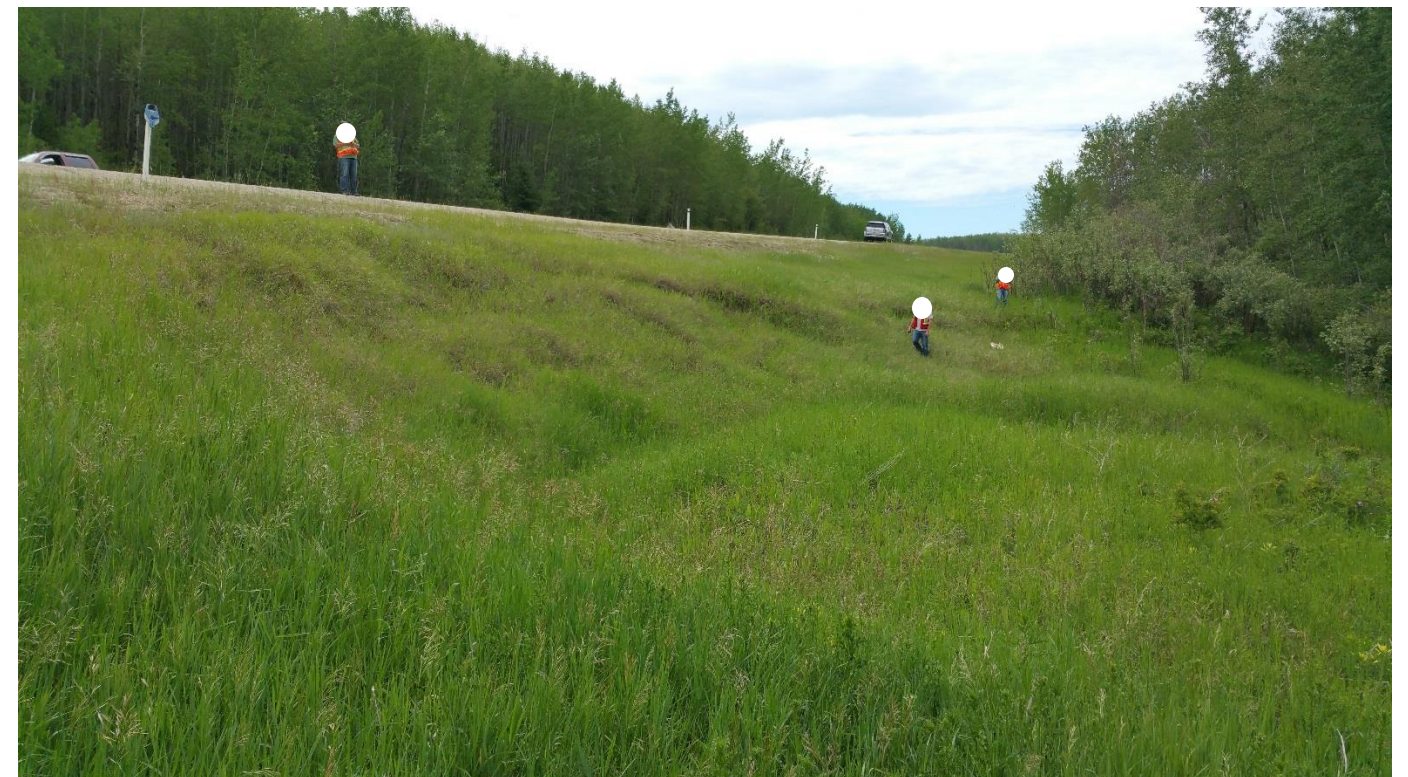
There was no evidence of movement activity at the time of the 2015 inspection. Little to no retrogression has occurred since 2011. Vegetation has grown along the failure mass and scarps and is relatively mature (Photos 2 and 3).

**Photo 2:** (looking south)  
Distance between the edge of the pavement and backscarp was unchanged from July 2014.

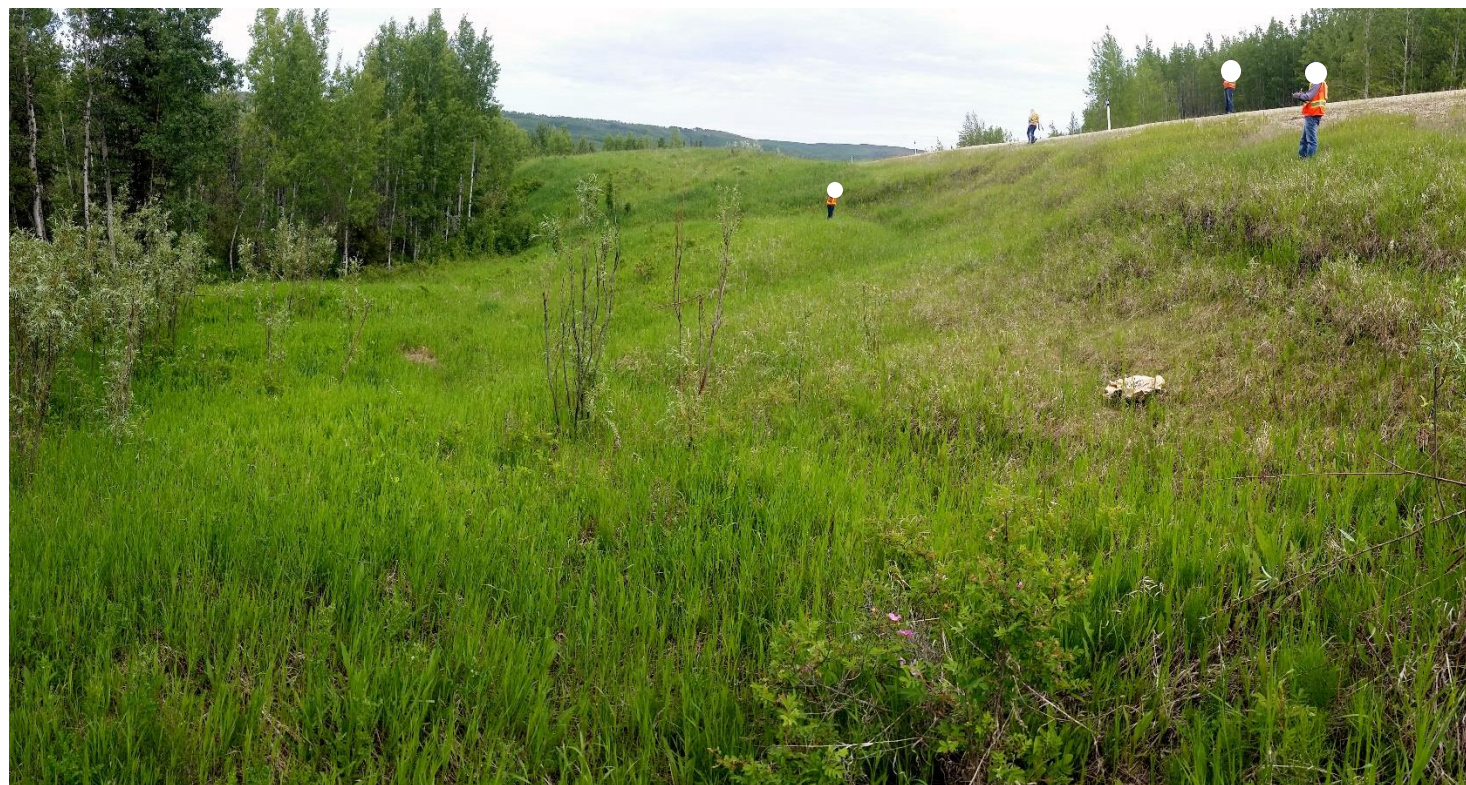
**Photo 3:** (looking northeast)  
Backscarp is well vegetated and no signs of retrogression were visible.
