# **ALBERTA TRANSPORTATION GEOHAZARD ASSESSMENT PROGRAM PART A: FILE REVIEW**

## **PEACE REGION – PEACE-HIGH LEVEL**

### **PH12 JUDAH HILL – HEART RIVER SLIDES**

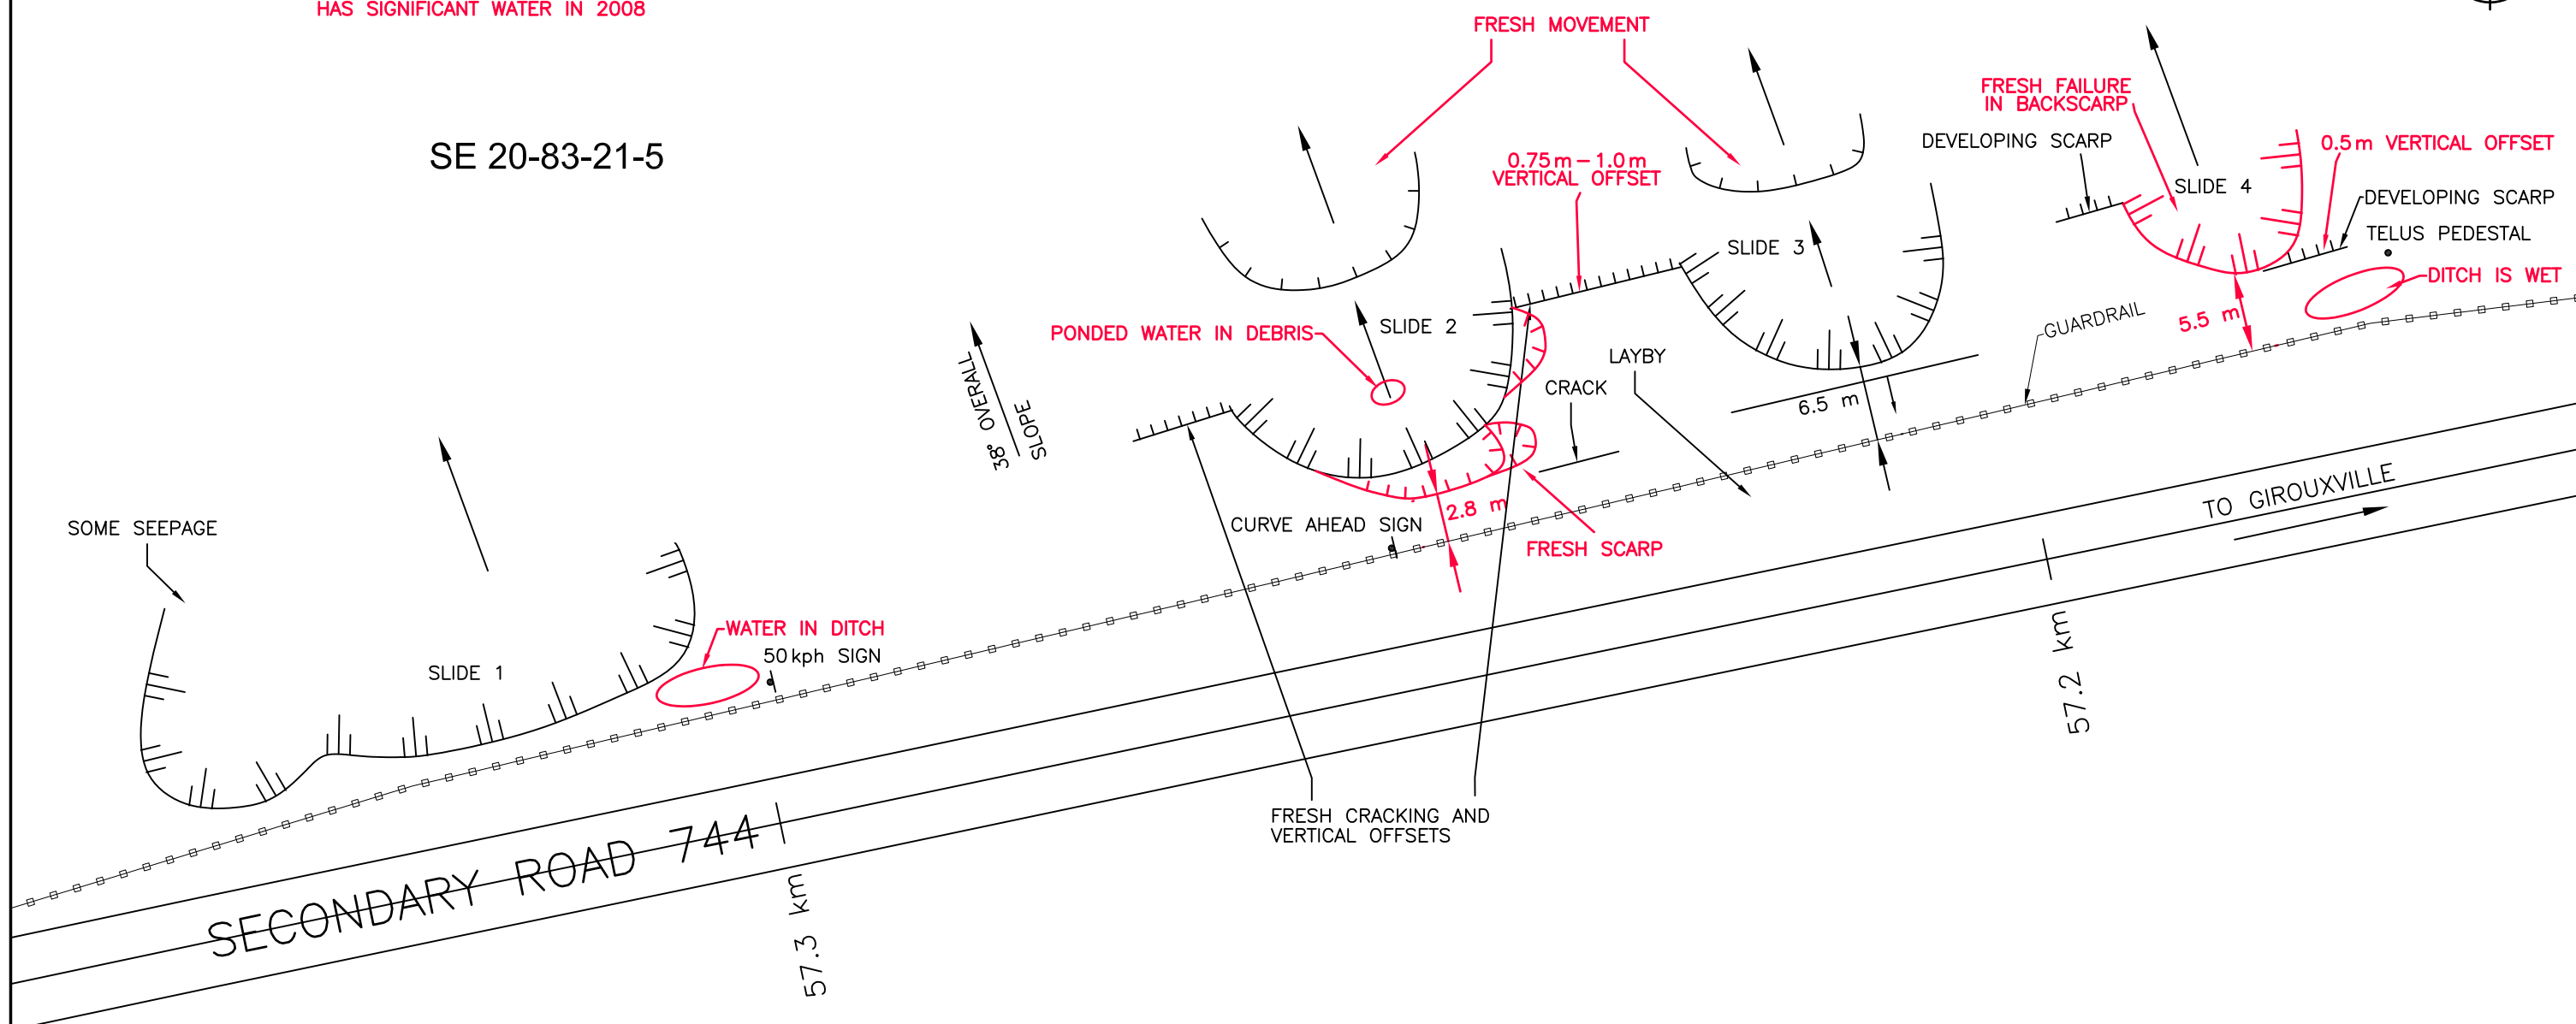
FIGURE 2

| June 2008 | Water noted in the ditch at the south end of Slide 1. Further expansion of Slide 2, though only slight retrogression towards the road. Ponded water and fresh debris noted in the bowl of Slide 2. Fresh movement at Slide 4 and retrogression by about 0.5 m. |

SAG POND AT BASE OF SLIDE  
HAS SIGNIFICANT WATER IN 2008

2 2008 OBSERVATIONS SHOWN IN RED
