**ALBERTA TRANSPORTATION
GEOHAZARD ASSESSMENT PROGRAM
PEACE REGION (PEACE RIVER DISTRICT)
2021 INSPECTION**

Site Number	Location	Name	Hwy	km
PH012	Judah Hill	Heart River Slides	744:04	57.114
Legal Description		UTM Co-ordinates		
SE¼ 20-083-21 W5M		11V E 483284	N 6229209

**PH012-1 JUDAH HILL HEART RIVER SLIDES
2021 SITE INSPECTION PLAN**

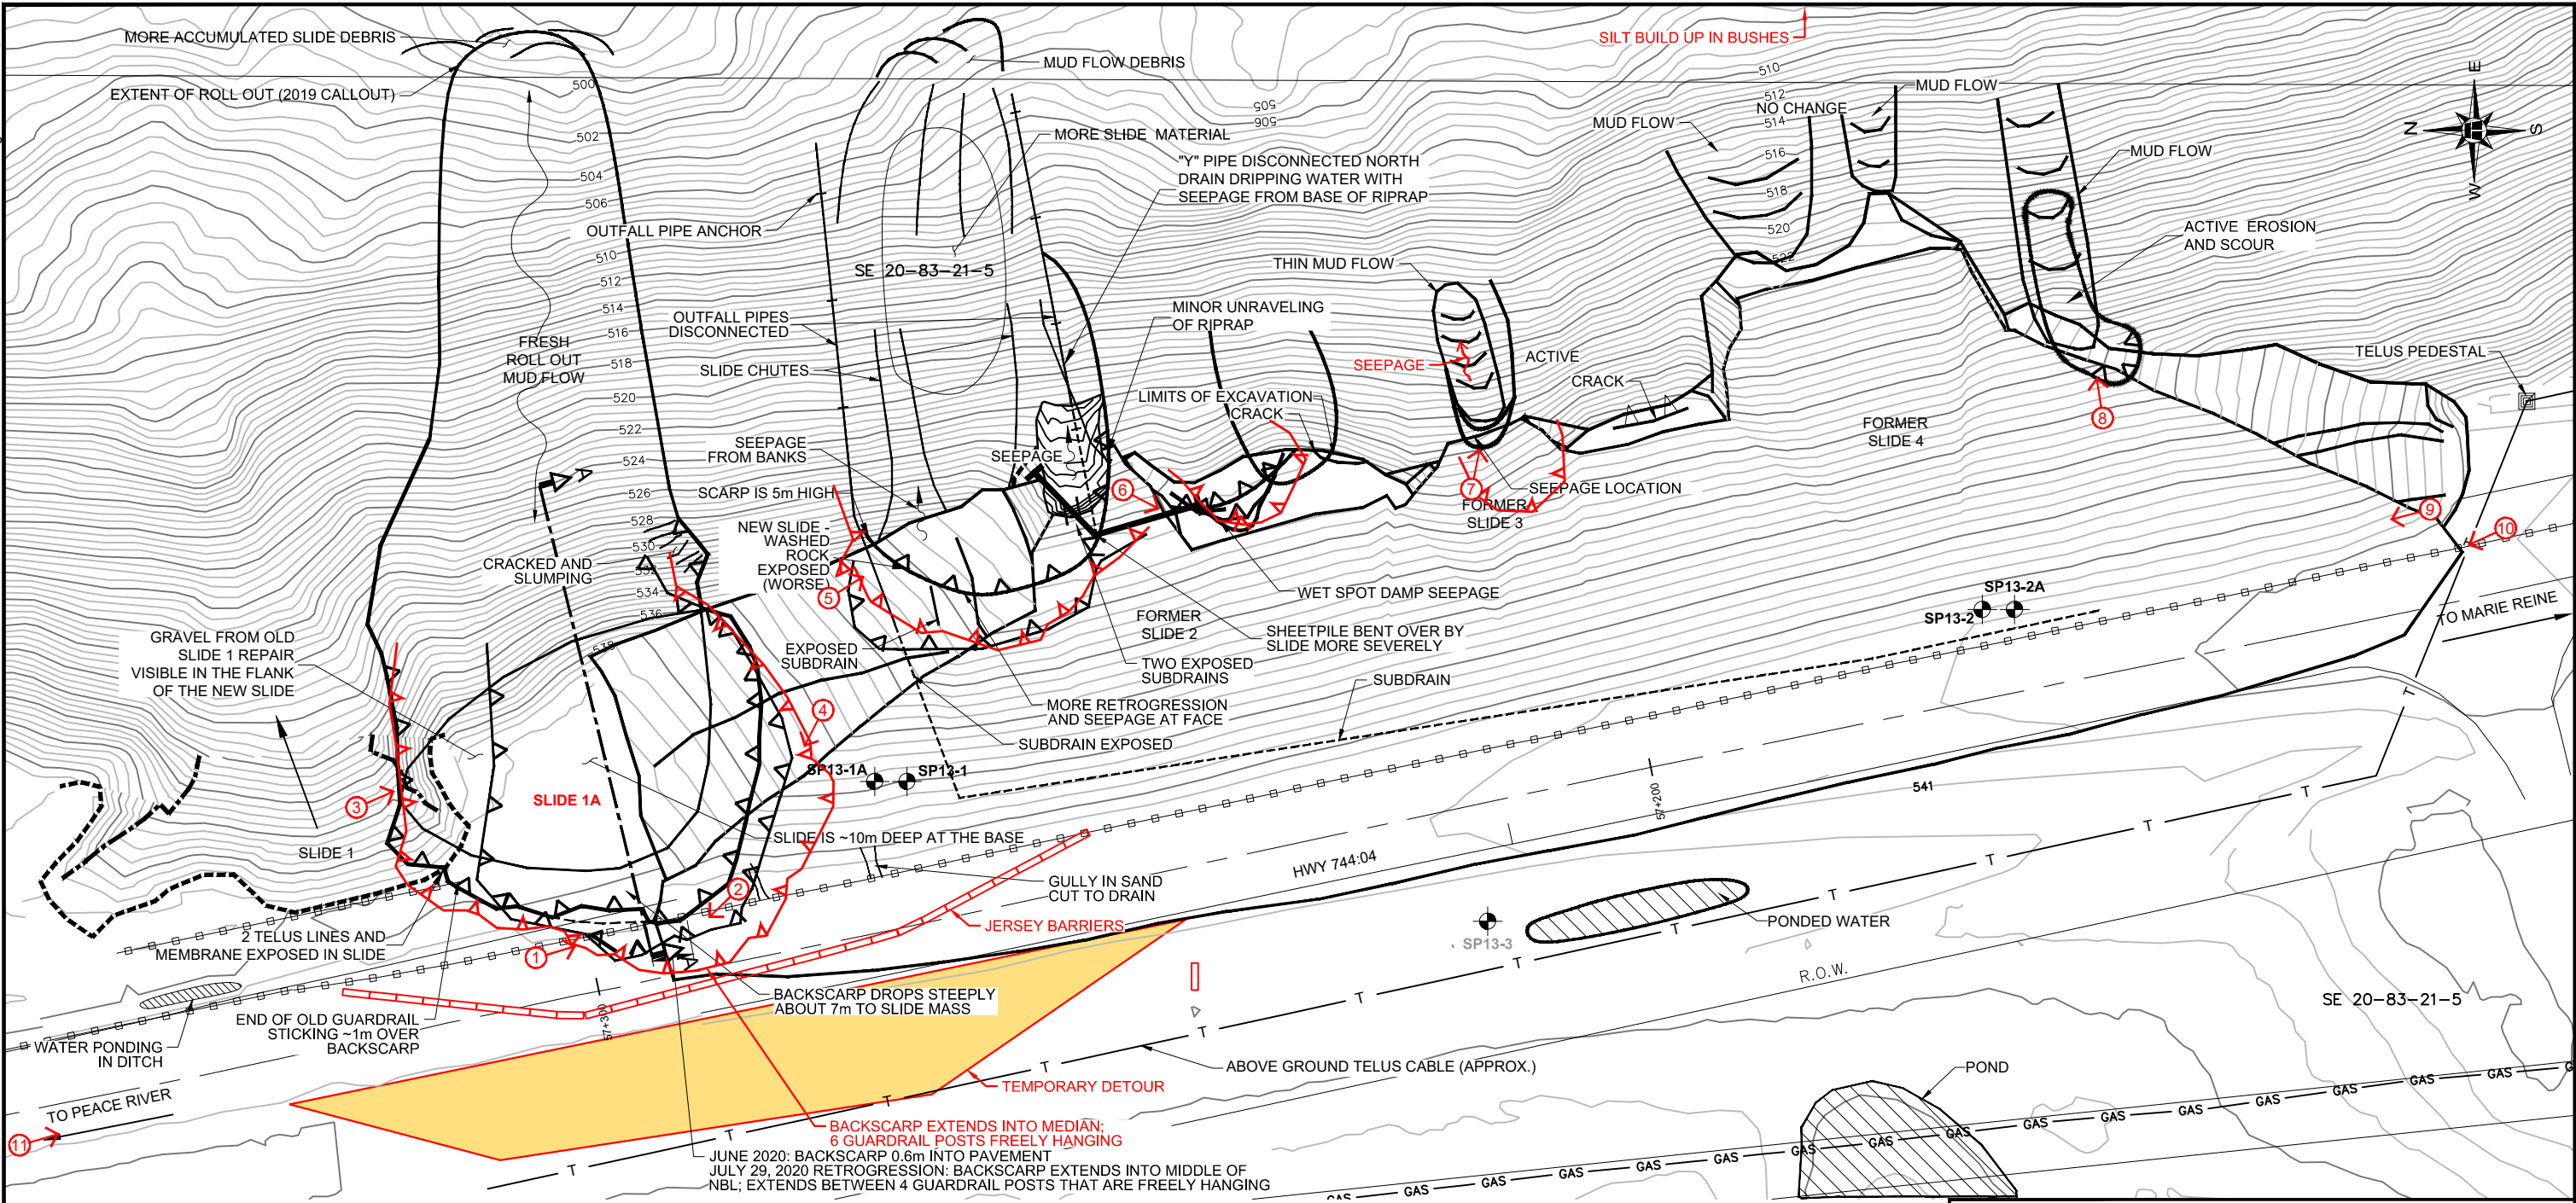
DWG No. 32121-PH012-1-1

- 1 LOCATION DATA RECORDED USING HAND HELD GPS RECEIVER. ALL LOCATIONS ARE APPROXIMATE AND ARE FOR ILLUSTRATIVE PURPOSES ONLY.
- 2 JULY 2021 OBSERVATIONS SHOWN IN RED

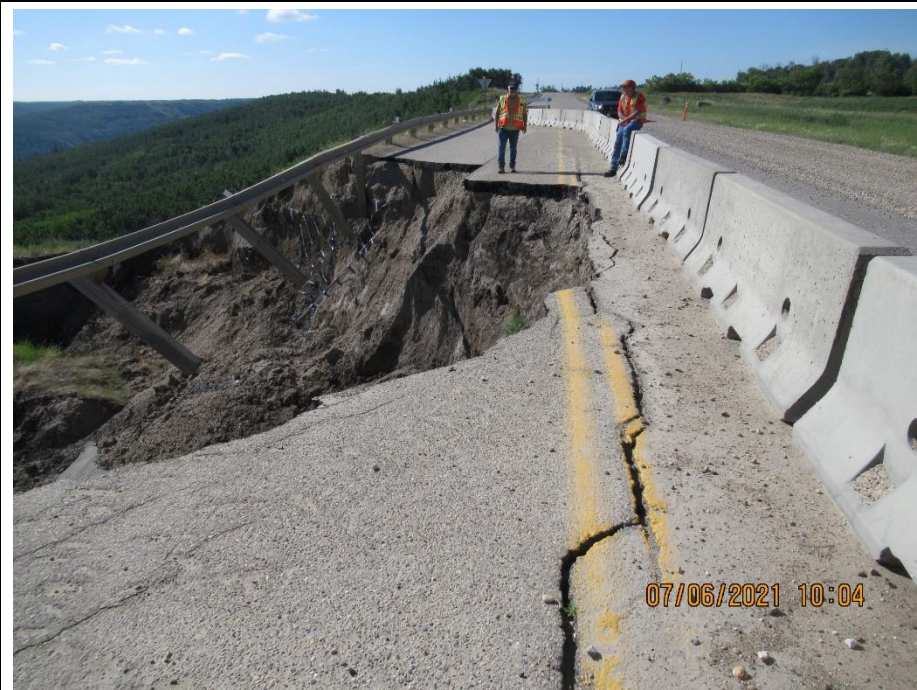
The main scarp of Slide 1A (formed between Slide 1 and the former Slide 2) has retrogressed to just past the highway centreline and will continue to retrogress towards the SBL. The rate of retrogression has reduced since September 2020; however, it is expected be highly dependent on groundwater and precipitation conditions. There is still risk the nearly vertical scarp at the highway could retrogress in sudden large increments by breaking off with relatively little warning. Signs of active seepage have been noted at the exposed scarp face and appear to be a driving factor in the loss of soil strength and rapid retrogression. Currently there is approximately 0.5 m of offset between the scarp and current concrete barriers

Photo 1.
Looking south from south end of Slide 1 from the NBL shoulder of Hwy 744:04 towards the top of the Slide 1A bowl (57+300). The main scarp of the slide has retrogressed entirely into the NBL: and has reached just past the median strip. Gravel detour has been constructed to expand the SBL.

The concrete barriers may need to be rapidly shifted to the west if a significant increment of movement occurs at the Slide 1A main scarp. This would result in the narrowing of the current detour to one-lane traffic and temporary automated lights may be required for safe traffic control, or the detour will need to be widened.

Consideration should be given to temporary stabilization measures at the main scarp face to reduce rate of retrogression and provide increased time allowance for long-term mitigation design and construction measures. This could involve installation of launched perforated soil nails. These would reinforce the main scarp face and reduce the magnitude of the incremental retrogression (i.e. significant "break-off" or calving at the scarp face) and would also reduce seepage induced pore pressures at the face.

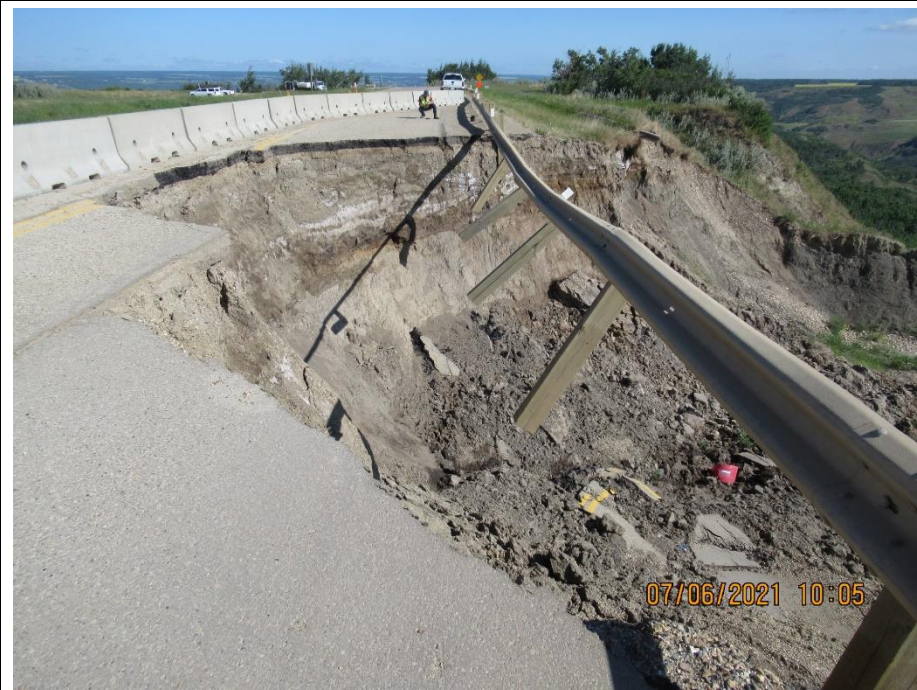
Photo 2.
Looking north towards the Slide 1A bowl flank and main scarp south of Slide 1. The main scarp now has reached past the highway median. Six guardrail posts are freely hanging.

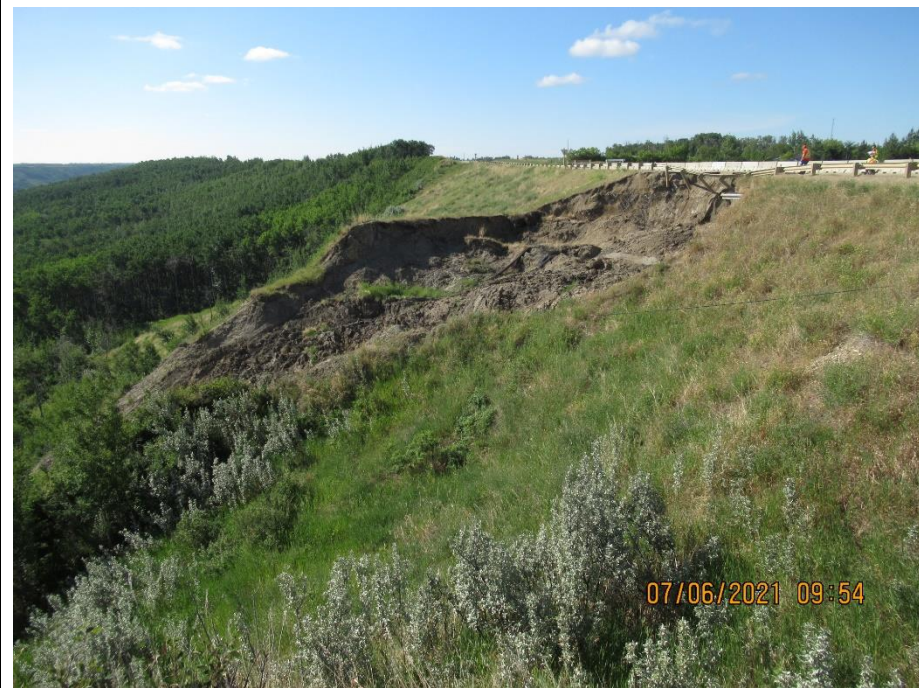
Photo 3.
Looking at the south flank of the Slide 1A area. South flank area expanded since the previous inspection. North flank has had minor expansion within the upper slope relative to the previous inspection.

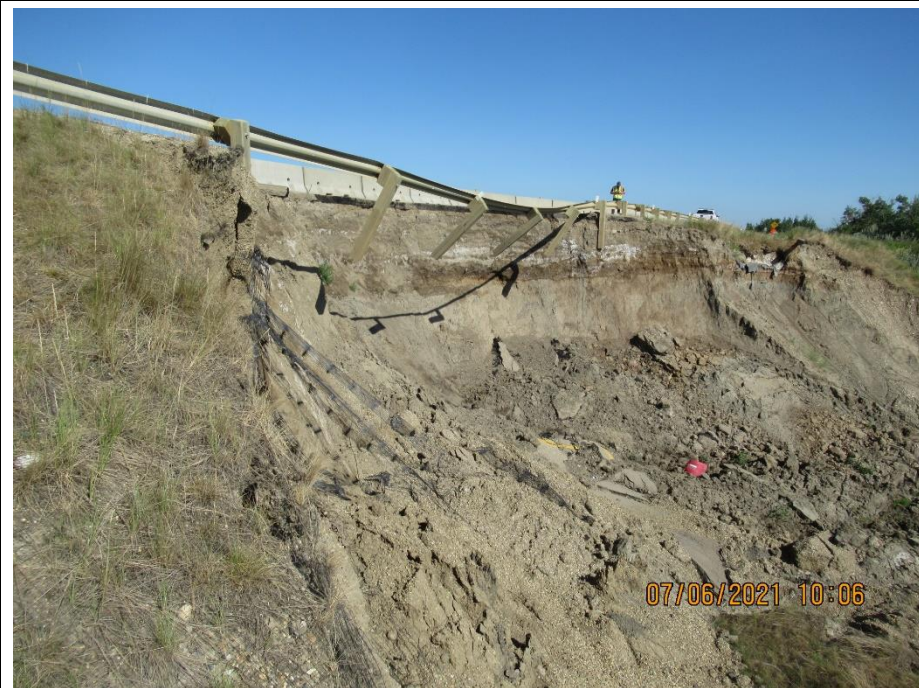
Photo 4.
Looking towards the northwest at the main backscarp of Slide 1A. Note the wet soil horizon and dried water deposits from seepage.

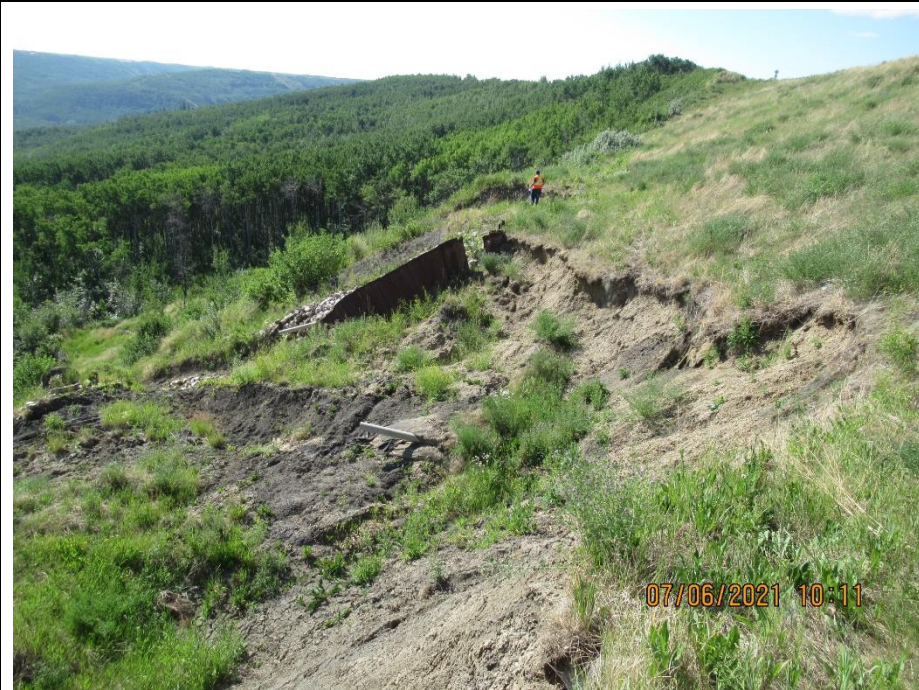
The sheet pile wall has been compromised from slope movements and is deflected and ineffective at its north end. Ongoing slide movement and loss of material upslope from the wall due to earth flows are expected in the following years. Loss of material here and further south of the sheetpile wall could begin to undermine the upslope repairs above former slides 2 and 3.

Photo 5.
 Looking southeast from north end of Heart River Landslide repair excavation (Former Slide 2). More slide / earth flow movement and main scarp retrogression has occurred since the previous inspection. The north end of the driven sheetpile has deflected further downslope.

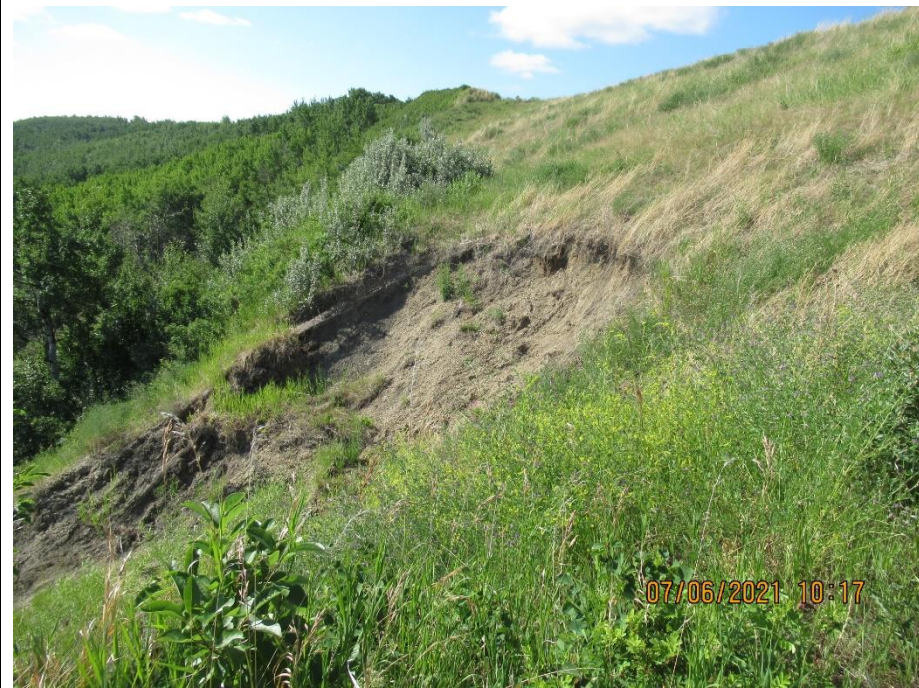
Photo 6.
 Looking southwest from north end of Heart River Landslide repair excavation (Former Slides 2, 3 and 4). Area has vegetated well through the Type B ECSC. Increased retrogression at the scarp and movement within the slide in the foreground.

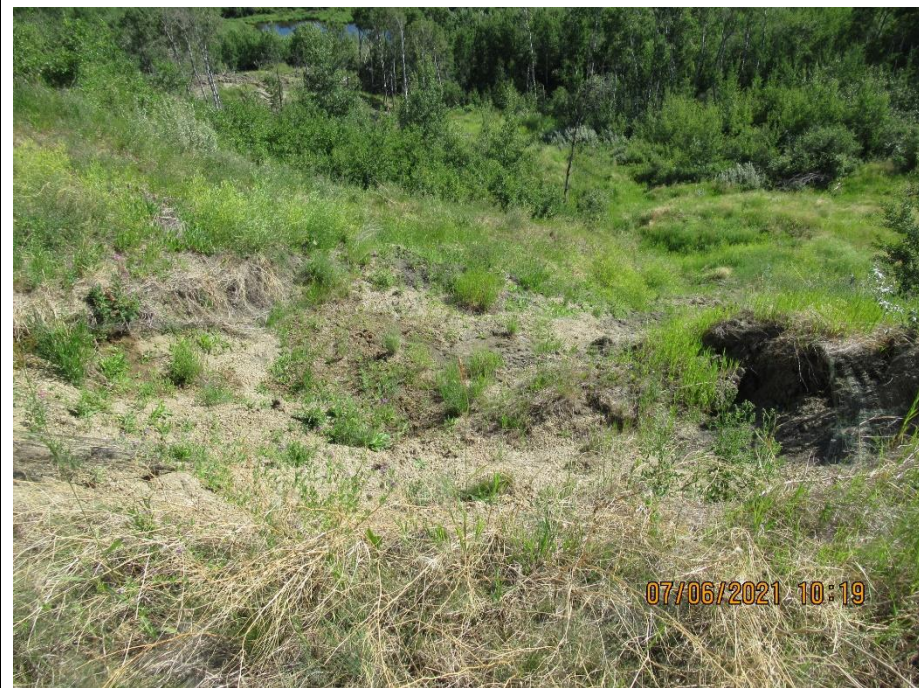
Scour in seepage zones in the till underlying the 2014-2015 repair from Contract CON0015153 continue to develop resulting in shallow earth flows on the colluvium slope below the locations of the former slides 2, 3 and 4.

Photo 7.
Looking east at mud flow at the location of former Slide 3, which has been more active since 2020. Decreased vegetation since previous inspection indicative of active soil movement.

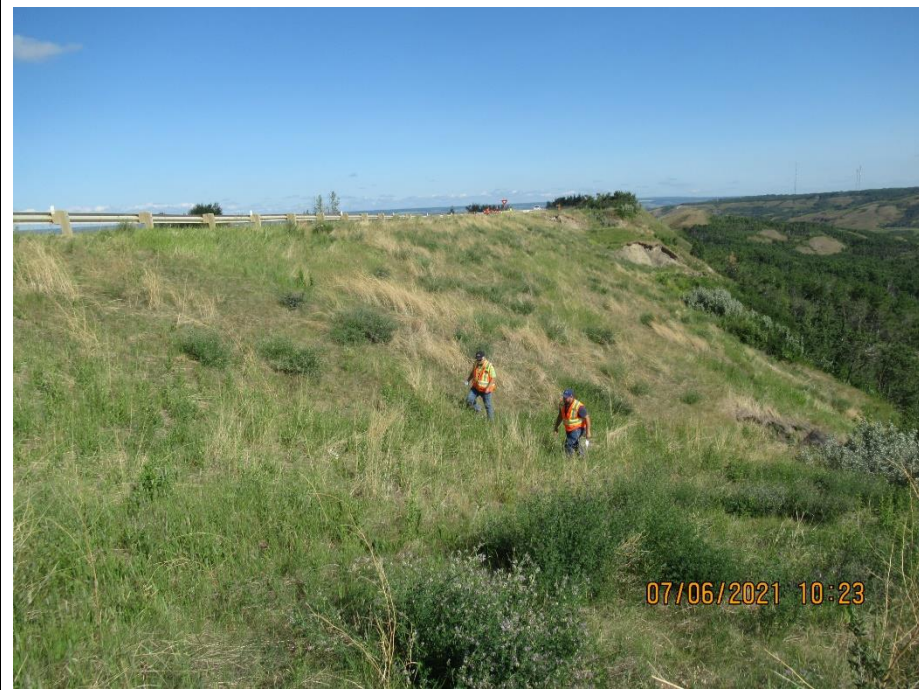
Photo 9.
Looking northwest from south of the location of former Slide 4. Overall repairs from 2014 are performing well in this area. Overall slope is well vegetated and there are no apparent slumps in the granular backfill slope. No change from 2020.

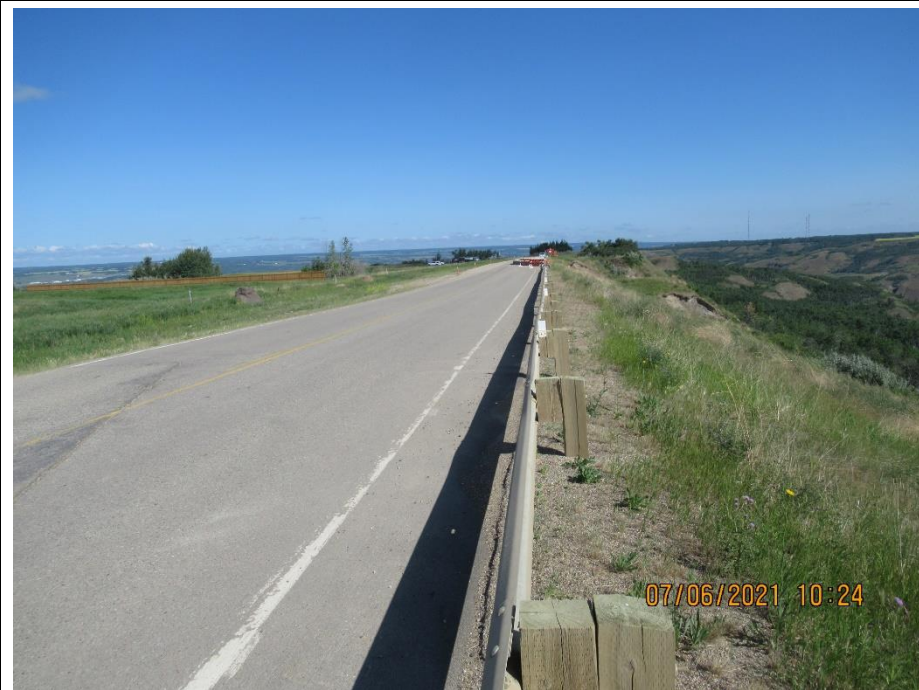
Photo 10.
Looking north along the highway from the south end of the site (57+120). No apparent pavement changes south of Slide 1A. Note detour signage at Slide 1A.

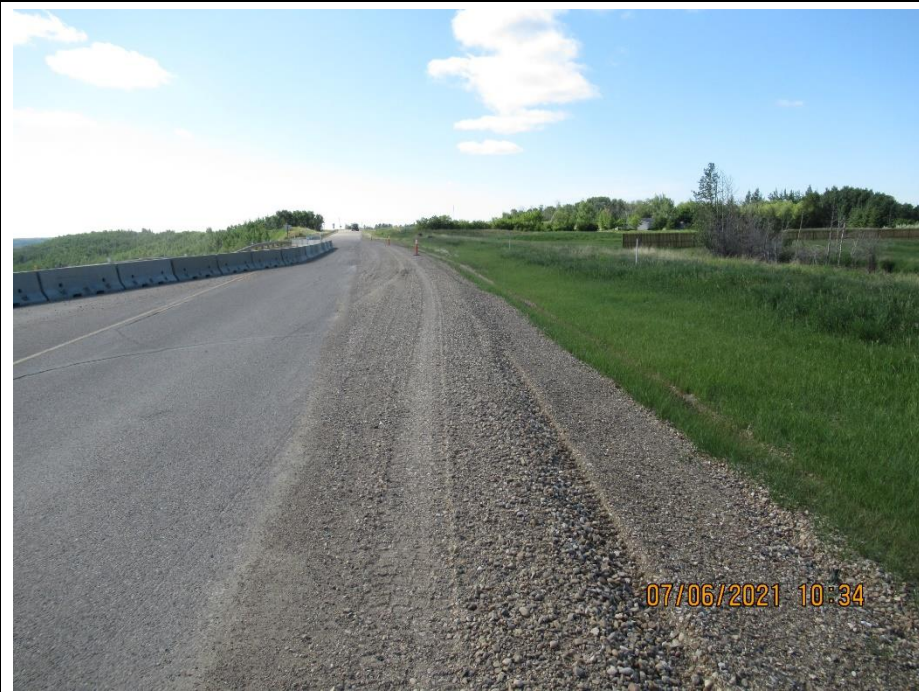
Photo 11.
Looking south along the highway from the north end of the site (57+375) at the gravel detour constructed next to the SBL by Slide 1A.

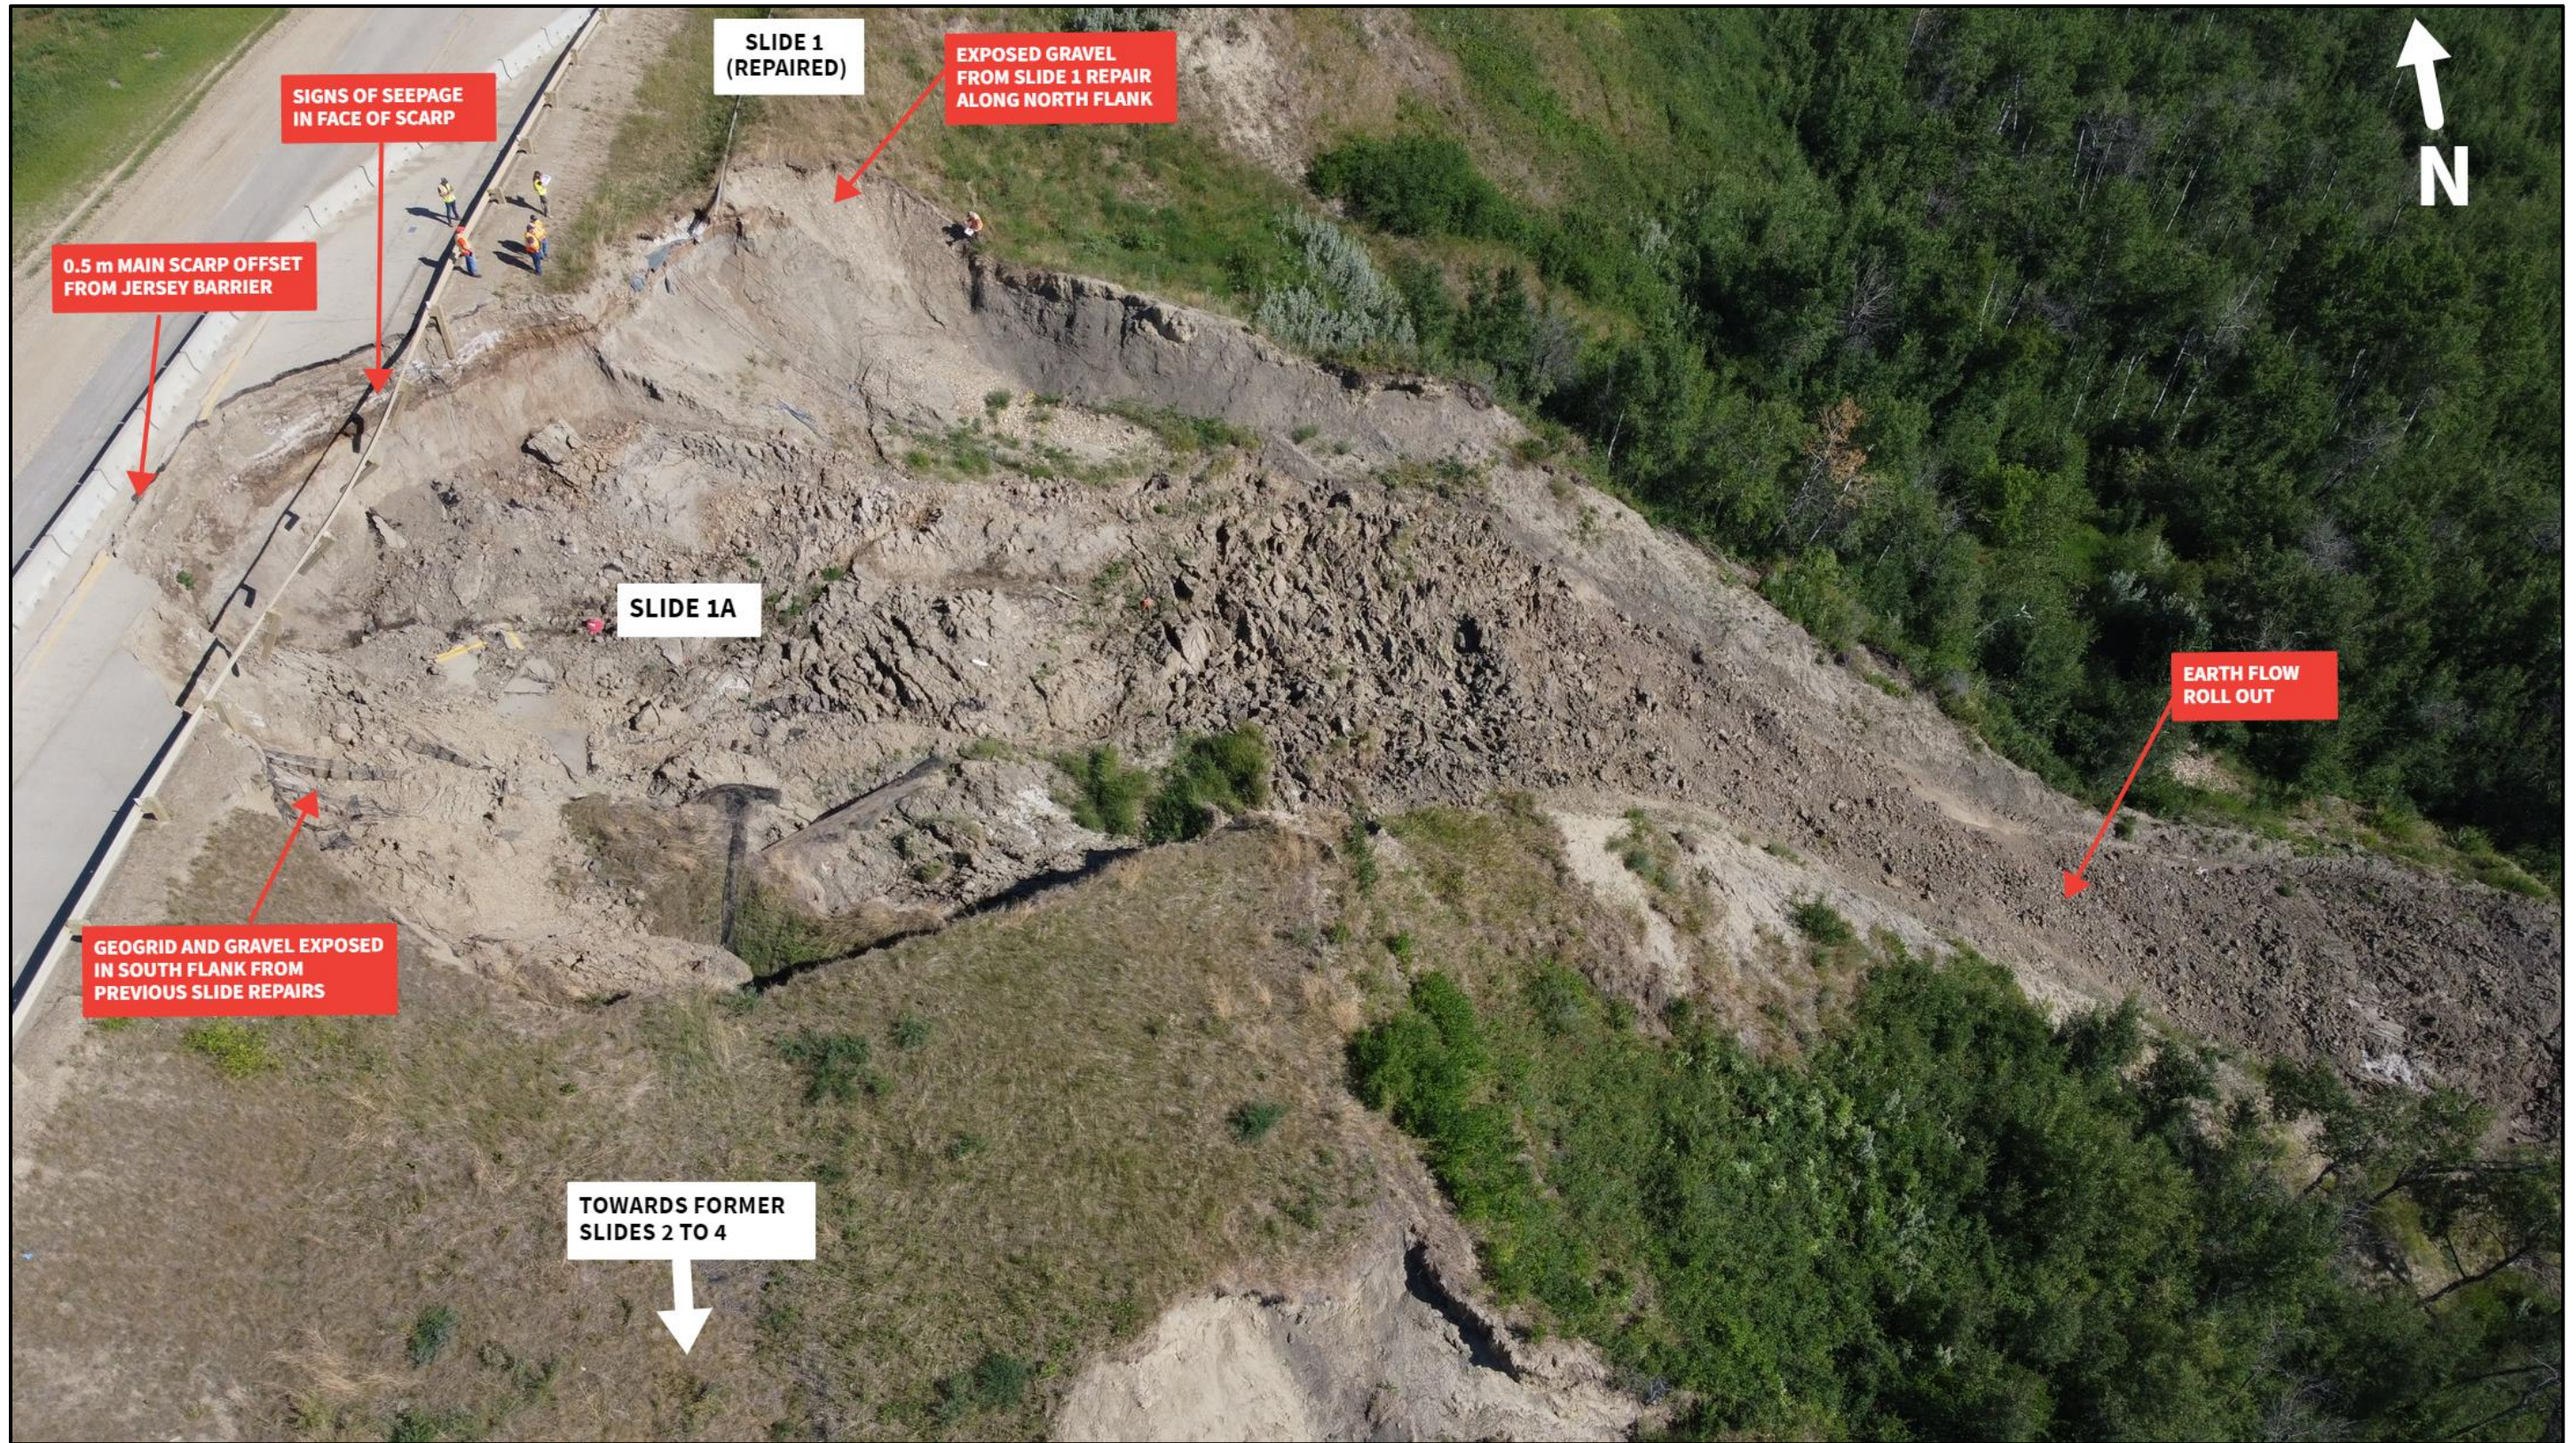
PH012 - Drone Photo 1
Aerial view looking north from the south side of Slide 1A.

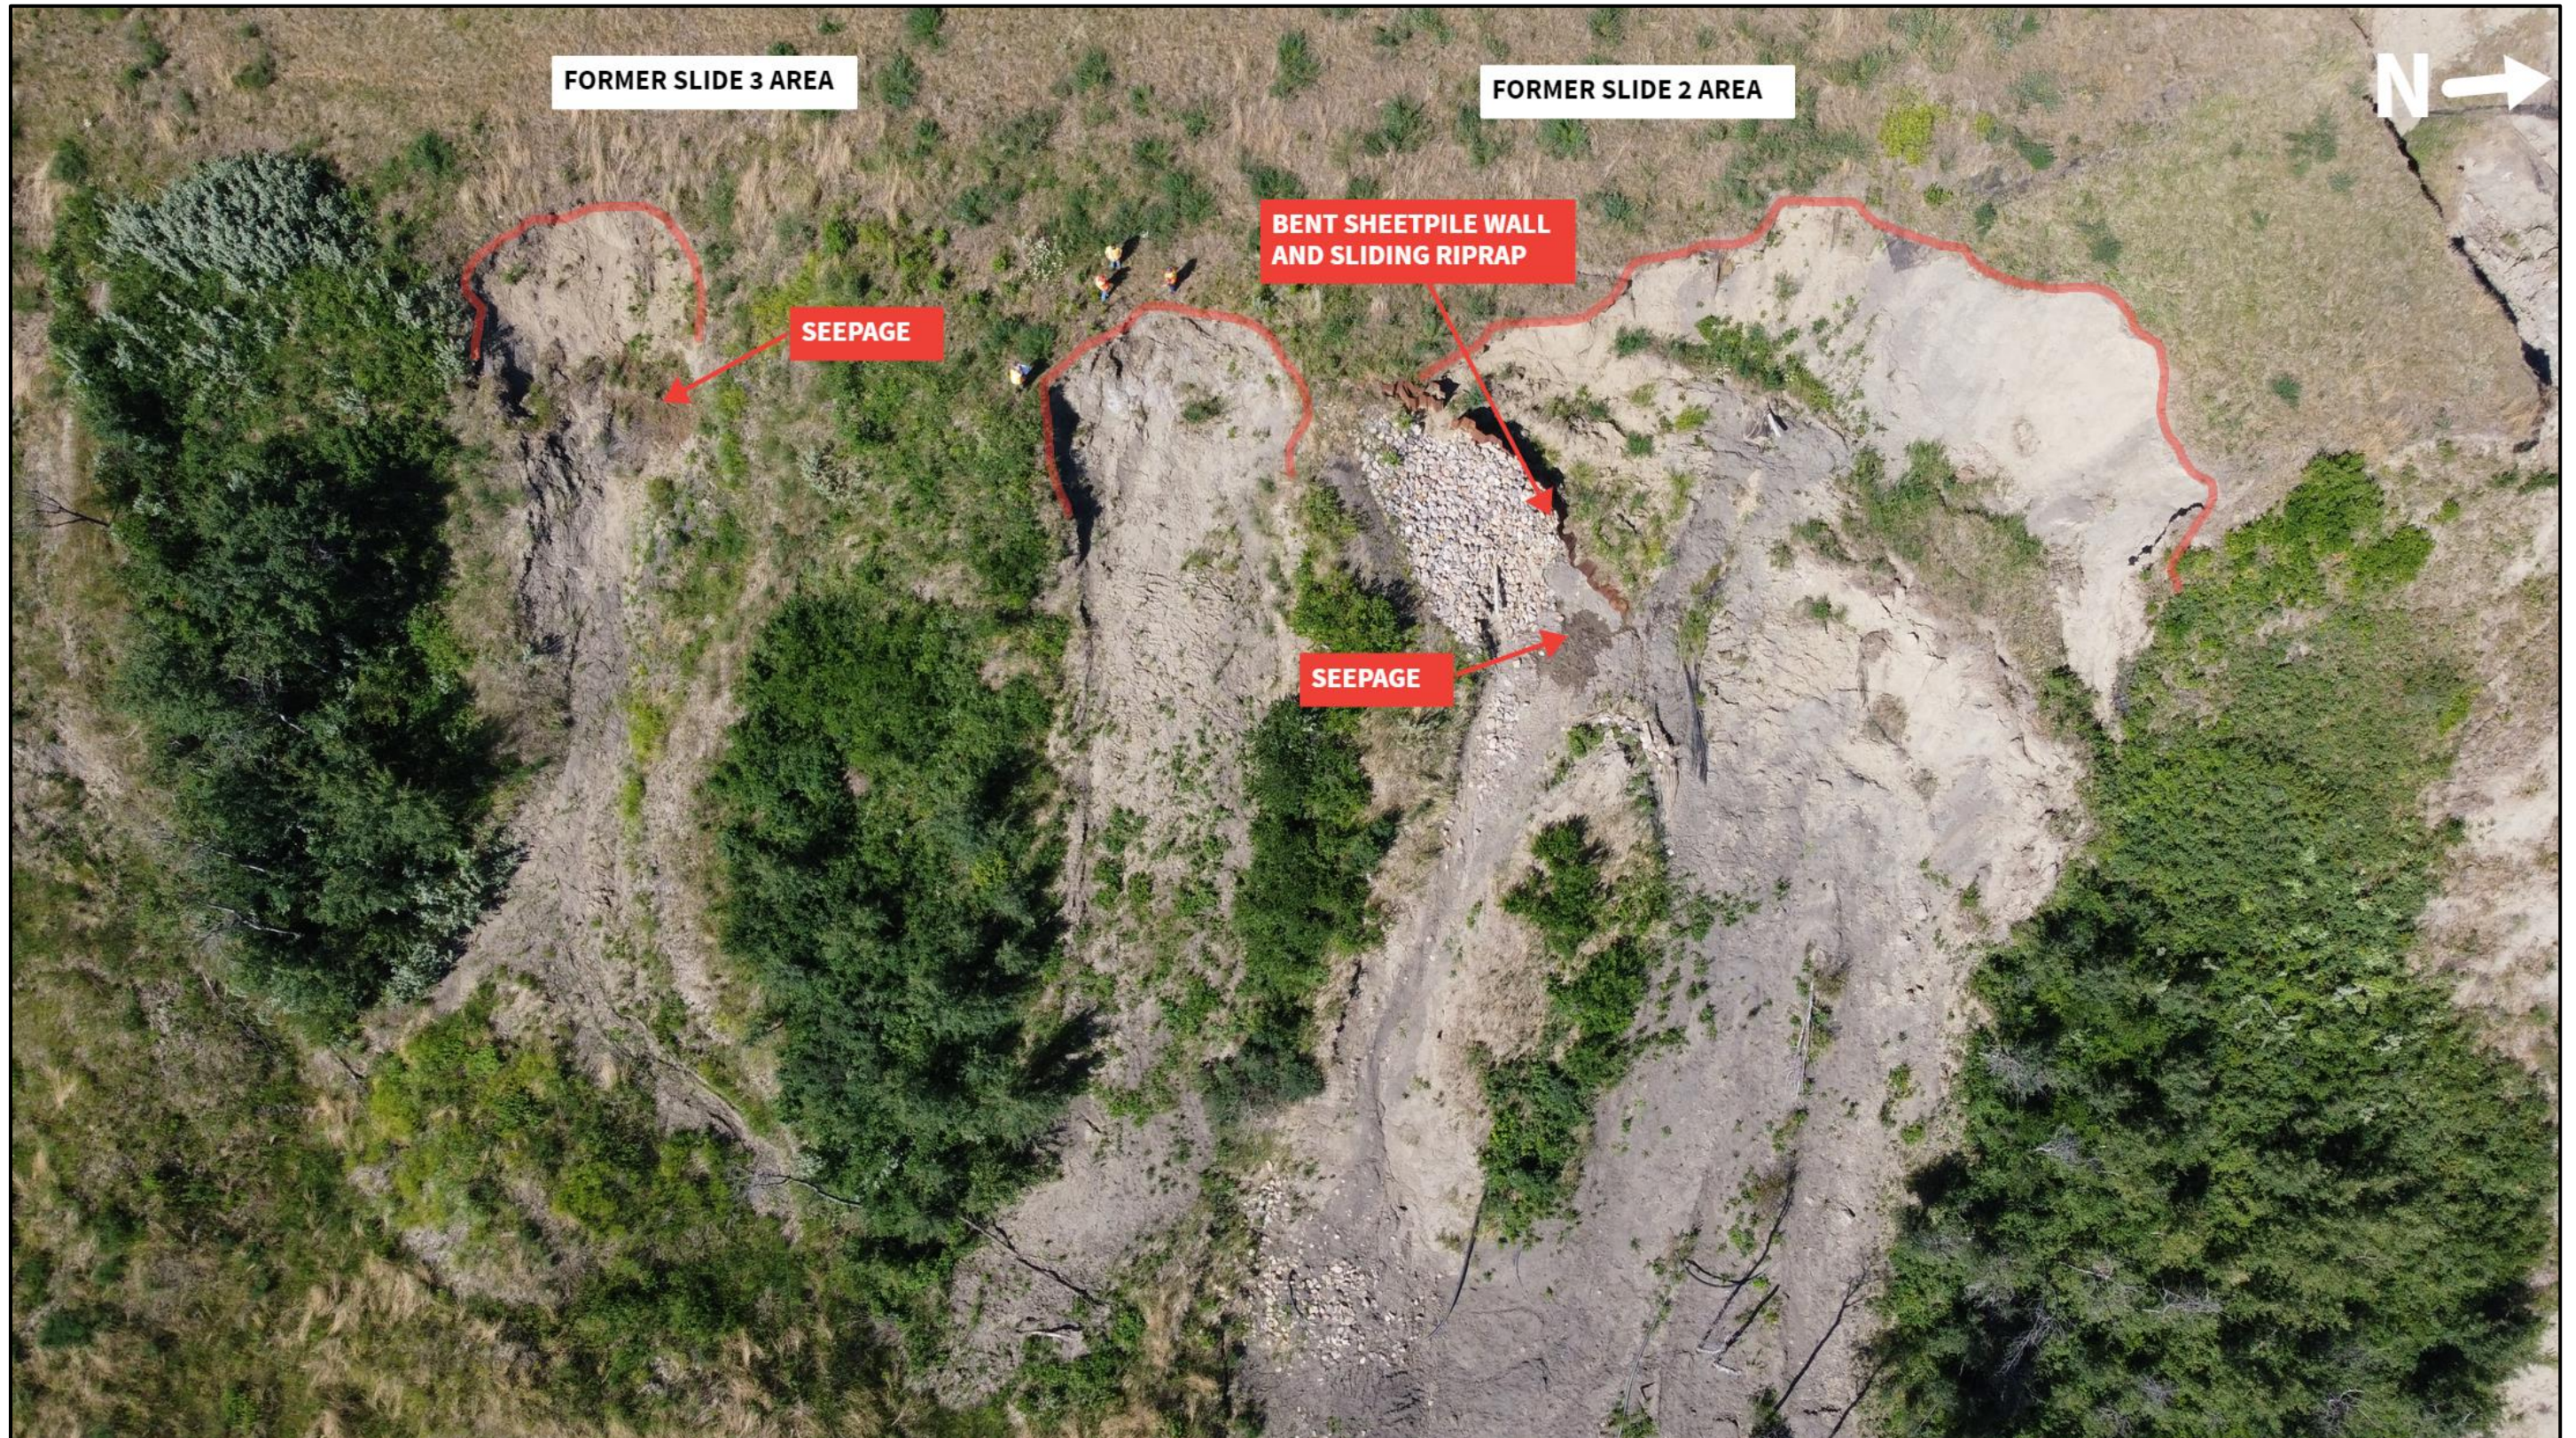
PH012 - Drone Photo 2

Aerial view looking west towards former area of Slides 2 and 3. Active retrogression was noted along the three scarps highlighted in red. Seepage is expected to be major contribution to the loss of soil strength and earth flow behavior at this site.
