**ALBERTA TRANSPORTATION
GEOHAZARD ASSESSMENT PROGRAM
PEACE REGION (PEACE RIVER DISTRICT)
2022 INSPECTION**

Site Number	Location	Name	Hwy	km
PH012	Judah Hill	Heart River Slides	744:04	57.114
Legal Description		UTM Co-ordinates		
SE¼ 20-083-21 W5M		11V E 483284	N 6229209

**PH012-1 JUDAH HILL HEART RIVER SLIDES
2022 SITE INSPECTION PLAN**

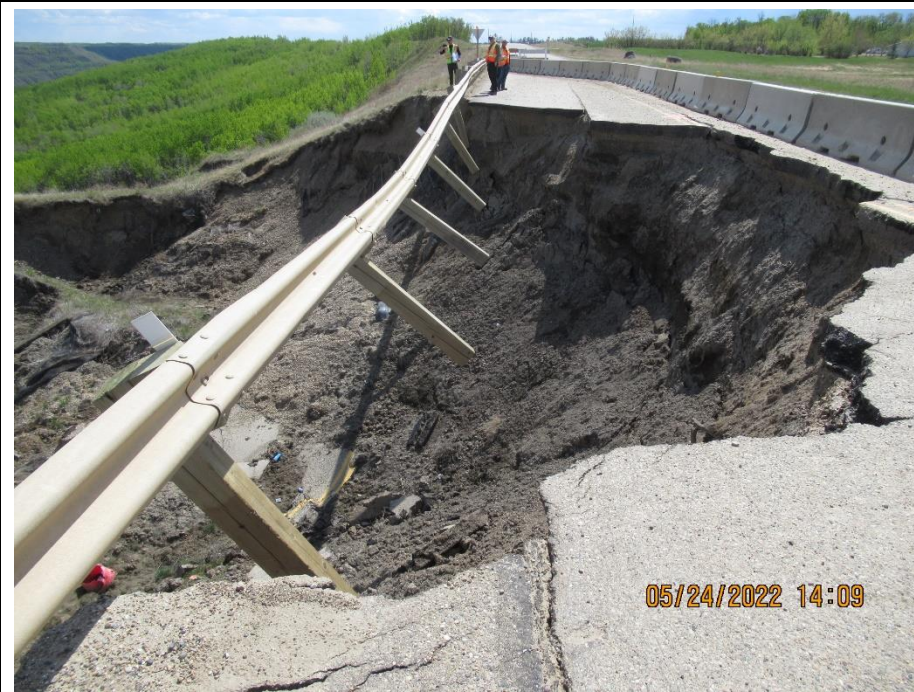
Photo 1.

Looking south from south end of Slide 1 from the NBL shoulder of Hwy 744:04 towards the top of the Slide 1A bowl (57+300). The main scarp of the slide has retrogressed entirely into the NBL: and has reached just past the median strip. Gravel detour has been constructed to expand the SBL.

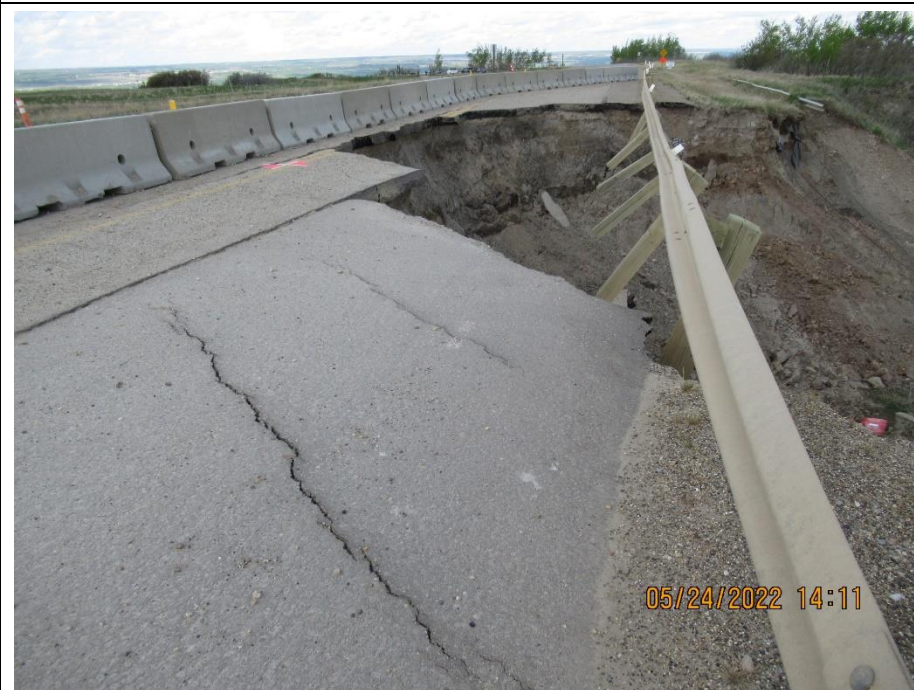
Photo 2.

Looking north towards the Slide 1A flank and main scarp south of Slide 1. New tension cracks had formed in the pavement above the south flank since the 2021 inspection.

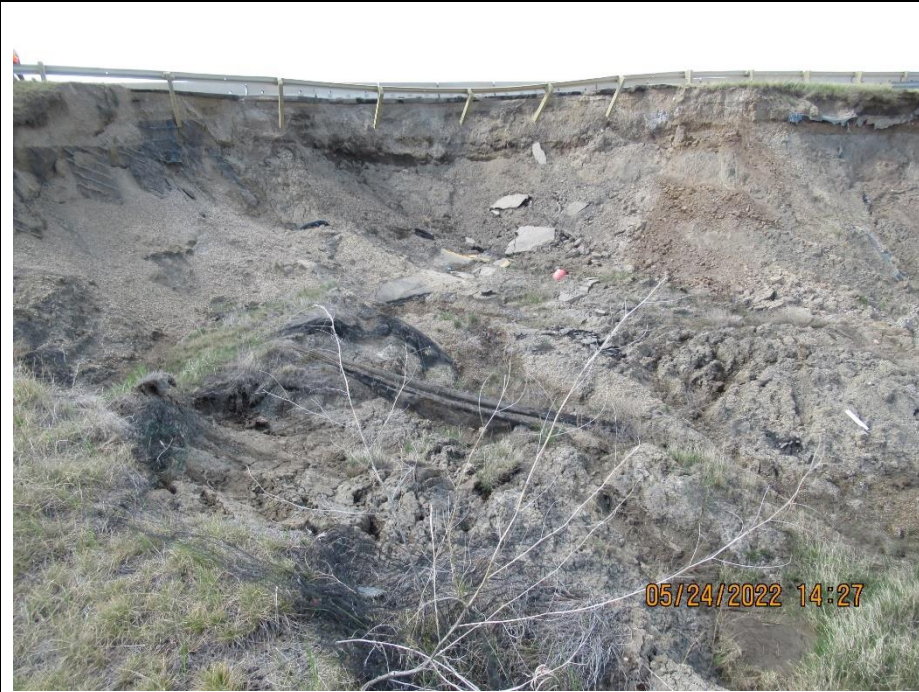
Photo 3.
Looking upslope towards the west at the main scarp of Slide 1A from the lower south flank.

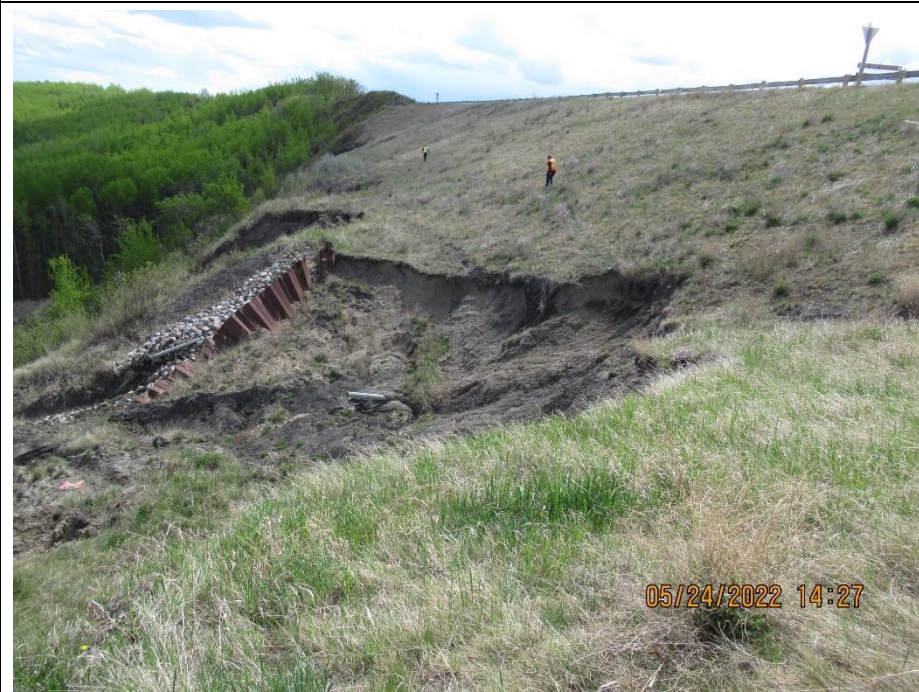
The sheet pile wall has been compromised from slope movements and is deflected and ineffective at its north end. Ongoing slide movement and loss of material upslope from the wall due to earth flows are expected in the following years. Loss of material here and further south of the sheetpile wall could begin to undermine the upslope repairs above former slides 2 and 3.

Photo 4.
Looking southeast from north end of Heart River Landslide repair excavation (Former Slide 2). Ongoing downslope movement but no significant retrogression of the main scarp or further deflection of the sheet pile wall.

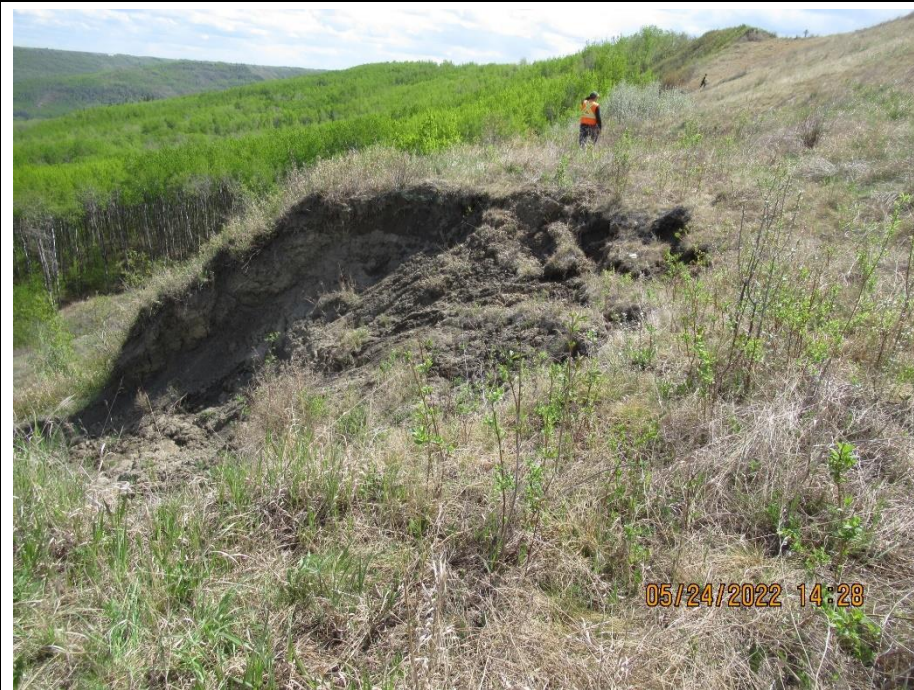
Photo 5.
Looking south at the slide south of the sheet pile wall with recent retrogression visible.

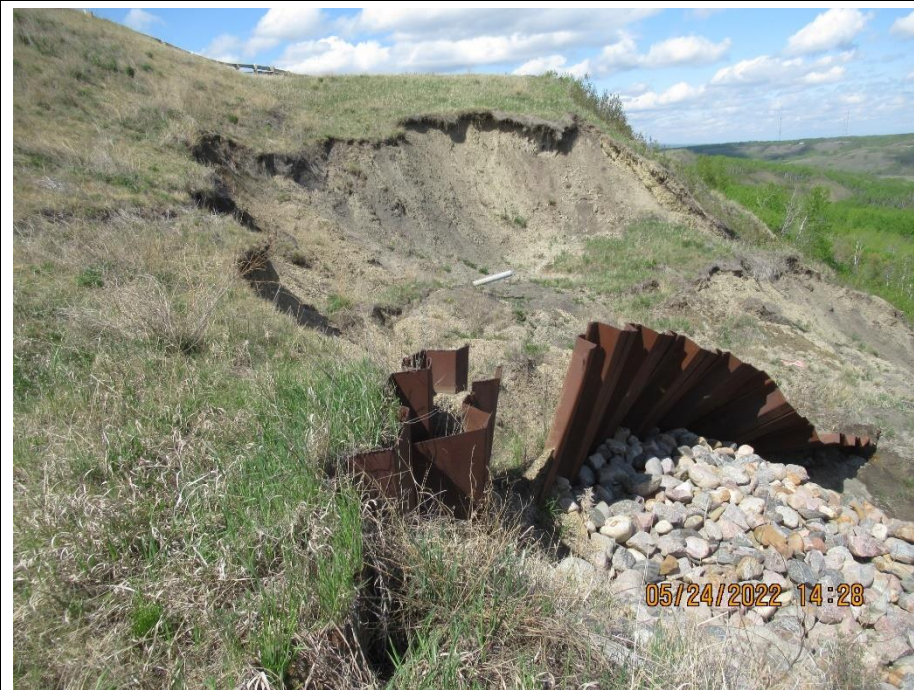
Photo 6.
Looking north at the former Slide 2 area with ongoing slide movement and erosion damage. Some retrogression of the main scarp since 2021.

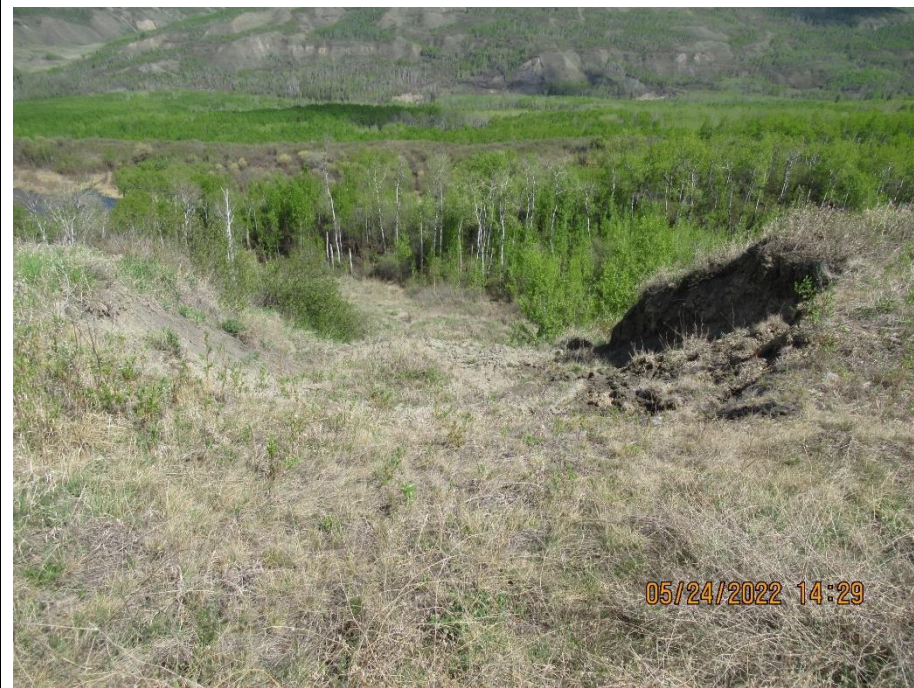
Scour in seepage zones in the till underlying the 2014-2015 repair from Contract CON0015153 continue to develop resulting in shallow earth flows on the colluvium slope below the locations of the former slides 2, 3 and 4.

Photo 7.
Looking east at mud flow at the location of former Slide 3, which has been more active since 2021. Decreased vegetation since previous inspection indicative of active soil movement.

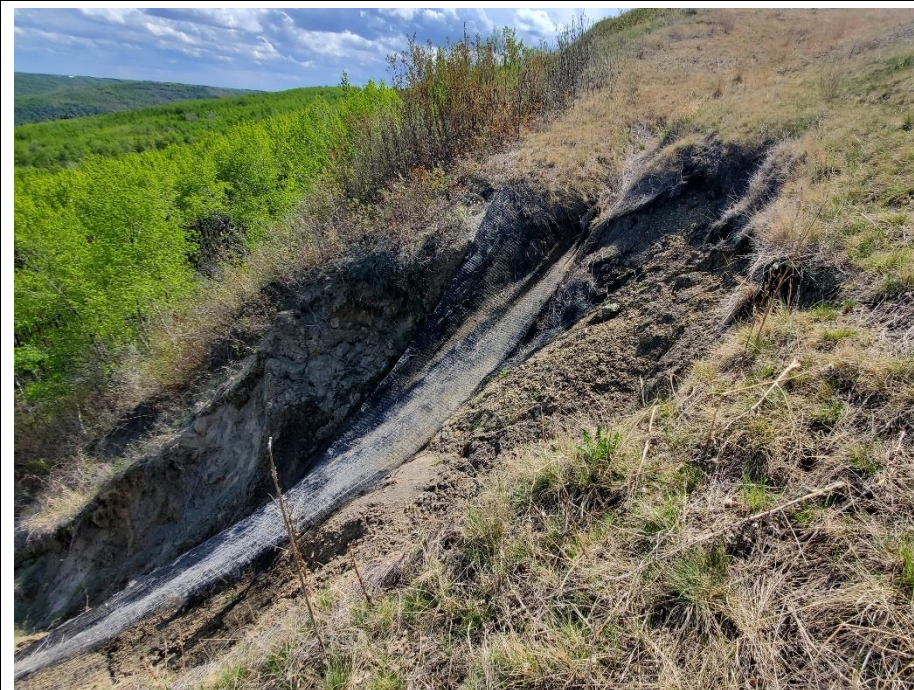
Photo 8.
Looking south at the scour that has formed south of the former Slide 4. Ongoing erosion since 2021.

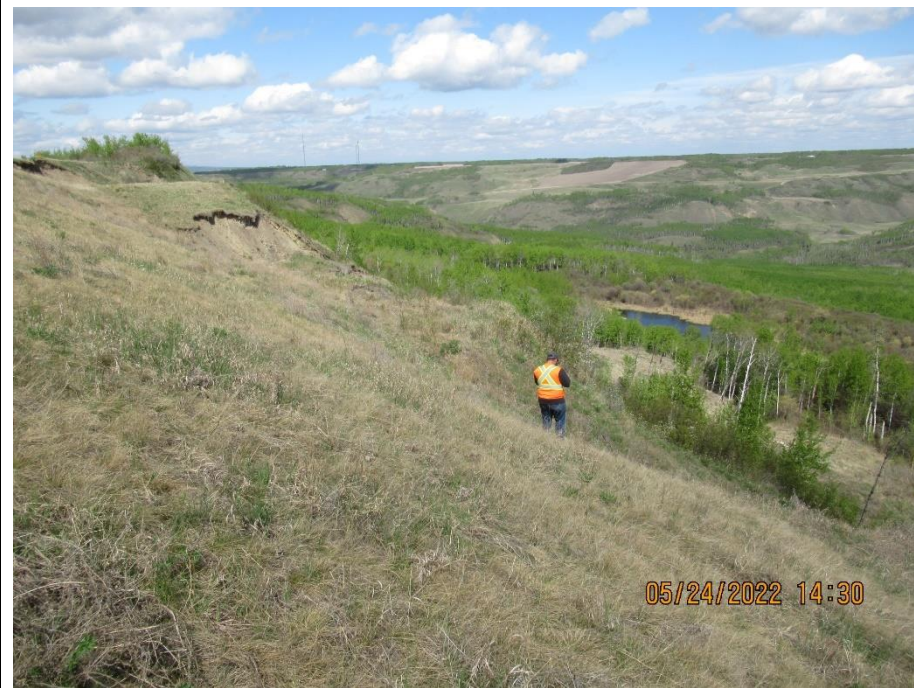
Photo 9.
Looking northwest from south of the location of former Slide 4. Overall repairs from 2014 are performing well in this area. Overall slope is well vegetated and there are no apparent slumps in the granular backfill slope.

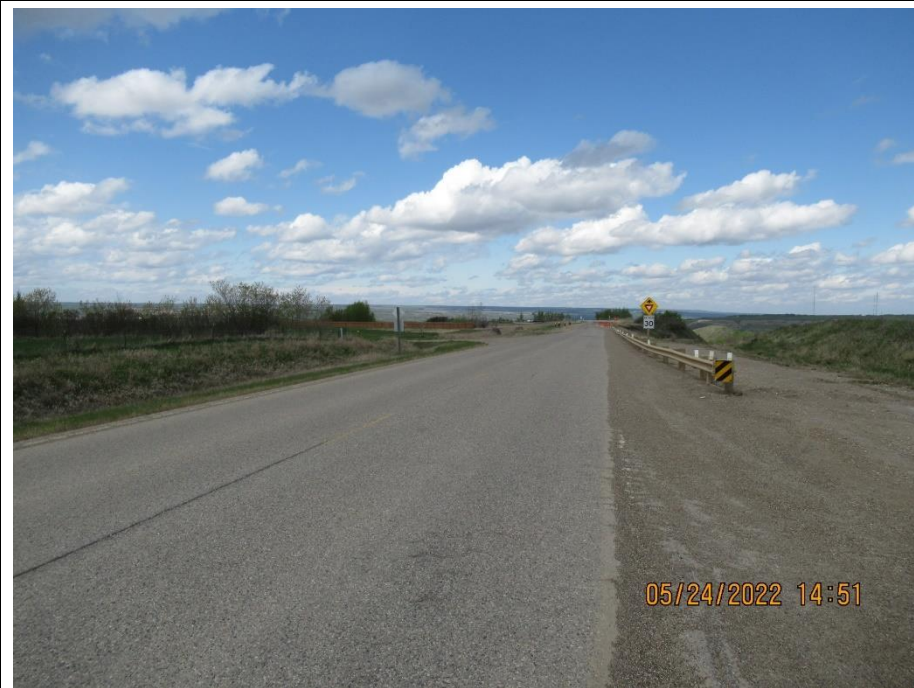
Photo 10.
Looking north along the highway from the south end of the site. No apparent pavement changes south of Slide 1A. Note detour signage at Slide 1A.

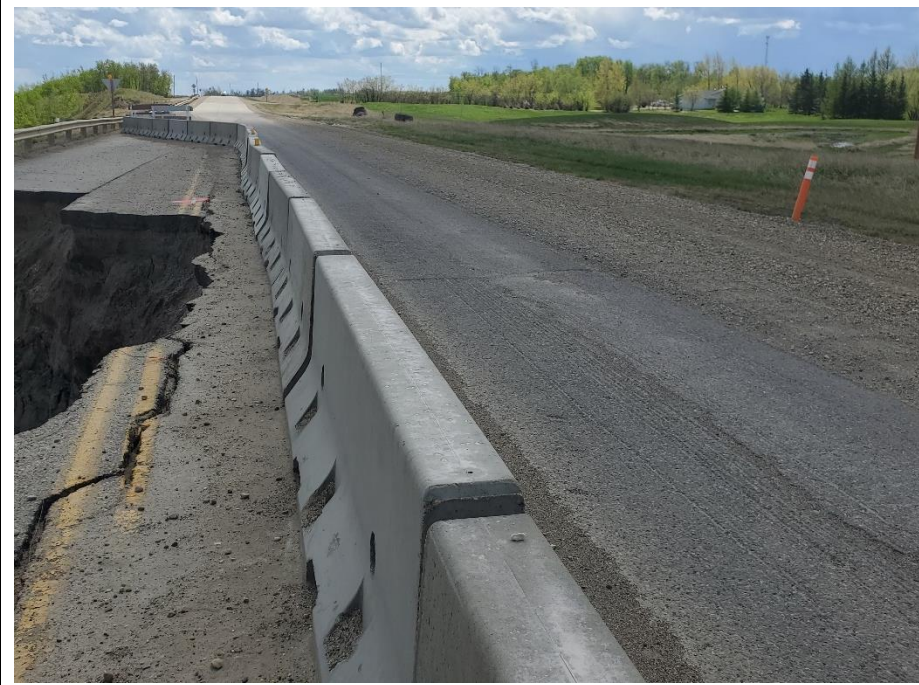
Photo 11.
Looking south along
the highway at the
gravel detour
