**ALBERTA TRANSPORTATION AND
ECONOMIC CORRIDORS
GEOHAZARD ASSESSMENT PROGRAM
PEACE REGION (PEACE RIVER DISTRICT)
2025 INSPECTION**

Site Number	Location	Name	Hwy	km
PH012	Judah Hill	Heart River Slides	744:04	57.114
Legal Description		UTM Co-ordinates (NAD 83)		
SE¼ 20-083-21 W5M		11V E 483284	N 6229209

PH012 JUDAH HILL HEART RIVER SLIDES
2025 SITE INSPECTION PLAN

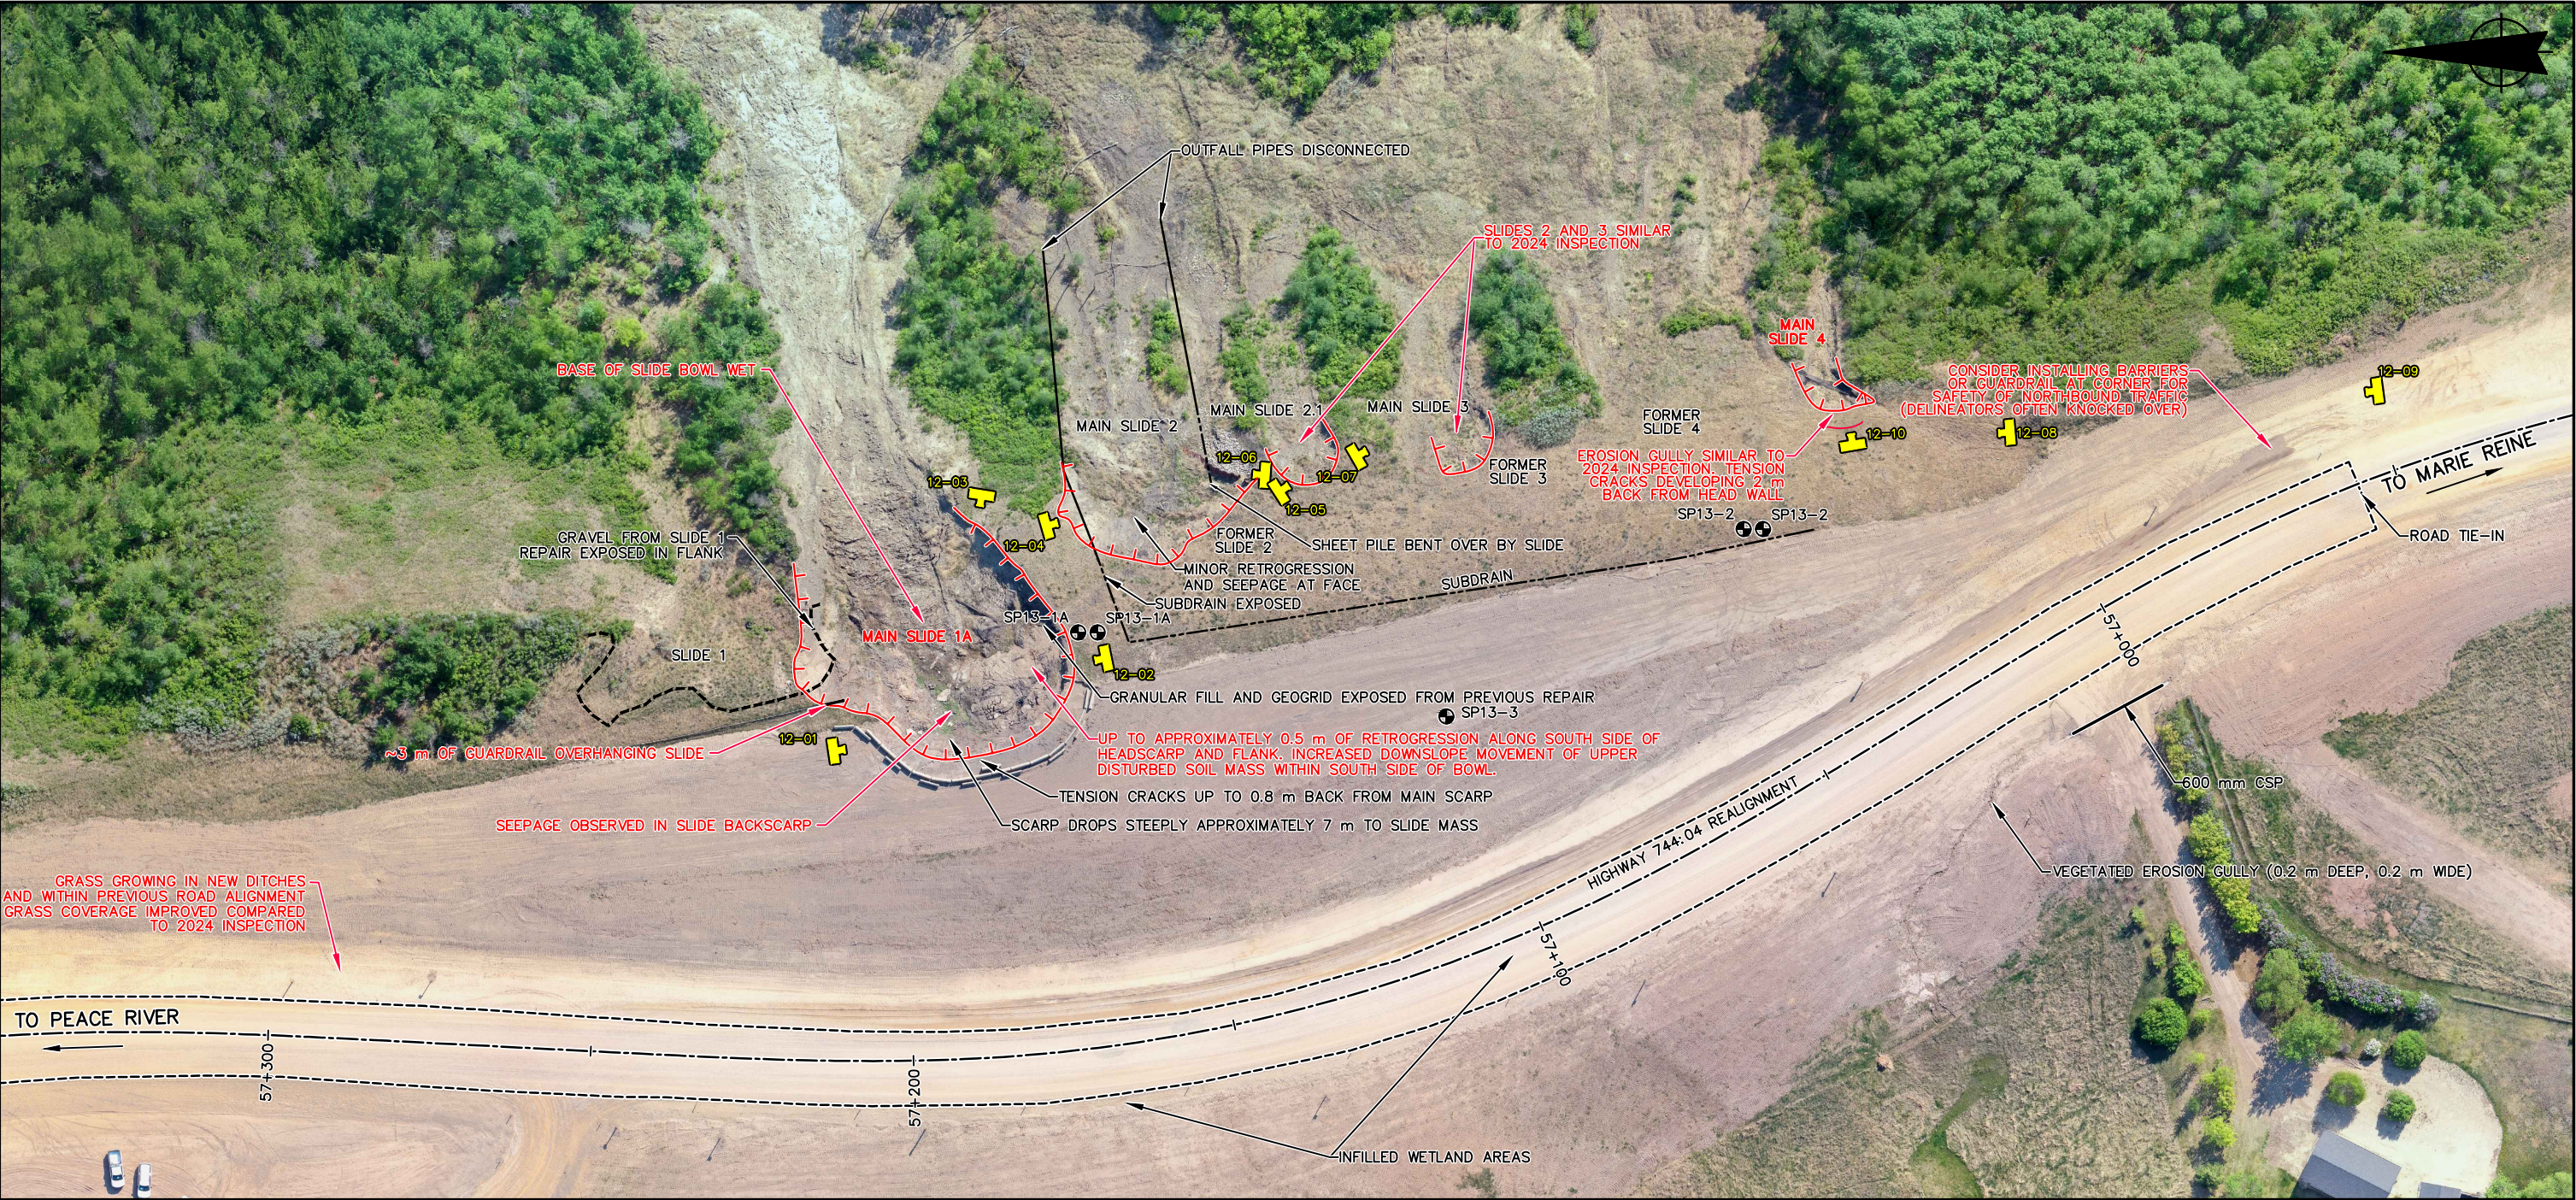
FIGURE PH012-1

A combination of weathering, heavy precipitation, and active seepage beneath the old highway embankment fill, which was built through a slough, and surface water drainage in the ditch appears to have caused the retrogression of Slides 2, 3 and 4 before they were repaired. The previous repair at Slide 1 continues to perform well, although Main Slide 1A is now starting to expand into the previously repaired area. No new cracking noted on the slope above these slide areas has been observed to date.

The backscarp of Main Slide 1A (formed between Slide 1 and the former Slide 2) continues to retrogress but at a reduced rate since the large increment of movement that occurred in September 2020. The rate of retrogression will be highly dependent on groundwater and precipitation conditions. Signs of active seepage have been noted at the exposed scarp face and appear to be a driving factor in the loss of soil strength and rapid retrogression. The offset from the main scarp and toe of the new gravel realignment embankment observed during the 2024 inspection was approximately 35 m and therefore the consequence factor for this site has been reduced. The excavation of the slide material and construction of a gravel wedge in Slide 1A during Summer 2025 (after our annual inspection) should slow the rate of retrogression towards the realigned highway.

The sheet pile wall has been compromised from slope movements and is deflected and ineffective at its north end. Ongoing slide movement and loss of material upslope from the wall due to earth flows are expected in the following years. Loss of material here and further south of the sheet pile wall could begin to undermine the upslope repairs above former slides 2 and 3.

Scour in seepage zones in the till underlying the 2014-2015 repair from Contract CON0015153 continue to develop resulting in shallow earth flows on the colluvium slope below the locations of the former slides 2, 3 and 4.

Thurber had previously recommended buttressing the Main Slide 1A area with a gravel wedge to reduce the rate of retrogression. This repair was completed in the Summer 2025 under Contract 23098 in conjunction with paving the realigned gravel road. The landslide repair included excavating the failed upper slide bowl material, constructing a wedge of compacted 2-20 GBC within the excavation area, digging a gravel drainage trench at the base of the GBC wedge and capping with a clay cap, topsoil and Type B erosion control blanket. The effectiveness of the repair should be assessed during subsequent annual inspection.

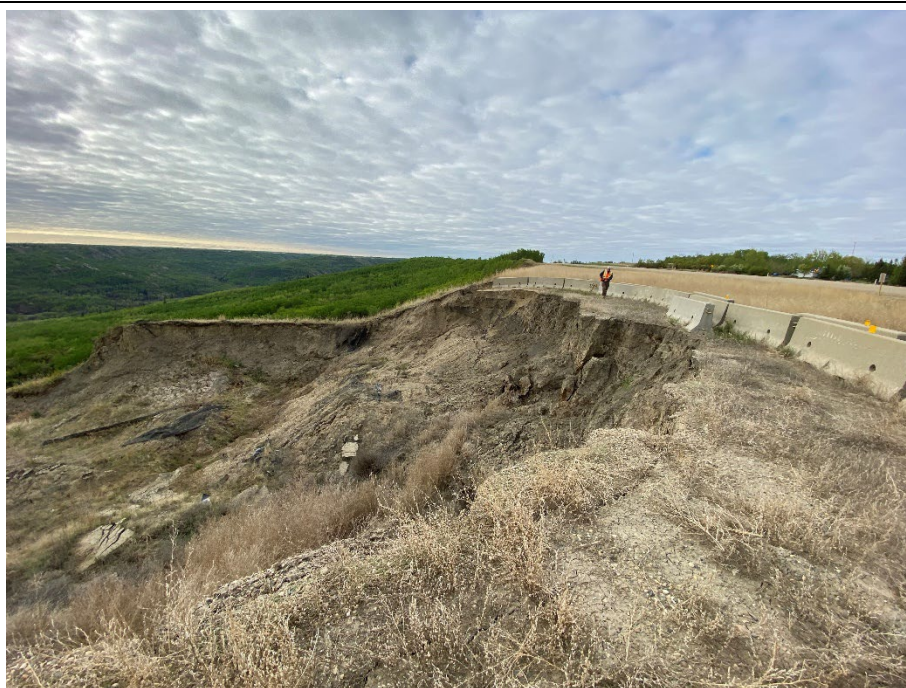
Photo 12-01.

Looking south from north side of Main Slide 1A. There is ongoing retrogression and erosion primarily within the southern half of the main scarp and south flank. Main scarp offset from the edge if the gravel realignment is approximately 35 m (unchanged from 2024).

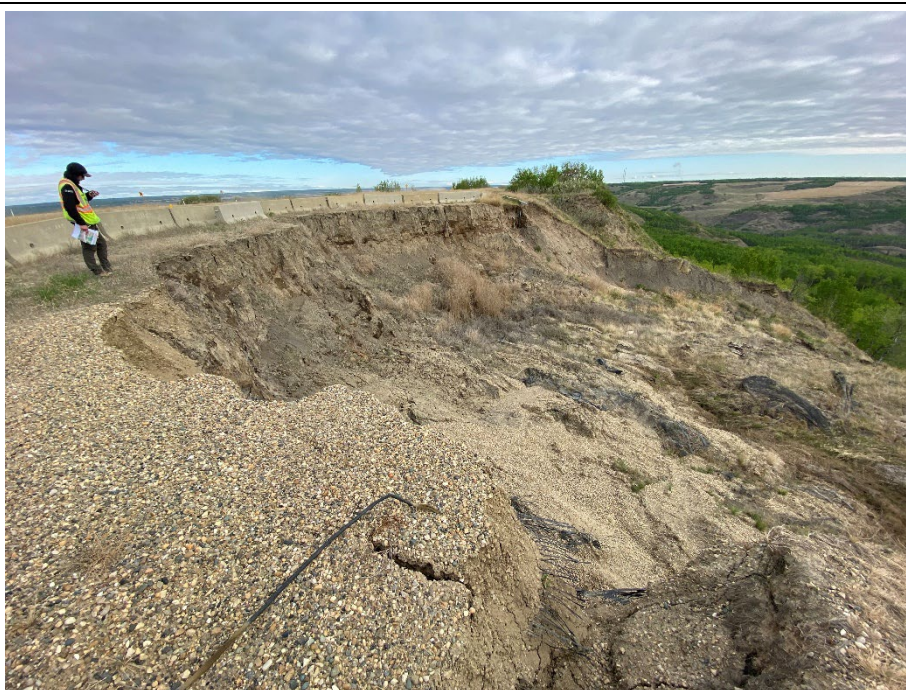
Photo 12-02.

Looking north towards the main scarp of Main Slide 1A. Disturbed slide mass within the upper slide bowl appeared to have increased downslope movement relative to the 2024 condition. Note dark seepage horizon visible in the main scarp and white mineral buildup.

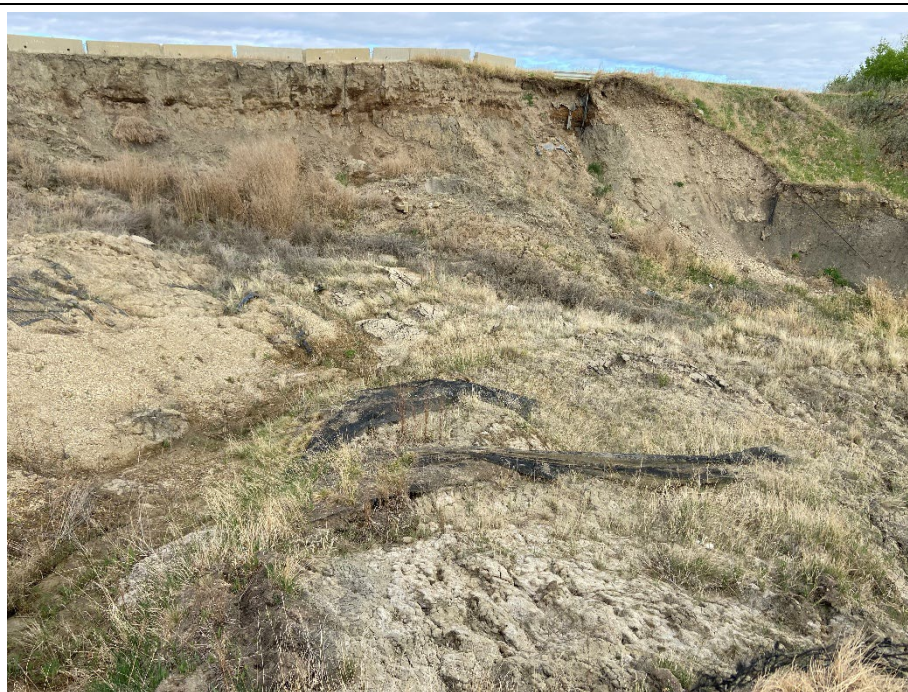
Photo 12-03.

Looking upslope towards the west at the main scarp and slide runout area of Main Slide 1A from the lower south flank.

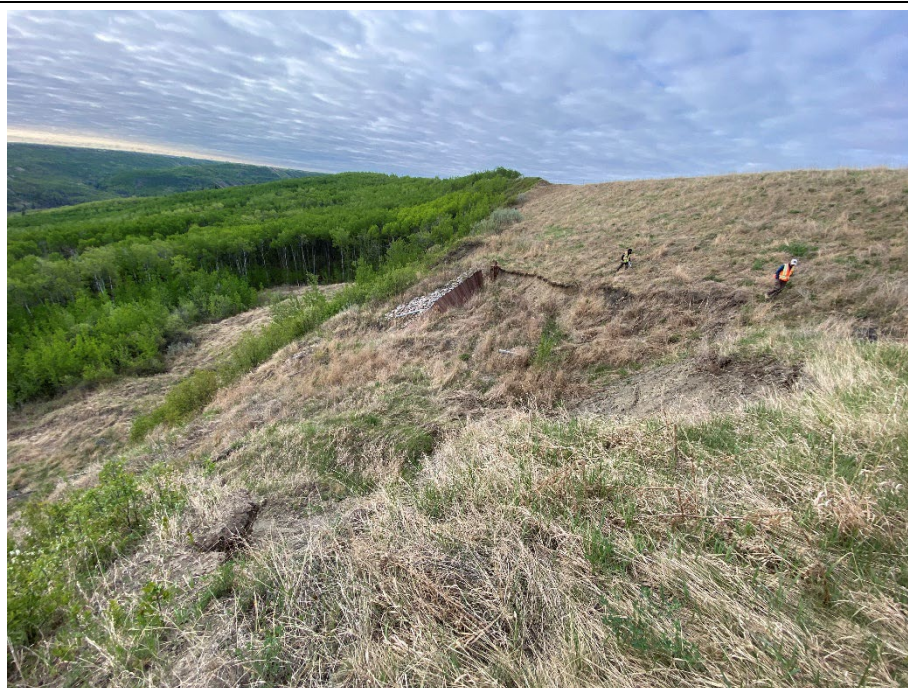
Photo 12-04.

Looking south at Main Slide 2 and 2.1 from the north end of Heart River Landslide repair excavation (Former Slide 2). Ongoing downslope movement and minor scarp erosion but no major retrogression / expansion of the scarp relative to the 2024 condition.

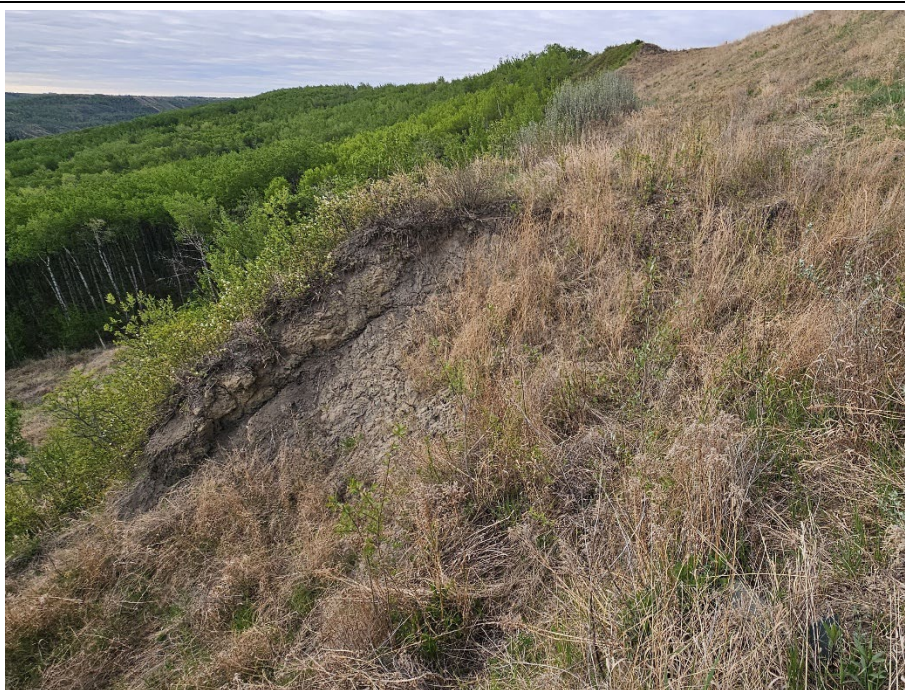
Photo 12-05.

Looking south at Main Slide 2.1 south of the sheet pile wall. No major retrogression of the scarp at this location since 2024.

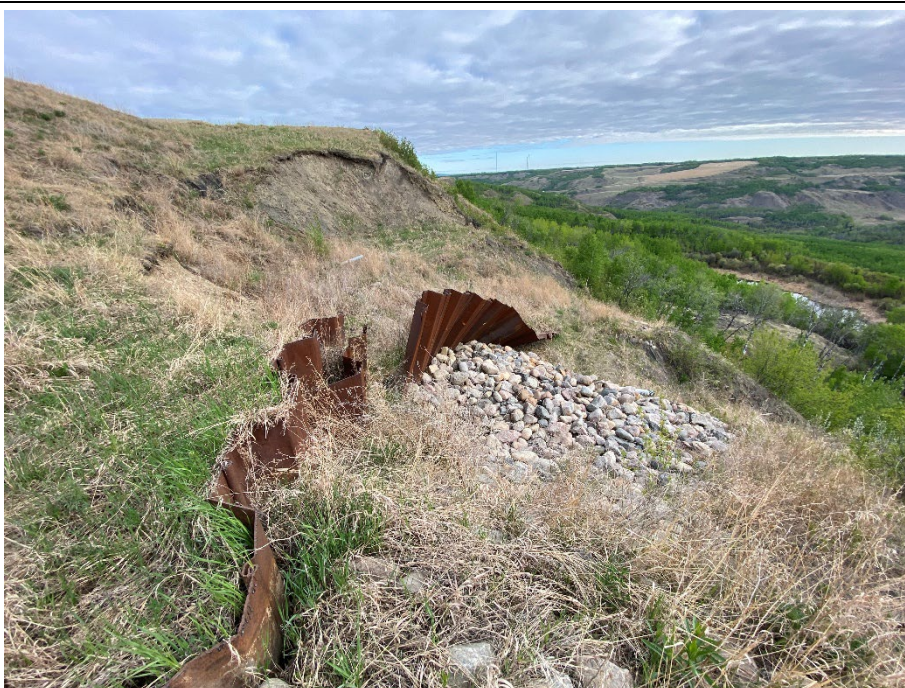
Photo 12-06.

Looking north at the former Slide 2 area with ongoing downslope slide movement and erosion of the upper scarp. No major changes observed since 2024. Deflection of the sheet piles appears similar to the 2024 condition.

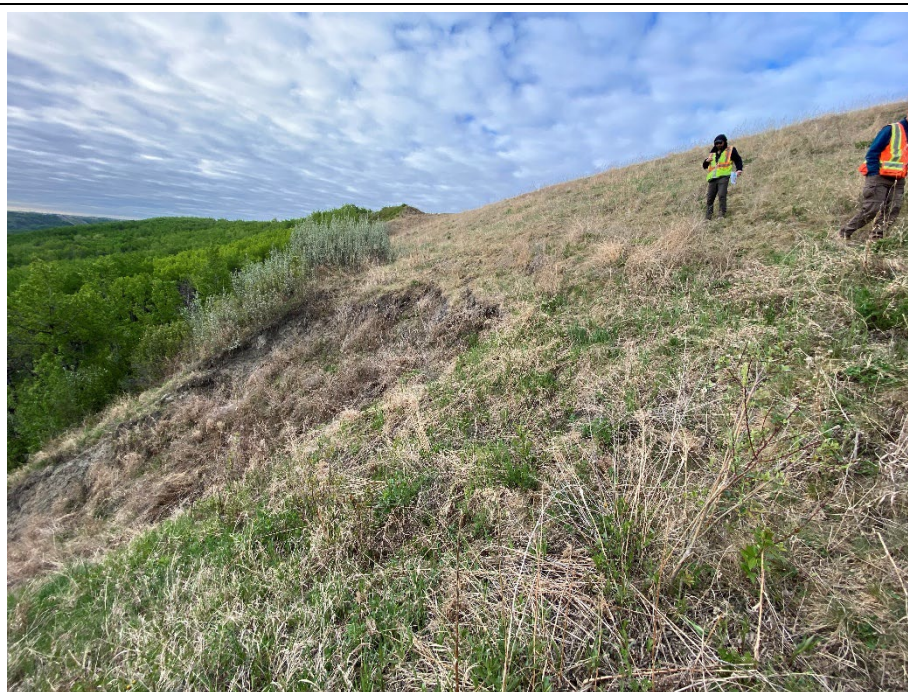
Photo 12-07.

Looking south at earth flow at Main Slide 3. No significant retrogression or expansion of the main scarp since 2024.

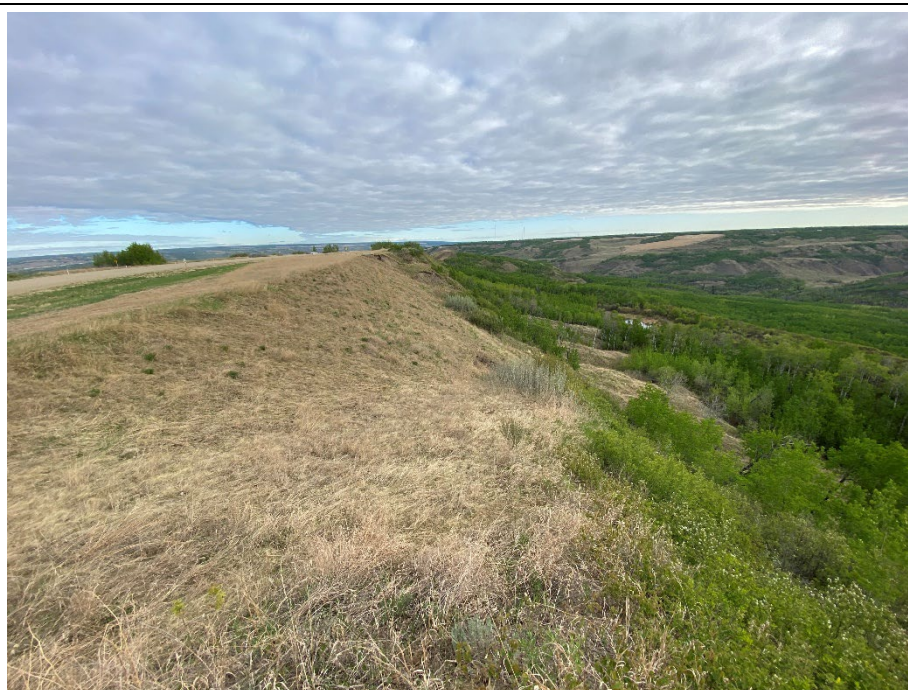
Photo 12-08.

Looking north from south end of the former Slide 4 repair area. Overall repairs from 2014 are performing well. Overall slope is well vegetated and with no visible indications of new slide development within the granular backfill slope. Old highway alignment at crest of slope has increased grass development since 2024.
