# **ALBERTA TRANSPORTATION GEOHAZARD ASSESSMENT PROGRAM PART A: FILE REVIEW**

## **PEACE REGION – PEACE-HIGH LEVEL**

### **PH30 JUDAH HILL – LOOKOUT SLIDE**

Legal Location:	SE¼20-083-21 W5M
Nearest Landmark:	2 km south along road from CNR crossing
Highway Control Section:	Hwy 744:04
Date of Initial Observation:	1984
Date of Last Inspection:	2008
Last Inspected By:	Thurber Engineering Ltd.
Instrumentation Installed:	None
Instrumentation Operational:	None
Risk Assessment: (as of last inspection)	PF = 8 CF = 3 Risk = 24

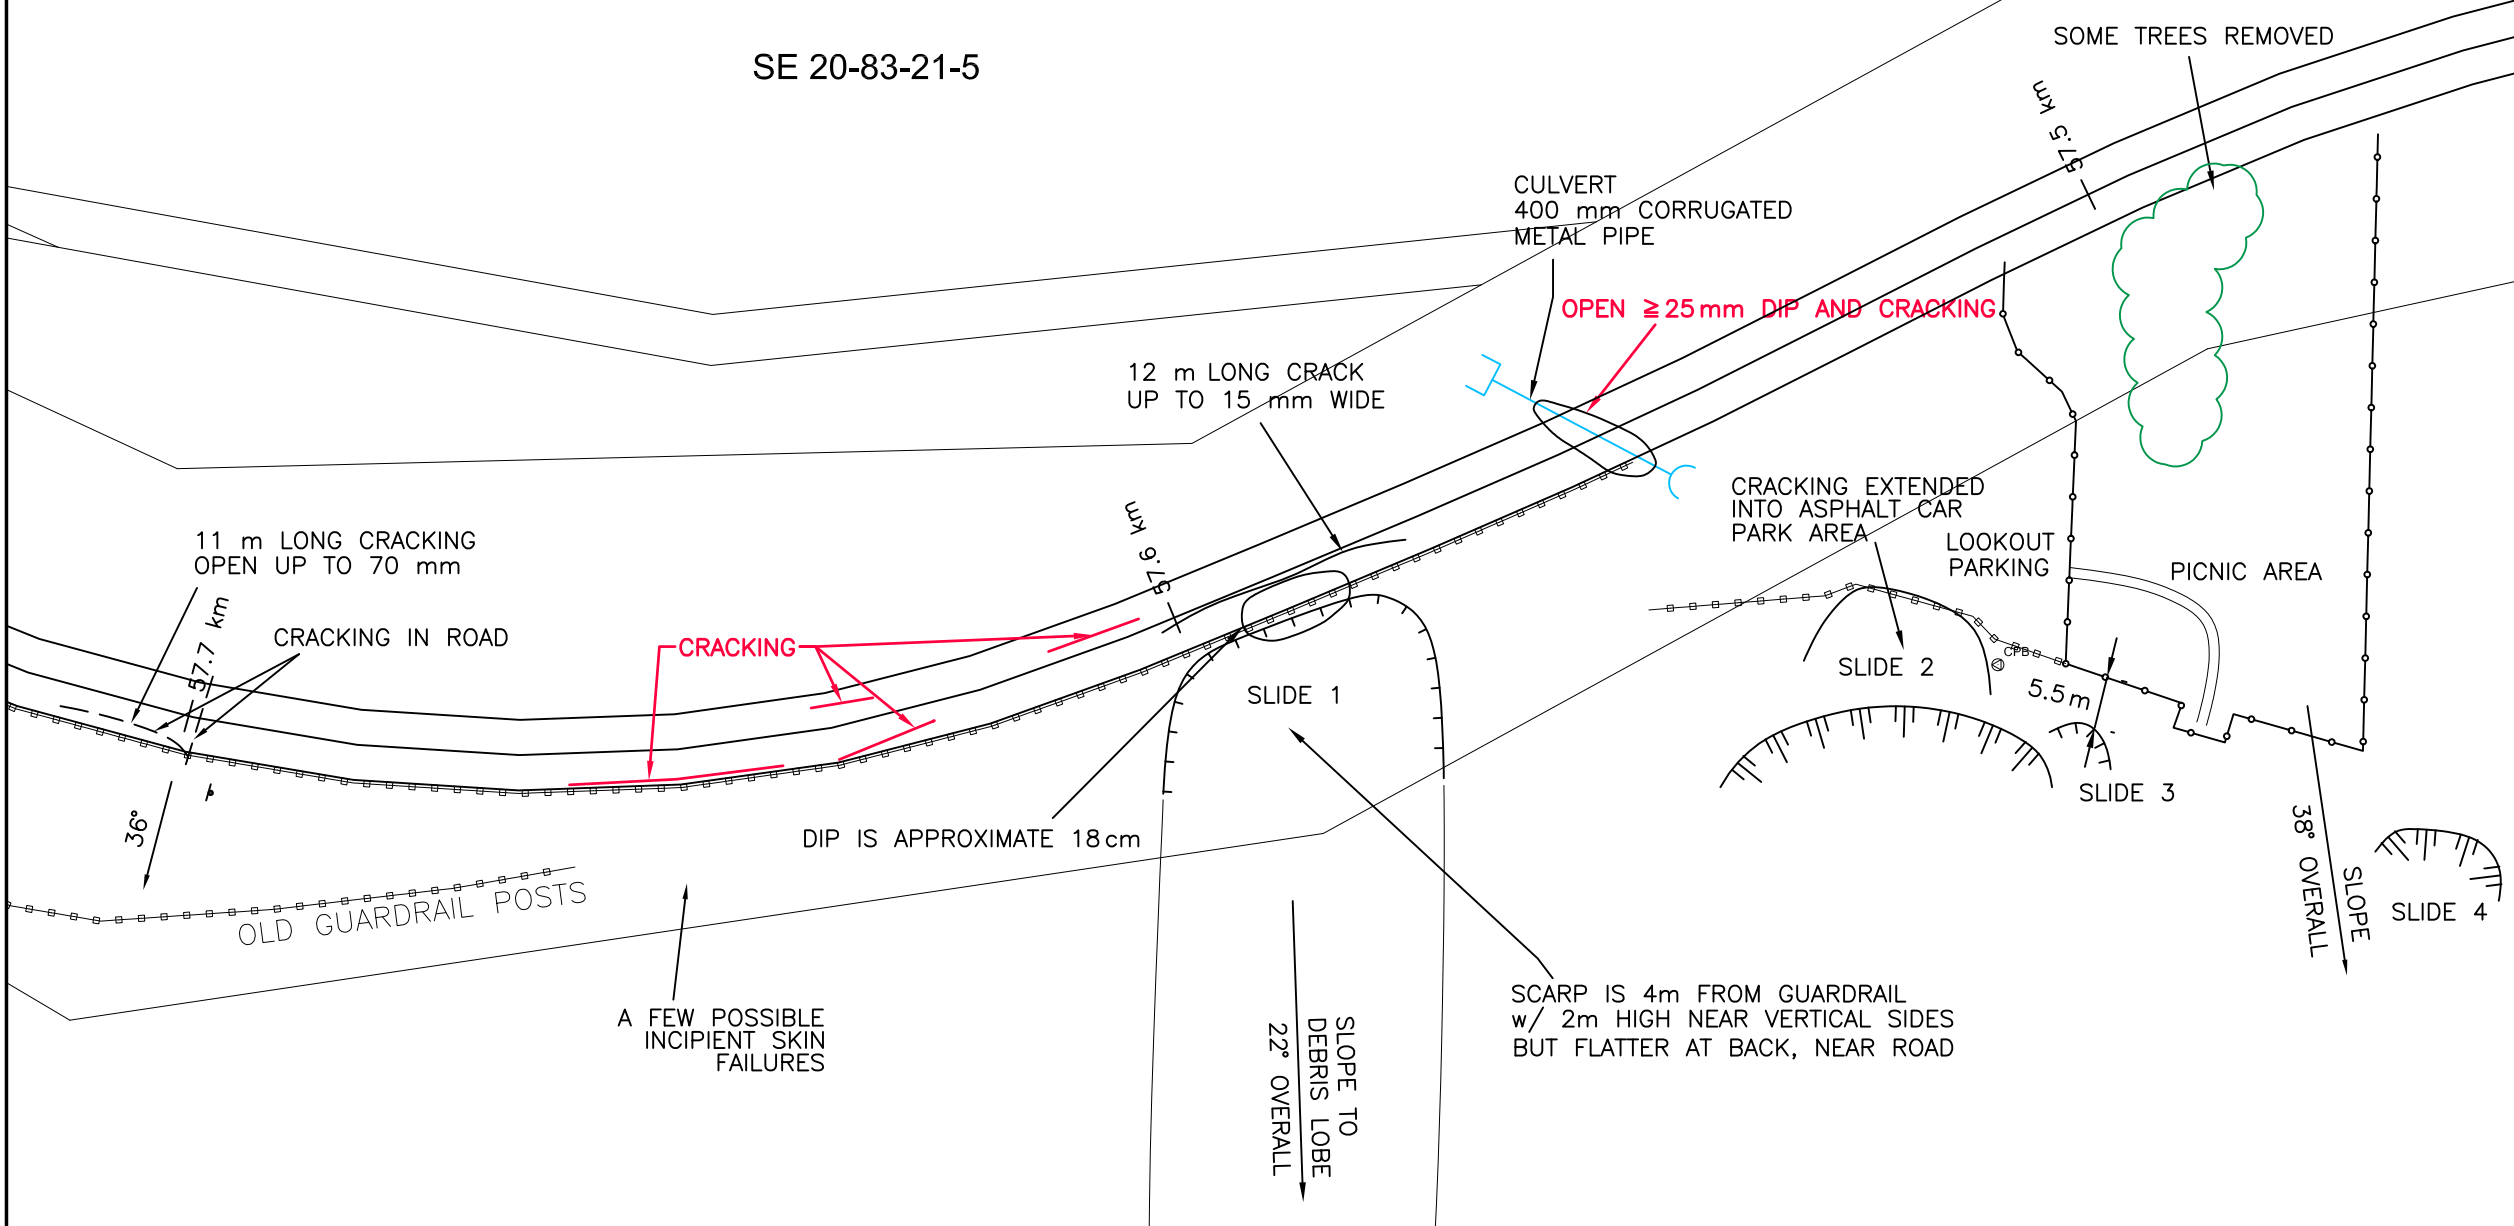
FIGURE 2

This site consists of four 5 m to 20 m wide slide bowls originating near the crest of the slope, with some indications of incipient slide movement further north. The upper portion of the slope is at around 38°, then flattens and becomes irregular as it descends towards the Peace River. Slide 1 is near the road, just north of the Lookout, and has a well defined lobe of debris extending downslope. Slide 2 is encroaching on the car park for the Lookout, while slides 3 and 4 are further south, near the picnic area. Slides 3 and 4 are relatively shallow features. Only Slide 1 directly affects the road.

- Slide 1, to the north of the lookout, is likely what was referred to as Debris Slide 6 in previous reports. It is apparently inactive at present, having been active in 1997 and 1998, with repair in August 1998 consisting of reinforced granular and light weight fill and a drain. It is currently a roughly 30 m wide feature with a 2 m high apparently stable (vegetated) backscarp roughly 4 m away from the guardrail. The overall slope from the backscarp to the toe of the earthflow is roughly 22 degrees.

- The Lookout slide (slide 2) is a roughly 20 m to 30 m wide feature that has extended into the parking area by 1 m to 2 m, requiring a jog in the Armco barrier around the feature. The slide runout appears to be an earthflow type feature, and extends roughly 100 m downslope into an area of trees. The earthflow appears inactive, and is grassed, but there are still cracks and possible movement in the backscarp area of this slide.

- Slide 3 is a roughly 5 m wide skin failure (probably of the order of 0.3 m to 0.5 m deep) at the crest of the slope at the south end of Slide 2. It is currently 5.5 m back from the new fence around the lookout area.

- Slide 4 is just south of the lookout area and is a roughly 10 m wide shallow failure that doesn't appear to be currently active. It isn't of immediate concern to the lookout area, and is roughly 70 m away from the road.

These features appear to be related to surface runoff or near-surface seepage, with retrogression of the backscarp apparently related to higher rainfall years.
