**ALBERTA TRANSPORTATION  
GEOHAZARD ASSESSMENT PROGRAM  
PEACE REGION (PEACE RIVER DISTRICT)  
2021 INSPECTION**

Site Number	Location	Name	Hwy	km
PH030	Judah Hill	Lookout Slides	744:04	57.43
Legal Description		UTM Co-ordinates		
SE¼ 20-083-21 W5M		11V E 483194	N 6229425

Date	PF	CF	Total
<b>Previous Inspection:</b>	10-June-2020	10	4	40
<b>Current Inspection:</b>	6-July-2021	10	4	40
<b>Road WAADT:</b>	600		<b>Year:</b>	2020
<b>Inspected By:</b>	Tyler Clay, TEL Ed Szmata, TRANS Max Shannon, TRANS		Don Proudfoot, TEL Kristen Tappenden, TRANS Erwin Kurz, TRANS	
<b>Report Attachments:</b>	<input checked="" type="checkbox"/> Photographs <input checked="" type="checkbox"/> Plans <span style="margin-left: 100px;"><input type="checkbox"/> Maintenance Items</span>

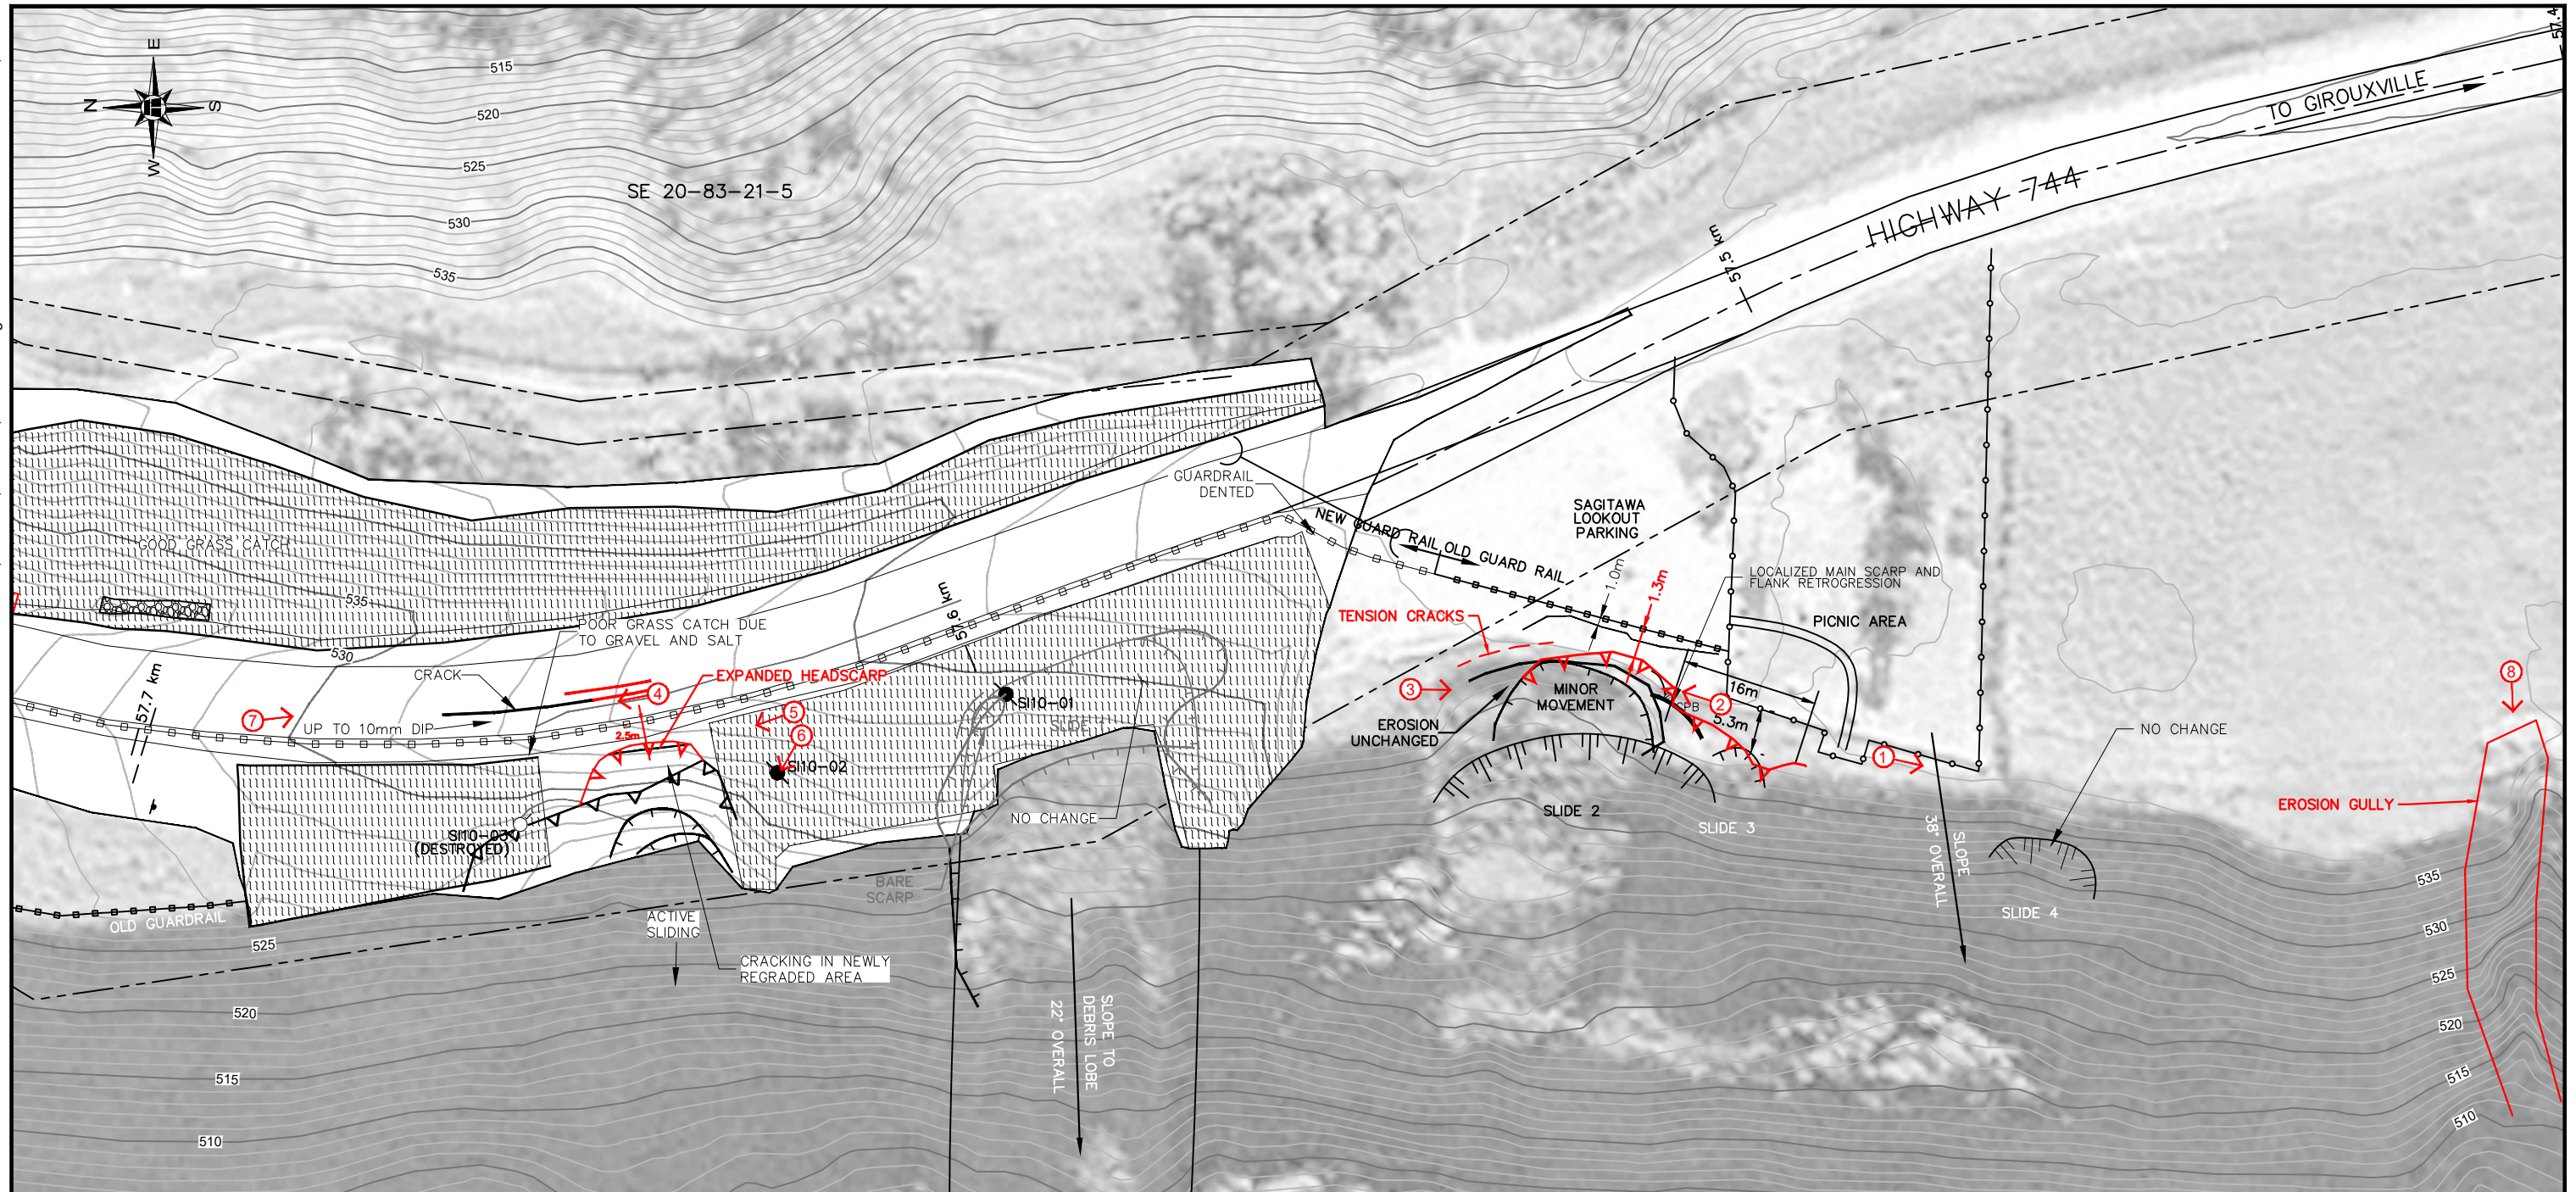
DWG No. 32121-PH030-1-1

PH030 LOOKOUT SLIDES  
 2021 SITE INSPECTION PLAN

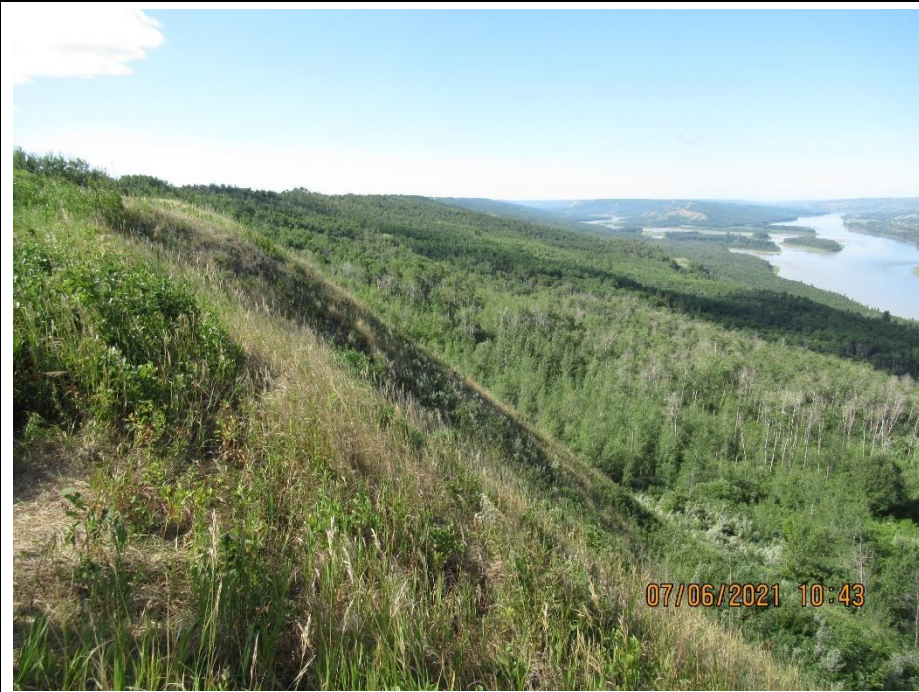
<input checked="" type="checkbox"/> Slope Movement	No changes observed at Slide 4 (Photo 1). Minor retrogression and some flank expansion observed at Slides 2 and 3. Slide 2 main scarp offset 1.3 m from the guardrail and upper slide area was well vegetated (Photos 2 and 3). The landslide scarp in the highway sideslope about 4.5 m downslope of the SBL guardrail at km 57.65 appears to be actively moving and a scarp has formed in the previously observed tension crack with increased dropdown (Photos 5 and 6); resulting in approximately	<input checked="" type="checkbox"/>

**Photo 1.**  
Looking southwest from above Slide 2 towards Slide 4 (No change since 2020).

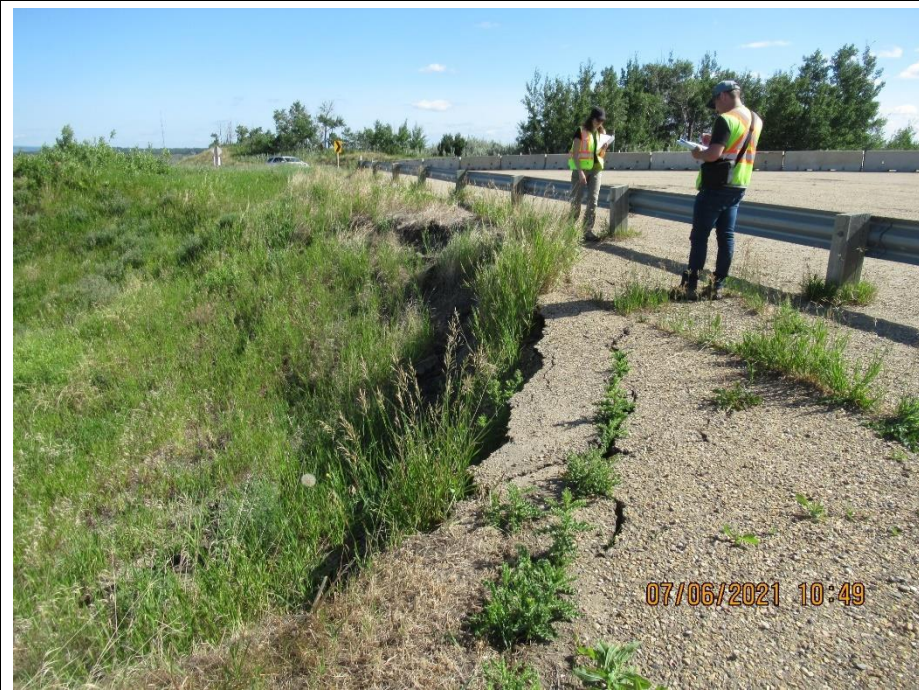
**Photo 2.**  
Looking northeast along backscarp of Slide 2 which is 1.3 m from the parking lot guardrail. Some minor localized main scarp retrogression, flank retrogression and additional pavement cracking since 2020.

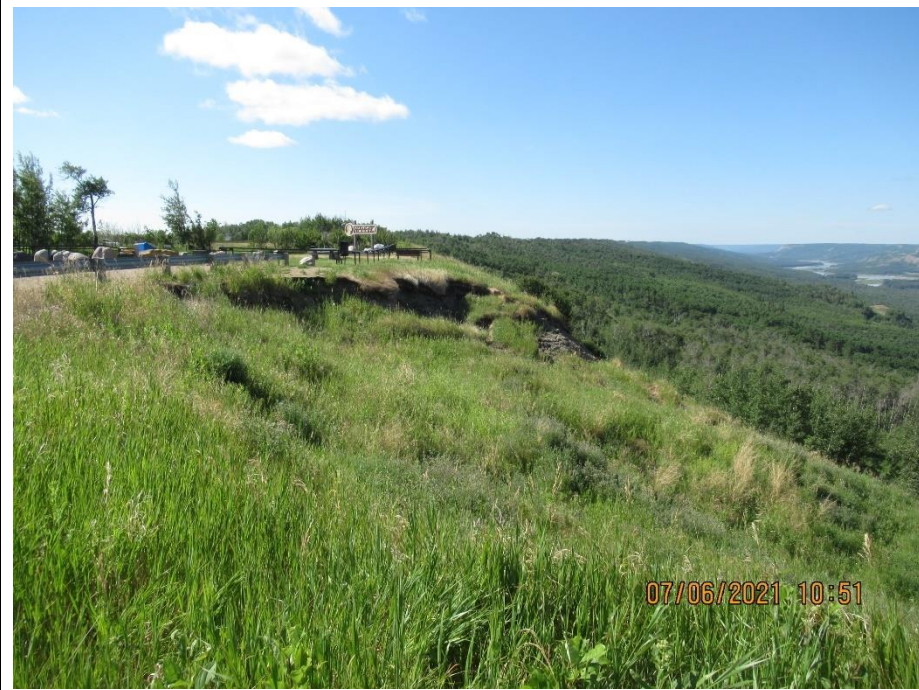
**Photo 3.**  
Looking southwest towards the upper part of Slides 2 and 3. Some minor retrogression and movement in the flanks and movement of the disturbed slide mass since 2020. Disturbed slide mass area is well vegetated.

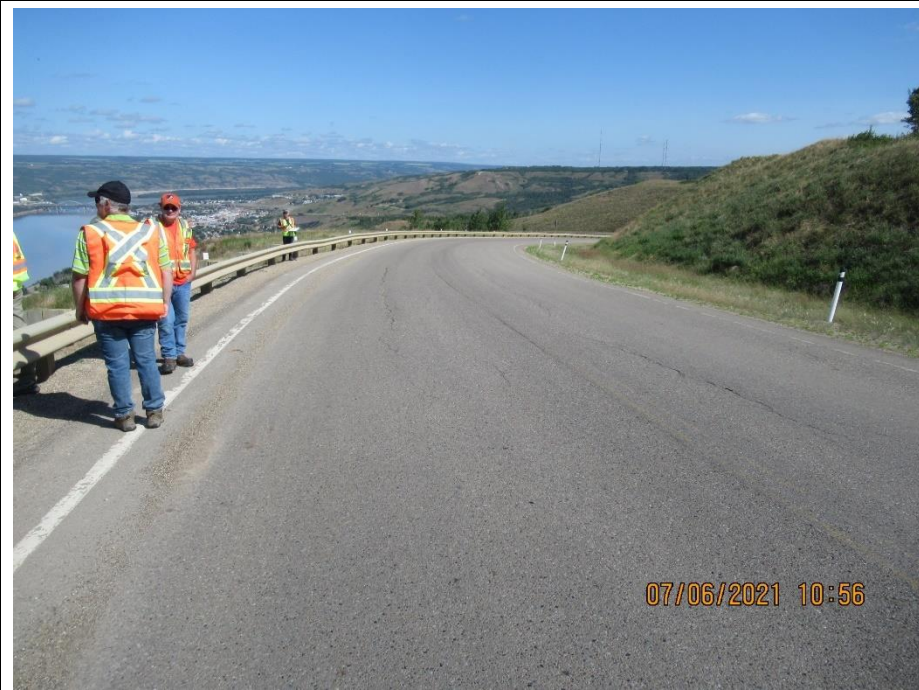
**Photo 4.**  
Looking northwest along from SBL of Hwy 744:04 at km 57.6 at south end of realignment done in 2015-2016. Minor longitudinal cracking that is largely unchanged since 2020.

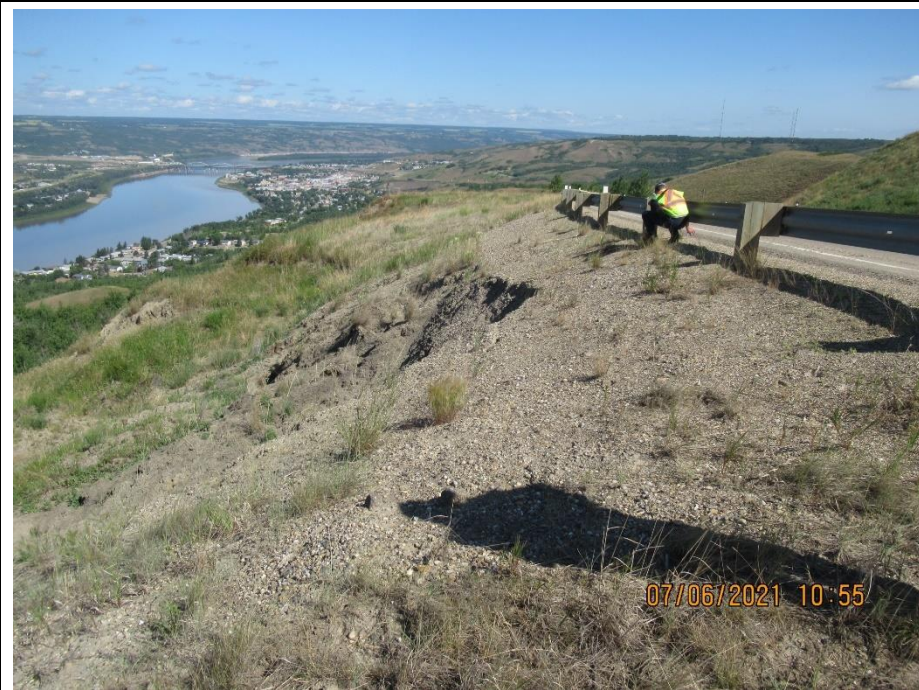
0.7 m of retrogression since 2020. Scarp is offset 2.5 m from the guardrail.	
<input checked="" type="checkbox"/> Erosion	An erosion gully was noted approximately 40 m south of Slide 4 at the southern end of the site (Photo 8).	<input type="checkbox"/>
<input type="checkbox"/> Seepage		<input type="checkbox"/>
<input type="checkbox"/> Bridge/Culvert Distress		<input type="checkbox"/>
<input type="checkbox"/> Other		<input type="checkbox"/>

**Photo 5.**  
 Looking north from downslope of the SBL of Hwy 744:04 at km 57.63. Increased dropdown within the disturbed slide mass. Headscarp has expanded to the previously observed tension crack location with 0.7 m of additional retrogression since 2020, offset from the guardrail is now at 2.5 m.

The landslide at km 57.65 is expected to continue to move and retrogress toward the new highway alignment. A tied back pile wall should be considered to protect the new alignment from this feature. The wall will need to be in the order of 35 m to 40 m wide with two rows of tie-back anchors.

Sub-excavation of the slide mass and replacement with shredded tire light weight fill could be considered as a shorter-term, cheaper solution.

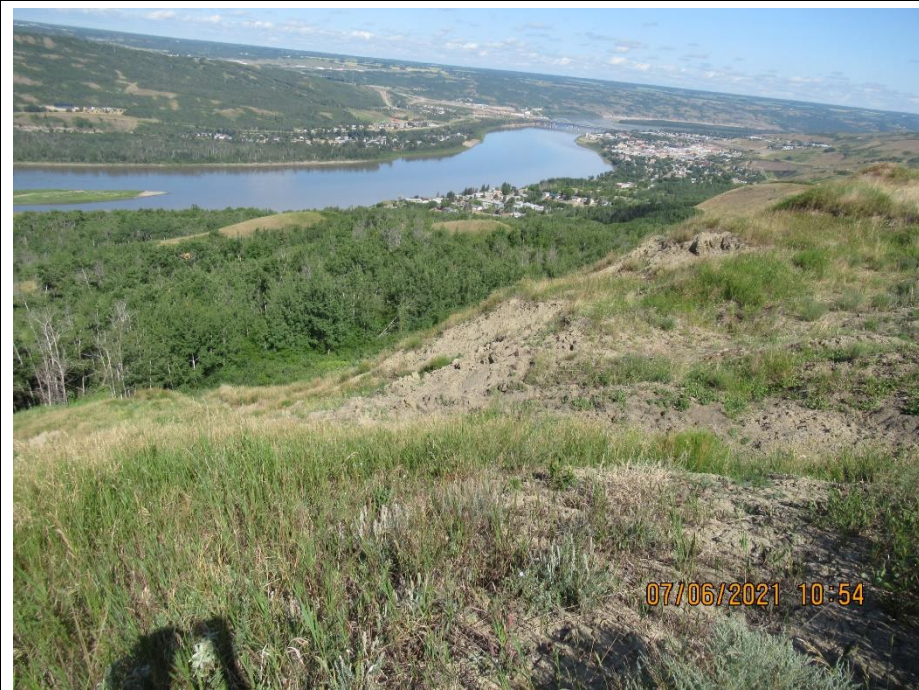
**Photo 6.**  
 Looking northwest from downslope of the SBL of Hwy 744:04 at km 57.63. Additional downslope movement apparent within disturbed slide mass.

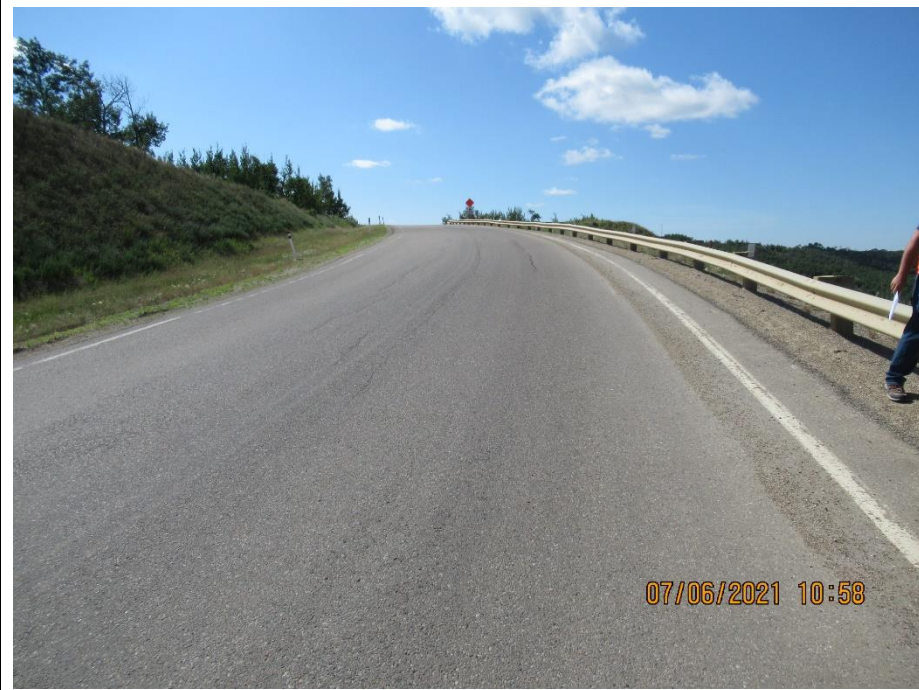
**Photo 7.**  
Looking south along SBL of Hwy 744:04 at km 57.68. Some additional minor longitudinal cracking noted in the NBL.

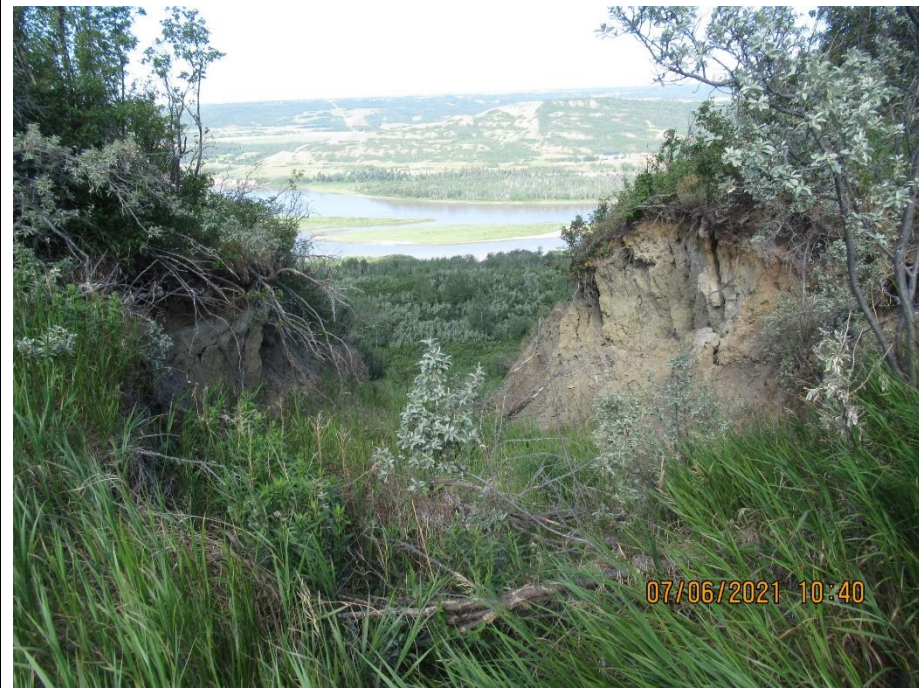
**Photo 8.**  
Looking at the top an erosion gully located at the southern edge of the site, approximately 50 m south of the Slide 4 area. Gully is offset approximately 70 m west of the highway.
