THURBER ENGINEERING LTD.

**ALBERTA TRANSPORTATION GRMP (CON0022164)
PEACE REGION (PEACE RIVER DISTRICT)
INSTRUMENTATION MONITORING RESULTS – FALL 2022**

SITE PH030: HWY 744:04, JUDAH HILL (LOOKOUT SLIDE)

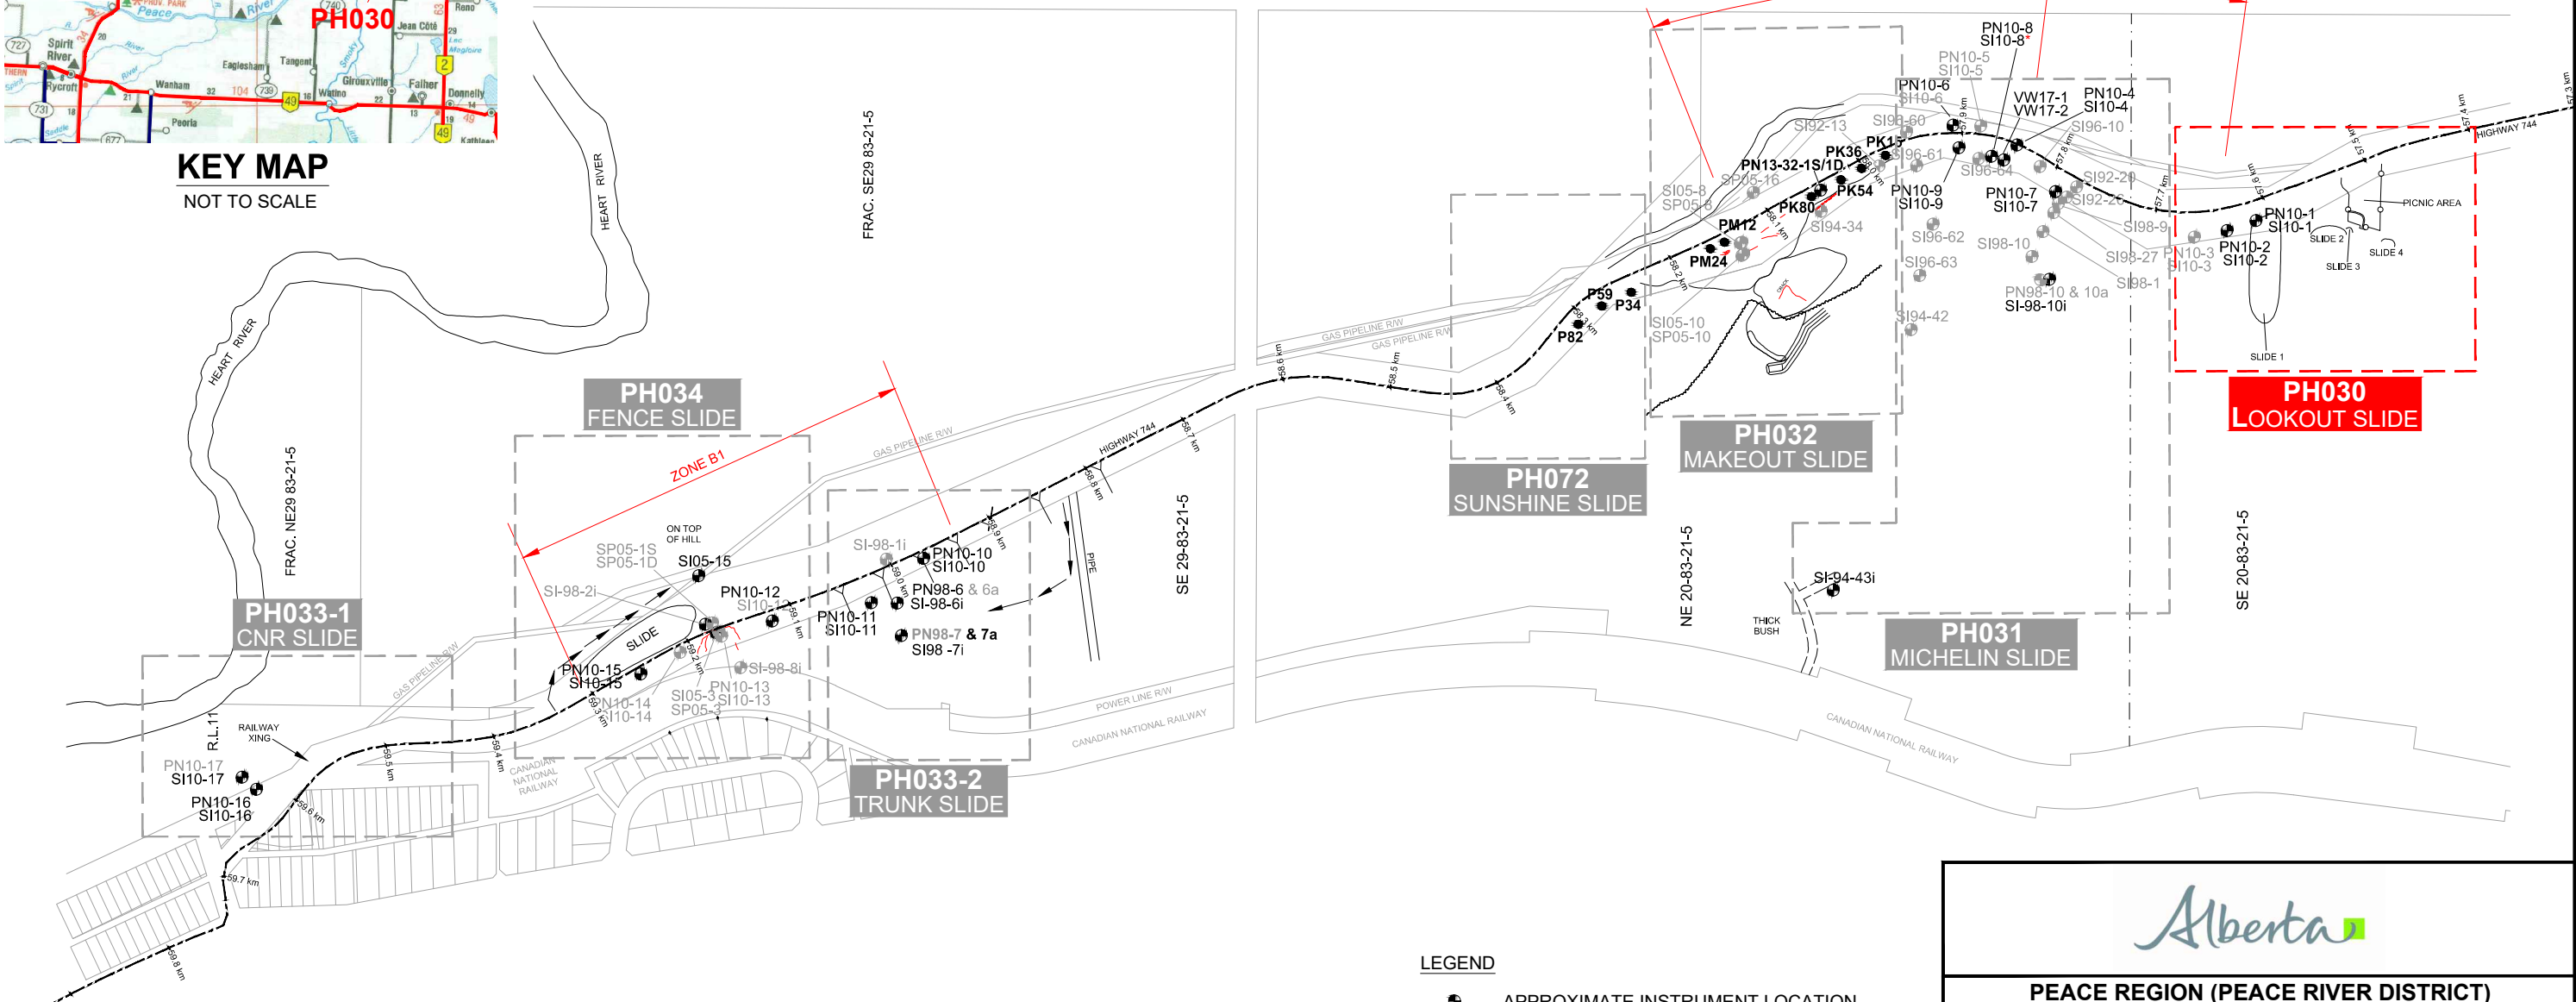
DWG No. 32121-PH030-1

Drawing 32121-PH030 in Appendix A provides a sketch of the approximate location of the monitoring instrumentation for this site.

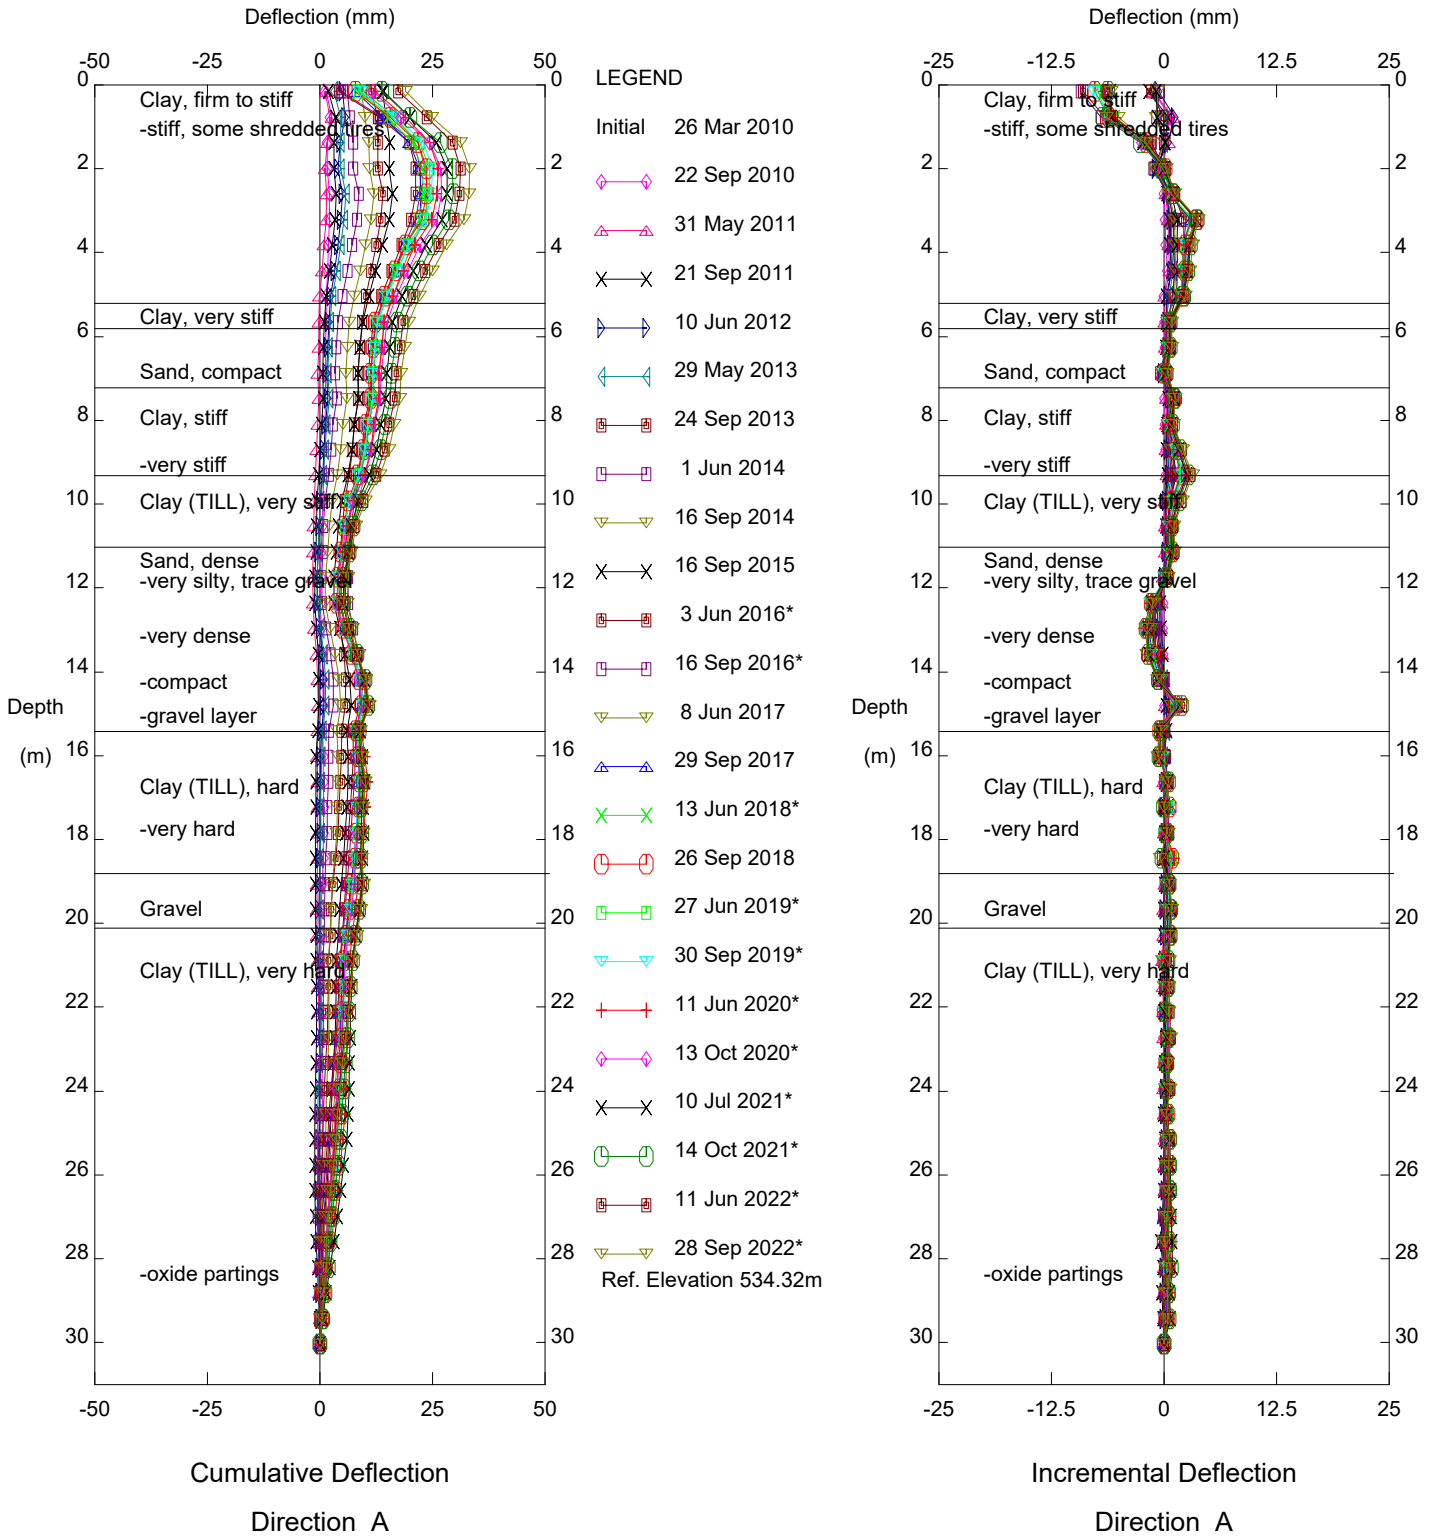
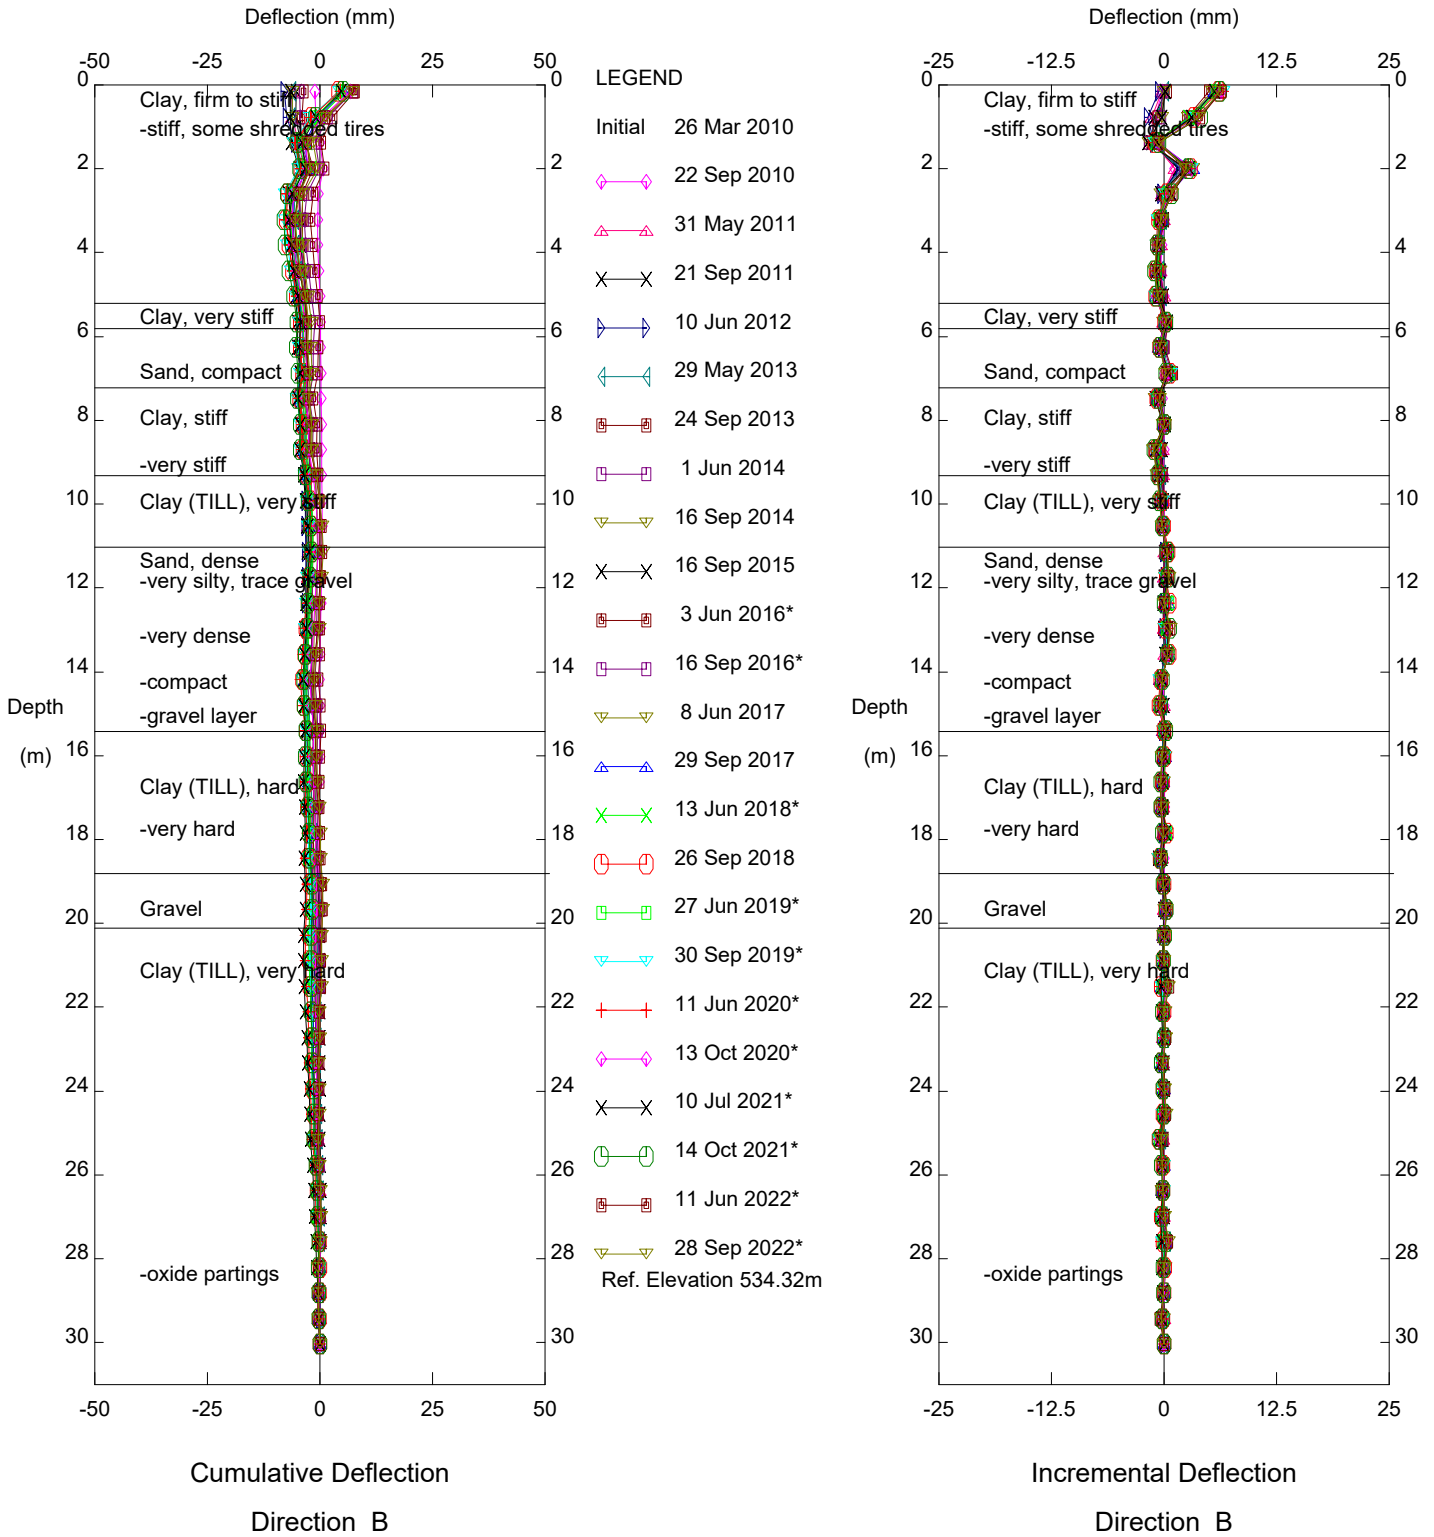
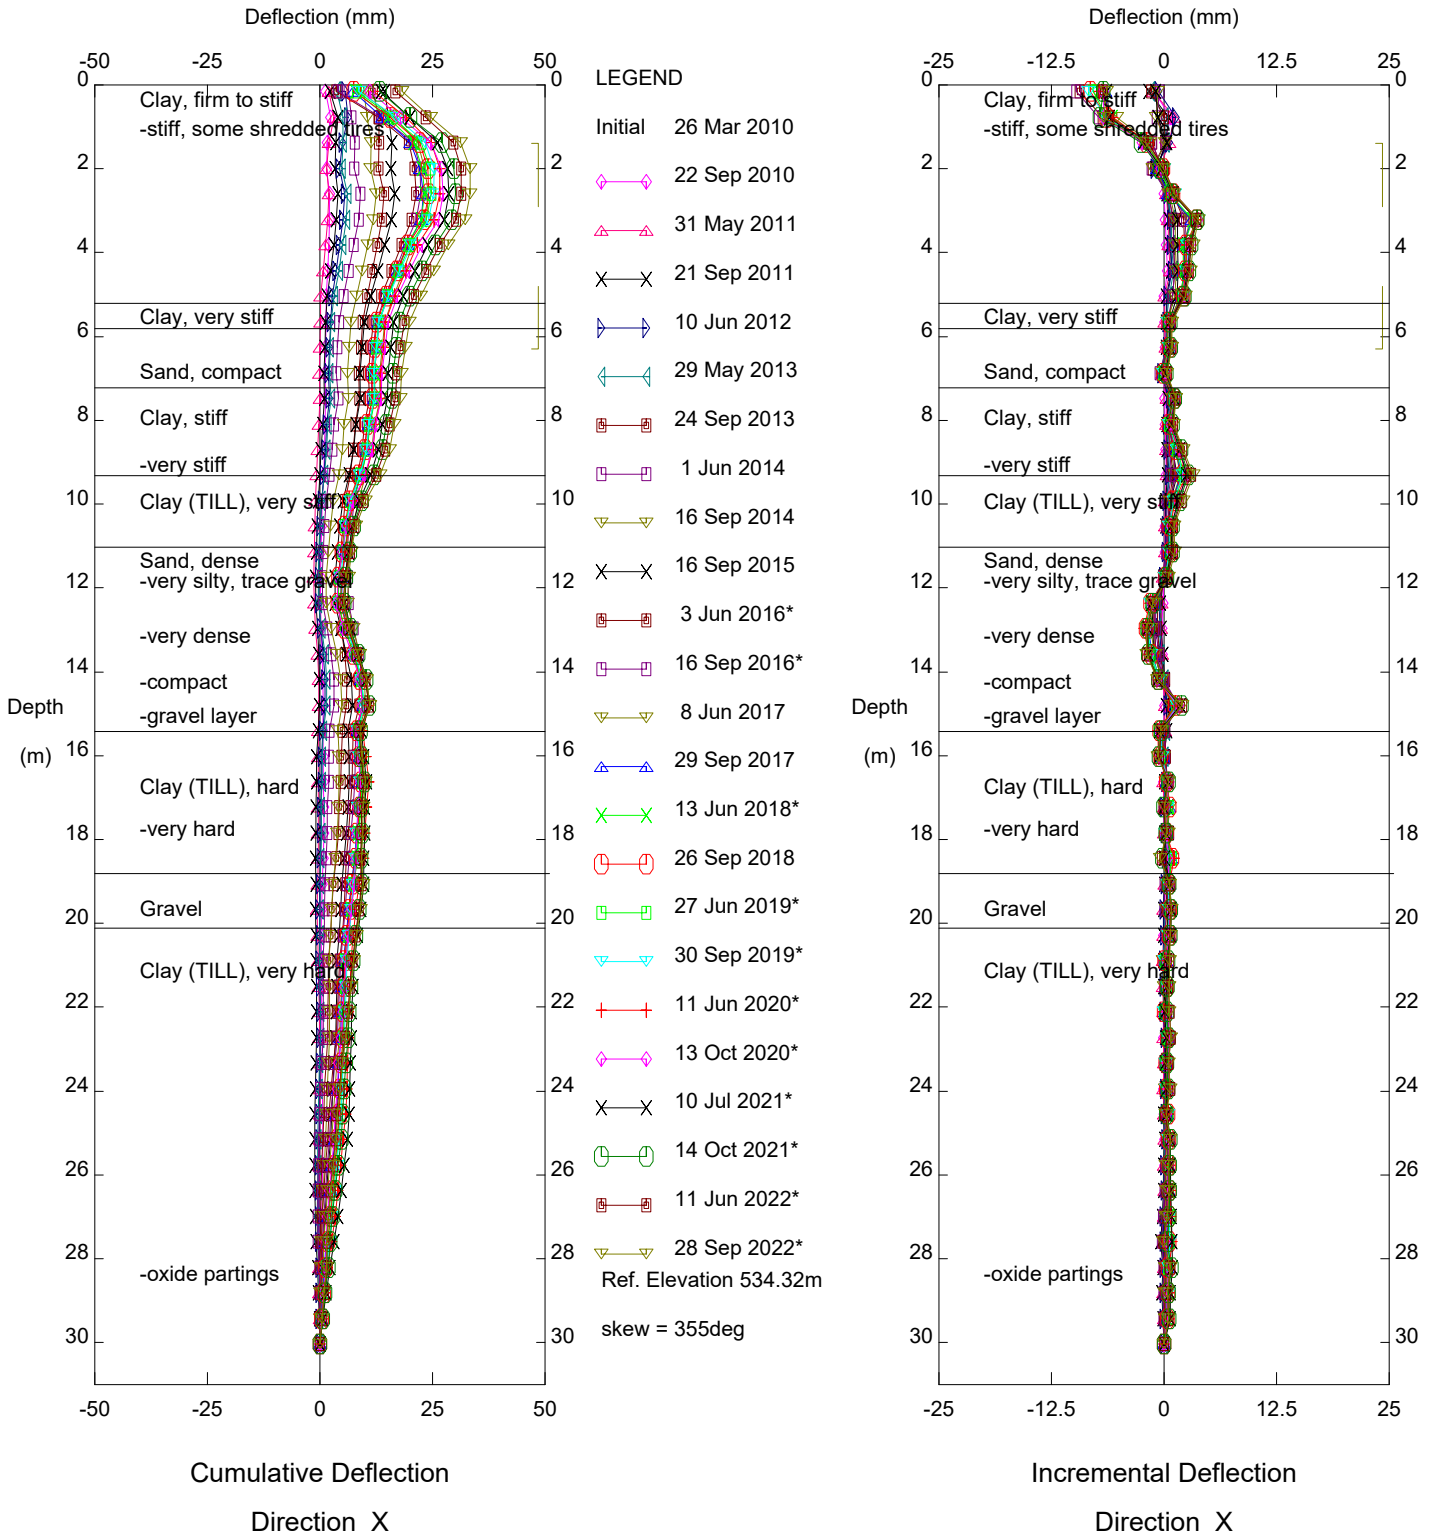
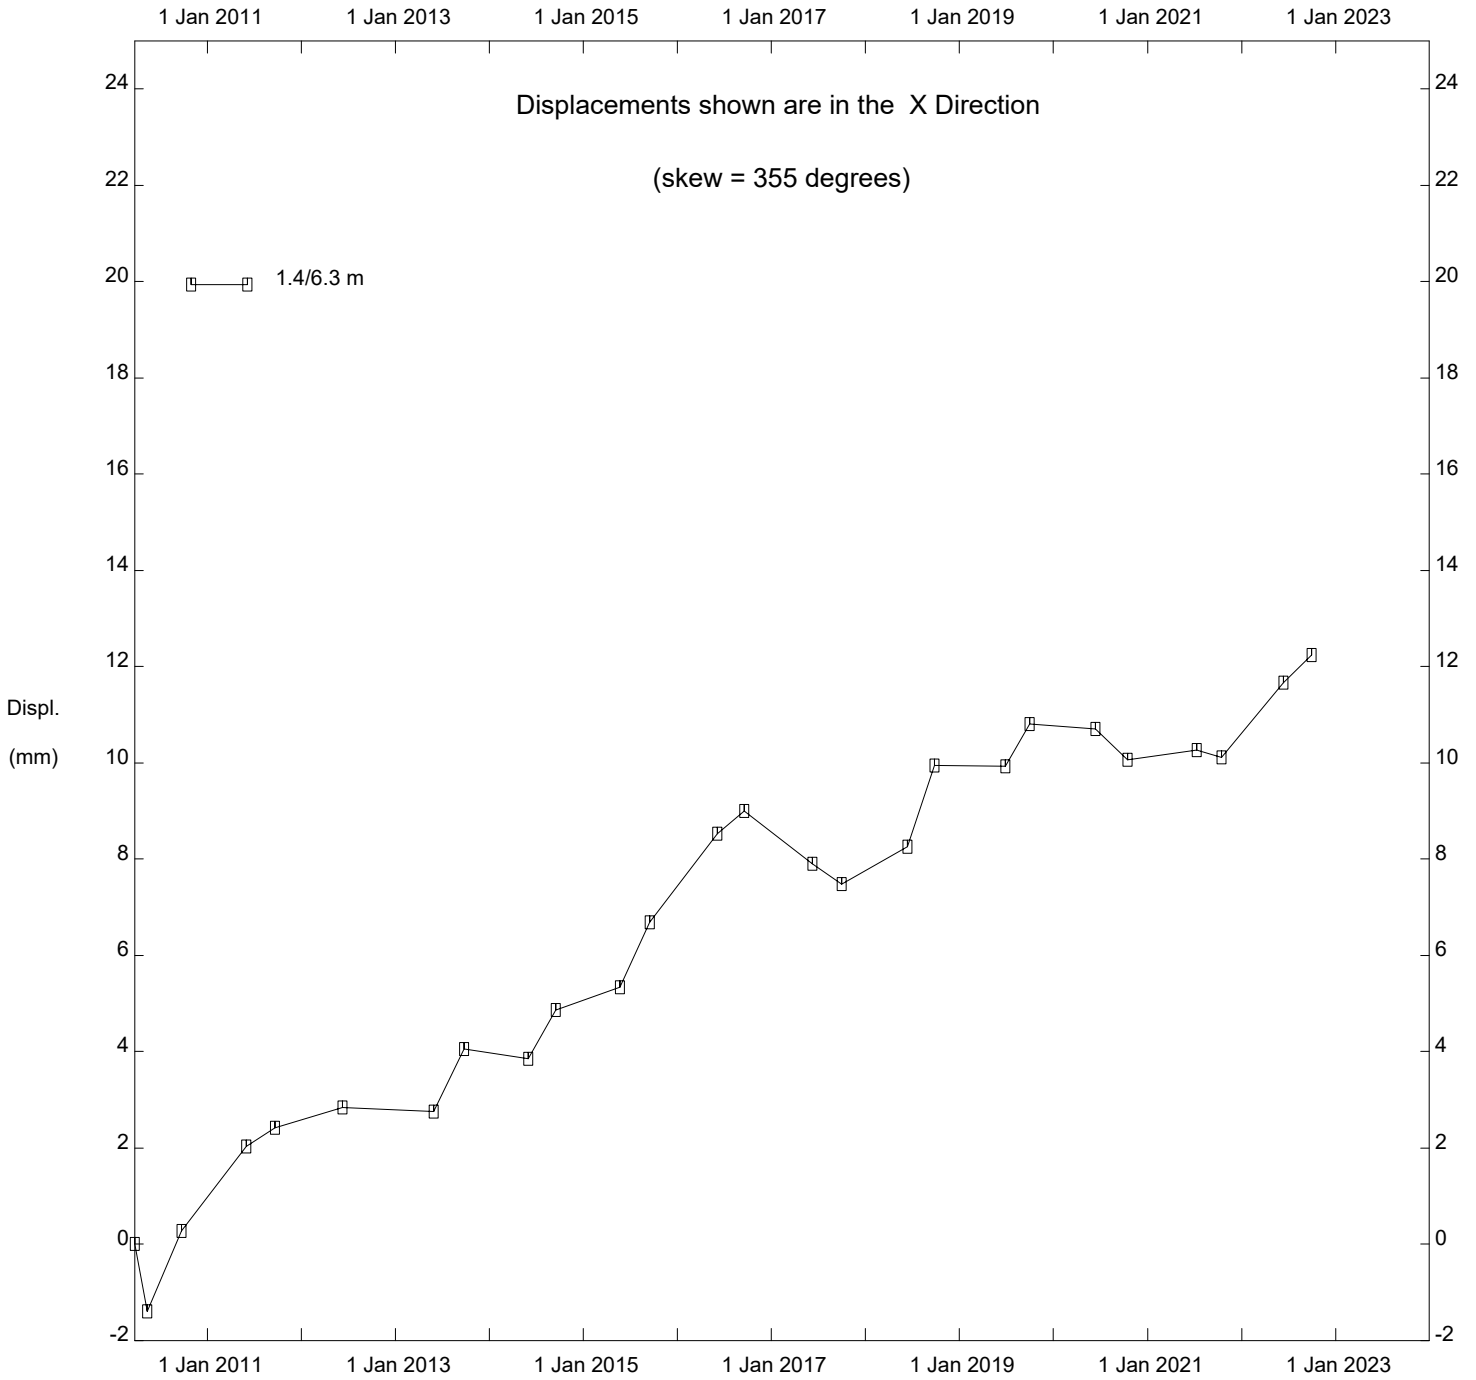
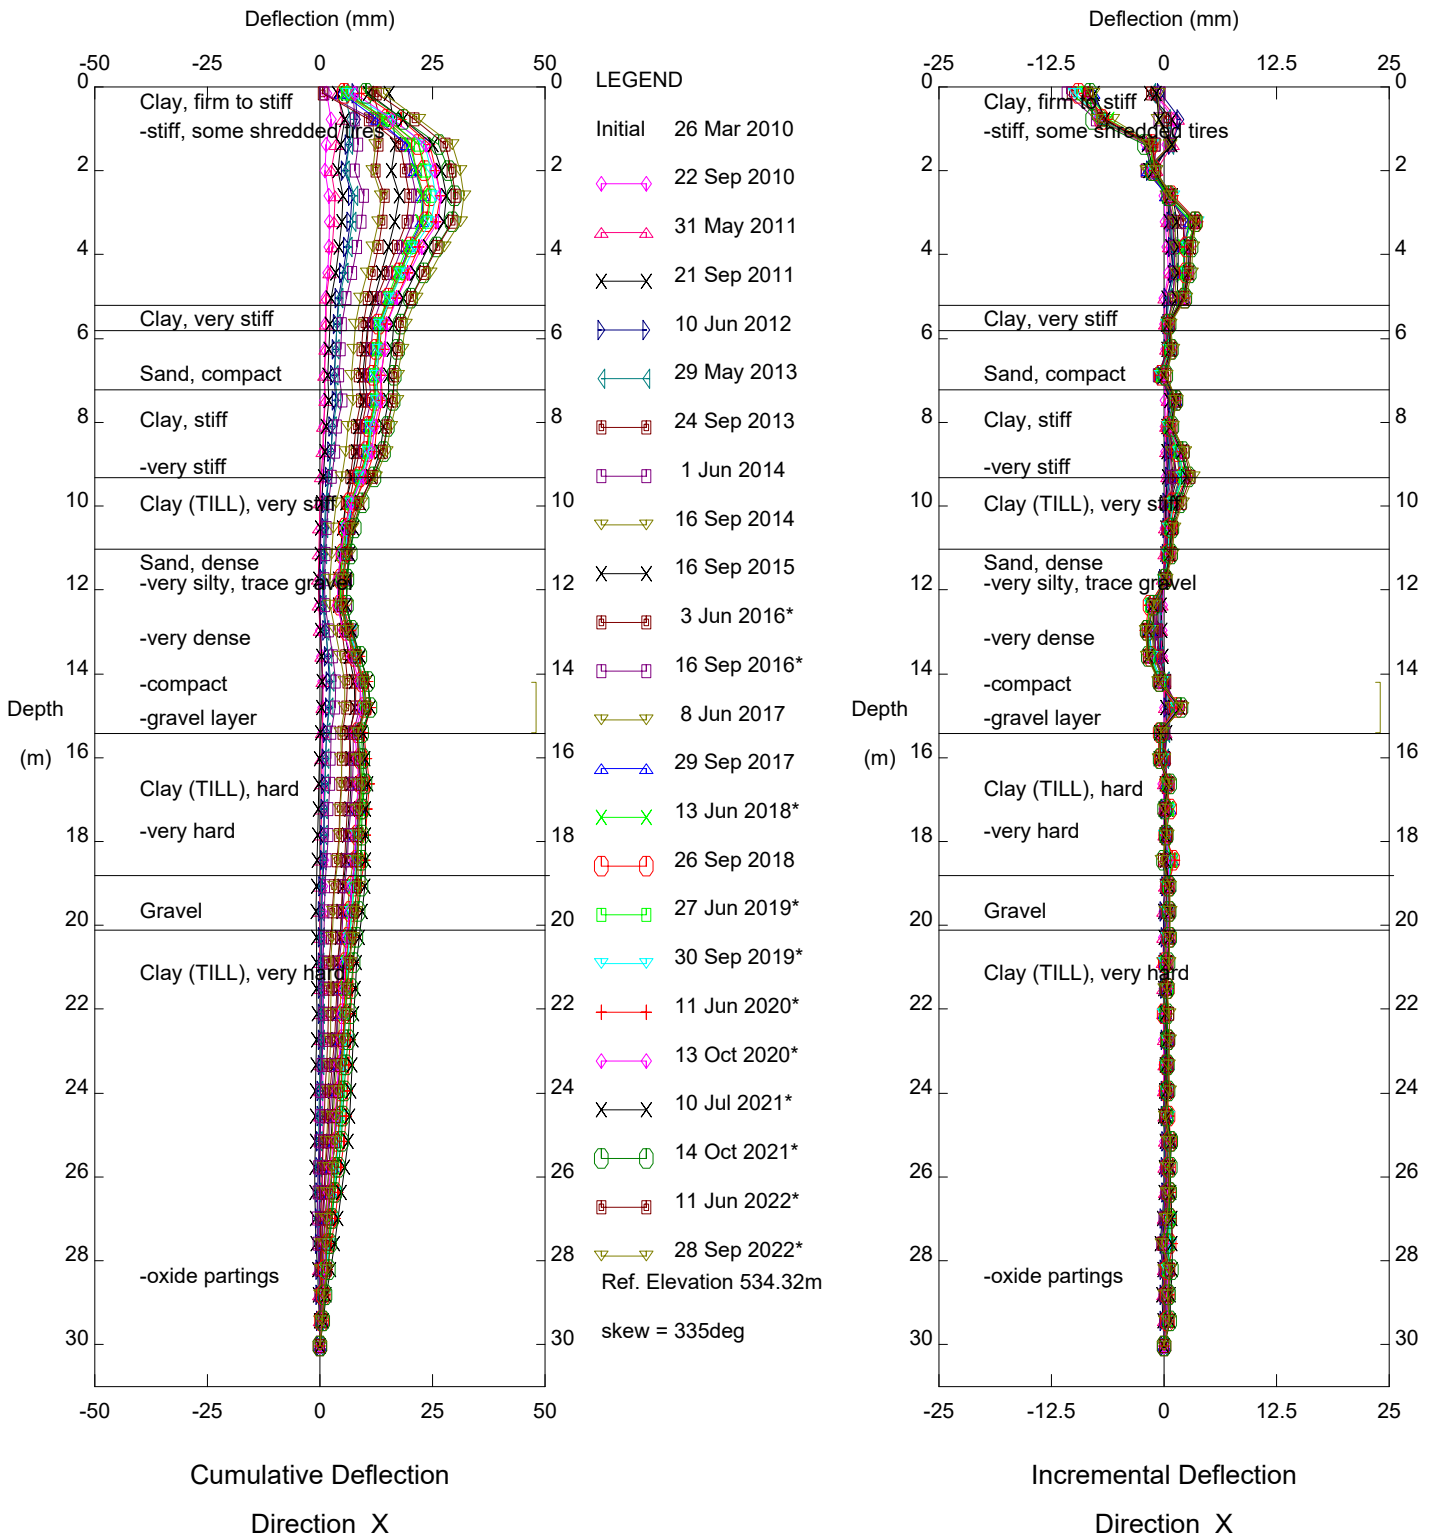
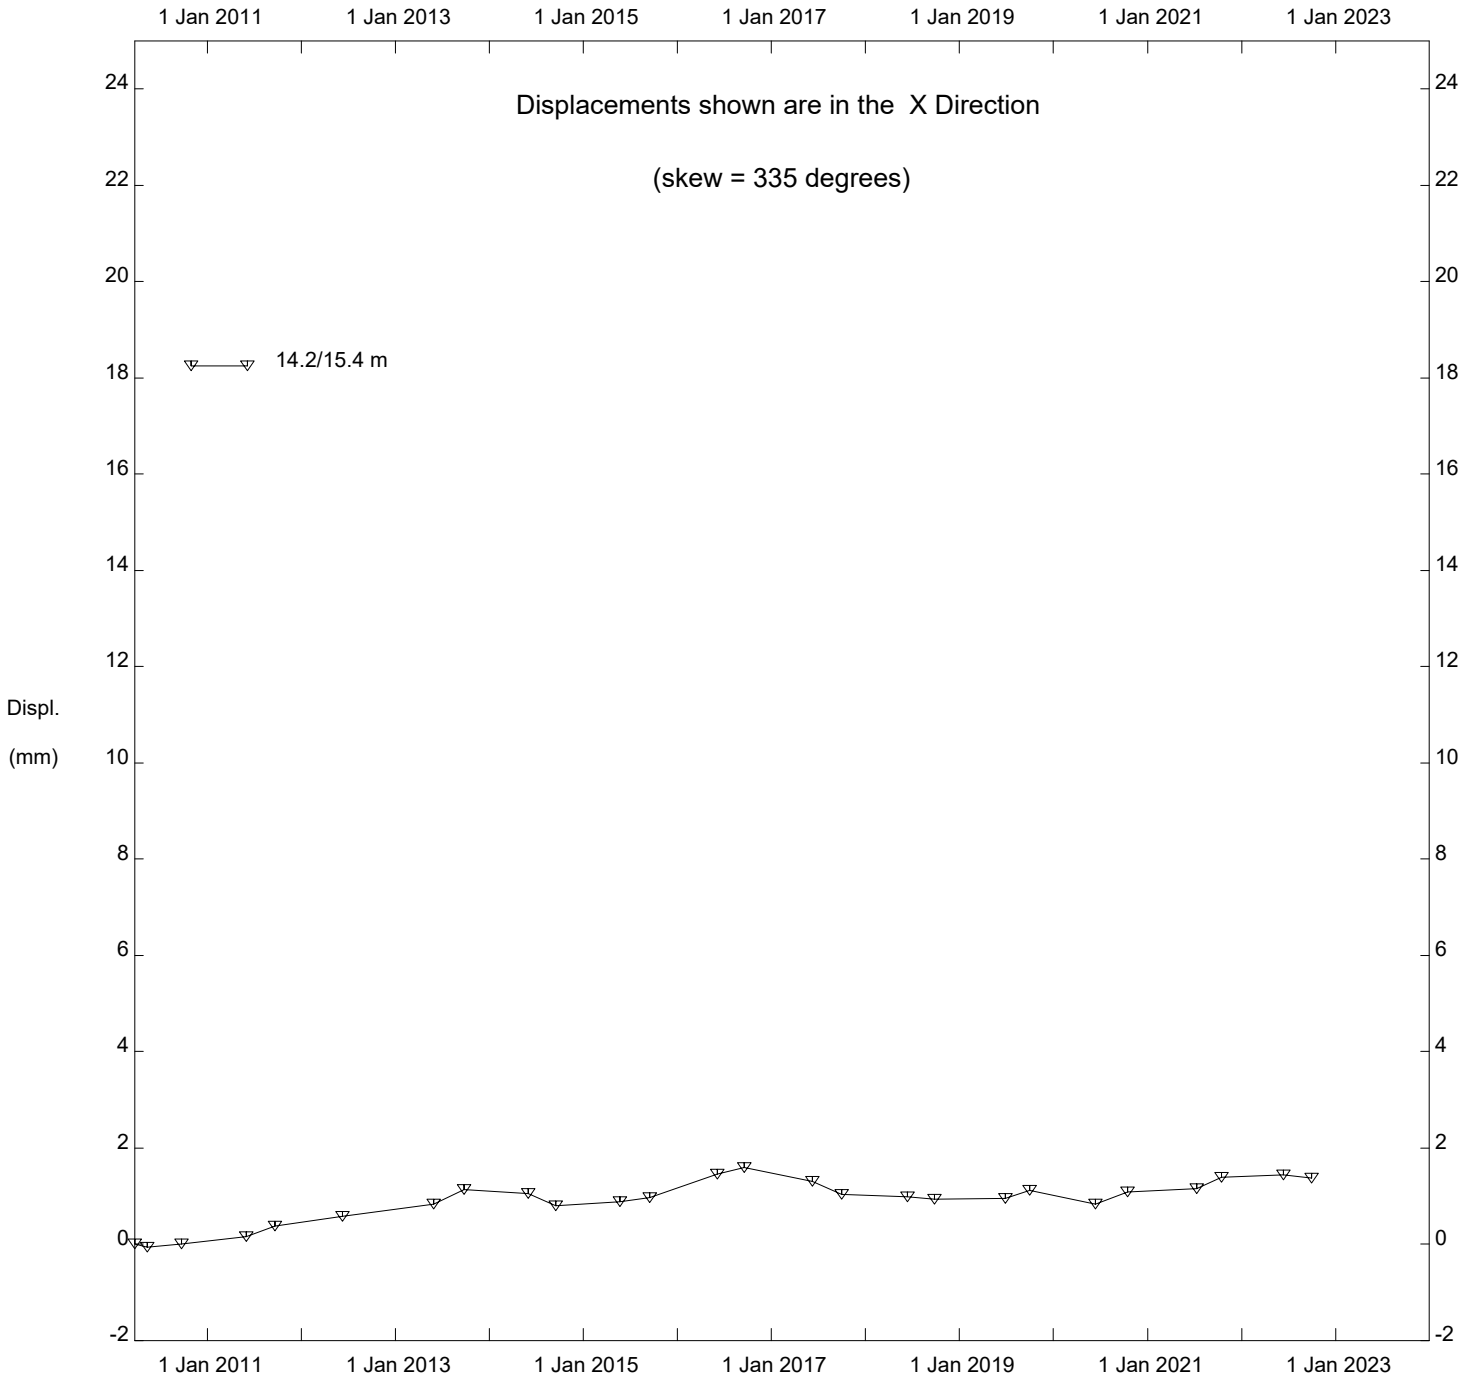
Judah Hill PH030, Inclinometer SI10-1

SI10-1 showed a rate of movement of 2.0 mm/yr over 1.4 m to 6.3 m depth and no discernible movement over 14.2 m to 15.4 m depth since the spring of 2022 readings. SI10-2 showed no discernible movement over 0.4 m to 4.1 m depth and a rate of movement of 4.4 mm/yr over 4.1 m to 8.3 m depth since the spring of 2022 readings.
