THURBER ENGINEERING LTD.

**ALBERTA TRANSPORTATION GRMP (CON0022164)
PEACE REGION (PEACE RIVER DISTRICT)
INSTRUMENTATION MONITORING RESULTS – FALL 2022**

SITE PH030: HWY 744:04, JUDAH HILL (LOOKOUT SLIDE)

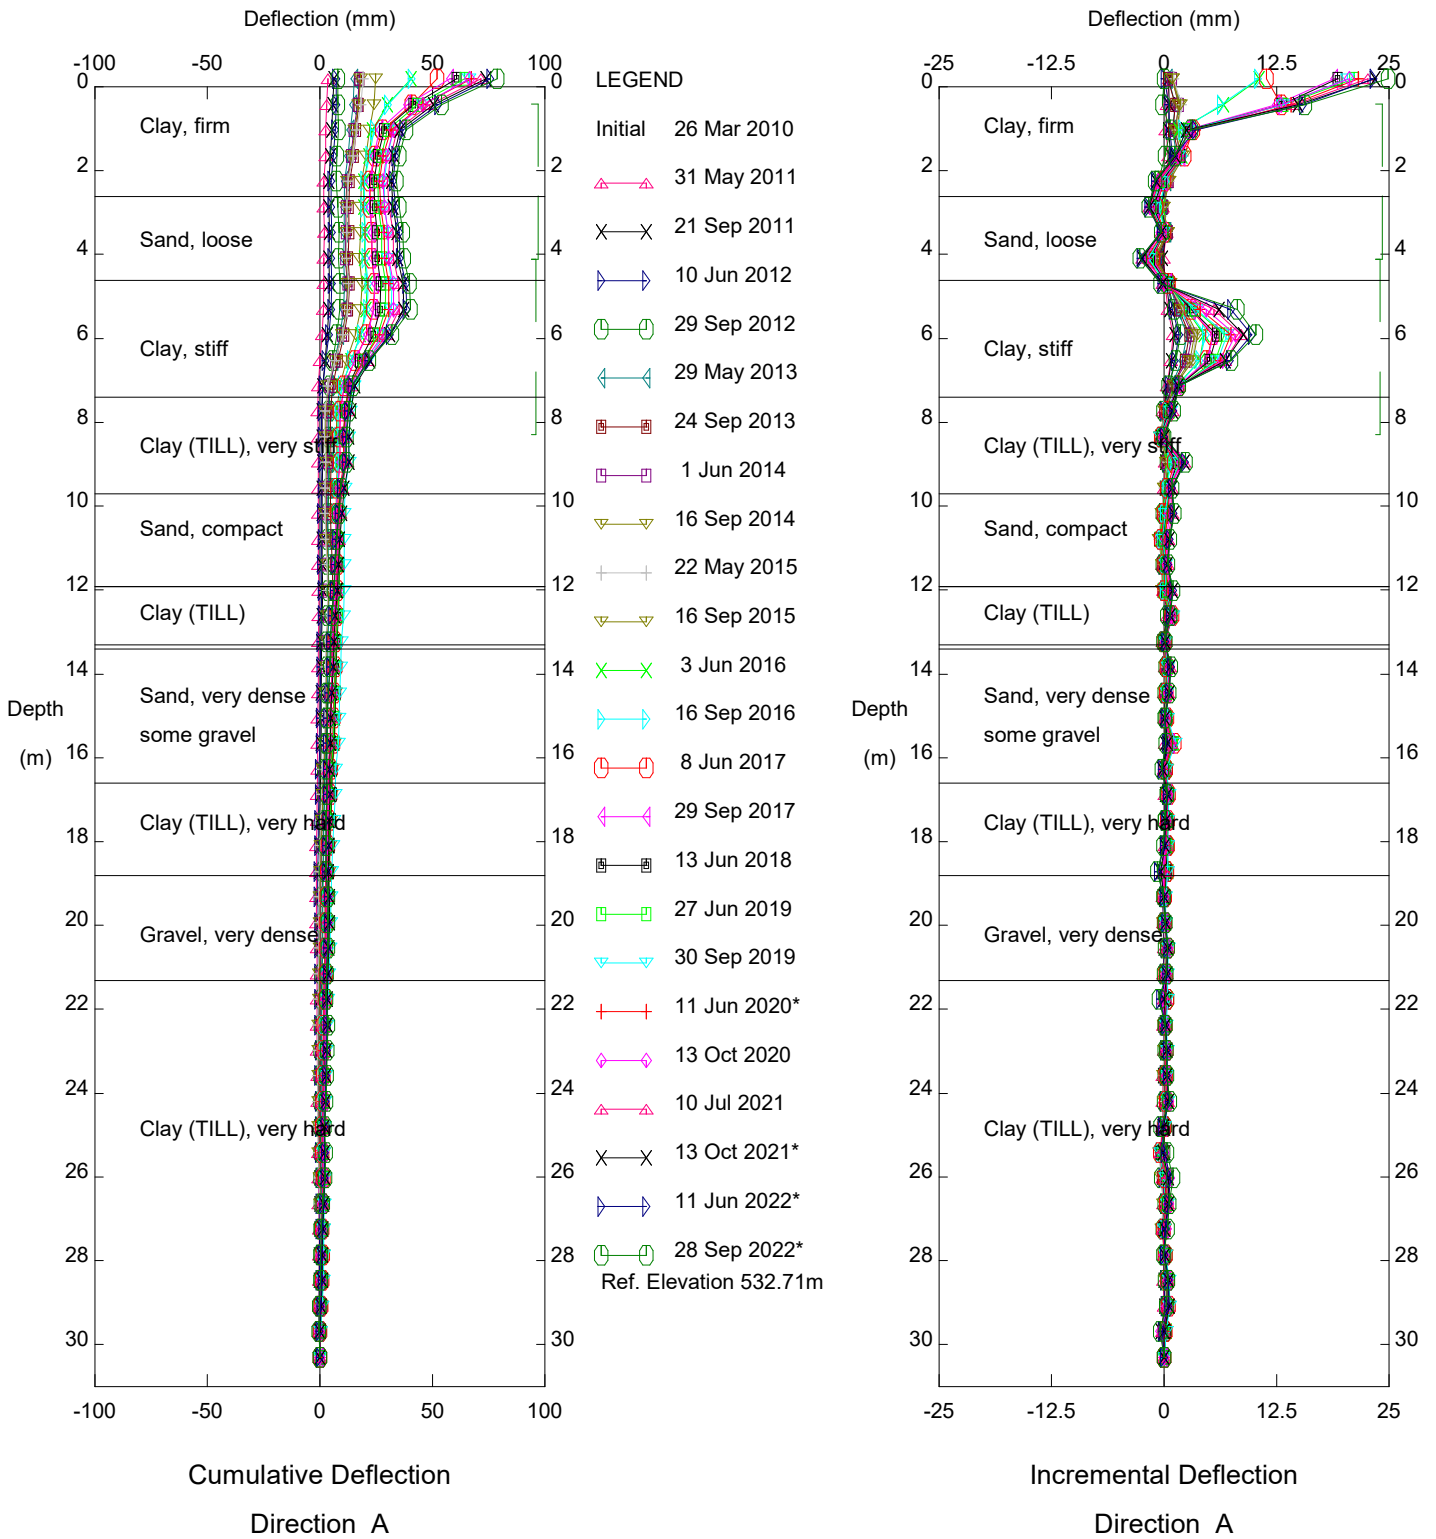
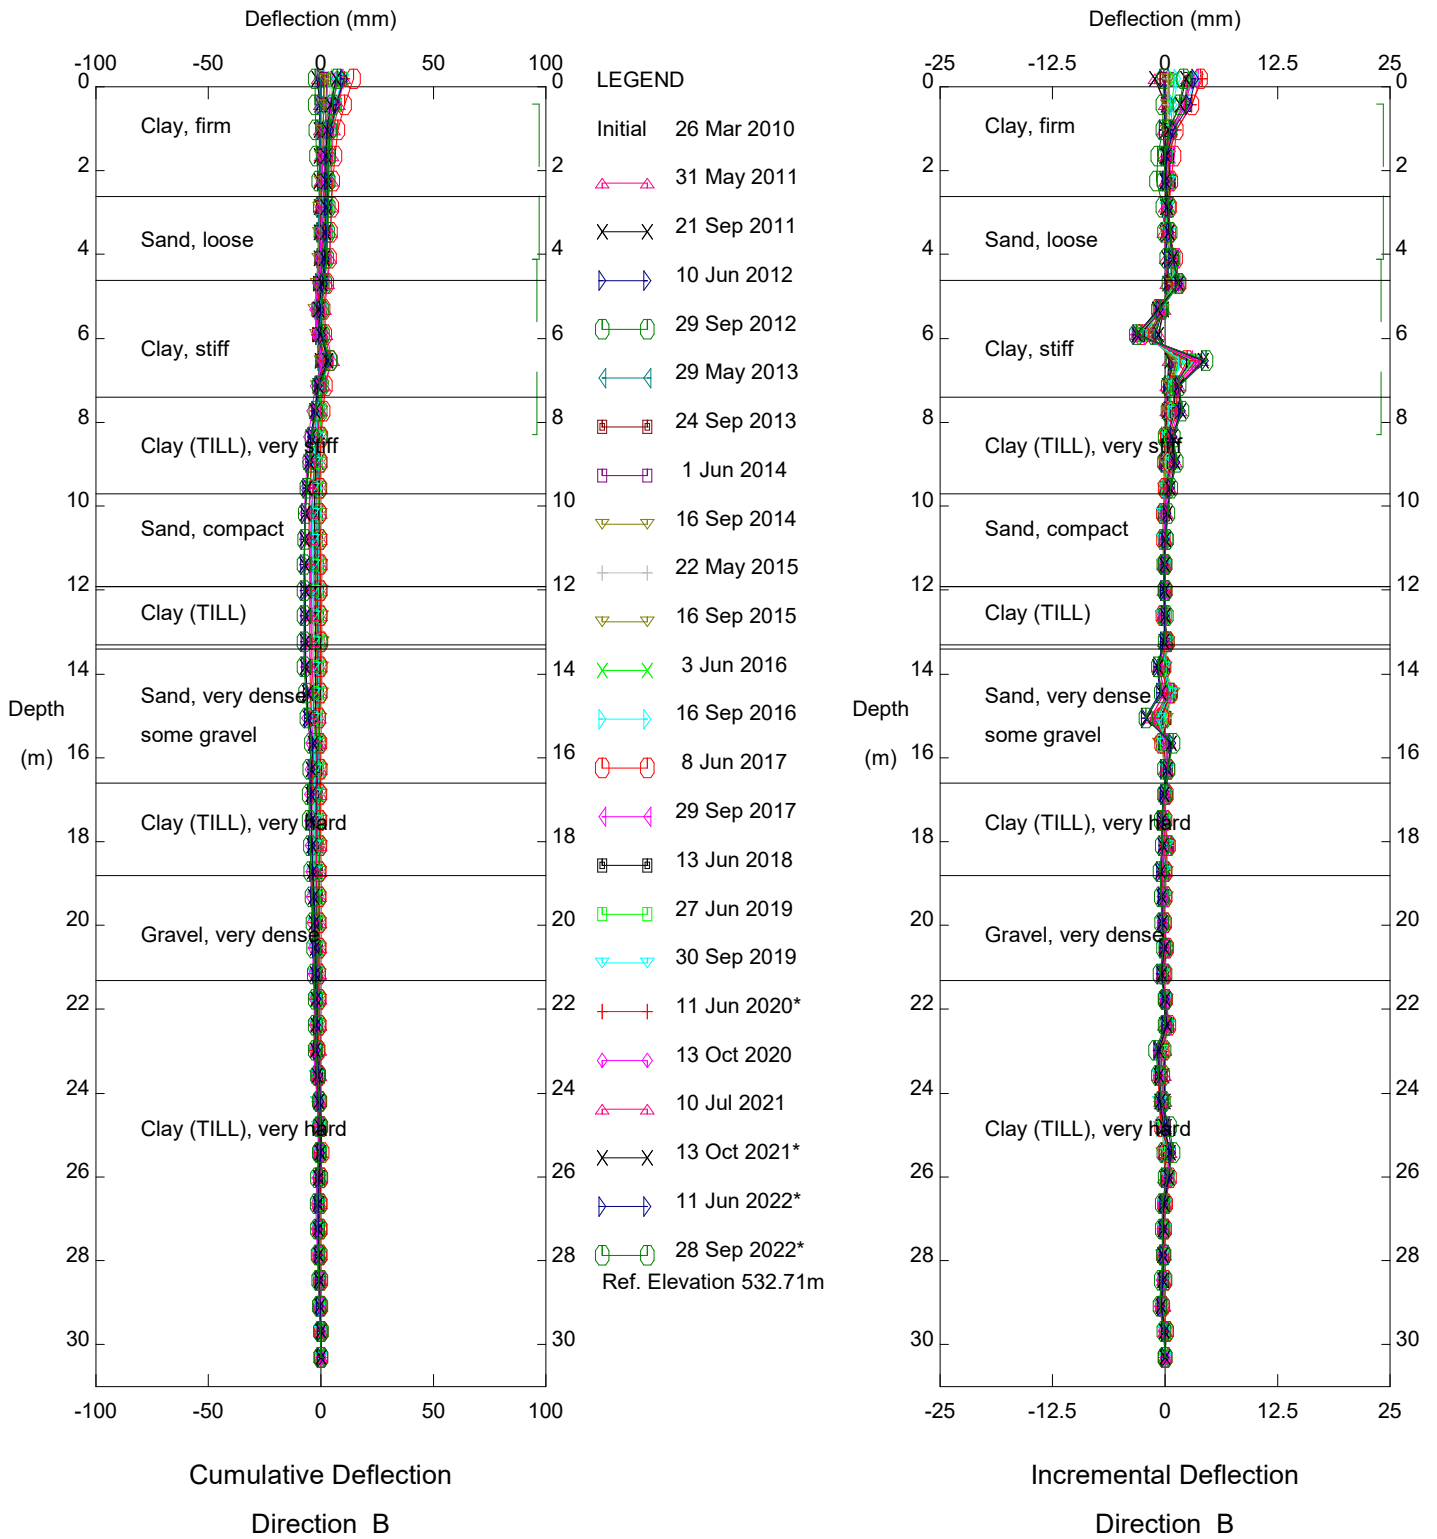
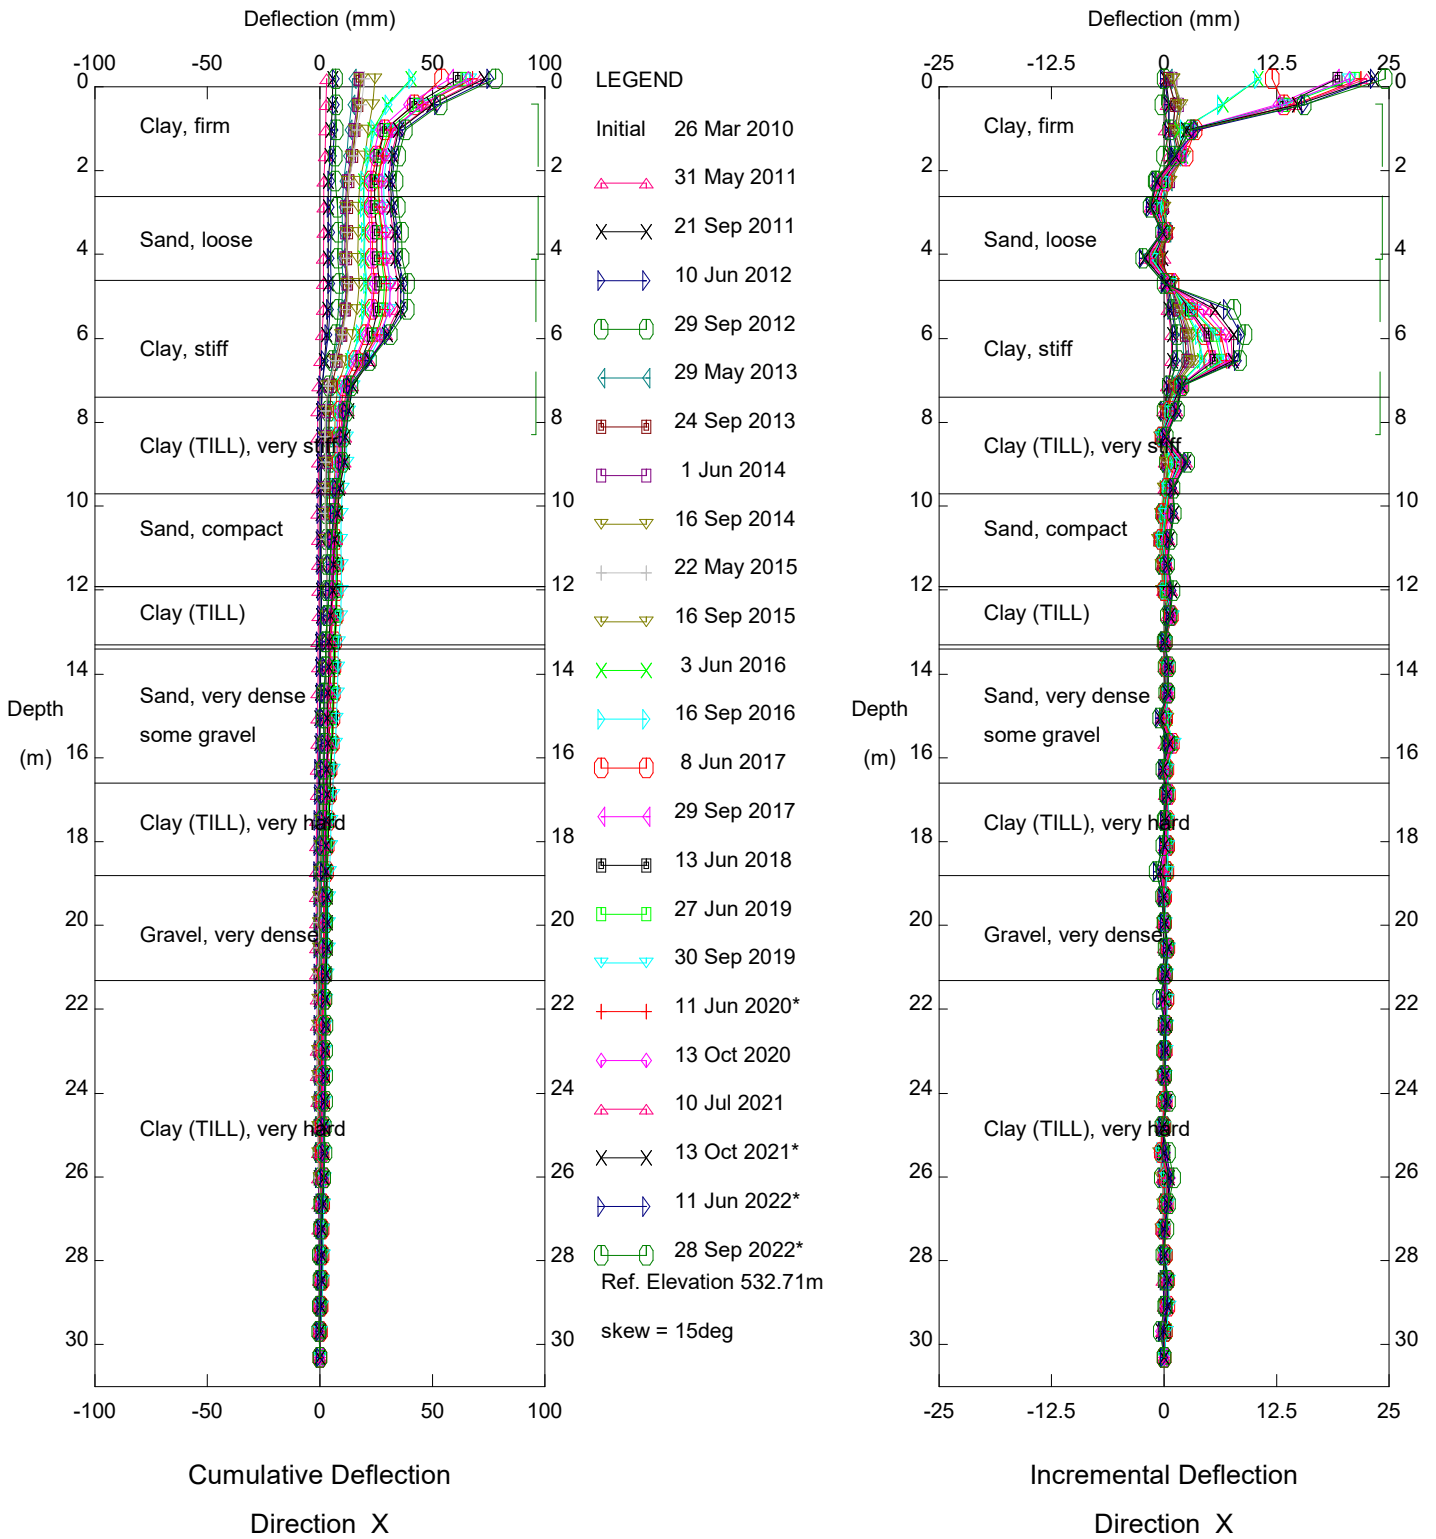
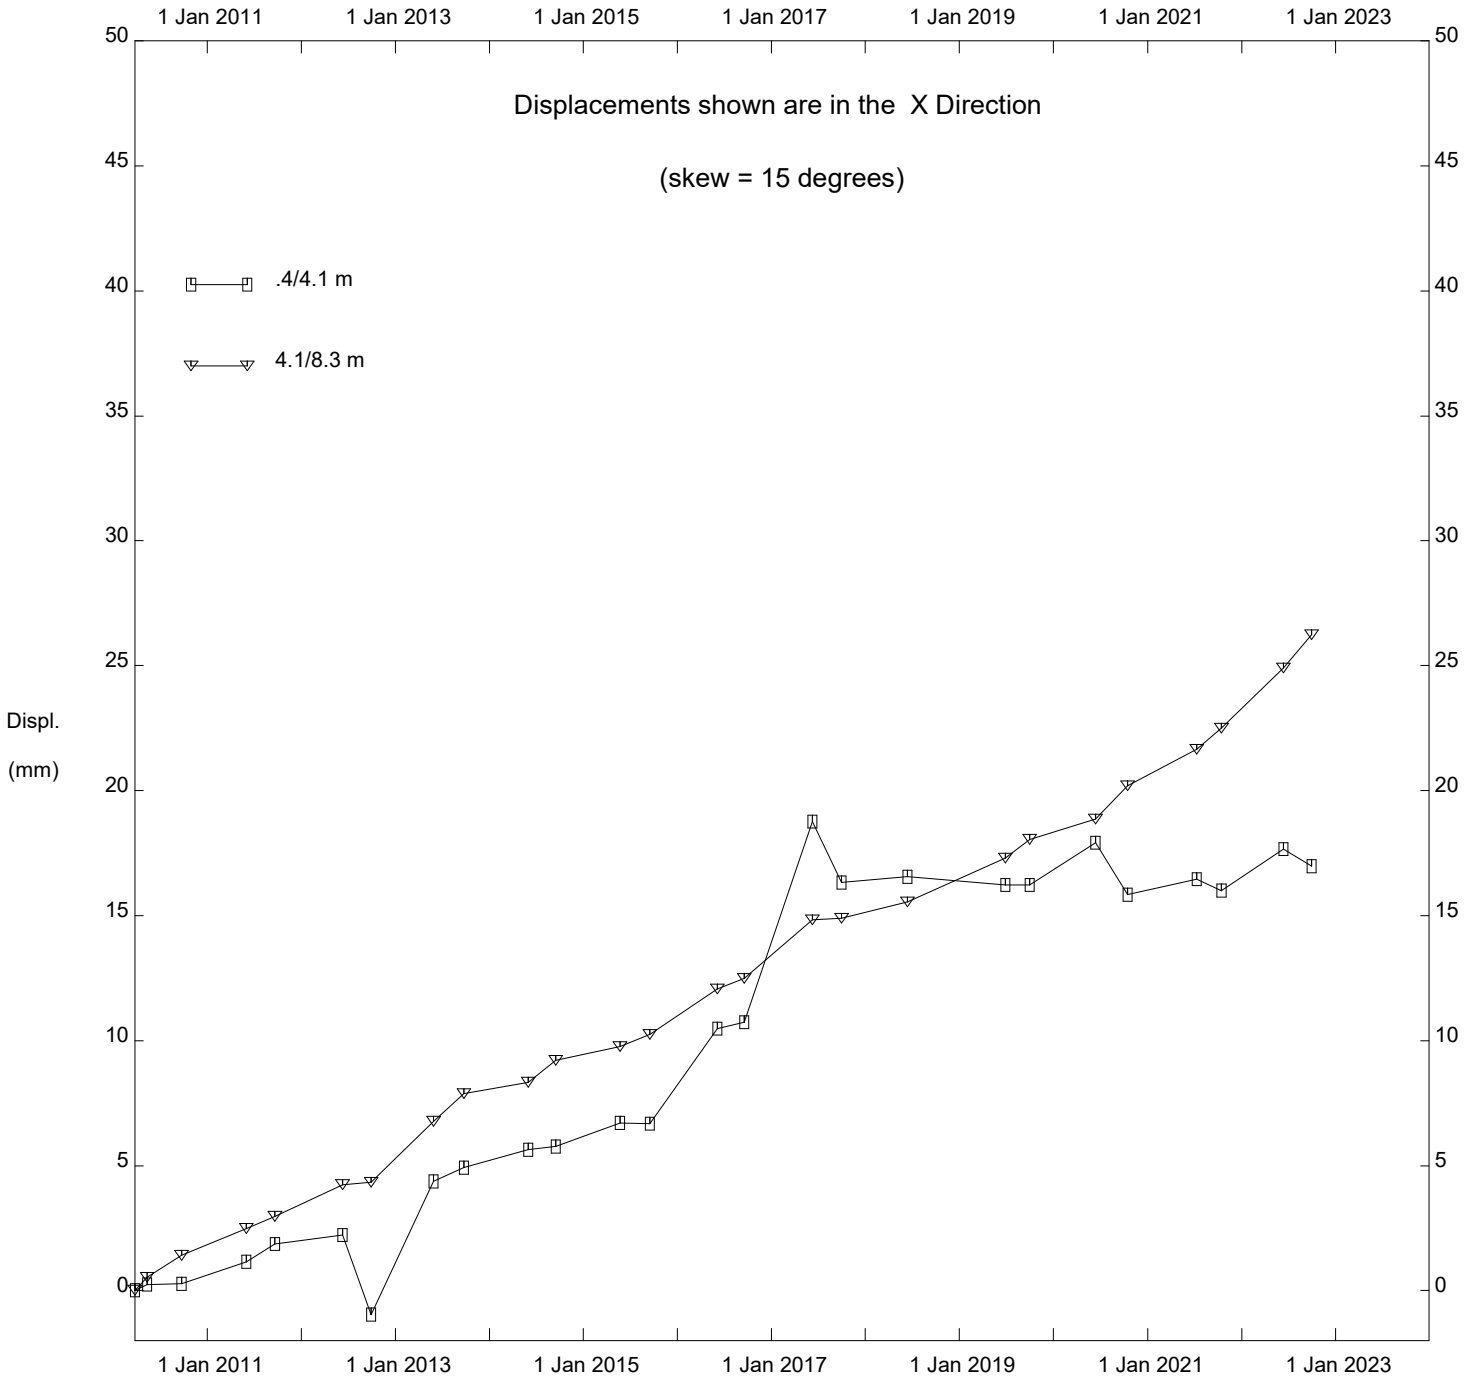
Judah Hill PH030, Inclinometer SI10-2

SI10-1 showed a rate of movement of 2.0 mm/yr over 1.4 m to 6.3 m depth and no discernible movement over 14.2 m to 15.4 m depth since the spring of 2022 readings. SI10-2 showed no discernible movement over 0.4 m to 4.1 m depth and a rate of movement of 4.4 mm/yr over 4.1 m to 8.3 m depth since the spring of 2022 readings.

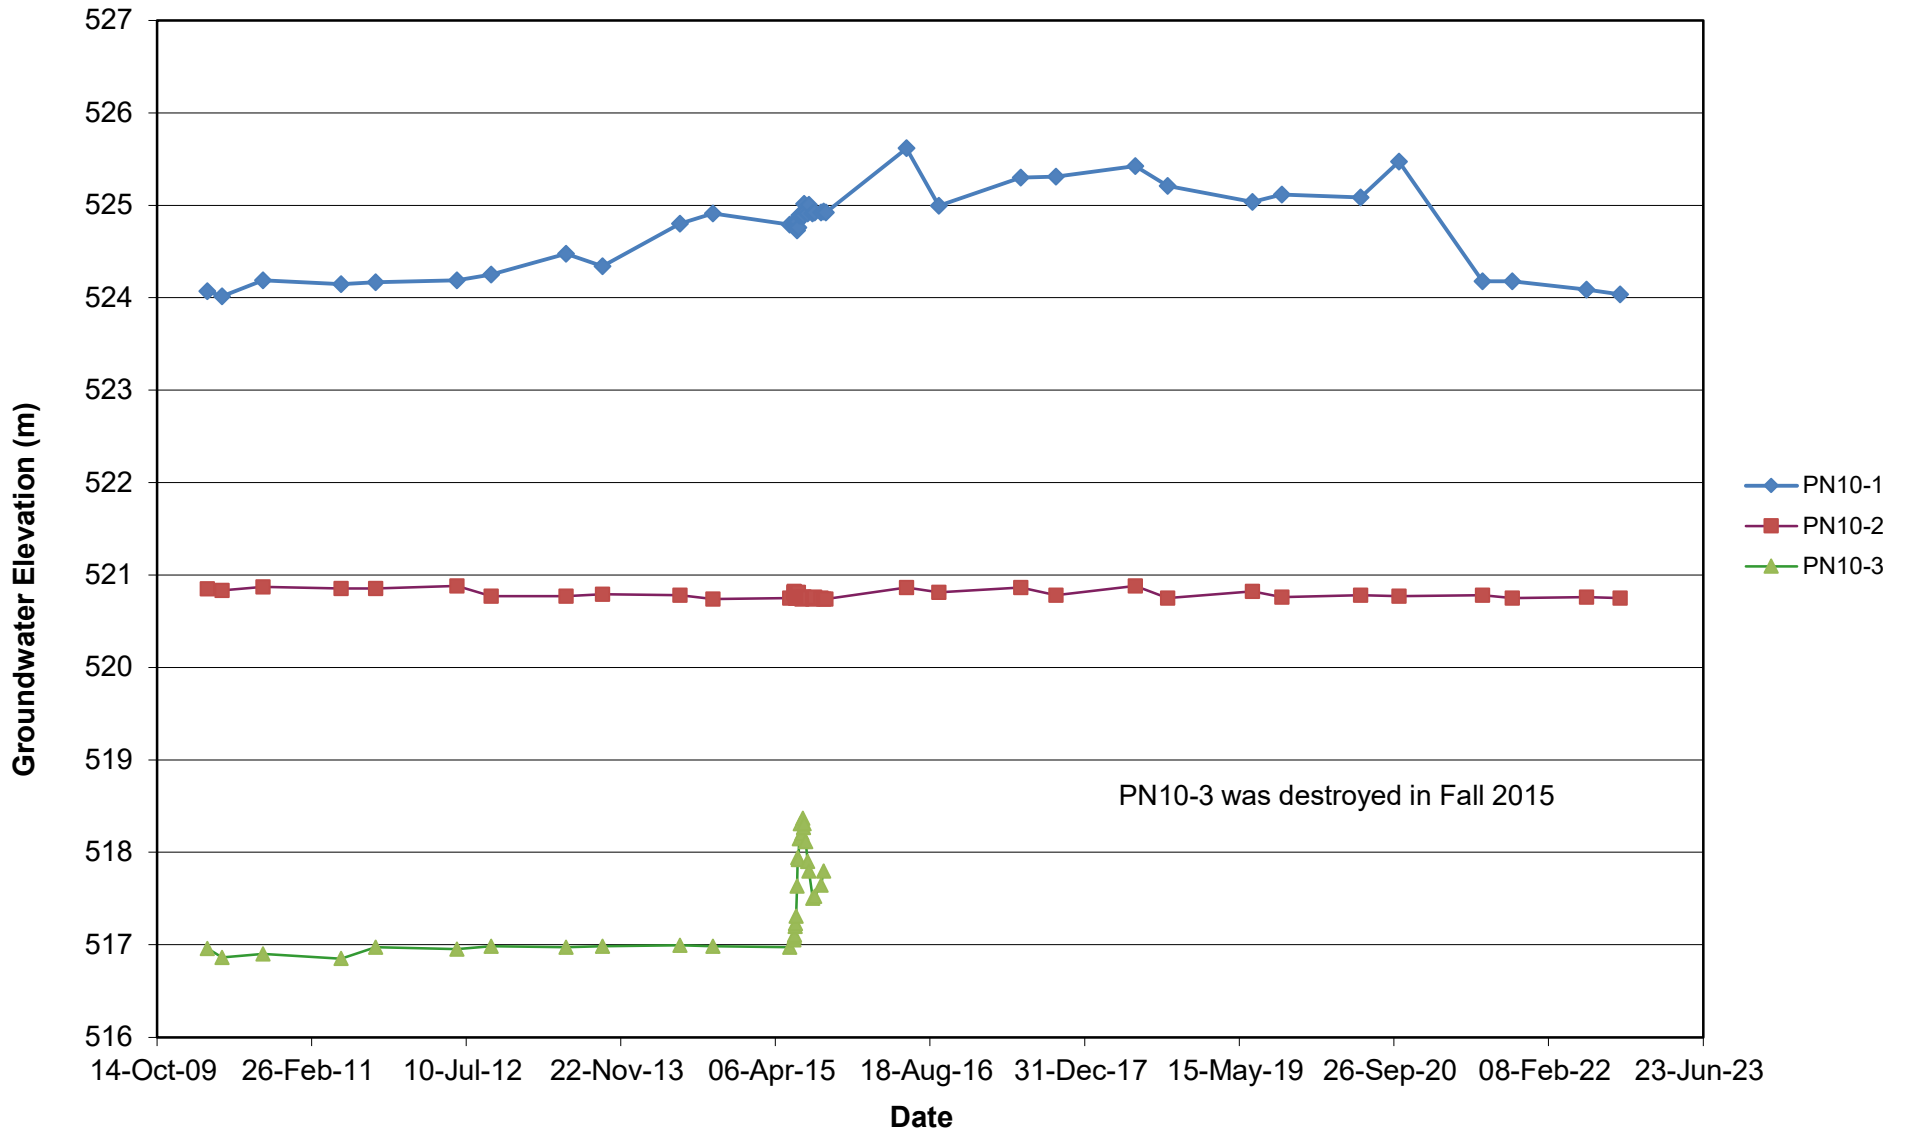
**FIGURE PH030-1
PIEZOMETRIC ELEVATIONS FOR HWY 744:04: JUDAH HILL (LOOKOUT SLIDES)**

Pneumatic piezometers PN10-1 and PN10-2 showed decreases in groundwater levels of 0.05 m and 0.01 m, respectively, compared to the spring of 2022 readings. The groundwater level measured in PN10-1 during the spring of 2022 reading is the lowest measured in the instrument since September 2011. Table PH030-2 summarizes the pneumatic piezometer readings. Pneumatic piezometer readings are also plotted in Figures PH030-1 (by elevation) and PH030-2 (by depth) in Appendix A.
