**ALBERTA TRANSPORTATION
GEOHAZARD ASSESSMENT PROGRAM
PEACE REGION (PEACE RIVER DISTRICT)
2022 INSPECTION**

Site Number	Location	Name	Hwy	km
PH030	Judah Hill	Lookout Slides	744:04	57.43
Legal Description		UTM Co-ordinates		
SE¼ 20-083-21 W5M		11V E 483194	N 6229425

**PH030 LOOKOUT SLIDES
2022 SITE INSPECTION PLAN**

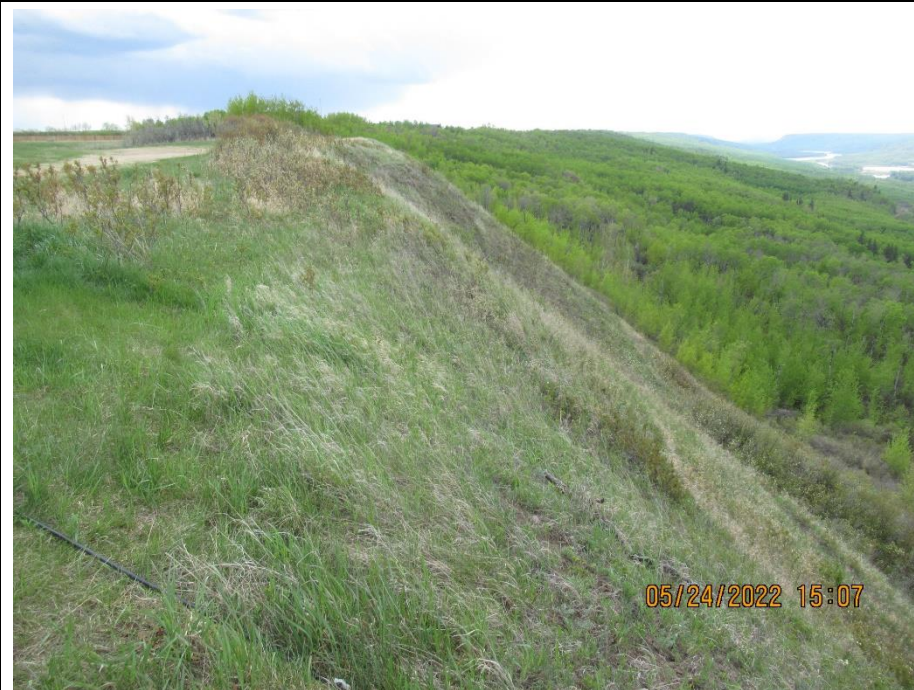
Photo 1.
Looking southwest from above Slide 2 towards Slide 4 (No change since 2021).

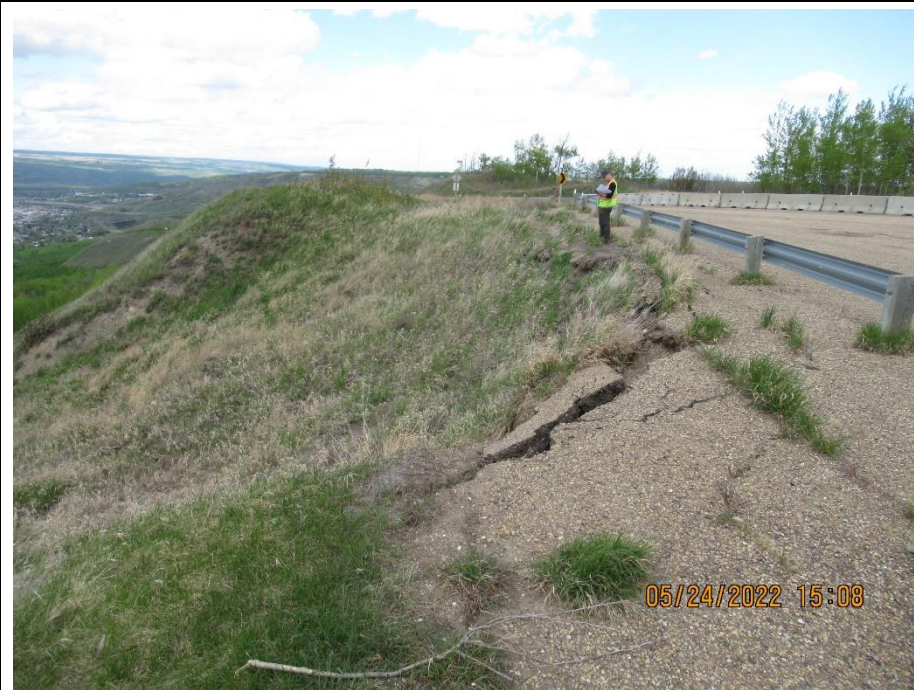
<input checked="" type="checkbox"/> Slope Movement	<p>No changes observed at Slide 4 (Photo 1). Increased retrogression and some flank expansion observed at Slides 2 and 3. Slide 2 main scarp offset 0.6 m from the guardrail and upper slide area was well vegetated (Photos 2 and 3).</p> <p>The landslide scarp in the highway sideslope at km 57.65 appears to be actively moving with increased downdrop (Photos 5 and 6) resulting in approximately 0.5 m of retrogression since 2021. Scarp is offset 2.0 m from the guardrail.</p>	<input checked="" type="checkbox"/>

Photo 2.
Looking northeast along backscarp of Slide 2 which is 0.6 m from the parking lot guardrail. Some localized main scarp retrogression, flank retrogression and additional pavement cracking since 2021.

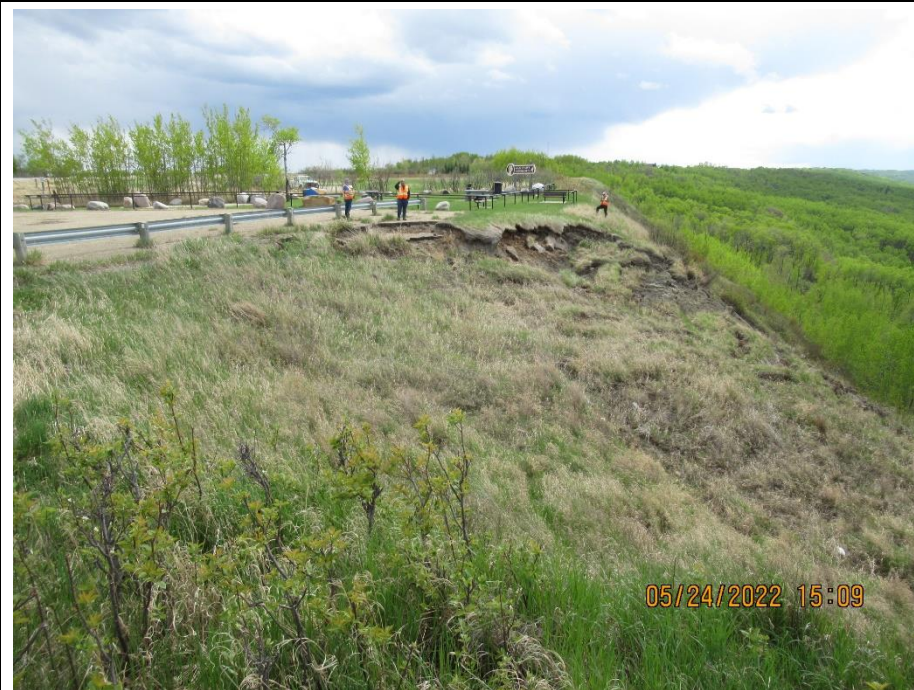
Photo 3.
Looking southwest towards the upper part of Slides 2 and 3. Visible retrogression and movement in the main scarp and upper southern flank since 2021. Disturbed slide mass area is well vegetated.

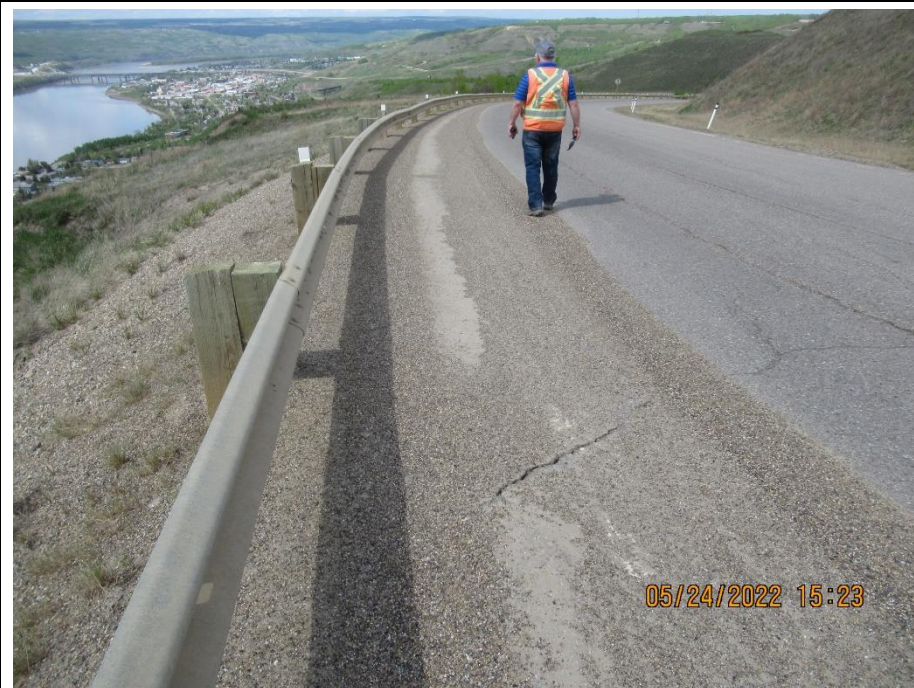
indicative that a slide surface is potentially undermining the NBL, and a large increment of movement could impact the driving surface. The operating SI near this area (SI10-2) appears to be outside of the main movement zone.

Photo 4.
Looking northwest along from SBL of Hwy 744:04 at km 57.6 at south end of realignment done in 2015-2016. New transverse cracks have formed joining the previous longitudinal crack in the NBL to form arc-shaped crack within the downslope slide extents.

The slide activity in the highway embankment sideslope and overall performance of the newly implemented surface drainage measures should be regularly monitored by the Maintenance Contractor in the meantime.

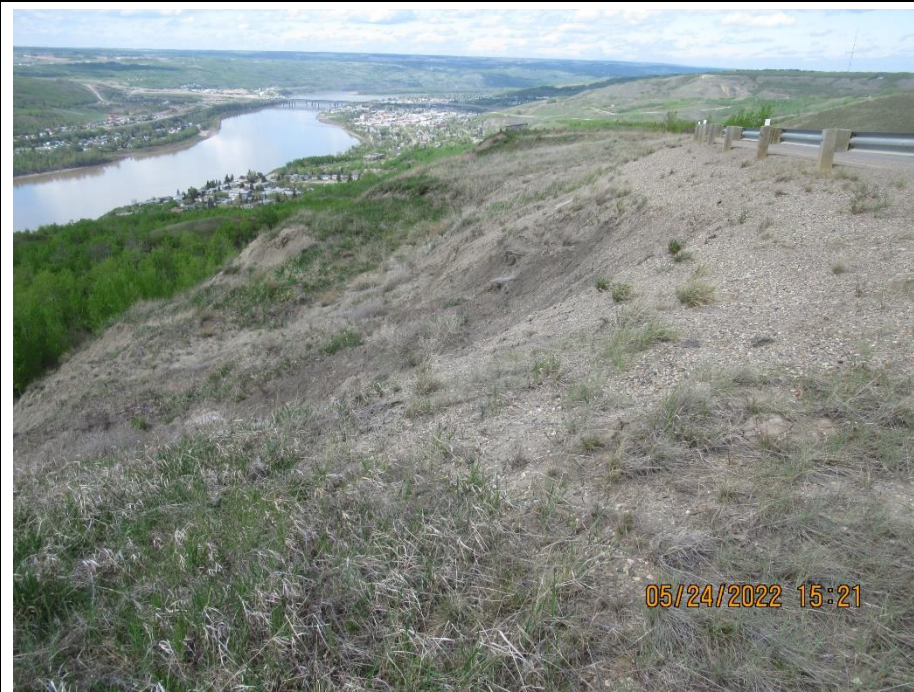
Photo 5.
Looking north from downslope of the SBL of Hwy 744:04 at km 57.63. Increased dropdown within the disturbed slide mass. Headscarp has retrogressed 0.5 m since 2021; offset from the guardrail is now at 2.0 m.

The landslide at km 57.65 is expected to continue to move and retrogress toward the new highway alignment. A tied back pile wall should be considered to protect the new alignment from this feature. The wall will need to be in the order of 35 m to 40 m wide with two rows of tie-back anchors.

Sub-excavation of the slide mass and replacement with shredded tire light weight fill could be considered as a shorter-term, cheaper solution.

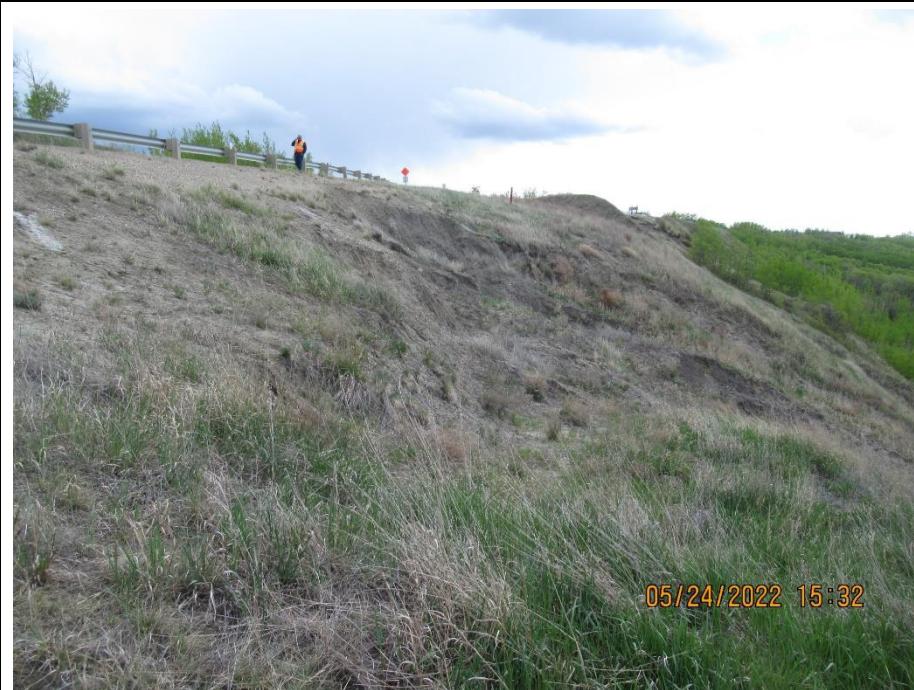
Photo 6.
Looking south at the active slide near km 57.65. Ongoing retrogression and erosion at the main scarp and south flank.

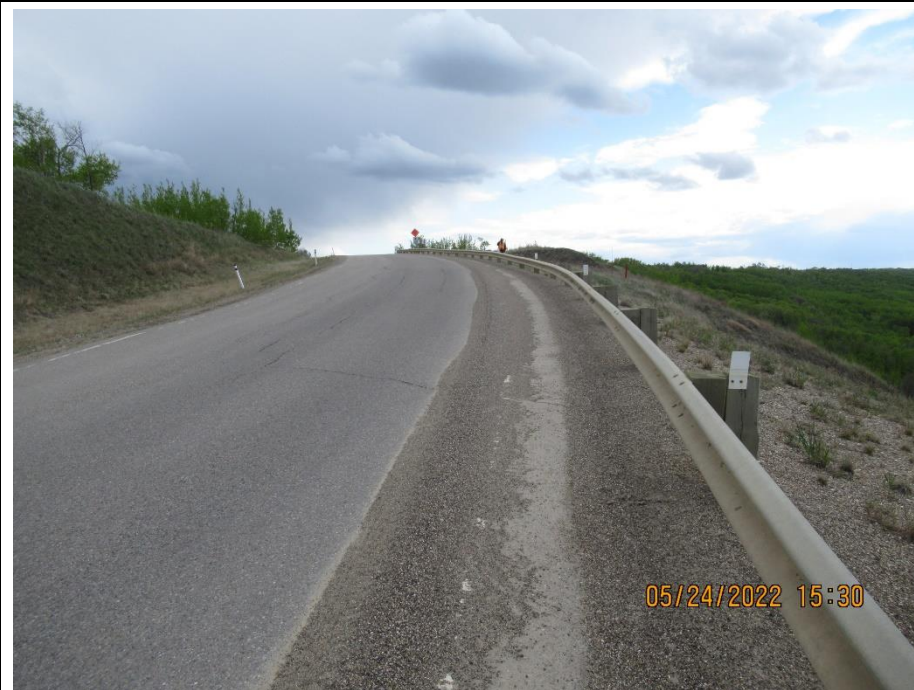
Photo 7.
Looking south along SBL of Hwy 744:04 at km 57.68. New transverse cracks have formed joining the previous longitudinal crack in the NBL to form arc-shaped crack within the downslope slide extents.

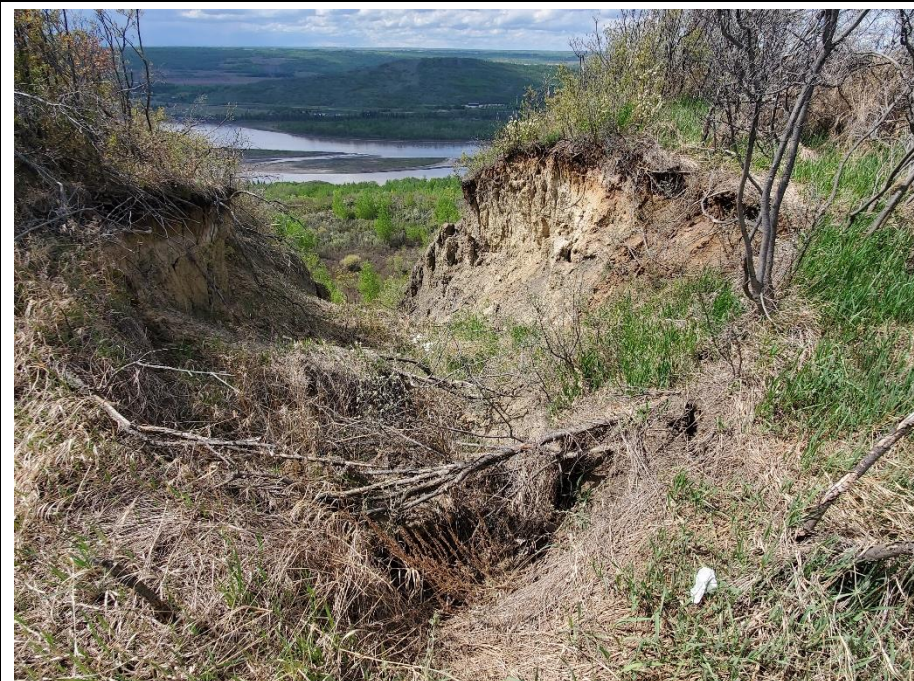
<input checked="" type="checkbox"/> Erosion	An erosion gully was noted approximately 40 m south of Slide 4 at the southern end of the site (Photo 8).	<input type="checkbox"/>
<input type="checkbox"/> Seepage		<input type="checkbox"/>
<input type="checkbox"/> Bridge/Culvert Distress		<input type="checkbox"/>
<input type="checkbox"/> Other		<input type="checkbox"/>

Photo 8.
Looking at the top an erosion gully located at the southern edge of the site, approximately 50 m south of the Slide 4 area. Gully is offset approximately 70 m west of the highway.
