**ALBERTA TRANSPORTATION  
GEOHAZARD ASSESSMENT PROGRAM  
PEACE REGION (PEACE RIVER DISTRICT)  
2021 INSPECTION**

Site Number	Location	Name	Hwy	km
PH031	Judah Hill	Michelin Slides	744:04	57.664
Legal Description		UTM Co-ordinates		
NE¼ 20-083-21 W5M		11V E 483226	N 6229678

**PH031-1 MICHELIN SLIDES  
2021 SITE INSPECTION PLAN**

**DWG No. 32121-PH031-1**

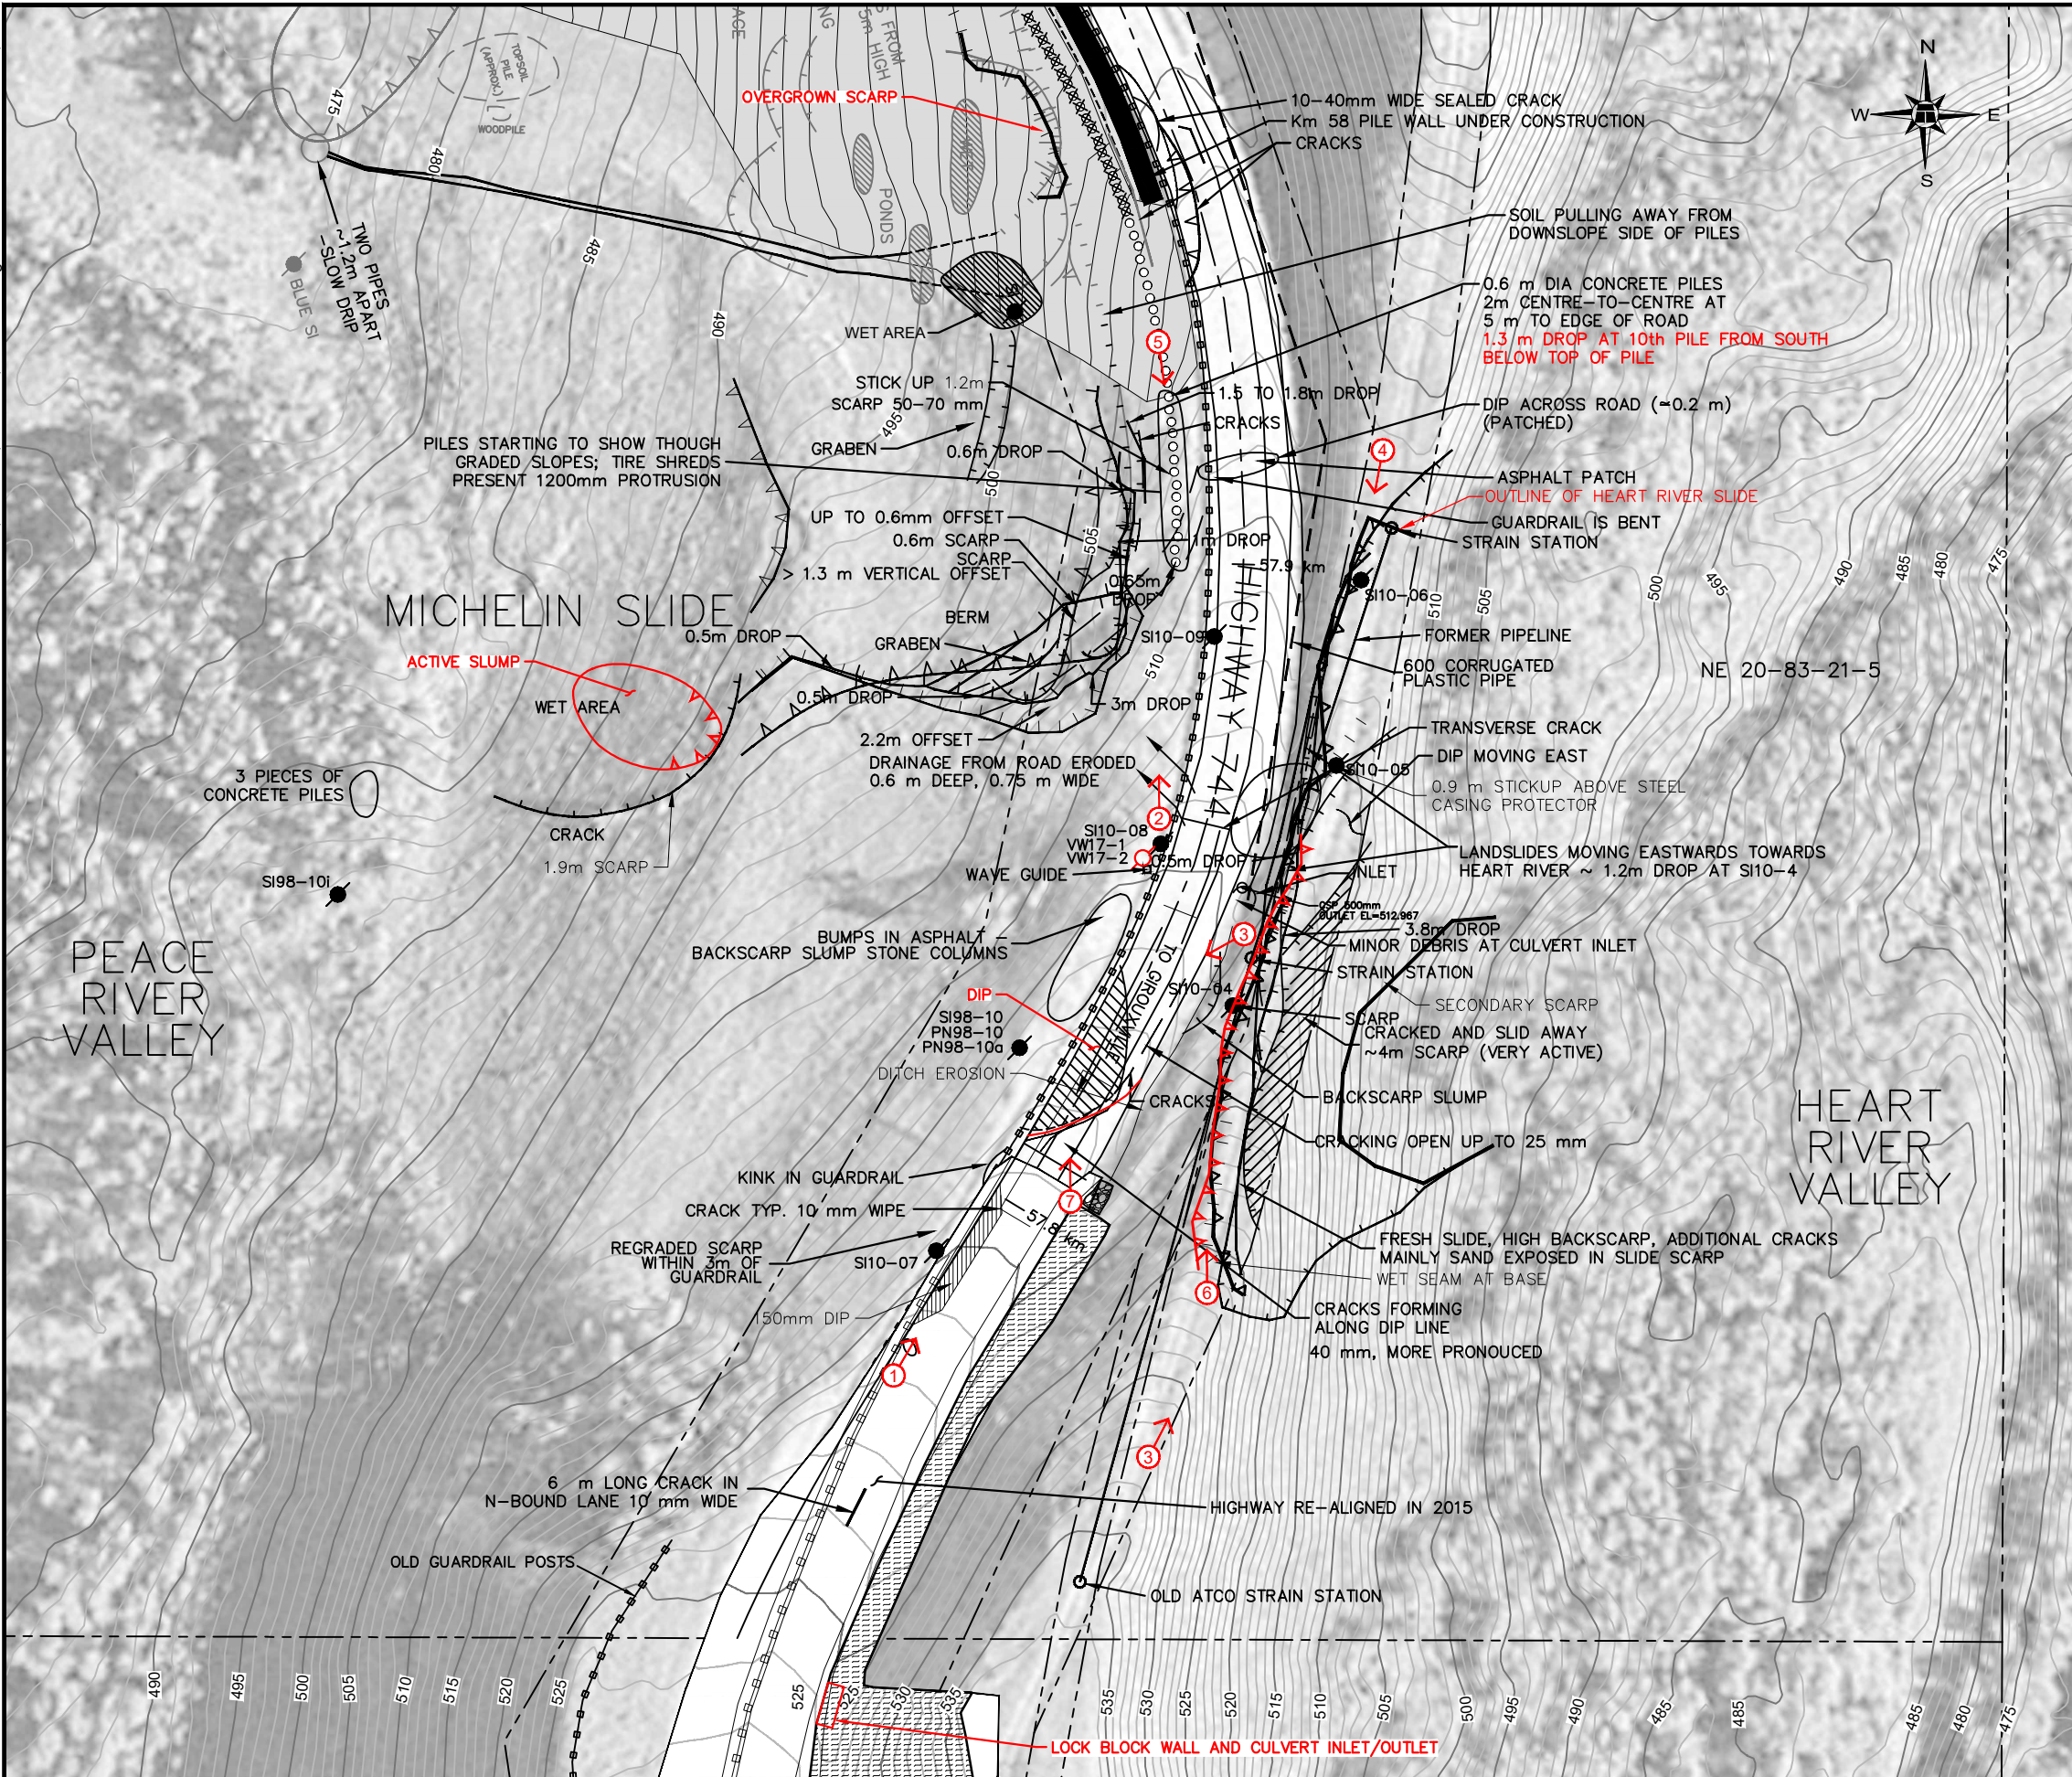
2 JULY 6, 2021 OBSERVATIONS SHOWN IN RED.

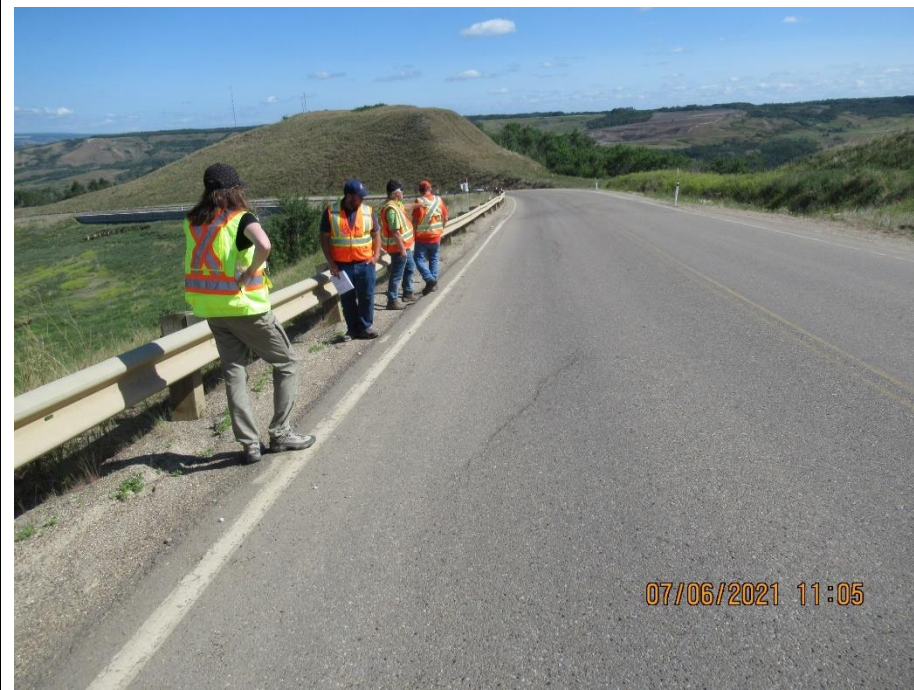
**Photo 1.**  
Looking northeast along the centerline of Hwy 744:04 at km 57.75 at the north end of the 2014-2015 realignment. No major changes observed from the 2020 pavement condition apart from some increased localized settlement at the shoulder.

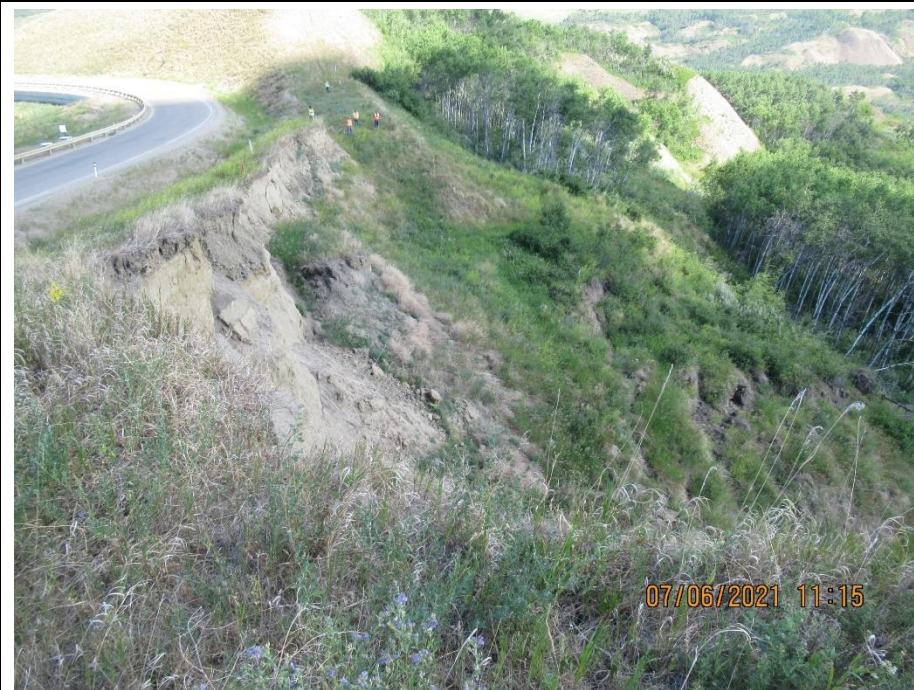
**Photo 3.**  
Looking northeast along the backscarp of the landslide at the top of the Heart River valley on Hwy 744:04 at km 57.8. Slide area has active movement within the disturbed scarp face leaving a higher backscarp since the previous inspection. Minor retrogression towards the road. The abandoned ATCO pipeline has been removed.

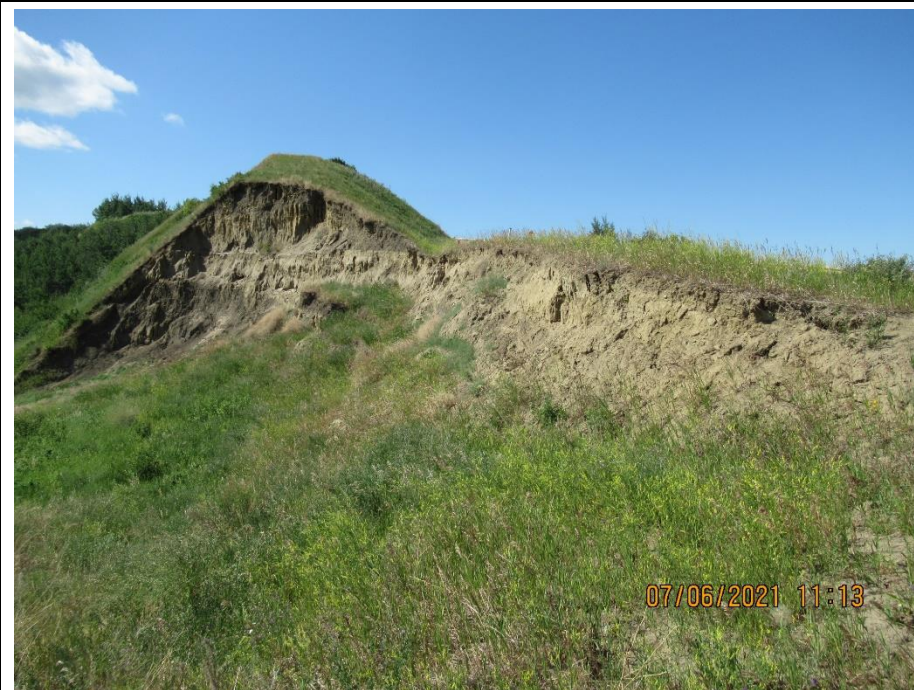
**Photo 4.**  
Looking south along the backscarp of the landslide at the top of the Heart River valley on Hwy 744:04 at km 57.85. North end of the slide area has less movement relative to the southern end.

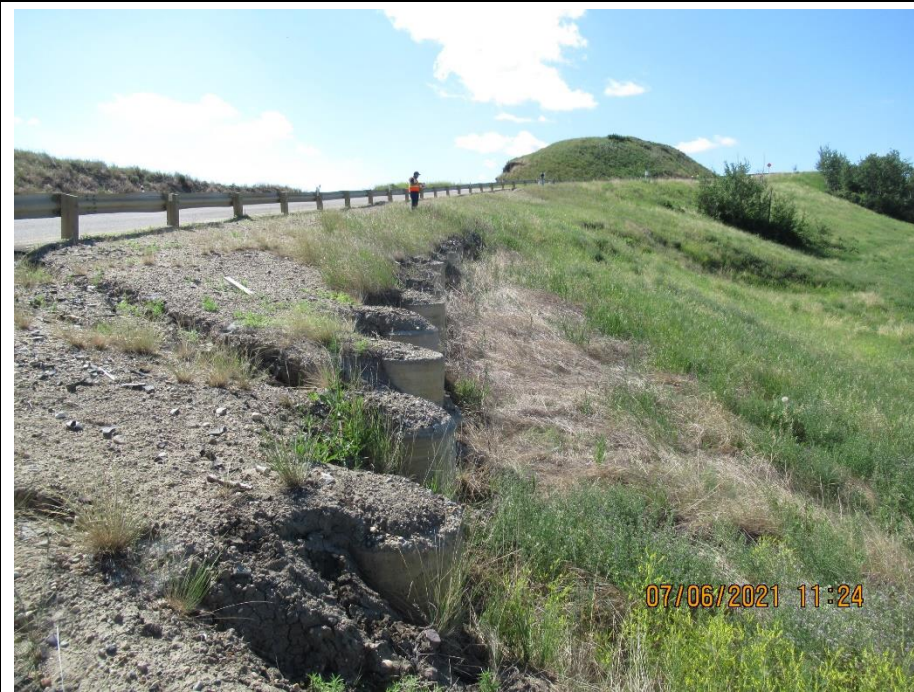
<p>wall maximum soil drop was as high as 1.8 m (Photo 5). Active slump was noted on the lower valley slope on the west side, offset approximately 70 m from the road.</p> <p>Active movement within the backscarp and disturbed slide mass at the landslide through the ATCO R/W towards the Heart River. Abandoned pipeline has been removed. Retrogression and erosion of the main backscarp was primarily within the south end of the slide area. (Photos 3 and 4, Drone Photo 1).</p>	
<input checked="" type="checkbox"/> Erosion	No significant change noted in previous erosion areas: east ditch between km 57.8 and 57.85 and from drainage off the road near km 57.84.	<input type="checkbox"/>
<input type="checkbox"/> Seepage		<input type="checkbox"/>
<input type="checkbox"/> Bridge/Culvert Distress		<input type="checkbox"/>
<input type="checkbox"/> Other		<input type="checkbox"/>
<b>Instrumentation:</b>		
	Installed at the toe of Michelin Slide repair:

**Photo 5.**  
Looking south along the west side of Hwy 744:04 at protruding piles near km 57.9. Max drop of 1.8 m below top of pile.

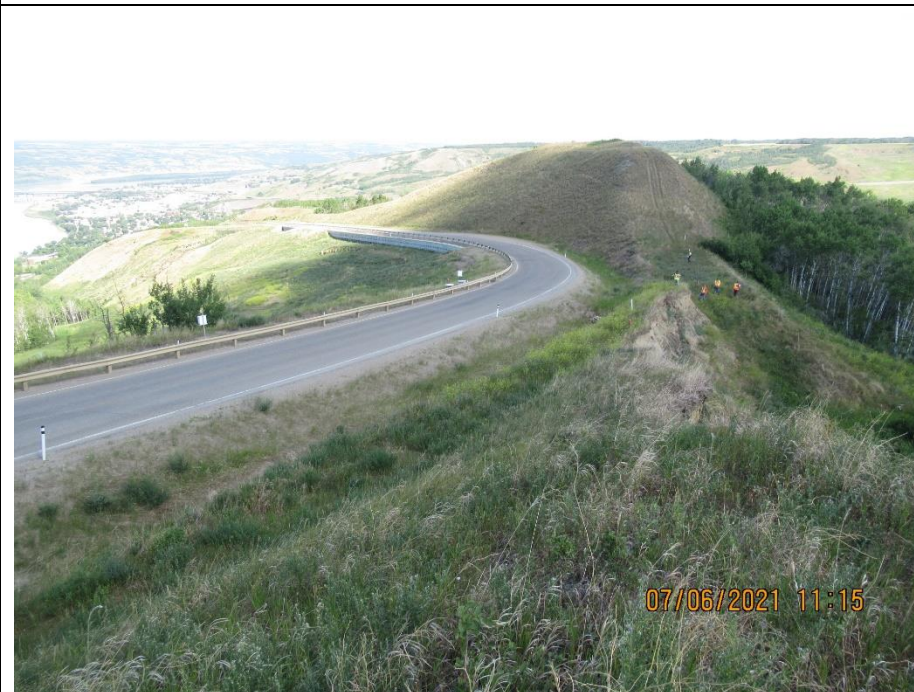
**Photo 6.**  
Looking north along the abandoned ATCO gas pipeline right-of-way on the east side (Heart River) of Hwy 744:04 at km 57.8.

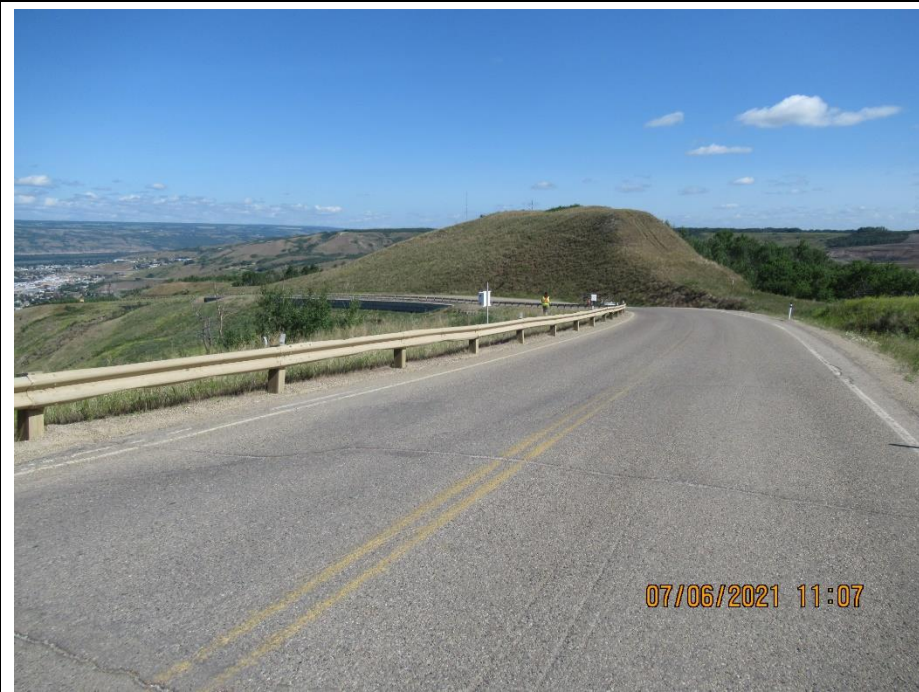
**Photo 7.**  
Looking north along  
Hwy 744:04 from  
km 57.8 at the  
crack and dip  
across the road.

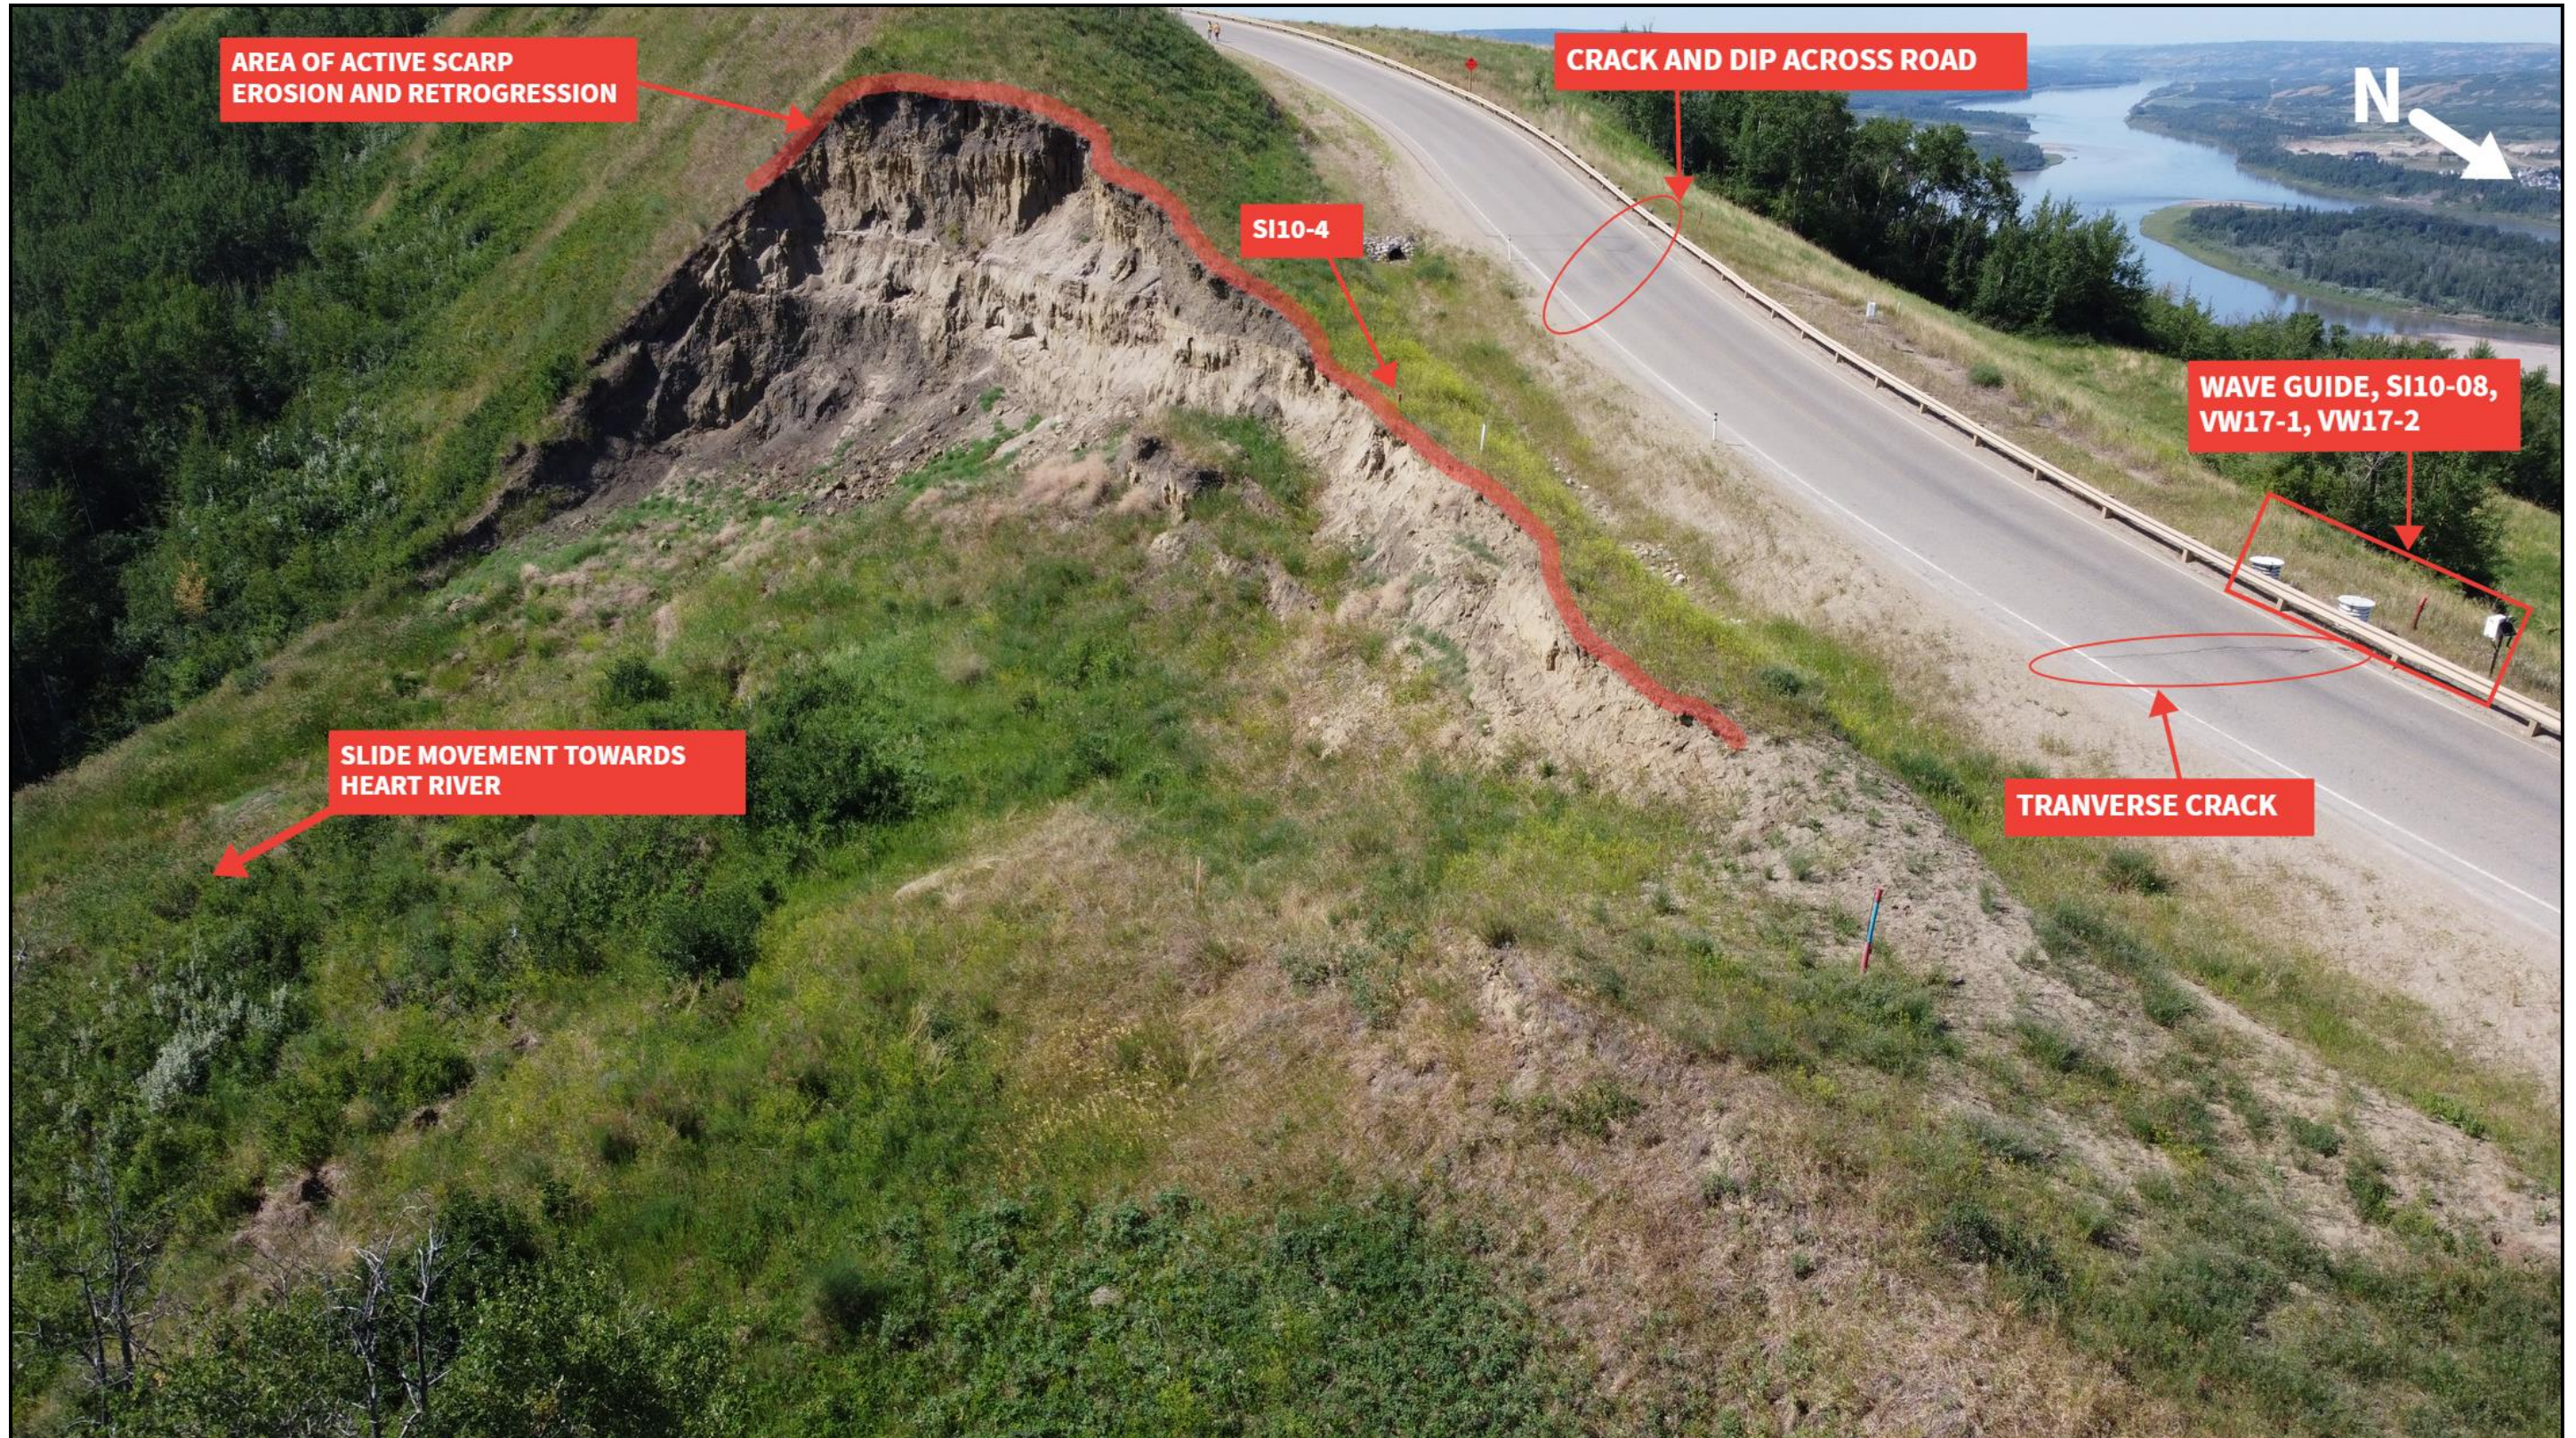
**PH031 - Drone Photo 1**  
Aerial view looking southwest from the north side of the main "Heart River" landslide east of Highway 744.
