**ALBERTA TRANSPORTATION
GEOHAZARD ASSESSMENT PROGRAM
PEACE REGION (PEACE RIVER DISTRICT)
2022 INSPECTION**

Site Number	Location	Name	Hwy	km
PH031	Judah Hill	Michelin Slides	744:04	57.664
Legal Description		UTM Co-ordinates		
NE¼ 20-083-21 W5M		11V E 483226	N 6229678

**PH031-1 MICHELIN SLIDES
2022 SITE INSPECTION PLAN**

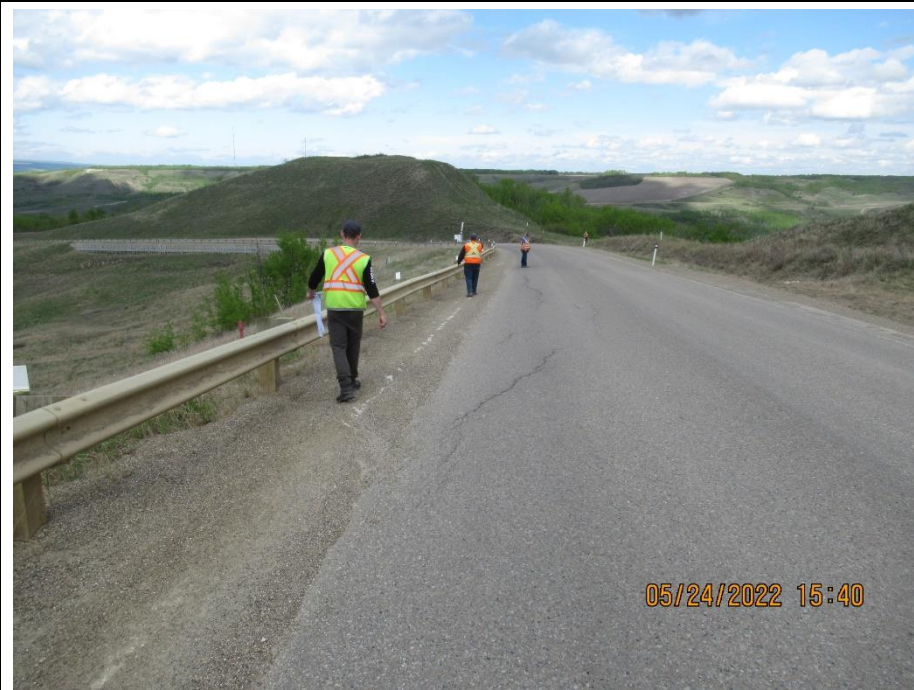
Photo 1.
Looking northeast along the centerline of Hwy 744:04 at km 57.75 at the north end of the 2014-2015 realignment. Cracks have become more apparent and there was increased localized settlement at the shoulder relative to the 2021 condition.

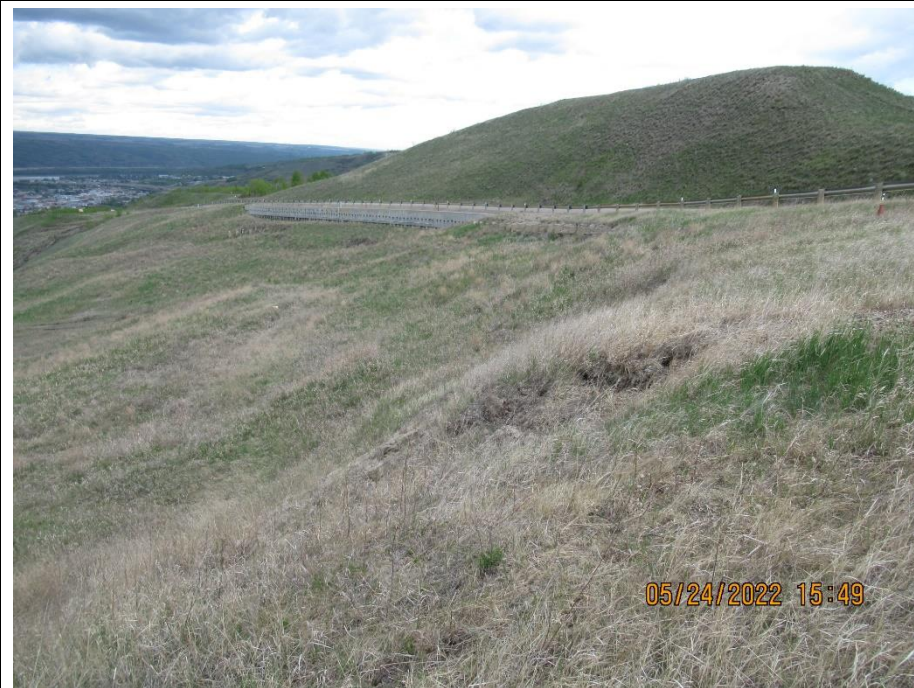
Maintenance:	Highway was closed from May 2013 to December 2013 due to the Sunshine Landslide failure at km 58.2 and no maintenance has been performed since then other than ancillary work performed in the surrounding areas as part of Contract CON0015153, such as the regrading of the NBL ditch, the profiling of the inlet to the 2005 NBL ditch subdrain pipe and the grading of the landslide scarp feature below the 1997 pile wall below the SBL.		
Observations:	Description	Worsened?	
<input checked="" type="checkbox"/> Pavement Distress	Cracks in the road at km 57.8 are more apparent with increased localized settlement since the 2021 pavement condition. Some increased settlement and more visible dip across the road in the road at km 57.83, just north of cracking near SI 10-07. (Photos 1 and 7).	<input checked="" type="checkbox"/>	
<input checked="" type="checkbox"/> Slope Movement	No significant slope changes were observed on the west side of the road and downslope below the old pile wall (Photos 2 and 5). At the old pile	<input checked="" type="checkbox"/>

Photo 2.
Looking north along the west sideslope of Hwy 744:04 at km 57.94 below the old pile wall.

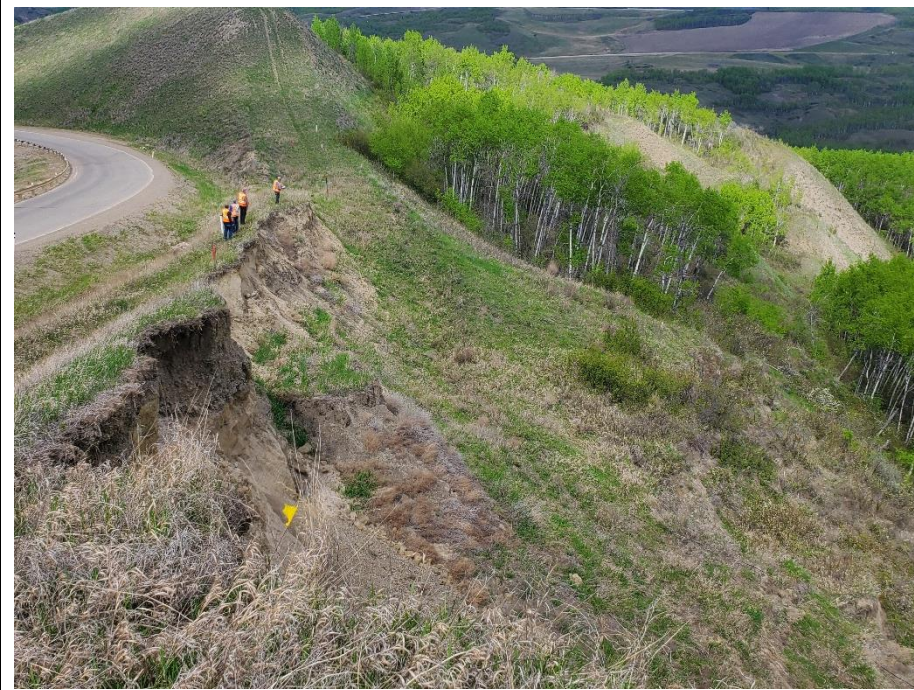
Photo 3.
Looking northeast along the backscarp of the landslide at the top of the Heart River valley on Hwy 744:04 at km 57.8. No change to the location of the main scarp. More erosion and downslope movement within the upper scarp face.

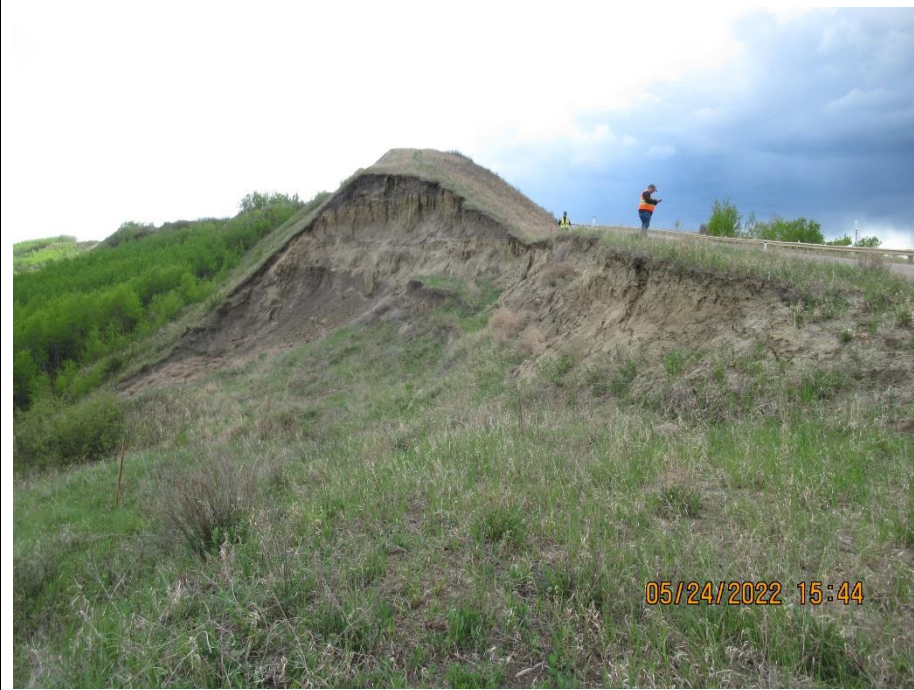
Photo 4.
Looking south along the backscarp of the landslide at the top of the Heart River valley on Hwy 744:04 at km 57.85. Larger buildup of soil at base of vertical scarp, indicative of ongoing erosion but no major retrogression since 2021.

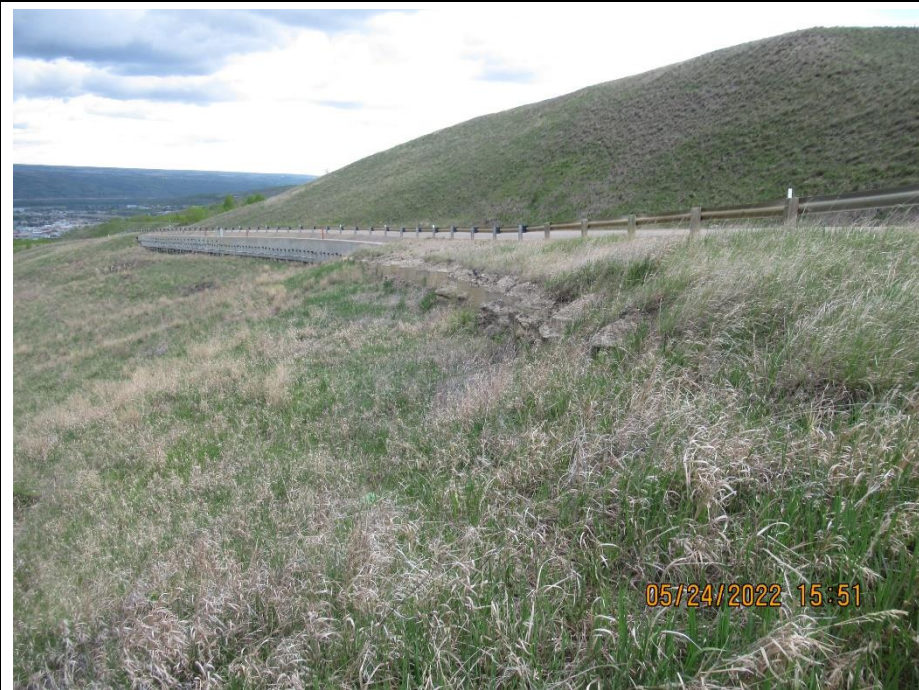
<p>wall maximum soil drop was as high as 1.8 m and additional piles were noted to be protruding at the ground surface (Photo 5). No major change to slump located on the lower valley slope on the west side, offset approximately 70 m from the road.</p> <p>Active erosion within the backscarp and ongoing minor movement within disturbed slide mass at the landslide through the ATCO R/W towards the Heart River. No major retrogression noted within the main scarp. Increased buildup of soil beneath the vertical, southernmost segment of the scarp (Photos 3 and 4).</p>	
<input checked="" type="checkbox"/> Erosion	No significant change noted in previous erosion areas: east ditch between km 57.8 and 57.85. Erosion gully from drainage off the road near km 57.84 was worse and is up to 1.0 m wide and 0.5 m deep (Photo 8).	<input checked="" type="checkbox"/>
<input type="checkbox"/> Seepage		<input type="checkbox"/>

Photo 5.
Looking north along the west side of Hwy 744:04 at protruding piles near km 57.9. Max drop of 1.8 m below top of pile.

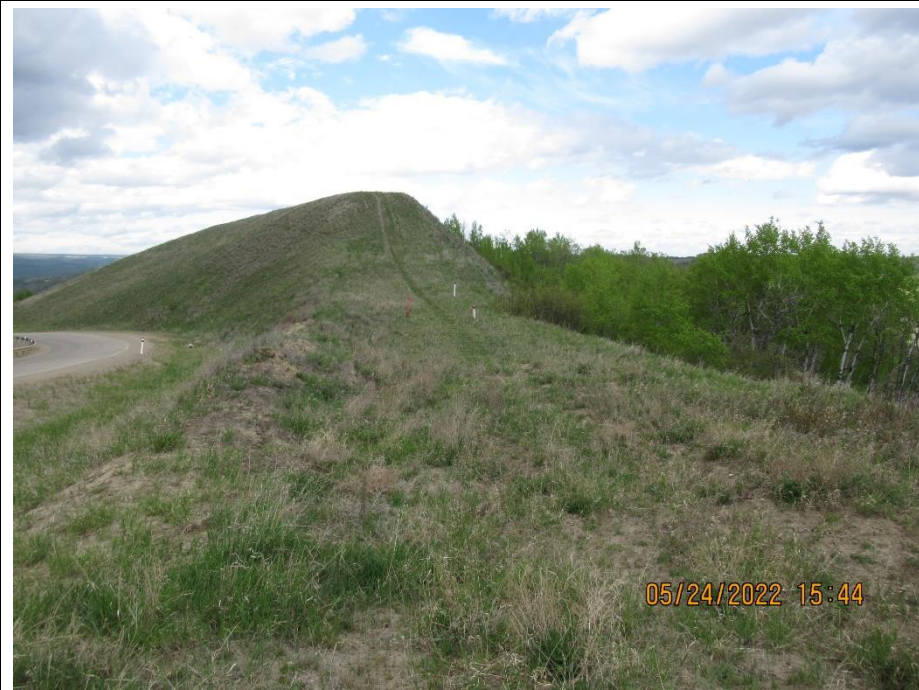
Photo 6.
Looking north along the abandoned ATCO gas pipeline right-of-way on the east side (Heart River) of Hwy 744:04 at km 57.8.

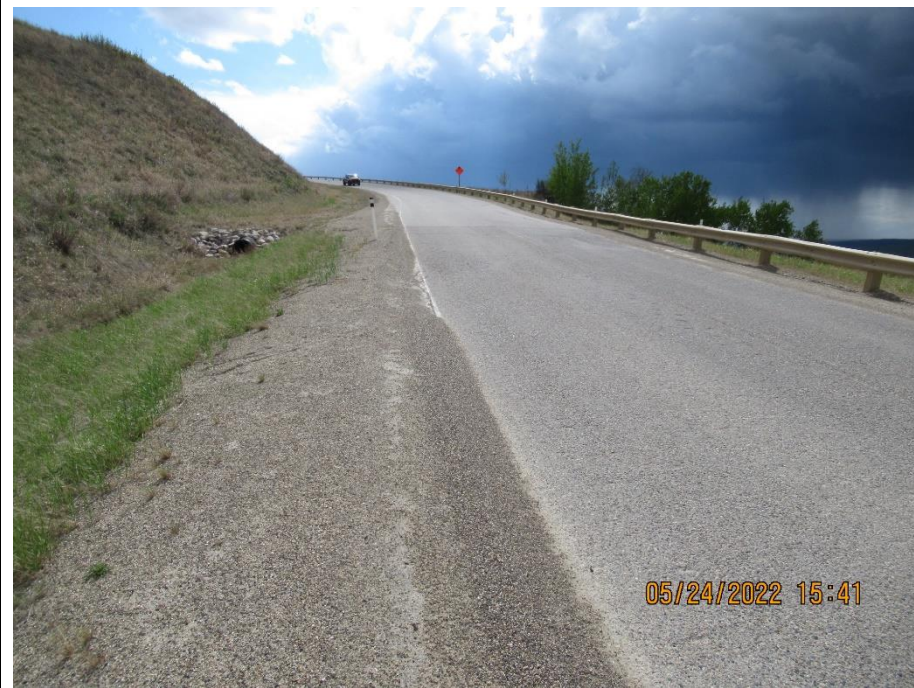
Photo 7.
Looking southwest along Hwy 744:04 from km 57.85 at the crack and dip across the road.

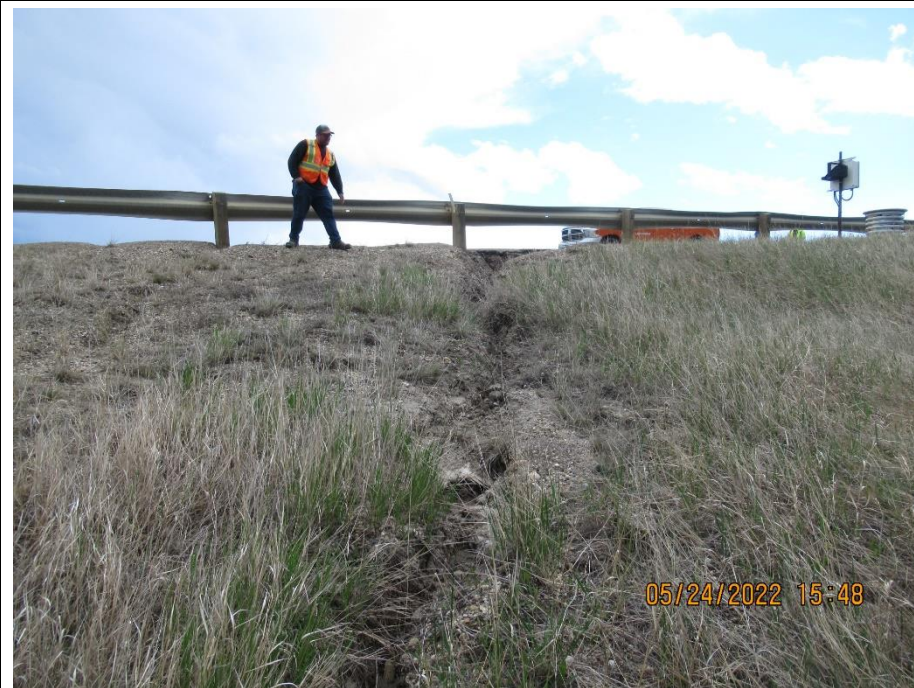
Photo 8.
Drainage erosion from the west side of the road near KM 58.86 that has become worse relative to the 2021 condition.
