**ALBERTA TRANSPORTATION AND
ECONOMIC CORRIDORS
GEOHAZARD ASSESSMENT PROGRAM
PEACE REGION (PEACE RIVER DISTRICT)
2025 INSPECTION**

Site Number	Location	Name	Hwy	km
PH031	Judah Hill	Michelin Slides	744:04	57.664
Legal Description		UTM Co-ordinates (NAD 83)		
NE¼ 20-083-21 W5M		11V E 483226	N 6229678

Date	PF	CF	Total
Previous Inspection:	May 28, 2024	13	7	91 (Slide Risk Rating)
Current Inspection:	May 15, 2025	13	7	91 (Slide Risk Rating)
Road WAADT:	630		Year:	2024
Inspected By:	Tyler Clay, Don Proudfoot (Thurber). Rocky Wang (TEC)			
Report Attachments:	<input checked="" type="checkbox"/> Photographs <input checked="" type="checkbox"/> Plans <input type="checkbox"/> Maintenance

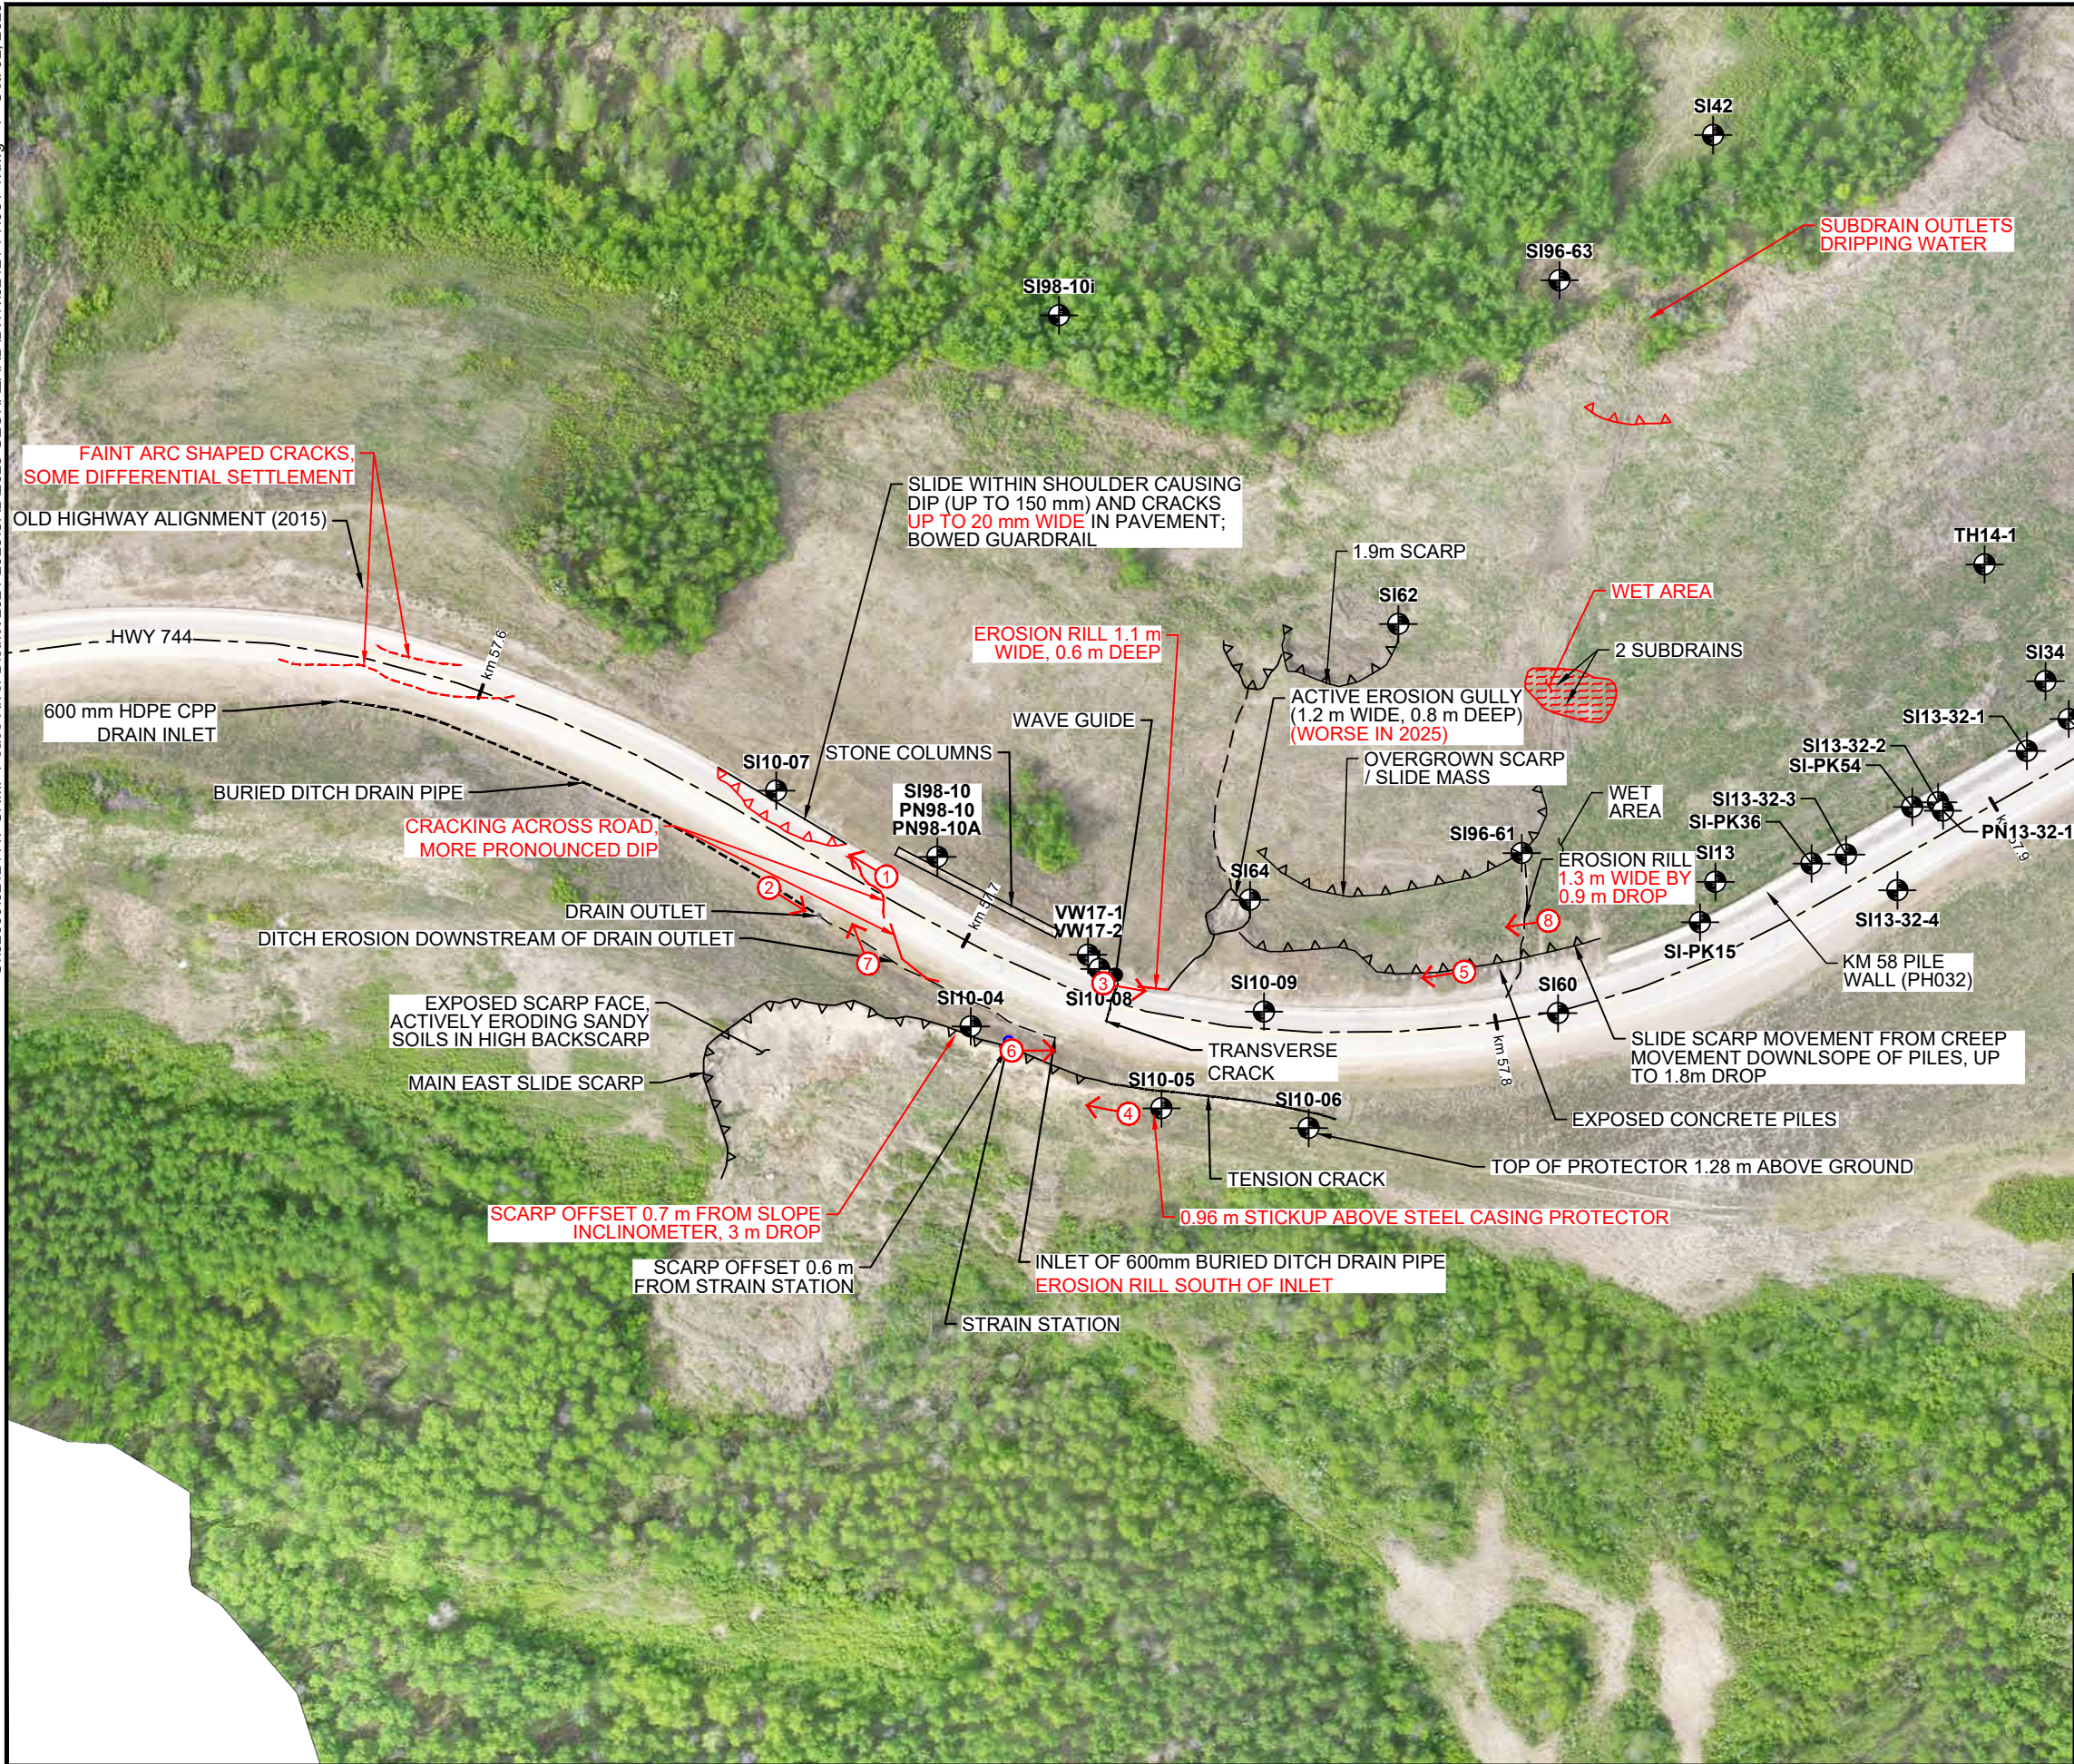
PH031-1 MICHELIN SLIDES
2025 SITE INSPECTION PLAN

Continued landslide creep downslope of the km 57.8 repair toward the Peace River is expected to continue, however the old pile wall is currently preventing damage to the highway. However, a more pronounced dip in the pavement and cracking was observed between km 57.65 and km 57.7, where there are no piles present. Erosion damage is occurring in localized areas; the active erosion gully west of the highway at km 57.75 appeared to have worsened during the current inspection.

Slope movement in the area west of the highway between the Michelin and Makeout landslides is ongoing at similar or slightly reduced rates that have been measured and observed in the past. Water being shed off the road on the inside of the bend may be contributing to the problem. Cracking and slope movement downslope of the pile wall is ongoing at similar or slightly reduced rates. The existing pile wall is still providing some support to the highway. The instruments on the west side of the highway show ongoing movement at rates previously observed or slightly reduced.

Intermittent movement and active erosion within the backscarp of the slide that is moving toward the Heart River indicates that the road is at risk from both eastward and westward movement. No accelerating movement trends were measured at S10-4 indicating a slide plane has not retrogressed further towards the highway beyond the visible scarp. As first mentioned in 2012, there is no room to move the road at this location and because of the severity and rapidity of movement, design for a pair of tied-together retaining walls should be conducted to limit the extent of work required.

- Long-term repair using ~ 230 m of tied back retaining walls. Approximately 80 m would be required on the Heart River side and 150 m on the Peace River side, extending south from the km 58 wall. (\$15M)

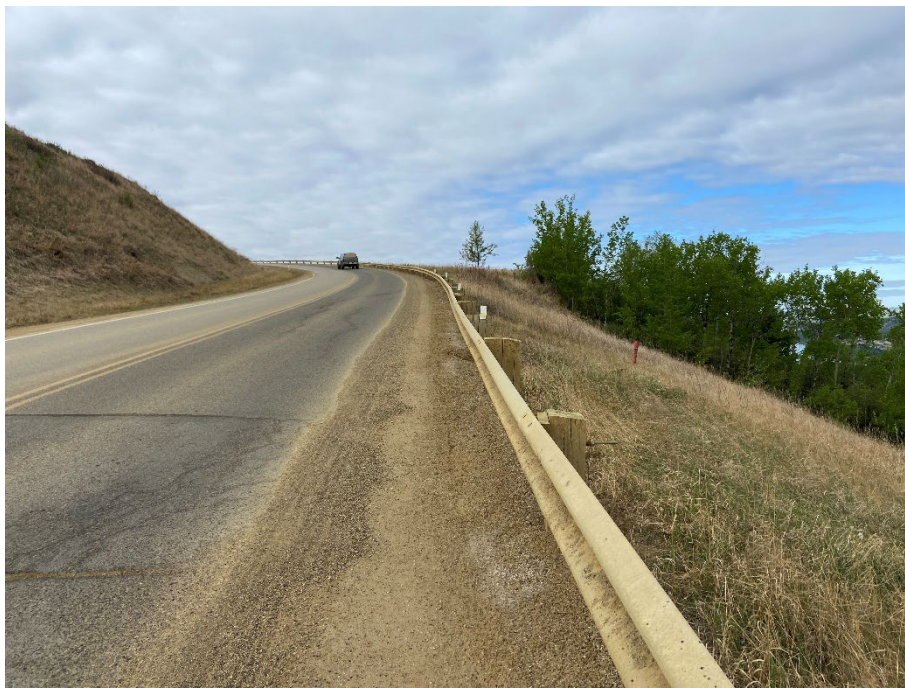
Photo 1.

Observations:	Description:	Worsened?	
		Yes	No
<input checked="" type="checkbox"/> Pavement	Cracks in the road at km 57.65 have opened to up to 20 mm wide with a 150 mm dip at the highway shoulder (Photo 1). The dip across the road at km 57.83, just north of cracking near SI 10-07 became more pronounced since the 2024 inspection. (Photo 7). Faint arc shaped cracks were observed at km 57.58 with some differential settlement in the pavement.	<input checked="" type="checkbox"/>	<input type="checkbox"/>
<input checked="" type="checkbox"/> Slope Movement	<p>The west upper sideslope had no major visible changes (Photo 8). At the old pile wall the maximum soil drop was unchanged from the 2024 condition and measured up to 1.8 m below top of pile (Photo 5).</p> <p>Some more movement was visible (relative to the 2024 condition) at the slide located on the lower valley slope on the west side near the outlets of the two 150 mm diameter subdrain pipes.</p> <p>Active erosion within the backscarp and ongoing movement within disturbed slide mass at the landslide through the ATCO R/W towards the Heart River. No major retrogression or expansion was apparent within the main scarp. Increased buildup of soil beneath the vertical, southernmost segment of the scarp. Similar visible changes as per the 2024 inspection. (Photo 4)</p>	<input checked="" type="checkbox"/>	<input type="checkbox"/>

Looking southwest along the centerline of Hwy 744:04 at km 57.68 near the north end of the 2015-16 realignment. Cracks are up to 20 mm wide. Localized settlement (estimated up to 150 mm) is more apparent at the shoulder relative to the 2024 condition.

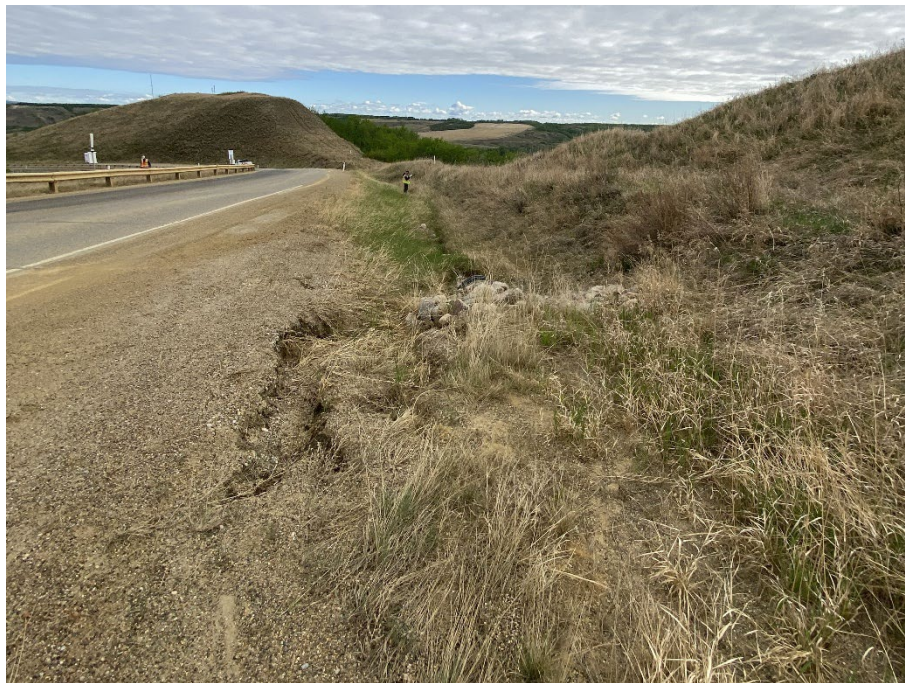
Photo 2.

<input checked="" type="checkbox"/> Erosion	<p>Erosion damage appeared somewhat worse in the east ditch between km 57.675 and 57.75 (Photo 2). There is also erosion visible above the outlet of the CPP drain pipe at this location.</p> <p>Erosion rill from drainage off the road near km 57.73 is up to 1.1 m wide and 0.6 m deep (Photo 3).</p> <p>Erosion rill has formed downslope of the old pile wall due to concentrated runoff from the road near km 57.8 (Photo 5).</p>	<input checked="" type="checkbox"/>	<input type="checkbox"/>
<input type="checkbox"/> Seepage		<input type="checkbox"/>	<input type="checkbox"/>
<input type="checkbox"/> Bridge/Culvert		<input type="checkbox"/>	<input type="checkbox"/>
<input type="checkbox"/> Other		<input type="checkbox"/>	<input type="checkbox"/>
Instrumentation: Instruments were read on June 9, 2025. <ul style="list-style-type: none"> SI98-10i (installed at the toe of Michelin Slide repair) - Movement rates are between 0 to 3 mm/yr within six distinct shear planes. Movement rates are largely similar to readings from the past several years. SI94-43i (installed approximately 450 m downslope of the road, approximately 100 m below road elevation) - Not read since the Spring 2021 readings; the Spring 2021 readings showed no discernible movement. SI10-4 (installed on the east / Heart River side of highway) -showed rates of movement between 1-2 mm/yr since Fall 2024. The movement is in the direction of the active landslide in the Heart

Looking northeast along the east ditch near km 57.67 where there is ongoing erosion above the CPP drain pipe outlet, and in the ditch beyond.

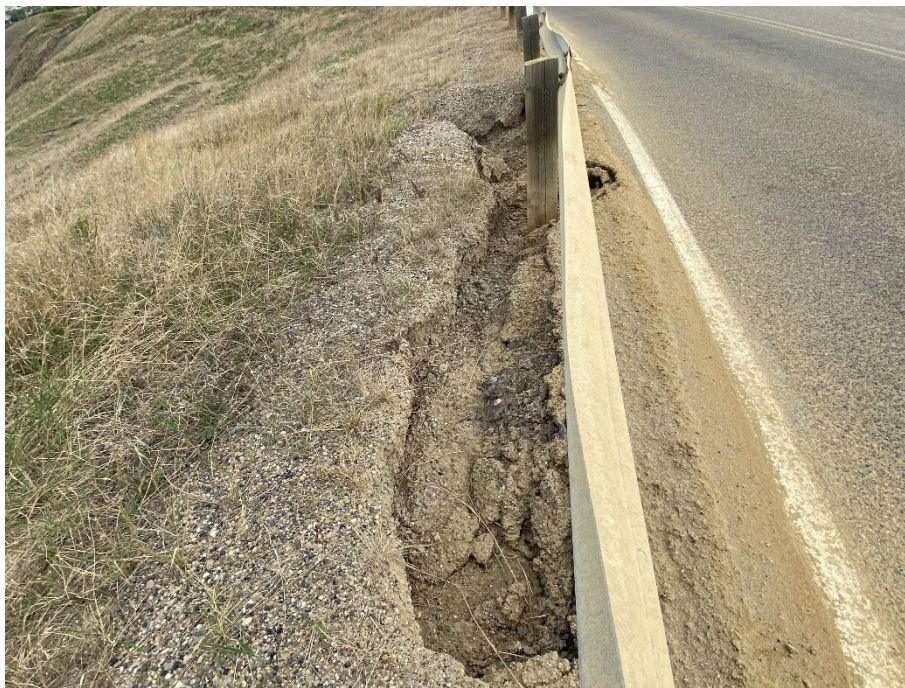
Photo 3.

Looking north at erosion rill on the west side of the highway near km 57.73. The rill is up to 1.1 m wide and 0.6 m deep.

- Granular fill should be used to fill the upper erosion gully near km 57.75 to reduce rates of further pavement and guardrail post undermining. Sand buildup from winter road sanding should also be removed from under the guardrail as this is what is concentrating the runoff that is creating the erosion gully
- Class 1M riprap should be added to the east ditch to reduce rates of erosion between km 57.675 and 57.75. Alternatively, the ditch should be cleaned out, regraded, and have ECB and synthetic check dams installed. Existing rock can be salvaged and placed back around the outlet and inlet areas of the culverts.

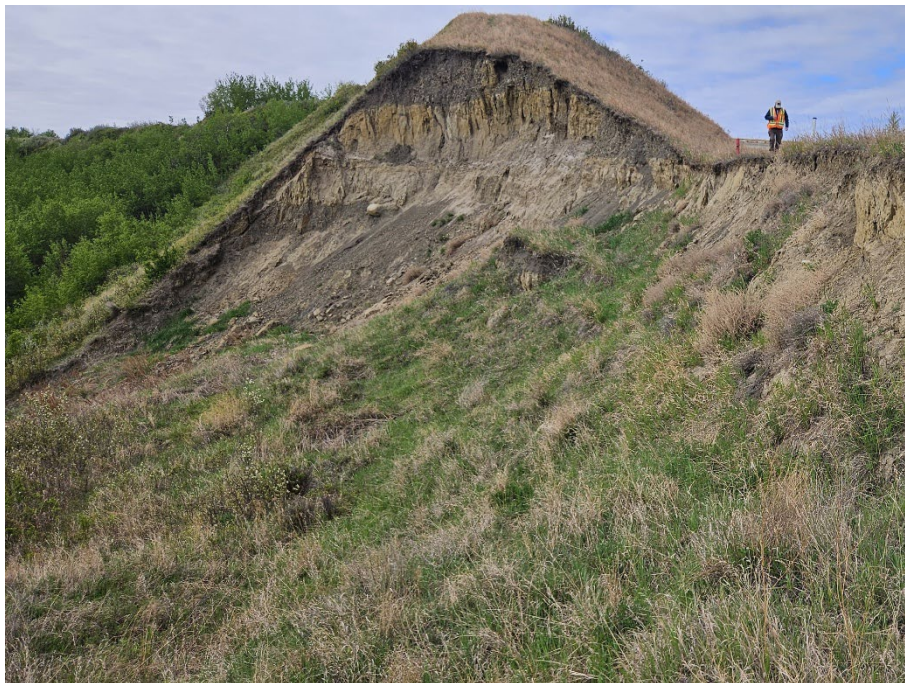
Photo 4.

Looking south along the landslide backscarp at the top of the Heart River valley on Hwy 744:04 at km 57.85.

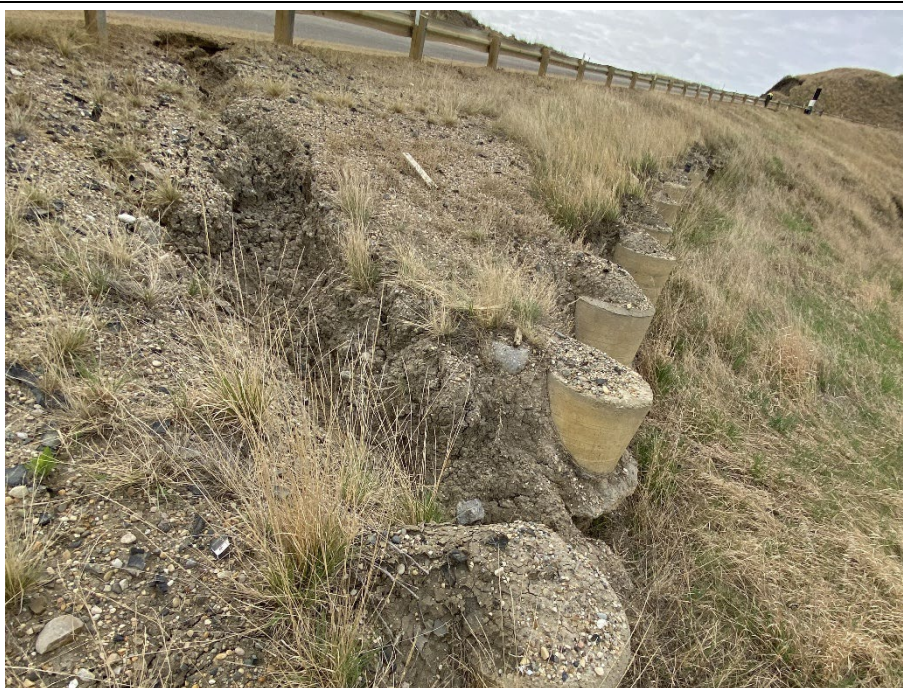
Photo 5.

Looking south along the west side of Hwy 744:04 at protruding piles near km 57.9. Max drop of 1.8 m below top of pile (unchanged since 2024). An erosion rill has formed from runoff between the piles.

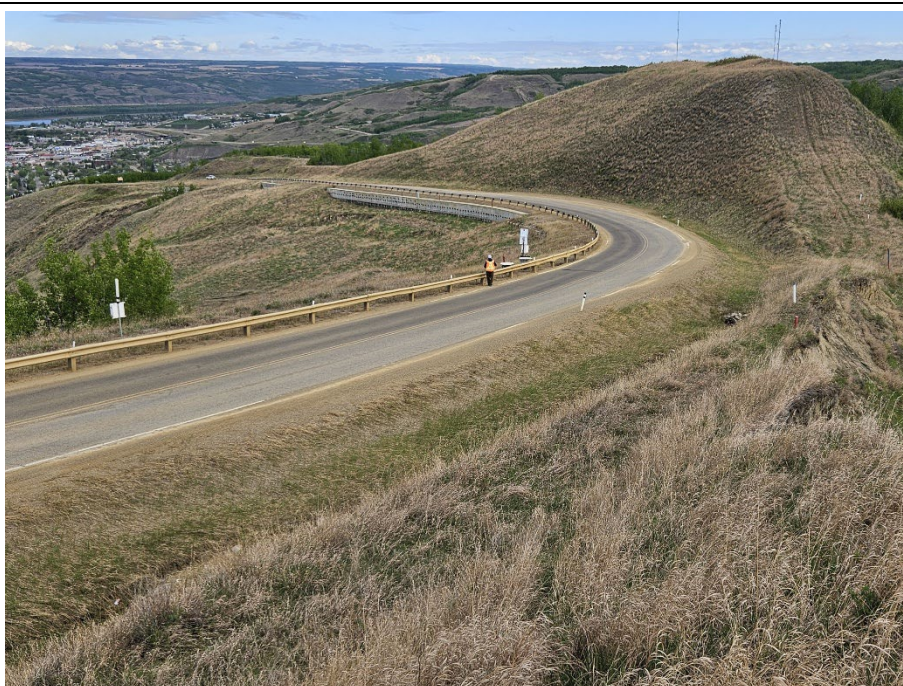
Photo 6.

Looking north along the east side of Hwy 744:04 at km 57.72 and upslope of the landslide movement towards the Heart River. No new cracks were apparent in the pavement or ditch area upslope from the backscarp.

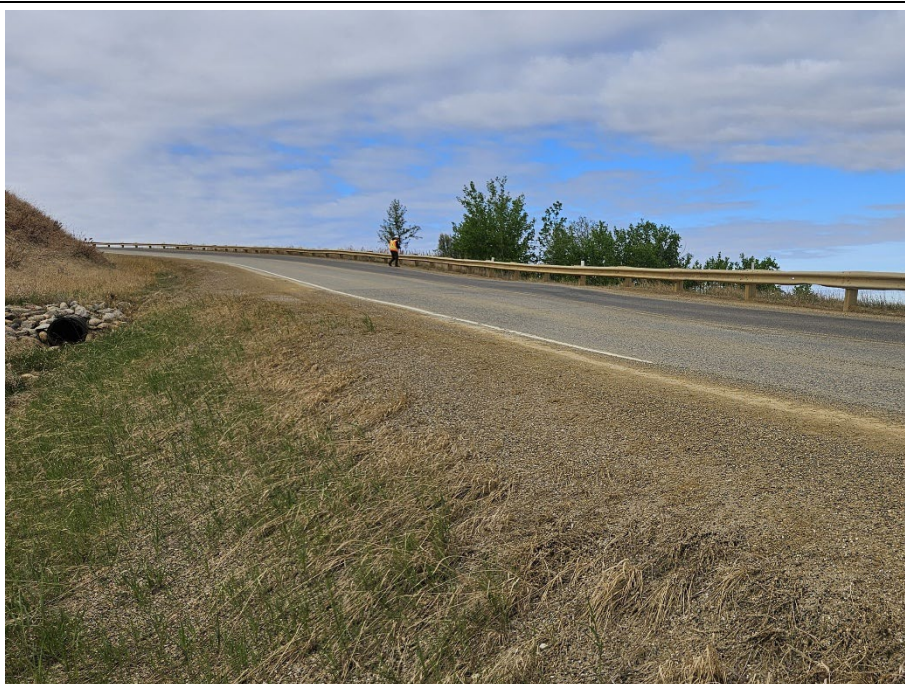
Photo 7.

Looking southwest along Hwy 744:04 from km 57.69 at the crack and dip across the road. Crack has opened up to 20 mm wide and the pavement dip has become more pronounced since the 2024 inspection.

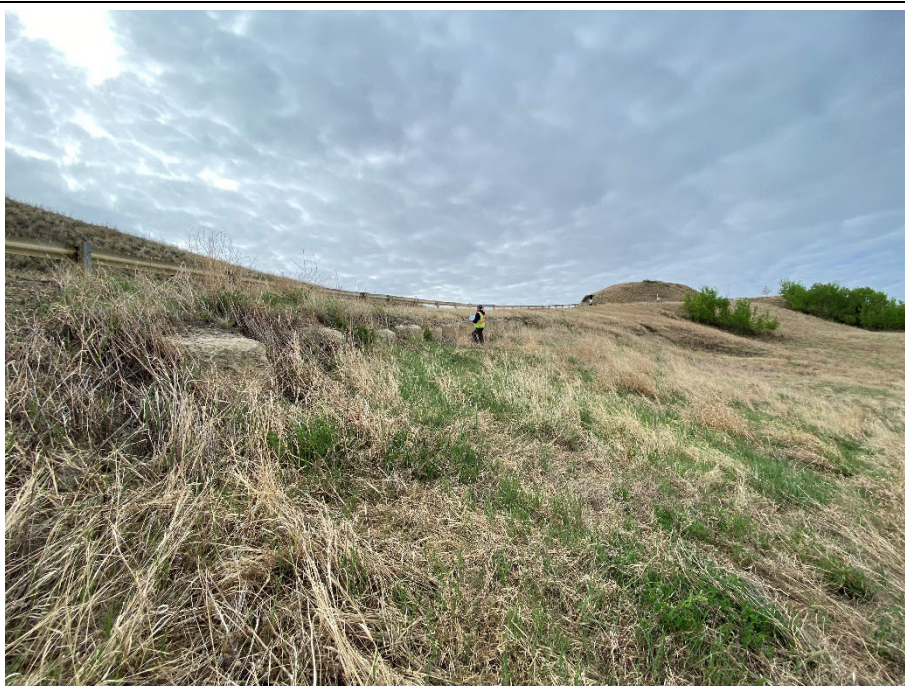
Photo 8.

Looking south near km 57.8 along the west side slope below the highway with active gully erosion and old, vegetated slide scarps. No major visible difference in the slide terrain within the upper slope relative to the 2024 condition.
