ALBERTA TRANSPORTATION AND
ECONOMIC CORRIDORS GRMP
PEACE REGION – (PEACE RIVER DISTRICT)
INSTRUMENTATION MONITORING - SPRING 2025

Site Number	Location	Name	Hwy	km
PH031	HWY 744:04 C1 57.7	Michelin Slide- Judah Hill	744:04	Km 57.7
Legal Description:		UTM Co-ordinates		
9-20-83-21 W5		11U E 483125.92	N	6229725.01

Current Monitoring:	9-Jun-2025	Previous Monitoring	21-Sep-2024
Instruments Read By:	Mr. Niraj Regmi, G.I.T and Mr. Godfred Etiendem, of Thurber

SITE PH031: HWY 744:04, JUDAH HILL (MICHELIN SLIDE)

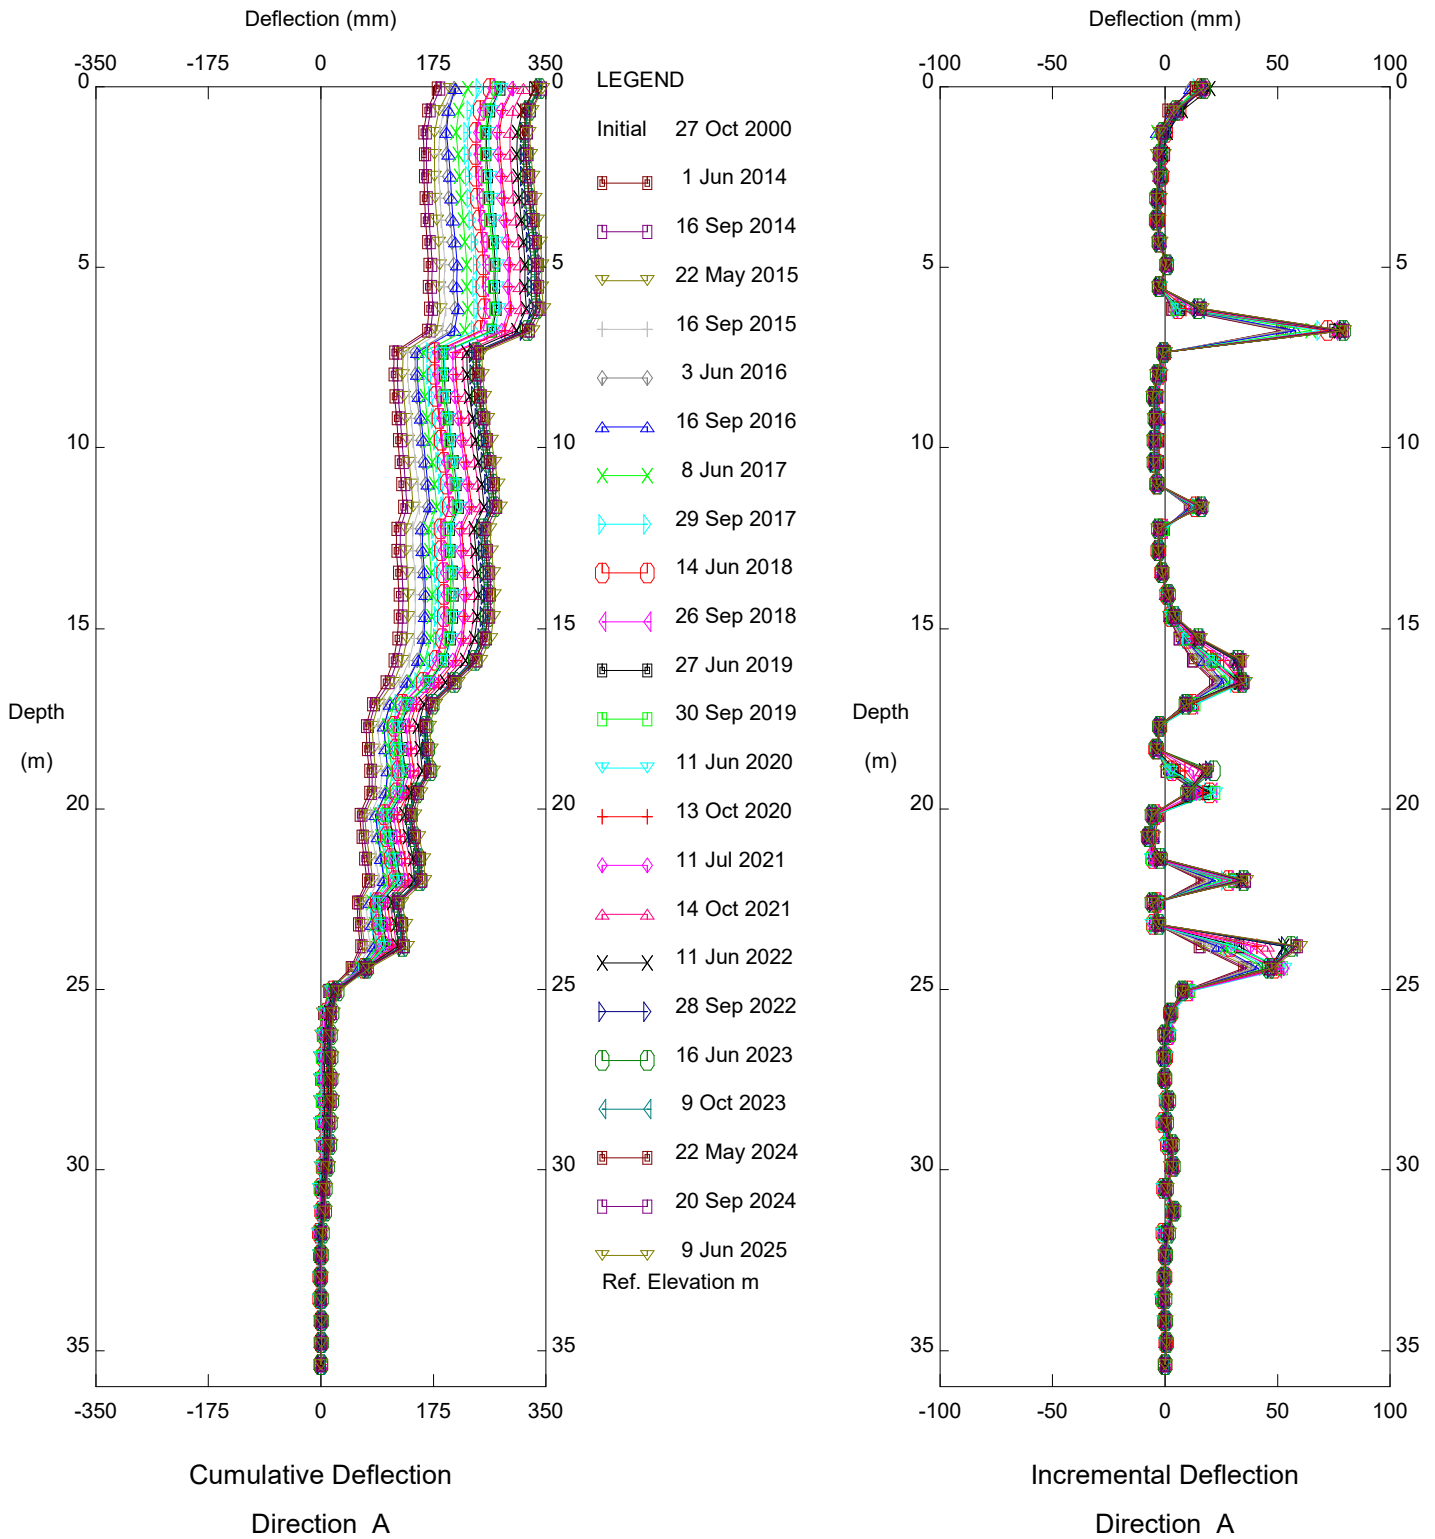
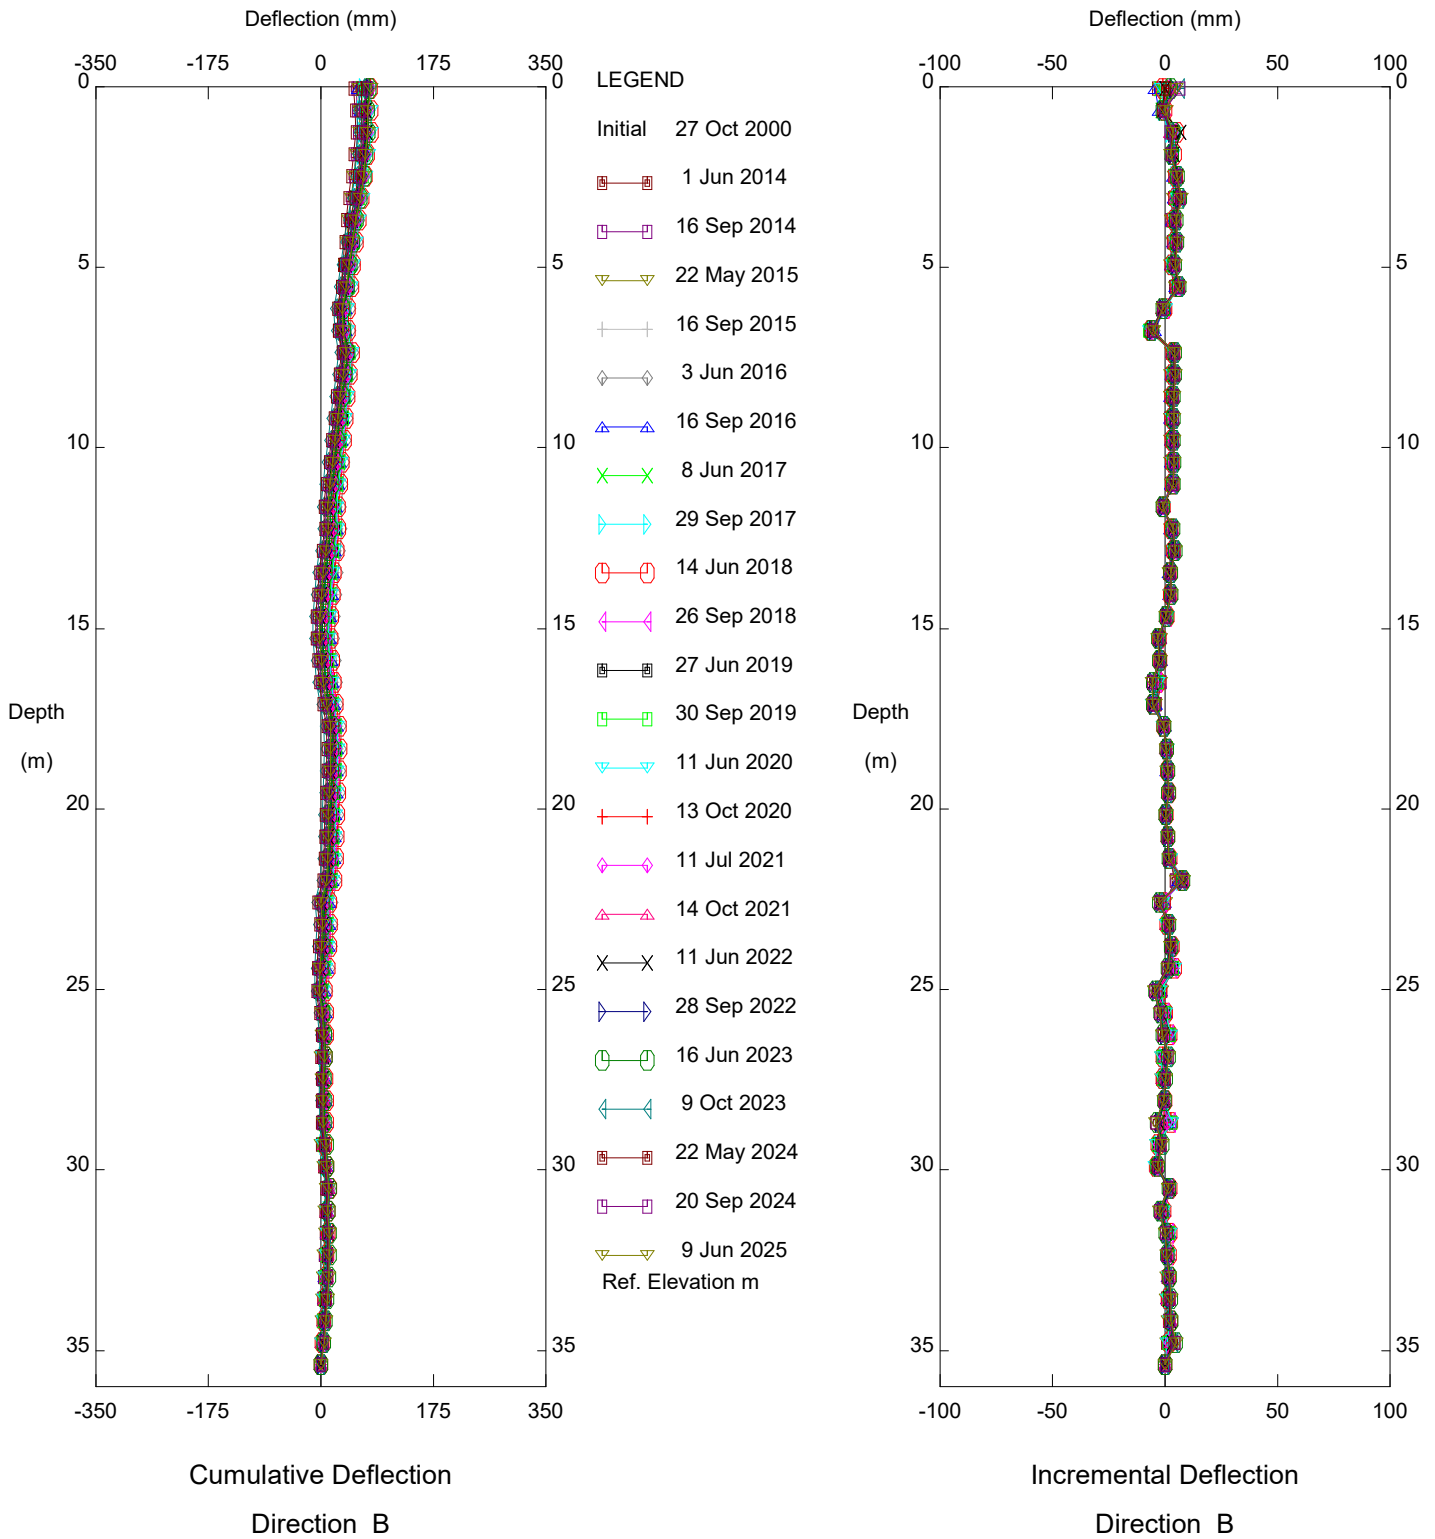
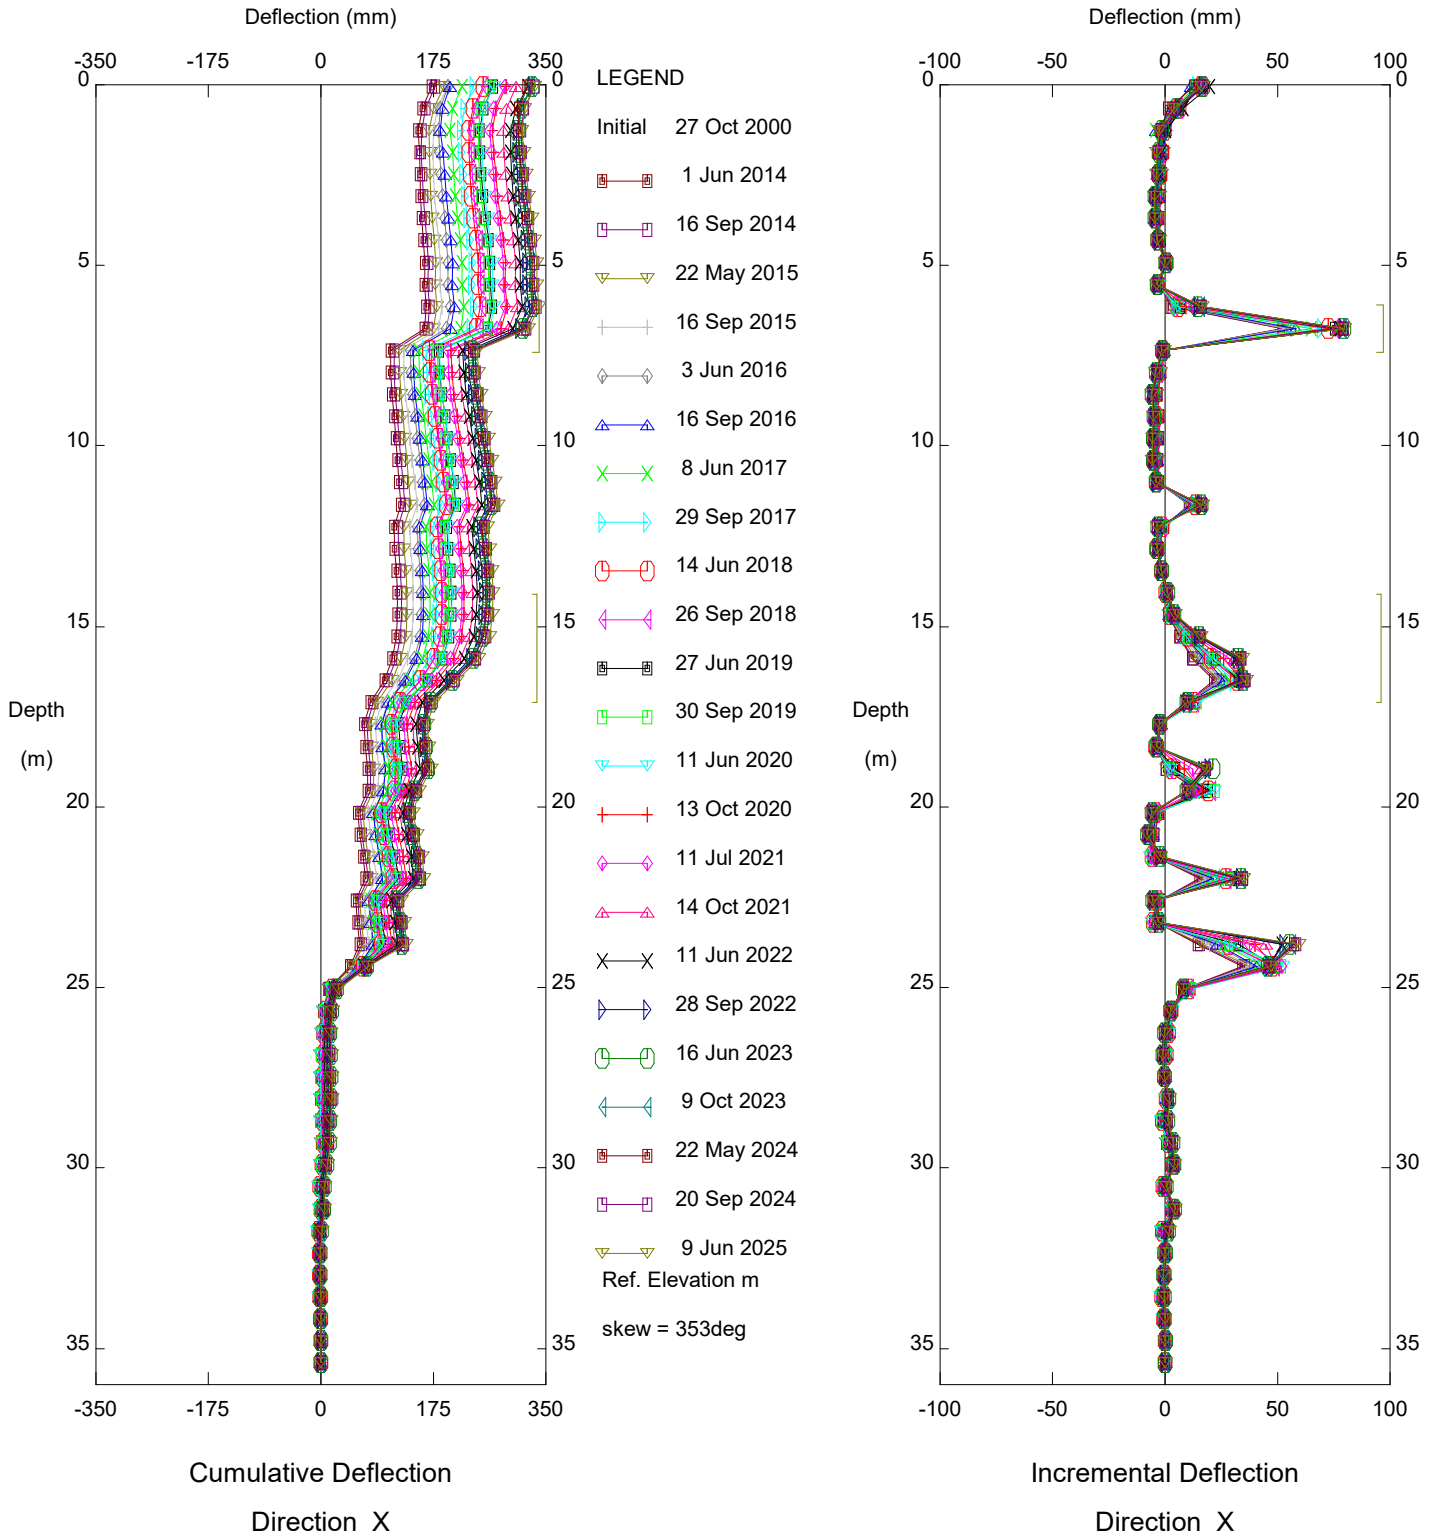
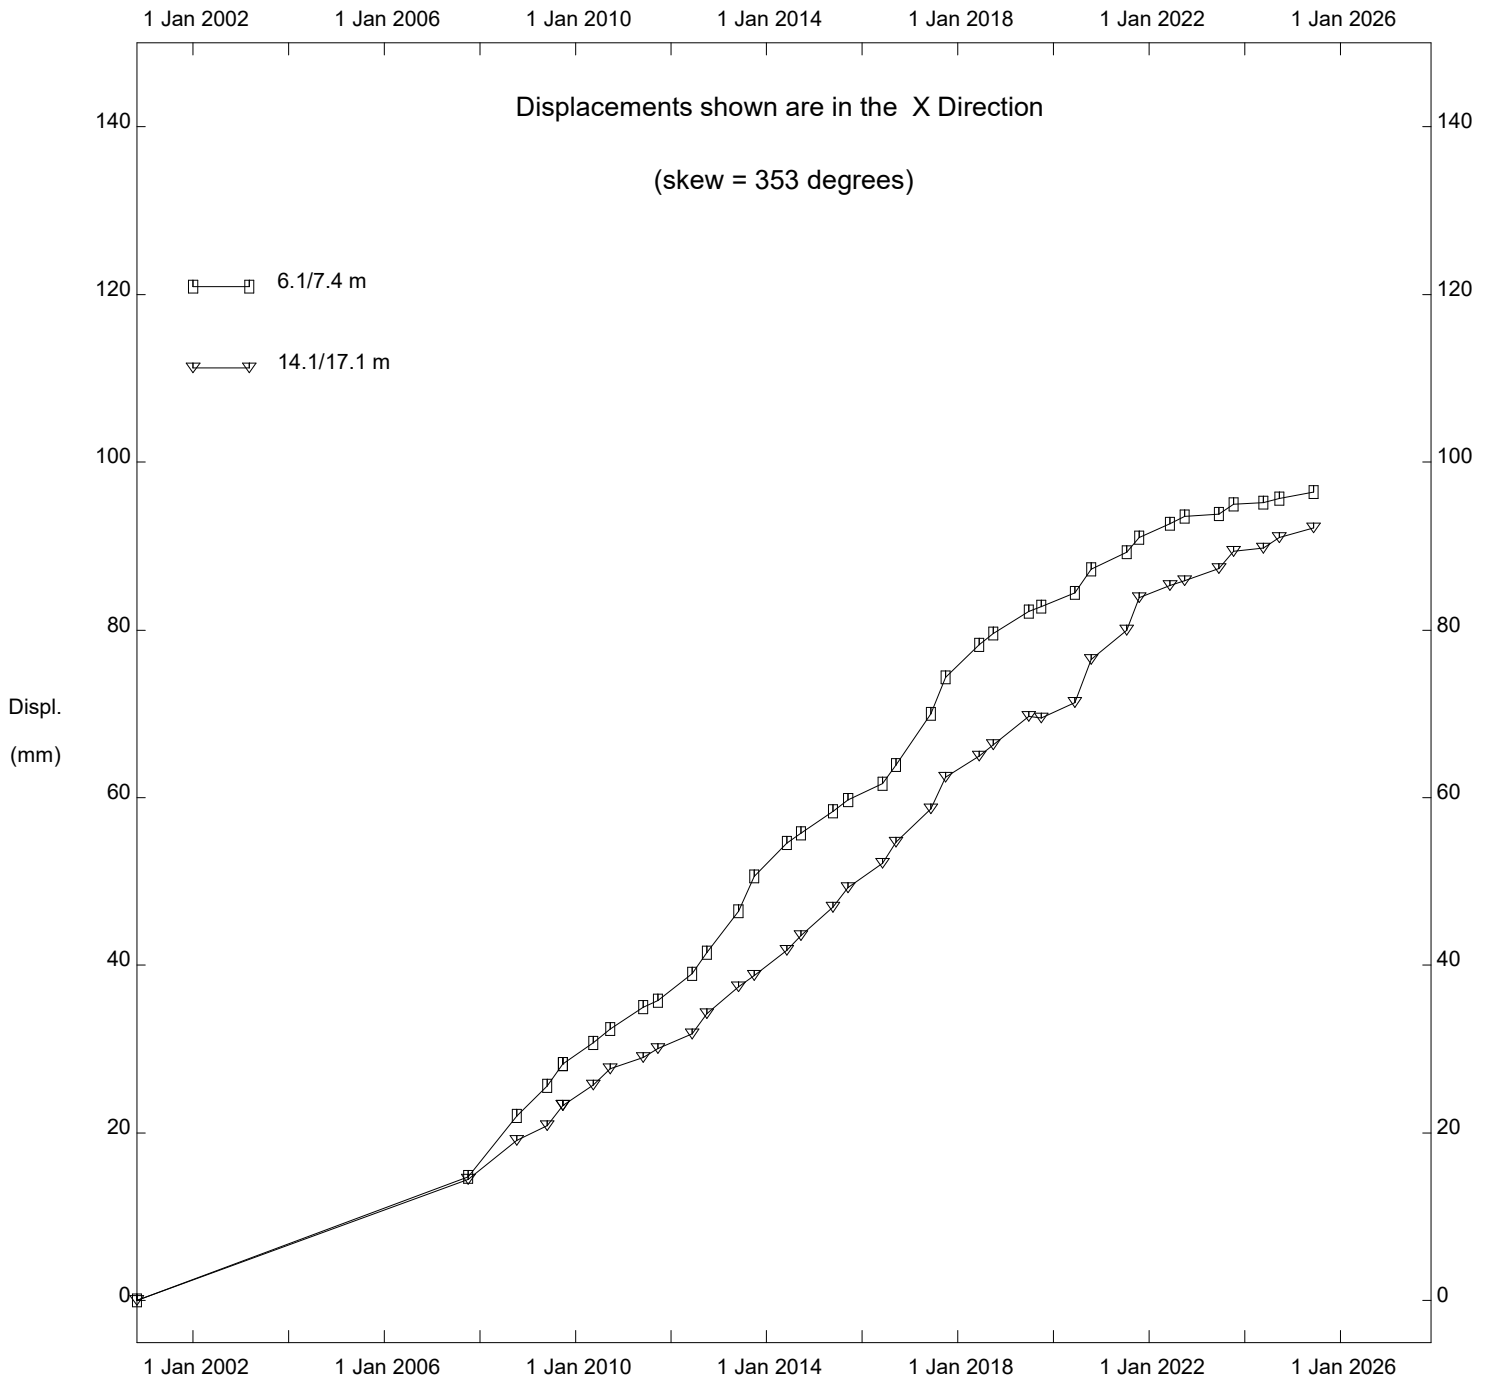
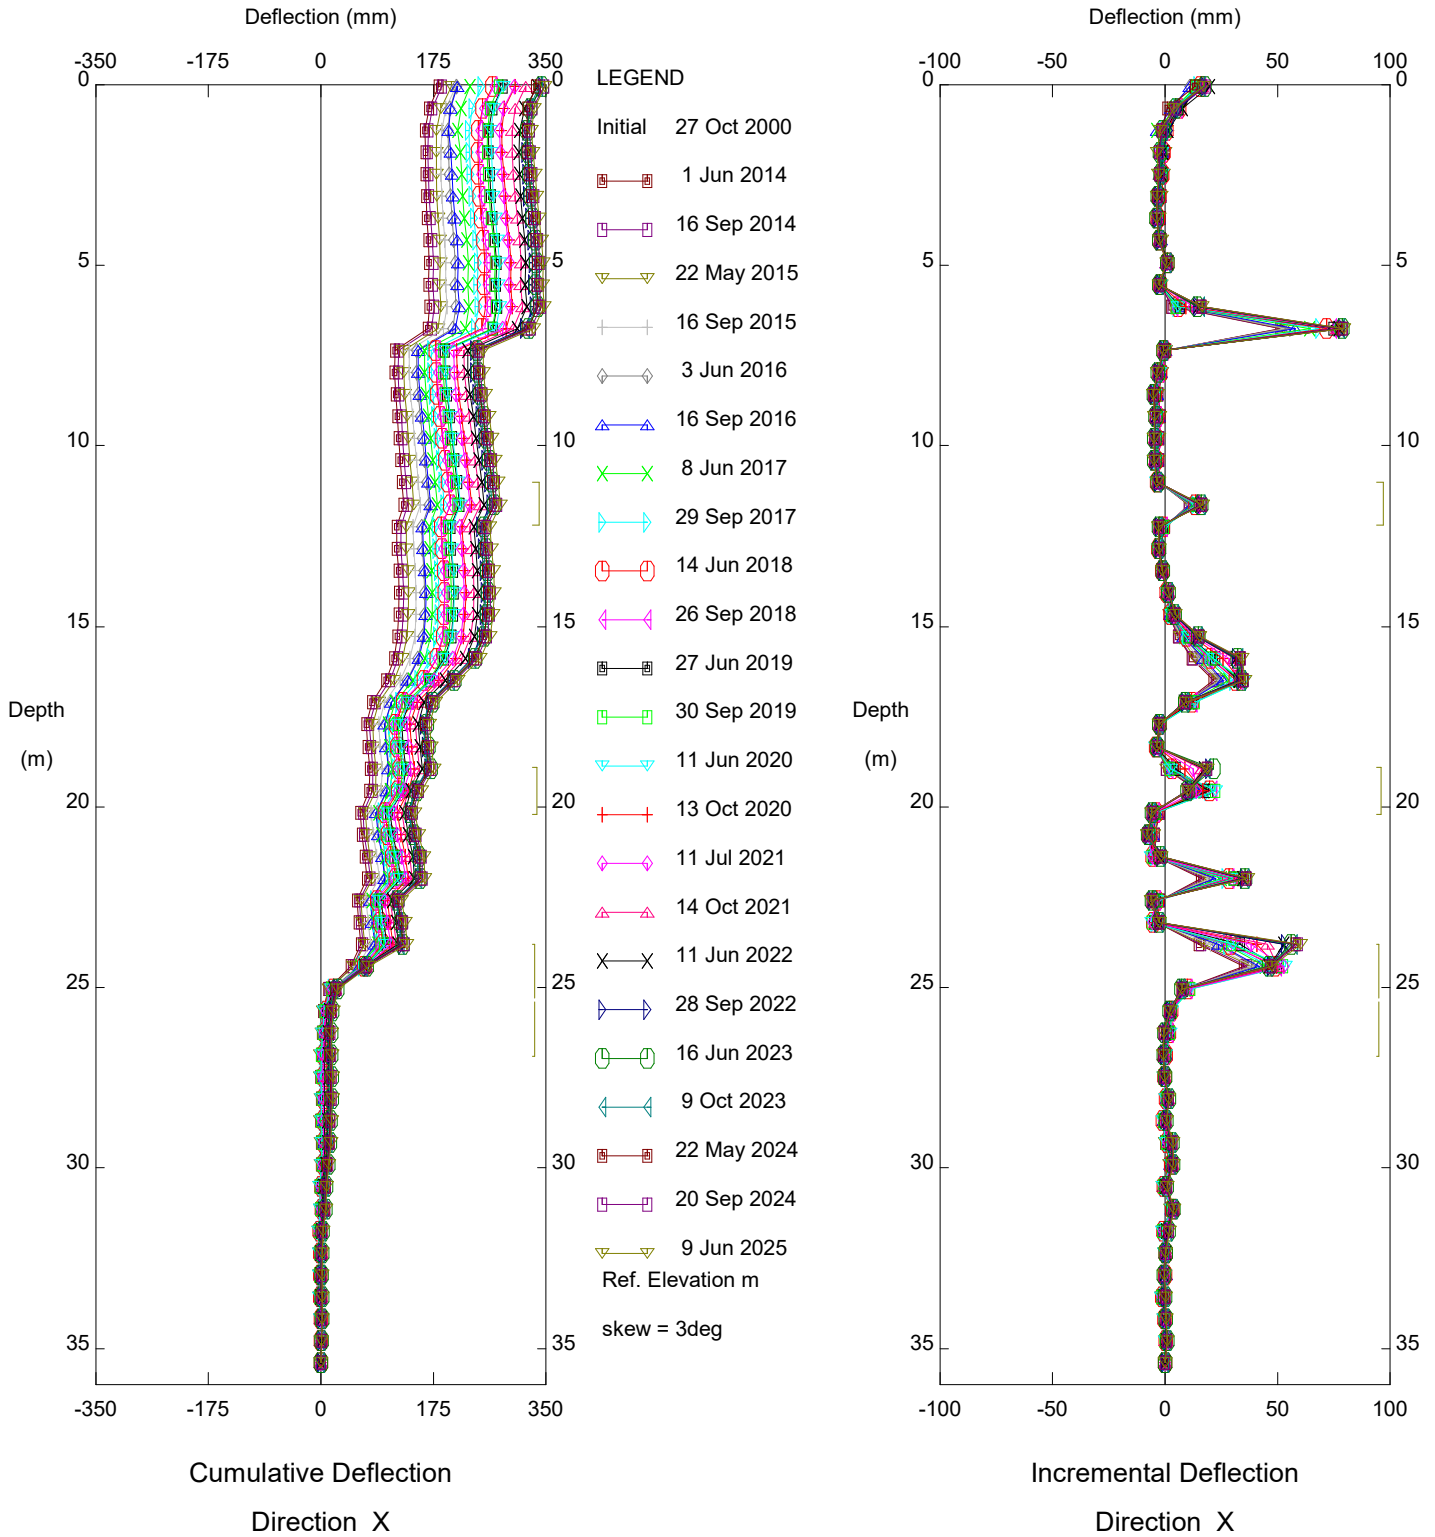
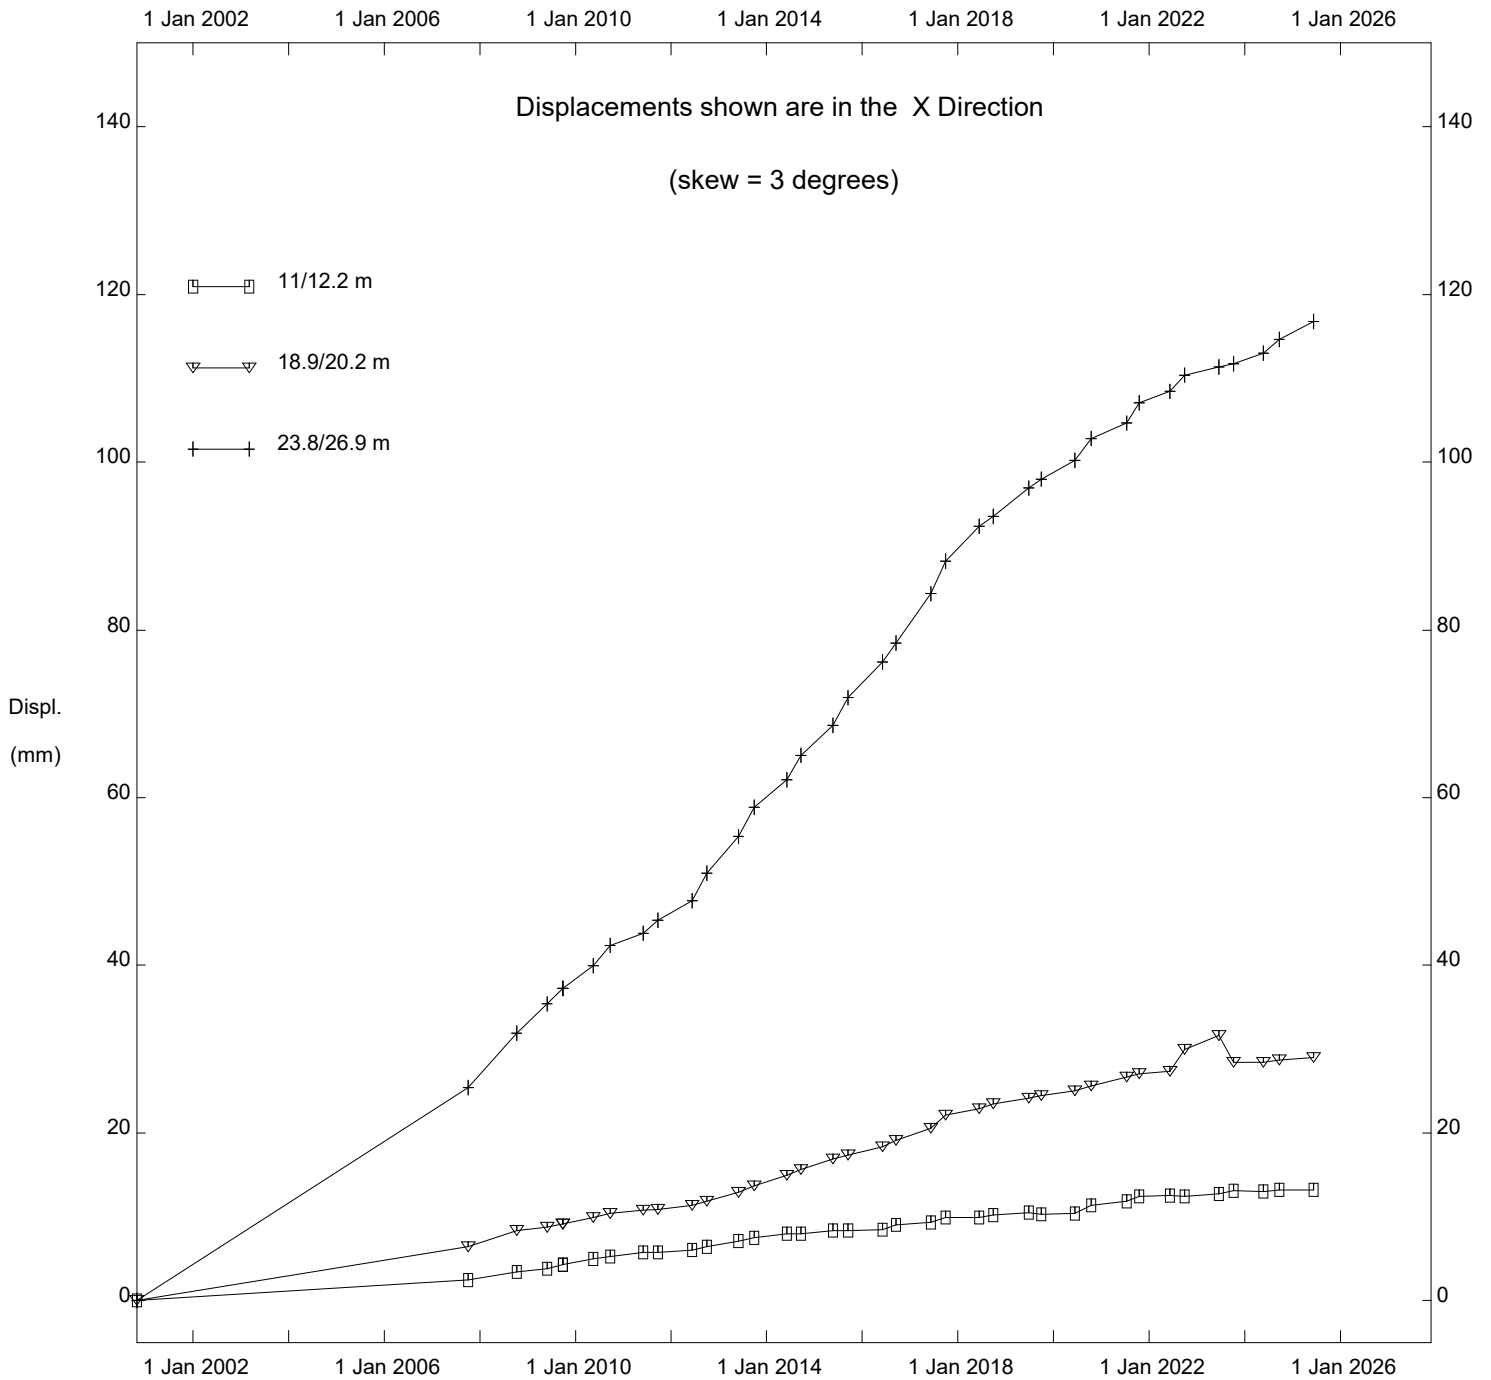
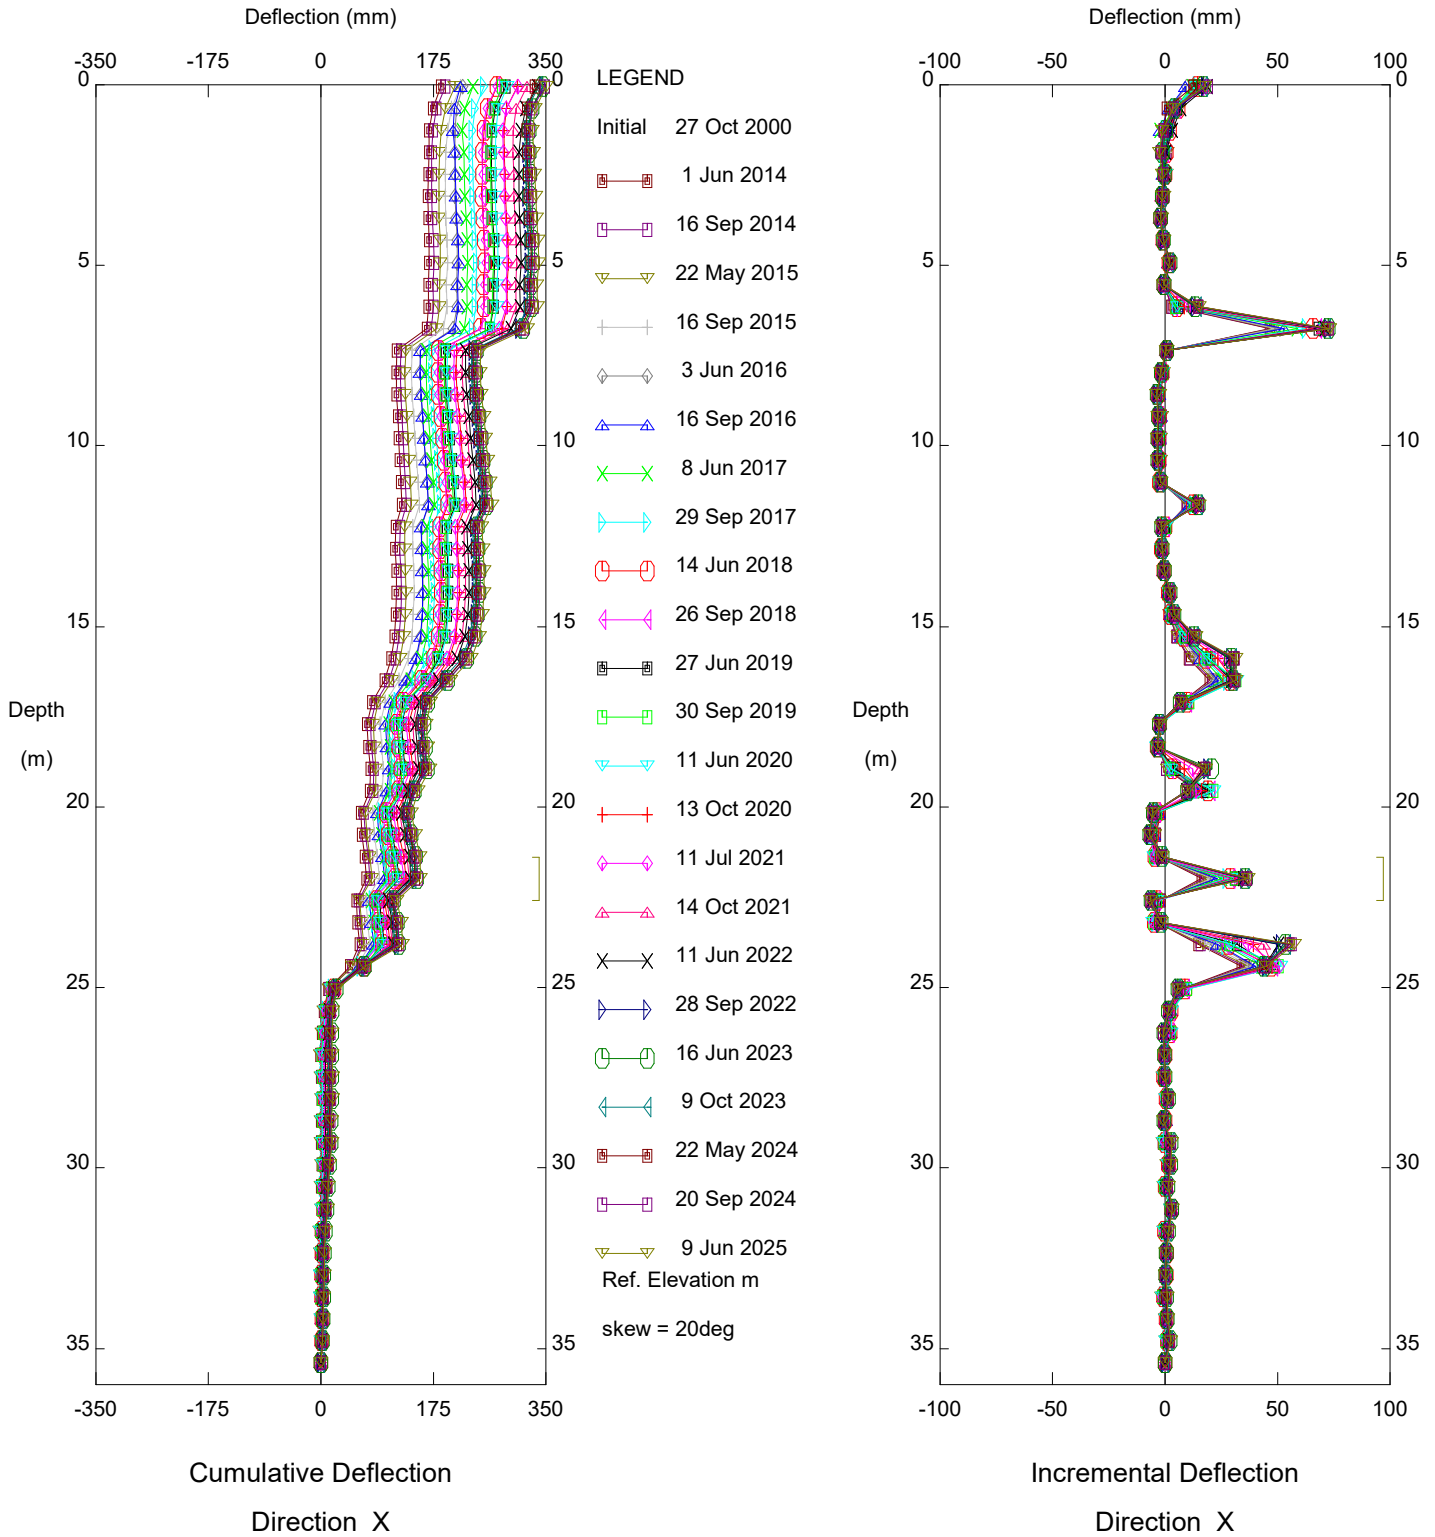
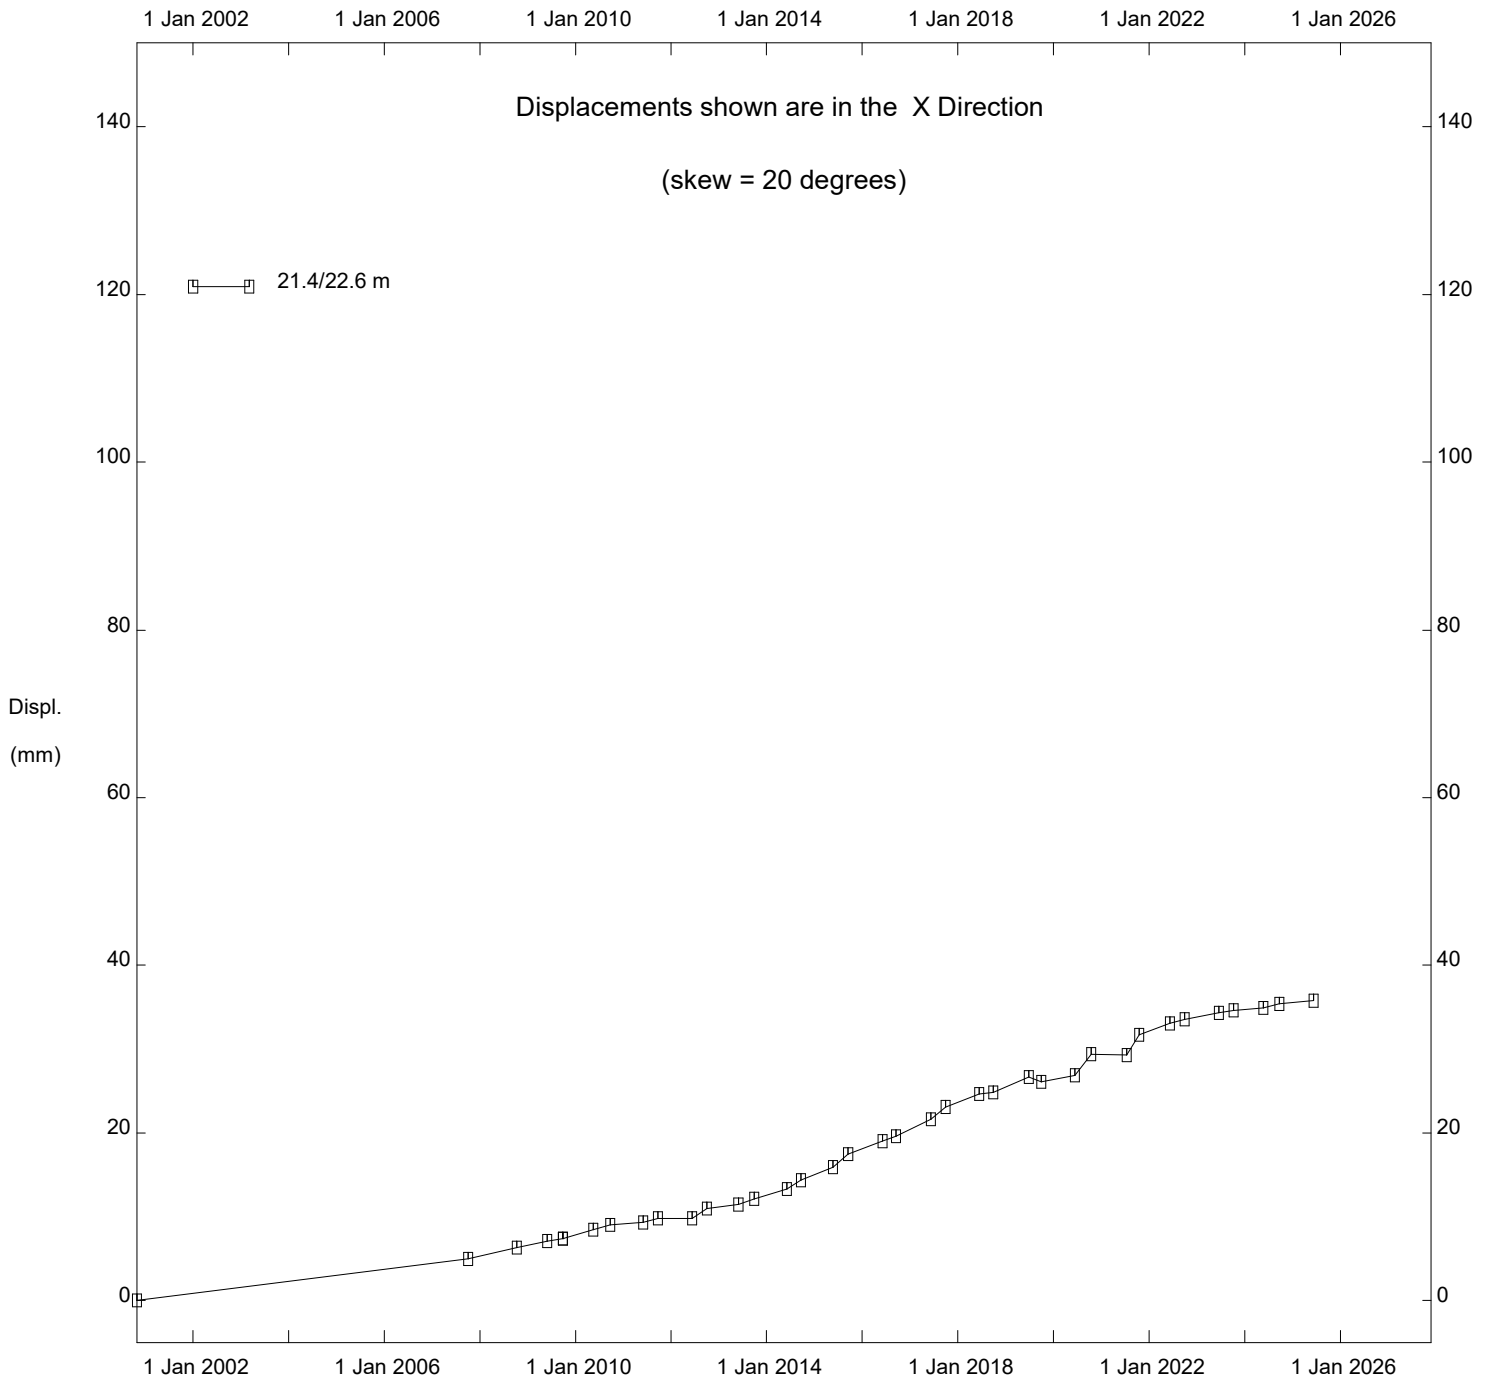
HWY 744:04 - STA. 57+700 to 58+000, Inclinator SI98-10i

Zones of New Movement:	None
Interpretation of Monitoring Results:	<p>Slope Inclinometers</p> <p>Slope inclinometer SI98-10i, located about 100 m downslope of the highway showed small incremental movements along six distinct shear planes, since the fall of 2024 readings. The multitude of distinct movement zones speaks to the complexity of ongoing valley wall deformations along Judah Hill. Since the slope indicator was installed in October 2000 the sum of the movements over all these zones is 383.3 mm. The movement rates in these zones has typically ranged between 1 mm/yr and 5 mm/yr with median rate below 3 mm/yr. The movement rates showed small decreases (less than 2 mm/yr) since the previous readings in the fall of 2024 with the exception an approximately 3 mm/yr increase in movement rate measured in the zones over 14.1 m to 17.7 m (3.7 mm/yr) depth and over 23.2 m to 26.9 m (4.7 mm/yr) depth.</p> <p>Slope inclinometer SI10-4 is located east of the highway and has one well defined movement zone at 6 m depth in a clay strata, and several subtle movement zones at greater depths in clay and clay till layers. A rate of movement of 1.6 mm/yr was measured over 5.7 m to 6.9 m depth and a rate of movement of 1.1 mm/yr over 11.8 m to 17.9 m depth</p>
