**ALBERTA TRANSPORTATION
GEOHAZARD ASSESSMENT PROGRAM
PEACE REGION (PEACE RIVER DISTRICT)
2021 INSPECTION**

Site Number	Location	Name	Hwy	km
PH032	Judah Hill	Makeout Landslide	744:04	57.924
Legal Description		UTM Co-ordinates		
NE¼ 20-083-21 W5M		11U E 483171	N 6229947

**PH032-1 JUDAH HILL - MAKEOUT SLIDE
2021 SITE INSPECTION PLAN**

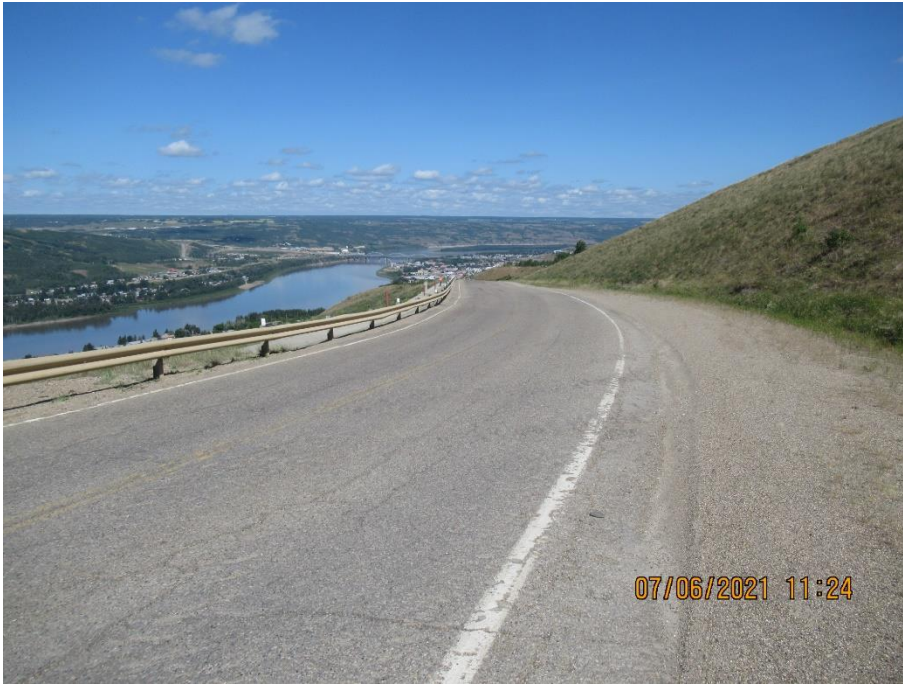
Observations:	Description	Worsened?
<input checked="" type="checkbox"/> Pavement Distress	Several cracks were observed in the ACP in 2013 (See Photos 1, 7 and 9) prior to the construction of the km 58 and Makeout pile walls and have not significantly changed since the previous inspection. A crack and minor dip in the SBL (km 58.04) behind the km 58 pile wall was slightly worse (Photo 7).	<input checked="" type="checkbox"/>
<input checked="" type="checkbox"/> Slope Movement	<p>The old landslide scarps below the km 58 pile wall that were regraded in 2015 have ongoing movement at intermittent rates. A scarp at the south end of the wall was well vegetated with no major expansion or significant downslope movement since 2020 (Photo 3). The tieback and waler of the old downslope wall are now exposed near the middle of the wall with a 1.2 m drop (Photo 4). Most of the piles from the old wall are now exposed with the highest drop at 2.0 m from the top of the exposed piles (unchanged from 2020).</p> <p>The bench and graded area below the 2015 Makeout pile wall was in good condition with no observable changes from 2020 (Photo 9).</p> <p>Lower slope area between the walls appears the most active; exacerbated by seepage and erosion processes from disconnected drains (Photo 6)</p>	<input checked="" type="checkbox"/>

Photo 1.
Looking northwest from the SBL shoulder of Hwy 744:04 at km 57.96 along the guardrail above the km 58 pile wall. There has been no major changes in the cracks in the ACP since 2020.

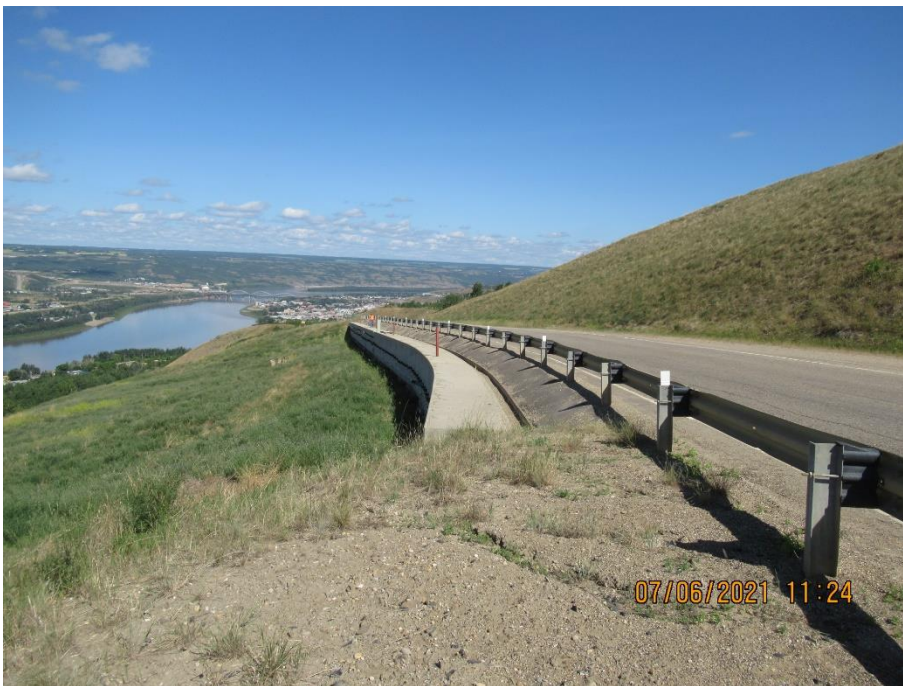
<input checked="" type="checkbox"/> Erosion	<p>Both ends of the km 58 pile wall have become eroded by runoff water and water overtopping the outlet of the pile wall due to blockage of the drain trough with sediment buildup. Scour at the north end of the wall has not changed since 2020.</p> <p>The solid HDPE outlet drainpipe for the clay backfilled area became disconnected from the perforated CSP drainpipe at the base in 2018 and erosion damage is ongoing (Photo 5).</p>	<input checked="" type="checkbox"/>
<input checked="" type="checkbox"/> Seepage	Seepage was noted in the lower slope area between the pile walls near the active erosion gully (Photo 6).	<input type="checkbox"/>
<input type="checkbox"/> Bridge/Culvert Distress		<input type="checkbox"/>
<input checked="" type="checkbox"/> Other	No change observed in the ACP shoulder protective cover at either pile walls (Photos 2 and 10).	<input type="checkbox"/>

Photo 2.
Looking northwest from the south end of the km 58 pile wall. The ACP shoulder protective cover was in good condition. No significant changes were noted downslope of the wall at this site relative to the 2020 condition.

The pile wall surface drainage gutters will require to be regularly cleaned in order to continue to provide erosion protection for the partially buried pile wall and avoid clogging of its solid down drain pipes.

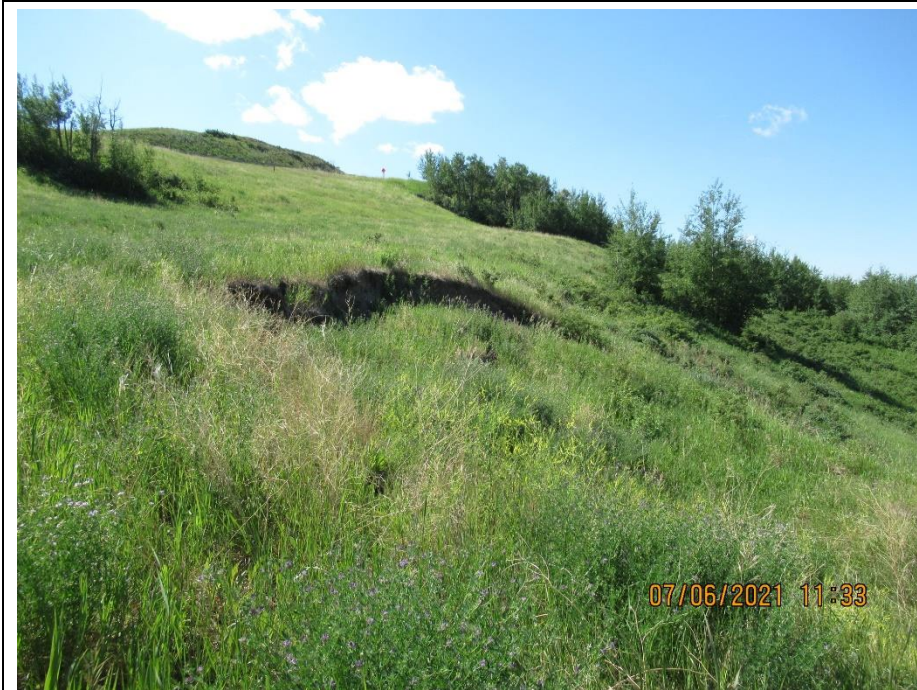
Photo 3.
Looking south at a scarp in the bench below the south end of the wall with approximately 1.5 m maximum drop. Area is well vegetated with no significant expansion or downslope movement since 2020.

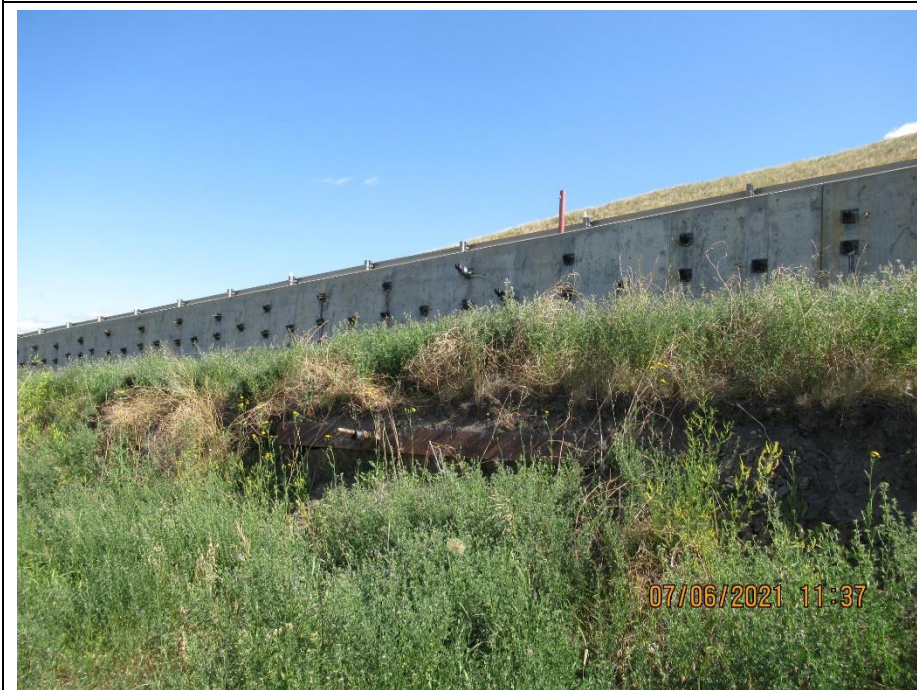
Photo 4.
Looking northeast from below the north end of the km 58 pile wall. The old landslide scarps below the pile wall that were regraded in 2015 have ongoing movement. Additional old tieback and waler was exposed from the movement at the south end. Highest drop was 2.0 m from the top of the exposed piles.

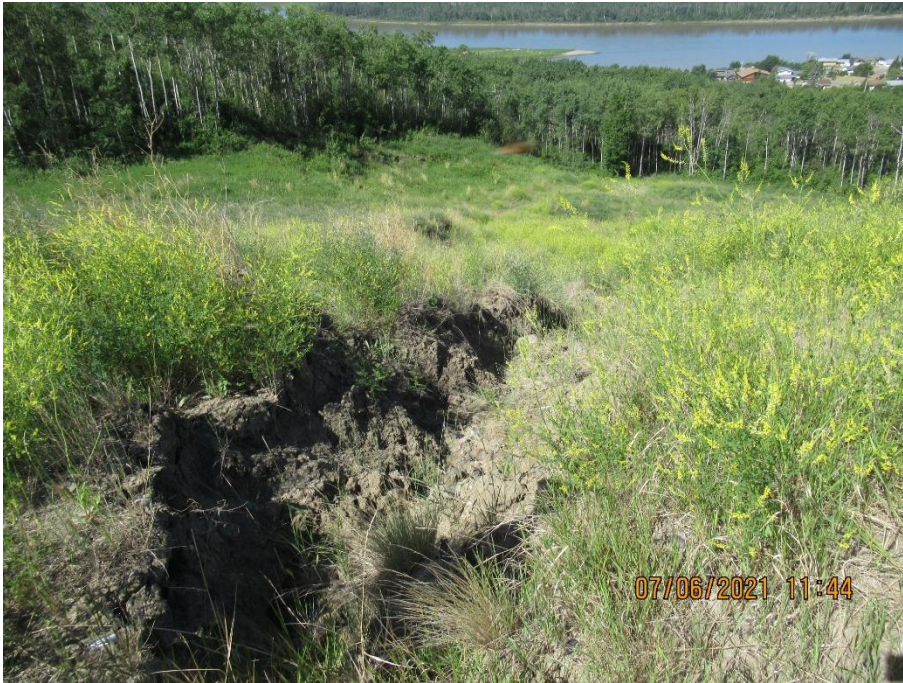
Photo 5.
View downslope towards the head of an active erosion gully approximately 40 m downslope from the north end of the pile wall and disconnected drainpipe further upslope.

Some further drainage efforts might be required at the wet area as a future maintenance item as history has shown that persistent seepage can lead to significant slide movements. The disconnected drainpipe below the north end of the km 58 pile wall should be reconnected to help prevent further retrogression of the landslide scarp that has formed below it.

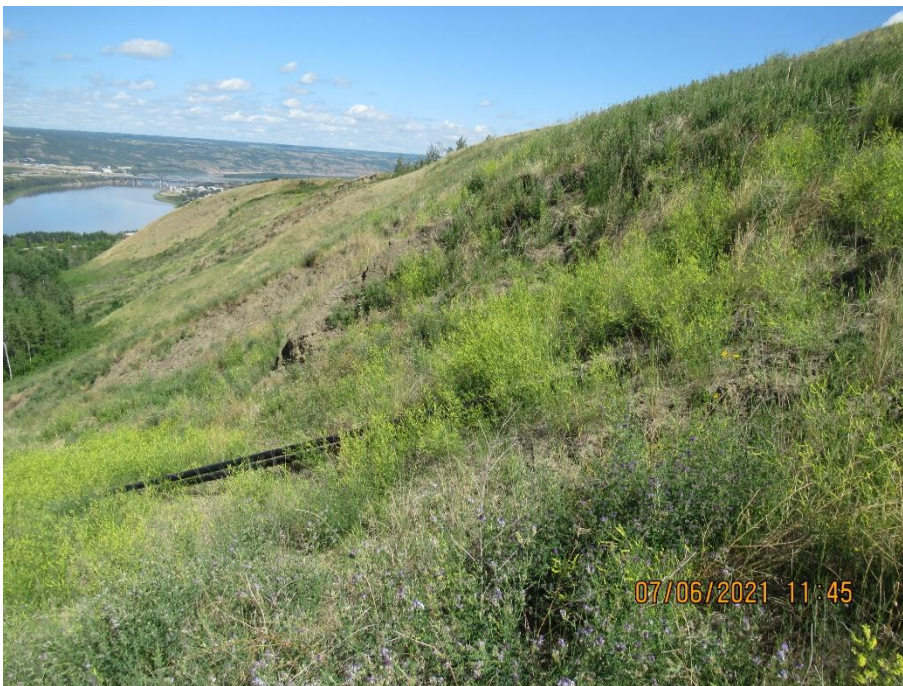
Photo 6.
Looking at the north flank of the lower slide area between the pile walls. Seepage from a disconnected drainage pipe is causing erosion and exacerbating slide movement.

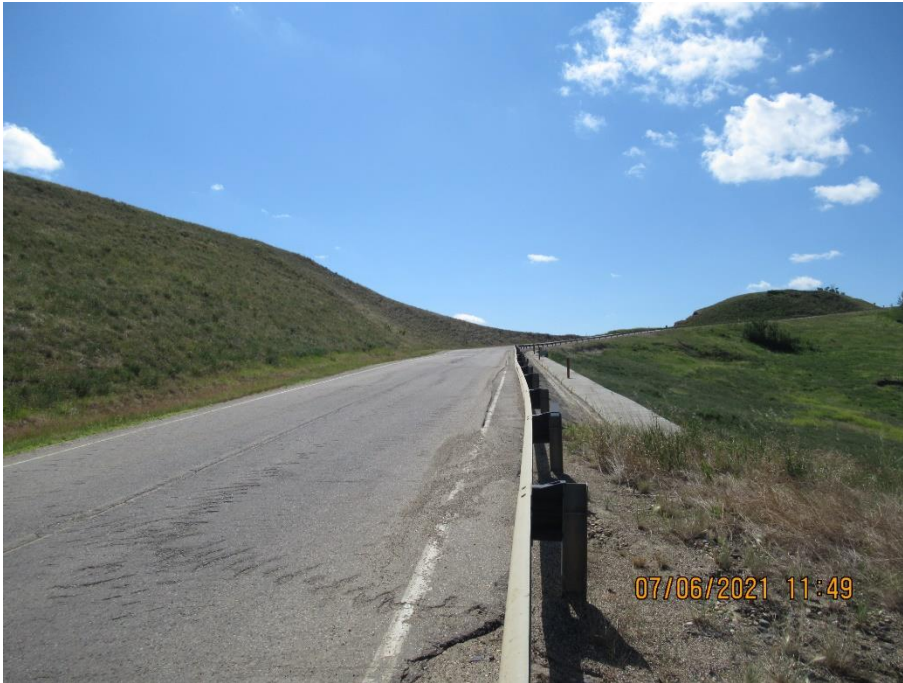
Photo 7.
Looking south from the north end of the km 58 pile wall. Slightly worse crack and dip within the ACP directly behind the wall but overall road condition has not significantly changed since the 2020 condition.

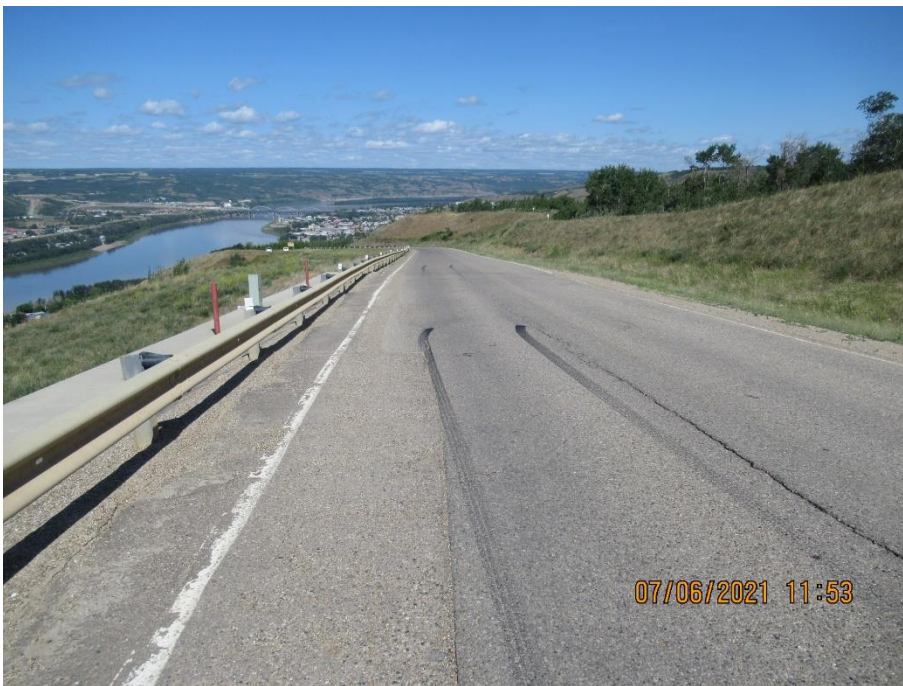
Photo 8.
Looking northwest at the highway above the "Makeout" pile wall. No major change to the dip around the SBL shoulder near the middle of the wall or ACP cracking relative to the 2020 condition.

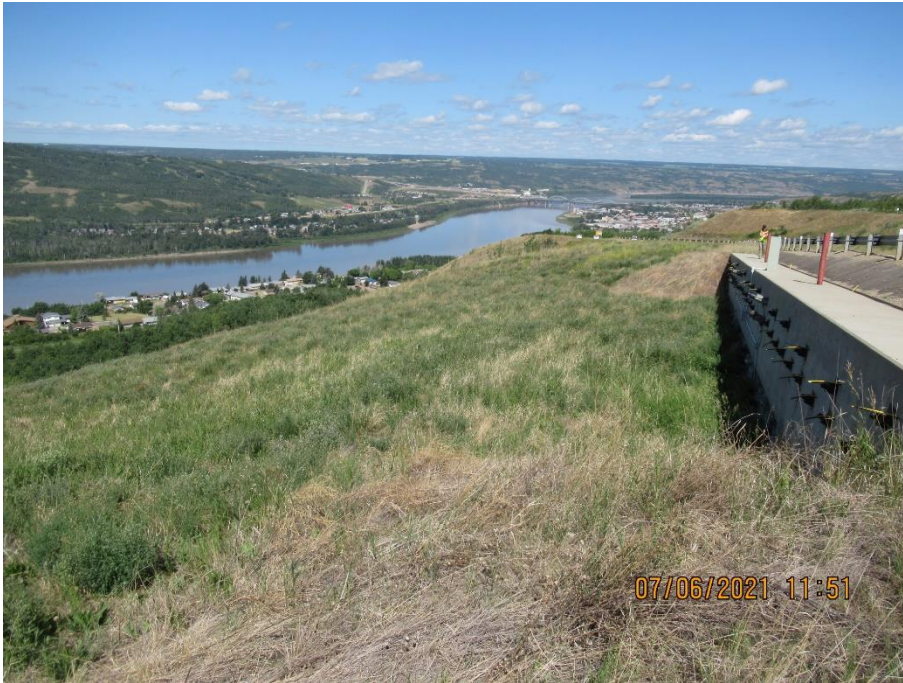
Photo 9.
Looking north at the bench and graded area below the “Makeout” pile wall. Area appeared in good condition and had no observable changes from 2020.

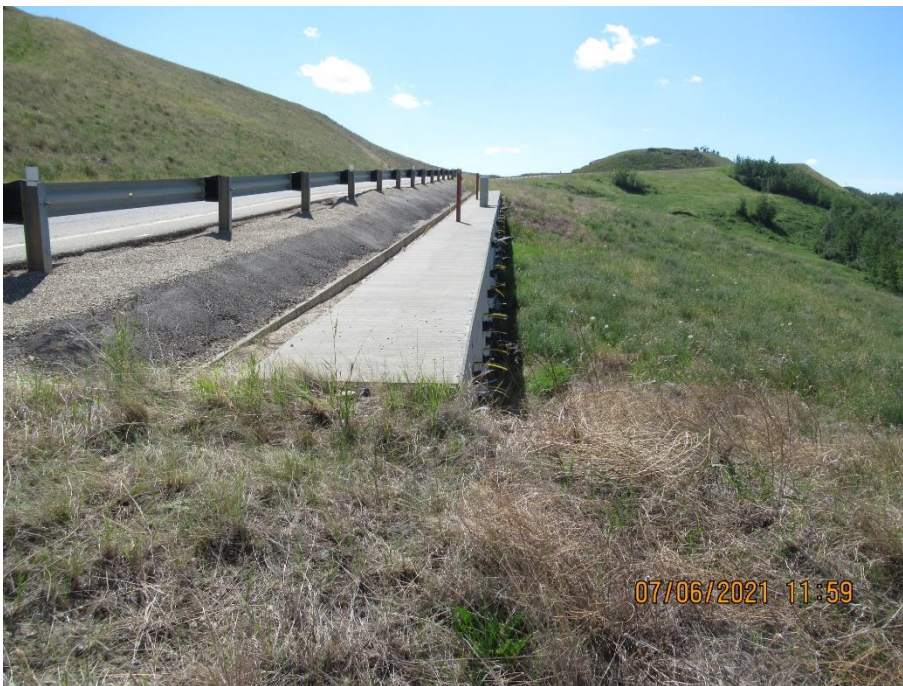
Photo 10.
Looking south along the top of the “Makeout” pile wall. ACP shoulder protective cover was in good condition. Drainage trough was relatively clear and functioning.
