November 16, 2022 File No.: 32121

ALBERTA TRANSPORTATION GRMP (CON0022164) PEACE REGION (PEACE RIVER DISTRICT) INSTRUMENTATION MONITORING RESULTS – FALL 2022

SITE PH032: HWY 744:04, JUDAH HILL (MAKEOUT SLIDE)

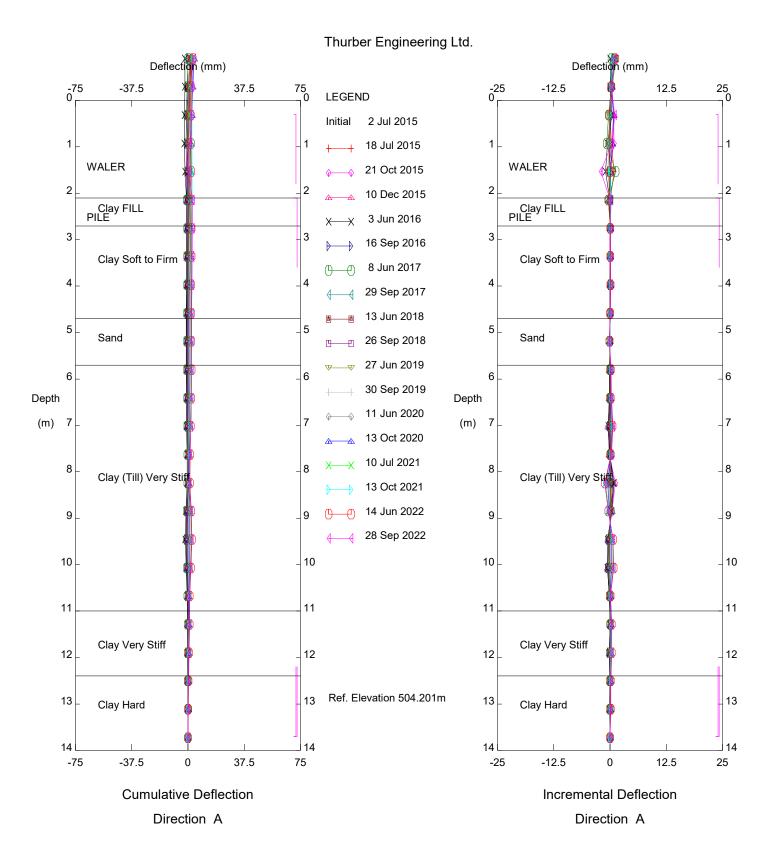
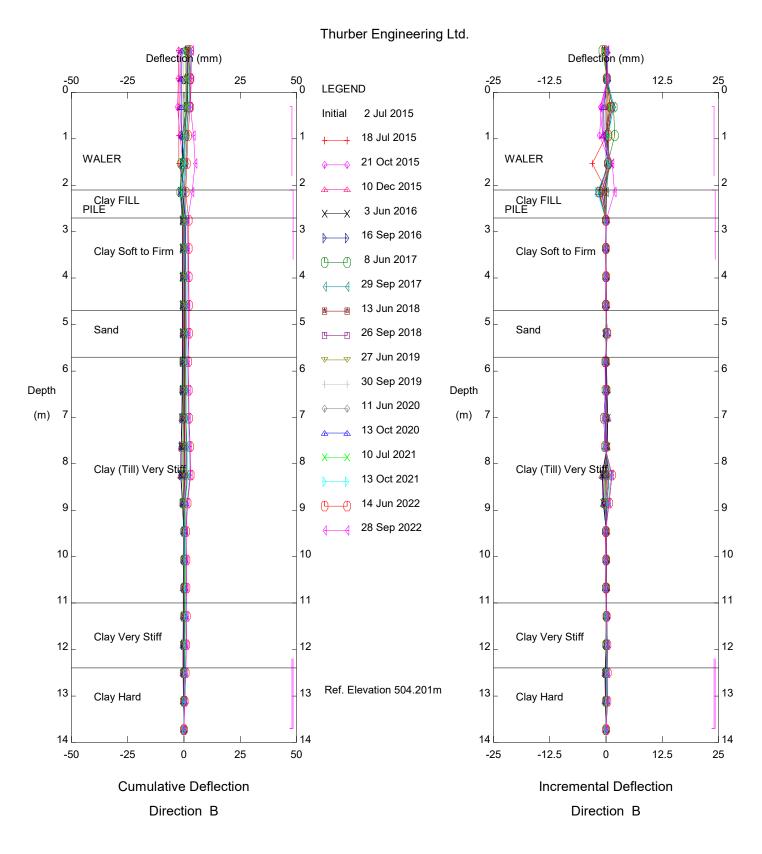
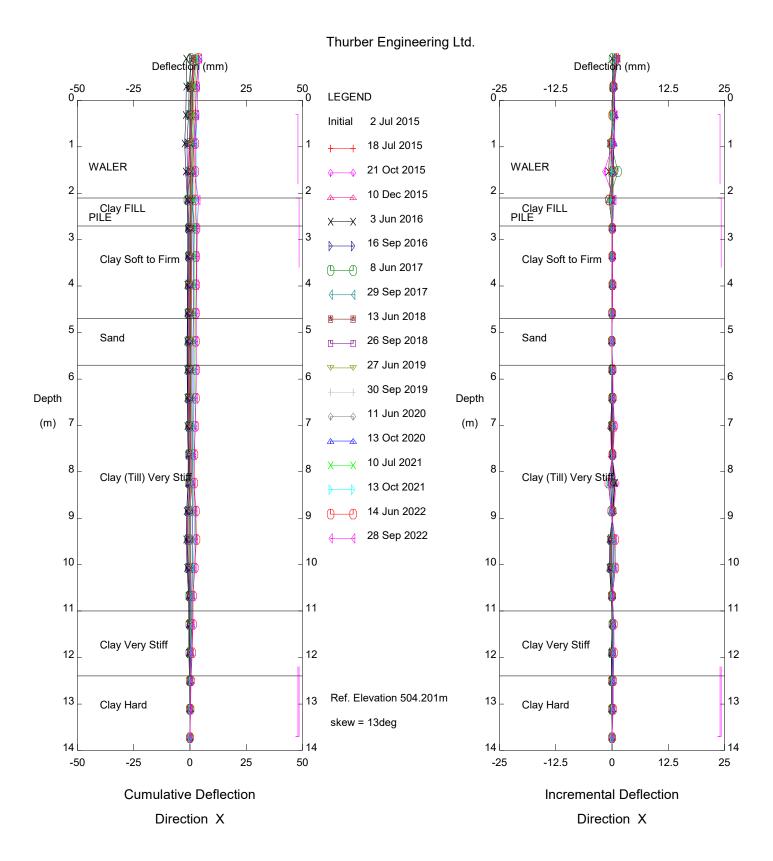
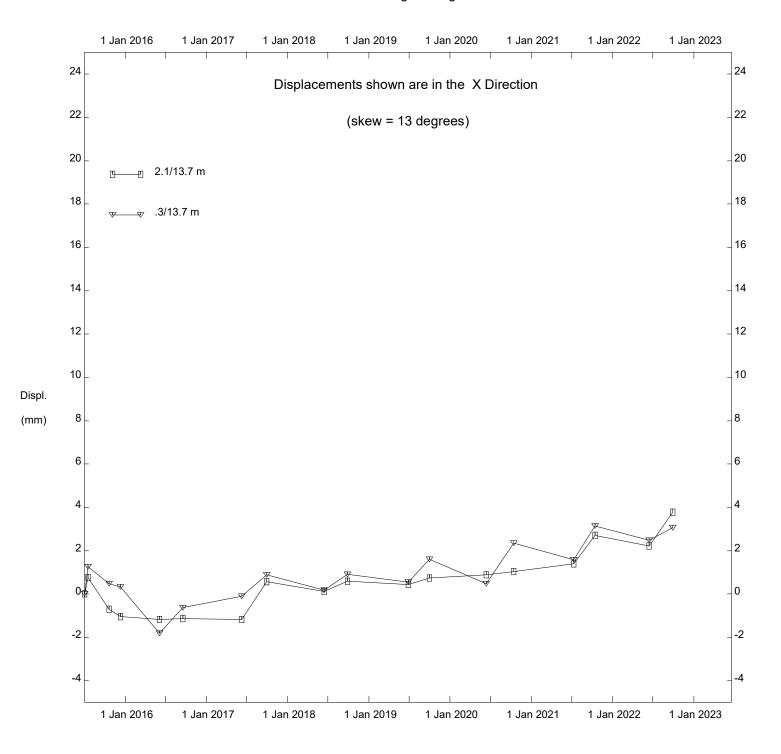
PH032 KM 58 (Post Construction), Inclinometer PK15

At the KM 58 pile wall, PK15 showed a rate of movement of 5.3 mm/yr over the length of the pile and 2.0 mm/yr over the combined length of the pile and waler since the spring of 2022 readings. Since the completion of construction, PK15 has shown a total cumulative deflection over the length of the pile of 3.8 mm in the downslope direction and a total cumulative movement of 3.1 mm in the downslope direction over the combined length of the pile and waler.

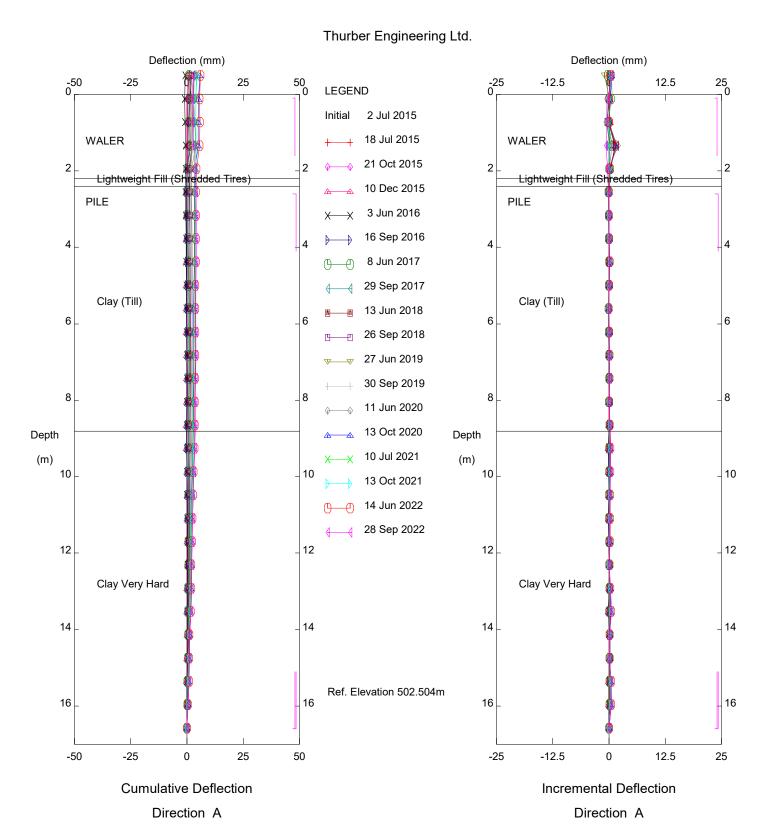
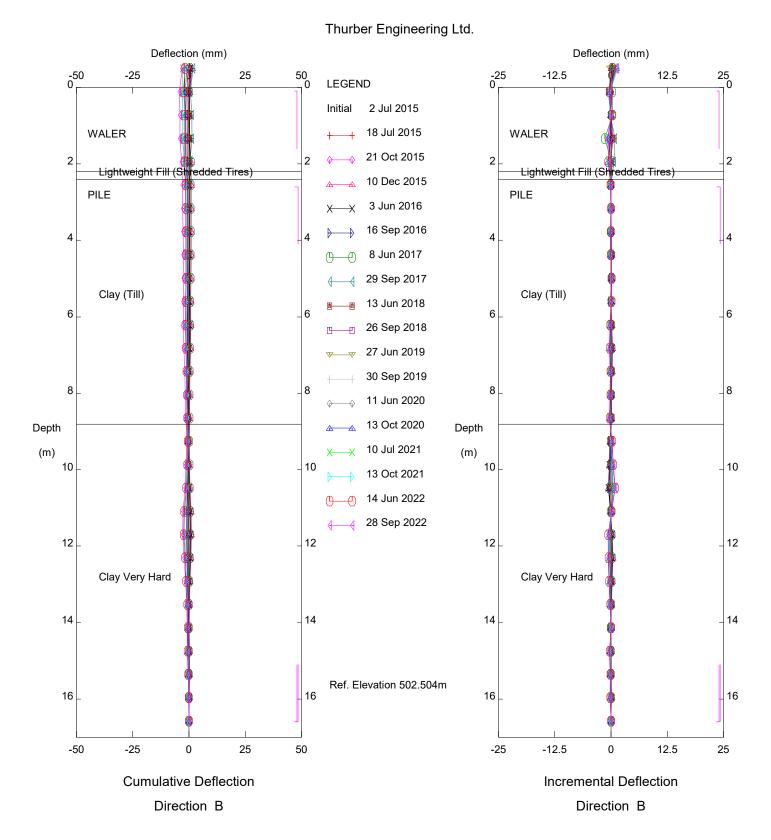
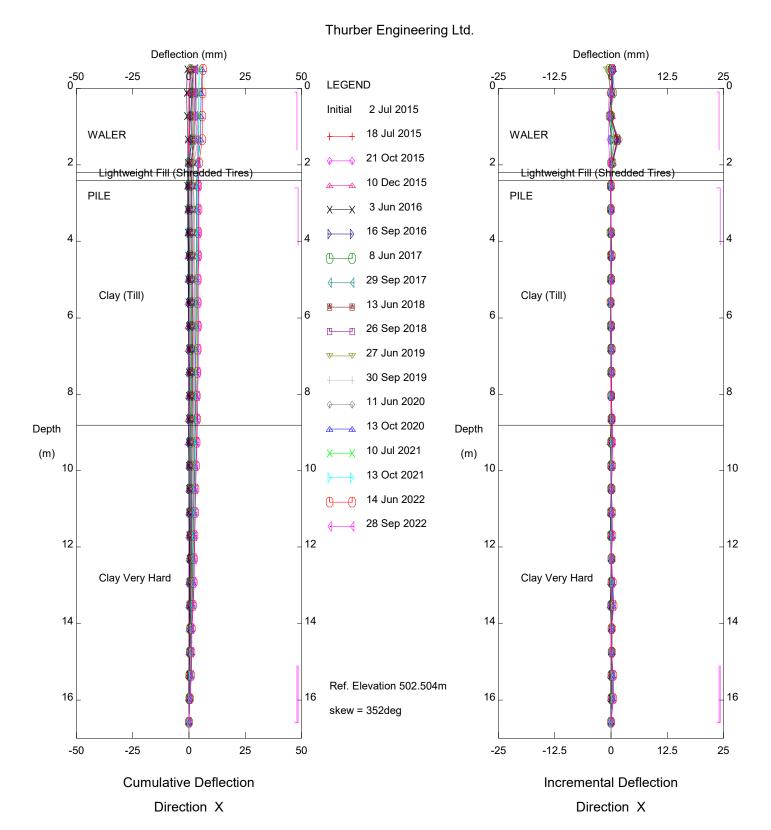
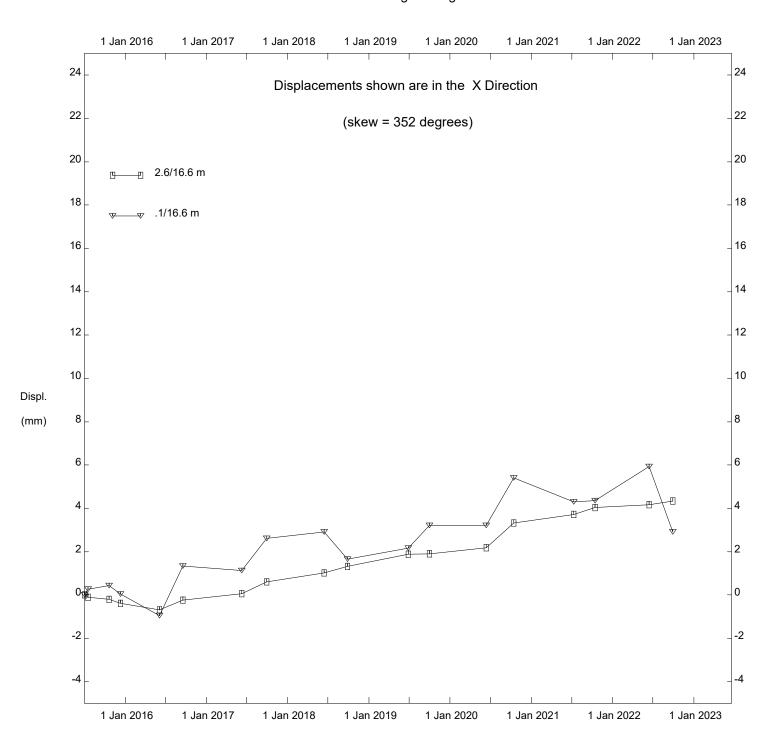
PH032 KM 58 (Post Construction), Inclinometer PK36

PK36 showed a rate of movement of 0.5 mm/yr over the length of the pile and no discernible movement over the combined length of the pile and waler. Since completion of construction, PK36 has shown total cumulative deflections of 4.3 mm in the downslope direction over the length of the pile and 2.9 mm in the downslope direction over the combined length of the pile and waler.

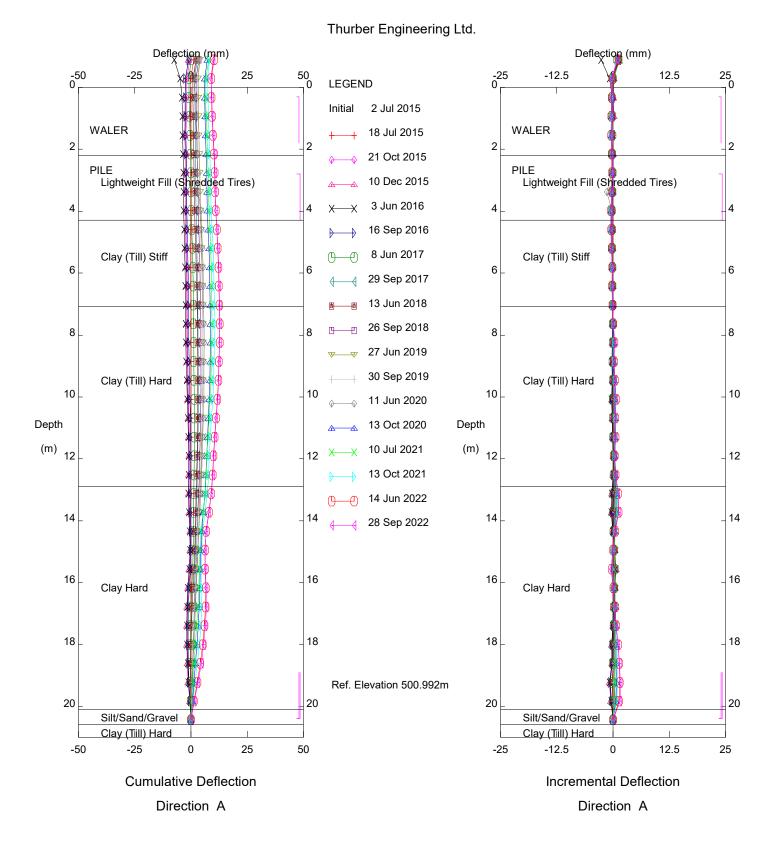
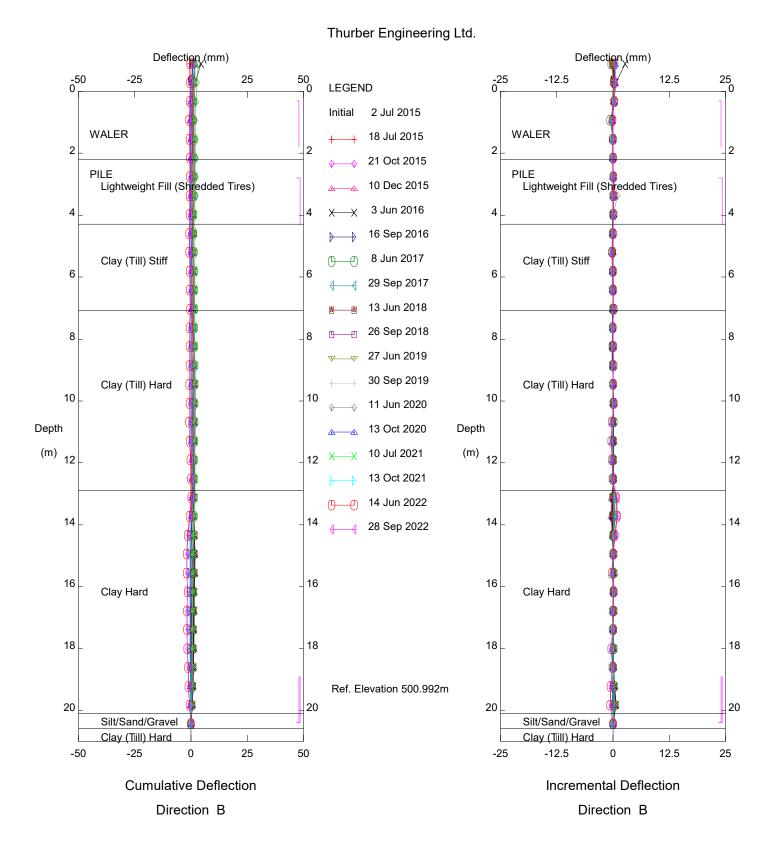
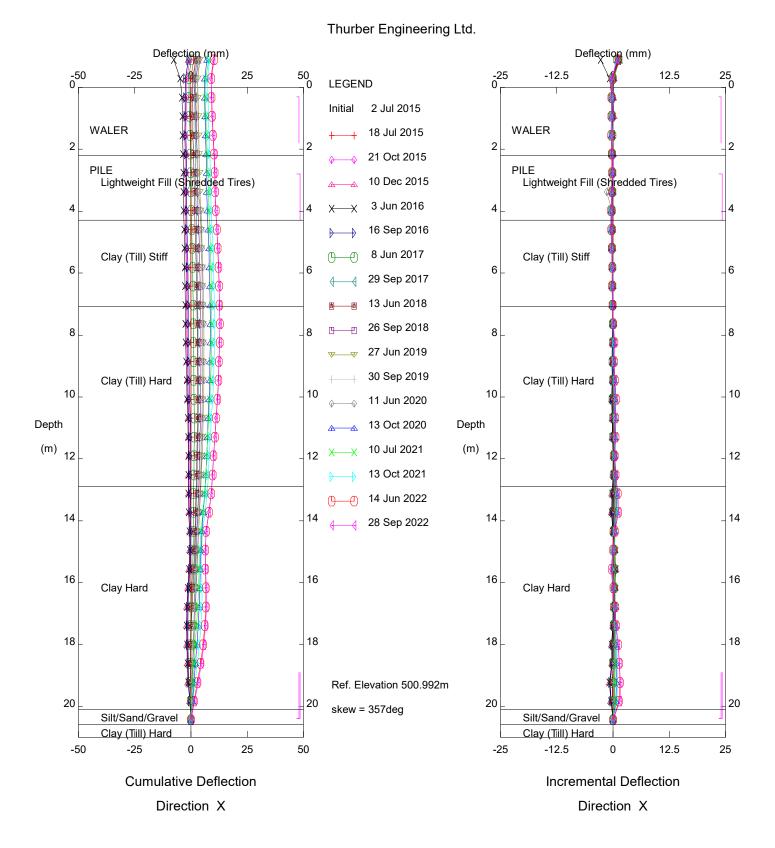
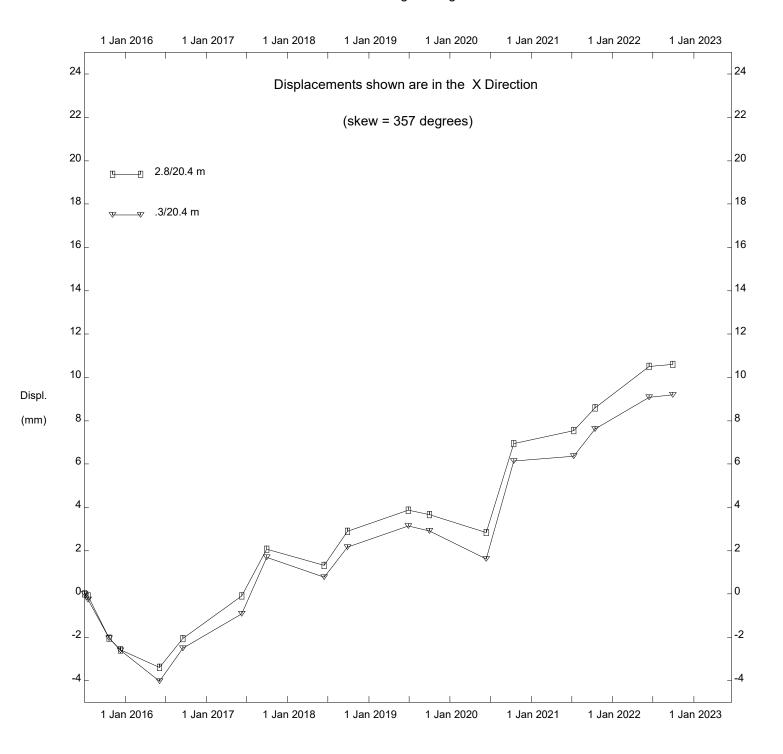
PH032 KM 58 (Post Construction), Inclinometer PK54

PK54 showed a rate of movement of 0.3 mm/yr over the length of the pile and a rate of movement of 0.4 mm/yr over the combined length of the pile and waler. Since the completion of construction, PK54 has shown total cumulative movements of 10.6 mm in the downslope direction over the length of the pile and 9.2 mm in the downslope direction over the combined length of the pile and waler.

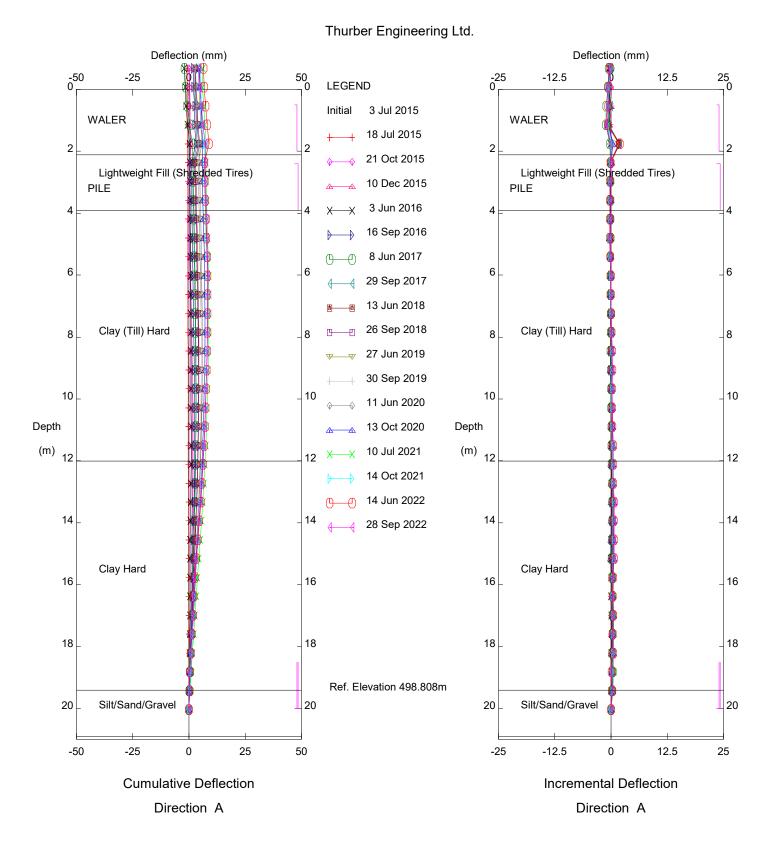
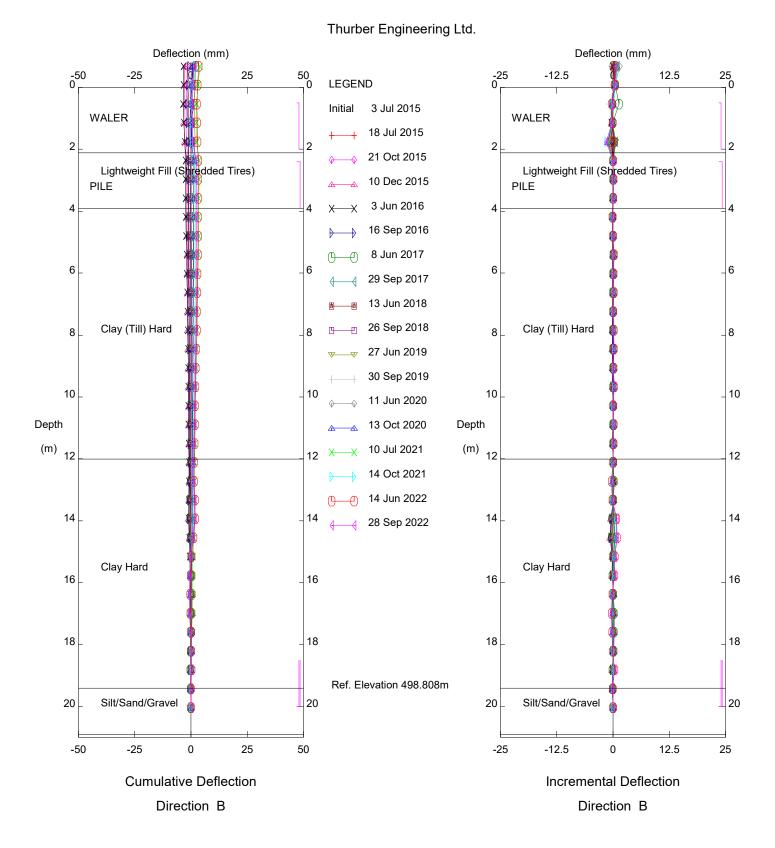
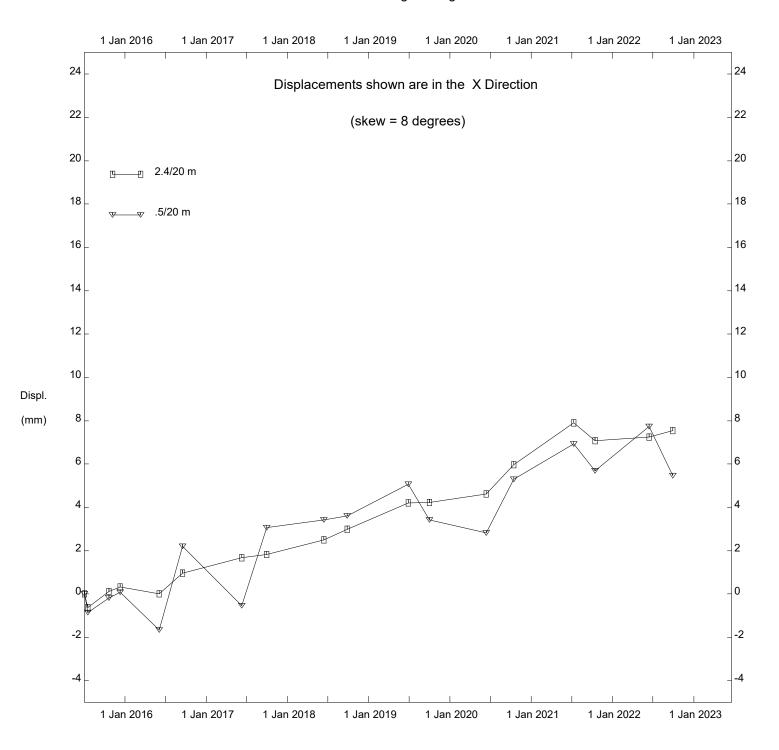
PH032 KM 58 (Post Construction), Inclinometer PK80

PK80 showed a rate of movement of 1.0 mm/yr over the length of the pile and no discernible movement over the combined length of the pile and waler. Since completion of construction, PK80 has shown 7.5 mm of total cumulative movement in the downslope direction over the length of the pile and 5.5 mm in the downslope direction over the combined length of the pile and waler.

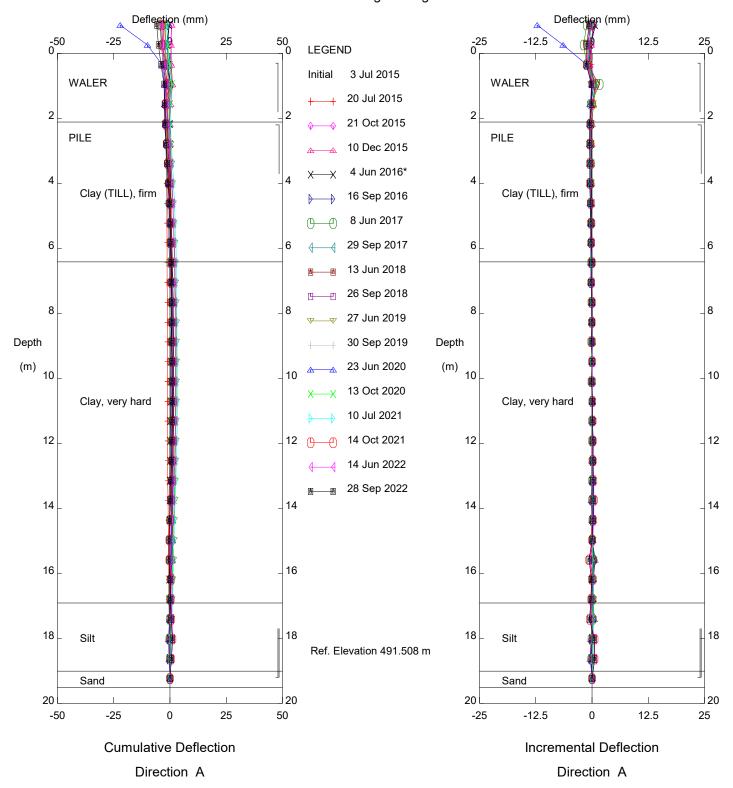
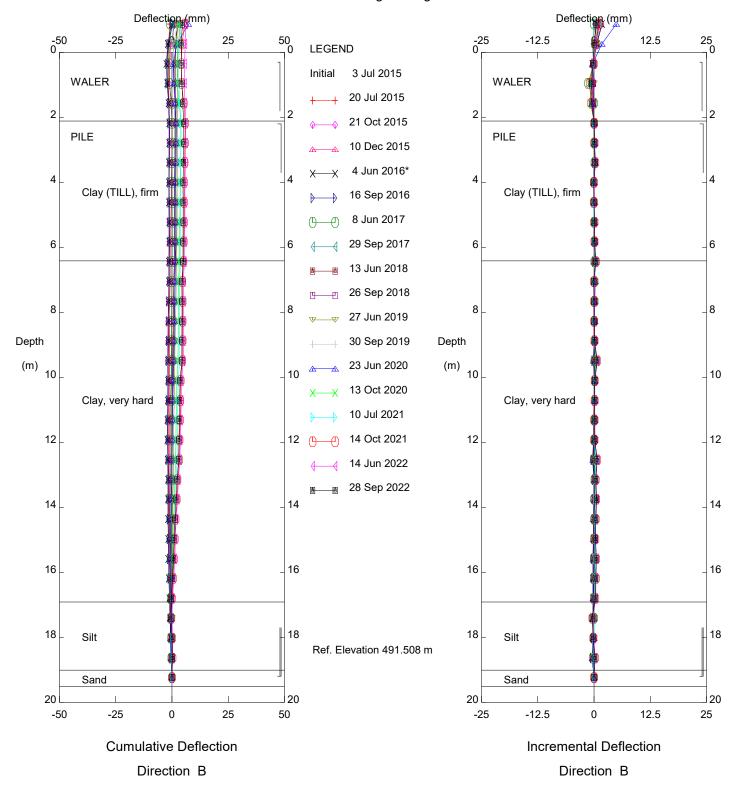
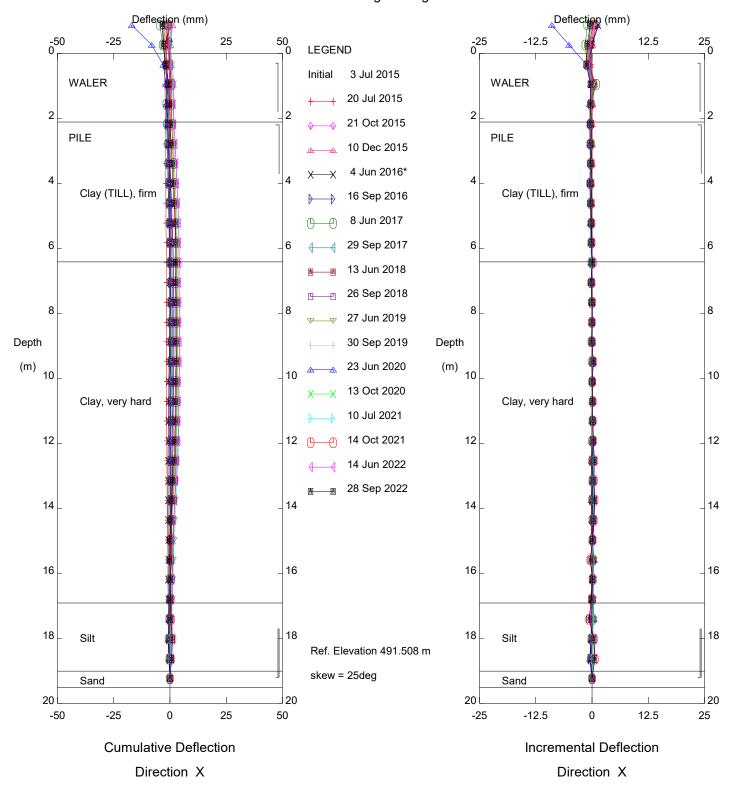
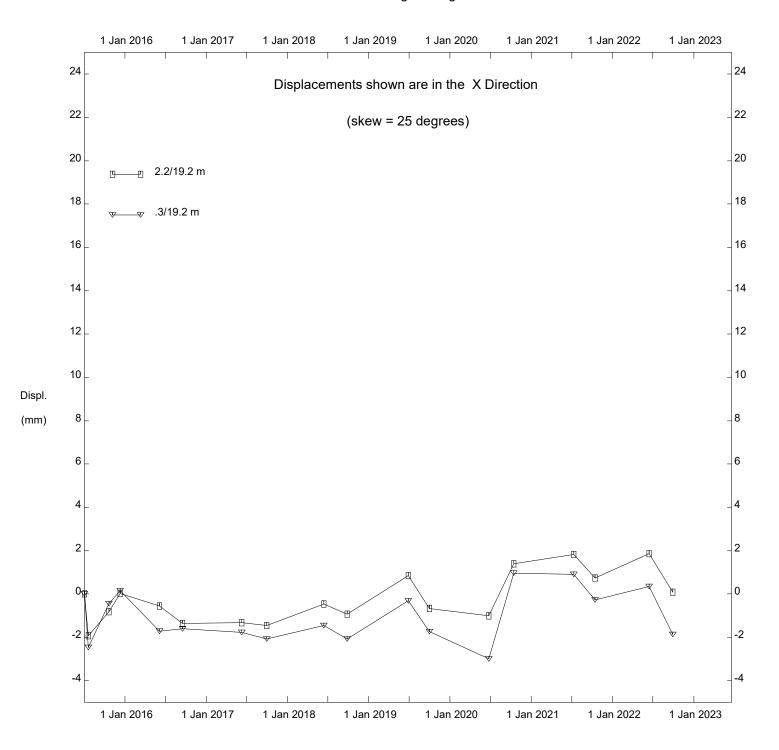
PH032 Makeout (Post Construction), Inclinometer PM12 Alberta Transportation

At the Makeout pile wall location, PM12 showed no discernible movement over the length of the pile or the combined length of the pile and waler. Since completion of construction, PM12 has shown total cumulative deflections of 0.1 mm in the downslope direction over the length of the pile and 1.9 mm in the upslope direction over the combined length of the pile and waler.

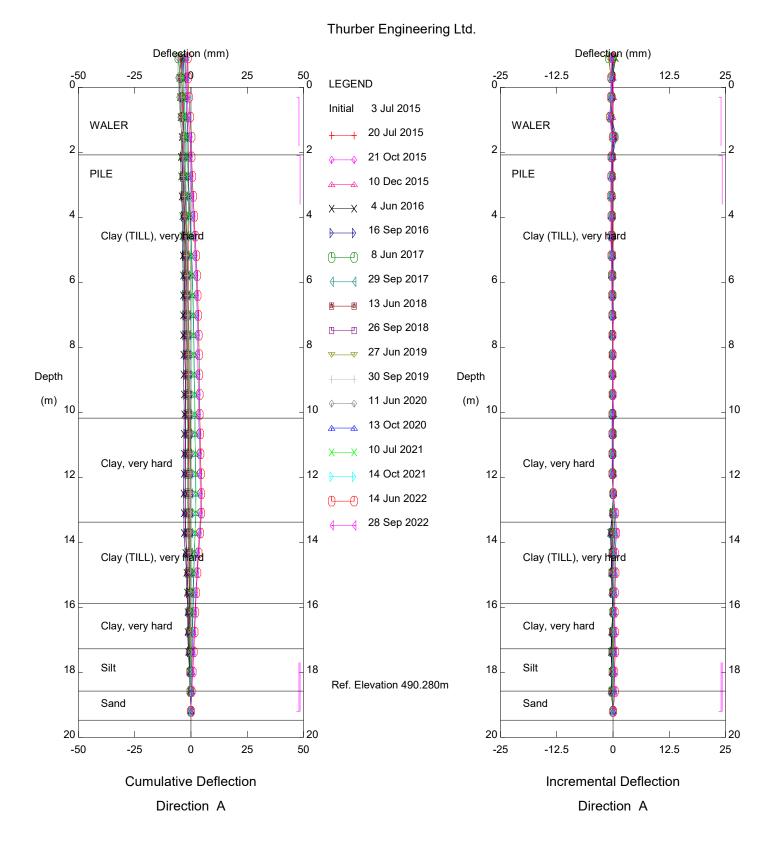
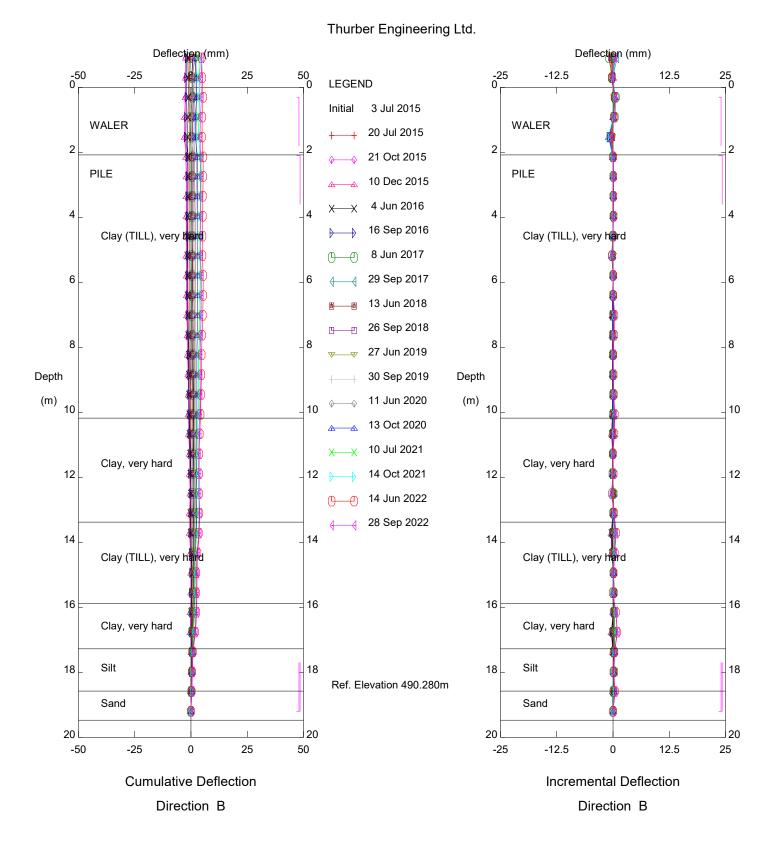
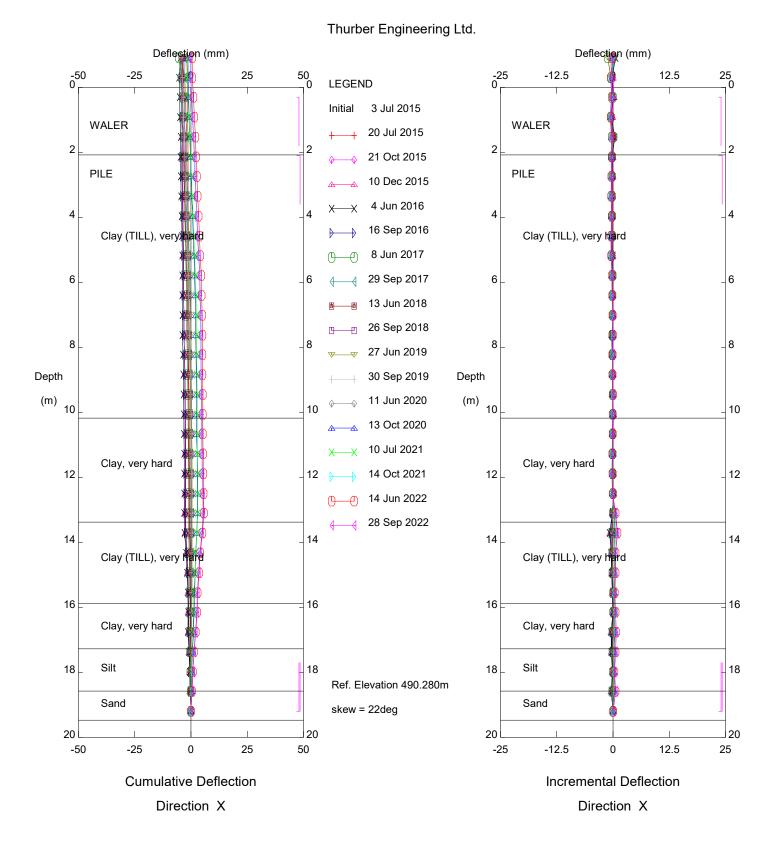
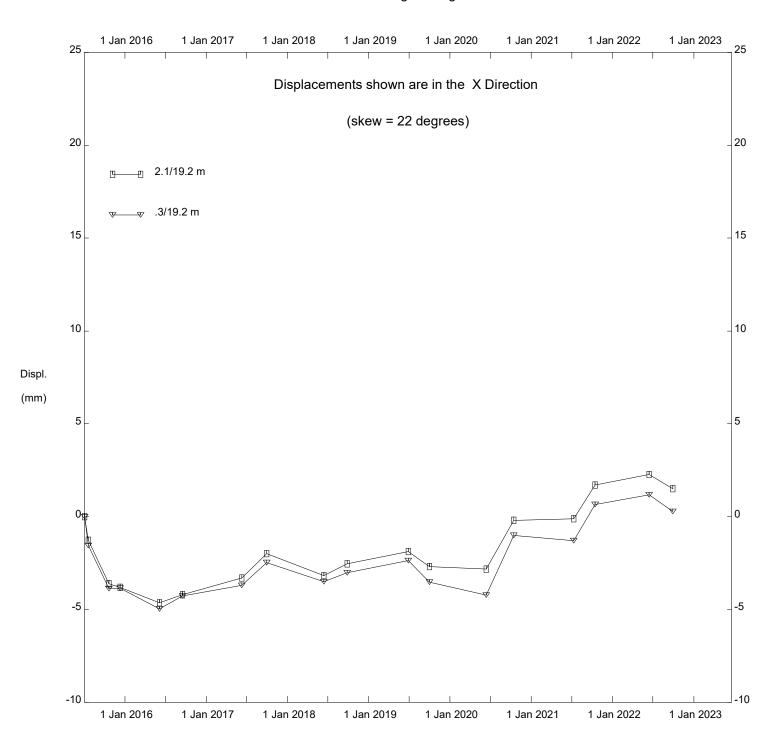
PH032 Makeout (Post Construction), Inclinometer PM24

PM24 showed no discernible movement over the length of the pile or the combined length of the pile and waler. Since completion of construction, PM24 has shown total cumulative movements of 1.5 mm in the downslope direction over the length of the pile and 0.3 mm in the downslope direction over the combined length of the pile and waler.

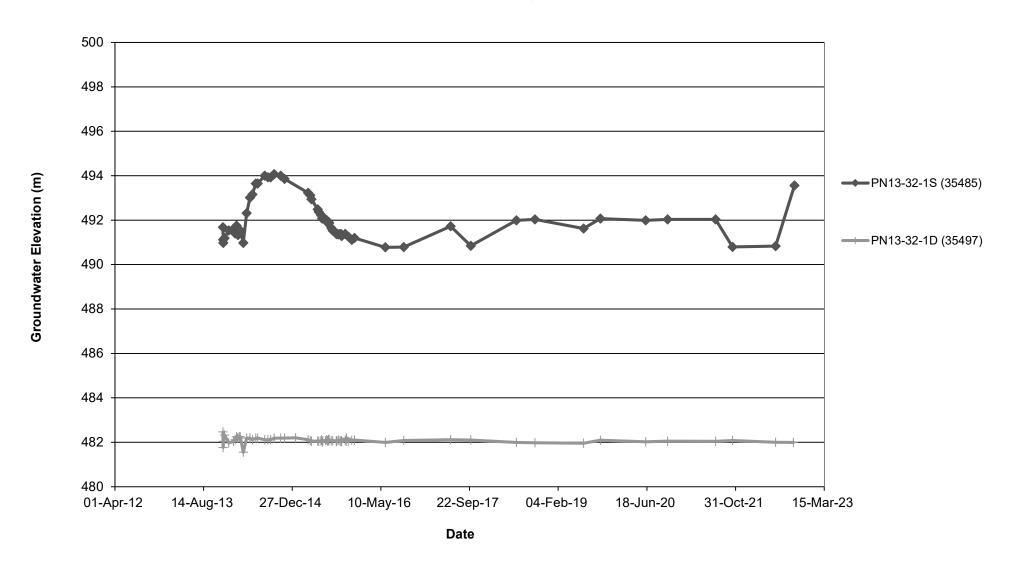
FIGURE PH032-1
PIEZOMETERIC ELEVATIONS FOR HWY 744:04, JUDAH HILL MAKEOUT SLIDE

Pneumatic piezometer PN13-32-1S showed an increase in groundwater level of 2.70 m since the spring of 2022 readings. The current water level reading in PN13-32-1S is the highest since the instrument was initialized. PN13-32-1D showed a decrease in groundwater level of 0.01 m since the spring of 2022 readings. Pneumatic piezometer results are summarized in Table PH032-2, and are plotted in Figures PH032-1 (by elevation) and PH032-2 (by depth below ground surface) in Appendix A.

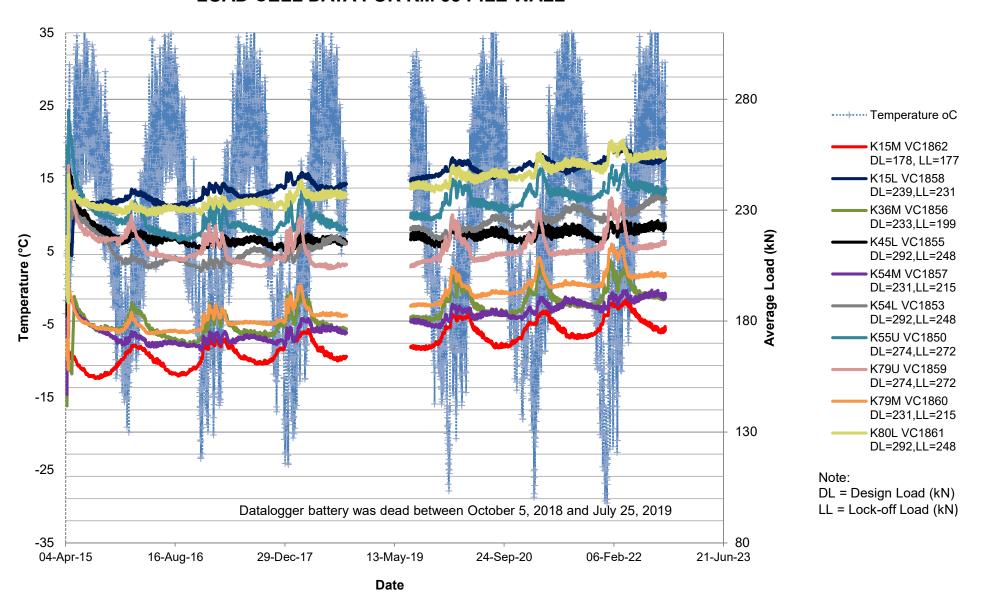
FIGURE PH032-3 LOAD CELL DATA FOR KM 58 PILE WALL

The load cells are connected to two dataloggers that are programmed to take two readings per day. Since the spring of 2022 readings, the load cells at the KM 58 wall showed a mix of increases and decreases in measured load, ranging from a decrease of 4.06 kN in VC1862 (anchor K15M) to an increase of 3.28 kN in VC1862 (anchor K54L). The anchors at the KM 58 wall show an overall trend of slowly increasing load, with seasonally higher loads during the winter months. The peak loads measured in the load cells correspond to frost penetration, and the peak anchor loads in some of the anchors appear to follow a period of extreme cold weather in late December 2021 to early January 2022. It should also be noted that load cell VC1858 (anchor K15L) is showing loads that are higher than the SLS design load.

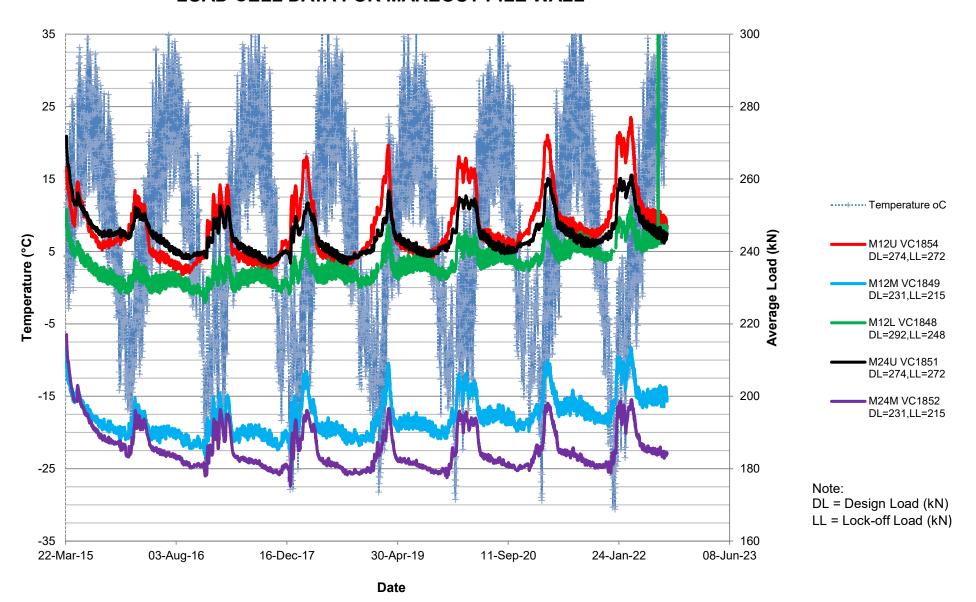
FIGURE PH032-4 LOAD CELL DATA FOR MAKEOUT PILE WALL

At the Makeout wall, the load cells showed a mix of increases and decreases in measured load ranging from a decrease of 2.99 kN in VC1851 (anchor M24U) to an increase of 1.58 kN in VC1848 (anchor M12L). The load cells at the Makeout wall have shown an overall trend of relatively stable loads since the end of construction, with seasonably higher loads during the winter months.
