**ALBERTA TRANSPORTATION GEOHAZARD ASSESSMENT PROGRAM
PEACE REGION – PEACE-HIGH LEVEL
2009 INSPECTION**

Site Number	Location	Name	Hwy	km
PH33	Judah Hill	Judah Trunk	744:04	58.90
Legal Description		UTM Co-ordinates		
SE¼ 29-083-21 W5M		11V E 482906	N 6230669

Site Number	Location	Name	Hwy	km
PH33	Judah Hill	CNR Slide	744:04	59.60
Legal Description		UTM Co-ordinates		
NE¼ 29-083-21 W5M		11V E 482645	N 6231308

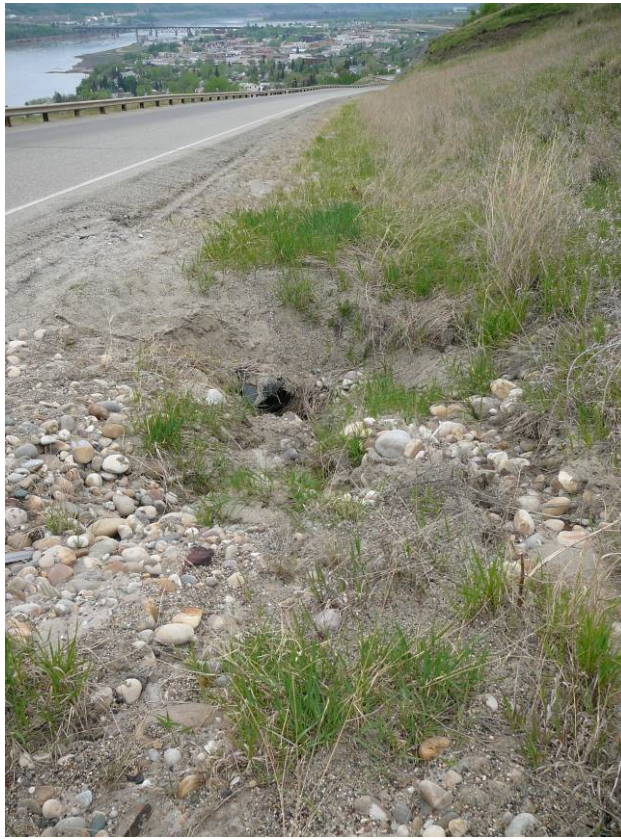
<input type="checkbox"/> Erosion		<input type="checkbox"/>
<input type="checkbox"/> Seepage		<input type="checkbox"/>
<input checked="" type="checkbox"/> Bridge/Culvert Distress	There is debris clogging the inlet to the down-drain (Photo 1). The connection between the culvert under the road and the down-drain has separated (Photo 2). All of the couplings on the corrugated plastic pipe down-drain have failed,	<input type="checkbox"/>

Photo 1.
Inlet for the Judah Trunk down drain. The inlet is clogged with debris and should be repaired.

Recommendations:		Cost
Check flow capacity required in down-drain (assess drainage area) as pre-requisite for repair (to determine pipe size).		Investigation
Install additional slope indicator casings on downslope shoulder of road to allow assessment of movement and provide information for design of repair measures, should this become necessary.		Investigation
Flatten/re-grade slopes around drain inlet, remove debris and re-armour (class 1M rip rap)		Maintenance
As a short-term fix, repair band couplings on down-drain using e.g. adhesive wrap or similar.		Maintenance
Remove slide debris from upslope ditch north of the drain inlet.		Maintenance
Replace corrugated plastic down drain with welded HDPE pipe with appropriate flow capacity. Repair connection to culvert under road.		\$ 150,000

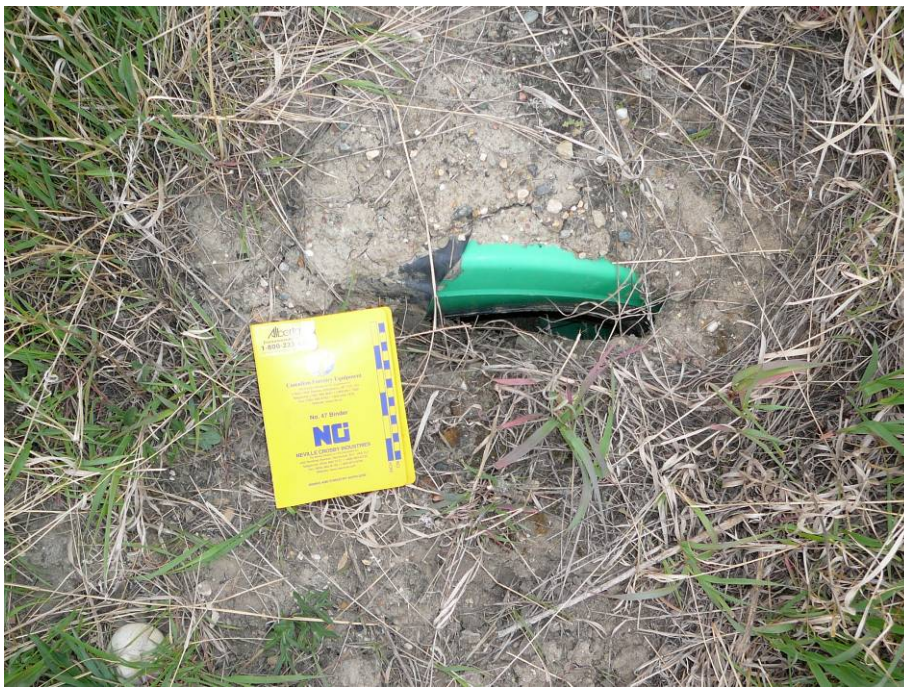
Photo 2.
Connection between the culvert and the down drain has failed, and should be repaired.

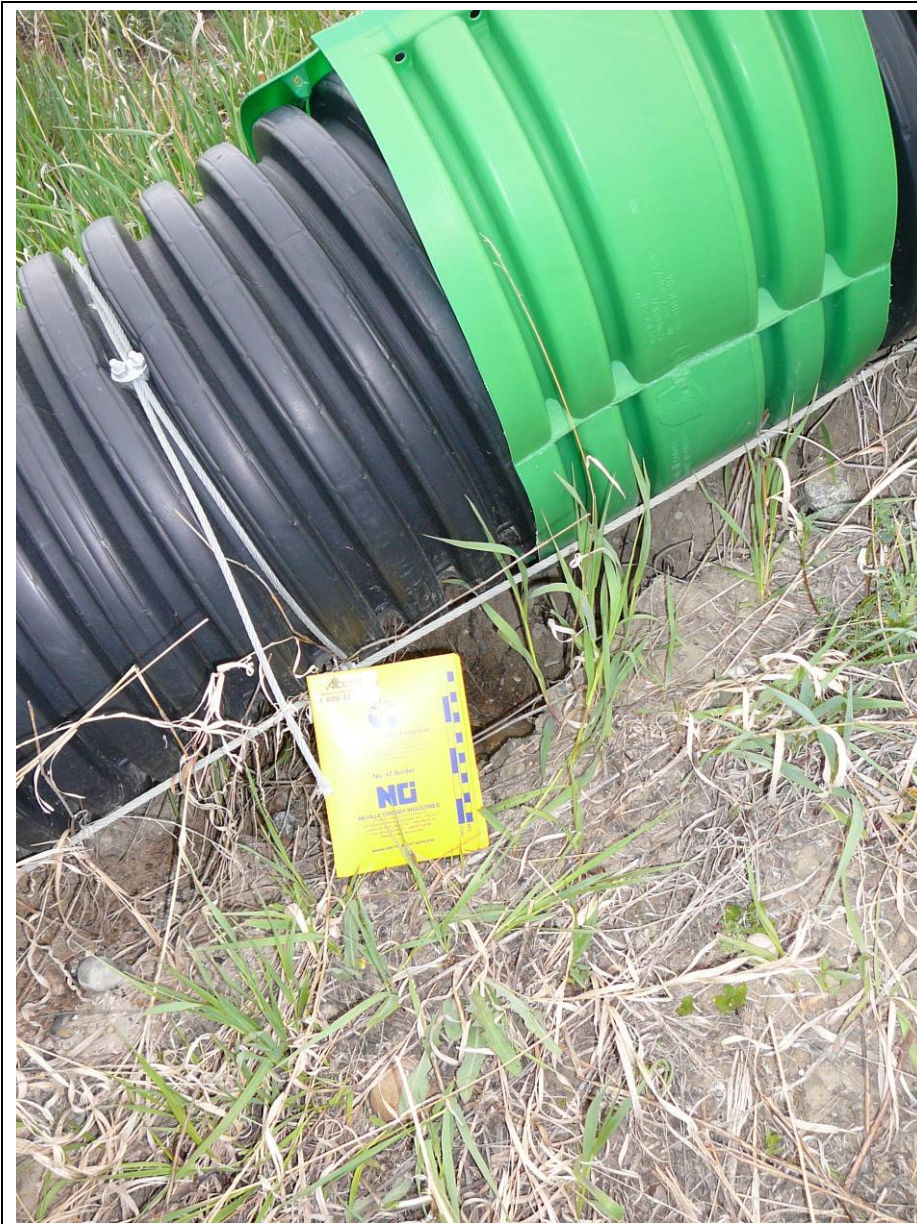
and erosion is occurring under the pipe (Photo	
<input type="checkbox"/> Other		<input type="checkbox"/>
Instrumentation:		
SI98-6i	Inclinometer installed at the toe of the slope, north of the drain. Minor movement in A-direction, with some surface creep. Total cumulative in B direction may be as high as 50 mm. No distinct shear planes identified.	
SI98-7i	Inclinometer installed at the toe of the slope, north of the drain. No distinct shear planes identified. Cumulative deflection in A-direction of approximately 15 mm, and 25 mm in B-direction.	
Piezometers PN98-6, PN98-6a PN98-7 PN98-7a	Generally show little historic variation – trend is relatively flat. Some increases in PN98-7 and PN98-6a. May pick up more variation if read more frequently (eg. datalogging of replacement VW or standpipe piezometers), in response to rain and/or snow events.	
Assessment:		
Further skin failures should be expected in the steep cut slopes above the road – the maintenance burden does not appear very great at this stage. The trunk down-drain should be repaired as a matter of urgency to prevent severe erosion on the slope. Given that it includes drainage along the road up to the Lookout slide, a larger pipe may be required. Cracking and pavement distress on the downslope shoulder might indicate slope stability problems.

Photo 3.
All of the band couplings on the Judah Trunk down drain have failed. At the uppermost band coupling, erosion under the drain has worsened.

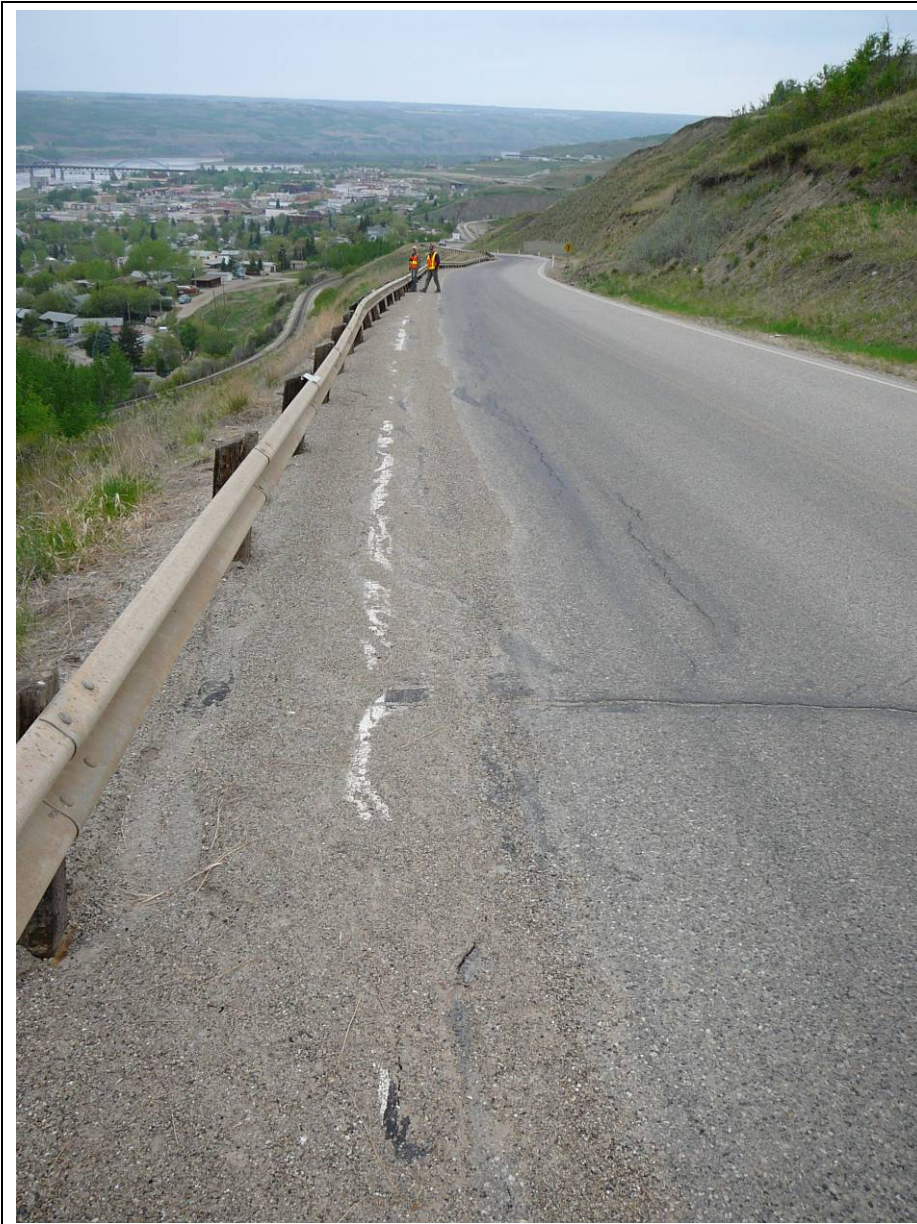
Photo 4.
Cracking along the
downslope road
shoulder has
worsened since
2008.

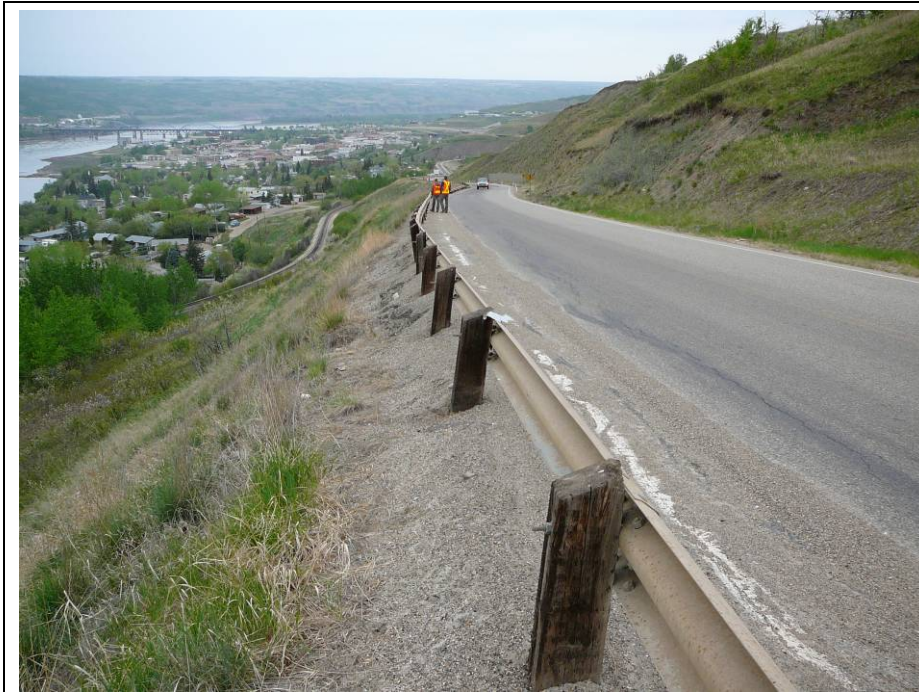
Photo 5.
Cracking in the road and erosion / sloughing of the road shoulder, north of km 59.

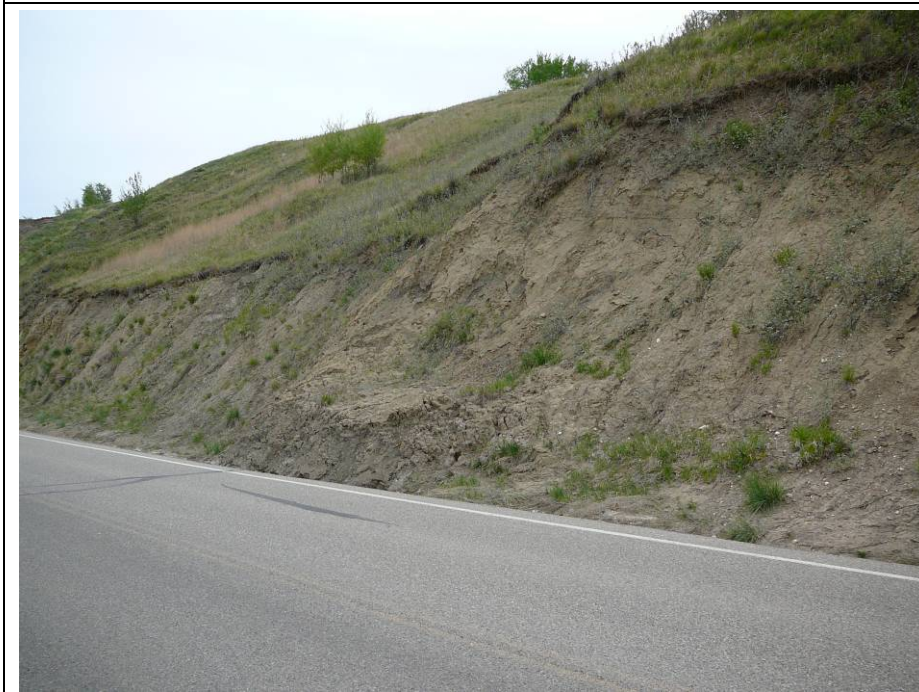
Primary Site Issue:	Failure of joints on band-coupled 450 mm diameter corrugated plastic pipe down-drain installed at km 58.9. Cracking and pavement distress on downslope shoulder of road.	
Dimensions:	Cracking and pavement distress extend from shoulder to the middle of the south-bound lane, along roughly 90 m length of road north of the down drain.	
Maintenance:	No maintenance conducted since 2008.	
Observations:	Description	Worsened?
<input checked="" type="checkbox"/> Pavement Distress	Longitudinal cracking and occasional transverse cracks along 90 m length of road north of the trunk drain. Longitudinal cracks extend from the downslope shoulder into the middle of the south-bound lane (Photos 4 and 5).	<input checked="" type="checkbox"/>
<input checked="" type="checkbox"/> Slope Movement	Small skin failure has occurred on the cutslope above the upslope ditch (Photo 6) and partially blocks the ditch.	<input checked="" type="checkbox"/>

Photo 6.
New skin failure in the upslope road cut. The failed material partially blocks the ditch and should be removed.

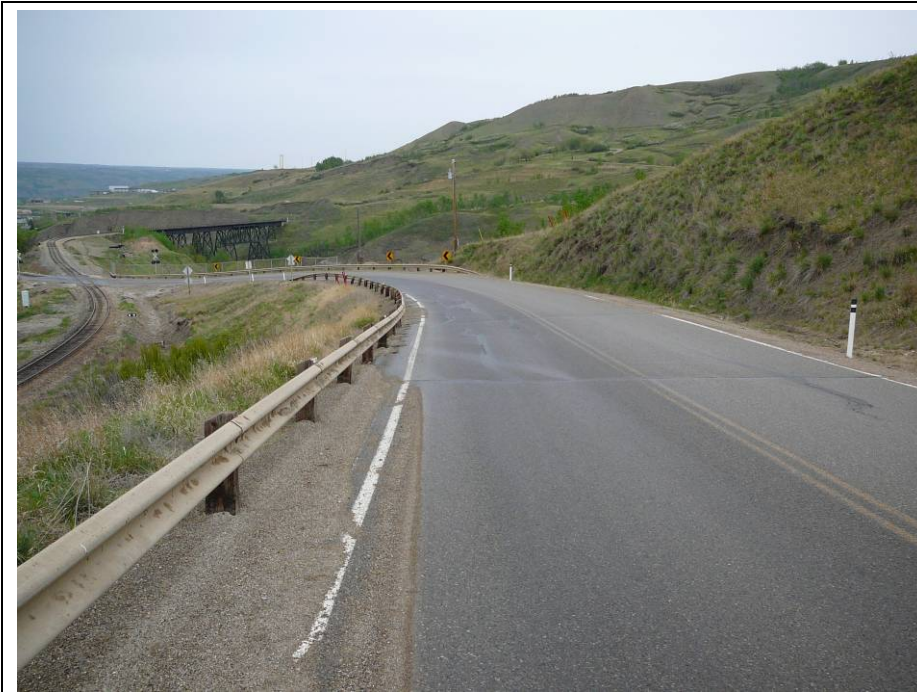
Photo 7.
Some cracking in the road on the inside of the bend on the approach to the CNR crossing.

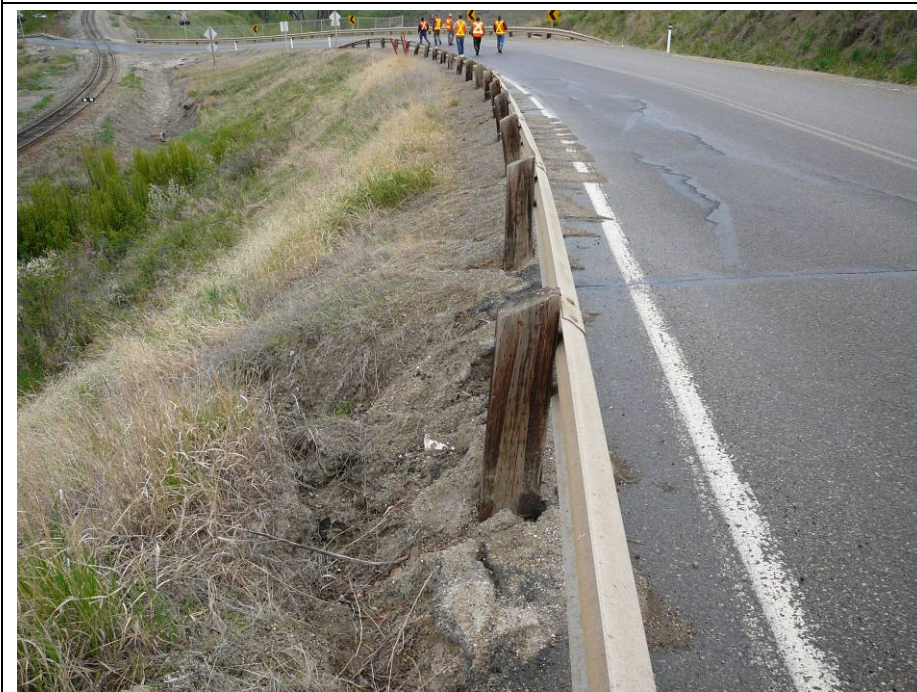
<input checked="" type="checkbox"/> Erosion	Erosion along the road shoulder to the south of the pile wall (Photo 8) – worsened since 2008. Heart River is eroding failed material at the toe of the slope. River has changed course after submerging the rip rap that was designed to keep it away from the toe of the slope	<input checked="" type="checkbox"/>

Photo 8.
Erosion on the road shoulder due to drainage off the road. Also note the cracking along the road.

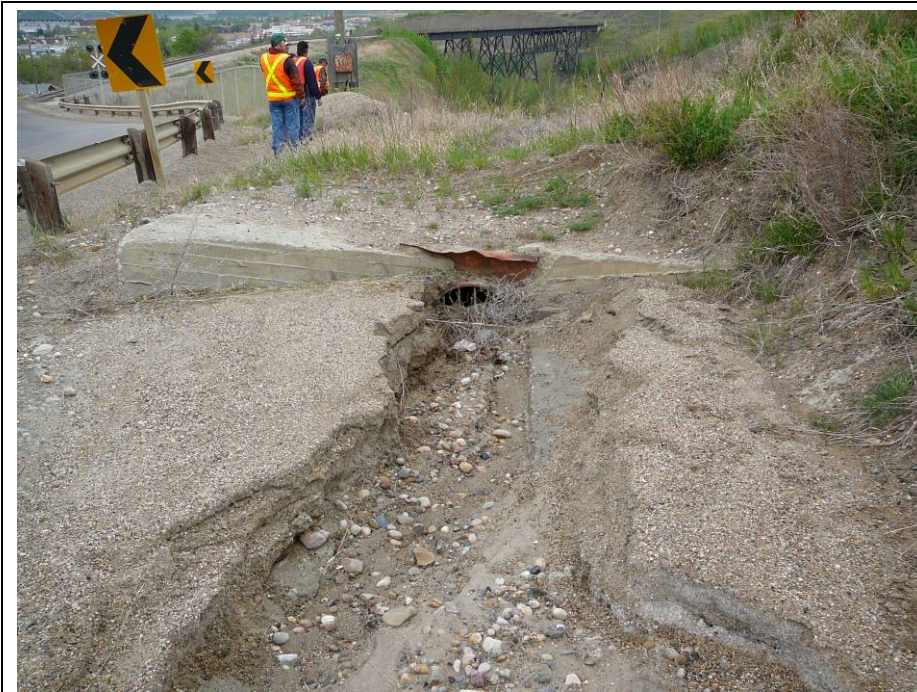
(Photo 13). River is also eroding rock exposed along the toe of the slope where landslide debris has been removed (Photo 12).	
<input type="checkbox"/> Seepage		<input type="checkbox"/>
<input checked="" type="checkbox"/> Bridge/Culvert Distress	Inlet to the CNR Trunk is clogged with debris (Photo 9). Band couplings along the CNR Trunk are beginning to fail – noted in previous years.	<input checked="" type="checkbox"/>
<input checked="" type="checkbox"/> Other	Parging between the piles on the CNR retaining wall has spalled locally (noted in previous years – has not worsened significantly) – see Photo 10.	<input type="checkbox"/>
Instrumentation:		
No instrumentation installed at this site.		
Assessment:		
<p>Movement at the toe of the CNR slide is continuing, worsened by erosion of failed material at the toe of the slide. Erosion at the toe of the slope, which started in 2007, is expected to continue, with consequent further slide movement and retrogression of the backscarp towards the rail line and road. The pile wall along Hwy 744 was drilled to 20 m depth, and terminated above the expected rupture surface, so would be vulnerable to loss of toe support.</p>

Photo 9.
Inlet to the CNR
Trunk down drain –
the inlet is partly
clogged, and requires
maintenance.

Recommendations:		Cost
Install mesh (welded wire or similar), anchored to the piles (and into the soil if possible) using Hilti anchors, for example, at areas of spalled parging. Place new parging to cover the mesh.		Maintenance
Remove debris from CNR Trunk down-drain. Repair band couplings on drain that are failed and appear to be leaking.		Maintenance
Install two slope indicator casings to EL. 332 (or lower to ensure at least 3 m embedment into sandstone below slickensided claystone / clay shale) between slide backscarp and pile wall. Log test holes to provide geotechnical information for design of possible tied-back pile wall to support current CNR Trunk wall. Install vibrating wire piezometers with data loggers in the sandstone, slickensided claystone / clay shale and clay till units at both inclinometer locations.		Investigation
Establish survey network around the pile wall, including benchmarks on 'stable' ground, and control points on the top and bottom of the wall. Conduct regular surveys every 1 – 2 years to detect movement / deflection of the wall, check for the length of exposed wall and movement of the ground around the wall.		Investigation

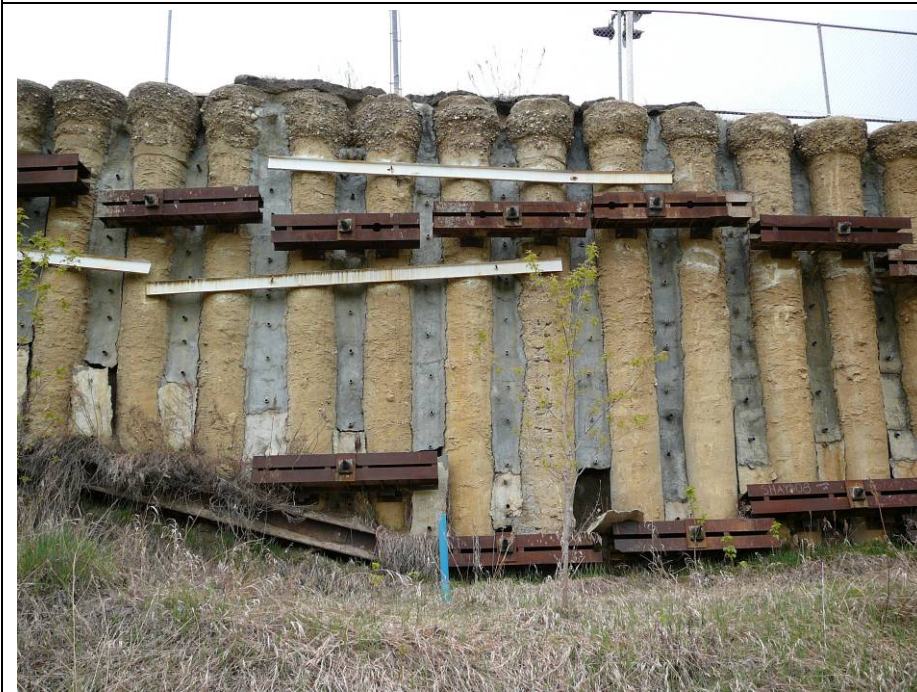
Photo 10.
Looking up at the
CNR retaining wall.
There are portions of
parging between the
piles that has spalled.
There isn't evidence
that significant soil is
being lost from
between the piles.

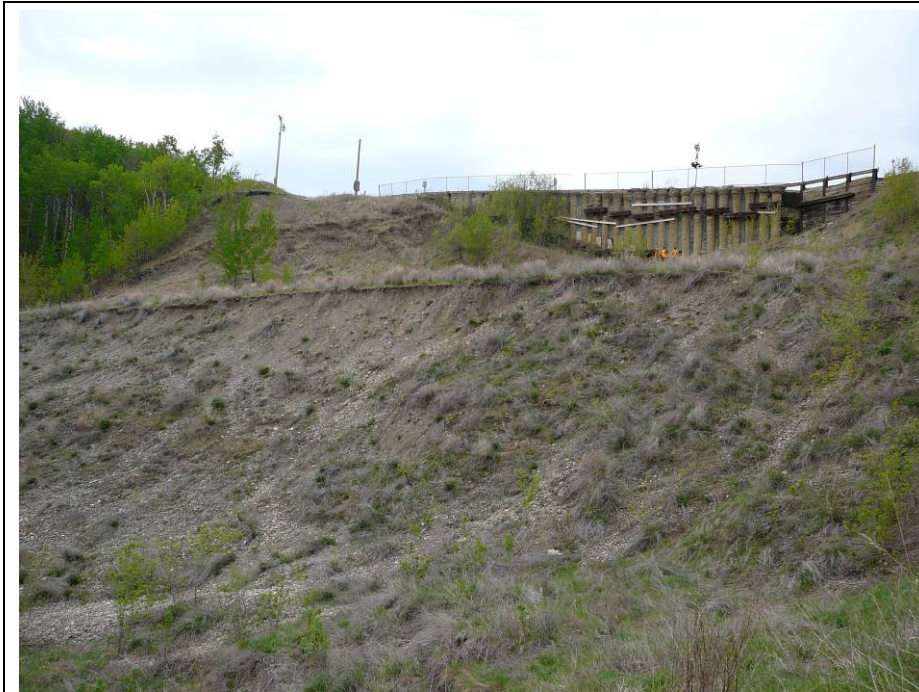
Primary Site Issue:	Two rotational slides, one above the other, with the toe being eroded at the Heart River. Slide movement apparently occurring over an eroded bedrock surface, above river level. Crest of slide(s) has previously affected the road and rail line near the level crossing. Pile walls installed to protect the road and rail line. Rip rap installed to protect the toe of the slope has been submerged by sediment in the Heart River.		
Dimensions:	80 m wide, 110 m long (plan view). Slide plane is probably 15 m to 20 m deep.		
Maintenance:	No maintenance since 2008.		
Observations:	Description	Worsened?	
<input checked="" type="checkbox"/> Pavement Distress	Minor pavement distress and erosion of the west (downslope) shoulder of the road (Photos 7 and 8).	<input checked="" type="checkbox"/>	
<input checked="" type="checkbox"/> Slope Movement	Significant movement of failed material at the toe of the landslide – movement visible during inspection (Photo 12). No obvious retrogression of backscarp since 2008 (Photo 11).	<input checked="" type="checkbox"/>

Photo 11.
Backscarp of slide in the toe berm in front of the CNR pile wall. The backscarp has not retrogressed significantly since 2008.

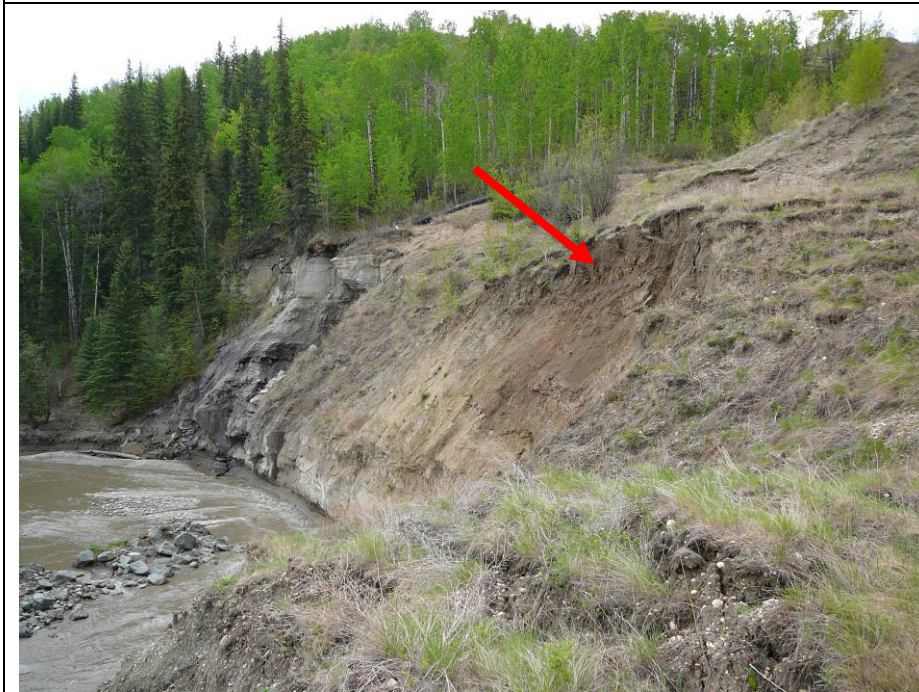
Photo 12.
Toe of the slope below the CNR pile wall. Significant additional slide movement has occurred, particularly at the south end of the failure. There was an area of active slide movement during the inspection (arrow).

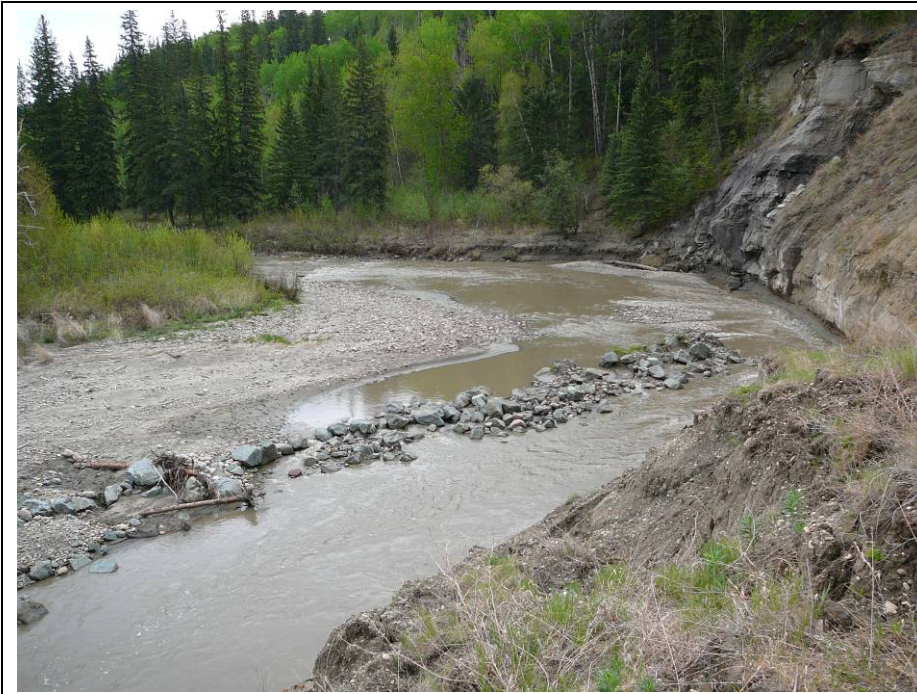
Photo 13.
The Heart River is now flowing entirely on the west side of the channel, having bypassed the rip rap. Erosion is occurring along the toe of the slope, removing debris (foreground) and undercutting the rock slope.

<p>Options to limit erosion by the Heart River at the toe of the slope should be assessed – this may require a review of river hydraulics. Mid-term to long-term repair options might include installation of a secant pile wall near the base of the slope. A shorter wall could be constructed nearer the toe of the existing pile wall at reduced cost. River training works such as rock vanes may be required in support of other repair options, or to limit further slope movement.</p>	<p>Investigation \$ 3 million to \$ 5 million \$ 300,000</p>
--	---
