# ALBERTA TRANSPORTATION GEOHAZARD ASSESSMENT PROGRAM PART A: FILE REVIEW

## PEACE REGION – PEACE-HIGH LEVEL

### PH33 JUDAH HILL – TRUNK AND CNR SLIDES

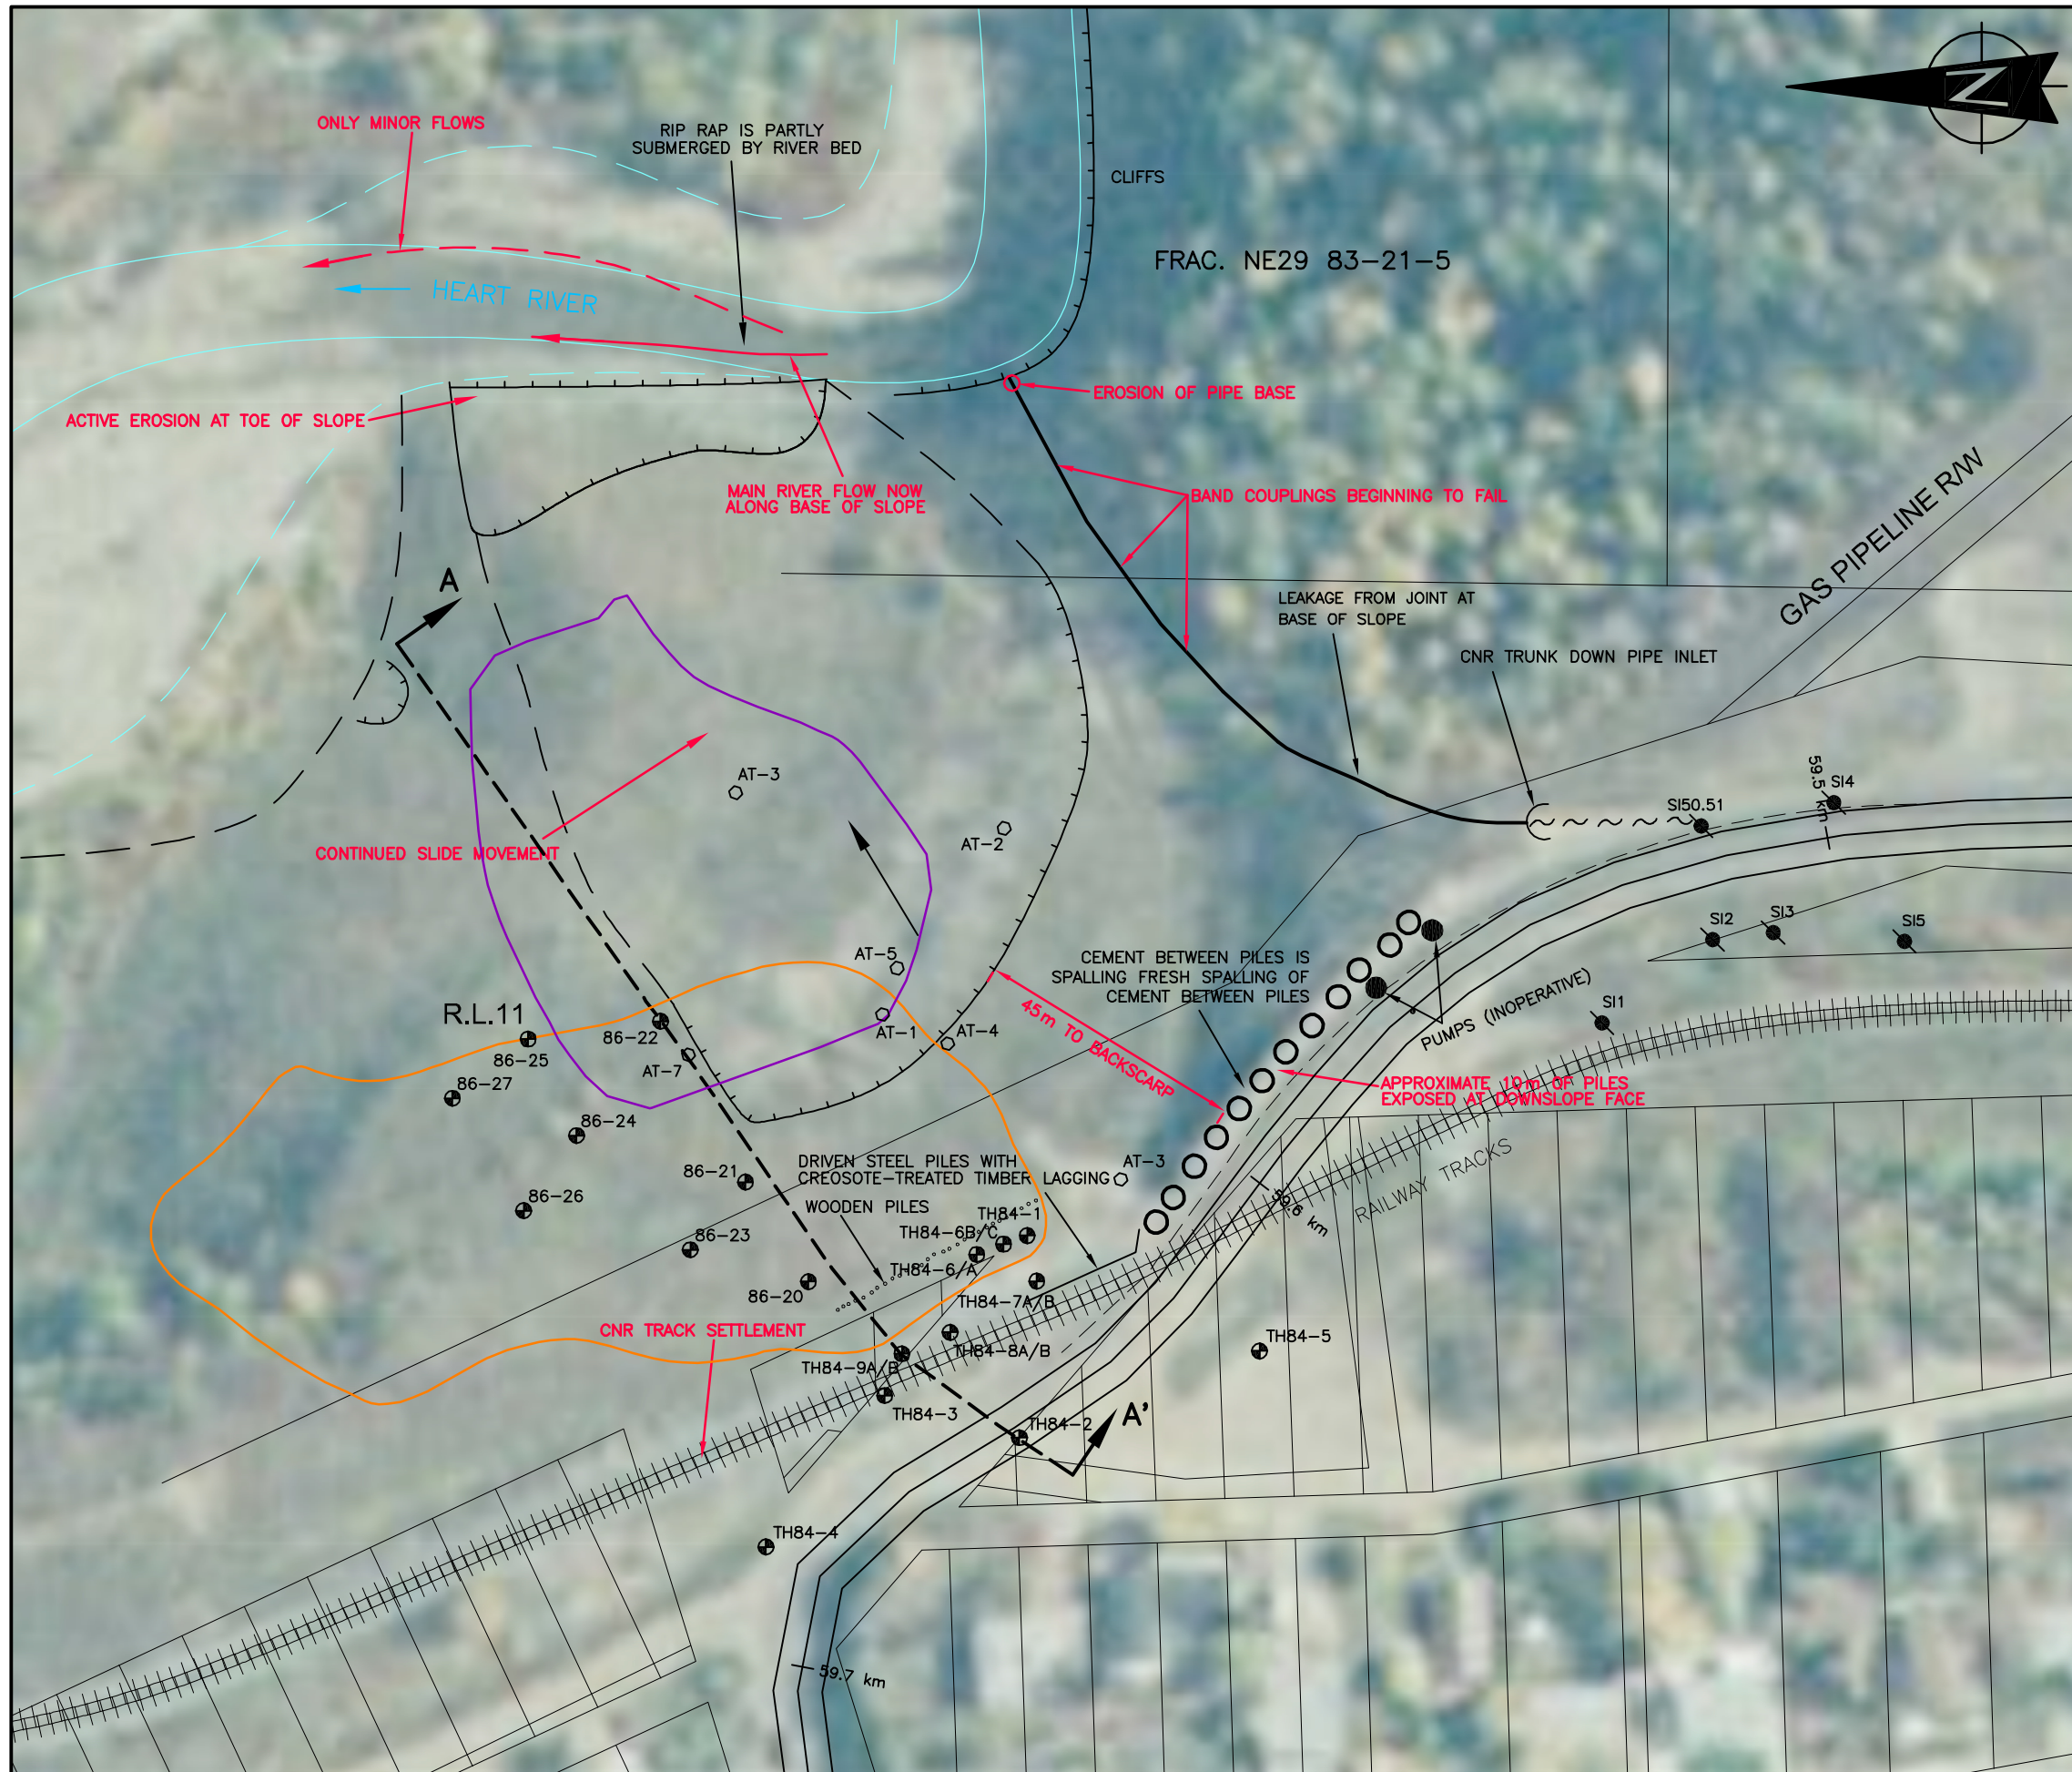
**FIGURE 2**

The CNR Slide is located on the east side of Hwy 744 at the CN Rail crossing as you enter the town of Peace River from the south. The road turns westwards to cross the rail line, at the end of a spur formed where the upland has been eroded on both sides by the Peace and Heart Rivers. The slide is on the NE side of the rail crossing, moving eastwards towards the Heart River, with a roughly 50 m wide lower scarp and active zone near the river, and an upper 80 m wide scarp in gravel fill within 45 m of the ATrans pile wall.

Significant settlement of rail grade just prior to site visit – being repaired during visit. Additional erosion by the Heart River and movement at the toe – backscarp is 45 m from toe of pile wall. Majority of Heart River flow is now occurring in the channel along the toe of the slide. Additional failure of band couplings on CNR Slide downdrain.

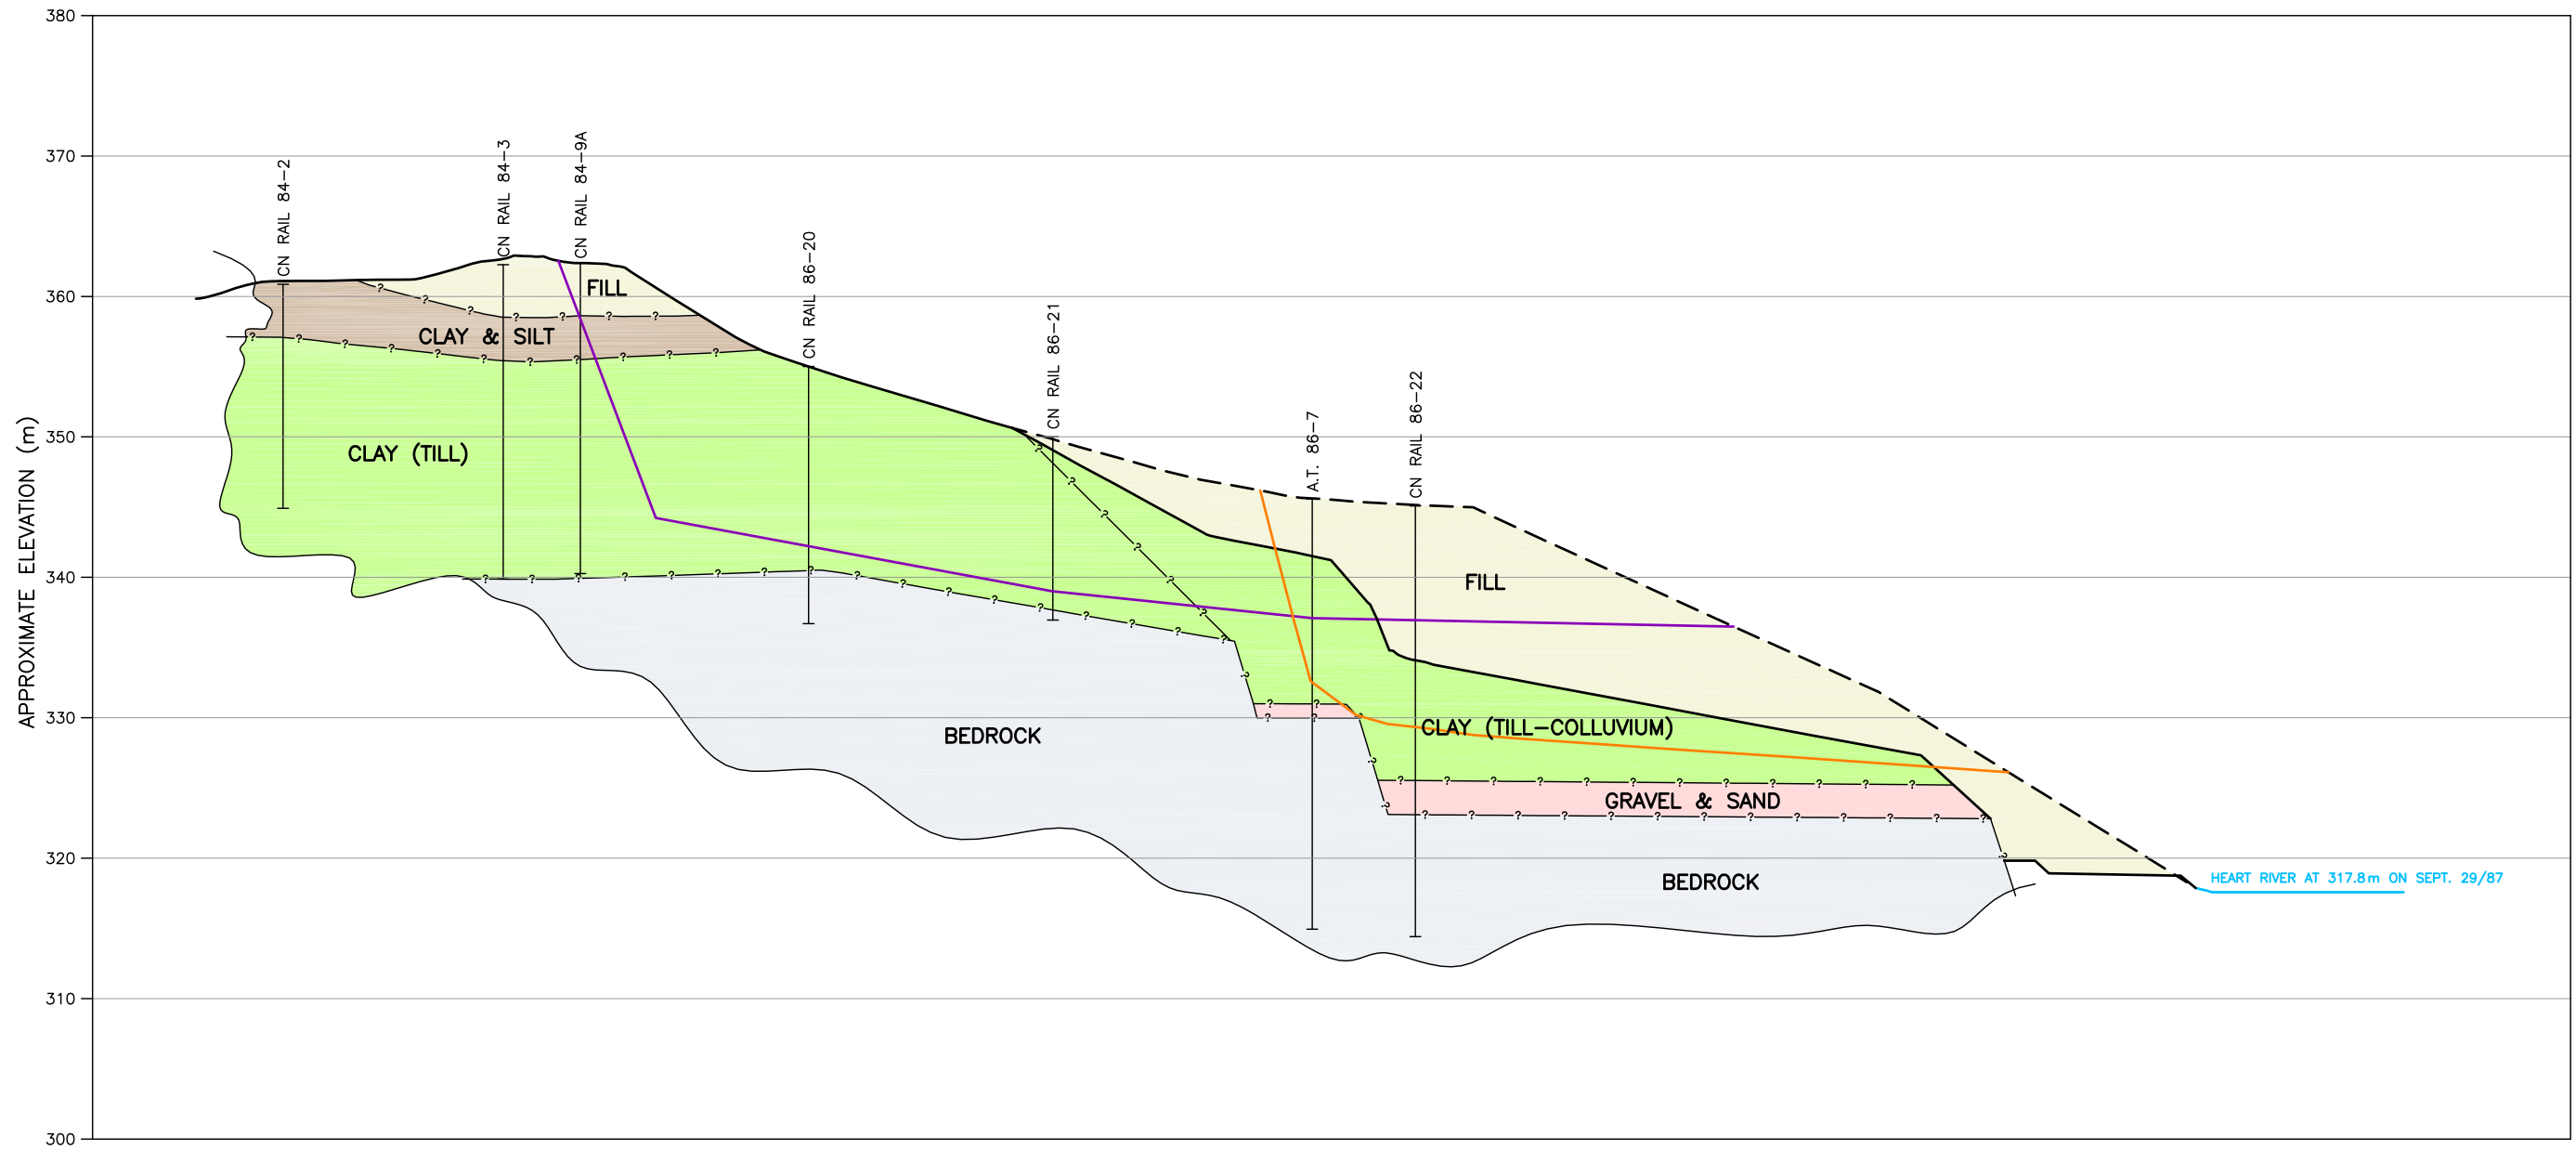
FIGURE 3

There have been a number of geotechnical investigations conducted by Alberta Transportation and CN rail at the CNR Slide. A cross-section prepared by Thurber Engineering for a report in 1988 summarising test hole information through the slide is presented on Figure 3.

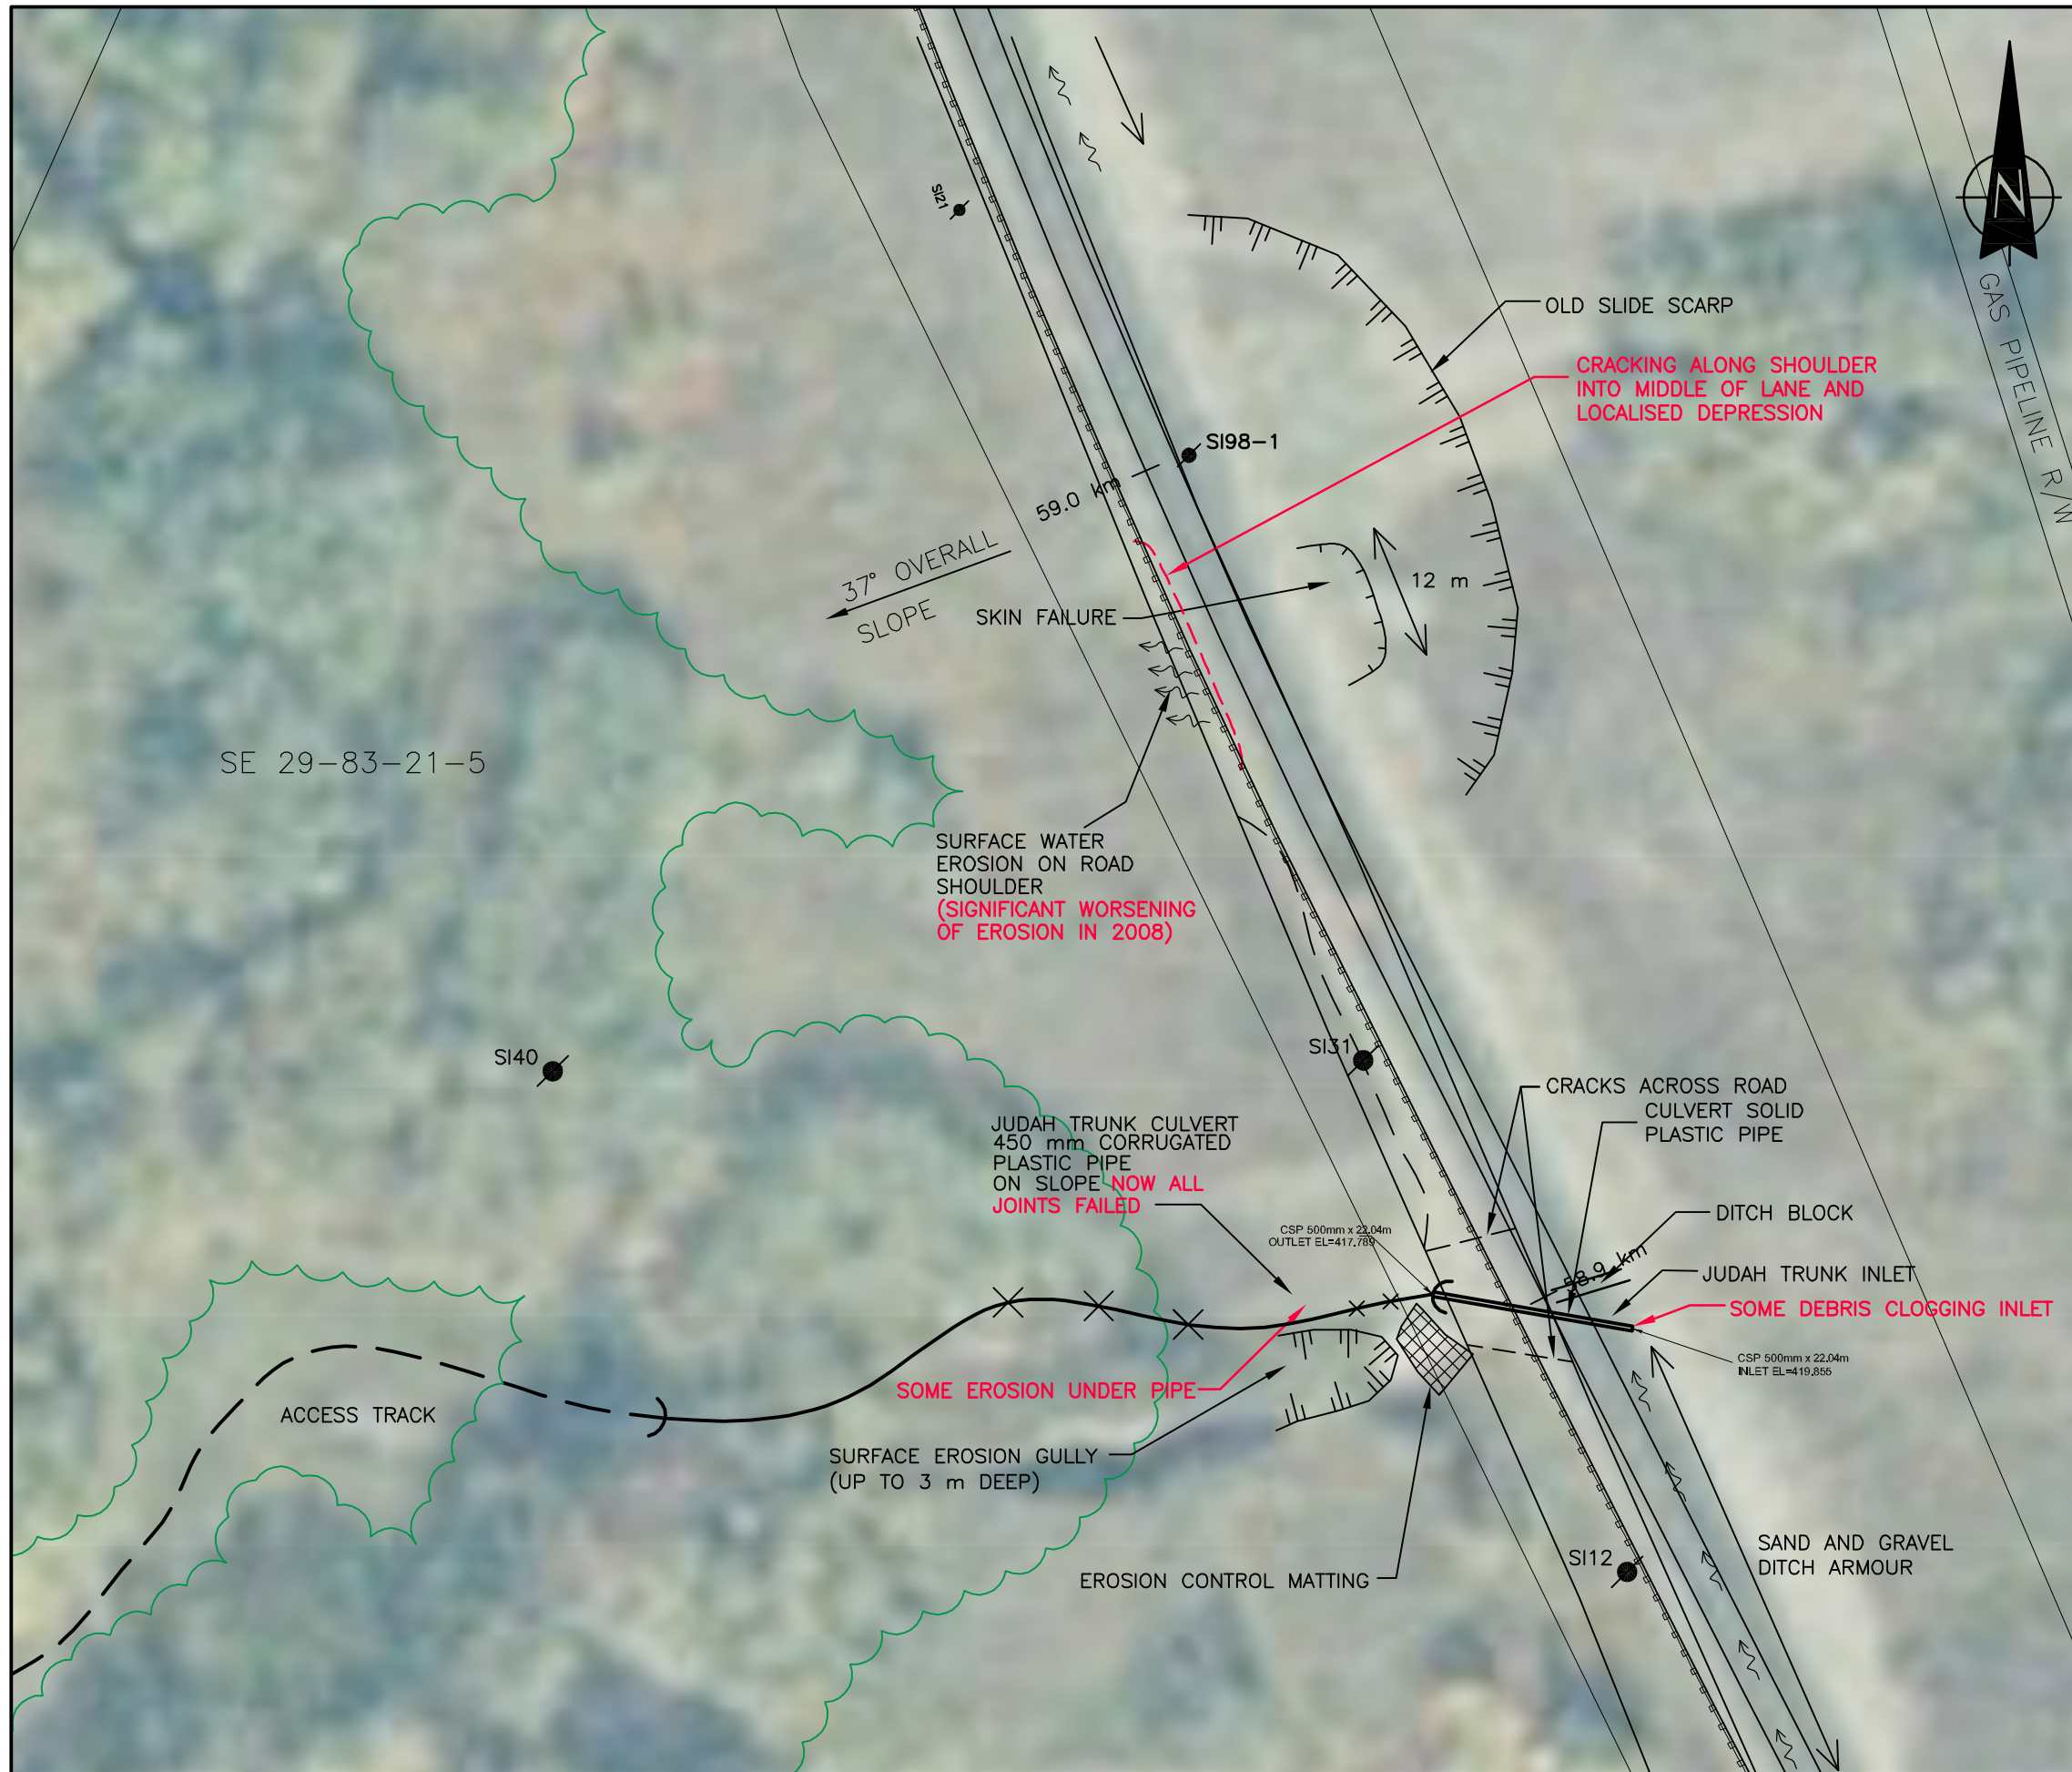
FIGURE 4

The Judah Trunk is approximately 700 m south of the railway crossing, where drainage from the upslope ditch is taken across the road and directed down the slope in a band-coupled corrugated plastic pipe. The pipe discharges on a flatter area immediately above the rail line.

At the Judah Trunk, the road is constructed in cut and fill, with a relatively steep fill slope below the downslope road shoulder. There are several older slide scarps in the uphill cutslope, with some recent near-surface slide activity. There is also cracking and surface water erosion along the downslope road shoulder. The catchment for the drain includes the upslope ditch southwards through the Makeout and Michelin slides and as far as the Lookout site. The drain is a similar band-coupled corrugated plastic pipe used at the East Hill drain (PH2) and the Dunvegan Elephant Trunk (PH36), both of which have experienced problems with coupling failure and leakage. Immediately south of the trunk down-drain is a deeply eroded gully where drainage was presumably previously directed.

Minor erosion in ditch upstream of Judah Trunk inlet. Debris at inlet. All band couplings on downdrain have failed, and erosion is occurring under first joint. Cracking and surface water erosion on downslope road shoulder has worsened.
