**ALBERTA TRANSPORTATION
GEOHAZARD ASSESSMENT PROGRAM
PEACE REGION (PEACE RIVER DISTRICT)
2021 INSPECTION**

Site Number	Location	Name	Hwy	km
PH033-1	Judah Hill	CNR Slide	744:04	59.451
Legal Description		UTM Co-ordinates		
NE¼ 29-083-21 W5M		11V E 482645	N 6231308

PH033-1 JUDAH HILL - CNR SLIDE
 2021 SITE INSPECTION PLAN

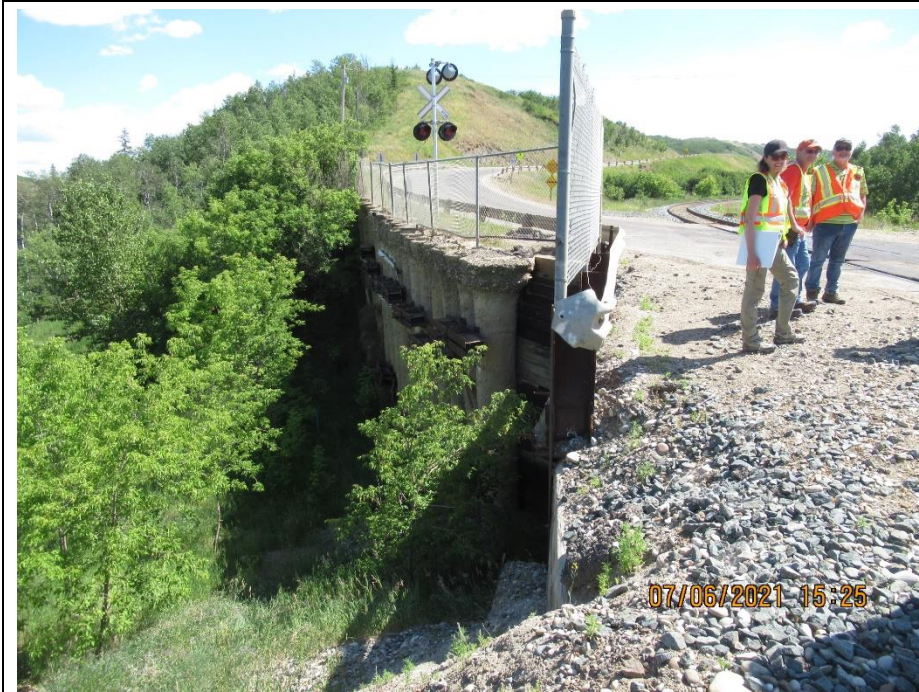
Photo 1.
Looking southeast from the north end of the CNR pile wall. Apart from ongoing ravelling and cement spalling between the piles there was no significant change observed at the downslope face of the pile wall or slope directly below since 2020.

Recommendations:		Cost
Install mesh (welded wire or similar), anchored to the piles (and into the soil if possible) using Hilti anchors, for example, at areas of spalled parging. Place new parging to cover the mesh and fill the voids between piles. Install drainpipes through the parging to avoid blocking seepage.		Maintenance

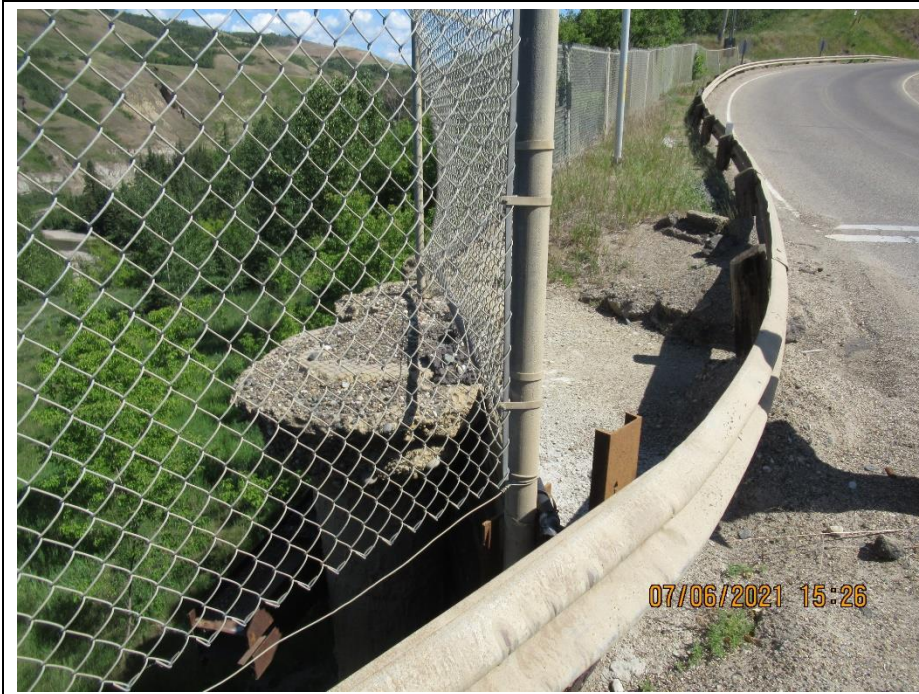
<input checked="" type="checkbox"/> Pavement Distress	Pavement distress with scouring and rills on the west (downslope) shoulder of the roadway embankment near km 59.53 (Photo 10). Repaired sink hole at pile was in good condition (Photo 2).	<input checked="" type="checkbox"/>	
<input checked="" type="checkbox"/> Slope Movement	No obvious retrogression of upper main backscarp since 2008 (Photo 6). No obvious slope movement directly downslope from the wall, upslope of S10-17 (Photo 1). Continued slope movement along lower portion of the north flank due to river erosion of the lower landslide toe (Photo 7).	<input checked="" type="checkbox"/>	
<input checked="" type="checkbox"/> Erosion	Erosion along the roadway west shoulder to the south of the pile wall. Ongoing ditch erosion and debris transportation near the CNR Trunk inlet along the highway upslope ditch. Ongoing sideslope erosion rills and gullying at km 59.55 and km 59.48 (Photos 8 to 10).	<input checked="" type="checkbox"/>

Photo 2.
Repaired area above the piles where a void formed from soil loss between the two northernmost piles at the CNR pile wall along the NBL shoulder of Hwy 744:04 at km 59.62 was backfilled with concrete. Repair was in good condition.

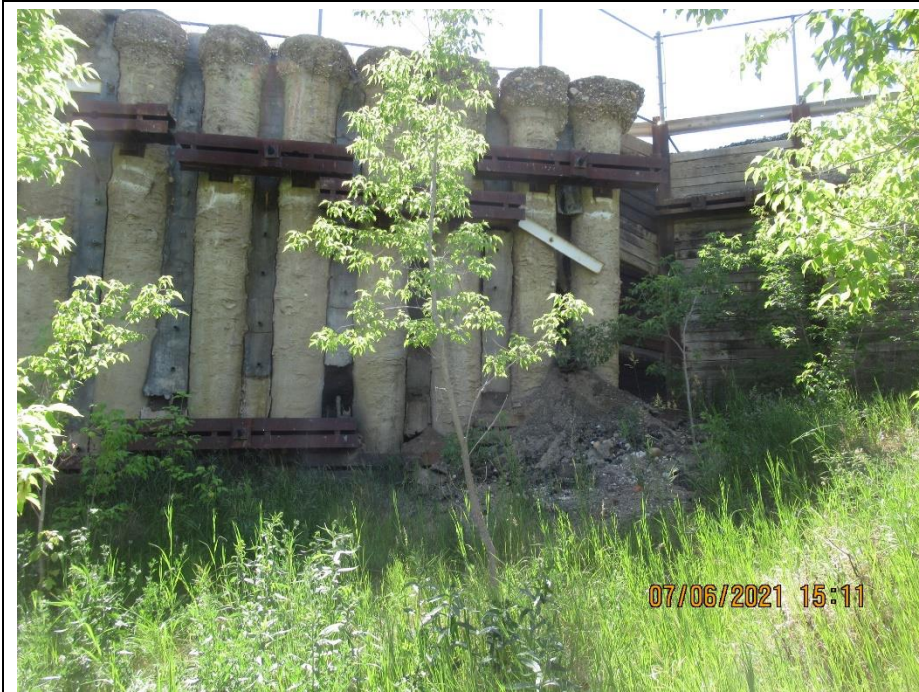
Erosion is occurring below the severed section of the CNR Trunk downslope drainpipe. There has been retrogression and lateral expansion since 2020. (Photos 4 and 5) River has changed course after submerging the rip rap that was designed to keep it away from the toe of the slope. River has exposed rock along the toe of the slope where landslide debris has been removed (Photo 7).	
<input type="checkbox"/> Seepage		<input type="checkbox"/>
<input checked="" type="checkbox"/> Bridge/Culvert Distress	Inlet to the CNR Trunk is partially buried with debris. The pipe conduit has completely failed immediately below the crest of the upper valley slope. As a result, a scour is rapidly forming in the slope below the breakage and sediment is accumulating in the intermediate plateau below (Photo 5).	<input checked="" type="checkbox"/>
<input checked="" type="checkbox"/> Other	Increased concrete spalling and sloughing between the piles on the CNR retaining (noted in previous years) (Photo 3).	<input checked="" type="checkbox"/>

Photo 3.
Looking south at the soil loss between the northernmost piles of the CNR pile wall north of Hwy 744:04 at km 59.61. Increased buildup of soil and concrete spalling between the piles since 2020.

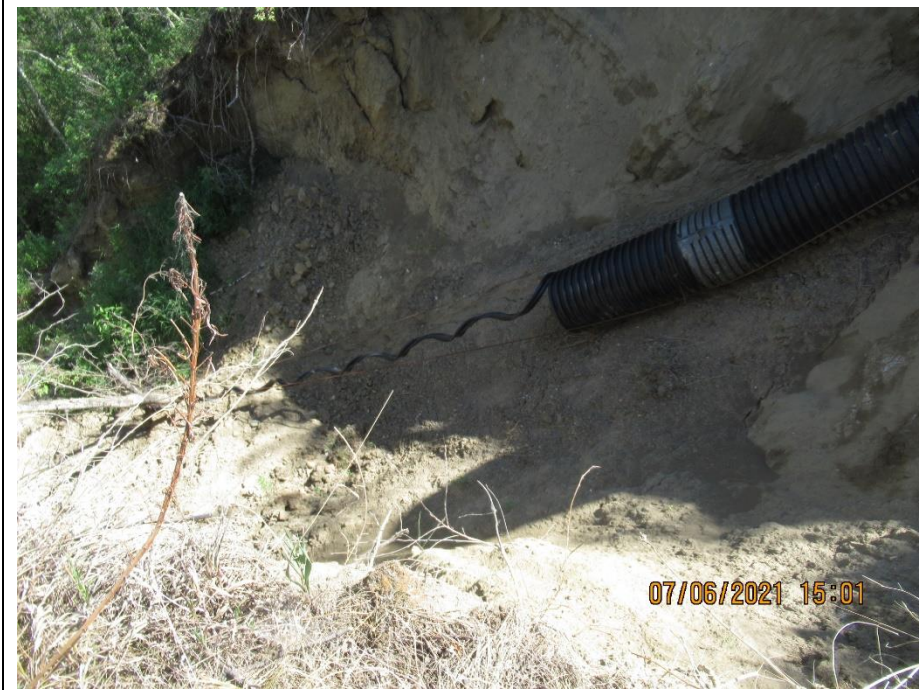
Photo 4.
Looking east at break in CNR CPP Trunk pipe and erosion gully at crest of the Heart River valley slope.

Replace CPP drainpipe with a realigned anchored welded pipe. Consider a curb and gutter along the edge of asphalt, or a depressed swale, to channel water away from edge of pavement and to divert runoff away from the back of the piles. Fill the rills and around the guardrail posts with gravel covered with seeded topsoil.	\$300,000 Maintenance
Establish survey network around the pile wall, including benchmarks on 'stable' ground, and control points on the top and bottom of the wall. Conduct regular surveys every 1 – 2 years to detect movement / deflection of the wall, check for the length of exposed wall and movement of the ground around the wall.	Investigation
Assess the stability of the wall and ability to resist overturning based on the length of exposed wall and current ground anchorages. Assess the need for a toe support wall.	Investigation
Options to limit erosion by the Heart River at the toe of the slope should be assessed – this will require a review of river hydraulics. Drone survey of the toe area would also be beneficial for detailed assessment and ongoing monitoring.	Investigation

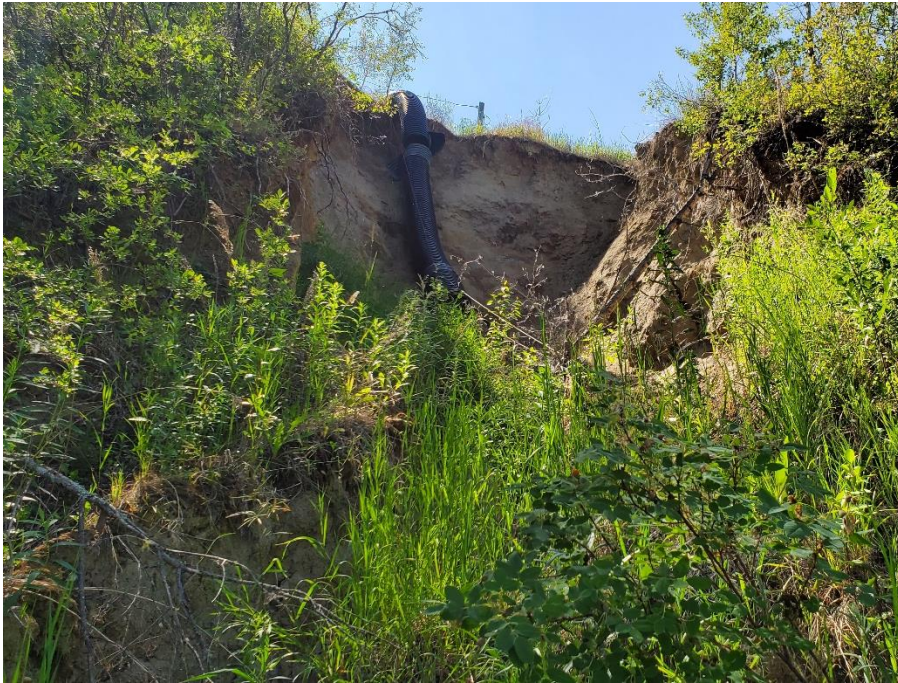
Photo 5.
Looking southwest from below the scour caused by the breakage in the CNR CPP Trunk pipe. There has been some retrogression and lateral expansion at the gully headwall since 2020.

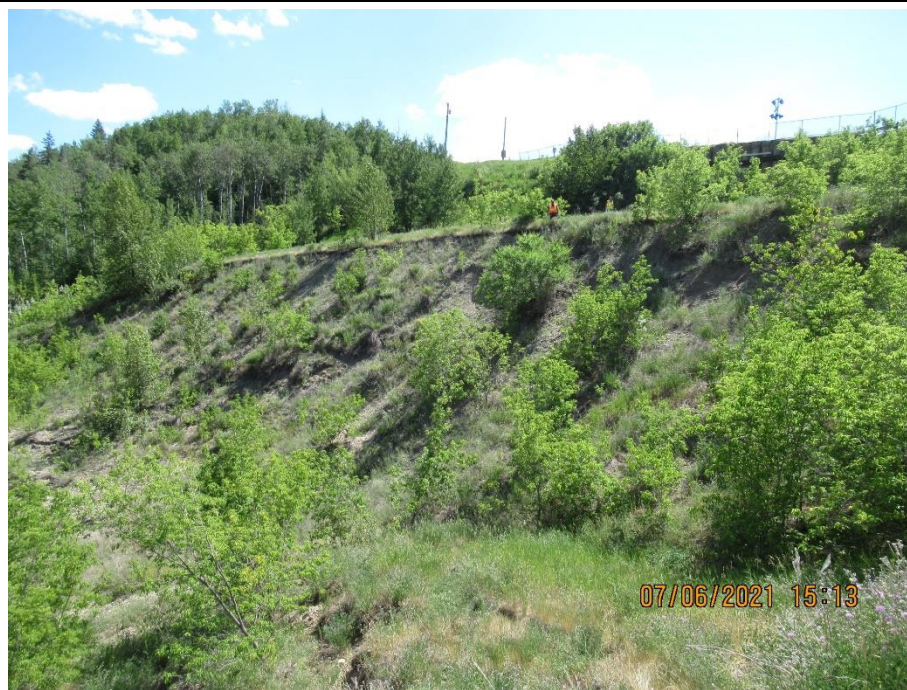
Photo 6.
Looking southeast from the north side of the lower slide. No major changes observed in the slope area below the pile wall since 2020.

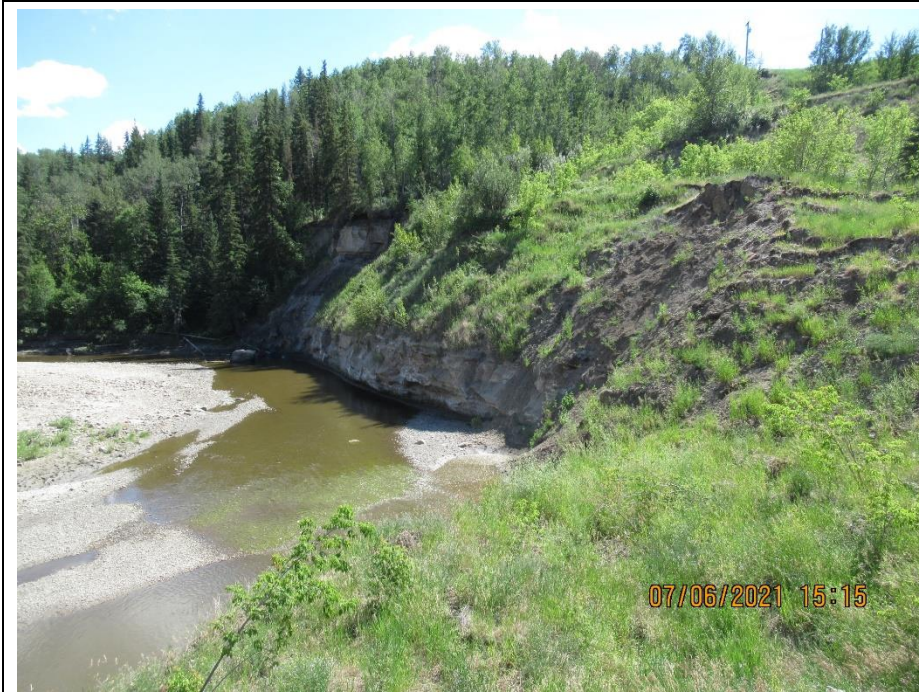
Photo 7.
Looking east along the toe of the lower landslide. Lower slide activity and toe erosion at the riverbank is active.

Mid-term to long-term repair options might include installation of a secant pile wall near the base of the slope. A shorter wall could be constructed nearer the toe of the existing pile wall at reduced cost.	\$ 3 million to \$ 5 million
River training works such as rock vanes may be required in support of other repair options, or to limit further slope movement.	\$ 500,000

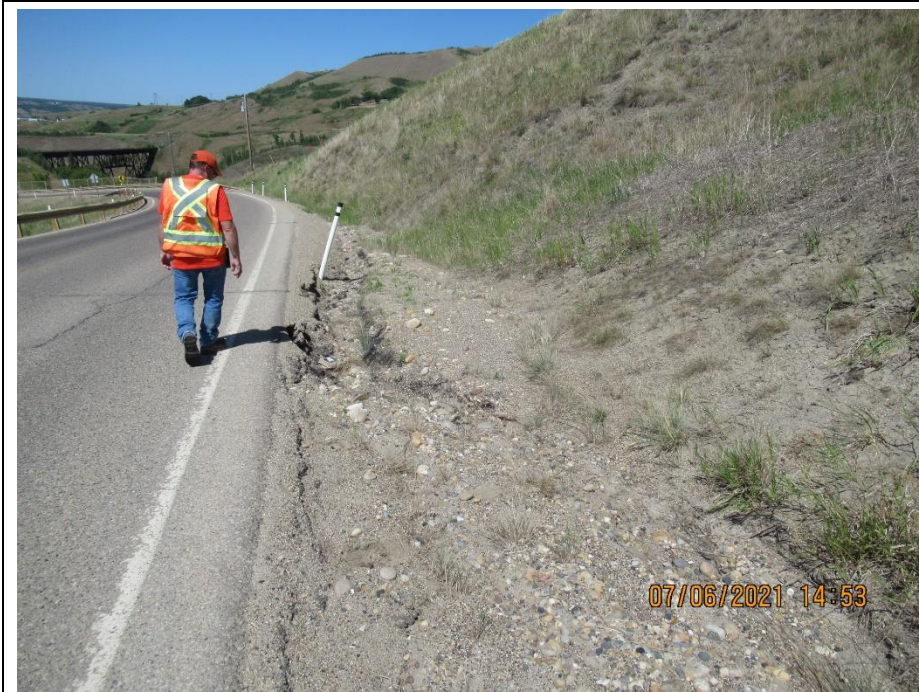
Photo 8.
Looking north towards the erosion in the east ditch.

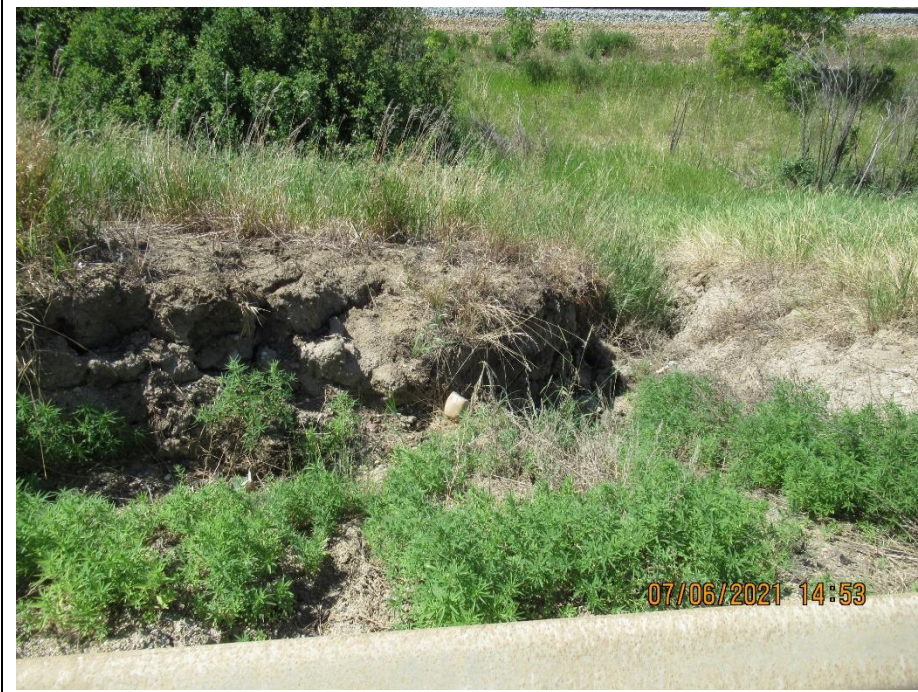
Photo 9.
Looking west at erosion gully in the embankment near KM 59.48. Expanded from previous inspection.

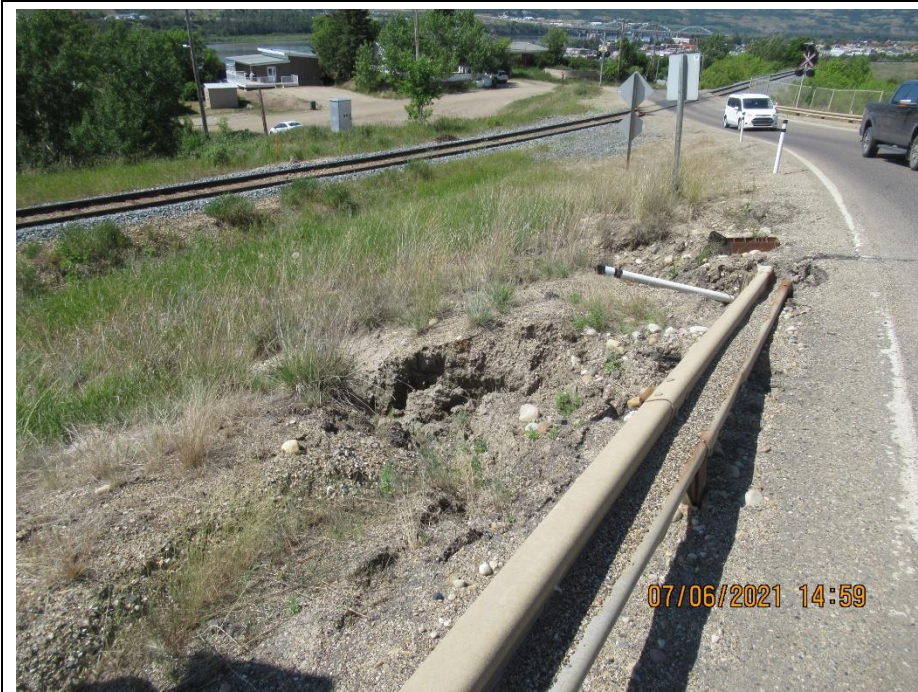
Photo 10.
Looking west at erosion rills and ACP shoulder damage in the embankment near KM 59.53. Slightly worse from previous inspection.
