November 16, 2022 File No.: 32121

ALBERTA TRANSPORTATION GRMP (CON0022164) PEACE REGION (PEACE RIVER DISTRICT) INSTRUMENTATION MONITORING RESULTS – FALL 2022

SITE PH033-1: HWY 744:04, JUDAH HILL (CNR SLIDE) SITE PH033-2: HWY 744:04, JUDAH HILL (TRUNK SLIDE)

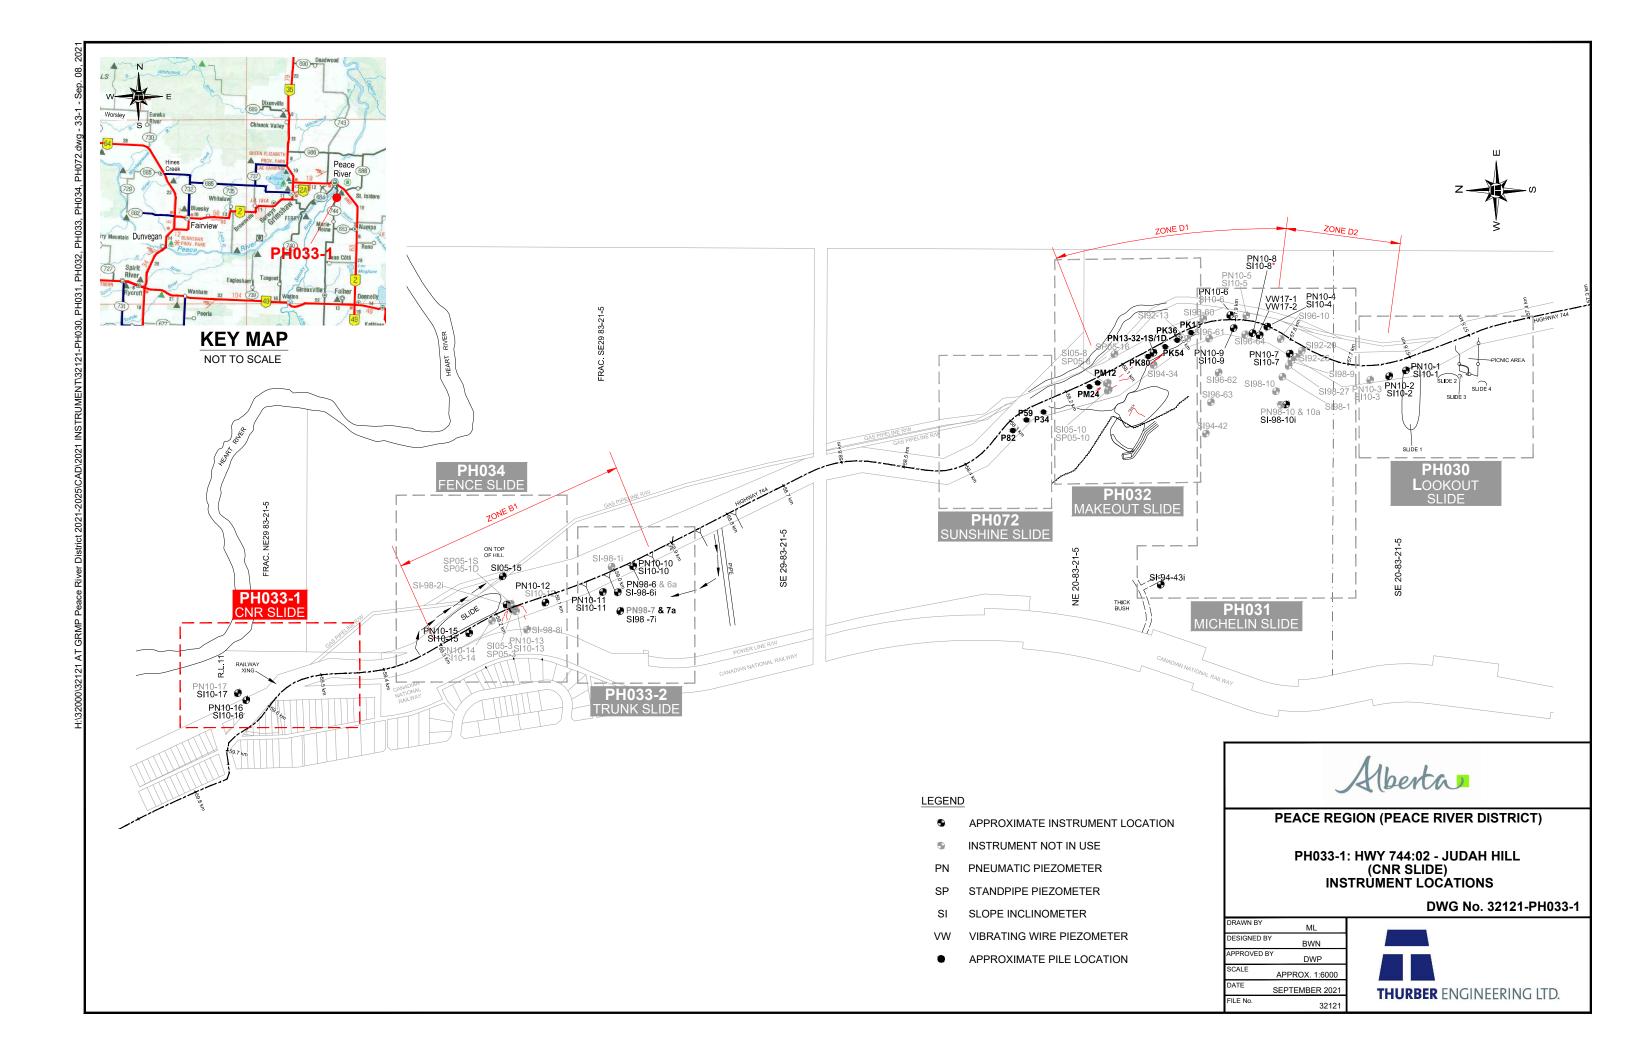
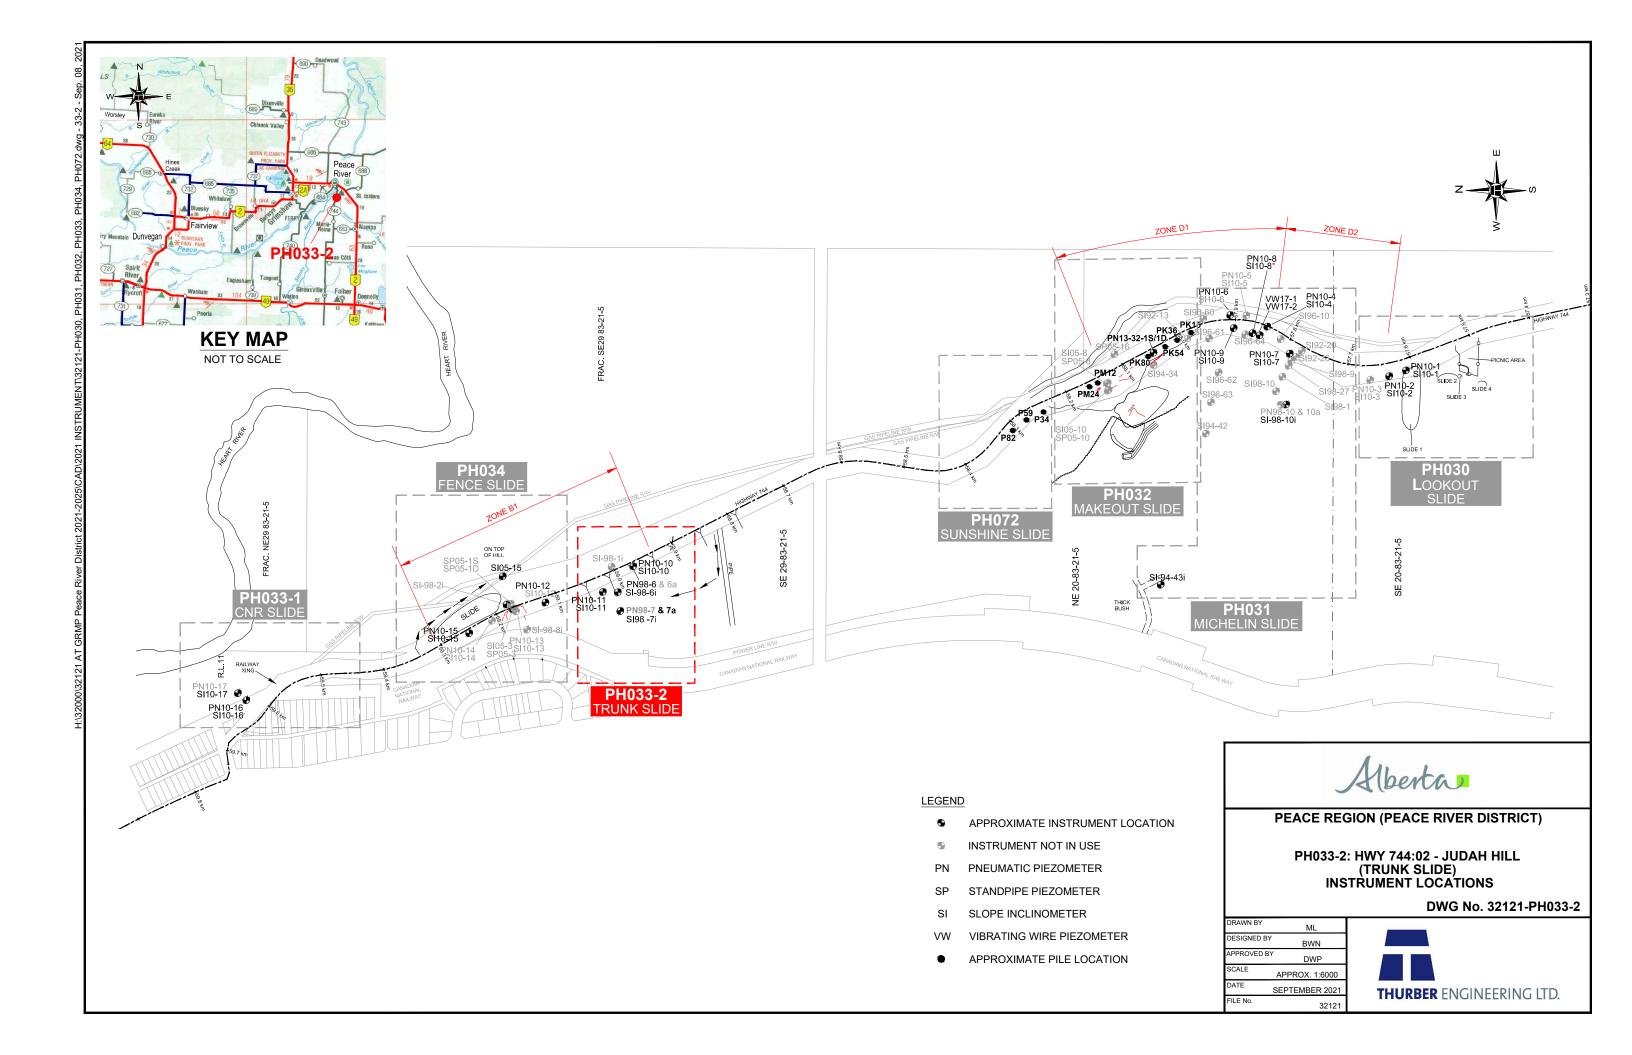
* For SI98-6i & SI98-7i multiply readings by 2 to get the plot in Gtilt.	
** PN top chewed by animal. Fix needed, have to dig down 1.0ft, splice and install PN top. No stickup protector on SI, see photograph

Pneumatic piezometer PN98-7a should be repaired to enable future groundwater readings. The current tip has been chewed off by an animal. To allow a repair, the pneumatic tubes will need to be excavated to an approximate depth of 1 ft to splice on a new pneumatic piezometer tip. It is also recommended to install a stickup protector over PN98-7a to reduce the potential for future damage to the instrument.

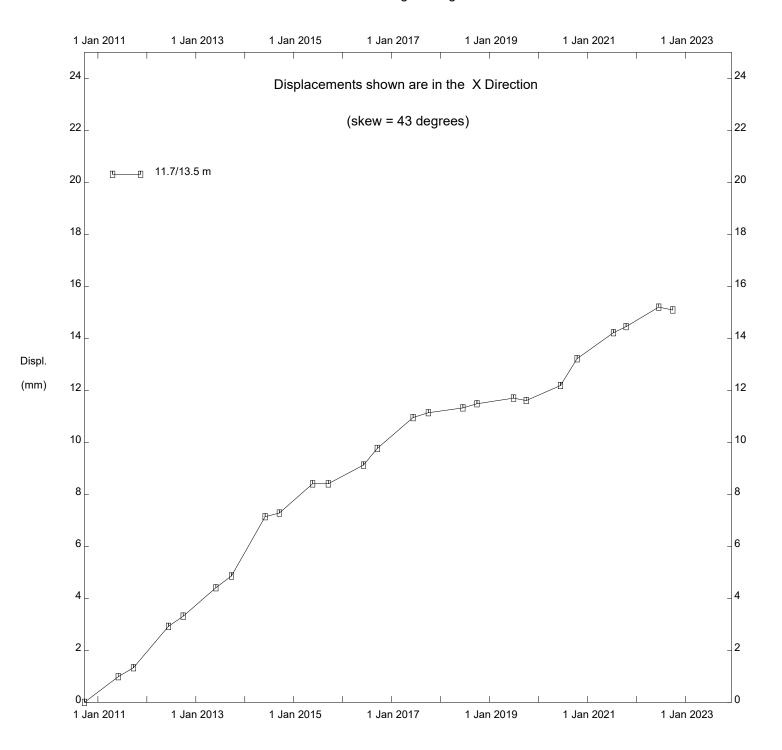
PH033-1 Judah Hill CNR Slide, Inclinometer SI10-16

SI10-16 showed no discernible movement over 11.7 m to 13.5 m depth since the spring of 2022 readings. SI10-17 showed a rate of movement of 0.4 mm/yr over 9.5 m to 11.3 m depth since the spring of 2022 readings.

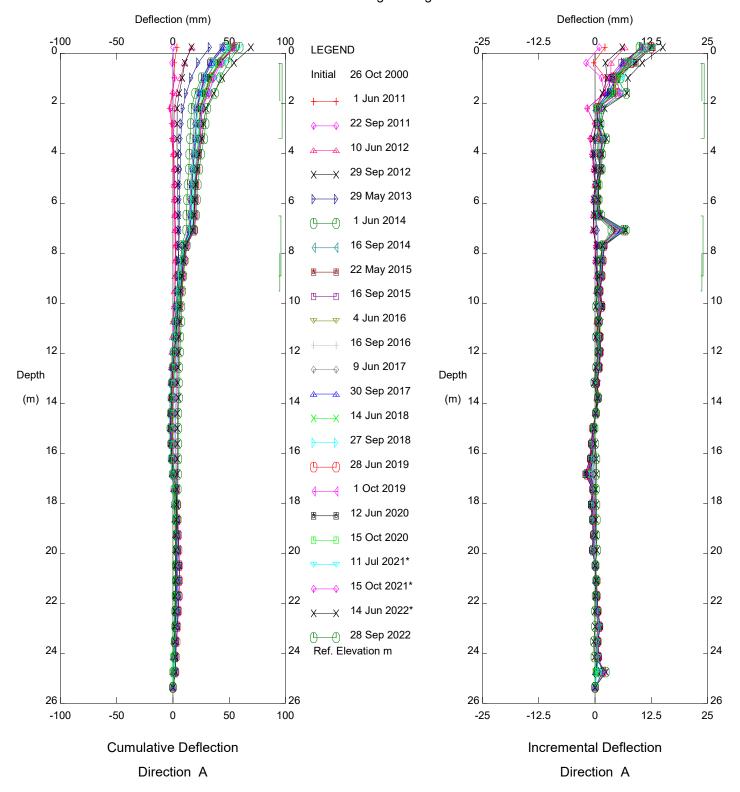
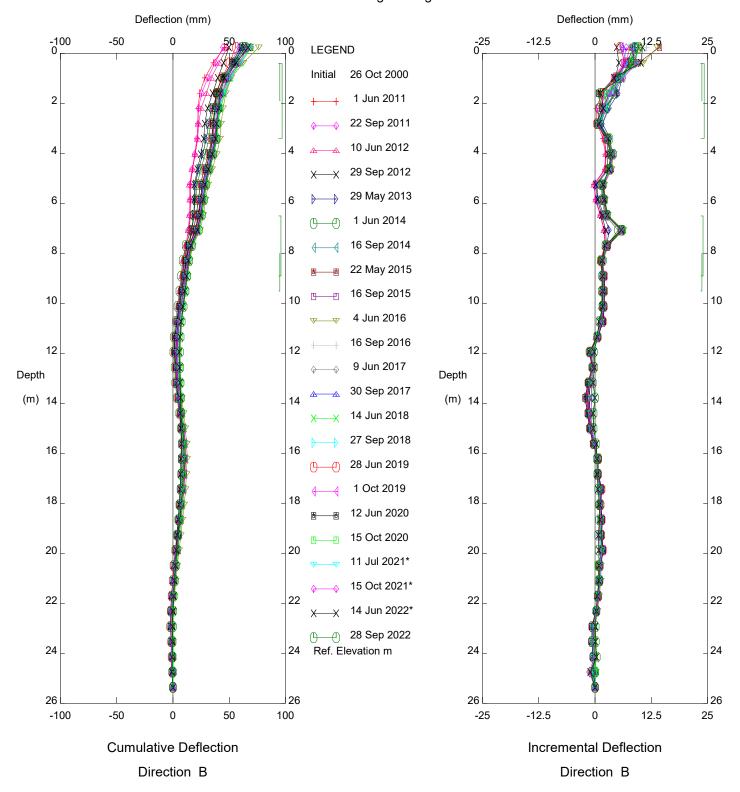
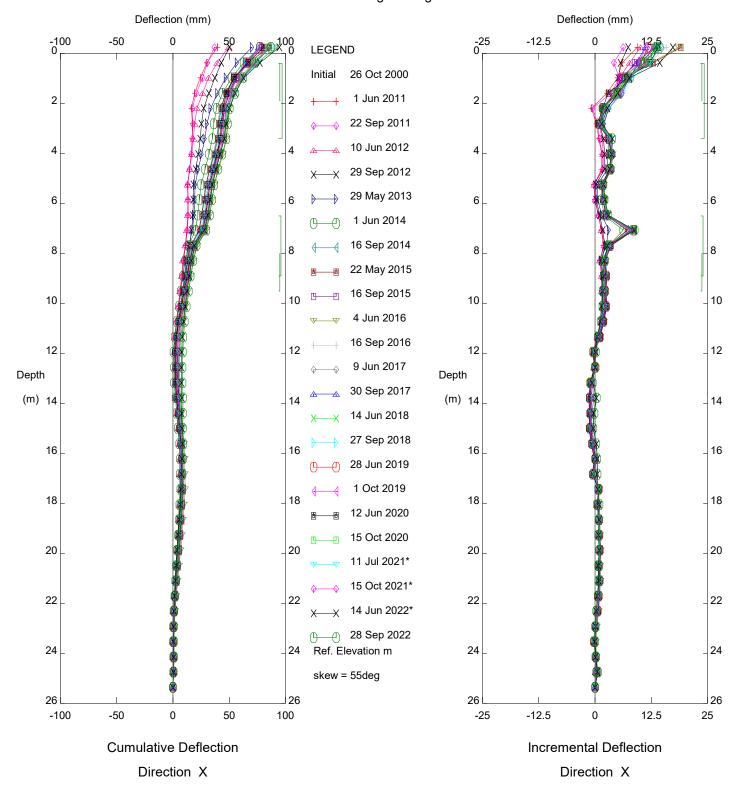
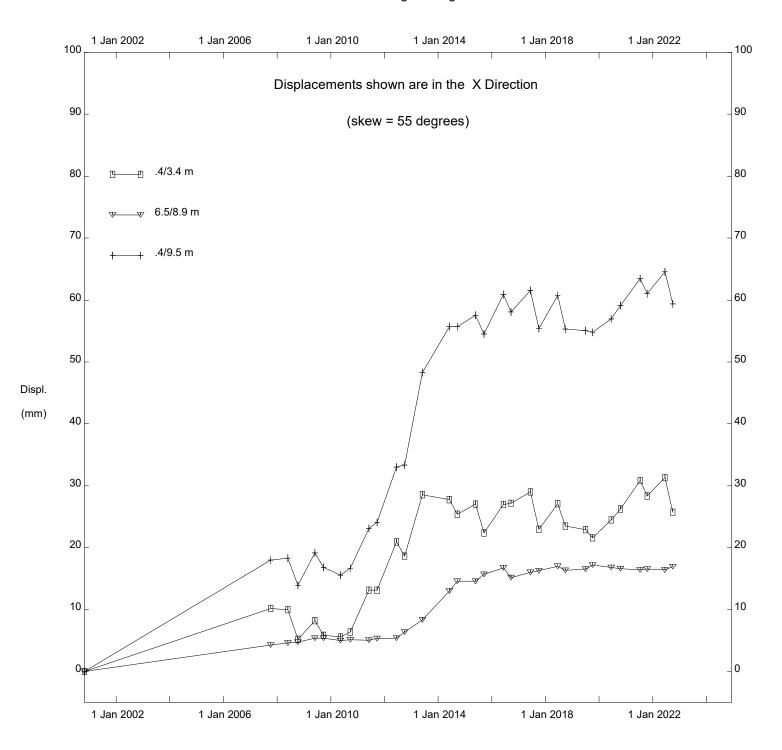
PH033-2 Judah Hill Trunk Slide, Inclinometer SI98-6i

SI98-6i showed no discernible movement over 0.4 m to 3.4 m depth, a rate of movement of 1.7 mm/yr over 6.5 m to 8.9 m depth and no discernible movement over 0.4 m to 9.5 m depth since the spring of 2022 readings. SI98-7i showed no discernible movement over 3.3 m to 4.5 m depth since the spring of 2022 readings.

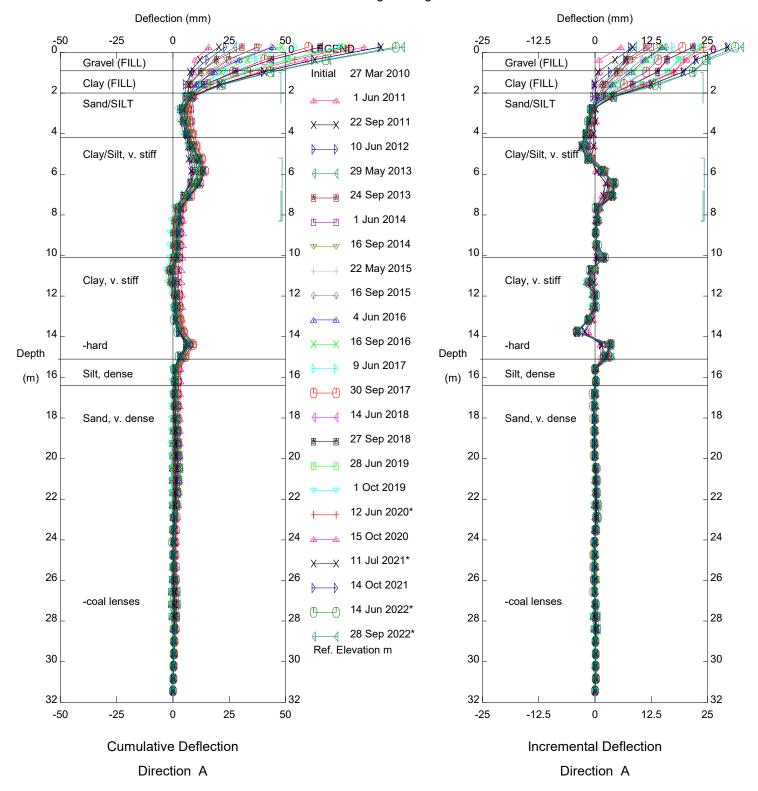
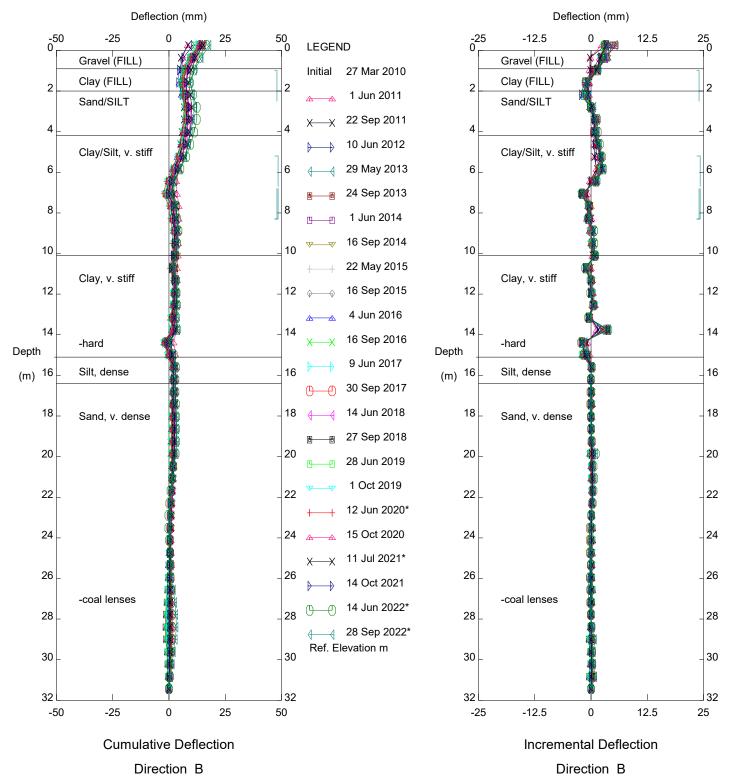
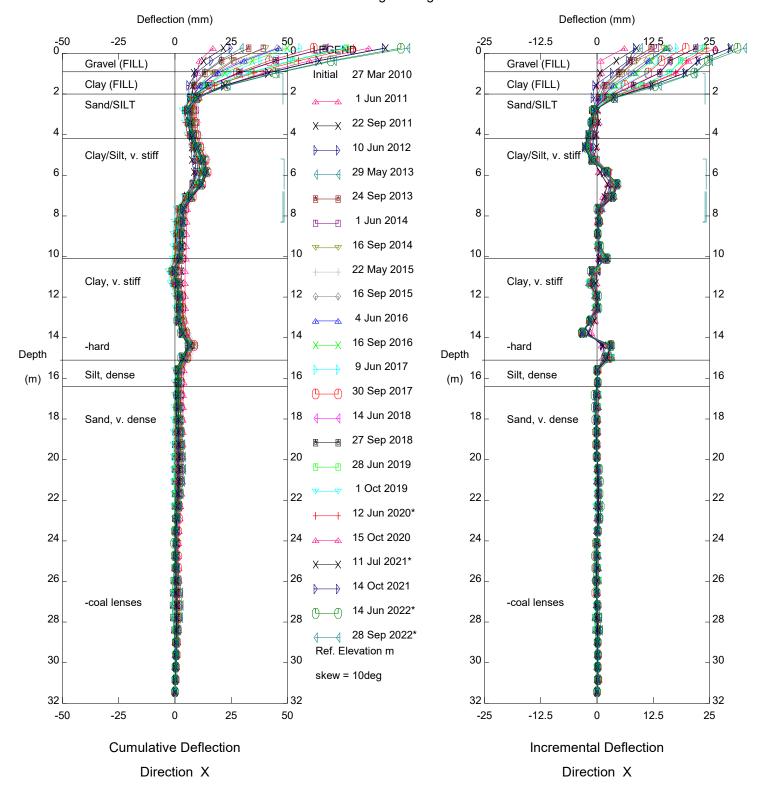
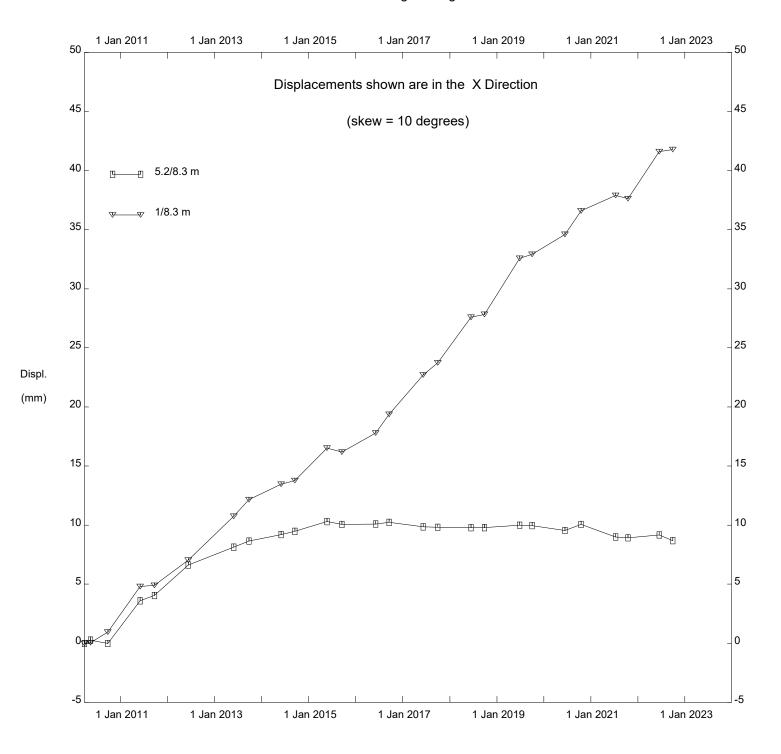
PH033-2 Judah Hill Trunk Slide, Inclinometer SI10-10

SI10-10 showed a rate of movement of 0.6 mm/yr over 1.0 m to 8.3 m depth and no discernible movement over 5.2 m to 8.3 m depth since the spring of 2022 readings. SI10-11 showed a rate of movement of 3.0 mm/yr over 2.0 m to 5.0 m depth since the spring of 2022 readings.

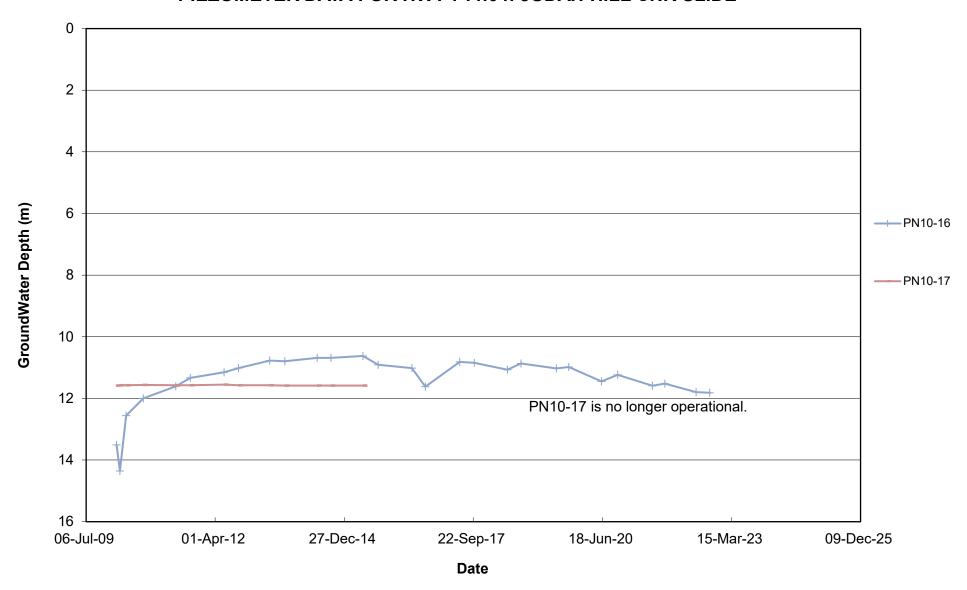
FIGURE PH033-1
PIEZOMETER DATA FOR HWY 744:04: JUDAH HILL CNR SLIDE

Pneumatic piezometer PN10-16 showed a decrease in groundwater level of 0.02 m since the spring of 2022 readings. The pneumatic piezometer readings are summarized in Table PH033-1-2, and are plotted in Figure PH033-1 (by depth) in Appendix A.

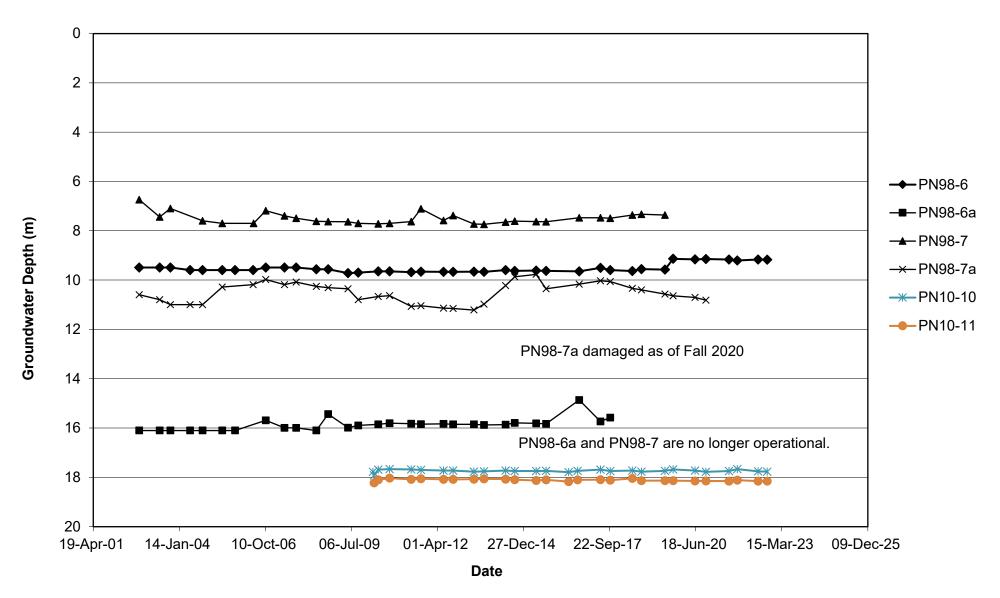
FIGURE PH033-2
PIEZOMETER DATA FOR HWY 744:04: JUDAH HILL TRUNK SLIDE

Pneumatic piezometer PN98-6 and PN10-11 showed no change in groundwater levels since the spring of 2022 readings. PN10-10 showed a decrease in groundwater level of 0.01 m since the spring of 2022 readings. The piezometer readings are summarized in Table PH033-2-2, and are plotted in Figure PH033-2 (by depth) in Appendix A.
