**ALBERTA TRANSPORTATION
GEOHAZARD ASSESSMENT PROGRAM
PEACE REGION (PEACE RIVER DISTRICT)
2022 INSPECTION**

Site Number	Location	Name	Hwy	km
PH033-1	Judah Hill	CNR Slide	744:04	59.451
Legal Description		UTM Co-ordinates		
NE¼ 29-083-21 W5M		11V E 482645	N 6231308

PH033-1 JUDAH HILL - CNR SLIDE
 2022 SITE INSPECTION PLAN

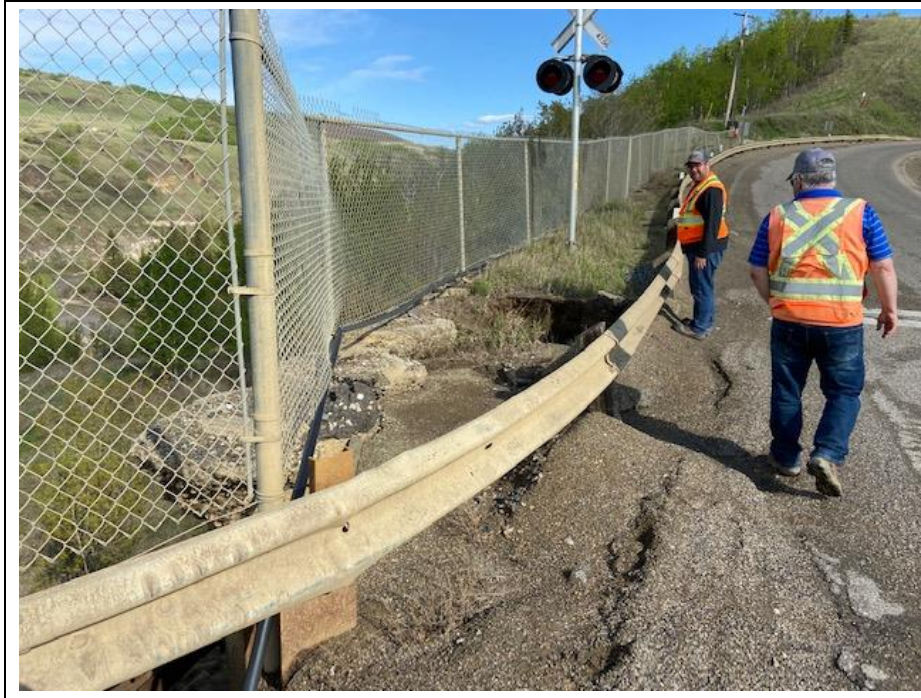
<p>been retrogression and lateral expansion since 2021. (Photos 4 and 5)</p> <p>A new erosion void has opened up behind the pile walls adjacent to the previously repaired void area. The void is a result of soil loss between the piles and extends to the base of the exposed piles (over 5 m in depth). The void bridges to previously repaired void area to the west. The void at the surface was 3 m x 2 m in size and was beginning to undermine the road shoulder (Photos 1, 2 and 9).</p>	
<input type="checkbox"/> Seepage		<input type="checkbox"/>
<input checked="" type="checkbox"/> Bridge/Culvert Distress	Inlet to the CNR Trunk is partially buried with debris. The pipe conduit has completely failed immediately below the crest of the upper valley slope. As a result, a scour is rapidly forming in the slope below the breakage and sediment is accumulating in the intermediate plateau below (Photos 4 and 5).	<input checked="" type="checkbox"/>

Photo 1.
Looking southeast from the north end of the CNR pile wall. A new erosion void has opened up behind the wall adjacent to the previously repaired void area.

Recommendations:	Cost
The inlet of the downpipe is being cleaned out and upstream ditch erosion and sideslope rilling addressed in a construction project currently being completed through the maintenance contract	
Install mesh (welded wire or similar), anchored to the piles (and into the soil if possible) using Hilti anchors, for example, at areas of spalled parging. Place new parging to cover the mesh and fill the voids between piles. Install drainpipes through the parging to avoid blocking seepage. Fill void behind the wall with grout or granular fill with geotextile filter	\$300,000
<p>Replace CPP drainpipe with a realigned anchored welded pipe.</p> <p>Consider a curb and gutter along the edge of asphalt, or a depressed swale, to channel water away from edge of pavement and to divert runoff away from the back of the piles. Fill the rills and around the guardrail posts with gravel covered with seeded topsoil.</p>	\$300,000 Maintenance

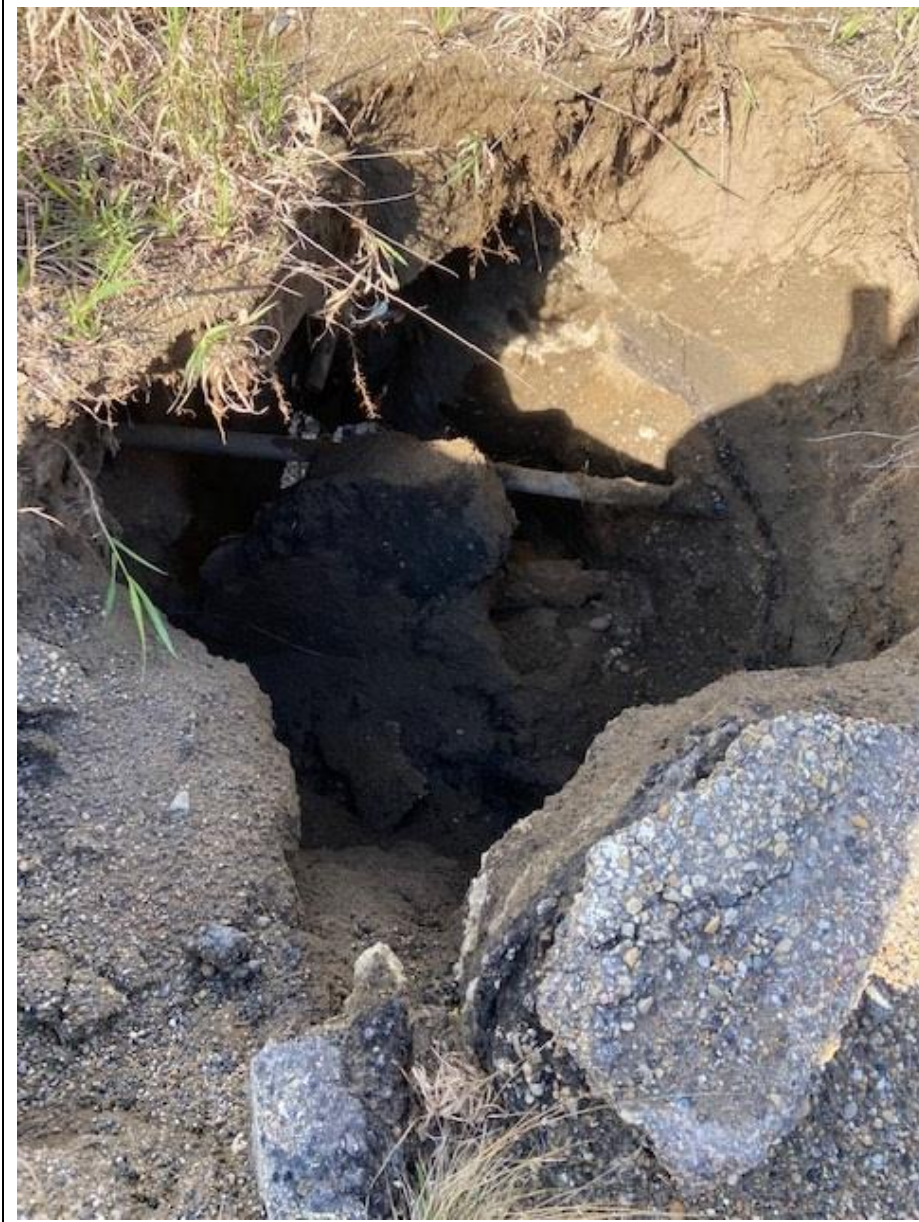
Photo 2.
View into the new erosion void behind the pile wall. Void has been created as a result of soil loss between the piles. Void was 3 x 2 m wide in size and over 5 m deep. The void 'bridged' to the other void repair area to the west.

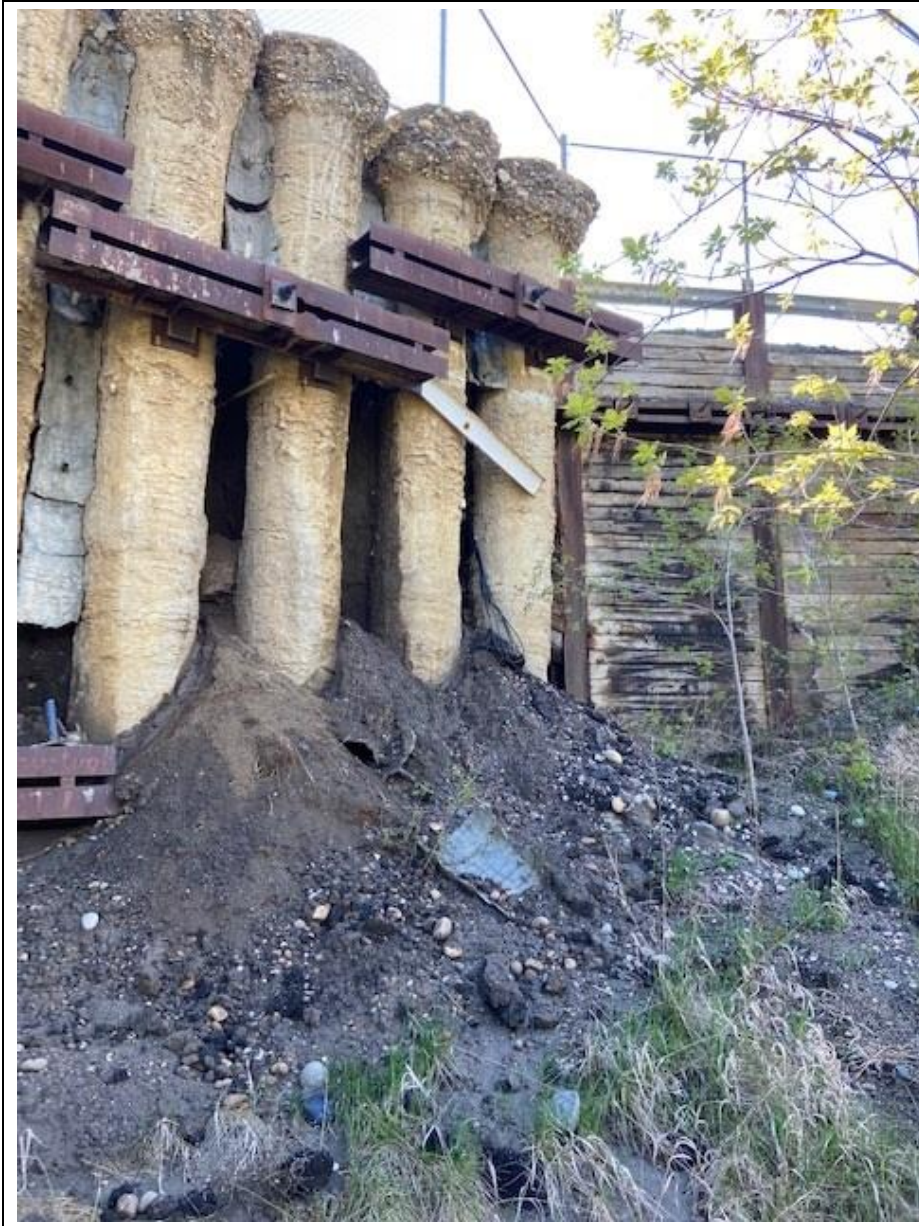
<input checked="" type="checkbox"/> Other	Increased concrete spalling and sloughing between the piles on the CNR retaining (noted in previous years) (Photo 3).	<input checked="" type="checkbox"/>
Instrumentation:		
SI10-16	Installed about 15 m downslope of the CNR pile wall. Showed a rate of movement of 1.1 mm/yr over 11.7 m to 13.5 m depth since fall of 2021 readings. Movement rate is consistent with historic trends (1 to 3 mm/yr) since 2010 and the total cumulative movement has been below 25 mm.	
SI10-17	Installed about 6 m from the crest of the main backscarp. Showed a rate of movement of 1.0 mm/yr over 9.5 m to 11.3 m depth since fall of 2021 readings. Movement rate is consistent with historic trends (1 to 3 mm/yr) since 2010 and the total cumulative movement has been below 15 mm.	
PN10-16	Near pile wall. PN10-16 showed a decrease in groundwater level of 0.28 m since the fall of 2021 readings. Ground level has shown a consistent trend since 2010 installation with groundwater depth between 10 m to 12 m.

Photo 3. Looking south at the soil loss between the northernmost piles of the CNR pile wall north of Hwy 744:04 at km 59.61. Increased buildup of soil and concrete spalling between the piles since 2021 that has resulted in an open void at the surface between the wall and the road.

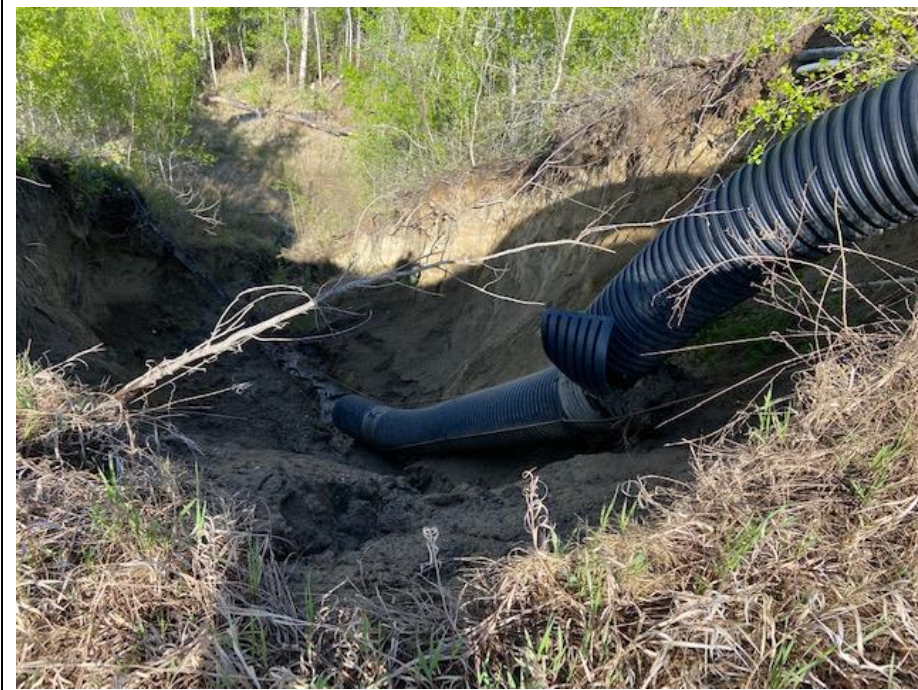
Photo 4.
Looking northeast at break in CNR CPP Trunk pipe and erosion gully at crest of the Heart River valley slope.

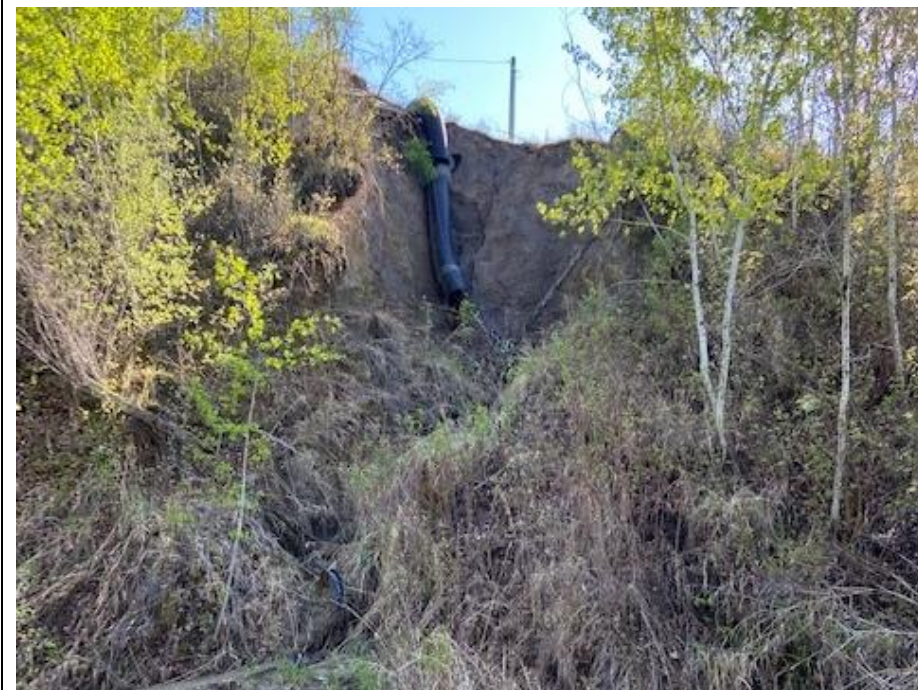
Photo 5.
Looking southwest from below the scour caused by the breakage in the CNR CPP Trunk pipe. There has been some retrogression and lateral expansion at the gully headwall since 2021.

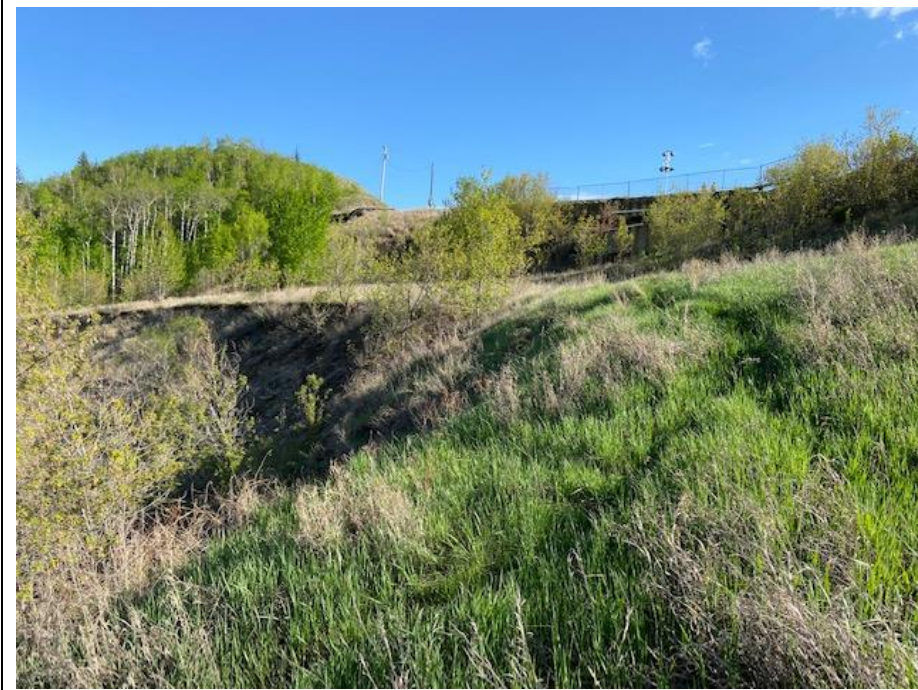
Photo 6.
Looking southeast from the north side of the lower slide. No major changes observed in the slope area directly below the pile wall since 2021.

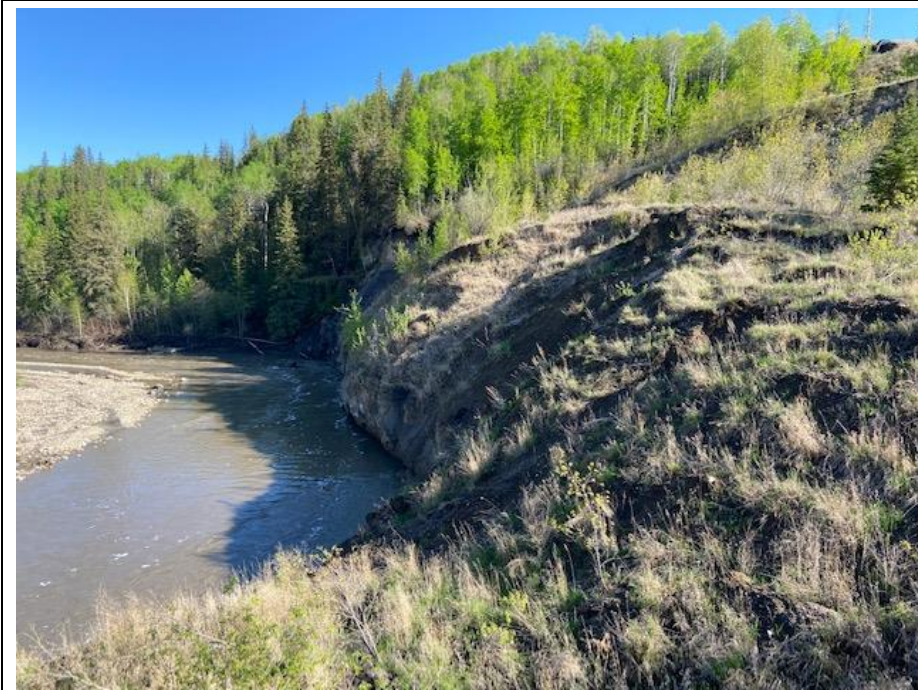
Photo 7.
Looking east along the toe of the lower landslide. Some minor lower slide activity and toe erosion at the river bank is active. No major visible differences from 2021.

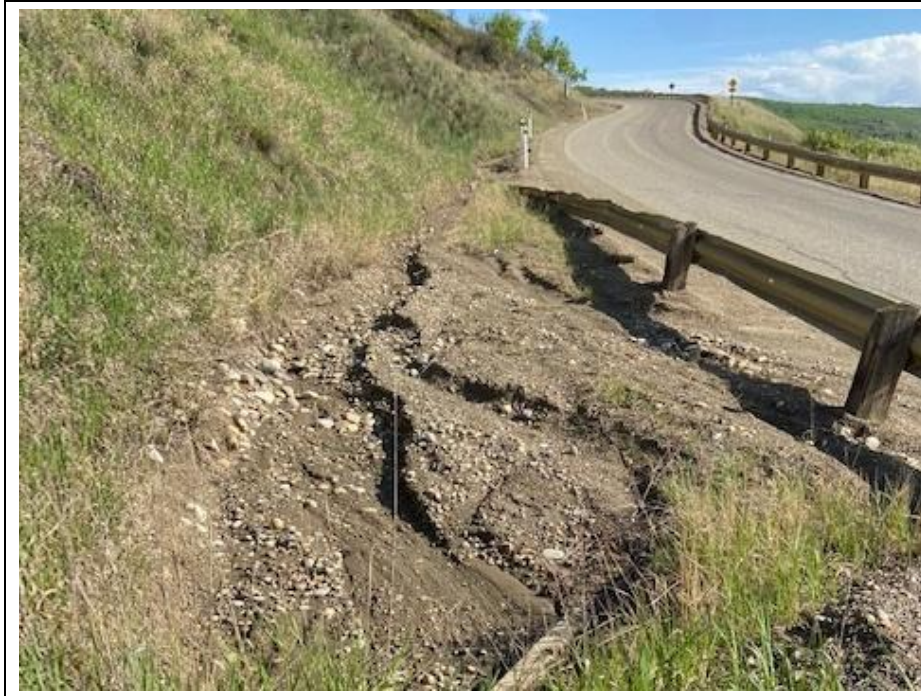
Photo 8.
Looking south
towards the
erosion in the east
ditch upslope from
the draining pipe
inlet.

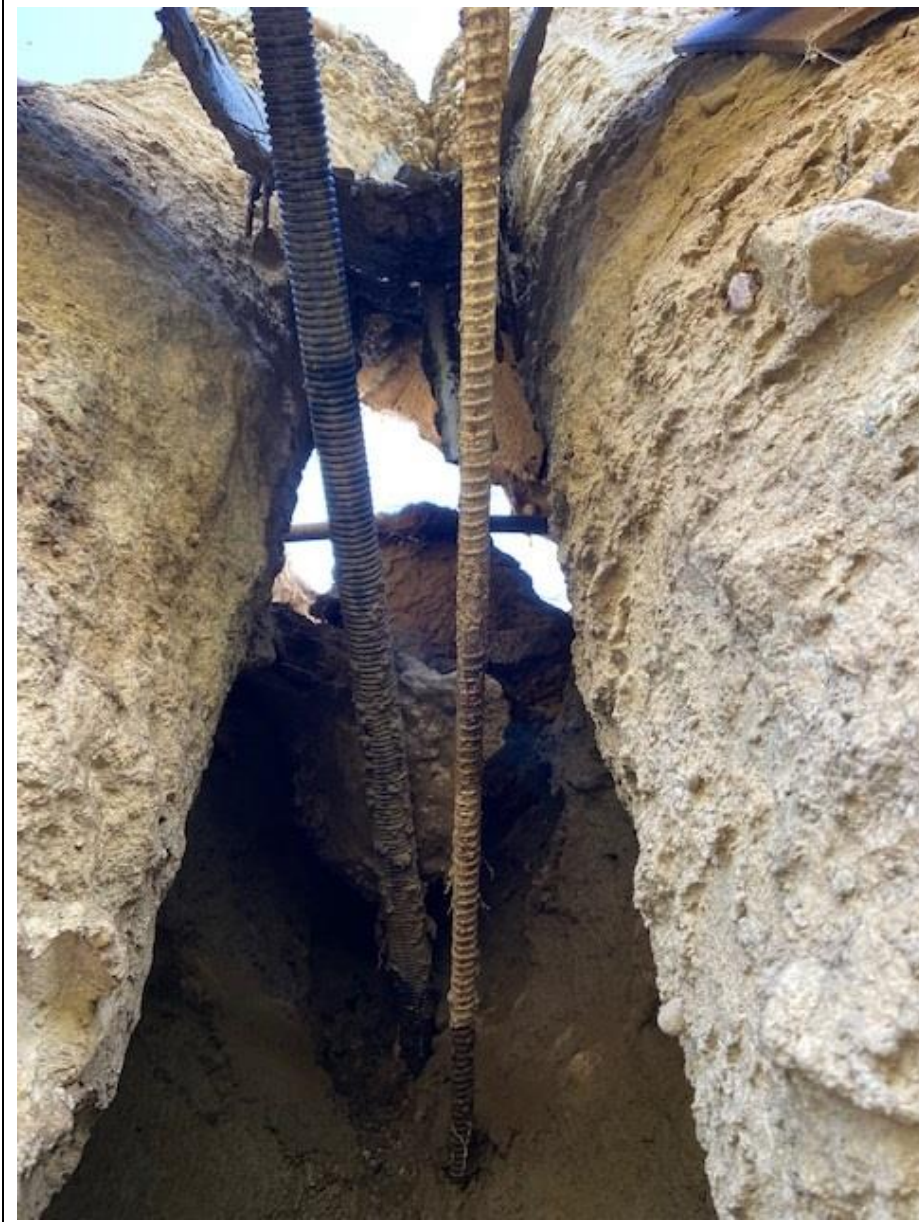
Photo 9.
Looking up into the erosion void between the piles. Void expanded in size to 3 x 3 m below the ground surface and extended to the base of the exposed piles at the lower bench.

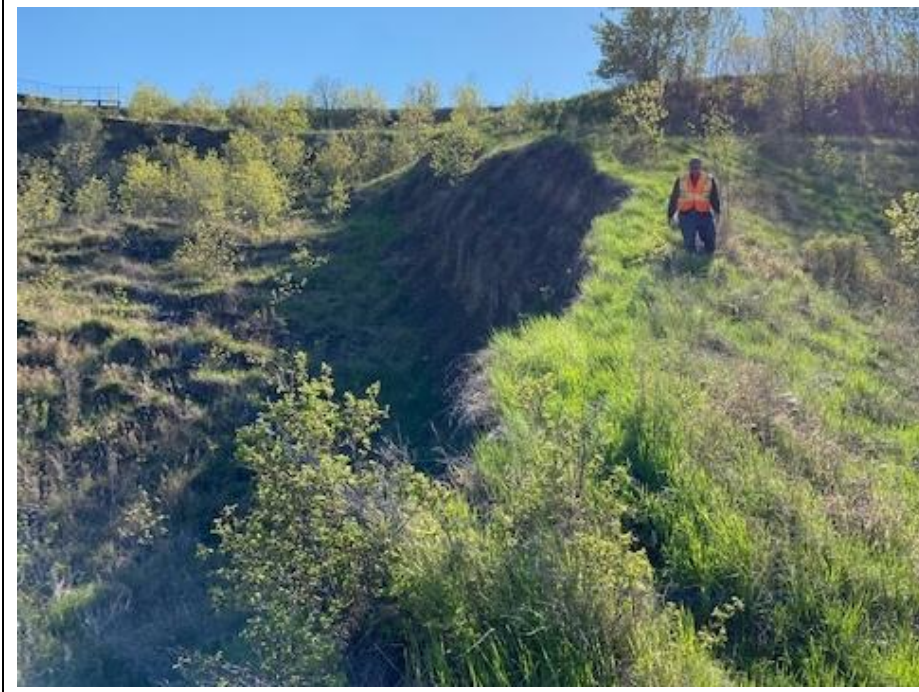
Photo 10.
Looking south towards the northwest flank of the lower slide. No major change from the 2021 condition.
