**ALBERTA TRANSPORTATION AND
ECONOMIC CORRIDORS
GEOHAZARD ASSESSMENT PROGRAM
PEACE REGION (PEACE RIVER DISTRICT)
2025 INSPECTION**

Site Number	Location	Name	Hwy	km
PH033	Judah Hill	CNR Slide	744:04	59.451
Legal Description		UTM Co-ordinates (NAD 83)		
NE¼ 29-083-21 W5M		11V E 482645	N 6231308

PH033-1 JUDAH HILL - CNR SLIDE
2025 SITE INSPECTION PLAN

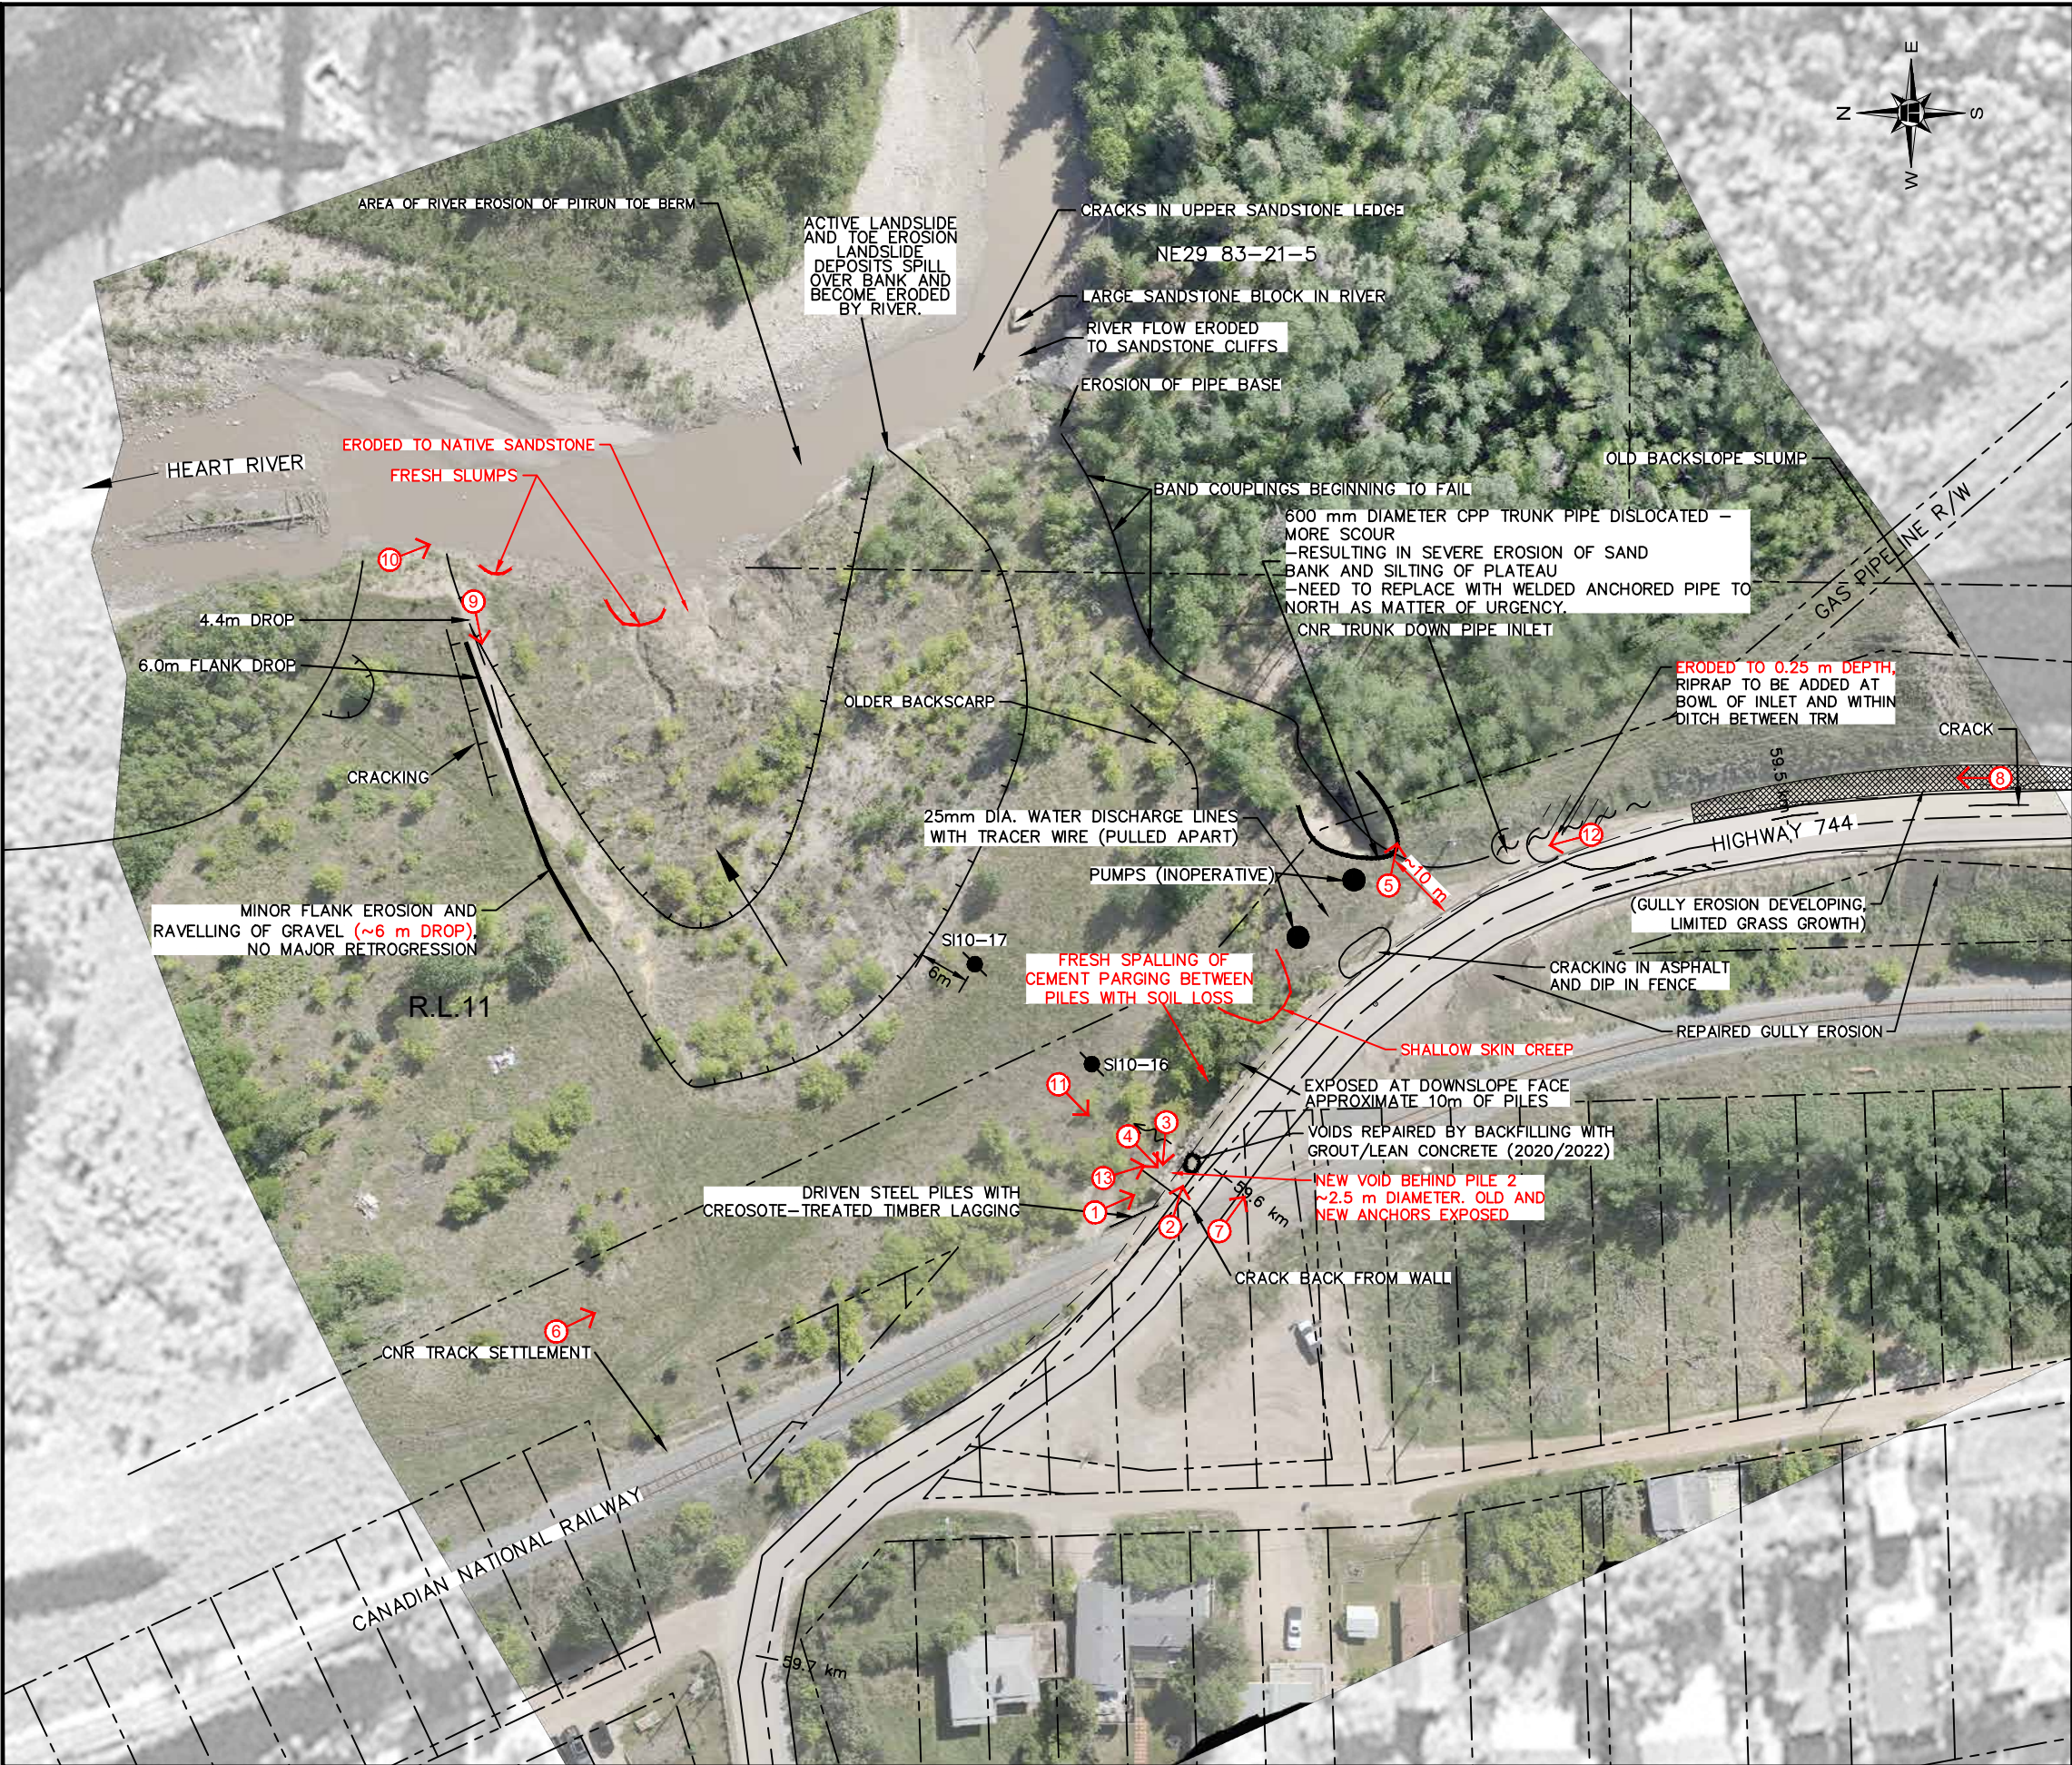
Movement at the toe of the CNR slide is continuing, worsened by river erosion of failed material at the toe of the slide. Erosion at the toe of the slope, which started in 2007, is expected to continue, with consequent further slide movement and retrogression of the backscarp towards the rail line and highway. Now that the river erosion has reached a hard bedrock face, the rate of lateral river erosion directly downslope of the pile wall has slowed.

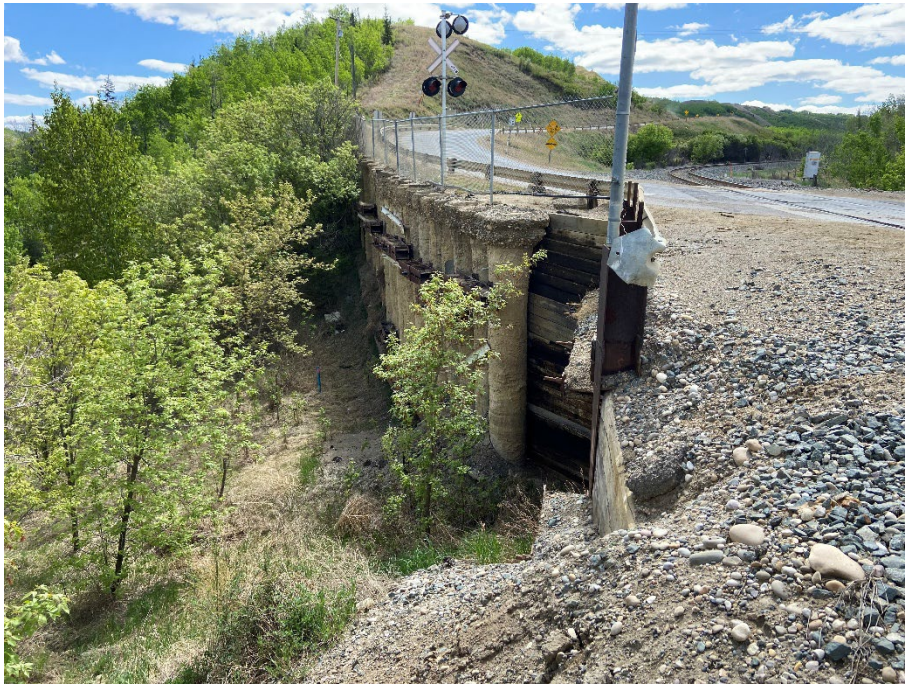
**Photo 1.**

Looking southeast from the north end of the CNR pile wall. Grout / lean concrete overflow from the 2022 repair of the void behind the wall is visible at the toe of the wall.

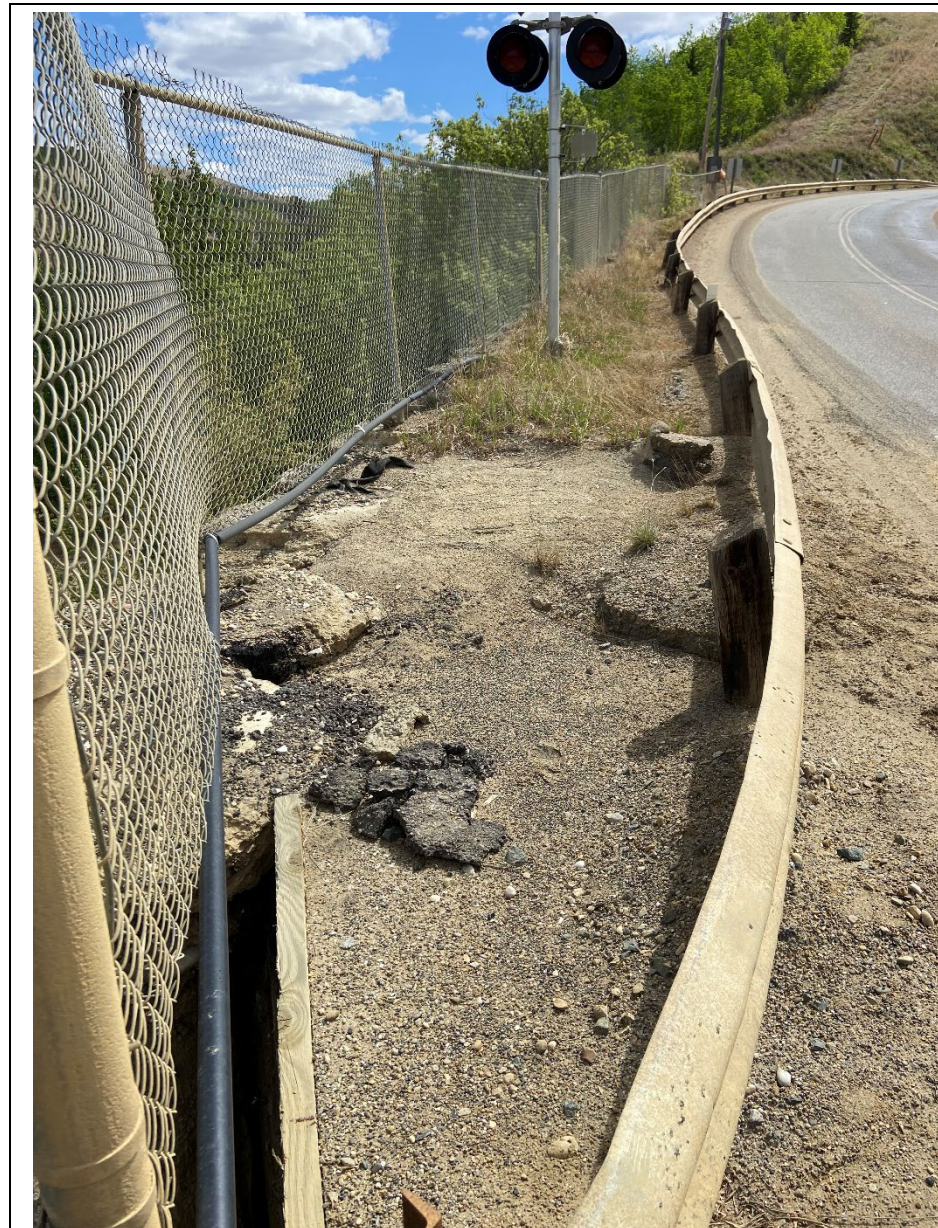
**Photo 2.**

The repairs to the erosion voids (formed behind the pile wall in 2020 and 2022) appear to be performing as intended but there is still ongoing erosion and soil loss between the piles which will likely lead to future formation of voids that can reach the ground surface behind the wall with little to no visible indication. A void has opened between two of the piles (which was repaired by filling with fillcrete under Contract CON0023098 in late summer of 2025). As part of the preliminary engineering assessment completed by Thurber the local stability of the wall and the issues with the wall facing were reviewed and options were provided for improving these.

View of the repaired area behind the pile wall where erosion voids formed in 2020 and 2022. The repair involved geotextile supported by wood cribbing and backfilled with grout/lean concrete. The voids were a result of soil loss between the piles. and over 5 m in depth prior to repair.

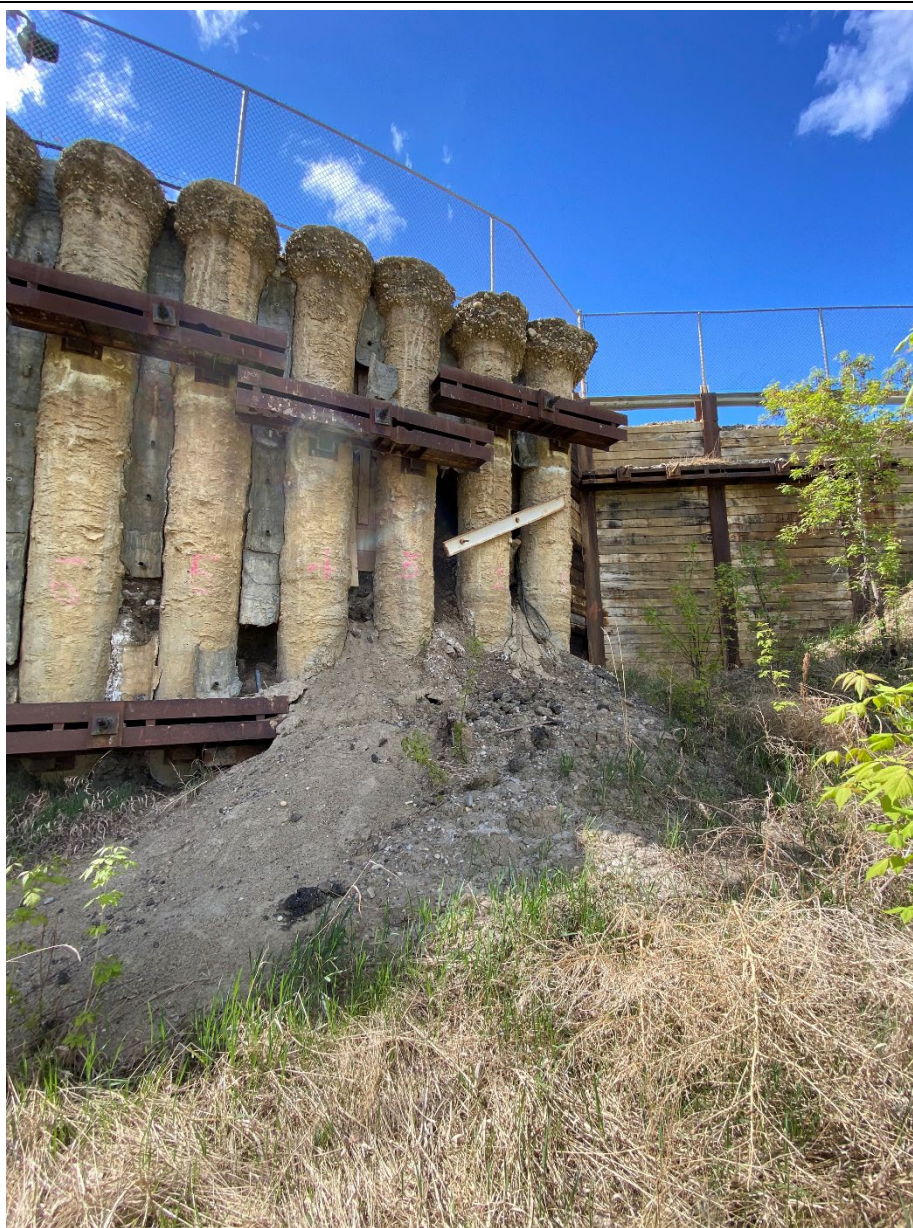
**Photo 3.**

Looking south at the soil loss between the northernmost piles (1 to 5) of the CNR pile wall north of Hwy 744:04 at km 59.61. Increased buildup of soil spalling between the piles since 2024. Note wood cribbing was set behind piles 3-4 to contain the grout backfill for the previous void repair; however, some grout still did flow through and has set along the toe of the piles.

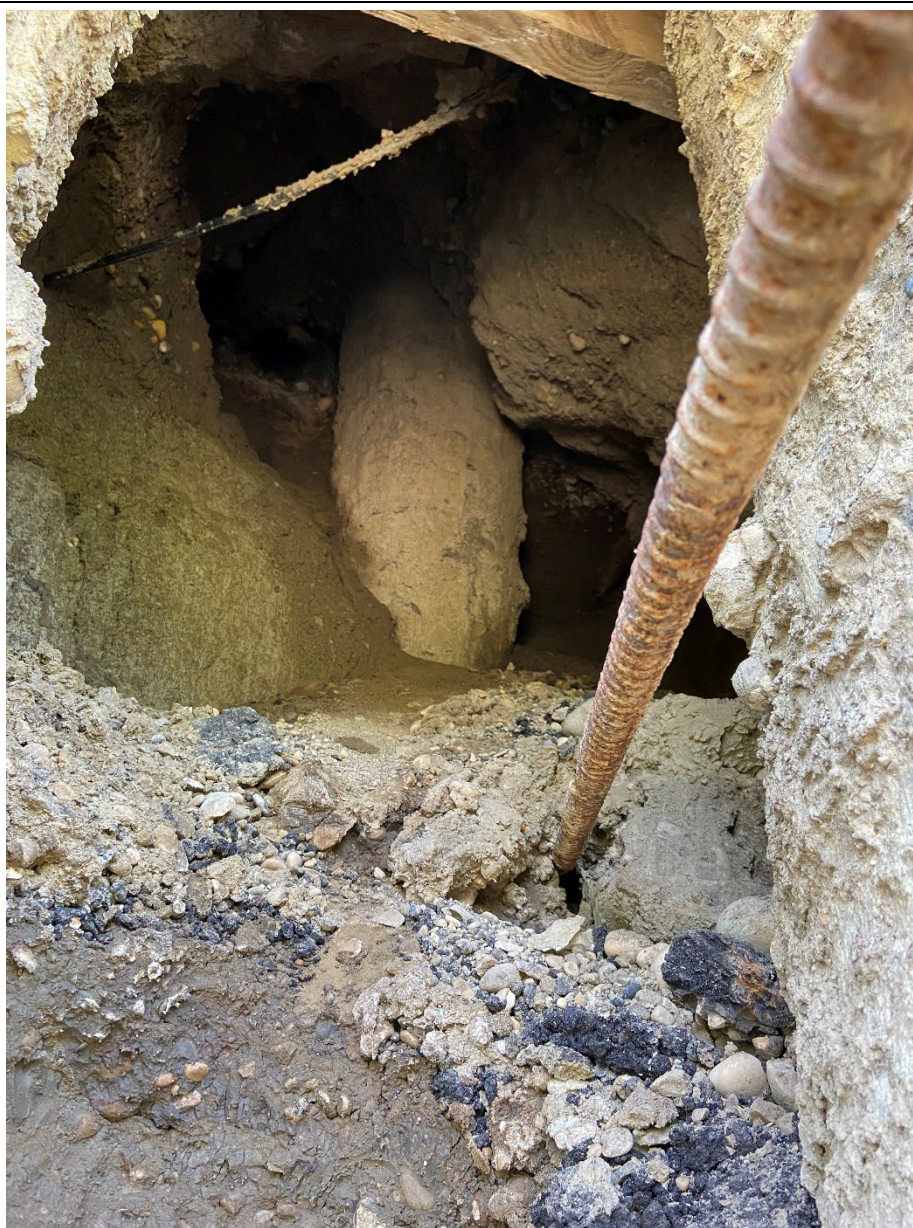
**Photo 4.**

Close up view of void that has developed between piles 2 and 3 at the north end of the CNR pile wall due to soil loss between the piles. Void is approximately 2.5 m in diameter. One of the additional piles installed in 1989 behind the original pile wall has been exposed by the void.

- Fill the void that has formed between the piles with fillcrete (this was already completed in 2025 as part of CON0023098).
- Replace the wall parging with a more robust solution and fill the voids between piles. Install drainpipes through the new wall facing to avoid blocking seepage. Fill any voids behind the wall with grout or granular fill with non-woven geotextile filter. TEC has elected to pursue a shotcrete facing repair option to replace the existing parging. Thurber has submitted a proposal for detailed design and tender work for the shotcrete facing repair, with LEX3 working as a structural subconsultant. Thurber and LEX3 have also recommended adding some tie-back soil anchors and walers to part of the exposed wall to improve the local stability, in conjunction with the facing repairs (\$650k ballpark costs for facing, tie-backs and walers).

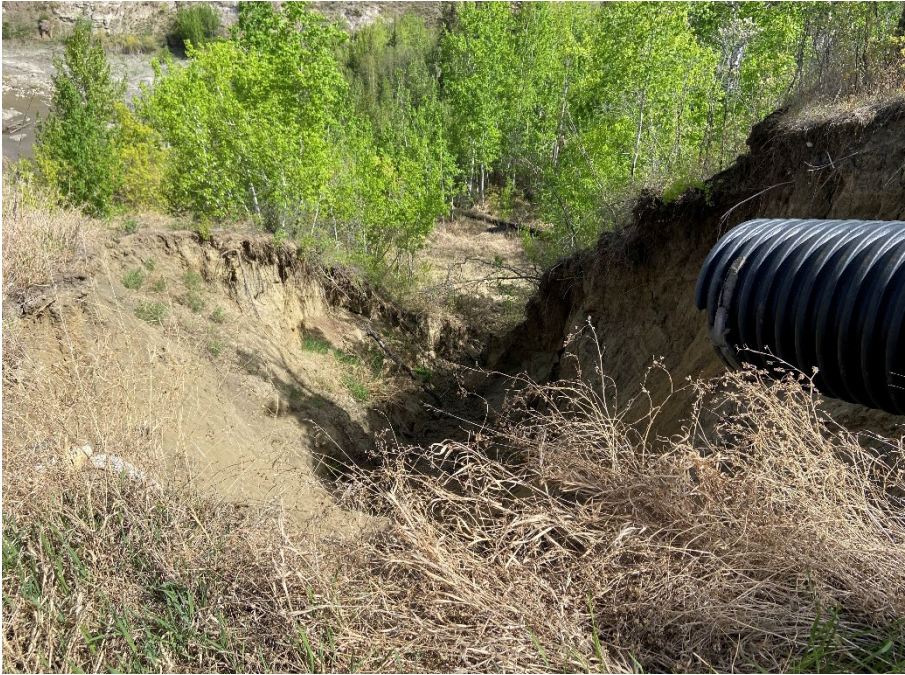
Photo 5.

The CNR drainage trunk pipe is broken immediately below the crest of the valley slope and both water and sediment are pouring directly onto the slope below. A large and active scour gully with vertical drop has formed immediately beneath the break in the pipe. We recommended that this be addressed as a matter of urgency, preferably by replacing the existing segmented CPP with a welded anchored smooth wall steel or HDPE pipe along a flatter alternate alignment in addition to re-profiling and armoring the inlet.

Looking east at the break in the 600 mm diameter CPP trunk pipe and associated erosion gully at the crest of the Heart River valley slope. The erosion gully is 10 m from the edge pavement of the northbound highway lane.

- Replace CPP drainpipe with a realigned anchored welded smooth wall steel or HDPE pipe. (\$300k - \$450k)

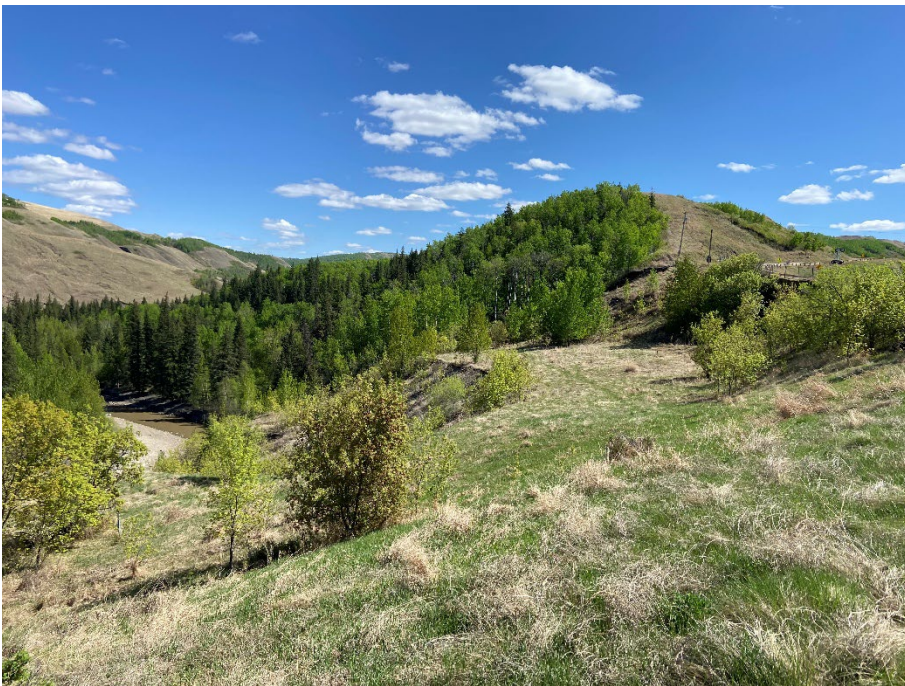
Photo 6.

Looking southeast from the north side of the lower slide main scarp. No major changes observed in the slope area directly below the pile wall since 2024.

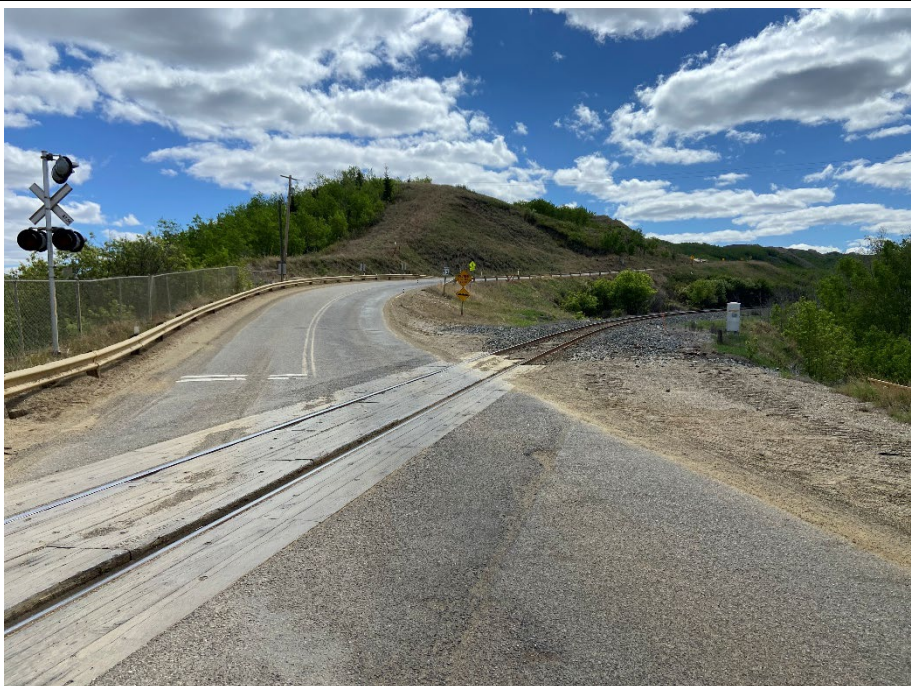
Photo 7.

Looking southeast at CNR rail crossing and at previous erosion repairs in highway embankment beyond. Sideslope erosion repairs appeared effective and similar to the 2024 conditions.

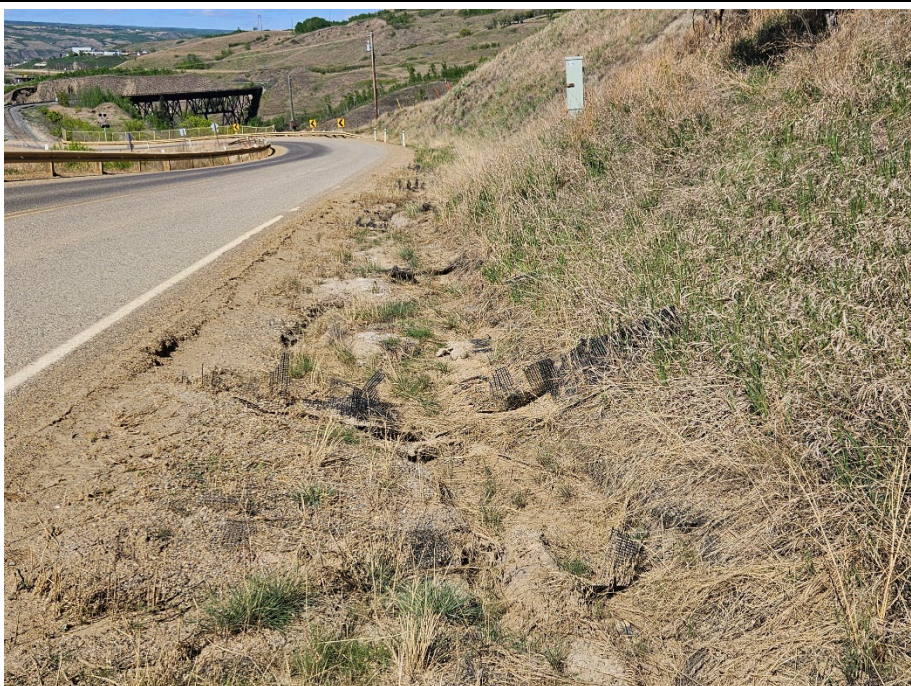
Photo 8.

Looking north towards the east ditch with previous erosion damage that was repaired in 2022 (reggraded, with TRM and ditch barriers). Vegetation was not well established and there was a minor erosion channel starting to develop within the ditch bottom and some barriers were partially undermined.

- Consider a curb and gutter along the edge of asphalt, or a depressed swale, to channel water away from edge of pavement and to divert runoff away from the back of the piles.
- Fill any new rills around the guardrail posts with gravel covered with seeded topsoil.
- Regrade the ditch where the check dams are undermined, line ditch bottom with granular fill and re-place the TRM, replace / re-install check dams. Clean out drain inlet area and use material to

fill in ditch where required. Alternatively, extend planned rock riprap from inlet area to 100 m to the south.

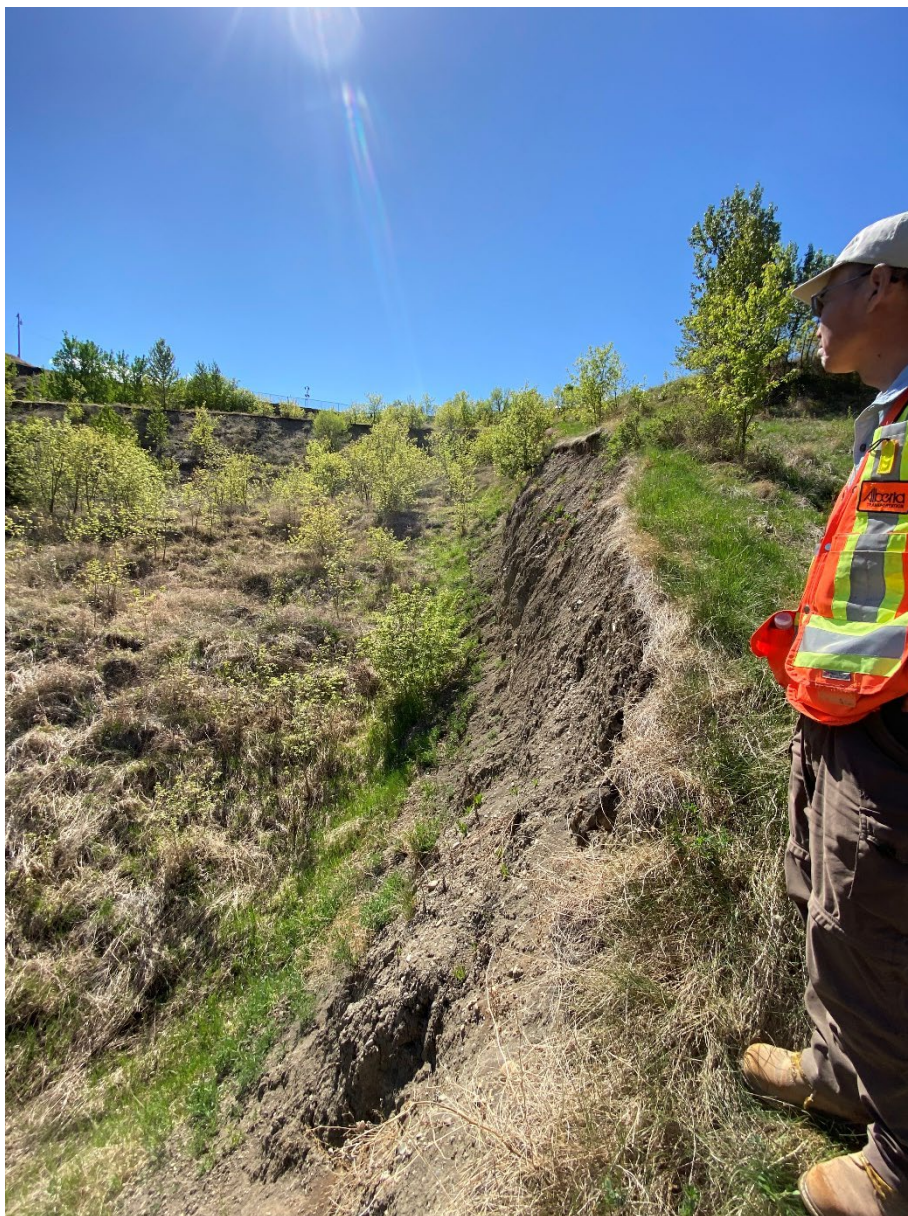
Photo 9.

Looking west at the lower slide mass. There was some increased erosion along the slide flank relative to the 2024 condition but no major expansion. The overall drop is approximately 6 m.

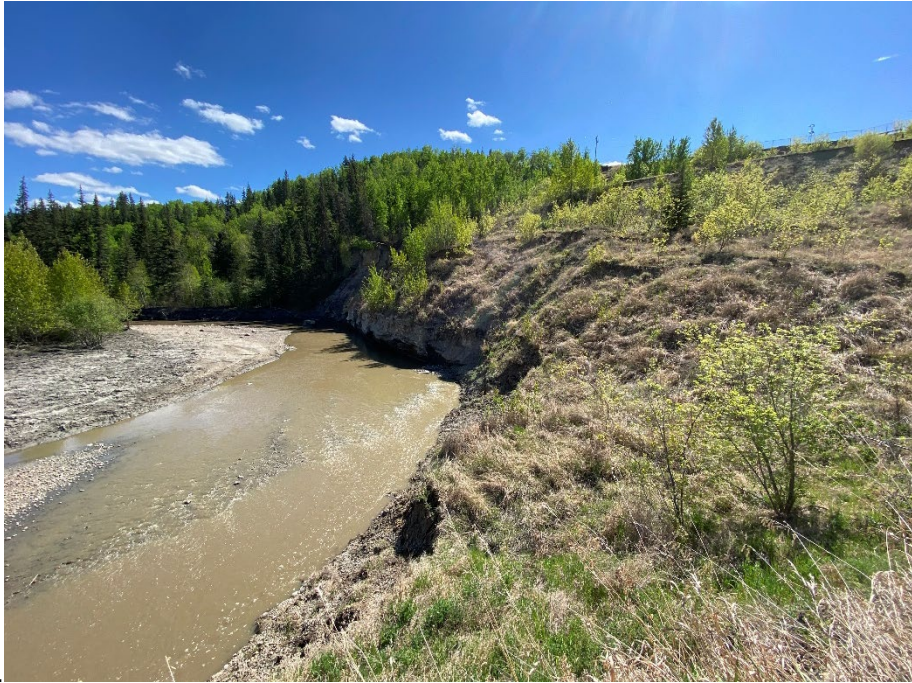
Photo 10.

Looking south towards the base of the lower slide and bedrock exposure at the river. Some minor lower slide activity with fresh slumps and active erosion of slide materials entering over the bank.

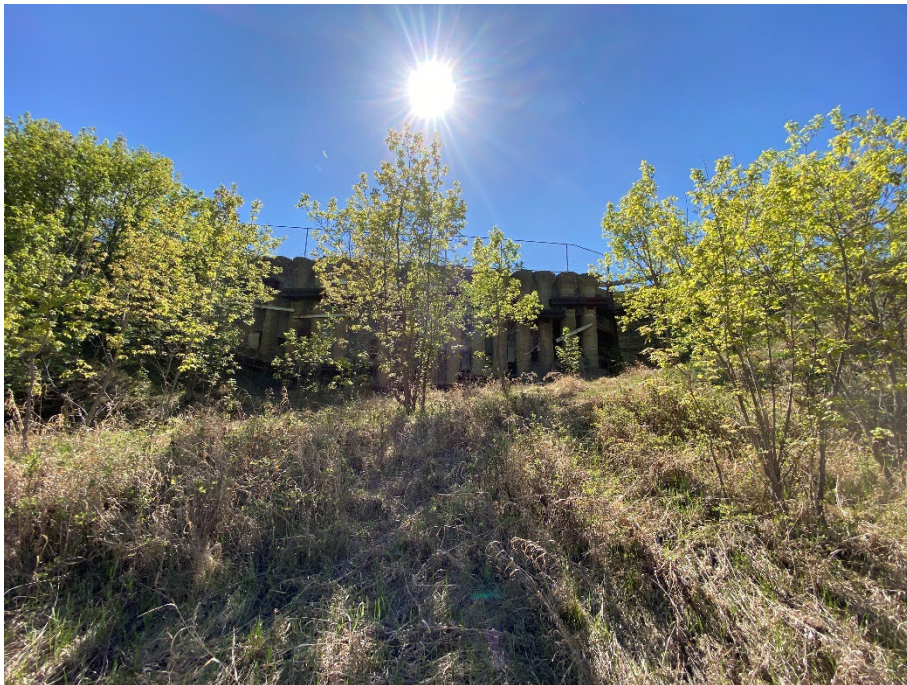
Photo 11.

View southwest towards the lower slope area downslope from the base of the pile wall and immediately upslope of the main slide scarp monitored by SI10-17. No visible indications of landslide movement were observed in this area and conditions were similar to 2024 inspection.

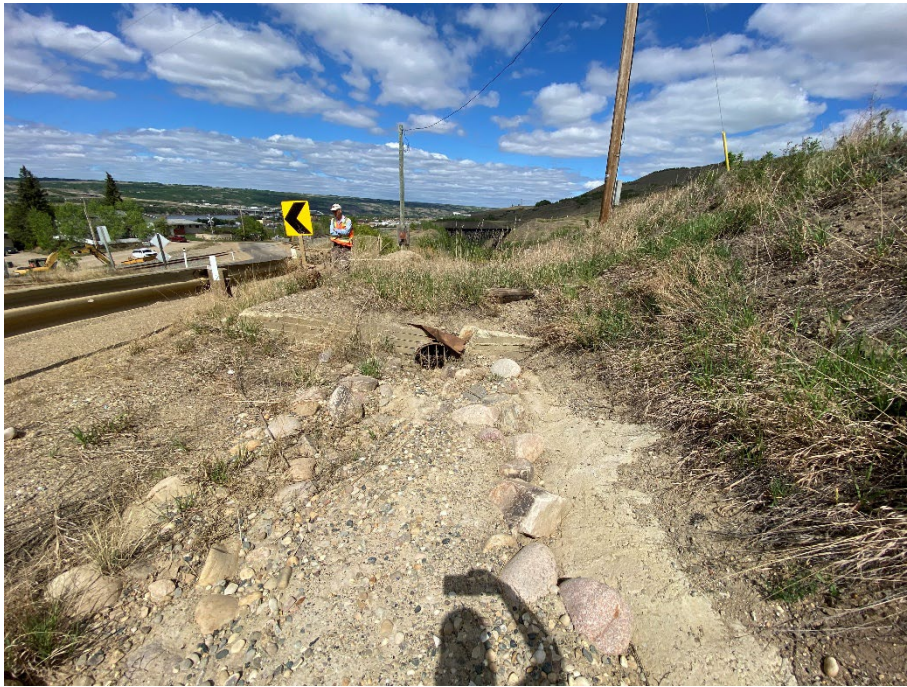
**Photo 12.**

Buildup of eroded ditch sediment (sand and gravel) at the down pipe trunk inlet. 0.25 m deep erosion rill has developed in this area.

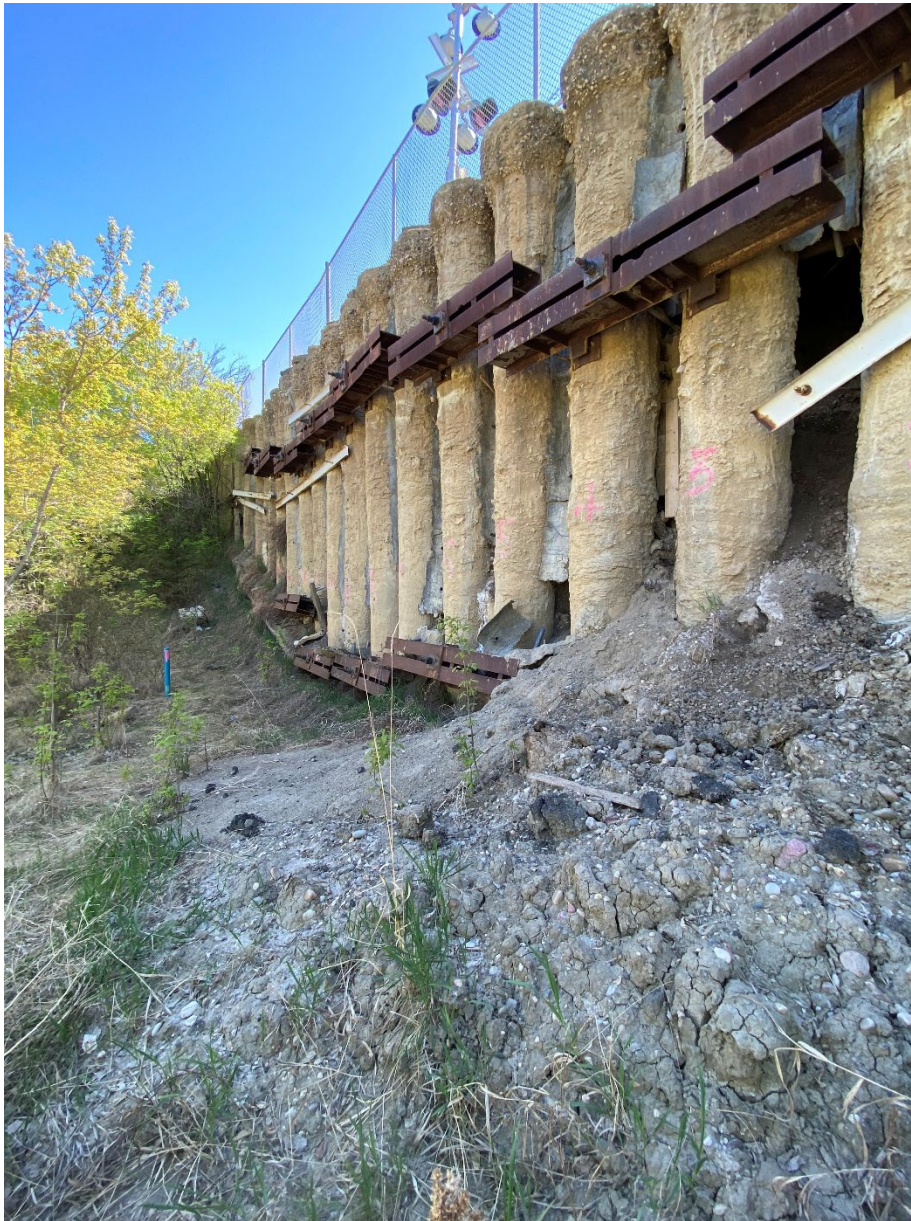
**Photo 13.**

Looking towards the southeast at the base of the pile wall with spalling concrete parging between the piles.
