ALBERTA TRANSPORTATION GEOHAZARD ASSESSMENT PROGRAM PART A: FILE REVIEW

PEACE REGION – PEACE-HIGH LEVEL

PH34 JUDAH HILL – FENCE SLIDE

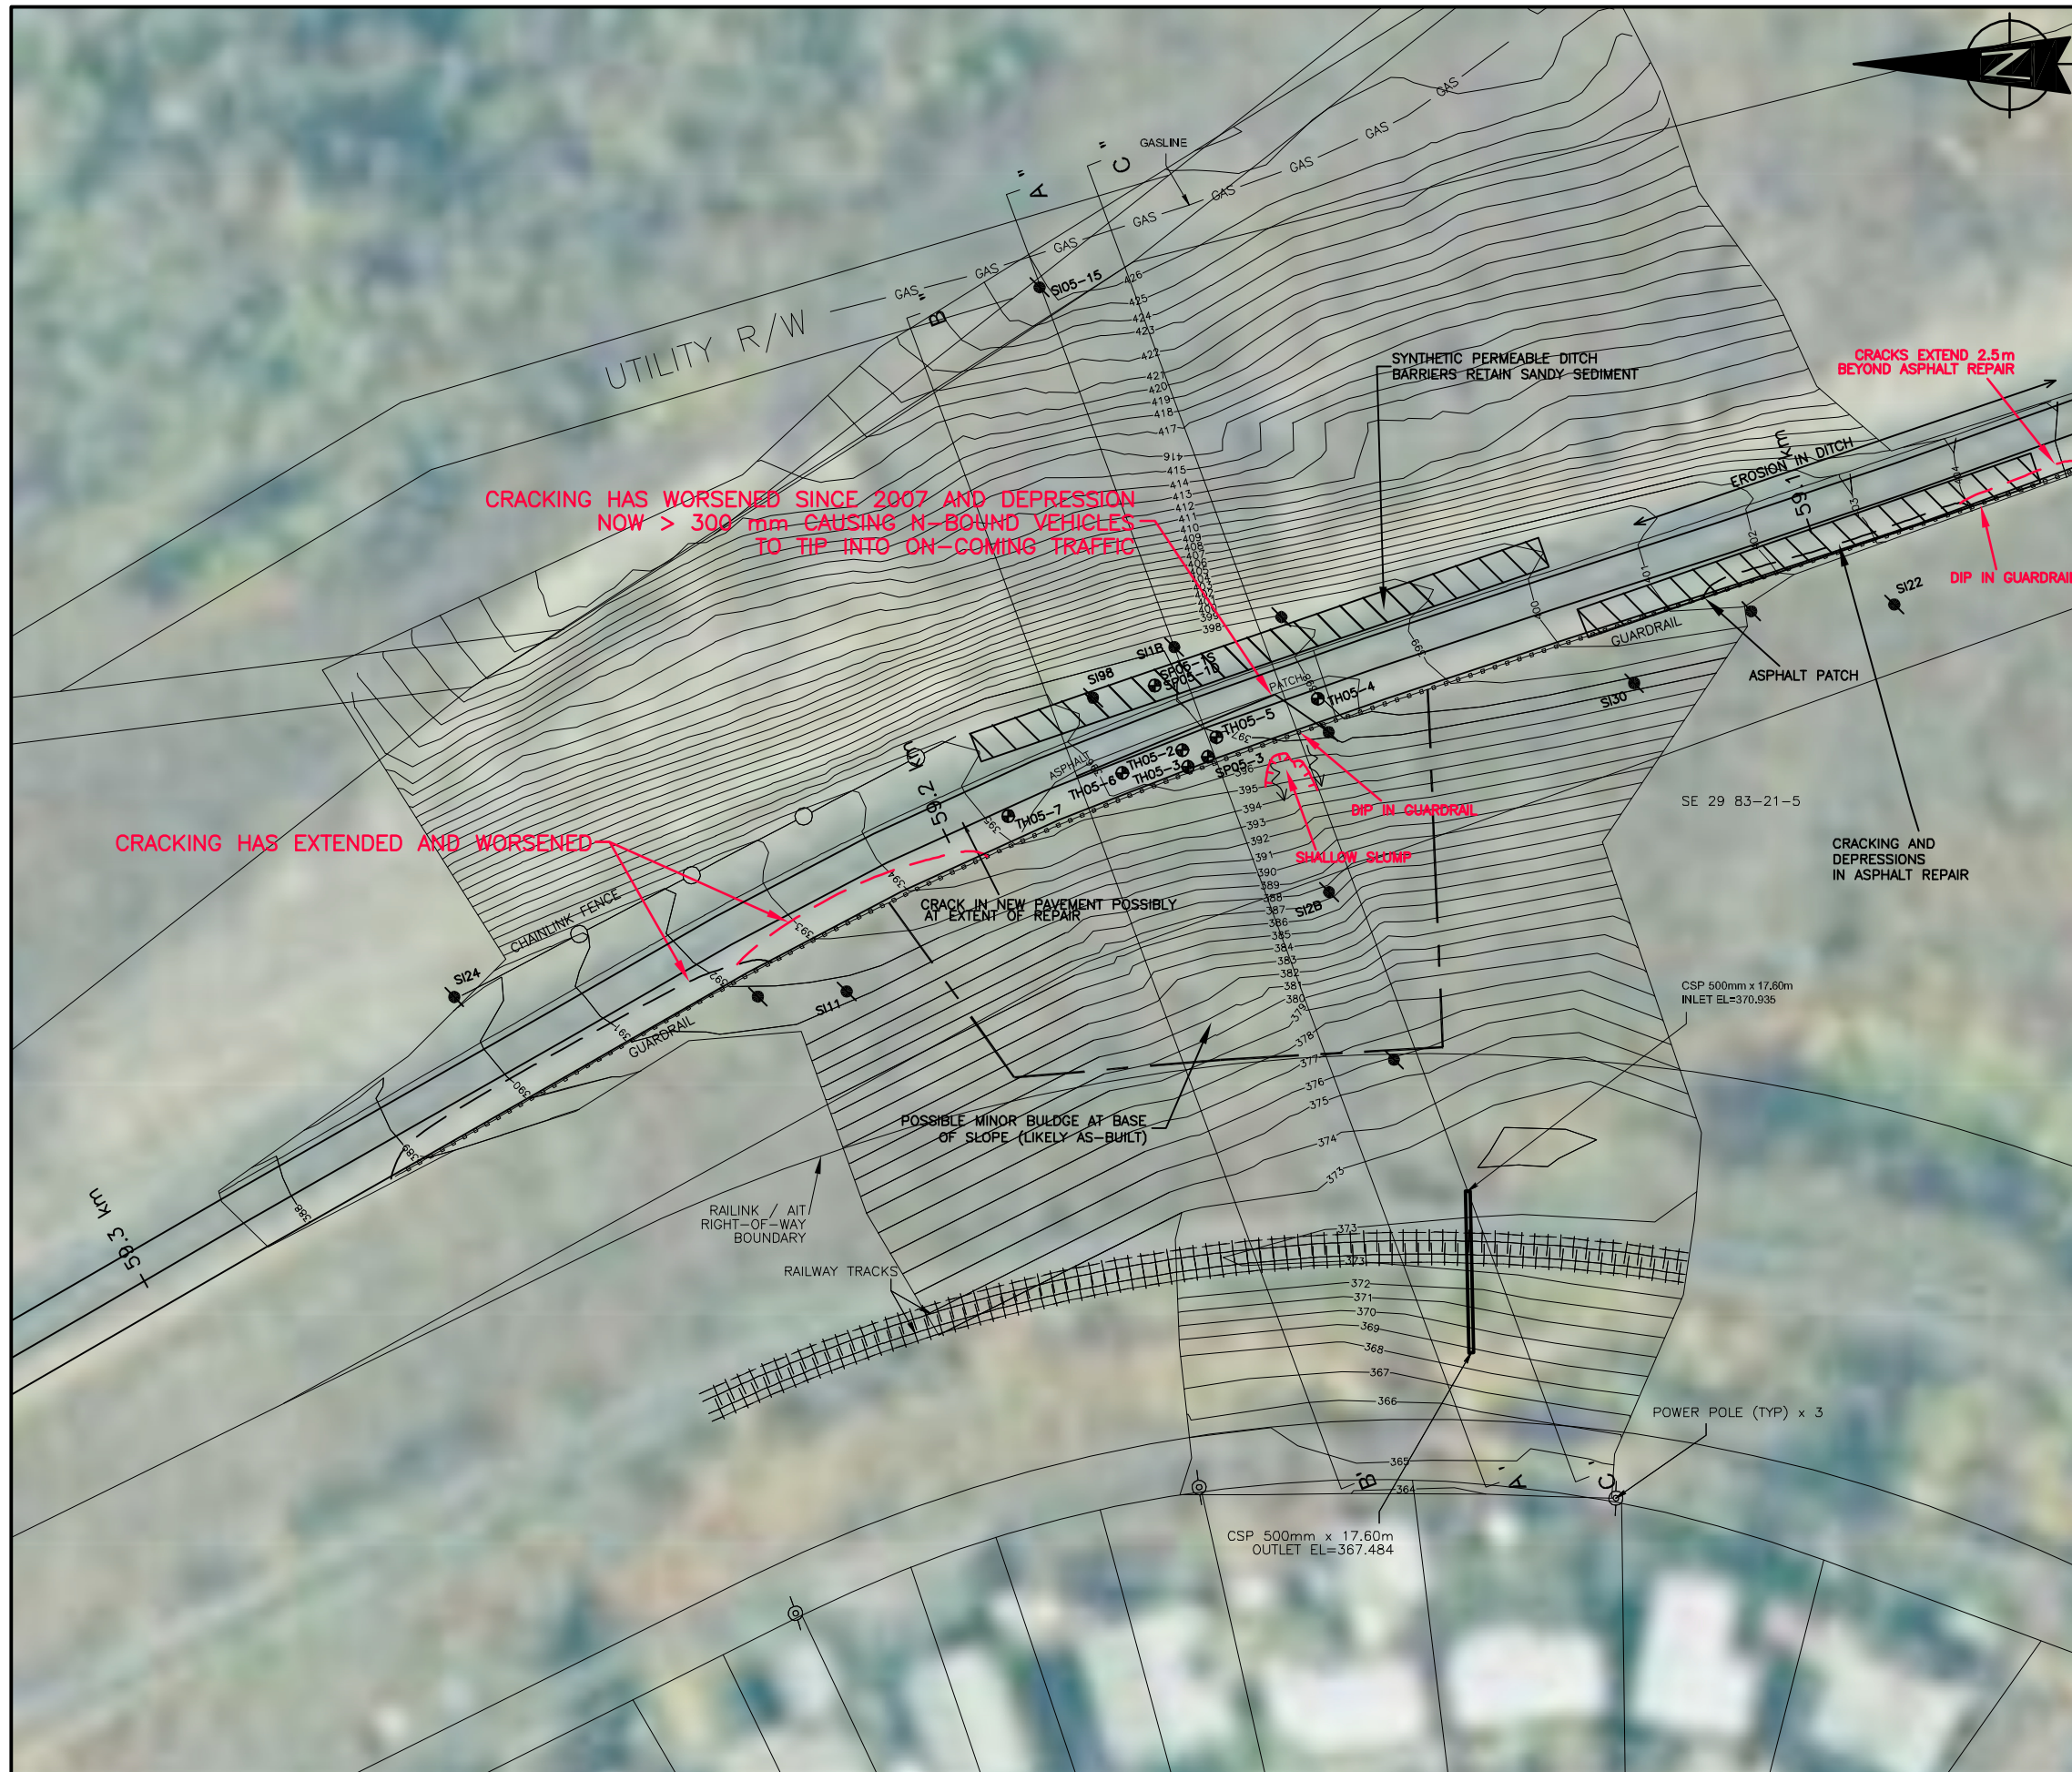
FIGURE 2

CRACKING HAS WORSENERD SINCE 2007 AND DEPRESSION NOW > 300 mm CAUSING N-BOUND VEHICLES TO TIP INTO ON-COMING TRAFFIC

CRACKS EXTEND 2.5m BEYOND ASPHALT REPAIR

CRACKING HAS EXTENDED AND WORSENERD

SHALLOW SLOMP

CRACK IN NEW PAVEMENT POSSIBLY AT EXTENT OF REPAIR

POSSIBLE MINOR BULGE AT BASE OF SLOPE (LIKELY AS-BUILT)

DIP IN GUARDRAIL

CRACKING AND DEPRESSIONS IN ASPHALT REPAIR
