**ALBERTA TRANSPORTATION  
GEOHAZARD ASSESSMENT PROGRAM  
PEACE REGION – PEACE-HIGH LEVEL  
2018 CALL OUT**

<b>Site Number</b>	<b>Location</b>	<b>Name</b>	<b>Hwy</b>	<b>km</b>
PH034	Judah Hill	Fence Slide	744:04	59.177
<b>Legal Description</b>		<b>UTM Co-ordinates</b>		
SE¼ 29-083-21 W5M		11V E 482792	N 6230946

**2018 PH034-1 CALLOUT PLAN**

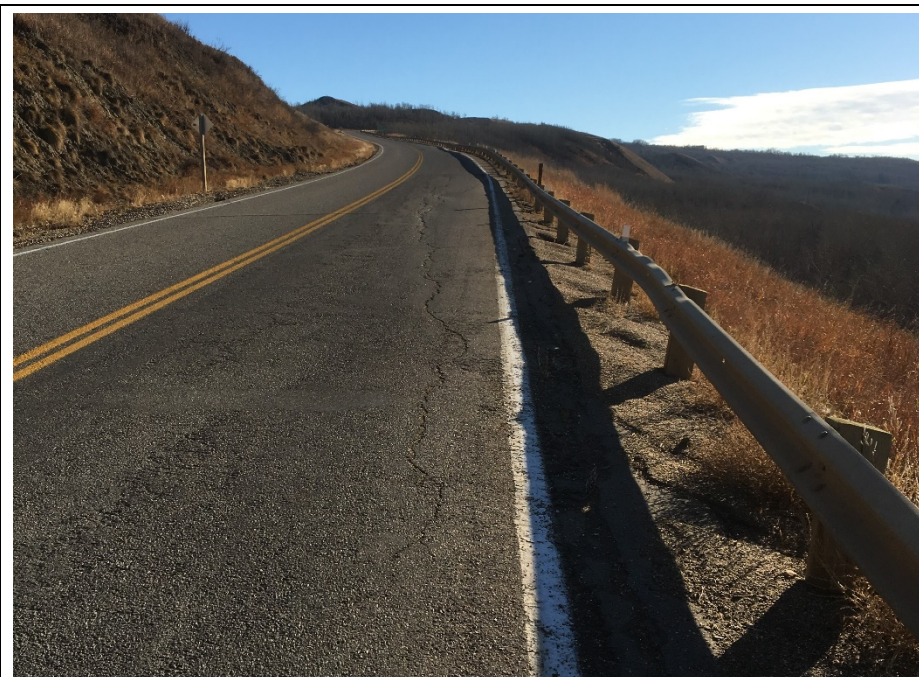
**Photo 1.**  
Looking southeast from the shoulder of the SBL at km 59.135 towards the cracks and dip in the pavement at SI10-12. The dip in the guardrail is at 210 mm and the cracks in the ACP or open from 50 to 60 mm with drops along the edges of cracks up to 70 mm.

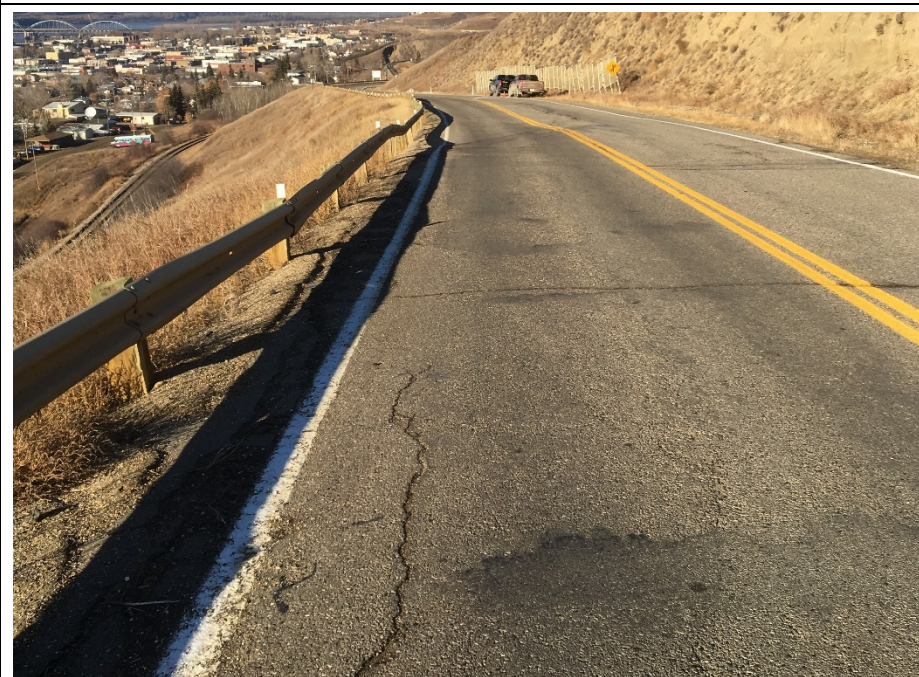
**Photo 2.**  
Looking northwest from km 59.145 along the outer edge of the SBL. The cracks along the white line in the SBL are open from 30 mm to 60 mm.

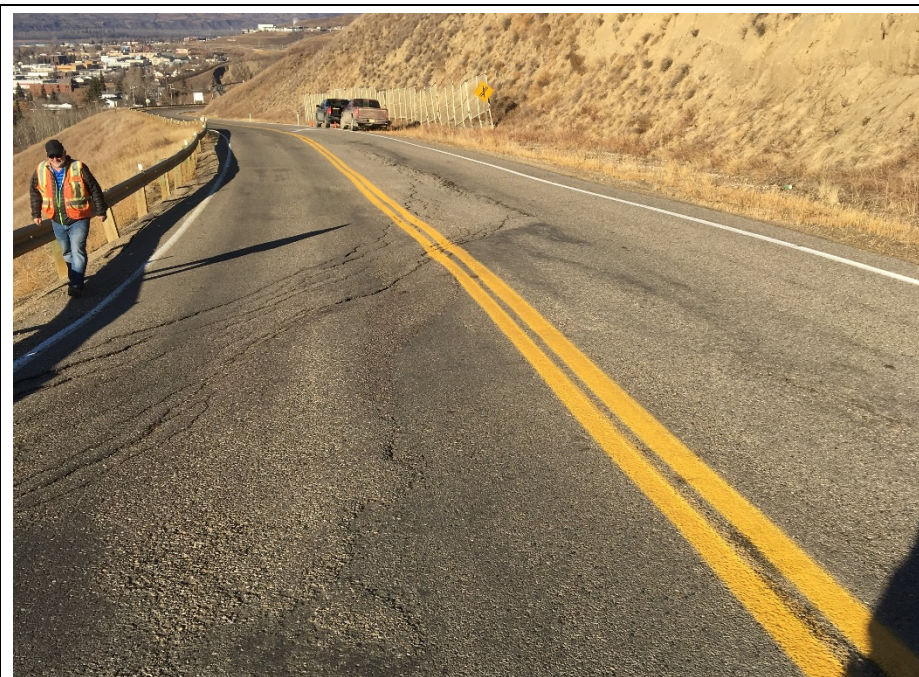
**Photo 3.**  
Looking north from km 59.15 at the south end of the Fence Slide repair. The dip and grown and extends 1.5 m into the NBL. Cracks in the SBL shoulder of the are now open to 60 mm.

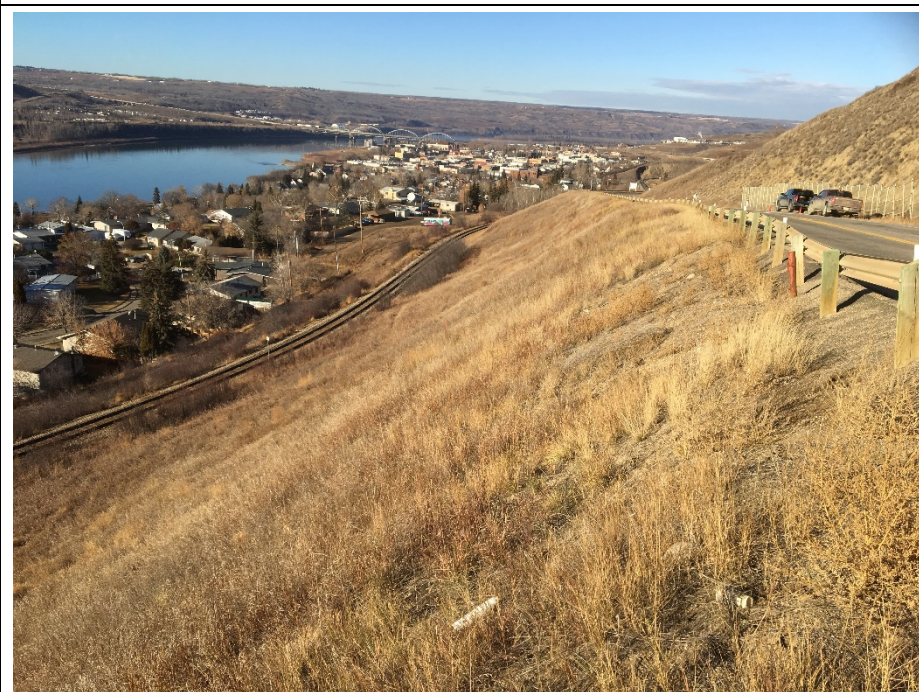
**Photo 4.**  
Looking north from km 59.155 along sideslope towards SI10-13. The dip in the guardrail is at 700 mm near the lowest point in the dip in the SBL. The shallow slump below SI10-13 is more apparent than in May 2018.

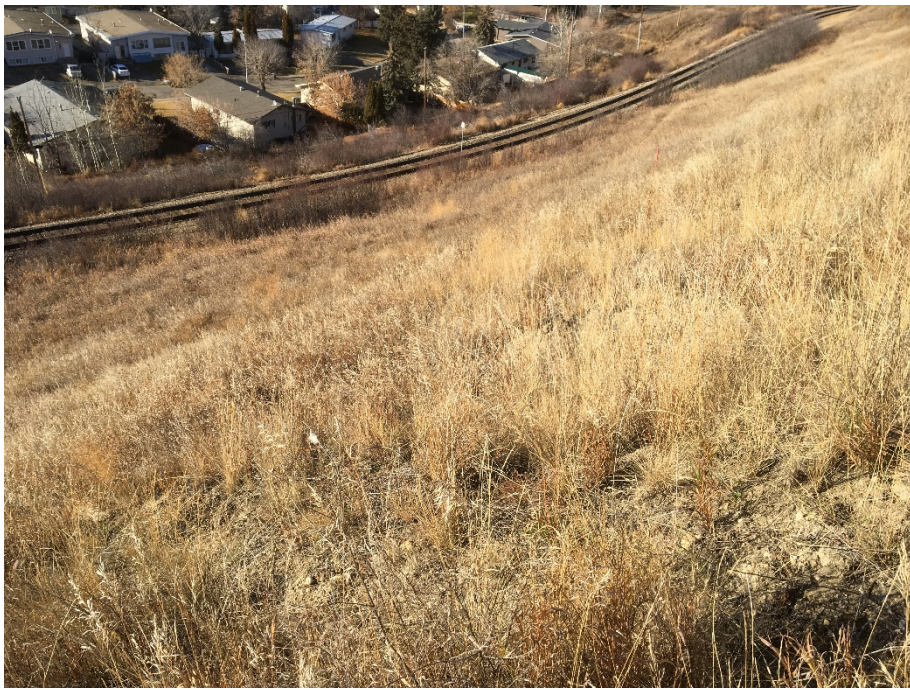
**Photo 5.**

Looking west downslope of the SBL shoulder from km 59.17 at the sloughing in the clay cap from the 2005 repair. There is a 0.3 m wide ledge exposed along the base of the clay fill. A shallow slump has also formed in the sideslope.

<b>Recommendations:</b>		
A short term solution for the shallow skin failures in the clay cap over the sideslope is to seed and cover the sideslope with Macmat and anchor it into the slope with Duckbill anchors. In addition to attenuating the dips at the landslide scarp in the roadway surface on-going crack sealing, milling and patching of the dipped pavement sections should be completed prior to the next anticipated asphalt resurfacing project.		<b>Cost</b> \$75,000
Mid-term to long term solutions would involve excavating and removing the upper clay backfill from the 2005 repair and rebuilding the highway embankment with granular fill reinforced with uniaxial geogrid, the reinstatement of the clay cap on the embankment sideslope and the placement of an overlying slope protection (Armormax anchored with Duckbill anchors).		\$ 500,000
Long term solutions to deal with the propagation of cracks to the north and south of the Fence Slide could consist of a realignment of the highway into the backslope (now that the natural gas pipeline will be decommissioned following the winter of

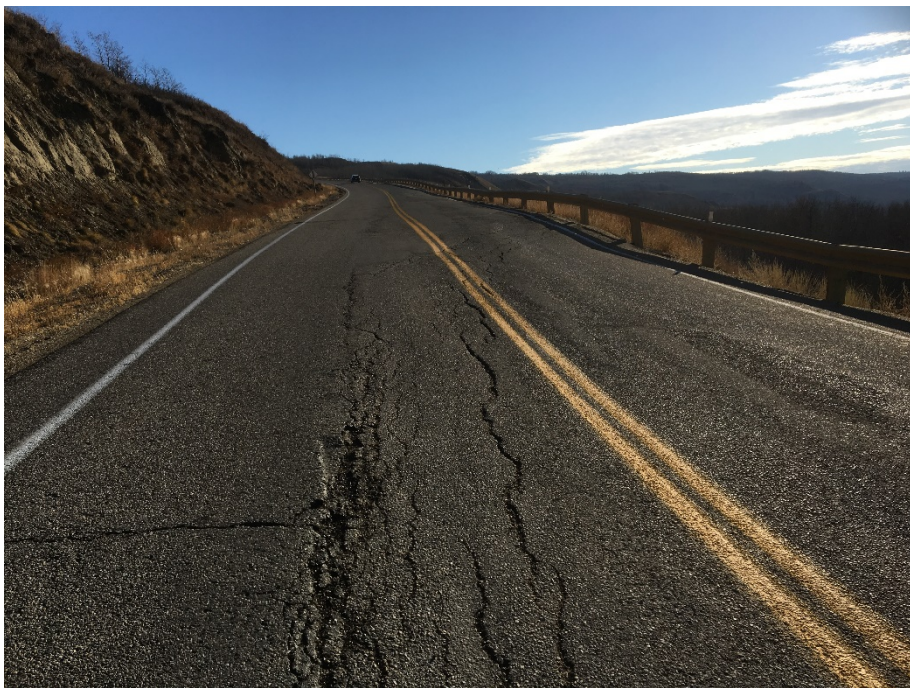
**Photo 6.**

Looking south in the NBL from km 59.18 at the south portion of the large dip in the highway in the NBL. The differential drop varies from 100 mm to 250 mm and there are more cracks on the ACP along the edge of the dip and more of the ACP as spalled since May 2018.

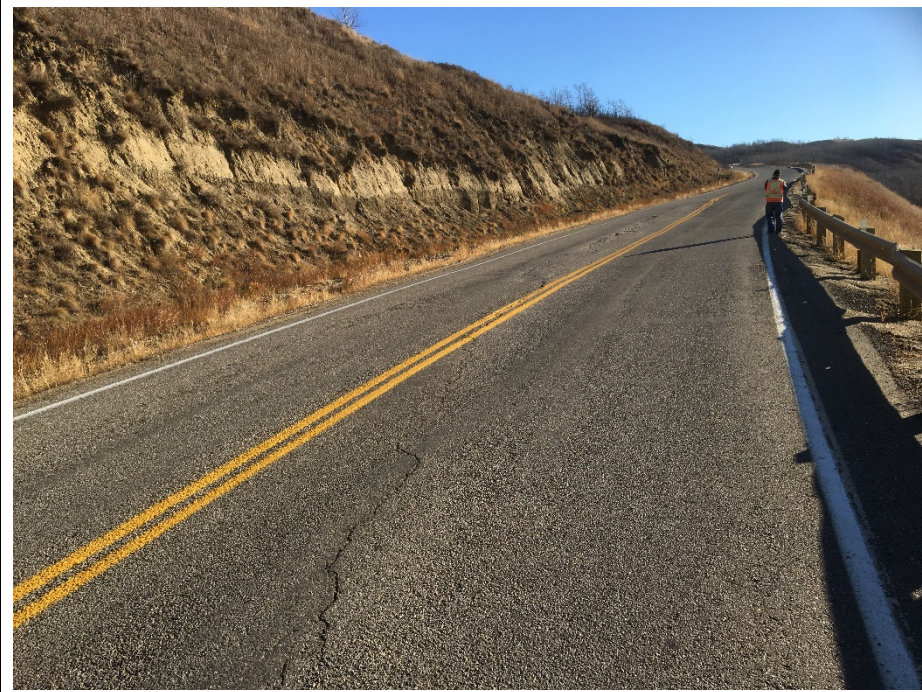
**Photo 7.**  
Looking southeast from km 59.198 in the SBL at the large dip. There are more cracks along the edge of the dip than in May 2018 and the overall drop along the dip at 400 mm.

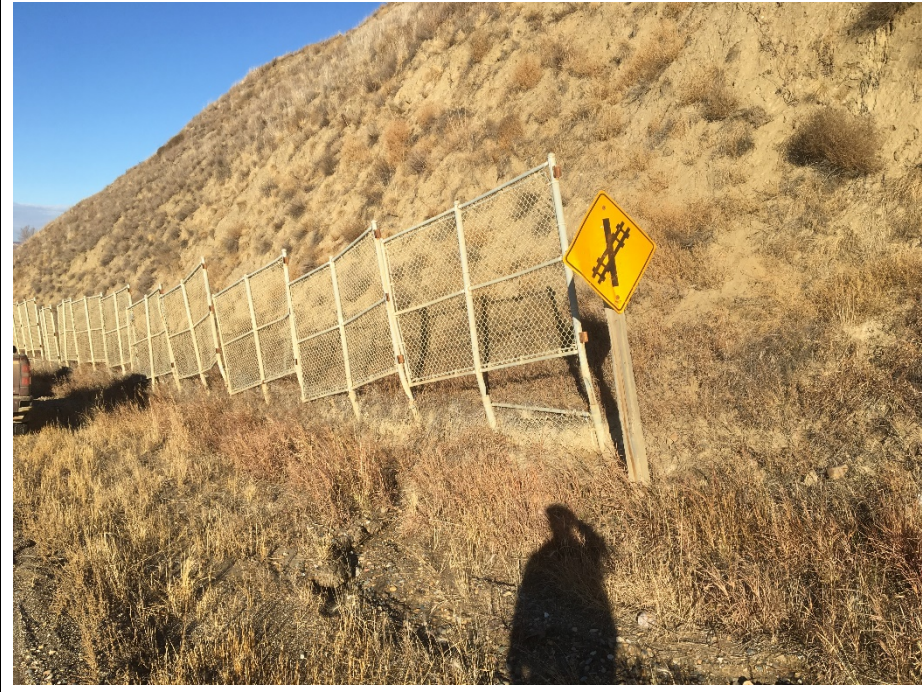
**Photo 8.**  
Looking northeast from NBL shoulder at km 59.23 towards the south end of the chain link fence. The six southernmost fence panels are more tilted/jacked than in May 2018.

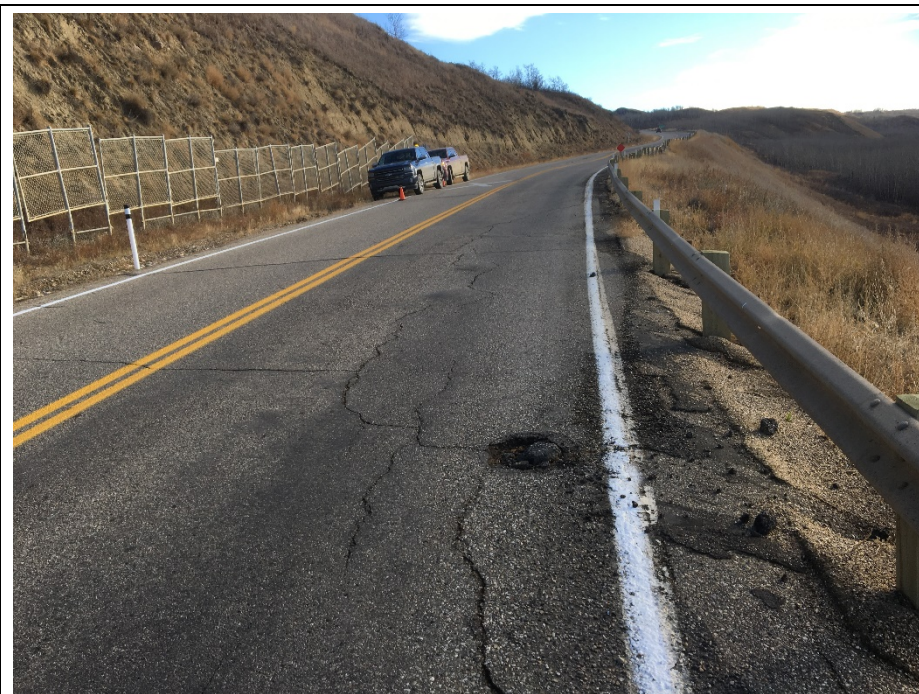
**Photo 9.**  
Looking southeast along the shoulder of the SBL at km 59.255. There is an old stone column protruding through the ACP and the dip in the guardrail is at 150 mm at SI10-15.

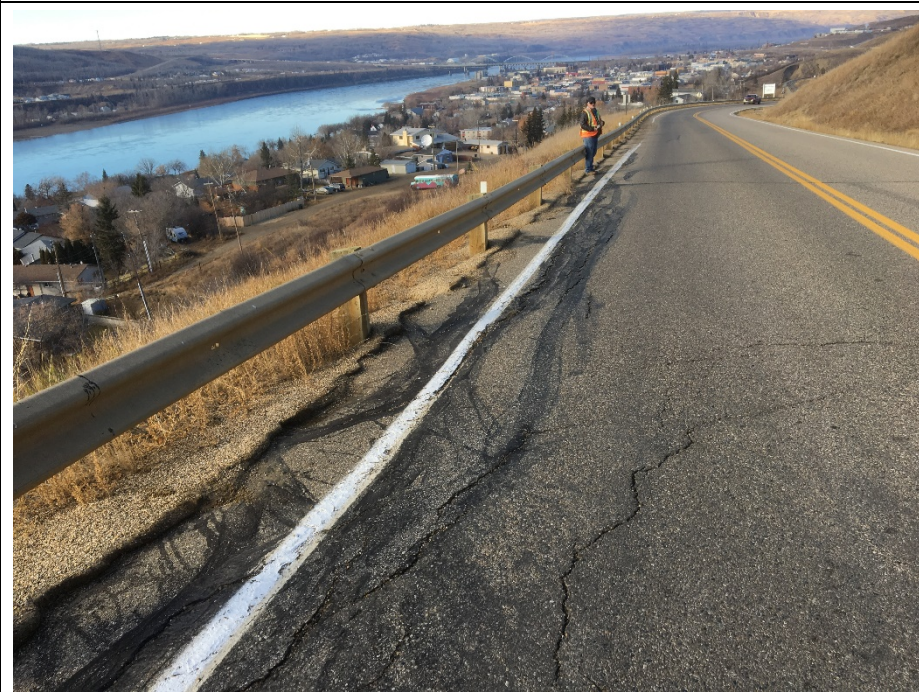
**Photo 10.**  
Looking south from the SBL at km 59.265 at the cracks in the shoulder of the ACP are open to 30 mm.
