**ALBERTA TRANSPORTATION
GEOHAZARD ASSESSMENT PROGRAM
PEACE REGION (PEACE RIVER DISTRICT)
2021 INSPECTION**

Site Number	Location	Name	Hwy	km
PH034	Judah Hill	Fence Slide	744:04	59.177
Legal Description		UTM Co-ordinates		
SE¼ 29-083-21 W5M		11V E 482792	N 6230946

PH034-1 JUDAH HILL FENCE SLIDE
2021 SITE INSPECTION PLAN

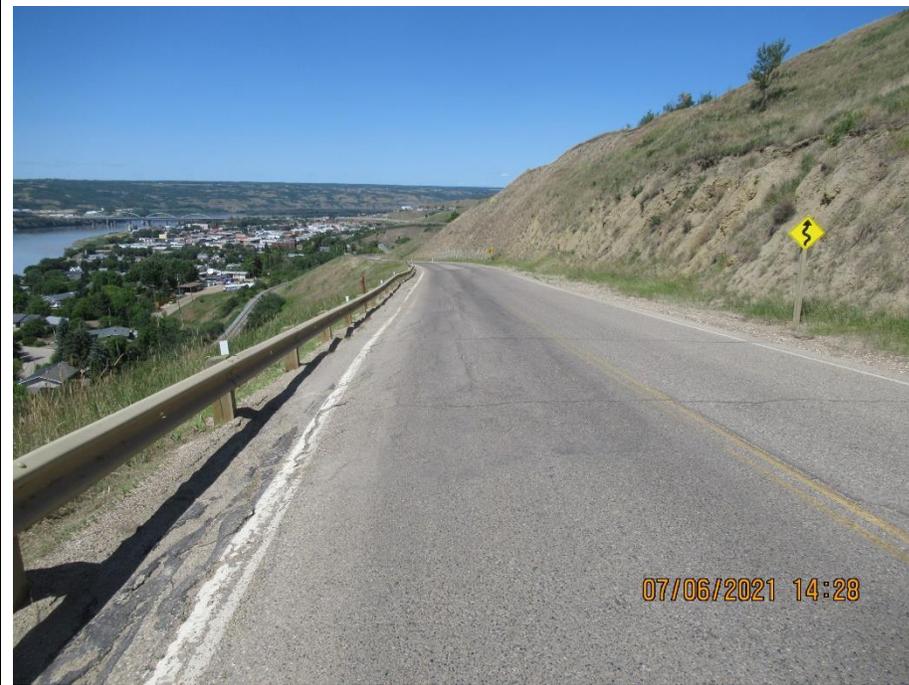
<input checked="" type="checkbox"/> Pavement Distress	<p>Near km 59.1 (near S110-12), subsidence within the SBL near the guardrail is up to 150 mm. No significant expansion or change from 2020. (Photo 1)</p> <p>Existing cracks in the SBL shoulder near km 59.13 did not change significantly since 2020.</p> <p>At the main repair area (km 59.14) the cracks in the SBL shoulder are worse and are open up to 100 mm. The depression has a differential drop up to 350 mm with a sharp differential edge in the ACP that is worse from the previous inspection in 2020. (Photos 2 and 3)</p> <p>Pavement condition at km 59.2 had no significant change from 2020. (Photo 6)</p>	<input checked="" type="checkbox"/>	
<input checked="" type="checkbox"/> Slope Movement	At main slide repair area: the previously observed shallow slump and skin failure in the	<input type="checkbox"/>

Photo 1.
Looking northwest from km 59.07 at the cracking and pavement distress along the downhill side of the road near S110-12. No significant visual change in the pavement from the 2020 condition.

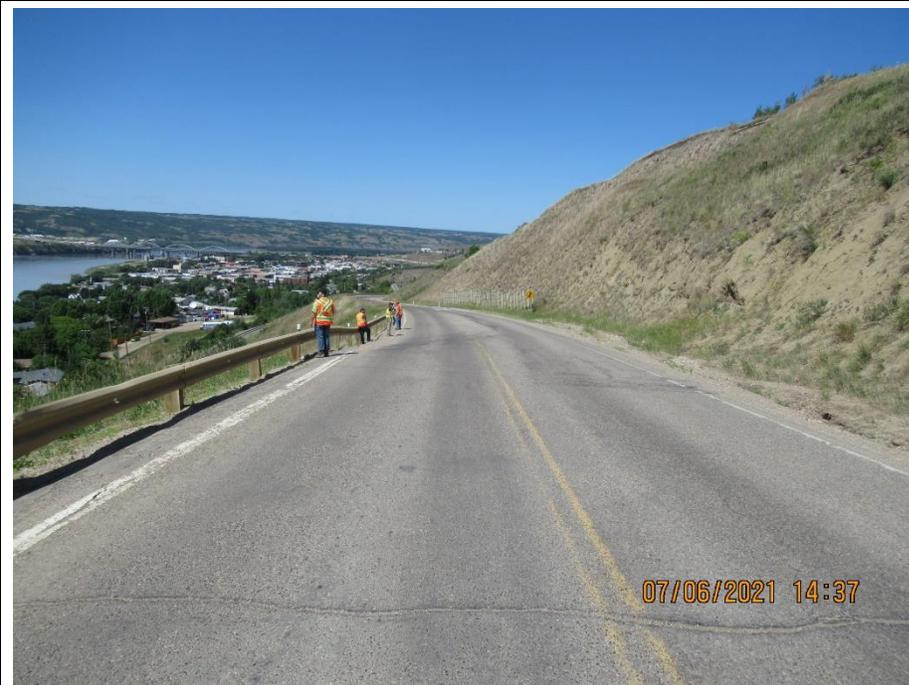
Photo 2.
Looking north from the south end of the Fence Slide repair at km 59.14. Slide damage extends into the NBL. Cracks in the SBL shoulder of the highway open to 100 mm and overall, the dip looks slightly more pronounced relative to the 2020 condition.

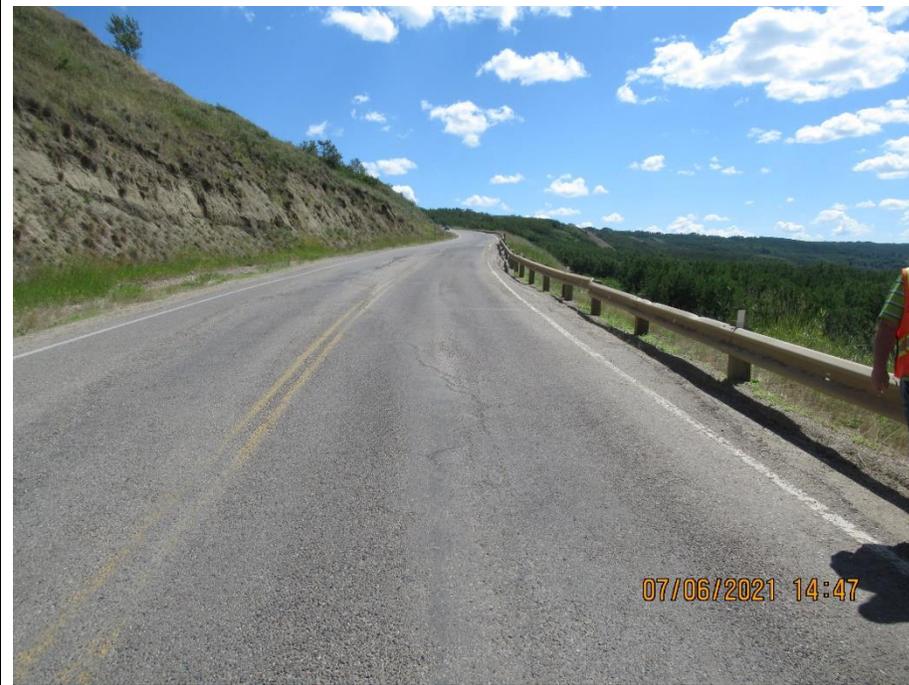
Photo 3.
Looking south from the north end of the Fence Slide repair at km 59.18. Depression extends into the NBL, and differential drop up to 350 mm.

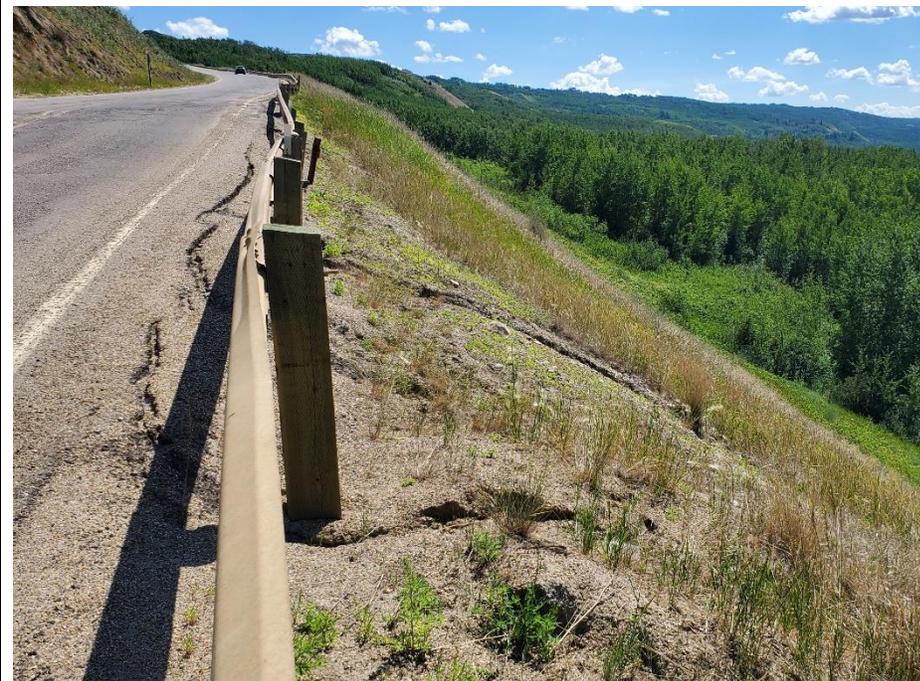
<p>clay cap that was constructed over the sideslope during the 2005 repairs had no changes. Except for surficial erosion, slope appears similar to 2020 condition. (Photo 4)</p> <p>A shallow and dry earth slide was noted below SI10-15 on the west sideslope (km 59.25). (Photo 7)</p>	
<input checked="" type="checkbox"/> Erosion	Increased rill erosion is present in the upper sideslope at the main slide repair area (km 59.18).	<input checked="" type="checkbox"/>
<input type="checkbox"/> Seepage		<input type="checkbox"/>
<input type="checkbox"/> Bridge/Culvert Distress		<input type="checkbox"/>
<input checked="" type="checkbox"/> Other	Geogrid installed as part of the 2005 repair has been previously observed becoming exposed on the embankment downslope resulting in a further reduction of its anchoring capacity.	<input type="checkbox"/>
Instrumentation:		
SI05-15	Slope inclinometer installed in 2005 at the top of the hill in the ATCO gas utility right of way above the Fence Slide, approximately 30 m elevation above the road, has not shown any consistent trend of movement since installation.

Photo 4.
Looking south from the west sideslope of Hwy 744:04 from km 59.18. The bow and vertical deflection in the guardrail are visible. ACP shoulder cracking is visible and there is increased rill erosion on the upper sideslope.

A short-term solution for the shallow skin failures in the clay cap over the sideslope is to seed and cover the sideslope with Macmat and anchor it into the slope with Duckbill anchors. In addition to attenuating the dips at the landslide scarp in the roadway surface on-going milling and patching of the dipped pavement sections should be completed prior to the next anticipated asphalt resurfacing project. \$75,000

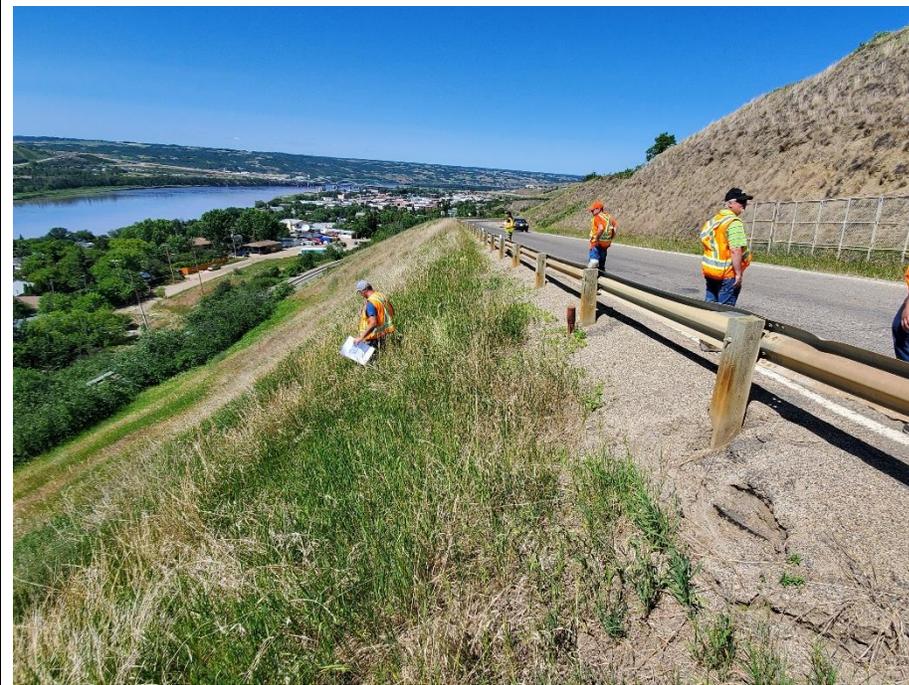
Photo 5.
Looking northwest from km 59.21 at the west sideslope below S110-15. Minor rill erosion otherwise no major change from 2020.

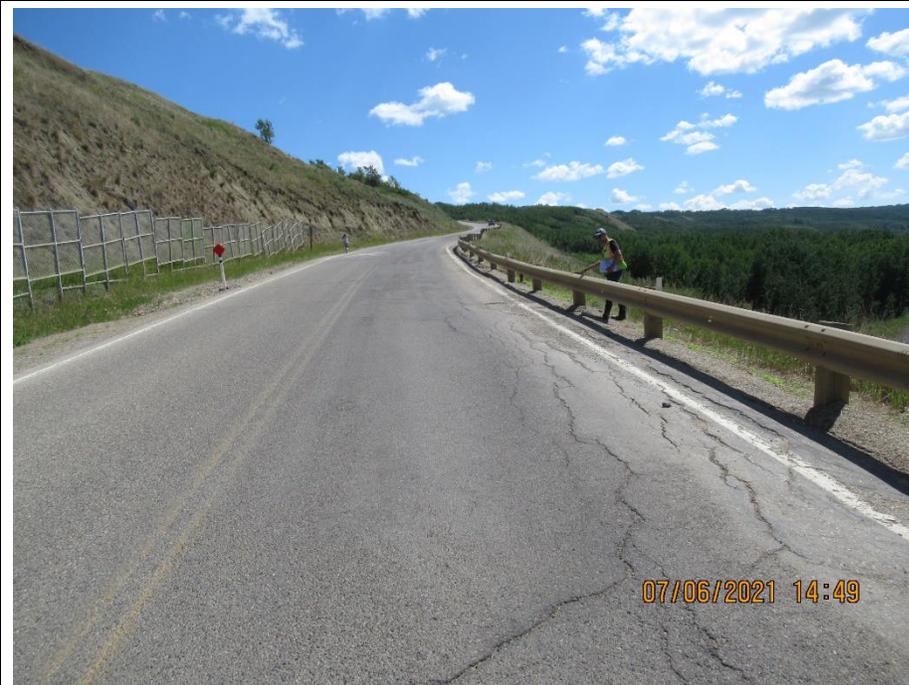
Photo 6.
Looking southeast from km 59.25 along the SBL with dip up to 150 mm along the guardrail. No change from the 2020 condition.

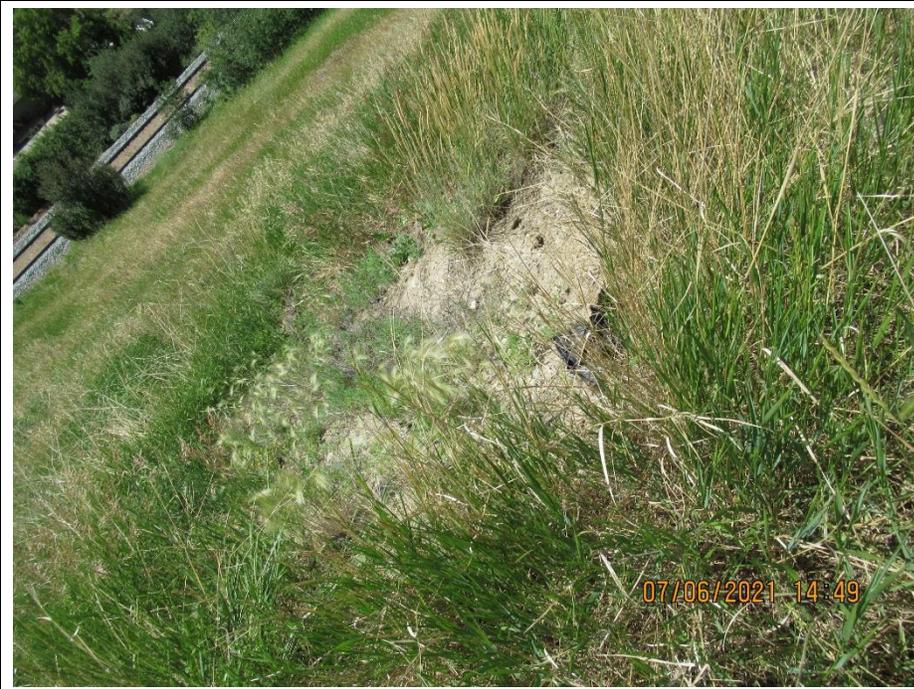
Photo 7.
Shallow dry slough
below S110-15 on
the west sideslope
below the highway
near km 59.25.
