**ALBERTA TRANSPORTATION
GEOHAZARD ASSESSMENT PROGRAM
PEACE REGION (PEACE RIVER DISTRICT)
2022 INSPECTION**

Site Number	Location	Name	Hwy	km
PH034	Judah Hill	Fence Slide	744:04	59.177
Legal Description		UTM Co-ordinates		
SE¼ 29-083-21 W5M		11V E 482792	N 6230946

PH034-1 JUDAH HILL FENCE SLIDE
2022 SITE INSPECTION PLAN

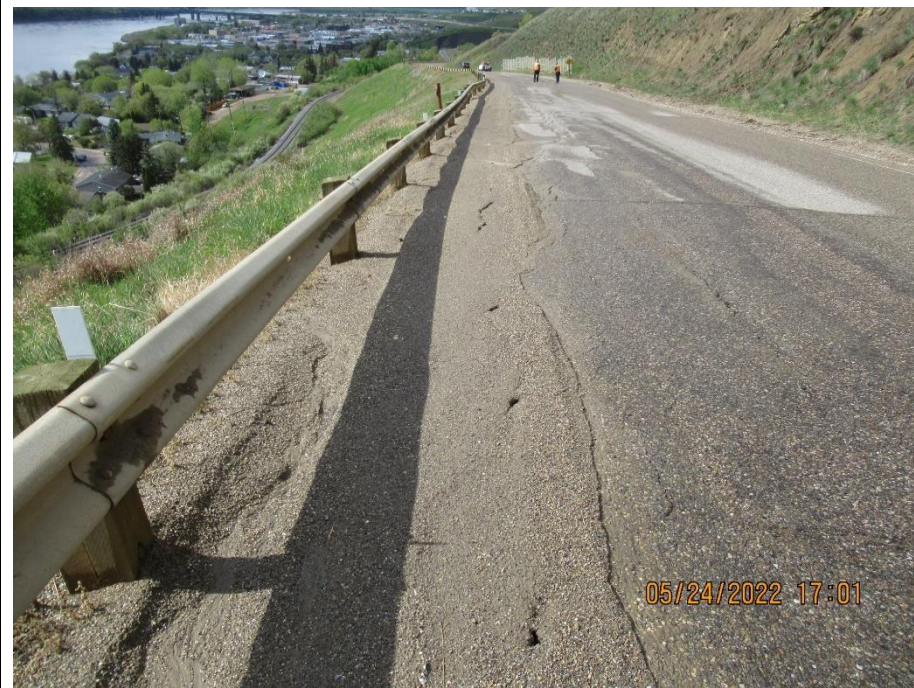
<input checked="" type="checkbox"/> Pavement Distress	<p>Near km 59.1 (near S110-12), subsidence within the SBL near the guardrail is up to 150 mm. No significant expansion or change from 2021. (Photo 1)</p> <p>Existing cracks in the SBL shoulder near km 59.13 did not change significantly since 2021.</p> <p>At the main repair area (km 59.14) the cracks in the SBL shoulder are worse and are open up to 100 mm. The depression has a differential drop up to 350 mm with a sharp differential edge in the ACP that is worse from the previous inspection in 2021. (Photos 2 and 3)</p> <p>Pavement condition at km 59.2 had no significant change from 2021. (Photo 6)</p>	<input checked="" type="checkbox"/>
<input checked="" type="checkbox"/> Slope Movement	At main slide repair area: the previously observed shallow slump and skin failure in the	<input type="checkbox"/>

Photo 1.
Looking northwest from km 59.07 at the cracking and pavement distress along the downhill side of the road near S110-12. No significant visual change in the pavement from the 2021 condition.

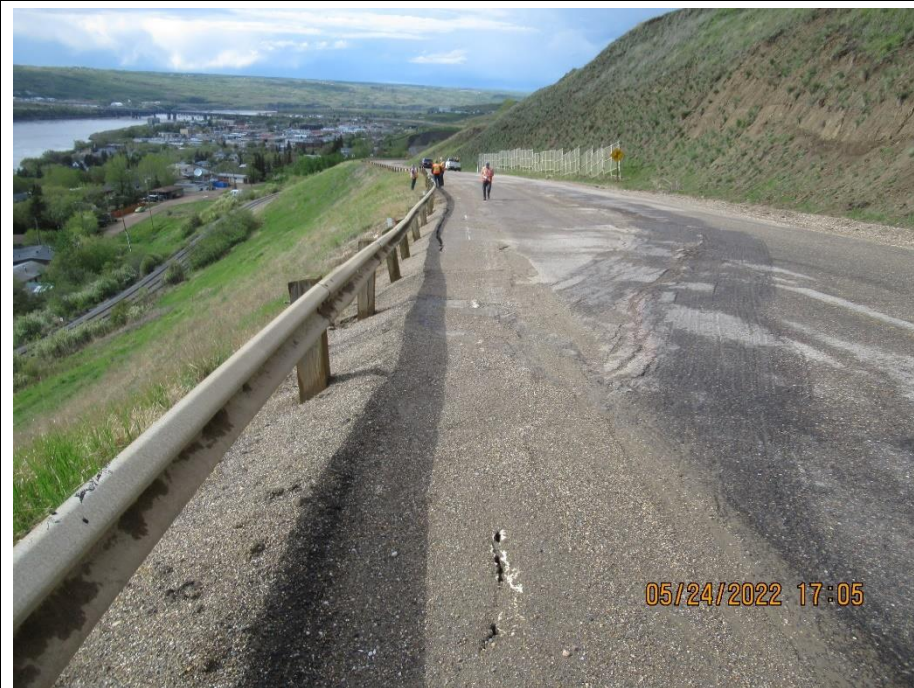
Photo 2.
Looking north from the south end of the Fence Slide repair at km 59.14. Slide damage extends into the NBL. The sharp pavement edge due to the dip has been milled.

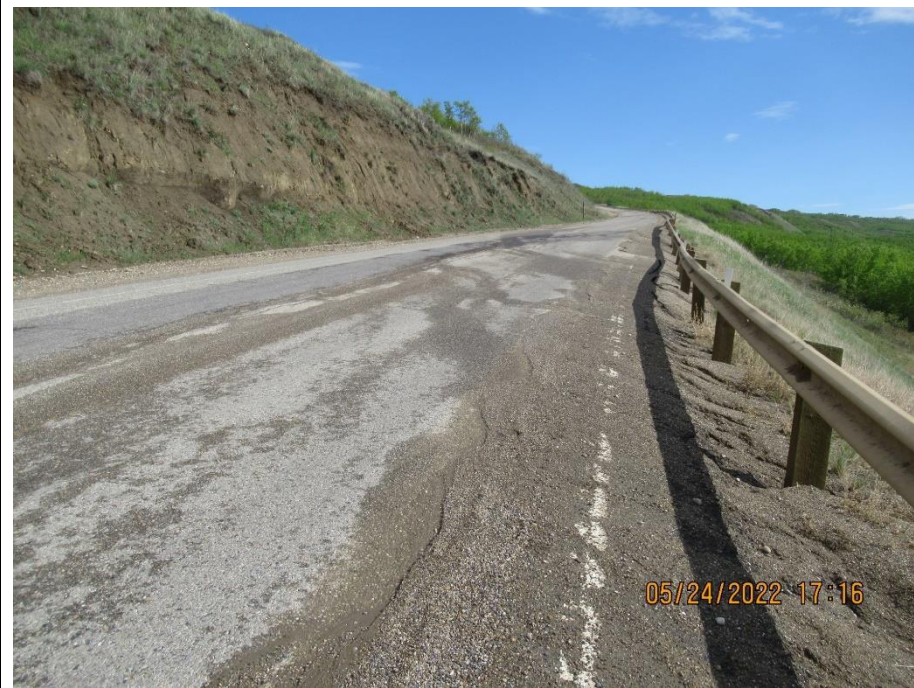
Photo 3.
Looking south from the north end of the Fence Slide repair at km 59.18. Depression extends into the NBL and appears more pronounced. Differential pavement edge has been milled.

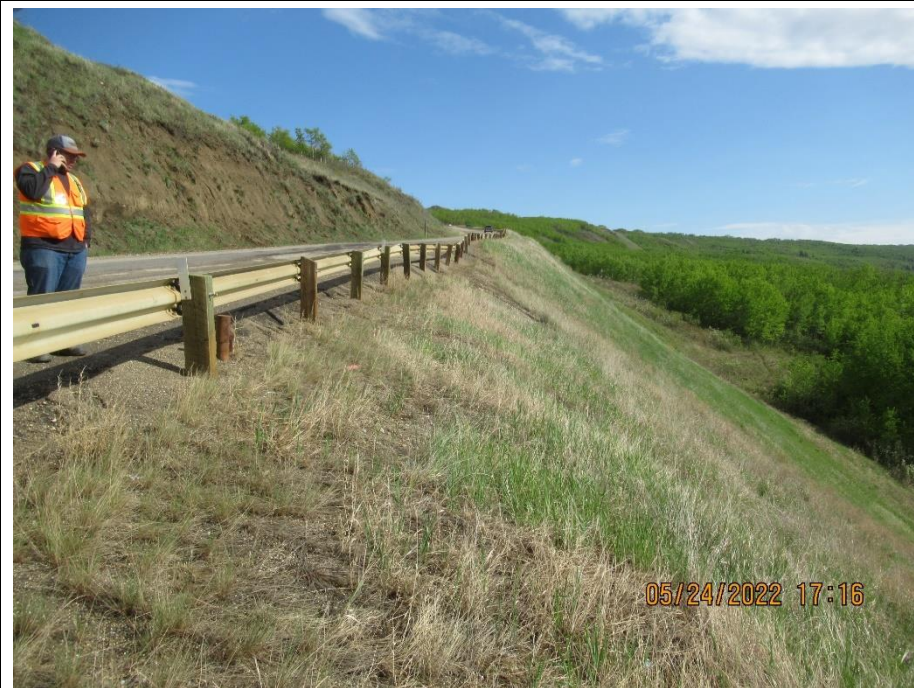
<p>clay cap that was constructed over the sideslope during the 2005 repairs had no changes. Except for surficial erosion, slope appears similar to 2021 condition. (Photo 4)</p> <p>A shallow and dry earth slide was noted below SI10-15 on the west sideslope (km 59.25). (Photo 7)</p>	
<input checked="" type="checkbox"/> Erosion	Increased rill erosion is present in the upper sideslope at the main slide repair area (km 59.18).	<input checked="" type="checkbox"/>
<input type="checkbox"/> Seepage		<input type="checkbox"/>
<input type="checkbox"/> Bridge/Culvert Distress		<input type="checkbox"/>
<input checked="" type="checkbox"/> Other	Geogrid installed as part of the 2005 repair has been previously observed becoming exposed on the embankment downslope resulting in a further reduction of its anchoring capacity.	<input type="checkbox"/>

It is postulated that the dipping in the highway pavement surface is the result of the clay fill settling and spreading over time. The shallow sloughing of the clay cap is considered due to the loss of cohesion as a result of weathering (wetting and desiccation cycles). The repaired sideslope is over-steepened and lateral spreading of the clay fill is expected to continue. The shear depth of the SI's correlates with this assessment.

Photo 4.
Looking south from the west sideslope of Hwy 744:04 from km 59.18. The bow and vertical deflection in the guardrail are visible.

<p>A short-term solution for the shallow skin failures in the clay cap over the sideslope is to seed and cover the sideslope with Macmat and anchor it into the slope with Duckbill anchors.</p>	<p>\$75,000</p>
<p>Mid-term to long term solutions would involve excavating and removing the upper clay backfill from the 2005 repair and rebuilding the highway embankment with granular fill reinforced with uniaxial geogrid, the reinstatement of the clay cap on the embankment sideslope and the placement of an overlying slope protection (Armormax anchored with Duckbill anchors).</p>	<p>\$ 300,000</p>
<p>Long-term solutions to deal with the propagation of cracks to the north and south of the Fence Slide could consist of a realignment of the highway into the backslope (now that the natural gas pipeline is decommissioned), digging out weaker clay layers and rebuilding the slope with geogrid reinforced gravel (like the Fence Slide repair from 2015) or pile walls. The cost could range from \$2,000,000 to \$10,000,000. The realignment is likely the cheapest option but will only buy some time until further retrogression occurs whereas the pile wall or dig and replace options should be a more permanent solution.</p>	<p>\$2M - \$10M</p>

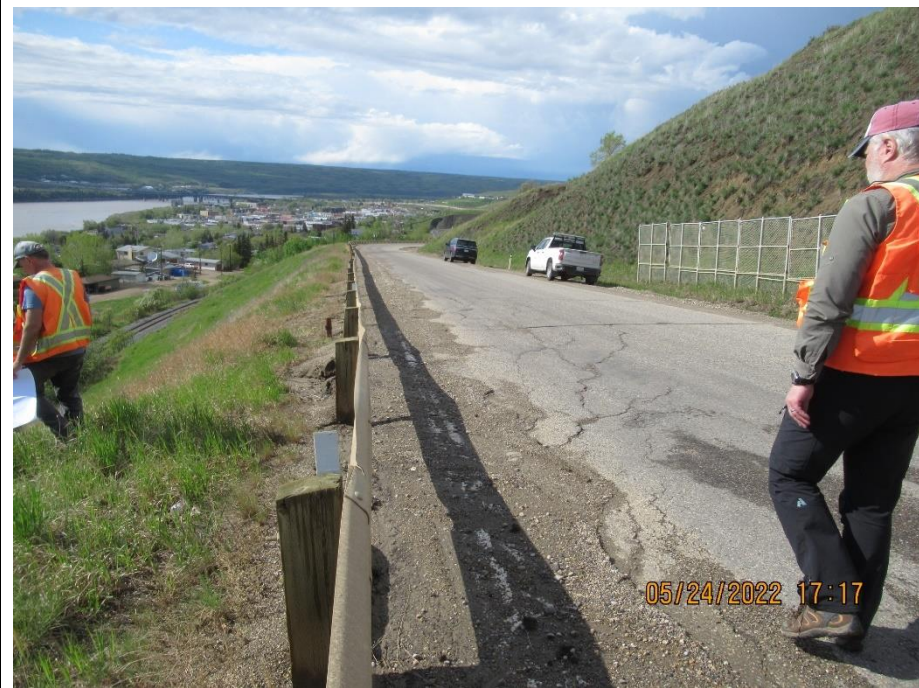
Photo 5.
Looking northwest from km 59.21 at the west sideslope below S110-15. Minor rill erosion otherwise no major change from 2021.

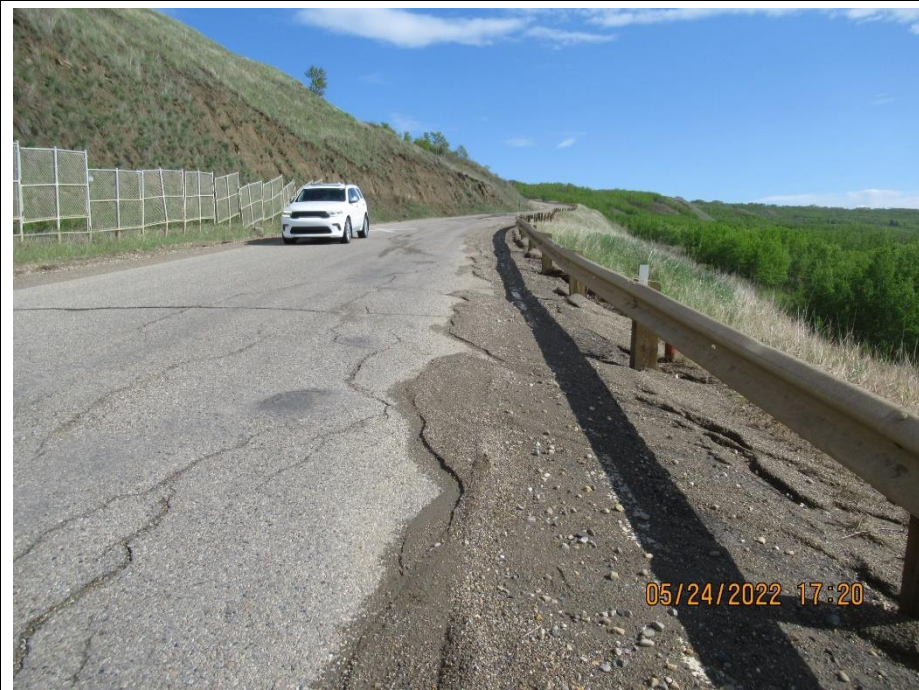
The development of additional cracks in the highway shoulder south and north of the Fence Slide (in the vicinity of SI10-12 and SI10-15) within the last few years are getting worse and likely indicate potential slope failures at these locations in the southbound lanes in the future. No toe bulge or other visible slide features have been apparent on the slope below the road in recent inspections.

Photo 6.
Looking southeast from km 59.25 along the SBL. Cracking and dip along the shoulder appeared slightly worse relative to the 2021 condition. Sand buildup along the shoulder.

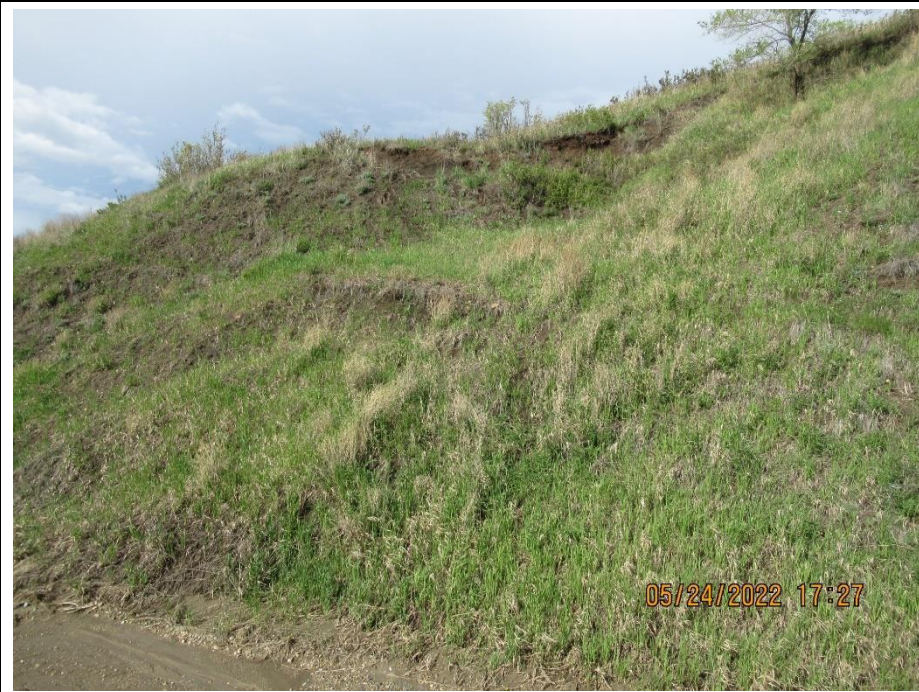
Photo 7.
View of old slump
in the backslope
near km 59.3.
Fresh soil visible in
the upper scarp
since the 2021
condition.
