**ALBERTA TRANSPORTATION AND
ECONOMIC CORRIDORS
GEOHAZARD ASSESSMENT PROGRAM
PEACE REGION (PEACE RIVER DISTRICT)
2025 INSPECTION**

Site Number	Location	Name	Hwy	km
PH034	Judah Hill	Fence Slide	744:04	59.177
Legal Description		UTM Co-ordinates (NAD 83)		
SE¼ 29-083-21 W5M		11V E 482792	N 6230946

PH034 JUDAH HILL FENCE SLIDE
2025 SITE INSPECTION PLAN

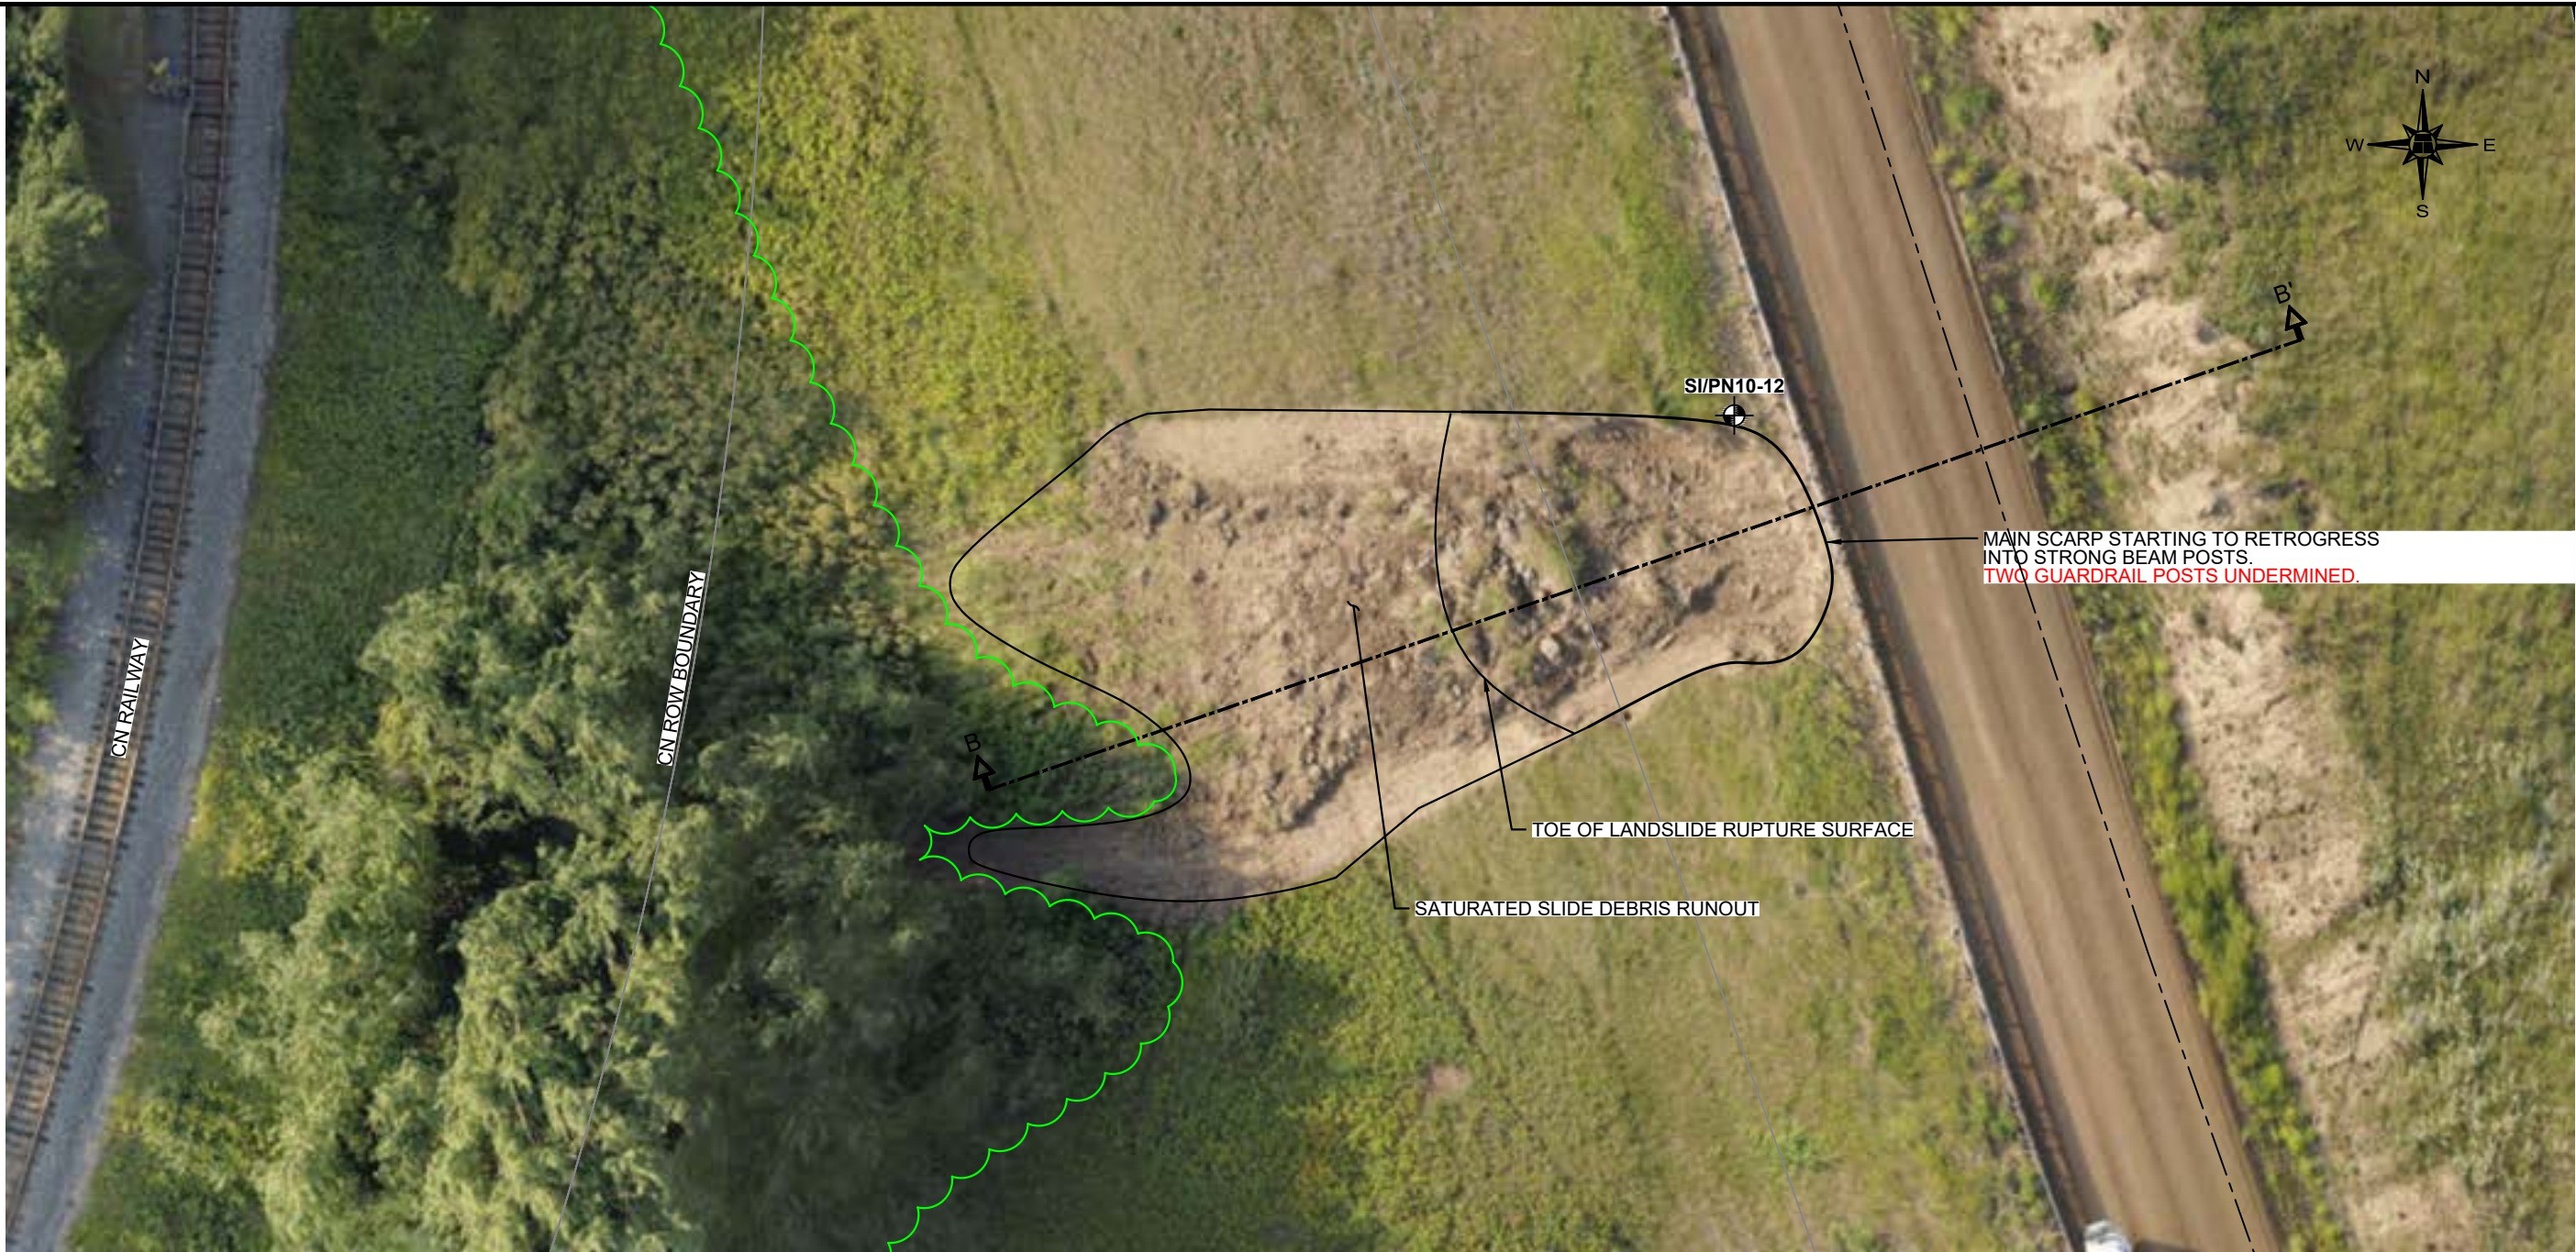
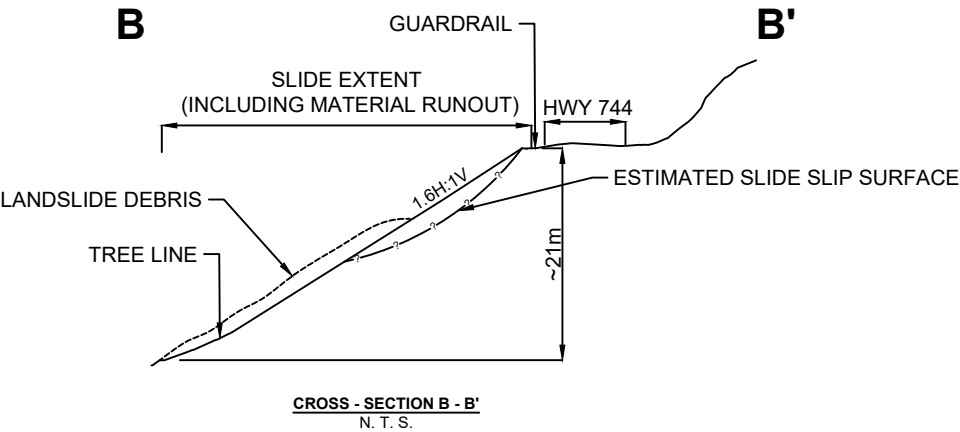
DWG No. 32121-PH034-2

- MAY 15, 2025 OBSERVATION SHOWN IN RED**
- AERIAL PHOTO TAKEN ON AUGUST 3, 2023
- MEASUREMENTS BASED ON APPROXIMATE FIELD MEASUREMENTS, HAND HELD GPS, AND LIMITED PHOTOGRAMMETRY
- REFER TO 2023 INSPECTION PLAN FOR HISTORIC INFORMATION

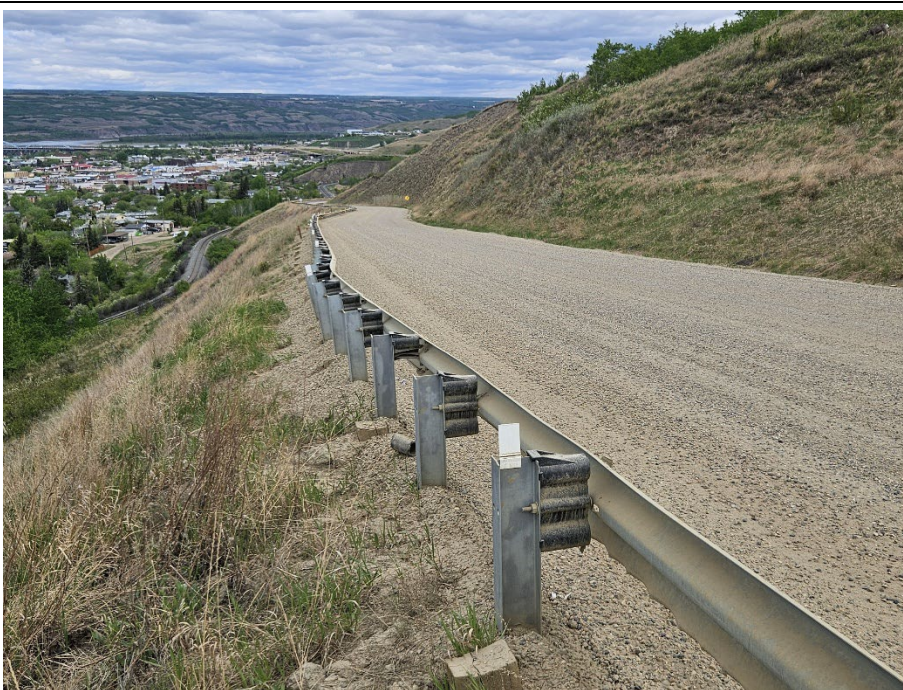
Photo 1.

Observations:	Description:	Worsened?	
		Yes	No
<input checked="" type="checkbox"/> Pavement	ACP removed and converted to gravel surface as part of fall 2022 construction work. Gravel road surface was in a good condition with no visible disturbance in areas with previously observed pavement damage. (Photo 1, 5 and 6)	<input type="checkbox"/>	<input checked="" type="checkbox"/>
<input checked="" type="checkbox"/> Slope Movement	At the new landslide near km 59.975 there has been slightly more retrogression and erosion of the main head scarp since the 2024 inspection. There is also ongoing erosion of the flanks. Two of the guardrail posts were undermined by the slide at the time of the inspection. (Photos 2 and 3) At main slide repair area: the previously observed shallow slump and skin failure in the clay cap that was constructed over the sideslope during the 2005 repairs had no visible changes except for surficial erosion and appears similar to the 2024 condition.	<input checked="" type="checkbox"/>	<input type="checkbox"/>

Looking north from km 58.87 at the converted ACP to gravel road surface within the southern site extents. Gravel road surface was in a good condition with no visible dips or cracking.

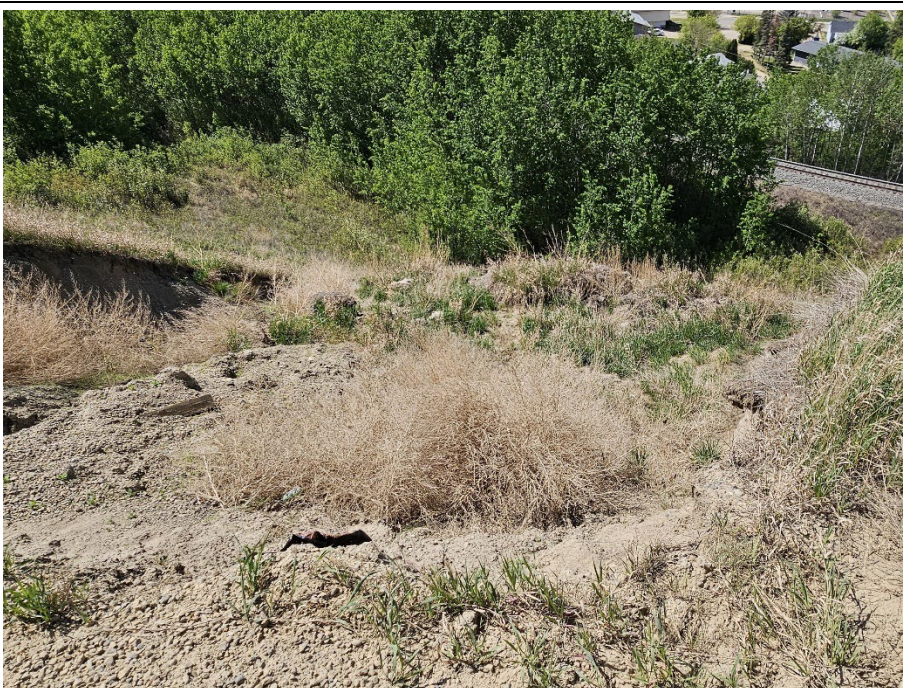
Photo 2.

Looking west from km 58.975 at south end of the new landslide that occurred in 2023 with main scarp that is below the guardrail of the SBL. No cracks were observed upslope of the slide area in the road.

- The new slide near km 58.975 should be regularly monitored for retrogression of the main scarp into the SBL. Further retrogression would require partial closure of the SBL and signage / barricades would need to be placed for one-way alternative traffic. It is recommended that if this

occurs a culvert should be placed in the upslope ditch to locally widen the gravel road in this section until a more permanent solution can be constructed.

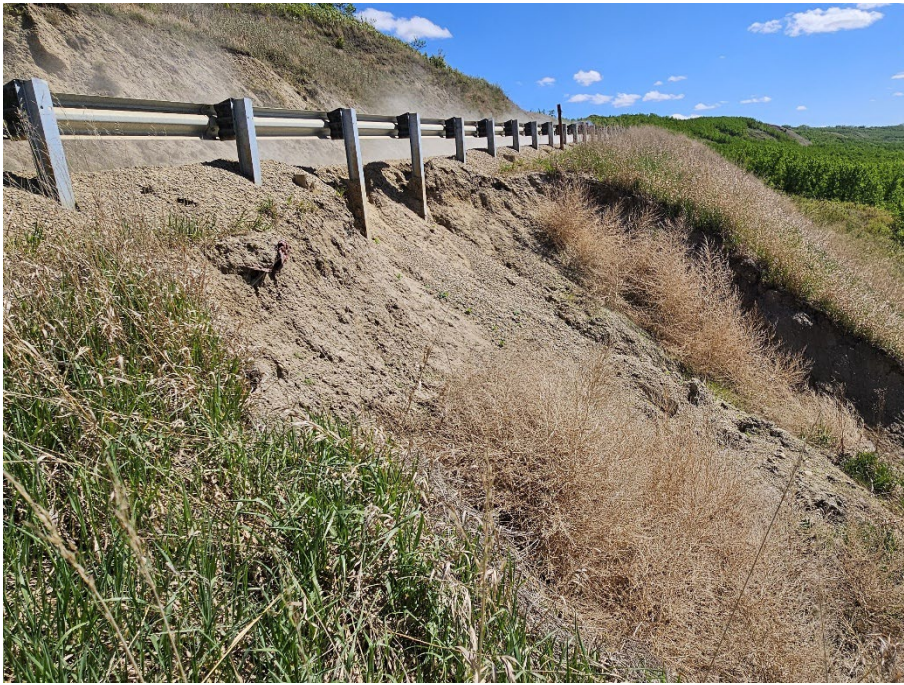
Photo 3.

Looking south from the north flank of the 2023 landslide near km 58.99. Ongoing erosion and retrogression of the main scarp since 2024 inspection. Two of the guardrail posts have been undermined.

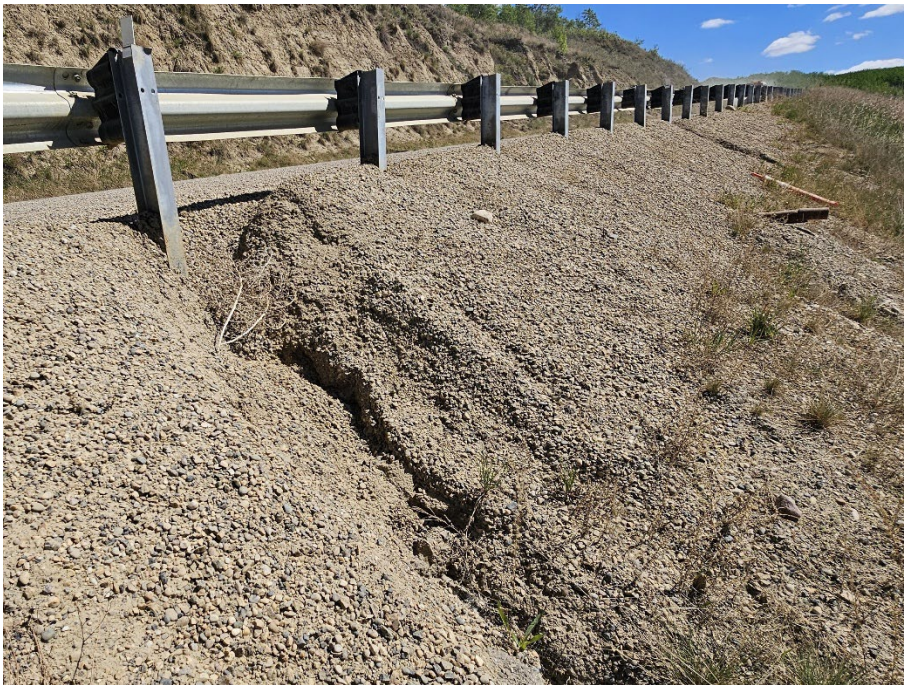
Photo 4.

<input checked="" type="checkbox"/> Erosion	Slightly worse rill erosion is present in the upper sideslope at the main slide repair area (km 59.03). (Photo 4)	<input checked="" type="checkbox"/>	<input type="checkbox"/>
<input type="checkbox"/> Seepage		<input type="checkbox"/>	<input type="checkbox"/>
<input type="checkbox"/> Bridge/Culvert		<input type="checkbox"/>	<input type="checkbox"/>
<input checked="" type="checkbox"/> Other	The synthetic ditch barriers installed as part of the erosion repairs have become broken at several locations, likely from impact with the grader blade or winter plowing due to the high ditch elevation. Limited grass growth was noted in the ditch south of km 58.9 towards the Judah Trunk Site (PH090). Geogrid installed as part of the 2005 repair has been previously observed becoming exposed on the embankment downslope resulting in a further reduction of its anchoring capacity.	<input type="checkbox"/>	<input checked="" type="checkbox"/>

Rill erosion and scouring below the highway SBL resulting from the concentrated water runoff in the lower dipped sections also needs to be addressed as it can lead to progressively larger erosion gullies, skin failures and landslide features, which could eventually retrogress into the roadway. Care will need to be taken when grading the gravel road surface to avoid a buildup of a windrow beneath the guardrail as breaches in a windrow could concentrate runoff and create erosion in the embankment sideslope.

Looking south near km 59.03 along the road segment where the downslope embankment had landslide repairs in 2005 and previous pavement damage had been observed prior to the ACP to gravel conversion in 2022. An erosion rill has opened up from concentrated runoff.

- Repair erosion rill areas on the upper sideslope with granular fill to reduce rates of undermining and loss of support for the guardrail posts. Consider establishing an armoured swale at known locations of concentrated runoff to reduce rates of erosion within the upper sideslope. The outlet areas would need to be directed as far down the sideslope (i.e. towards the west) as practical to avoid saturating the embankment fill and initiating new slides. Clear any ridges of gravel under the guardrail to encourage sheet flow runoff rather than concentrated runoff from the road over the side slope.
- High elevated areas of the ditch profile may need to be adjusted (lowered) to prevent damage to the synthetic ditch barriers during road maintenance activities and to reduce risk of ditch overflow onto the road and causing erosion damage.

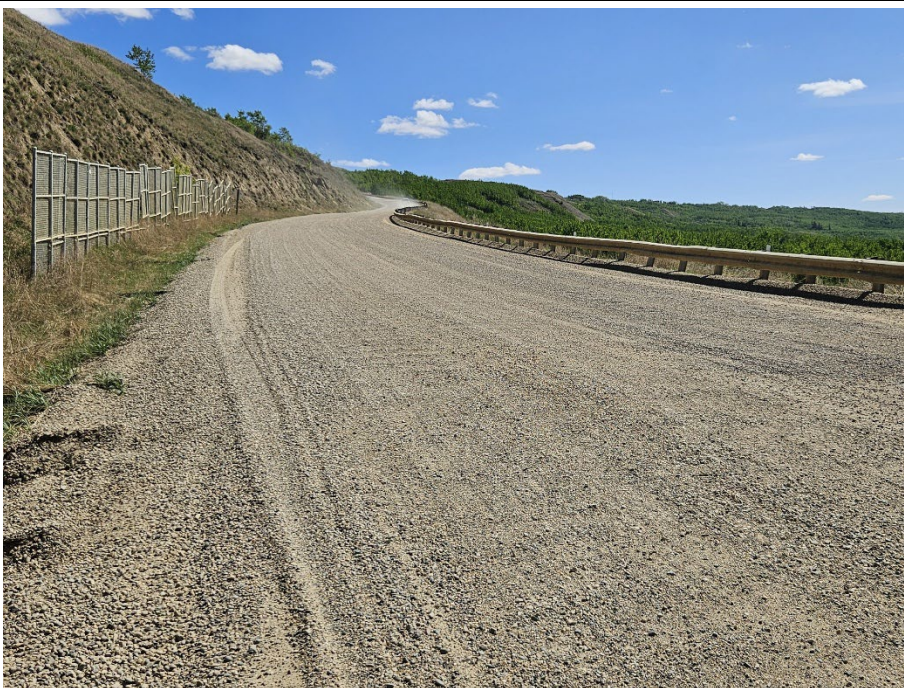
Photo 5.

Looking south near north end of chain link fence at km 59.12. Gravel conversion road surface appeared to be in good condition. Vegetation is growing well in the section ditch erosion repaired with Type C TRM and ditch barriers.

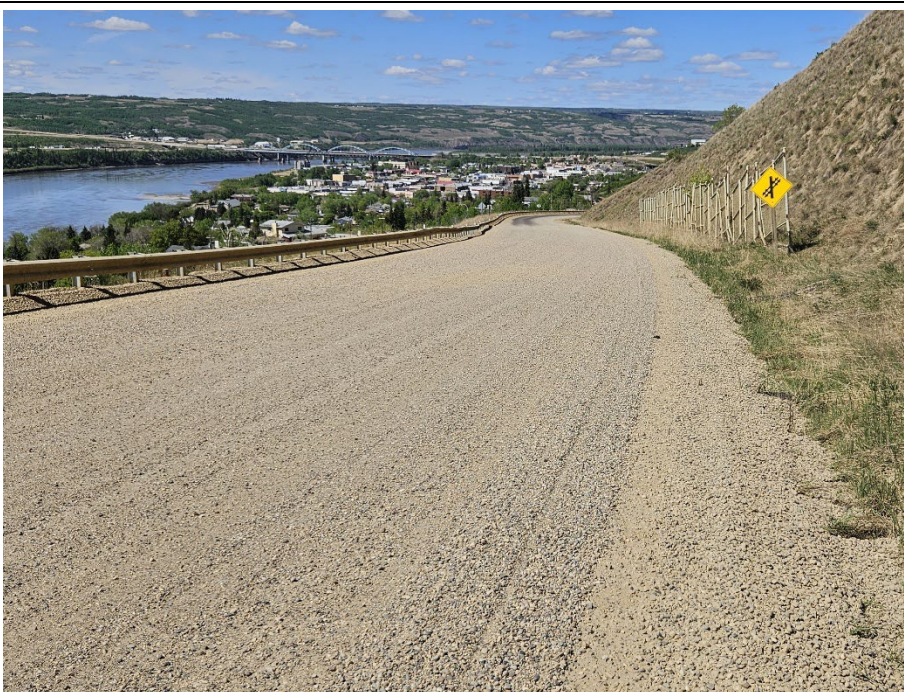
Photo 6.

Looking north near the south end of the chain link fence at km 59.05.
