**ALBERTA TRANSPORTATION  
GEOHAZARD ASSESSMENT PROGRAM  
PEACE REGION (PEACE RIVER DISTRICT)  
2021 INSPECTION**

Site Number	Location	Name	Hwy	km
PH065	44+700 to 45+200	Trib. to Heart River	744:04	45.0
Legal Description		UTM Co-ordinates		
NE12-82-22 W5M SE13-82-22 W5M NW7-82-21 W5M SW18-82-21 W5M		11V E 481975 N 6217485

TRIB TO HEART RIVER  
HWY 744:04 (PH065)  
LOCATION PLAN

**TRIB TO HEART RIVER  
 HWY 744:04 (PH065)  
 DETAILED PLAN**

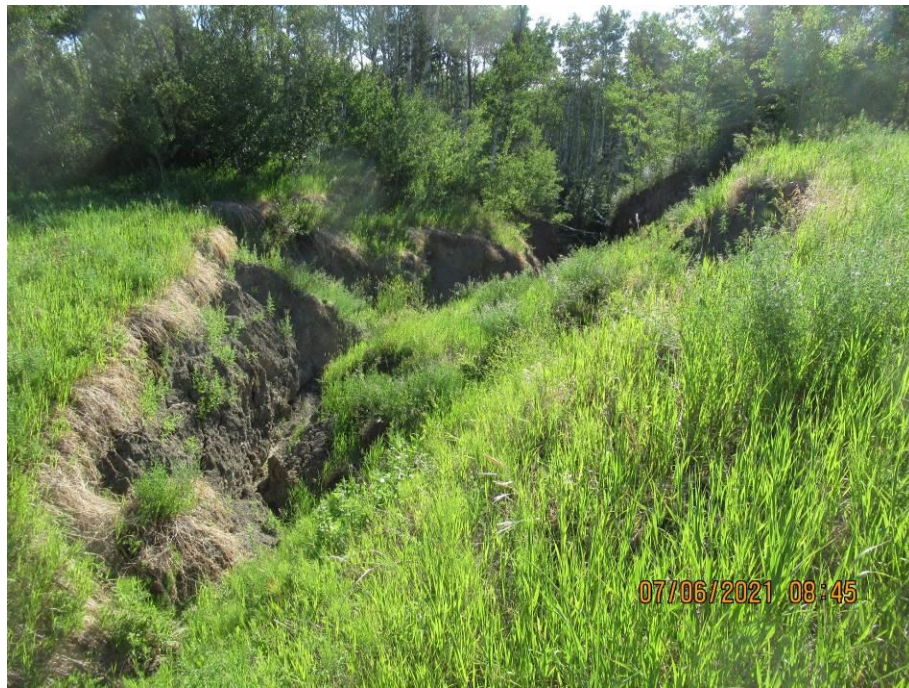
<input checked="" type="checkbox"/> Erosion	<p>Erosion at northernmost culvert outlet 45+200 has increased.</p> <p>At Bridge File culvert outlet (45+000) ongoing decrease of toe support on both sides of the embankment due to erosion and localized slumping (Photos 65-5 and 65-6).</p> <p>Scour near the culvert inlet has not significantly worsened since previous inspection condition (Photo 65-11).</p>	<input checked="" type="checkbox"/>
<input type="checkbox"/> Seepage		<input type="checkbox"/>
<input checked="" type="checkbox"/> Bridge/Culvert Distress	<p>A section of an abandoned culvert (buried upstream of the inlet) has been washed through the main culvert beneath the road in a 2017/2018 high-flow event. The old culvert is still jammed against the displaced rip-rap creating a blockage of woody debris near the outlet opening, increasing erosion, scour and reducing flow capacity (Photo 65-7).</p>	<input checked="" type="checkbox"/>

**Photo 65-1.**  
Erosion gully at the culvert outlet (45+200) had increased sliding along the flanks.

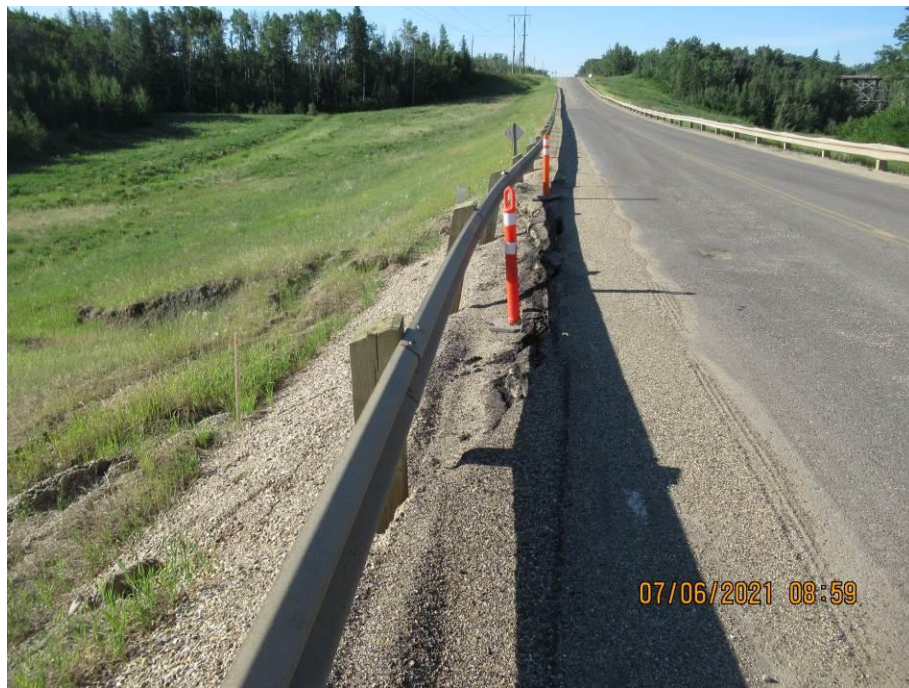
<p>in vicinity of 44+850. Longitudinal cracks (about 15 mm to 50 mm wide in average) near the centre lines and shoulders of both northbound and southbound lanes. Arc-shaped cracking near active slide area (Photo 65-2) has retrogressed a bit further into the pavement.</p> <p>Wheel rutting and longitudinal cracking at south end of site within southbound lane between 44+750 to 44+840.</p>	
<input checked="" type="checkbox"/> Slope Movement	<p>West cutslope repair is performing well, no change from 2020 (45+100). Slumping on east side, downstream of culvert at 45+200 has expanded with increased sliding at the flanks (Photo 65-1). Active slide at 45+000 (Photos 65-2 to 65-4) appears more defined with increased downdrop and minor retrogression into the road shoulder with a 1.7 m high scarp located 0.7 m from the guardrail. Very active sliding around and above culvert outlet at 45+020 (Photos 65-5 and 65-7).</p> <p>West side of the embankment between 44+775 to 44+830 appears similar to 2020 condition (Photo 65-10) with overgrown scarps around the culvert. Active slope movement above culvert inlet (44+830) offset approximately 27 m from highway and at culvert inlet headwall (Photo 65-9 and 65-10). Inactive slide scarp at the west embankment was offset 2.6 m from guardrail Photo 65-8).</p>	<input checked="" type="checkbox"/>

<input checked="" type="checkbox"/> Other	<p>Slumping on east side of roadway is affecting power transmission pole anchor wires (Photo 65-6) but flanks have not significantly expanded from 2020 condition.</p> <p>Damaged guardrail posts along the northbound side of highway near 44+800 and three unsupported posts near active slide scarp at 45+000 (Photo 65-2).</p>	<input checked="" type="checkbox"/>

Widespread shallow slumping is attributed to the loss of soil strength in high plastic soils, particularly on fill/embankment slopes. Deeper instability upstream and downstream of culverts is attributed to erosion of toe of slope by creek. The slide scarp at 45+000 has continued to retrogress into the pavement of the road shoulder. Further movement and retrogression in this area is expected to cause damage to the road structure and eventual closure of the northbound lane if localized landslide mitigation repairs are not carried out within the next few years (understood repairs are planned for 2023). The slide affecting the road is currently expected to be shallow but could be related due a deeper instability mechanism in the lower half of the embankment. Thurber completed a site investigation and slope stability assessment in July 2020 to determine conceptual repair options (refer to Thurber's April 2021 report File No. 29199).

**Photo 65-2.**  
Looking south towards the scarp retrogressing into the road pavement (45+00). Slide scarp was first noted in 2016 and is now approximately 1.7 m high at the pavement and retrogressed 0.7 m from the guardrail into the pavement with three posts hanging freely.

Immediate maintenance at the culvert outlet required to clear debris and restore full flow capacity.	Maintenance
Continue to undertake annual inspections.	-
Conceptual repair options for stabilizing the east embankment were determined from Thurber's site investigation and preliminary engineering assessment. The option included the following (alternative for an increased extent of the repair is provided for some options):	-
<ul style="list-style-type: none"> <li>▪ Pile Wall (40 m - \$457k, 70 m – \$742k)</li> <li>▪ Soil Nails (40 m - \$402k, 70 m – \$621k)</li> <li>▪ Granular Fill (70 m - \$593k)</li> </ul>	
Additional geotechnical investigation with piezometers and a series of test pits may be required (pending initial investigation results) to support long-term site stabilization design.	\$ 30,000
Long-term stabilization measures would likely consist of extensive erosion control measures and bank armouring of the creek, coupled with shallow stabilization measures such as granular blankets, soil nails or granular trenches. Alternatively, extension of the culvert on both sides with slope flattening should be considered especially for the landslide developing at 45+000.	\$ 3,000,000

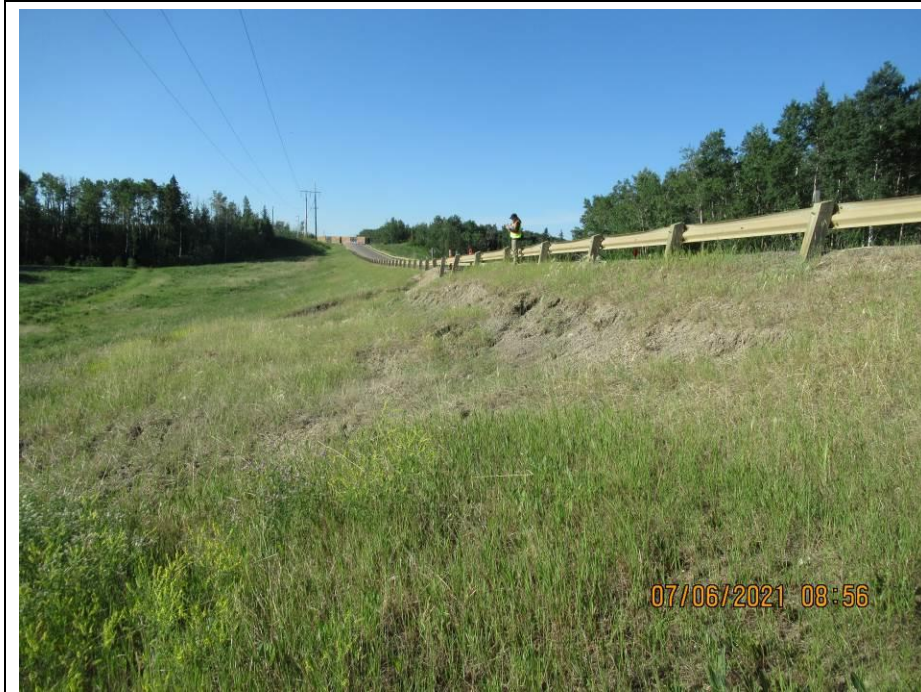
**Photo 65-3.**  
Looking south along the east side of the highway embankment towards an active main slide scarp (45+015) first identified in 2016. Increased dropdown since 2020.

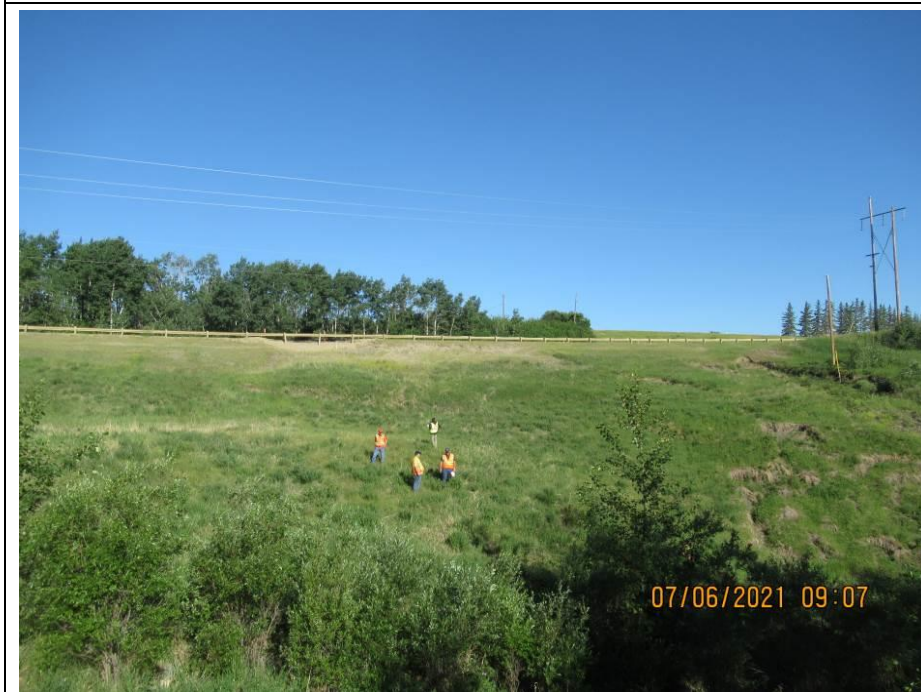
**Photo 65-4.**  
View towards recently active slide area above culvert outlet that has retrogressed to the pavement on the east embankment (44+975). Note visible toe roll.

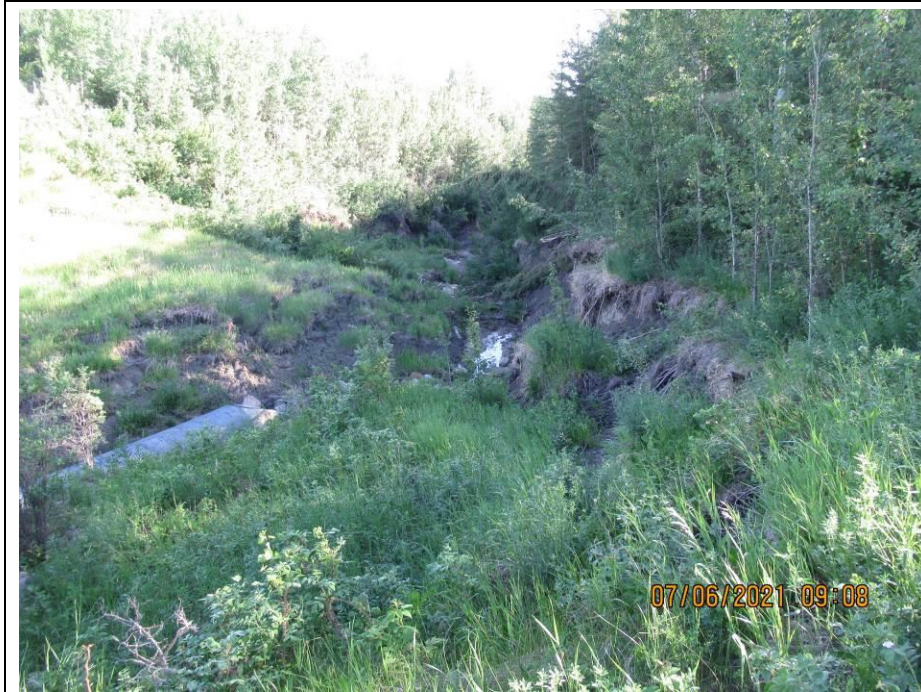
**Photo 65-5.**  
Active bank sliding and erosion area around the culvert outlet (44+975). Worse since 2020.

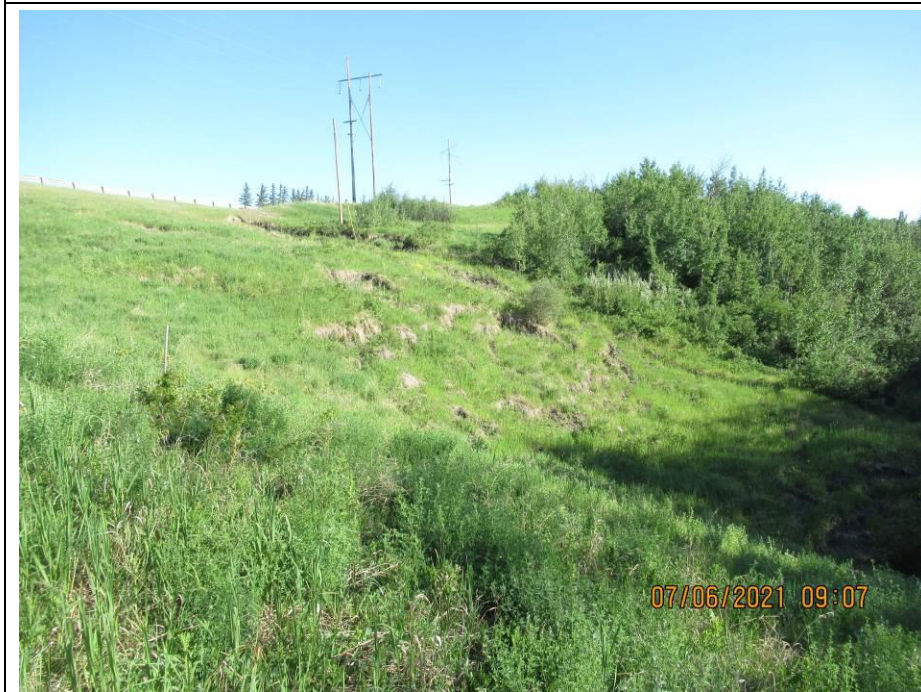
**Photo 65-6.**  
Looking northwest towards multiple active, shallow slides coalescing above the culvert outlet. Area has ongoing movement, especially near the toe where there is active bank erosion (44+975) but no significant retrogression of the headscarp towards the highway.

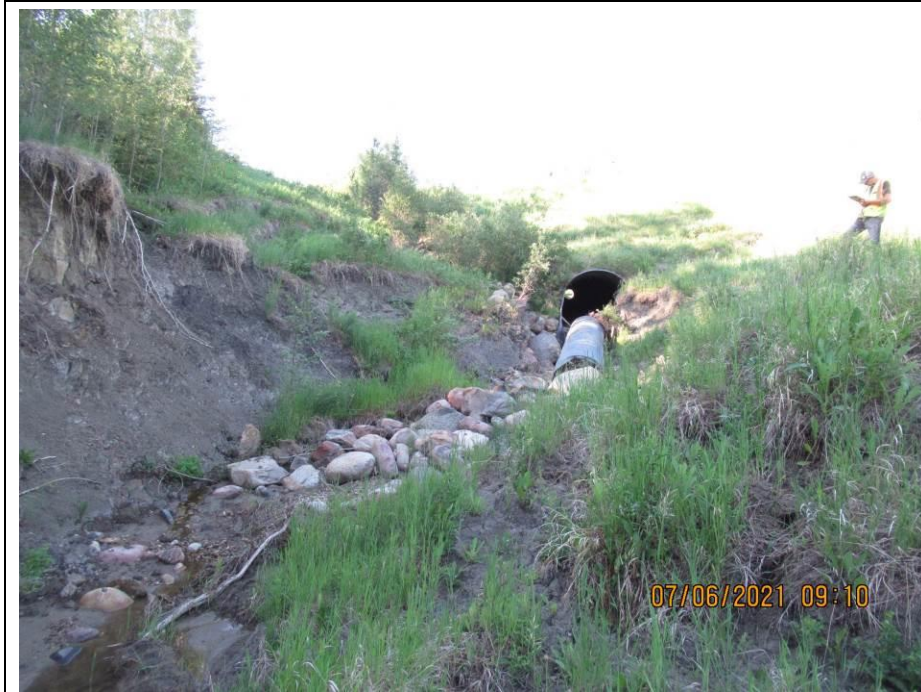
The area experienced a high-flow event between the 2017/2018 inspections that caused scour and debris buildup at the main functioning culvert beneath the road embankment. The partially blocked culvert outlet should be cleared immediately by maintenance crews to prevent further blockage, scour and potential culvert damage in the next high-flow event. Additional scour and bank loss around the culvert inlet/outlets will reduce toe support for the embankment slope.

**Photo 65-7.**  
Active sliding and erosion area around the headwall of the culvert outlet (45+000). Movement has pinched the outlet area of an armoured swale to the south of the outlet. Note old washed through culvert section causing debris jam.

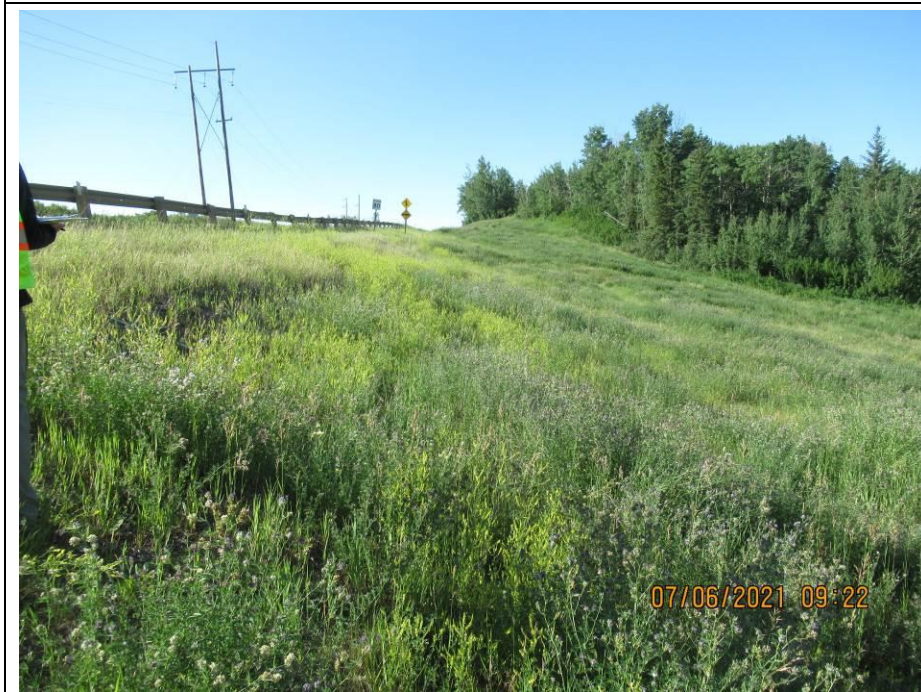
**Photo 65-8.**  
Looking south along the upper slope of the west side of the road embankment. No major changes noted since previous inspection.

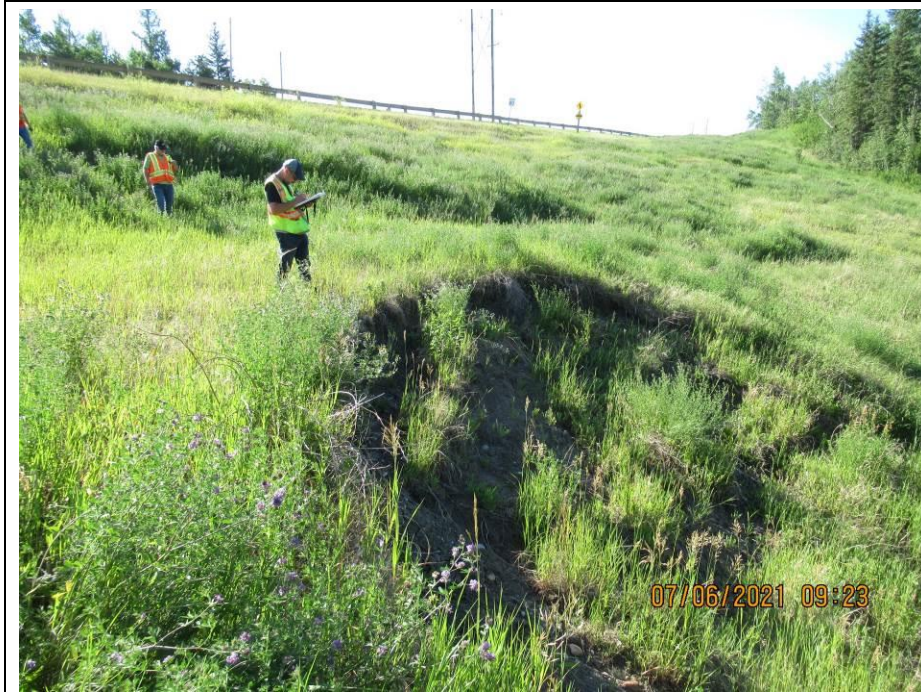
**Photo 65-9.**  
Looking southeast towards a recently active shallow earth slide above the culvert inlet (44+830). Slide is offset approximately 27 m west of the highway edge.

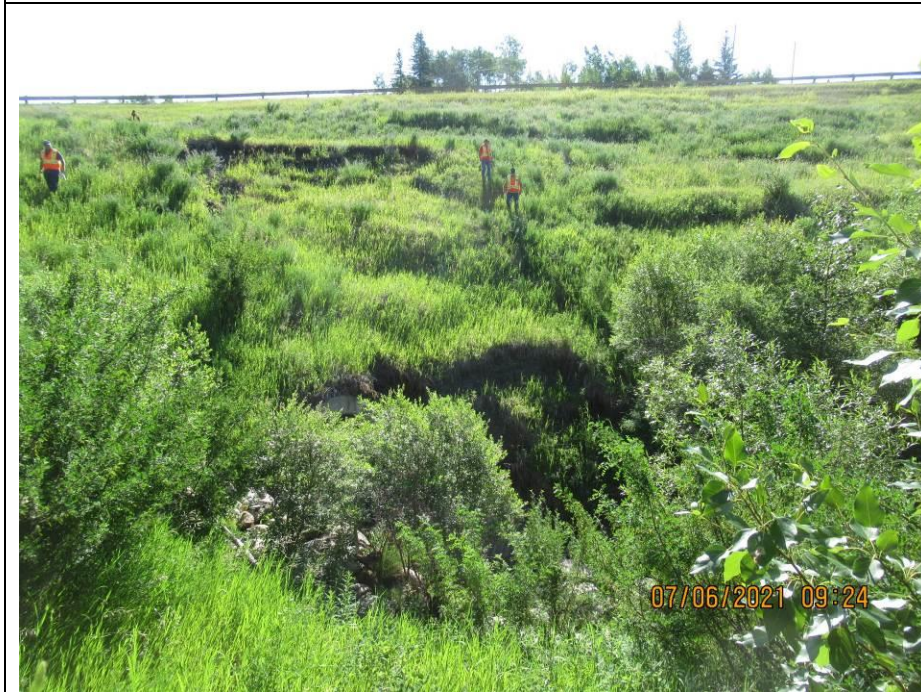
**Photo 65-10.**  
Looking east towards the road embankment with active shallow slide activity immediately above the culvert inlet (near inspectors) and near the headwall.
