**ALBERTA TRANSPORTATION
GEOHAZARD ASSESSMENT PROGRAM
PEACE REGION (PEACE RIVER DISTRICT)
2022 INSPECTION**

| Site Number | Location | Name | Hwy | km |
|---|---|---|---|---|
| PH065 | 44+700 to 45+200 | Trib. to Heart River | 744:04 | 45.0 |

TRIB TO HEART RIVER
HWY 744:04 (PH065)
LOCATION PLAN

**TRIB TO HEART RIVER
 HWY 744:04 (PH065)
 DETAILED PLAN**

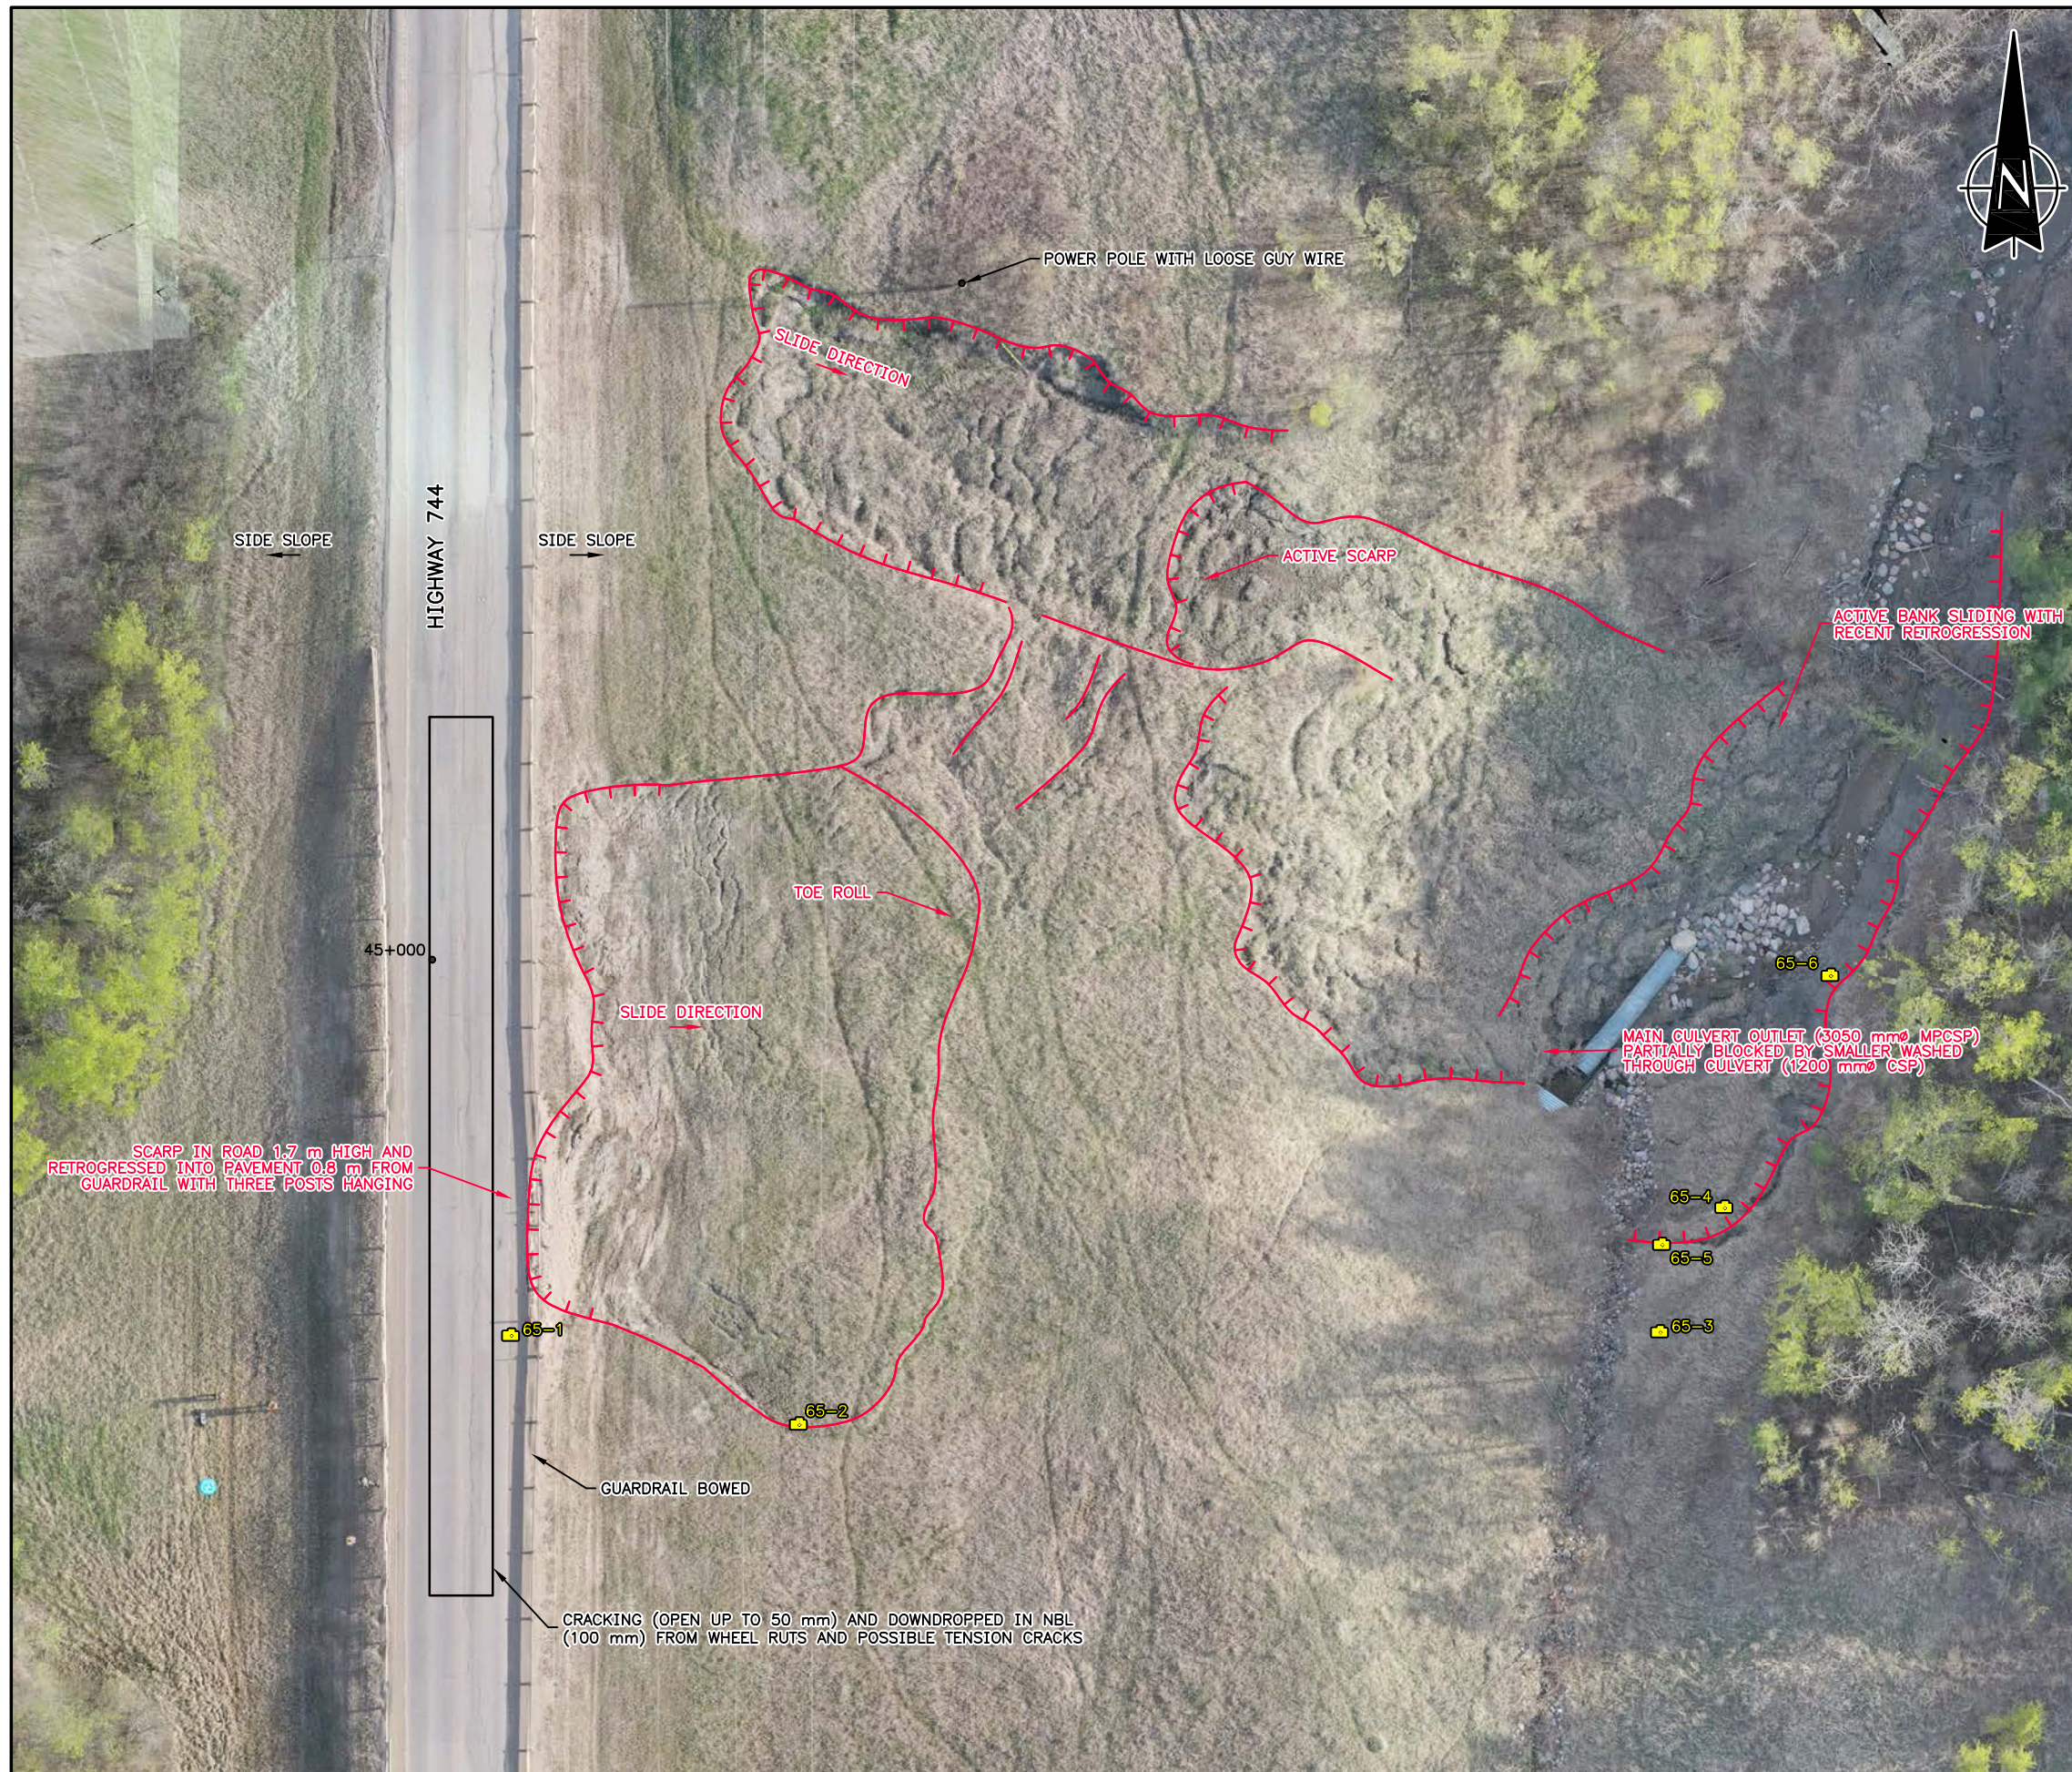
FIGURE PH065-2

SCARP IN ROAD 1.7 m HIGH AND RETROGRESED INTO PAVEMENT 0.8 m FROM GUARDRAIL WITH THREE POSTS HANGING

POWER POLE WITH LOOSE GUY WIRE

ACTIVE BANK SLIDING WITH RECENT RETROGRESSION

MAIN CULVERT OUTLET (3050 mm ϕ MPCSP) PARTIALLY BLOCKED BY SMALLER WASHED THROUGH CULVERT (1200 mm ϕ CSP)

GUARDRAIL BOWED

CRACKING (OPEN UP TO 50 mm) AND DOWNDROPPED IN NBL (100 mm) FROM WHEEL RUTS AND POSSIBLE TENSION CRACKS

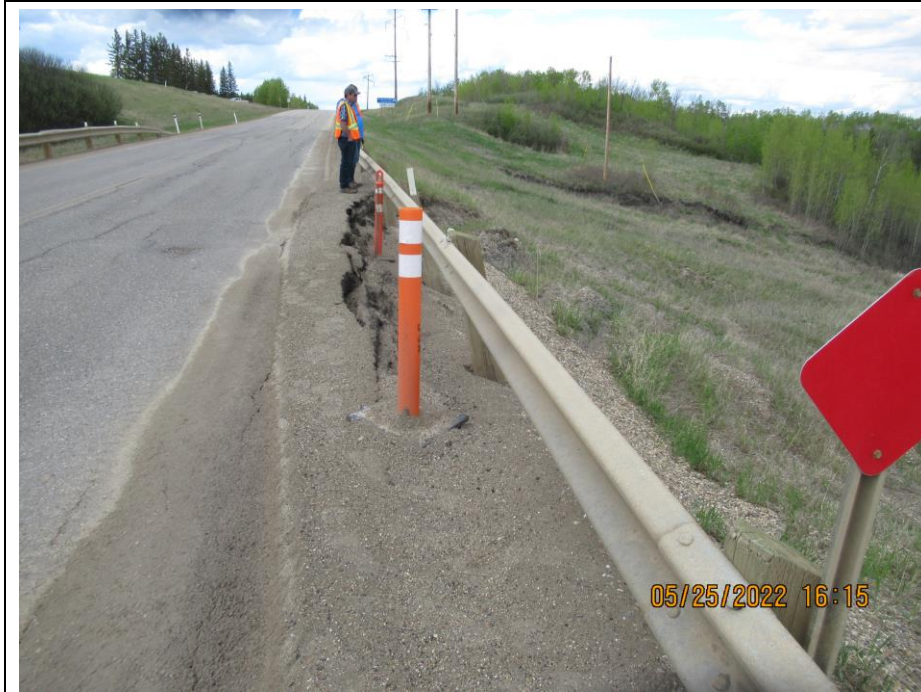
| | vicinity of 44+850. Longitudinal cracks (about 15 mm to 50 mm wide in average) near the centre lines and shoulders of both northbound and southbound lanes. Arc-shaped cracking near active slide area (Photo 65-1 and 65-2) has not significantly worsened but there was additional damage to the shoulder near the active slide. Wheel rutting and longitudinal cracking at south end of site within southbound lane between 44+750 to 44+840. | |
| <input checked="" type="checkbox"/> Slope Movement | West cutslope repair is performing well, no change from 2021 (45+100). Active slide at 45+000 (Photos 65-1 to 65-3) appears to have similar extents with minor retrogression into the road shoulder with a 1.7 m (± 0.0 m) high scarp located 0.8 m (+0.1 m) from the guardrail. Very active sliding around and above culvert outlet at 45+020 (Photos 65-4 to 65-6). West side of the embankment between 44+775 to 44+830 appears similar to 2021 condition (Photo 65-7) within the upper embankment (main scarp had 2.6 m minimum offset from guardrail). Toe roll is visible along the lower slope and has encroached into the armored drainage swale at the south end of the site (Photo 65-8 and 65-9). Active slope movement with some minor retrogression above culvert inlet (44+830) offset approximately 27 m from highway and at culvert inlet headwall (Photo 65-8 and Photo 65-9). Inactive slide scarp at the west embankment was offset 2.6 m from guardrail Photo 65-8). | <input checked="" type="checkbox"/> |

Photo 65-1.
Looking north towards the scarp retrogressing into the road pavement (45+00). Slide scarp was first noted in 2016 and is now approximately 1.7 m high at the pavement and retrogressed 0.8 m from the guardrail into the pavement with three posts hanging freely.

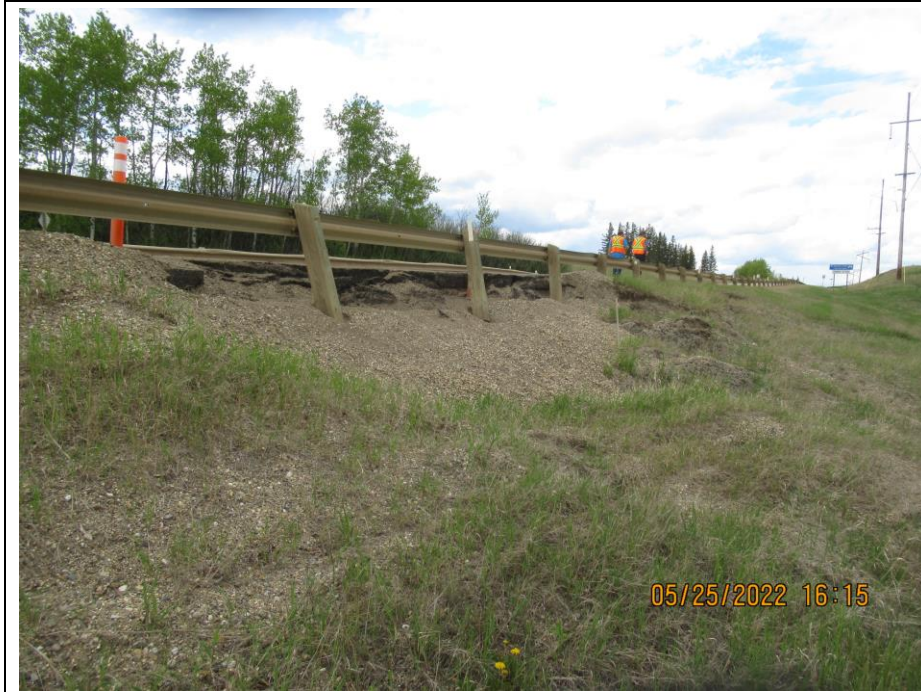
| <input checked="" type="checkbox"/> Other | Slumping on east side of roadway is affecting power transmission pole anchor wires (Photo 65-6) but flanks have not significantly expanded from 2021 condition. Damaged guardrail posts along the northbound side of highway near 44+800 and three unsupported posts near active slide scarp at 45+000 (Photo 65-2). | <input type="checkbox"/> |

Photo 65-2.
Looking north along the east side of the highway embankment towards an active main slide scarp (45+015) first identified in 2016. Slightly increased retrogression since 2021, minor change to the scarp height.

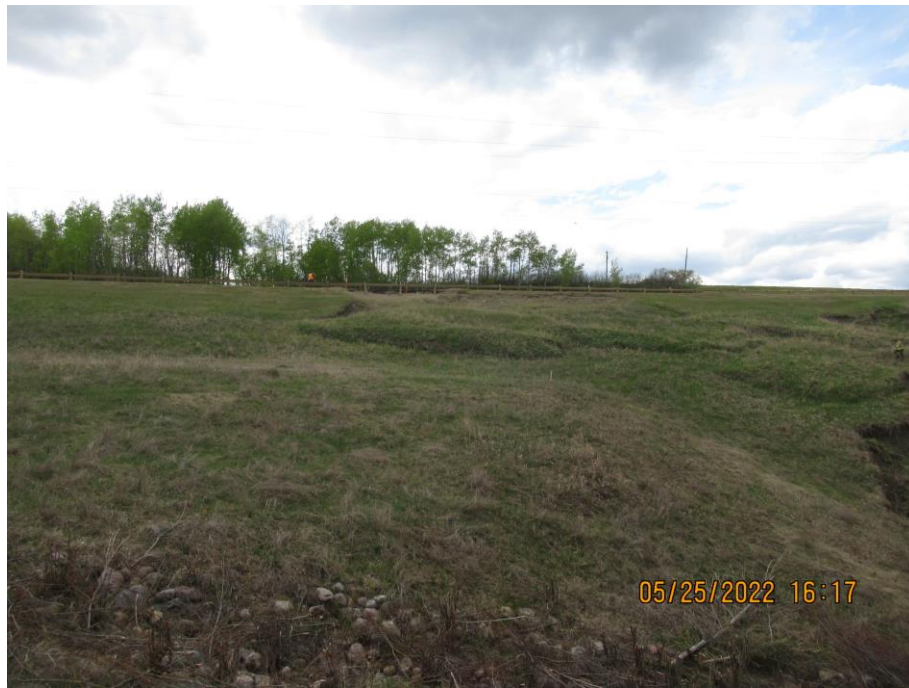
Photo 65-3.
View towards recently active slide area above culvert outlet that has retrogressed to the pavement on the east embankment (44+975). Note visible toe roll.

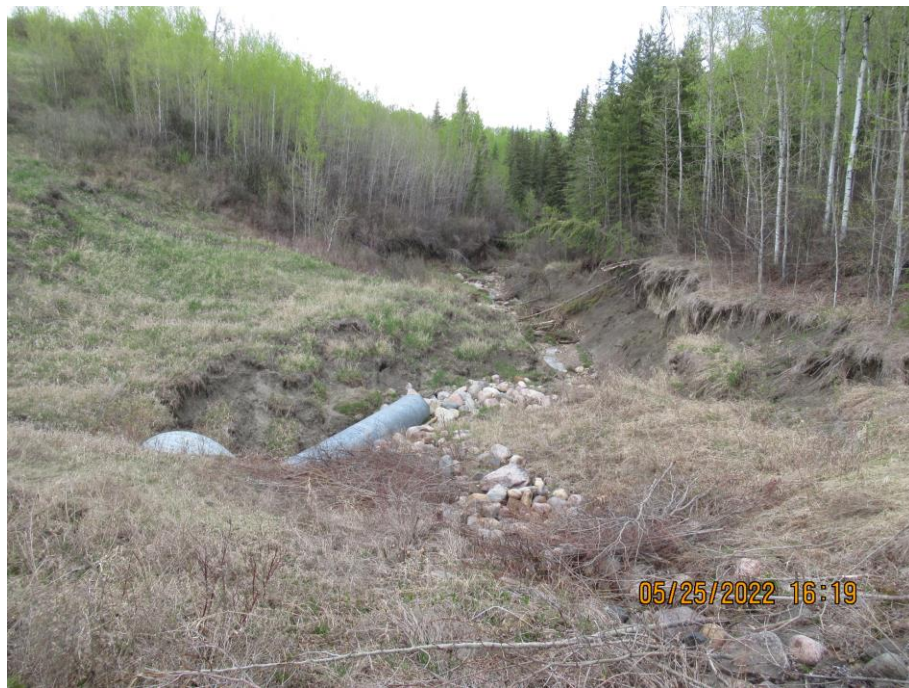
Photo 65-4.
Active bank sliding and erosion area around the culvert outlet (44+975). Worse since 2021.

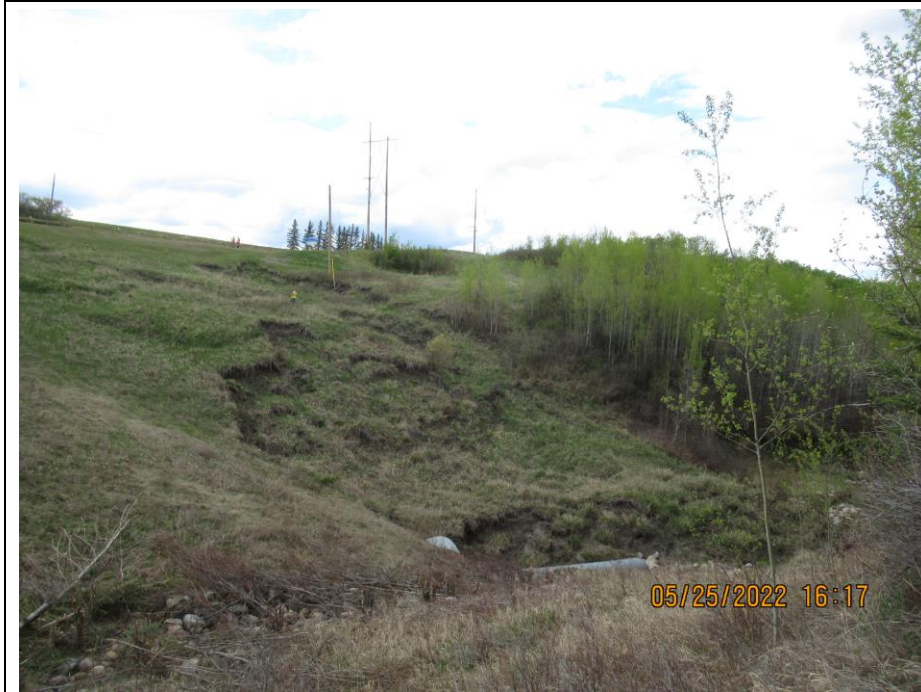
| <input checked="" type="checkbox"/> Erosion | Erosion at northernmost culvert outlet 45+200 is ongoing along the gully flanks. At Bridge File culvert outlet (45+000) ongoing decrease of toe support on both sides of the embankment due to highly active erosion and localized slumping (Photos 65-5 and 65-6). Scour near the culvert inlet has not significantly worsened since previous inspection condition (Photo 65-9). | <input checked="" type="checkbox"/> |

Photo 65-5.
Looking northwest towards multiple active, shallow slides coalescing above the culvert outlet. Area has ongoing movement, especially near the toe where there is active bank erosion (44+975) but no significant retrogression of the headscarp towards the highway.

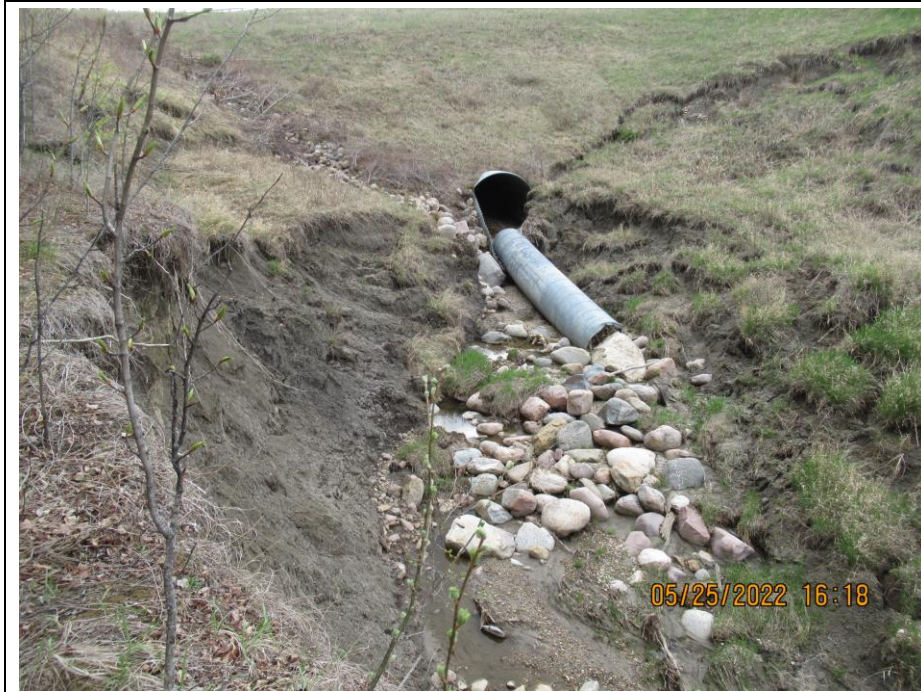
| <input checked="" type="checkbox"/> Bridge/Culvert Distress | A section of an abandoned culvert (buried upstream of the inlet) has been washed through the main culvert beneath the road in a 2017/2018 high-flow event. The old culvert is still jammed against the displaced rip-rap creating a blockage of woody debris near the outlet opening, increasing erosion, scour and reducing flow capacity (Photo 65-6). | <input checked="" type="checkbox"/> |

The area experienced a high-flow event between the 2017/2018 inspections that caused scour and debris buildup at the main functioning culvert beneath the road embankment. The partially blocked culvert outlet has likely resulted in an increased rate of scour and bank loss around the culvert that reduces toe support for the embankment slope.

Photo 65-6.
Active sliding and erosion area around the headwall of the culvert outlet (45+000). Movement has pinched the outlet area of an armoured swale to the south of the outlet. Note old washed through culvert section causing debris jam. There was increased erosion around the outlet and creek banks.

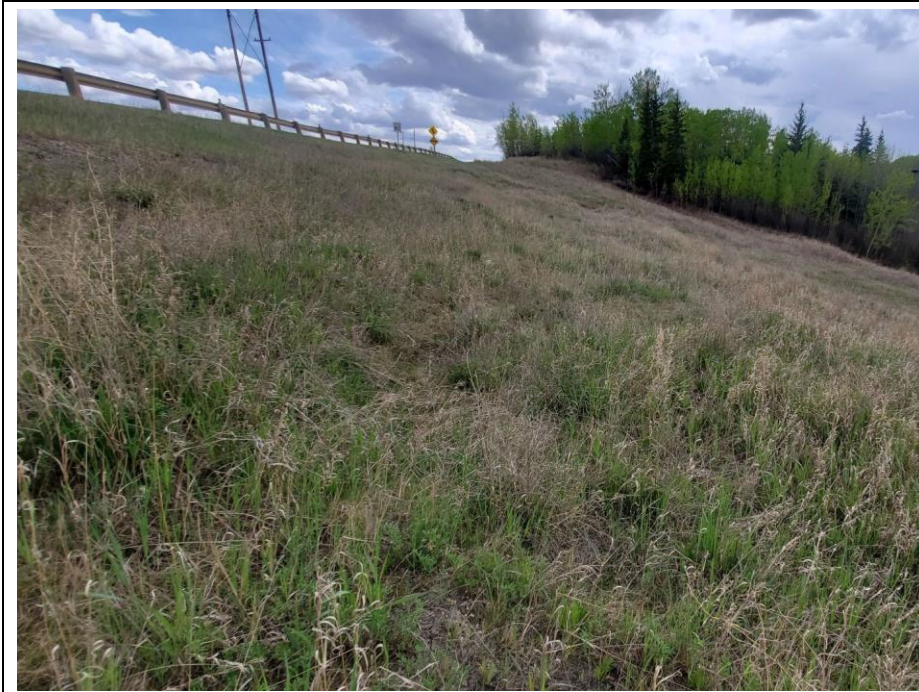
Photo 65-7.
Looking south along the upper slope of the west side of the road embankment. No major changes noted at the head of the slides near the highway.

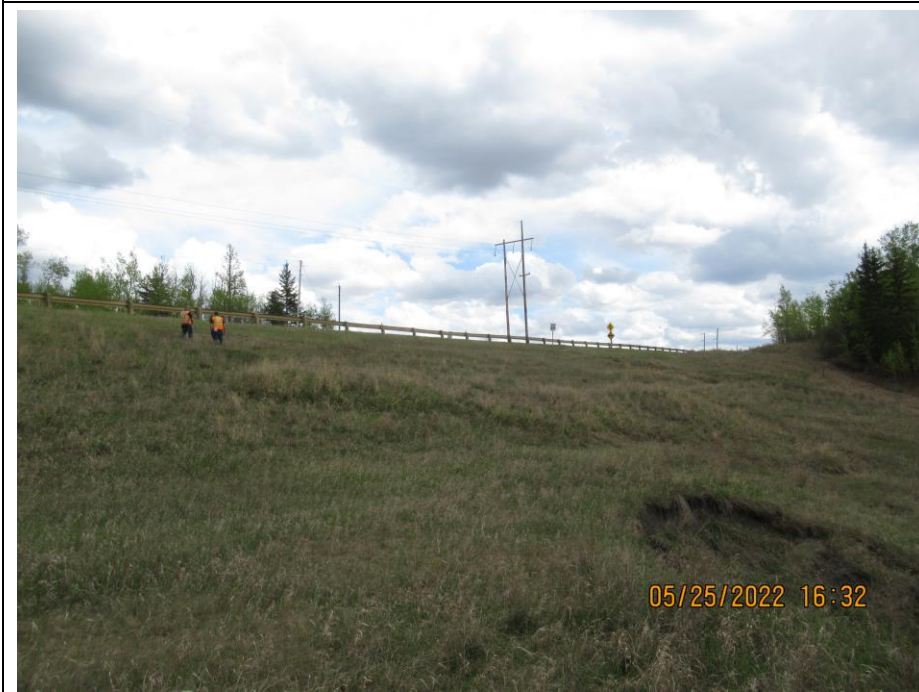
Photo 65-8.
Looking southeast towards a recently active shallow earth slide above the culvert inlet (44+830). Slide is offset approximately 27 m west of the highway edge. Minor retrogression has occurred at the main scarp (lower right of photo).

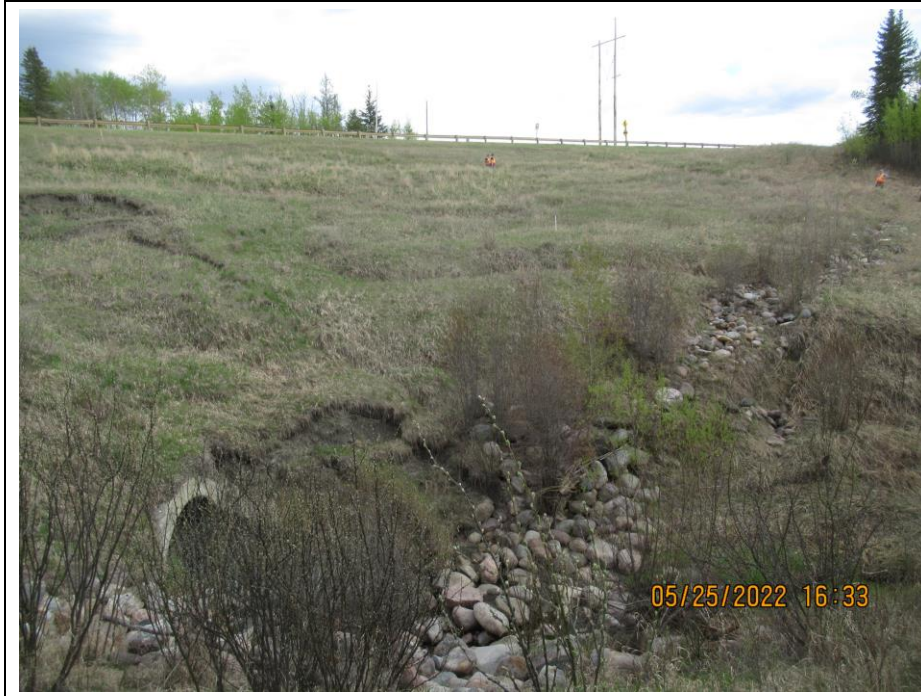
Photo 65-9. Looking east towards the west road embankment with active shallow slide activity immediately above the culvert inlet (near inspectors) and near the headwall. Note visible toe roll of slide which has begun to encroach into the armored drainage swale on the right side of the photo.
