**ALBERTA TRANSPORTATION
GEOHAZARD ASSESSMENT PROGRAM
PEACE REGION – PEACE-HIGH LEVEL
2018 INSPECTION**

Site Number	Location	Name	Hwy	km
PH072	Judah Hill	Sunshine Landslide	744:04	58.154
Legal Description		UTM Co-ordinates		
NE¼ 20-083-21 W5M		11U E 483150	N 6230060

**PEACE REGION (PEACE RIVER/HIGH LEVEL)
PH072-1 SUNSHINE SLIDE**

2018 PH072-1 INSPECTION PLAN

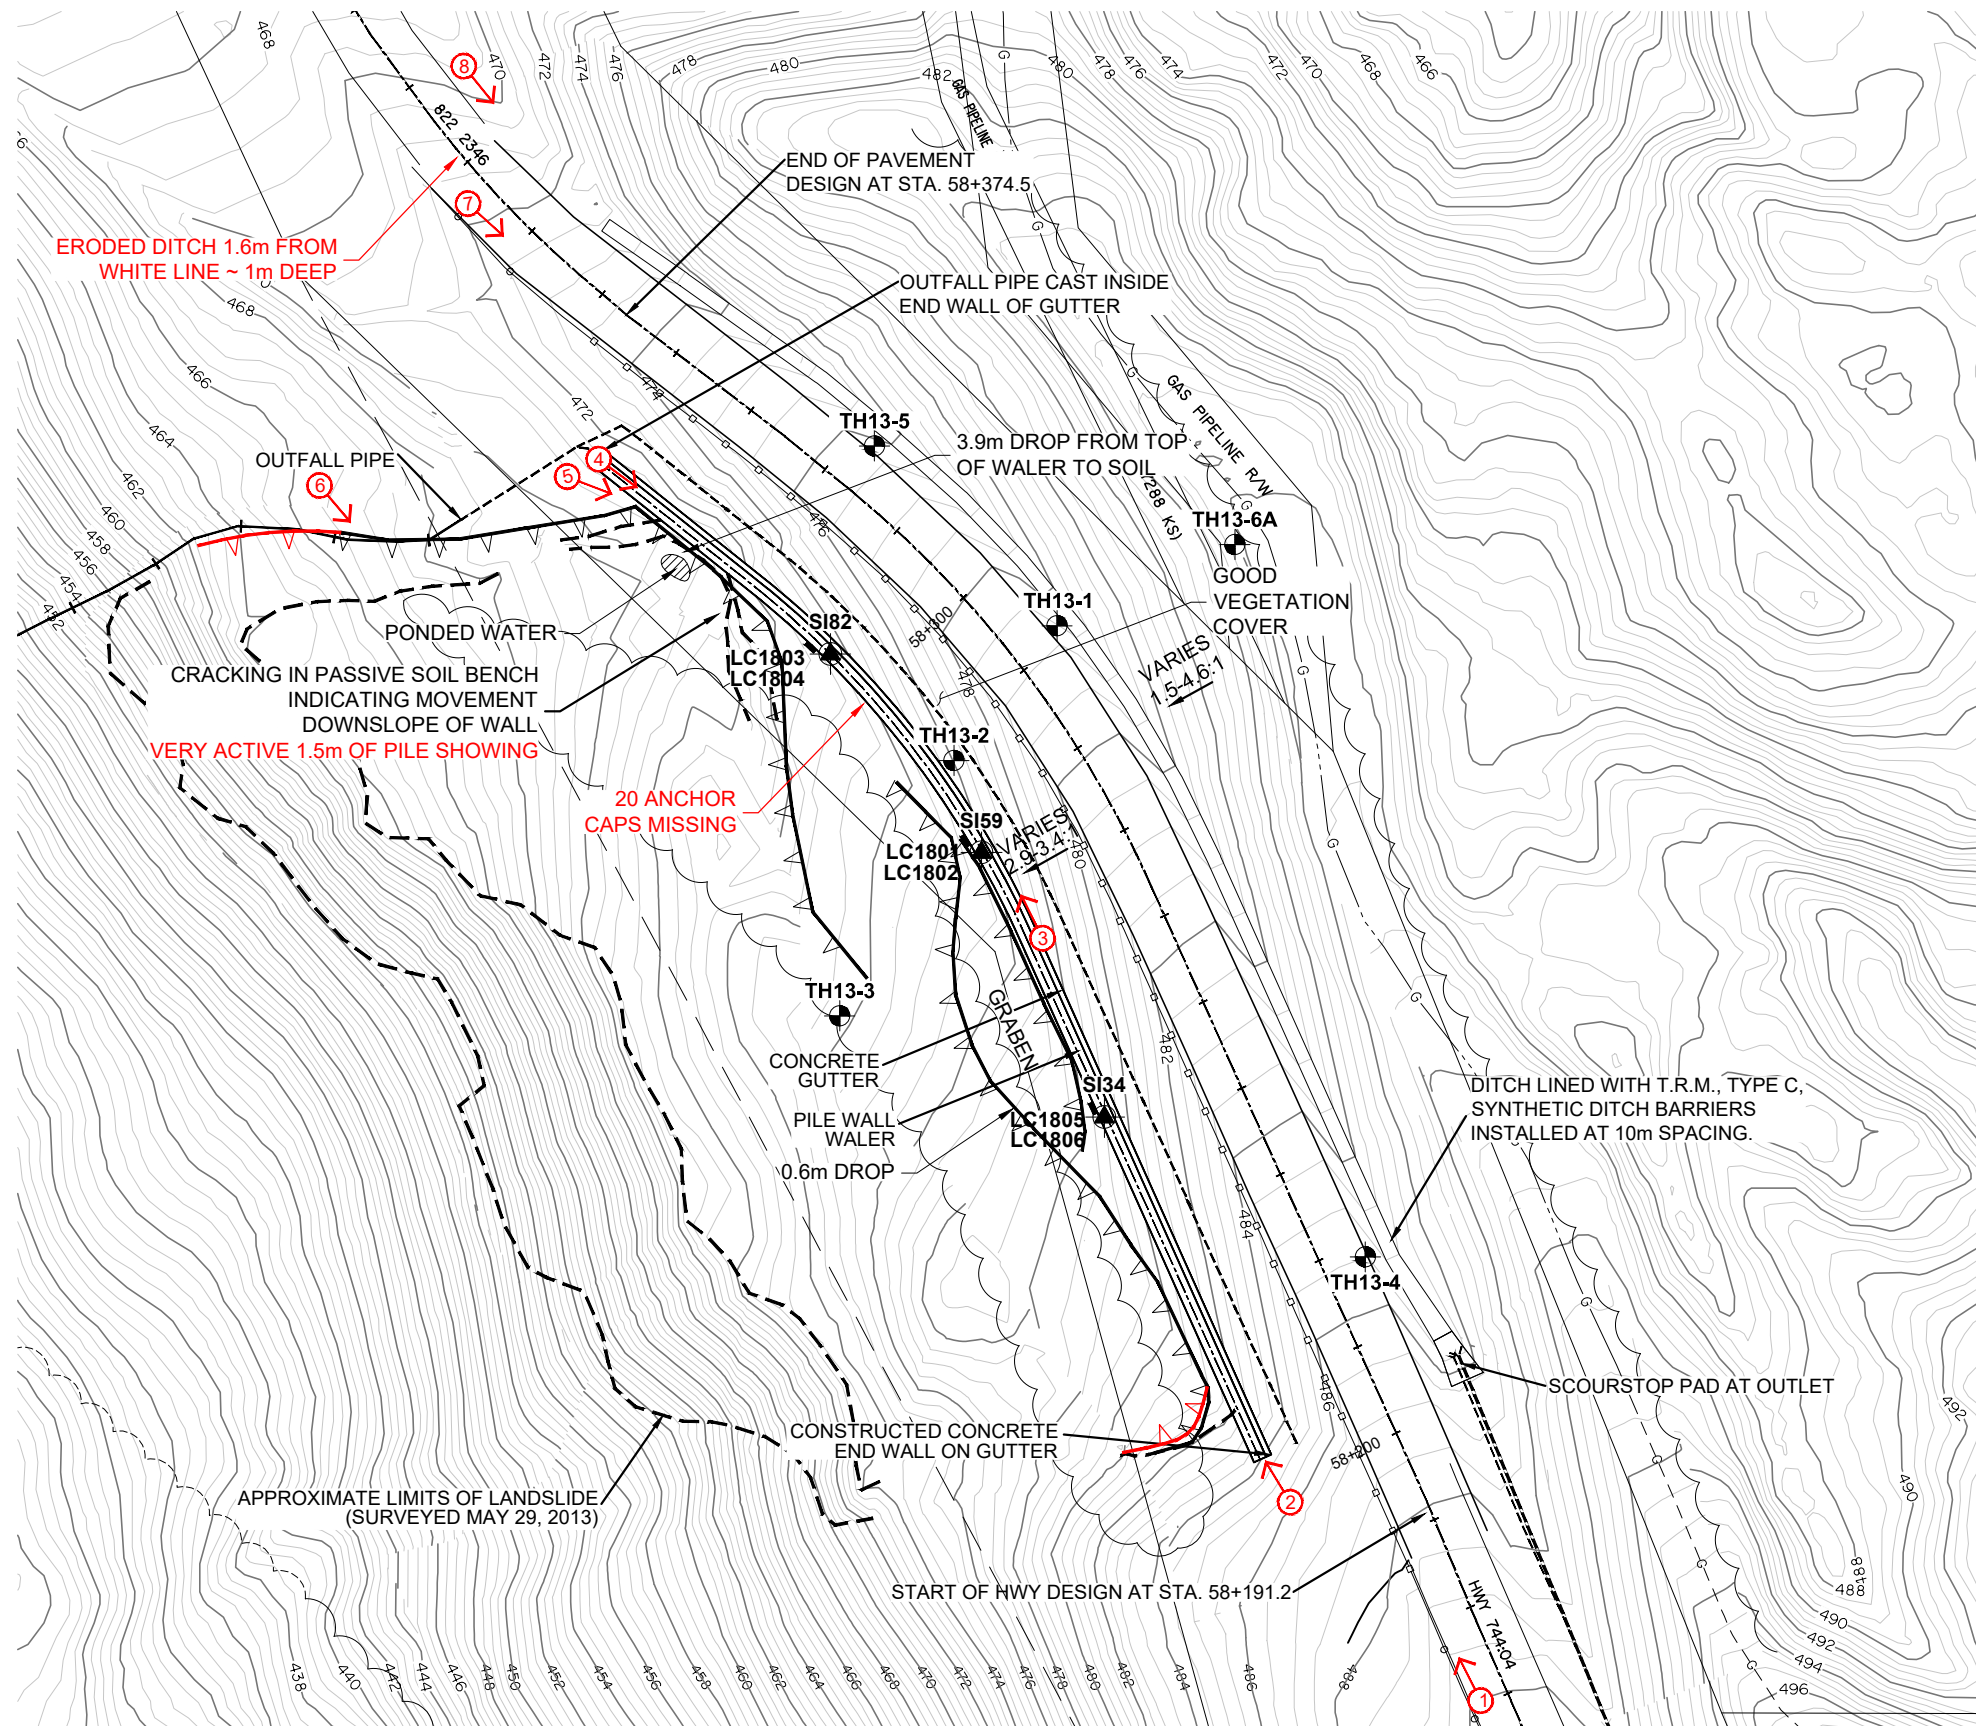
DWG No. 13351-PH072-1

NOTE:
1 MAY 14, 2018 OBSERVATIONS SHOWN IN RED.

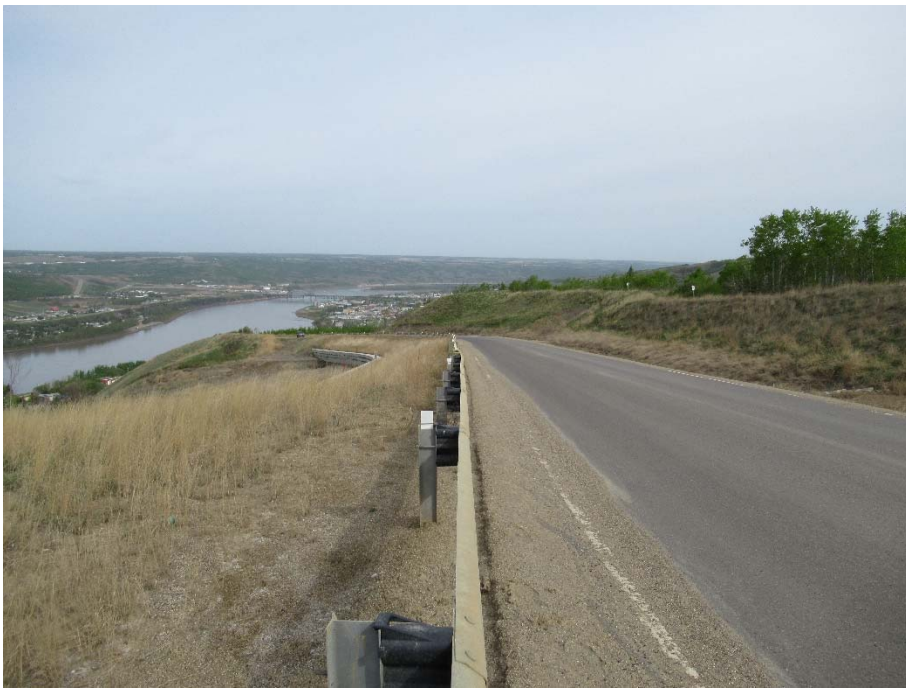
Photo 1.
Looking northwest from the guardrail of the SBL of Hwy 744:04 at km 58.170 at the south end of the Sunshine pile wall. No signs of any cracks in the ACP.

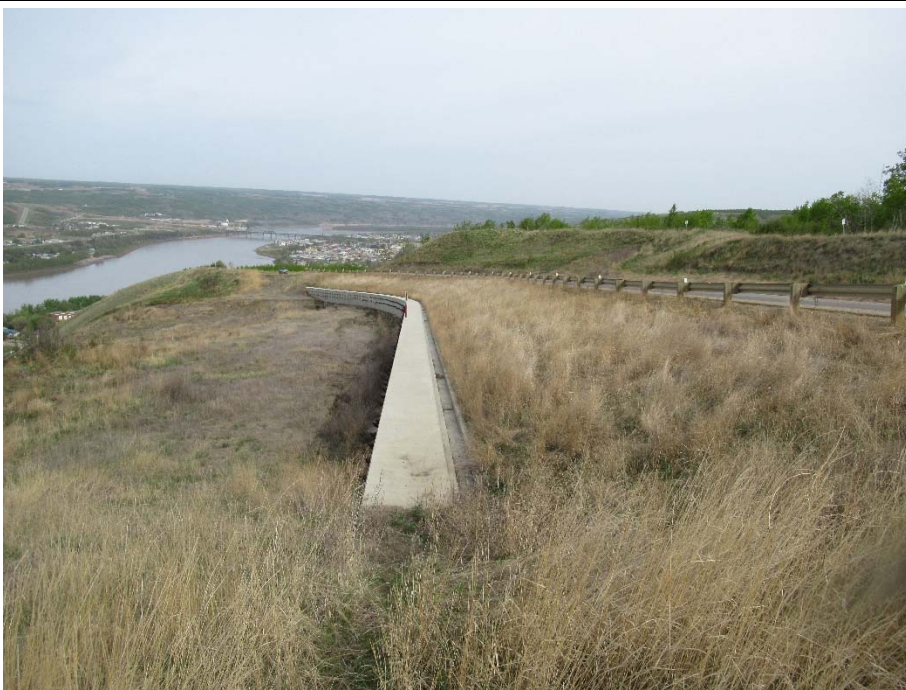
Photo 2.
Looking northwest from south end of the Sunshine pile wall at km 58.200. Vegetation directly above the pile wall is still thick.

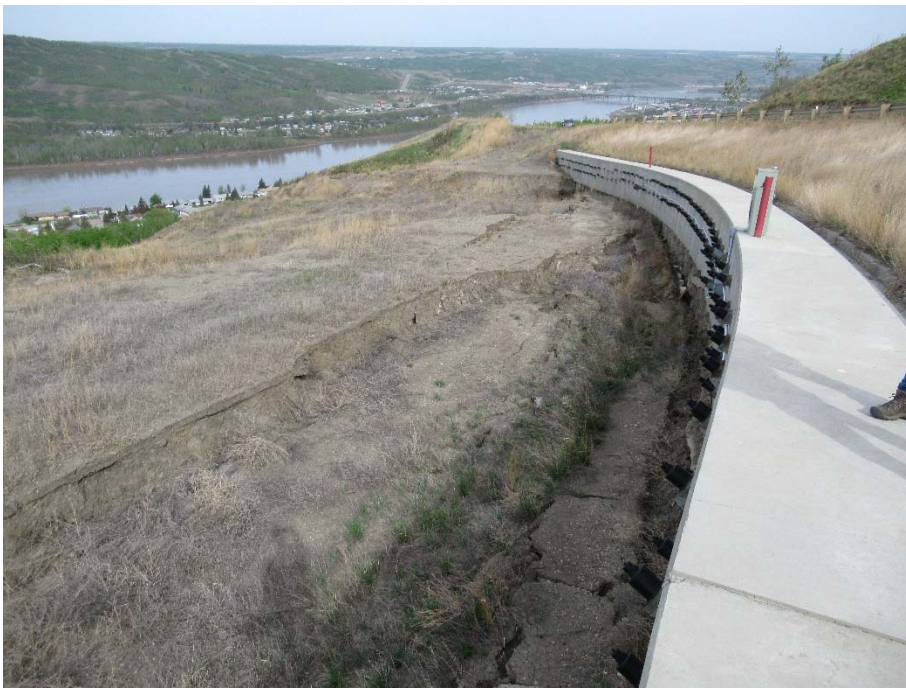
Observations:	Description	Worsened?
<input type="checkbox"/> Pavement Distress		<input type="checkbox"/>
<input checked="" type="checkbox"/> Slope Movement	The passive support bench downslope of the newly constructed pile wall is showing signs of failure below the wall (Photos 2 to 6).	<input checked="" type="checkbox"/>
<input checked="" type="checkbox"/> Erosion	There is a scour forming in the bottom of the NBL ditch at km 58.38	<input checked="" type="checkbox"/>
<input type="checkbox"/> Seepage		<input type="checkbox"/>
<input type="checkbox"/> Bridge/Culvert Distress		<input type="checkbox"/>
<input checked="" type="checkbox"/> Other	The wall surface gutter drain periodically clogs with sediment and needs to be cleaned on a regular basis.	<input checked="" type="checkbox"/>

Photo 3.
Looking northwest from below the pile wall at km 58.26. Slide in bench below wall is very active. Some piles are exposed to 1.5 m. About 20 anchor grease caps have fallen off.

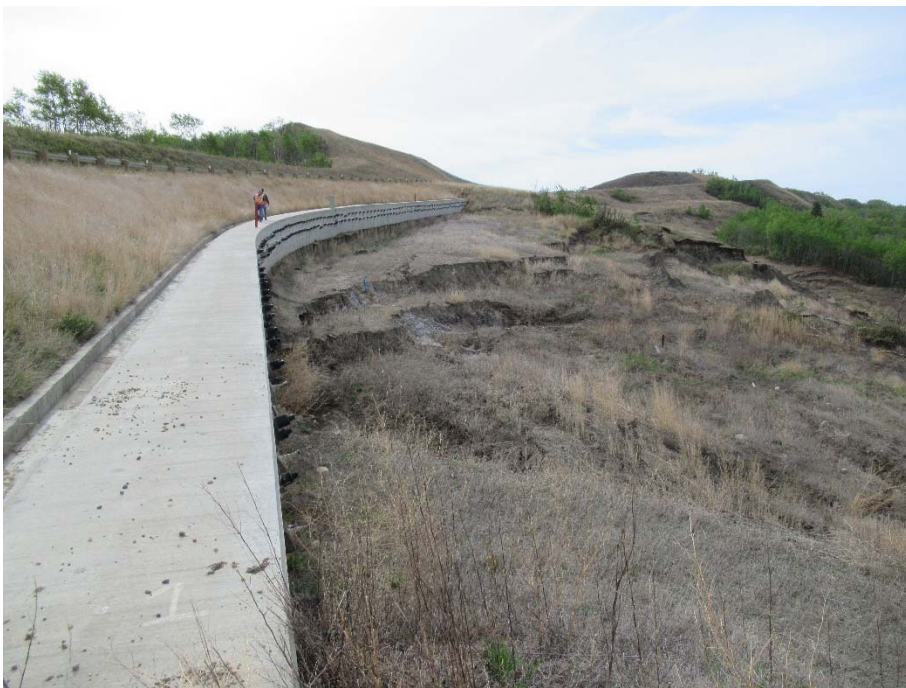
Photo 4.
Looking southeast along the pile wall at km 58.33. The cracking in the passive soil bench below the pile wall has grown since 2017.

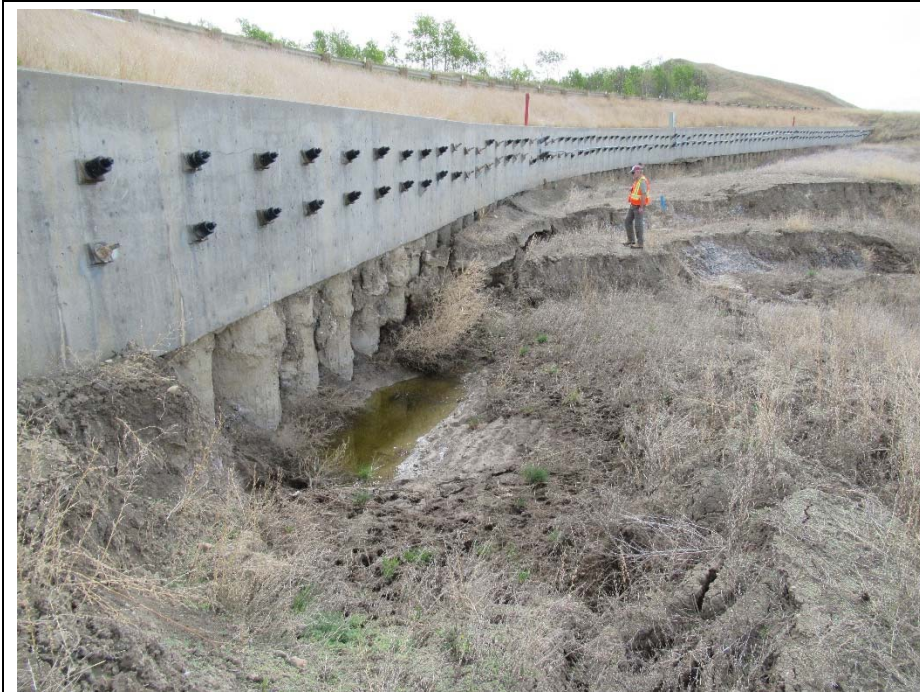
Photo 5.
Looking southeast along the pile wall at km 58.33. The cracking in the passive soil bench below the pile wall has grown since 2017. Some piles are exposed to 1.5 m. About 20 anchor grease caps have fallen off. Water is ponding in graben area along the wall.

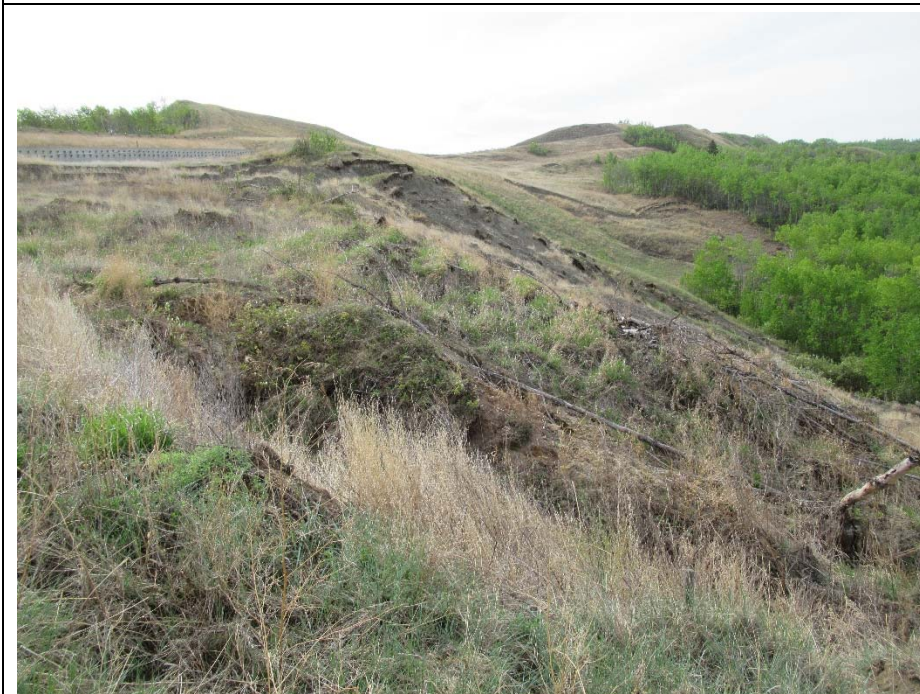
Photo 6.
Looking southeast from 30 m south of the pile wall along the backscarp at the slide bowl.

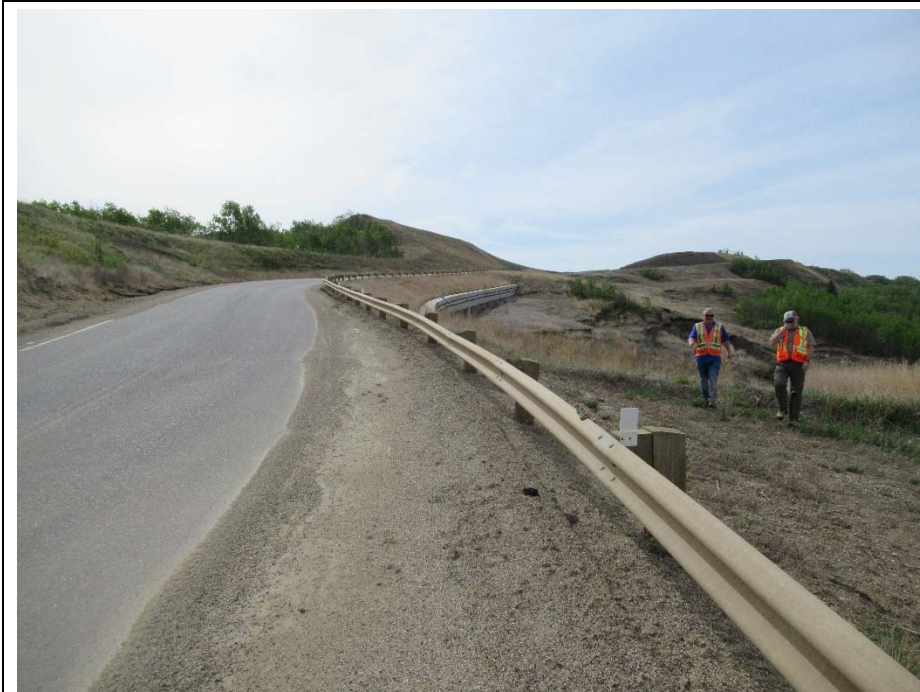
Photo 7.
Looking southeast from the centerline of Hwy 744:04 at km 58.34 at the reinstated embankment.

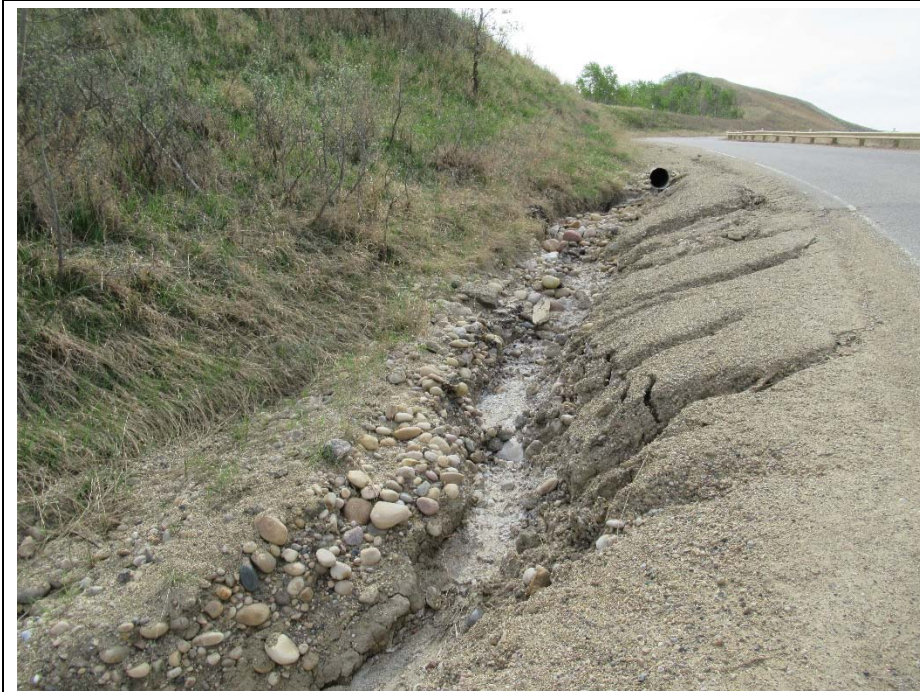
Photo 8.
Looking south from the NBL shoulder of Hwy 744:04 at km 58.38. The scour in the ditch bottom is worse than in 2017 and is now at 1.6 m from the white line.

Recommendations:	Cost
The slope inclinometers will continue to be read manually twice per year and the datalogger installed at the site will continue to take readings of the load cells twice daily as part of the Geohazard Assessment Program.	Monitoring
The pile wall surface drainage gutter will require to be regularly cleaned to continue to provide erosion protection for the partially buried pile wall and avoid clogging of its solid down drain evacuation pipe.	Maintenance
The base of the NBL ditch should where a scour has formed should be excavated and rebuilt with compacted clay. Consideration should be given to placing a TRM Type C mat or a gabion mattress in the ditch to reduce the risk of further scouring.	\$25,000
