**ALBERTA TRANSPORTATION  
GEOHAZARD ASSESSMENT PROGRAM  
PEACE REGION – PEACE-HIGH LEVEL  
2020 INSPECTION**

<b>Site Number</b>	<b>Location</b>	<b>Name</b>	<b>Hwy</b>	<b>km</b>
PH072	Judah Hill	Sunshine Landslide	744:04	58.154
<b>Legal Description</b>		<b>UTM Co-ordinates</b>		
NE¼ 20-083-21 W5M		11U E 483150	N 6230060

**2020 PH072-1 INSPECTION PLAN**

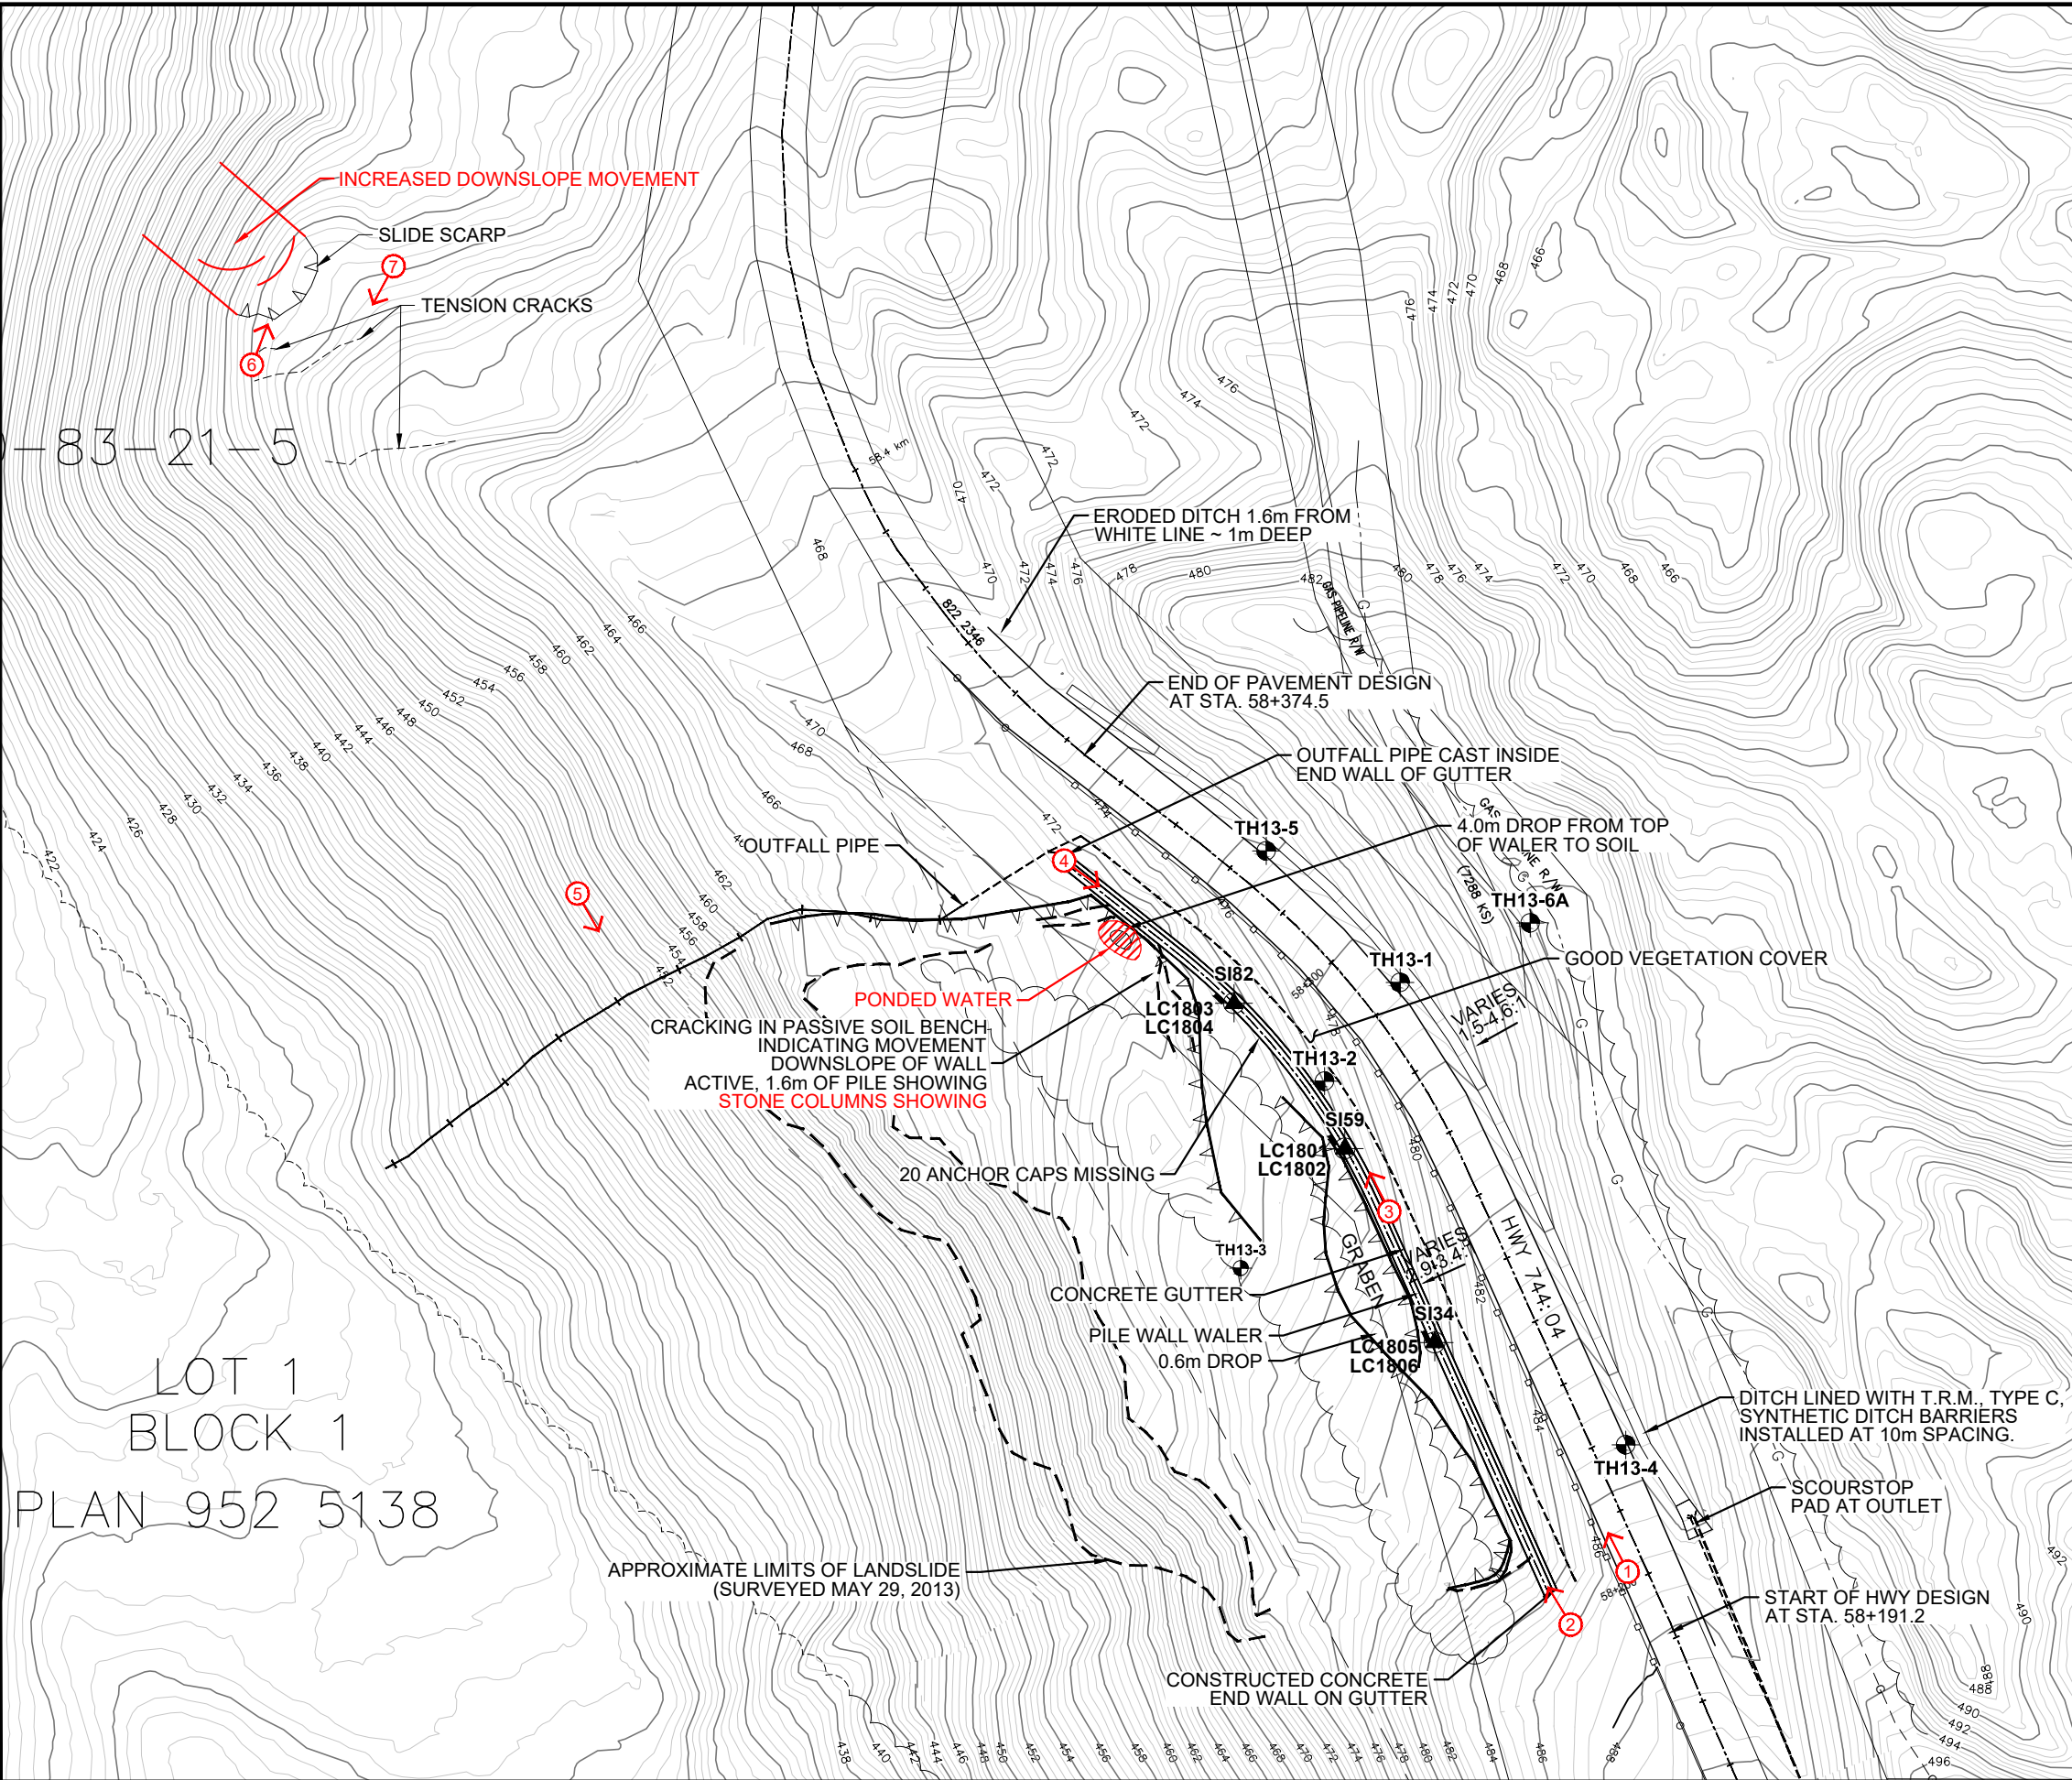
**NOTE:**  
1. JUNE 10, 2020 OBSERVATIONS SHOWN IN RED.

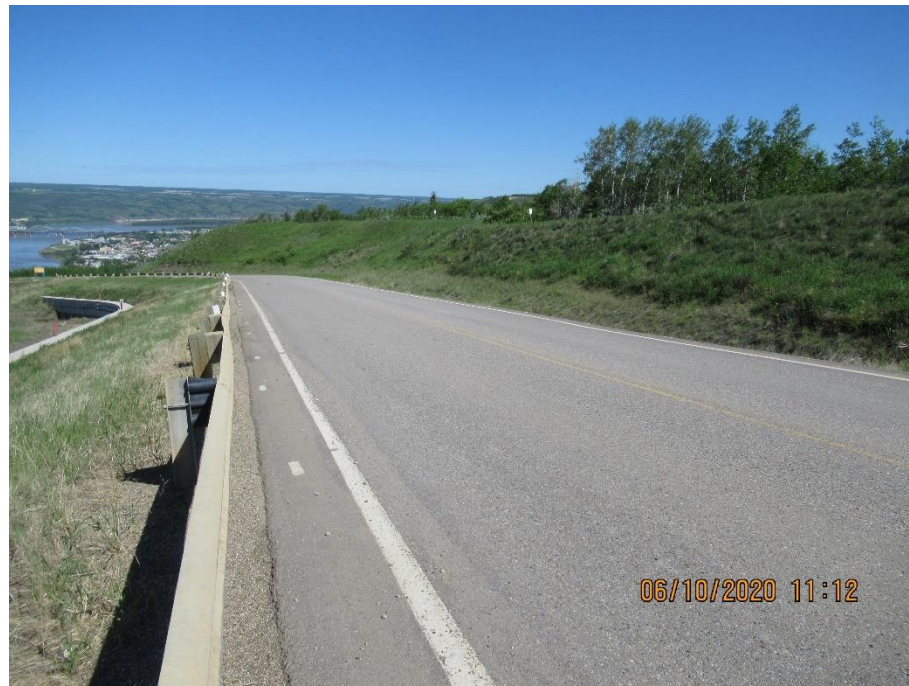
**Photo 1.**  
Looking northwest from the guardrail of the SBL of Hwy 744:04 at km 58.2 at the south end of the Sunshine pile wall. No signs of any damage in the ACP.

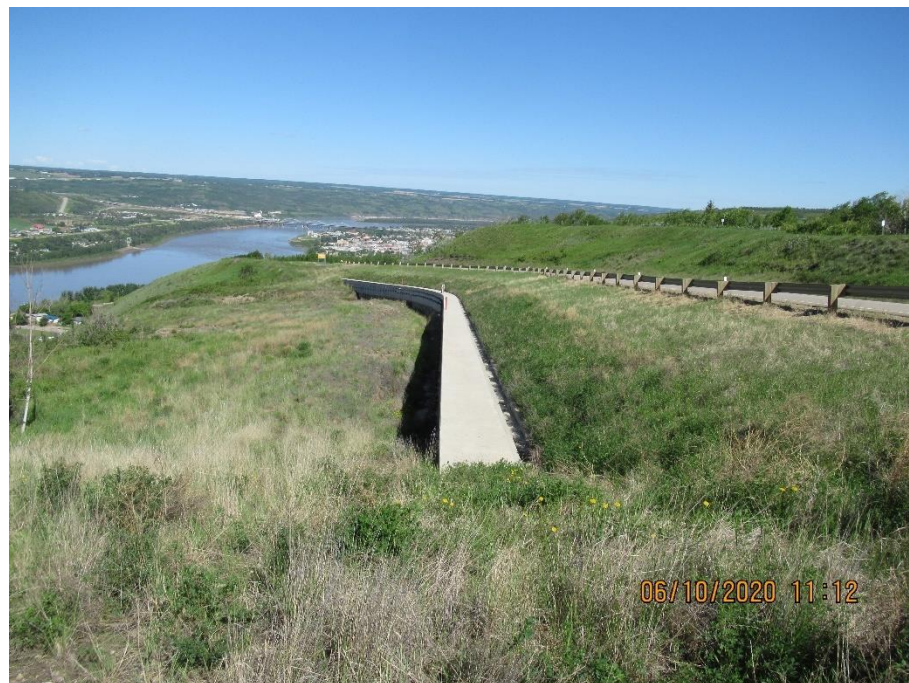
Observations:	Description	Worsened?
<input type="checkbox"/> Pavement Distress		<input type="checkbox"/>
<input checked="" type="checkbox"/> Slope Movement	The passive support bench downslope of the newly constructed pile wall is showing signs of failure below the wall (Photos 2 to 4). The	<input checked="" type="checkbox"/>

**Photo 2.**  
Looking northwest from south end of the Sunshine pile wall at km 58.200. Vegetation directly above the wall is well established. Some thicker vegetation growth noted directly below the wall relative to the previous inspection.

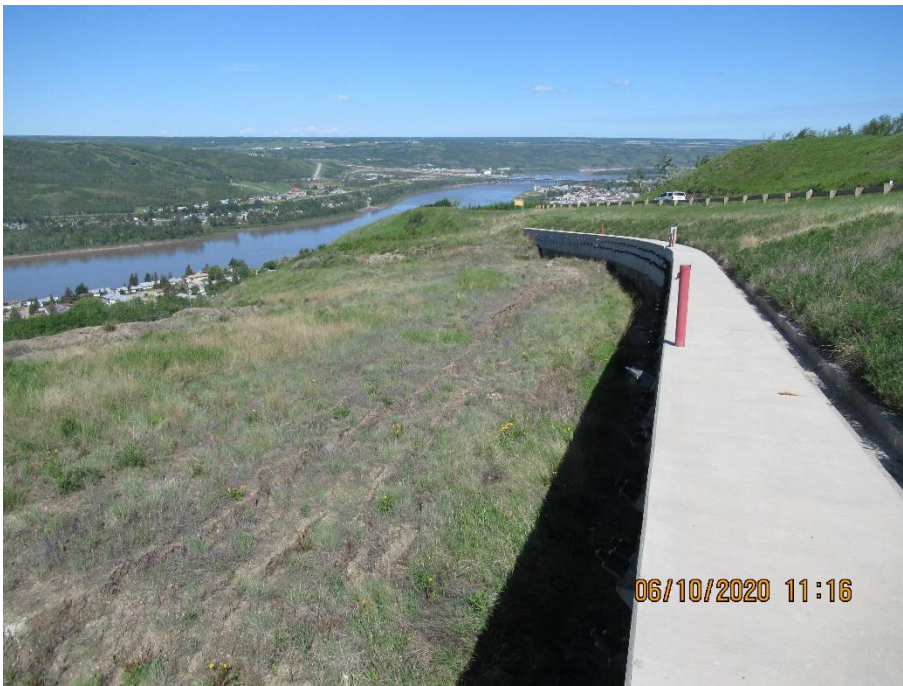
**Photo 3.**  
Looking northwest from below the pile wall at km 58.26. Slide in bench below wall is very active. Some piles are exposed up to 1.6 m in height (no change from 2019).

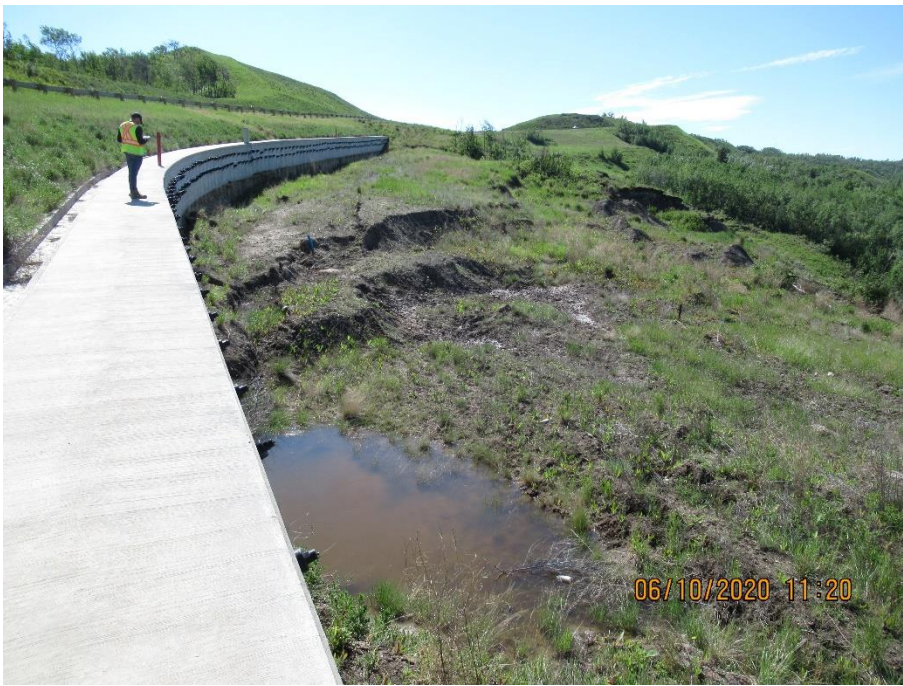
**Photo 4.**  
Looking southeast along the pile wall at km 58.33. The cracking/ signs of visible movement in the passive soil bench below the pile wall has not changed significantly. Sliding in the lower slope appears active. Water had increased ponding in graben area along the wall relative to the 2019 inspection.

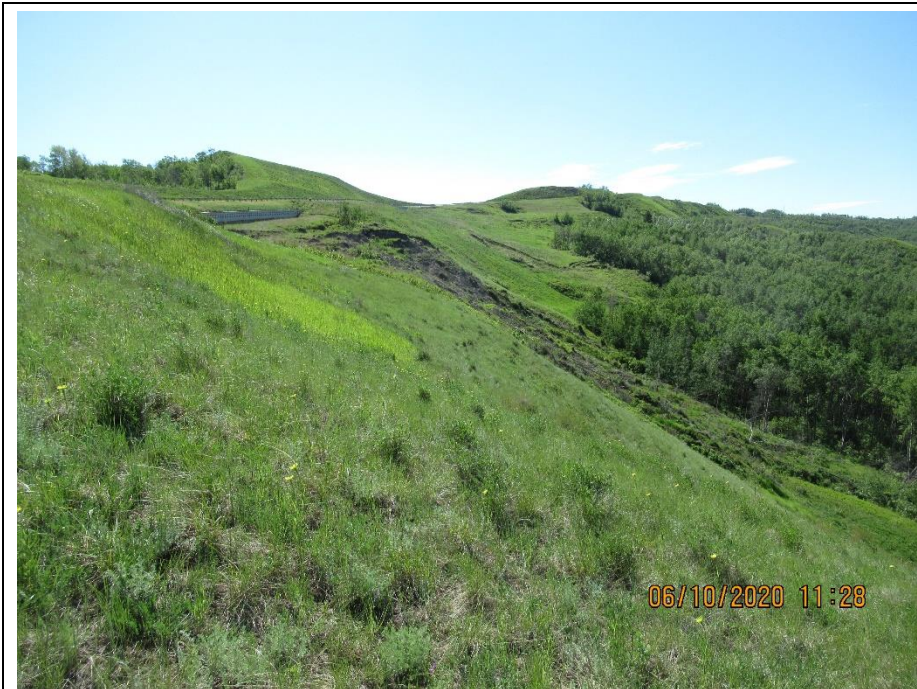
<p>cracking/ signs of visible movement in the passive soil bench below the pile wall has not changed significantly. Sliding in the lower slope appears active (Photo 5). Stone columns were visible on the soil bench at the NW side of the wall.</p> <p>Slide area (first observed in 2019) approximately 100 m northwest from the north end of the pile wall. 15 m wide scarp with tension cracks that are offset approximately 50 m from the west highway edge. No major change at the headscarp since the 2019 inspection. More movement downslope was noted. (Photos 6 and 7).</p>	
<input checked="" type="checkbox"/> Erosion	Scour was noted in previous inspections in the bottom of the NBL ditch at km 58.38 near the drain outlet. Ongoing erosion but no significant changes from 2019 condition.	<input type="checkbox"/>
<input type="checkbox"/> Seepage		<input type="checkbox"/>
<input type="checkbox"/> Bridge/Culvert Distress		<input type="checkbox"/>

**Photo 5.**  
Looking southeast at the lower slide area below the wall. Very active in lower slope.

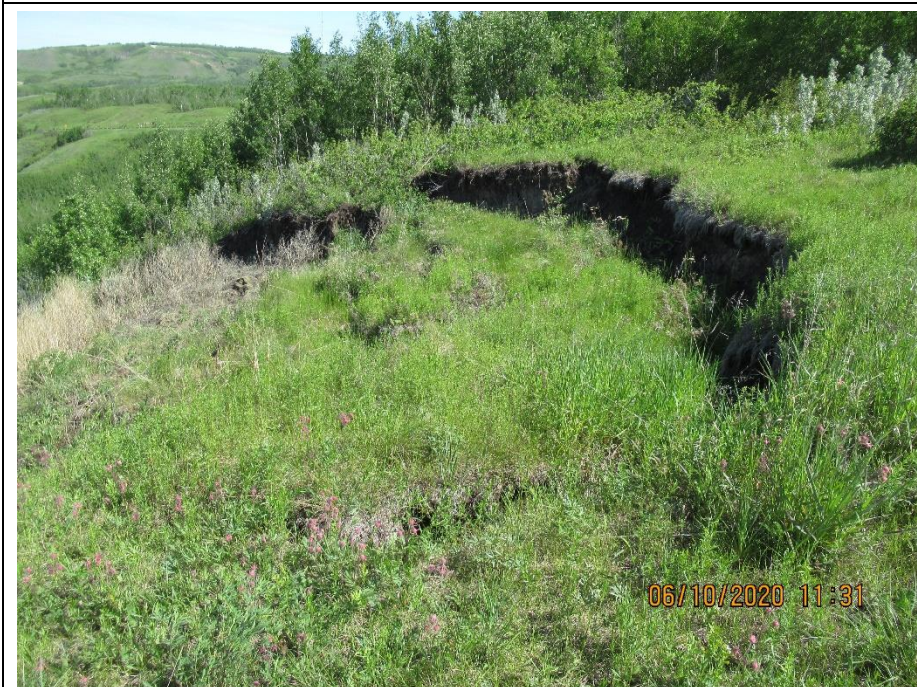
<b>Assessment:</b>		
<p>The newly reconstructed highway embankment and supporting pile wall appear to be performing well. Recent movement observed in the passive soil bench below wall was anticipated and accounted for in the design.</p> <p>New slide area is expected to retrogress closer to the highway in the next 10 years. A new inspection site may eventually be required.</p>

**Photo 6.**  
New slide area (first observed in 2019) approximately 100 m NW of the north end of the pile wall. No major change at the headscarp since the 2019 inspection. More movement downslope was noted.

<b>Recommendations:</b>	<b>Cost</b>
New slide area should be monitored during the PH72 annual inspections or alternatively a new site should be created.	Monitoring
The slope inclinometers will continue to be read manually twice per year and the datalogger installed at the site will continue to take readings of the load cells twice daily as part of the Geohazard Assessment Program.	Monitoring
The pile wall surface drainage gutter will require to be regularly cleaned to continue to provide erosion protection for the partially buried pile wall and avoid clogging of its solid down drain evacuation pipe.	Maintenance
A small ditch should be dug to drain the ponded water from the soil bench downslope of the wall. This will help slow down the movements in the bench area.	Maintenance
The base of the NBL ditch should where a scour has formed should be excavated and rebuilt with compacted clay. Consideration should be given to placing a TRM Type C mat or a gabion mattress in the ditch to reduce the risk of further scouring.	\$25,000

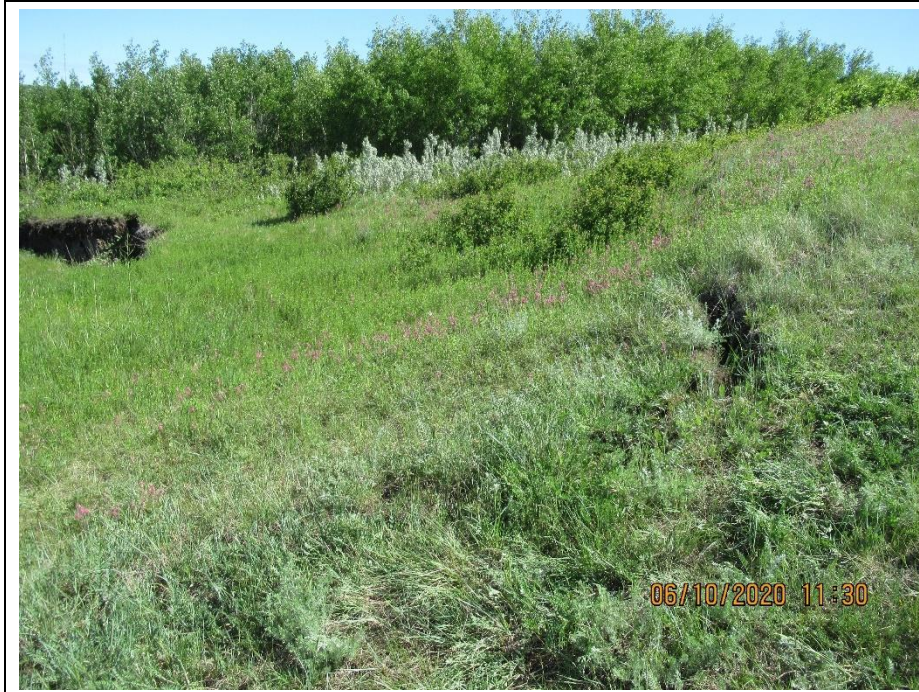
**Photo 7.**  
Same location as Photo 6 looking northeast at one of three tension cracks observed upslope from the slide scarp. Tension crack had a minimum offset of approximately 50 m from the highway, no change from the 2019 condition.
