ALBERTA TRANSPORTATION GRMP (CON0022164) PEACE REGION (PEACE RIVER DISTRICT) INSTRUMENTATION MONITORING RESULTS – SPRING 2022

SITE PH072: HWY 744:04, JUDAH HILL (SUNSHINE SLIDE)

TABLE PH072-1 SPRING 2022 – HWY 744:04 JUDAH HILL (SUNSHINE SLIDE) SLOPE INCLINOMETER INSTRUMENTATION READING SUMMARY

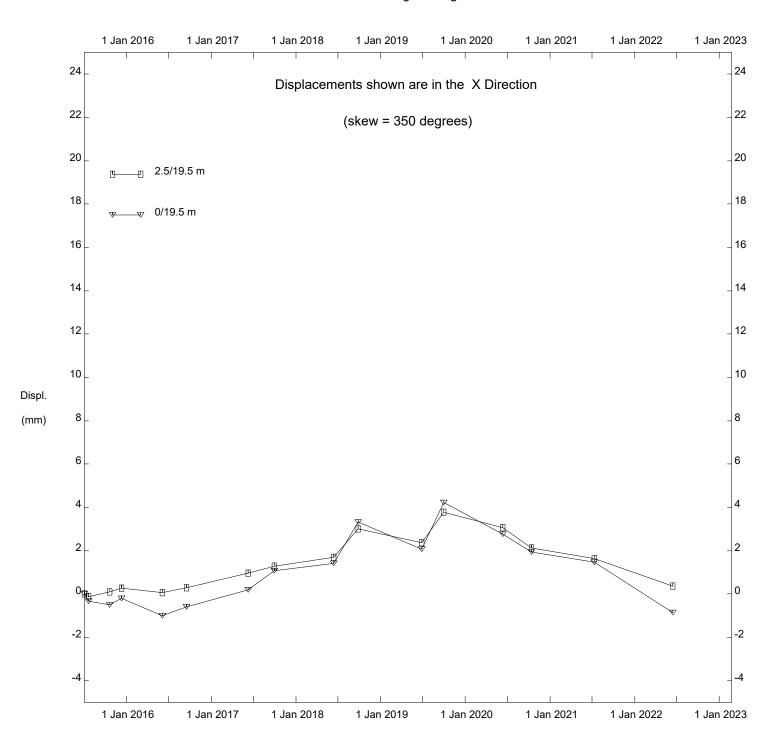
PH072 Sunshine (Post Construction), Inclinometer Pile 34

Pile 34 showed no discernible movement over either the length of the pile or the combined length of the pile and waler since the spring of 2021 readings. Pile 34 has shown a total cumulative pile head movement of 0.4 mm in the downslope direction since completion of construction and a total cumulative movement of 0.9 mm in the upslope direction over the combined length of the pile and waler.

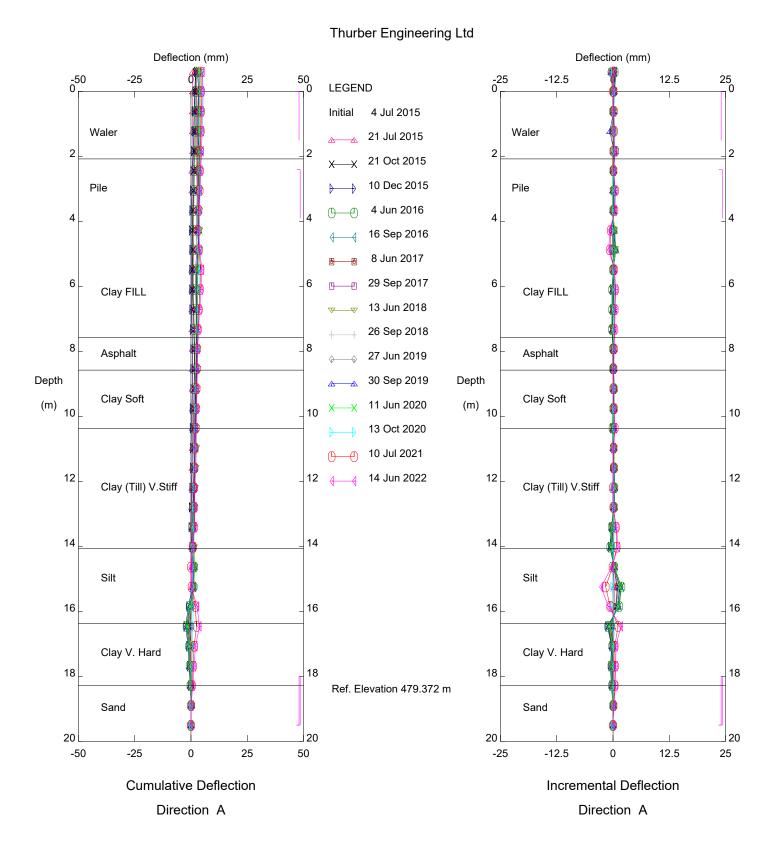
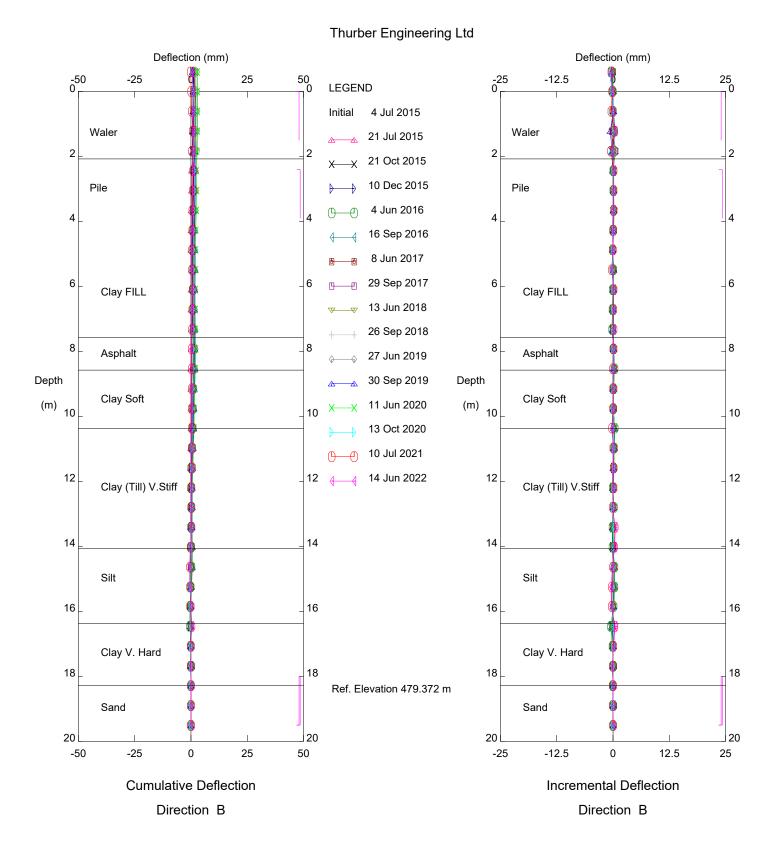
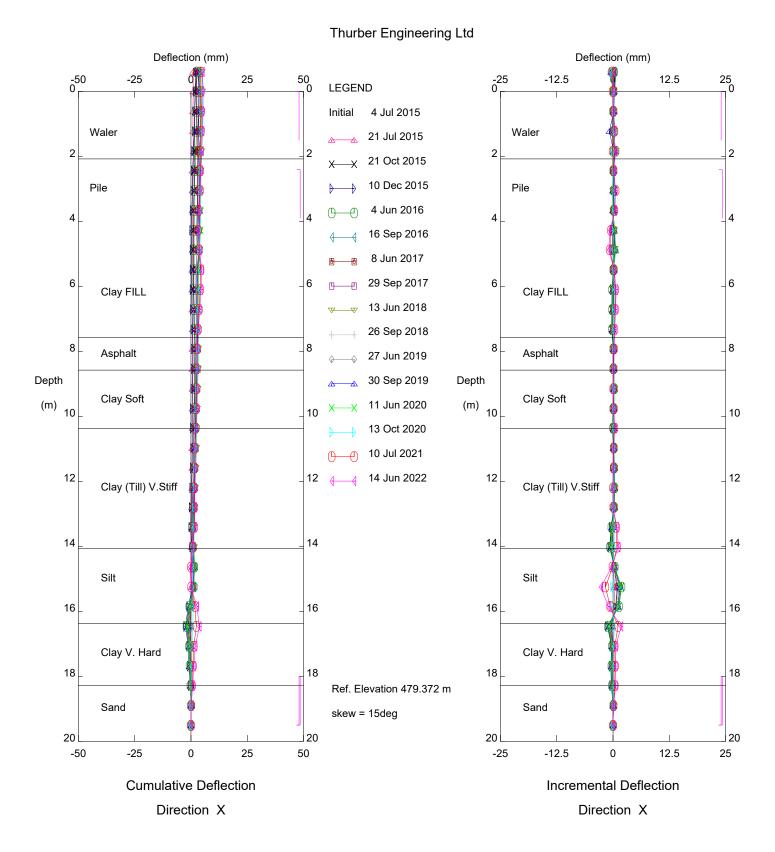
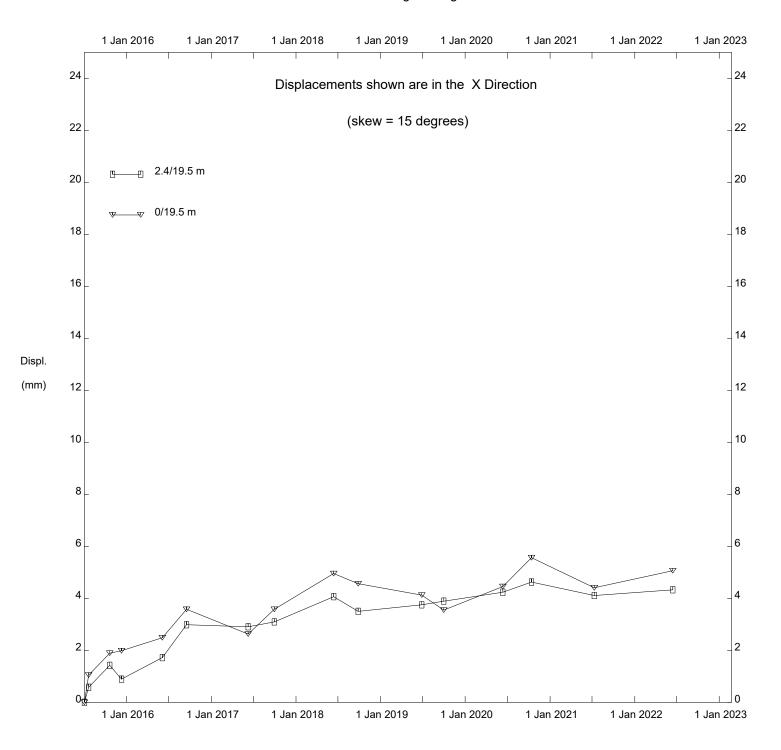
PH072 Sunshine (Post Construction), Inclinometer Pile 59

Pile 59 showed a rate of movement of 0.2 mm/yr over the length of the pile and a rate of movement of 0.7 mm/yr over the combined length of the pile and waler since the spring of 2021 readings. Pile 59 has shown a total cumulative pile head movement of 4.3 mm in the downslope direction since completion of construction with a total cumulative movement of 5.1 mm in the downslope direction over the combined length of the pile and waler.

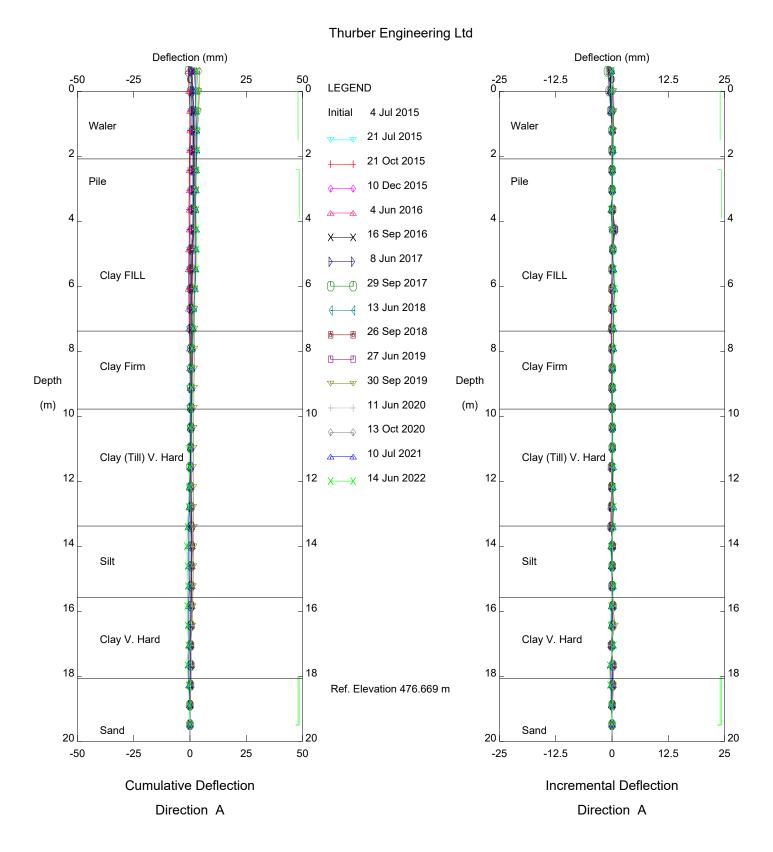
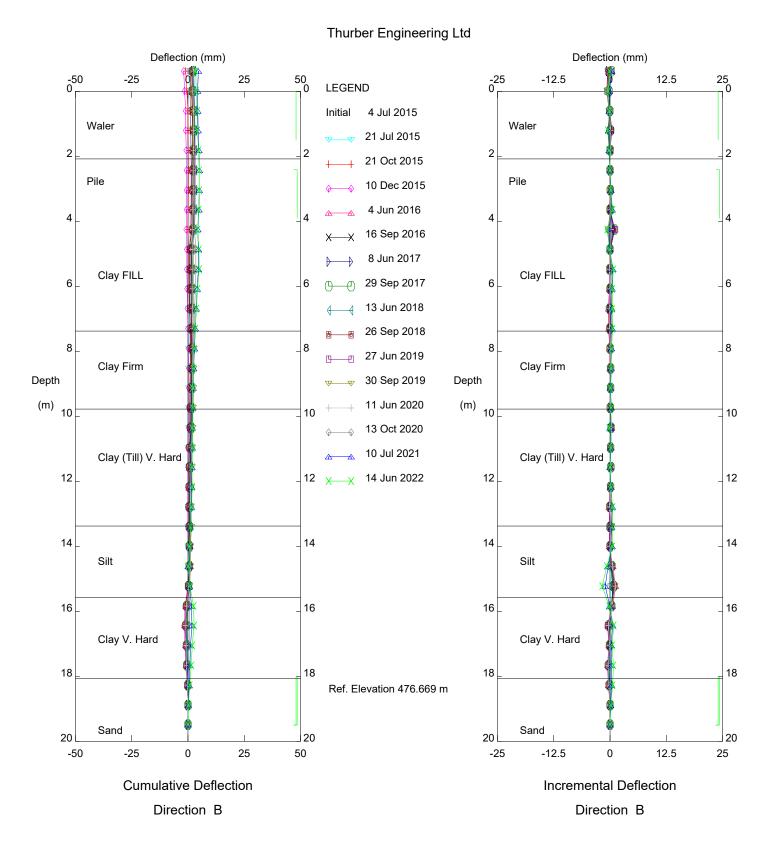
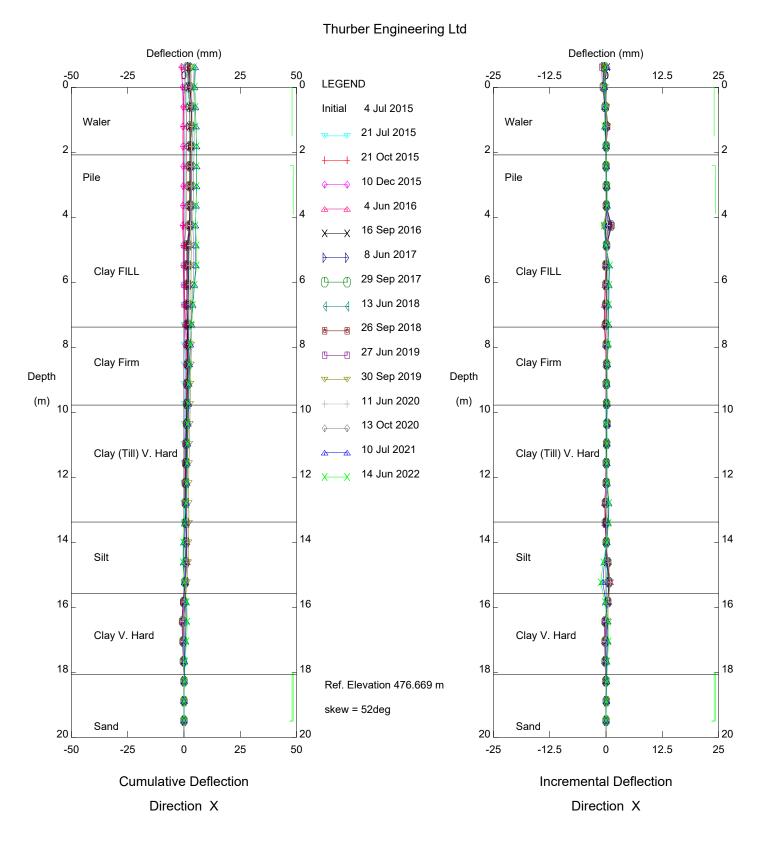
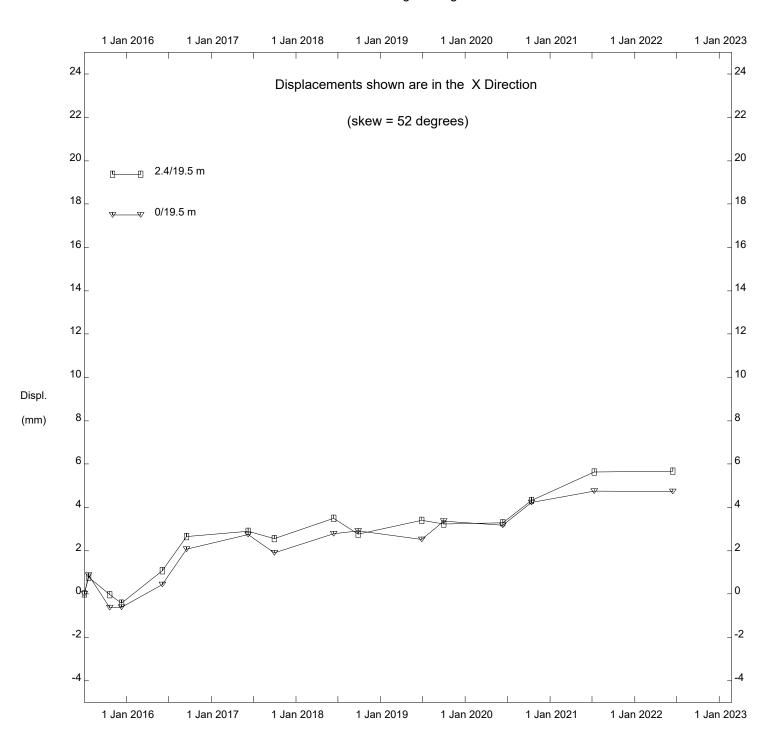
PH072 Sunshine (Post Construction), Inclinometer Pile 82

Pile 82 showed a rate of movement of less than 0.1 mm/yr over the length of the pile and no discernible movement over the combined length of the pile and waler since the spring of 2021 readings. Pile 82 has shown a total cumulative pile head movement of 5.7 mm in the downslope direction since completion of construction and a total cumulative movement of 4.7 mm in the downslope direction over the combined length of the pile and waler.

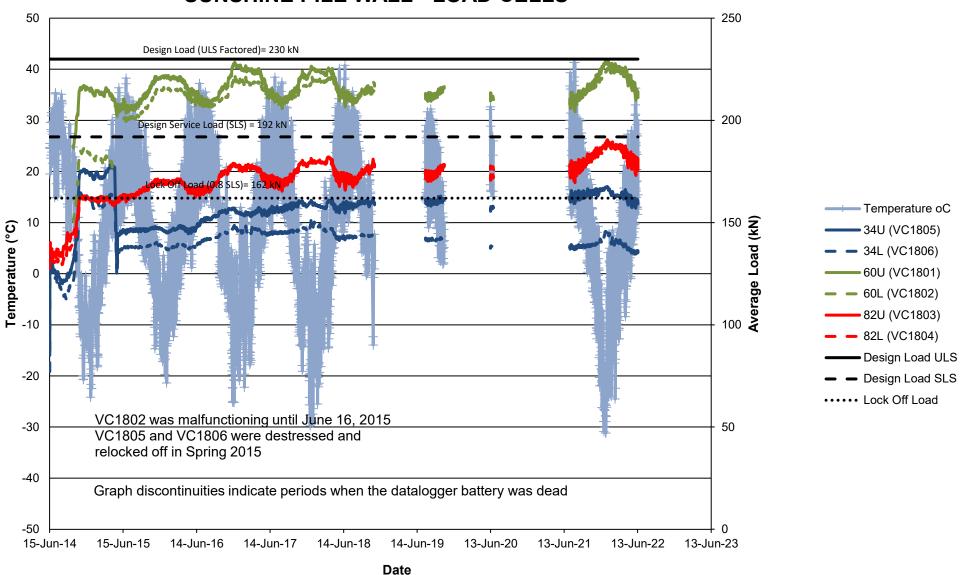
FIGURE PH072-1 SUNSHINE PILE WALL - LOAD CELLS

The six load cells (VC1805, VC1806, VC1801, VC1802, VC1803 and VC1804) are connected to an RST DT2040 datalogger which was initially programmed to take readings once per day. Starting in the spring of 2015, the datalogger was reprogrammed to take readings twice per day. The latest load cell readings, as of June 14, 2022, show minor changes compared to the previous readings taken in on July 11, 2021. The changes range from a decrease of 2.46 kN in load cell VC1805 (anchor 34U) to an increase of 2.99 kN in VC1802 (anchor 60L). Load cells VC1801 (anchor 60U), VC1802 (anchor 60L), VC1803 (anchor 82U) and VC1804 (anchor 82L) measured all-time high loads during a period from January 6-16, 2022. These high anchor loads appear to correspond to a period of extreme cold weather from late December 2021 to early January 2022. It should also be noted that load cells C1801 (anchor 60U), VC1802 (anchor 60L) are showing loads that are slightly higher than the design loads.

The load cell readings are summarized in Table PH072-2 above and are plotted in Figure PH072-1 in Appendix A. Overall, the load cells show a trend of stable loads over the past several readings cycles.
