**ALBERTA TRANSPORTATION AND  
ECONOMIC CORRIDORS  
GEOHAZARD ASSESSMENT PROGRAM  
PEACE REGION (PEACE RIVER DISTRICT)  
2025 INSPECTION**

Site Number	Location	Name	Hwy	km
PH072	Judah Hill	Sunshine Landslide	744:04	57.924
Legal Description		UTM Co-ordinates (NAD 83)		
SE¼ 20-083-21 W5M		11U E 483150	N 6230060

**PH072-1 SUNSHINE SLIDE  
2025 SITE INSPECTION PLAN**

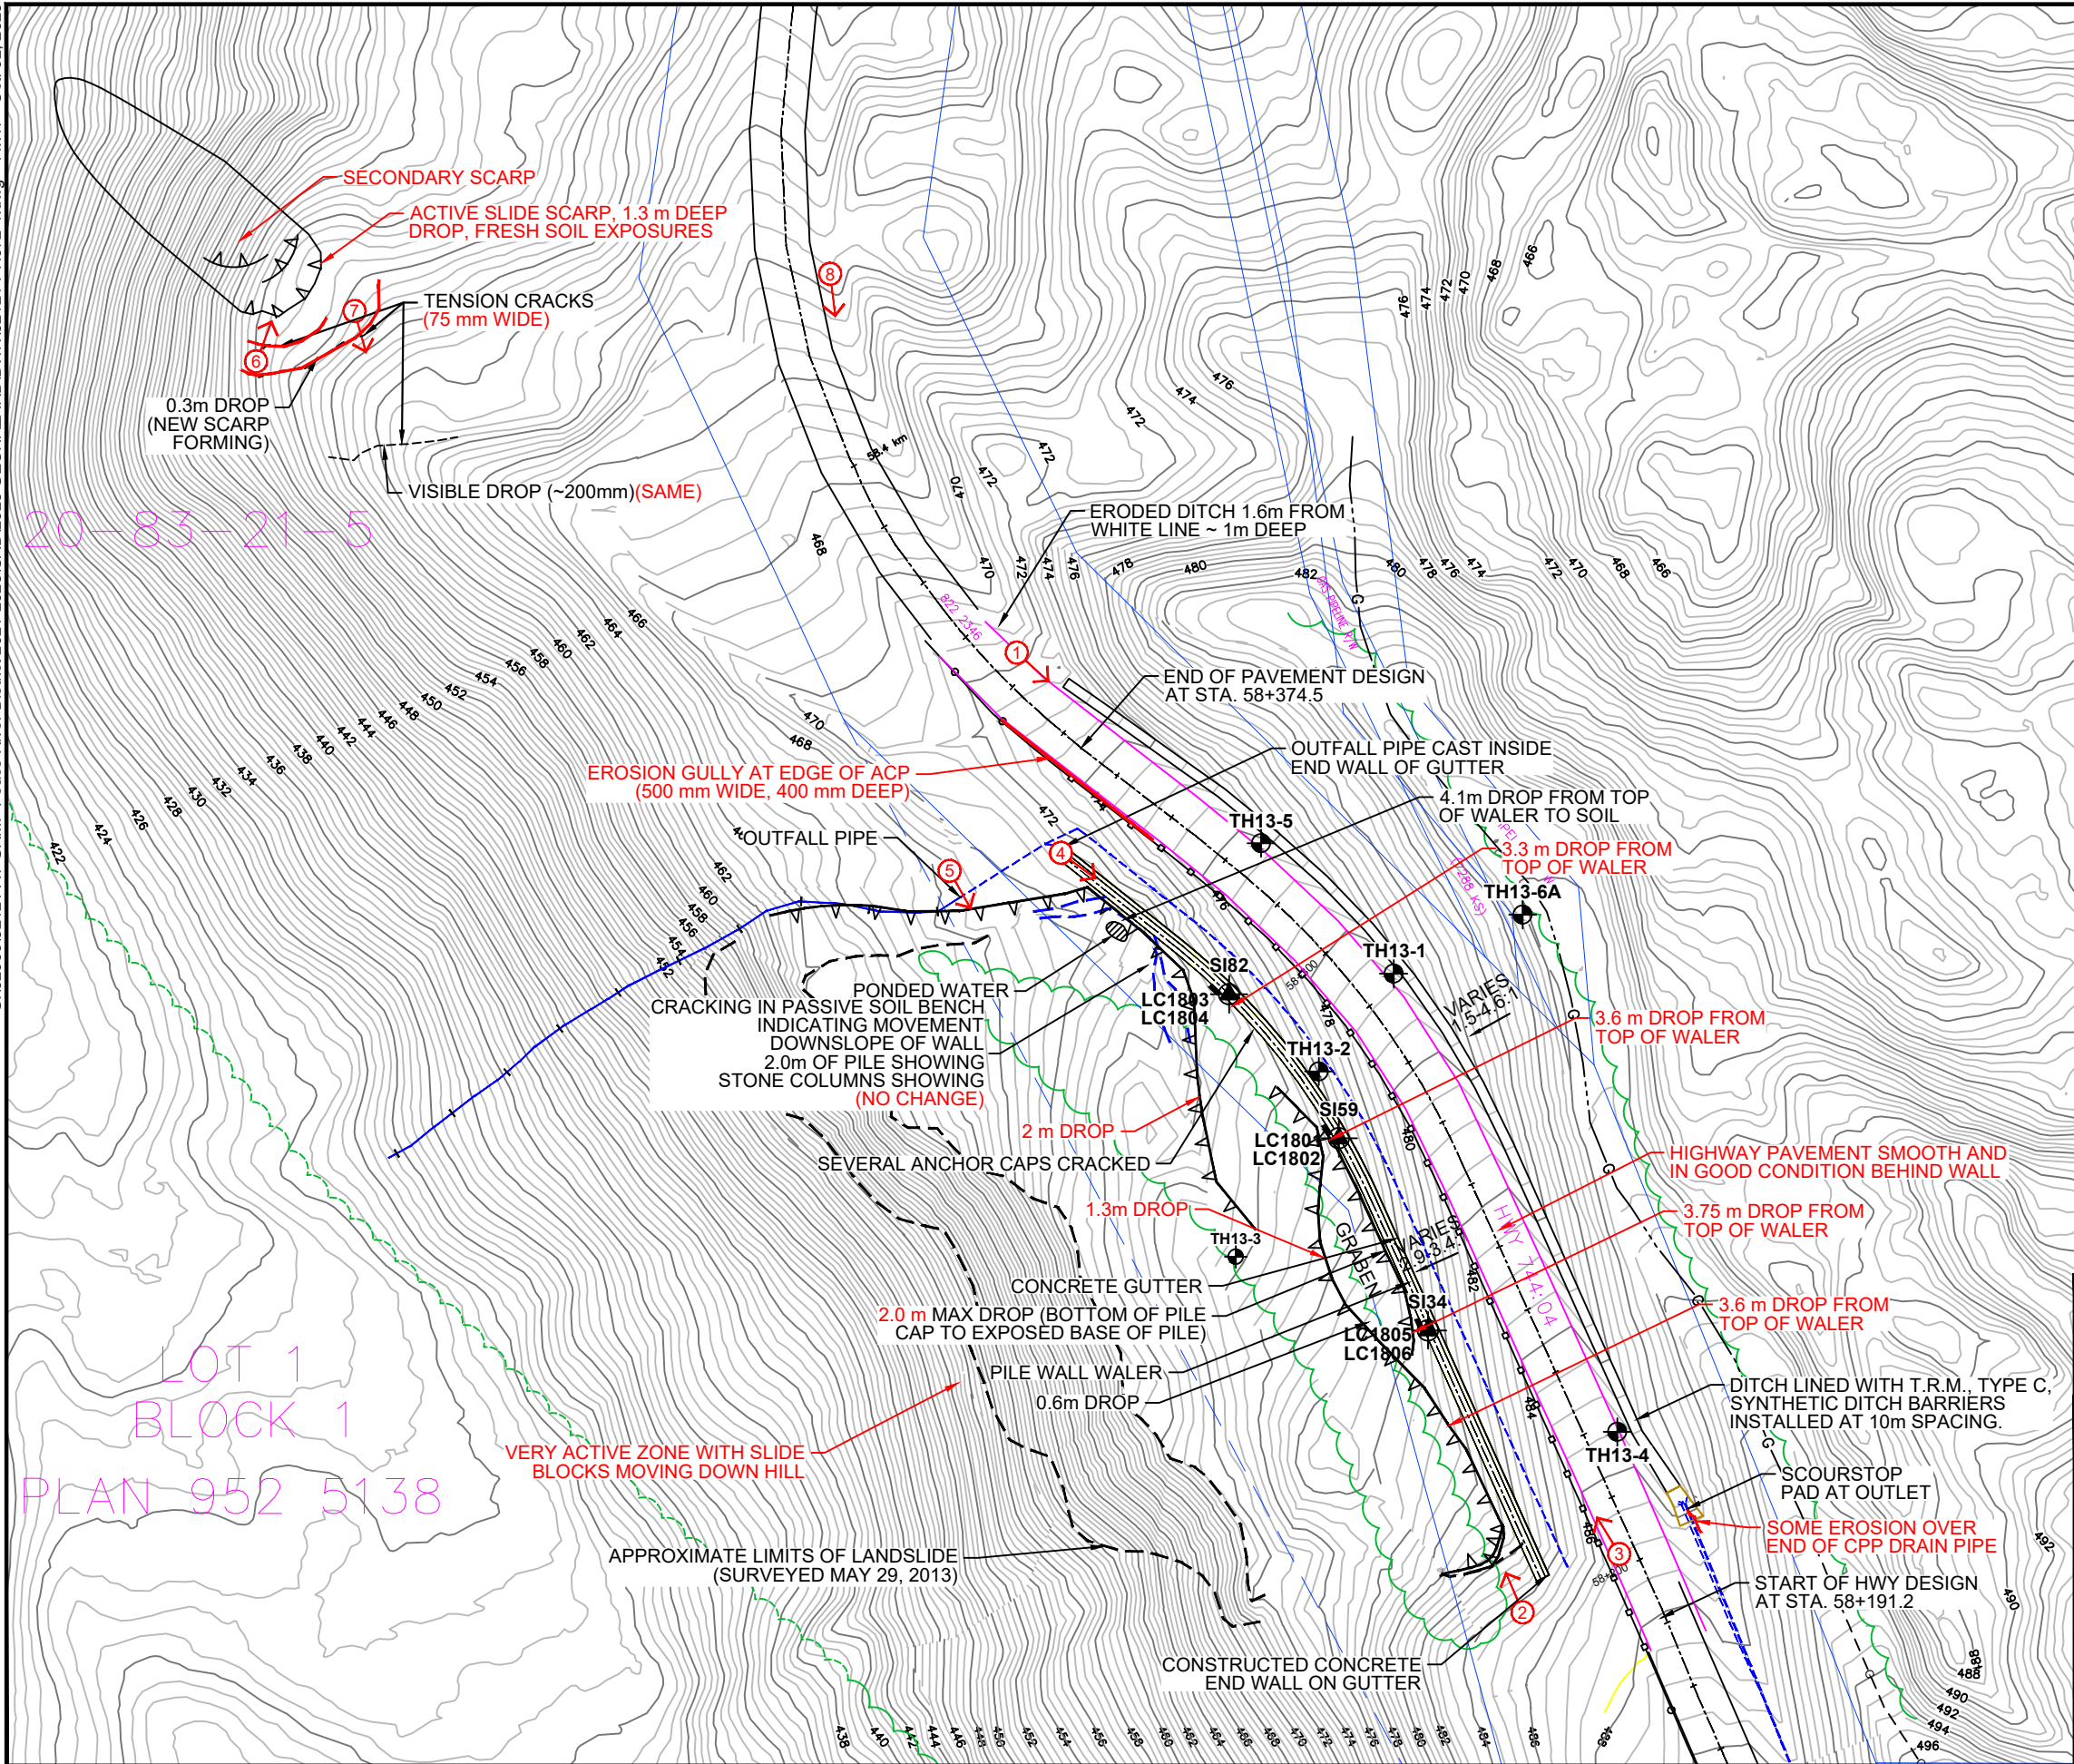
**DWG No. 32121-PH072-1**

The reconstructed highway embankment and supporting pile wall appear to be performing well. The movement observed in the passive soil bench below the wall was anticipated and accounted for in the wall design.

The northwest slide area is expected to retrogress closer to the highway in the next 10 years. A new inspection site may eventually be required.

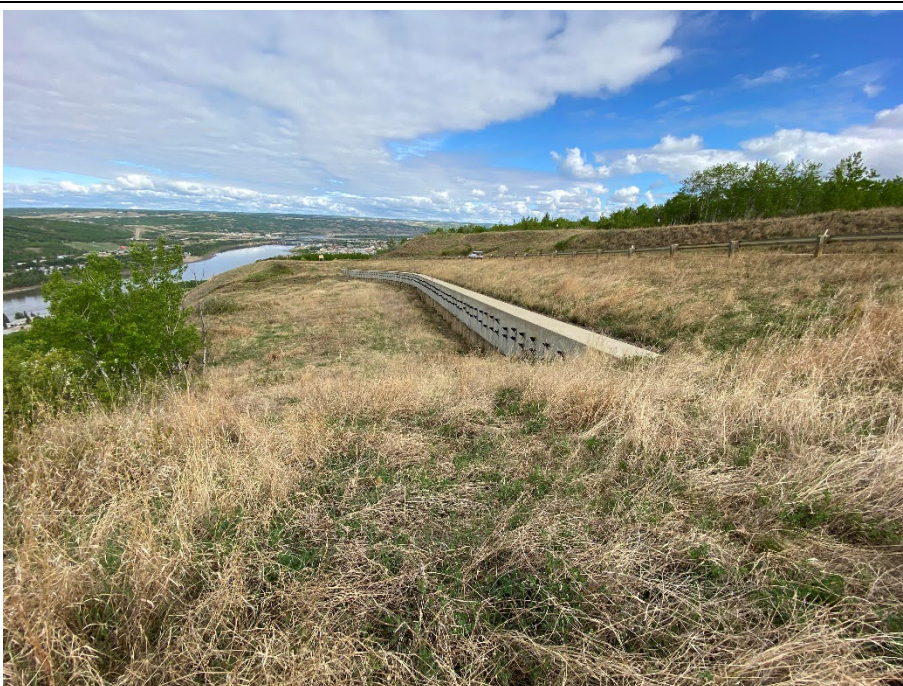
**Photo 2.**

Looking northwest from the south end of the Sunshine pile wall at km 58.20. No major visible changes from the 2023 condition.

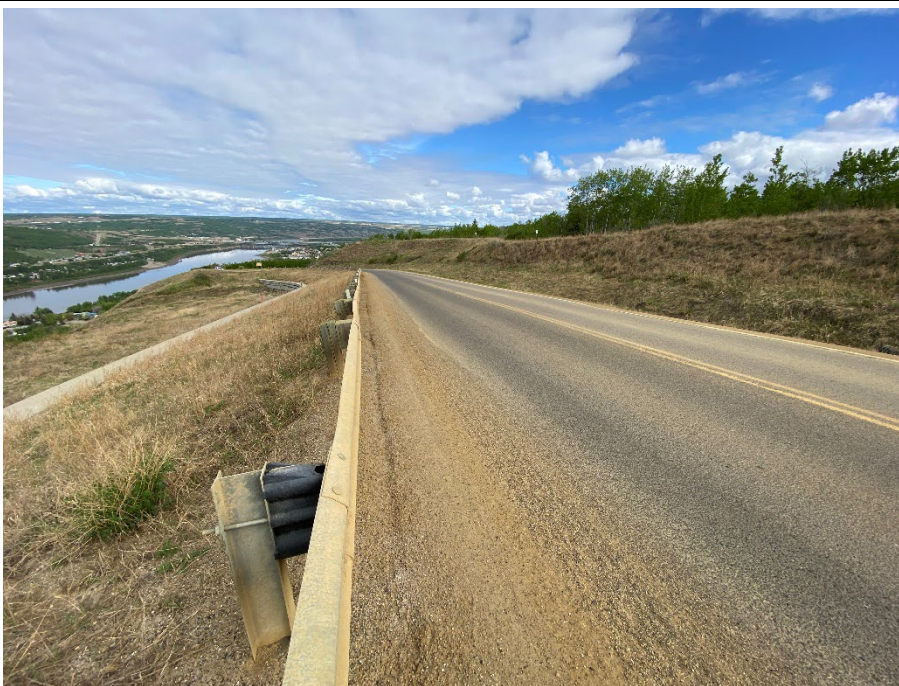
**Photo 3.**

Looking northwest from south end of the Sunshine pile wall at km 58.20 along the highway. No distress to the ACP surface was observed.

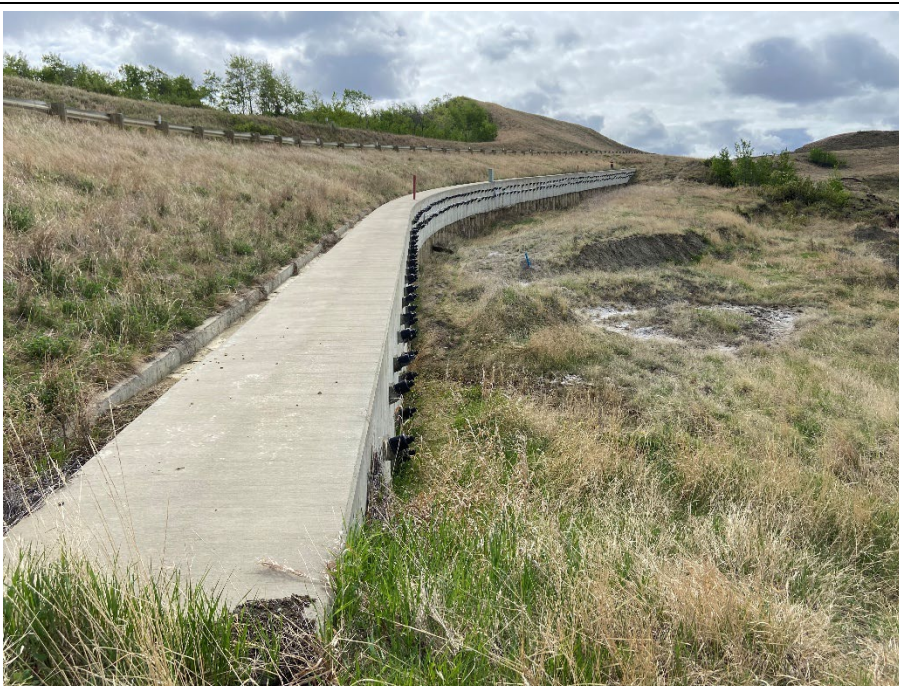
**Photo 4.**

<p>the northern segment of the wall. Sliding in the lower slope appears active with fresh soil exposures (Photos 4 and 5).</p> <p>Slide area approximately 100 m northwest from the north end of the pile wall. 15 m wide scarp with tension cracks that are offset approximately 50 m from the west highway edge. Minor downslope movement noted. Main scarp crack is 1.3 m deep with some fresh soil exposures. Tension cracks upslope of the main scarp. A secondary scarp is forming at one of the tension crack locations. (Photos 6 and 7).</p>		
<input checked="" type="checkbox"/> Erosion	<p>An erosion gully (0.5 m wide, 0.4 m deep) approximately 30 m in length has developed parallel to the edge of the SBL ACP near the north end of the pile wall near KM 58.35</p> <p>Ditch erosion present in NBL ditch beyond the north end of the pile wall. Scattered Class 1M riprap is present in the ditch bottom. (Photos 1 and 8)</p>	<input type="checkbox"/>	<input type="checkbox"/>

Looking southeast along the pile wall at km 58.33. Head scarp cracks downslope of the wall showed a 2.0 m drop.

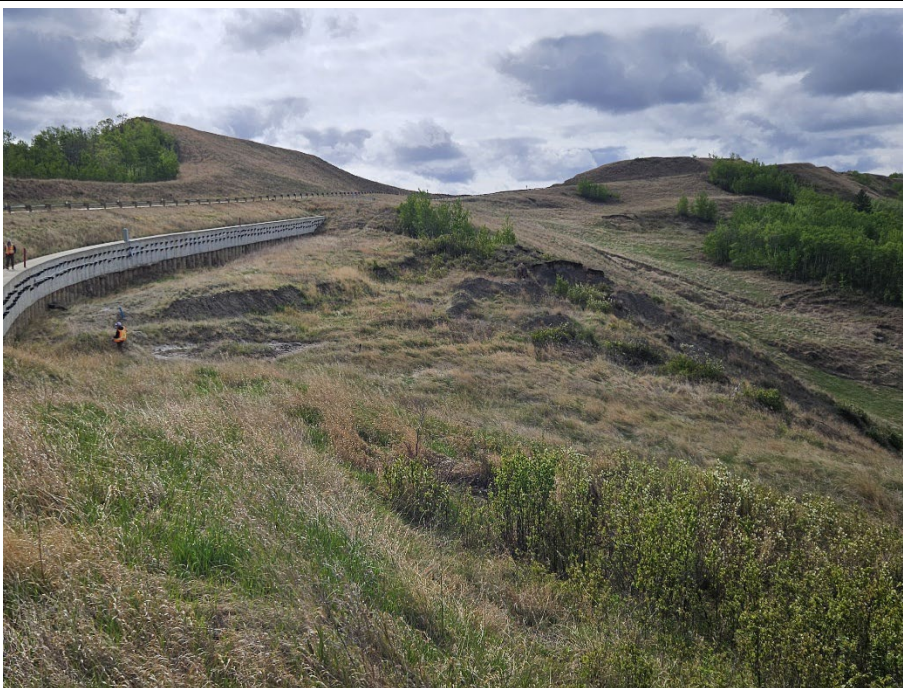
**Photo 5.**

Looking southeast at the lower slide area below the wall. Active ongoing slide movement within the lower slope.

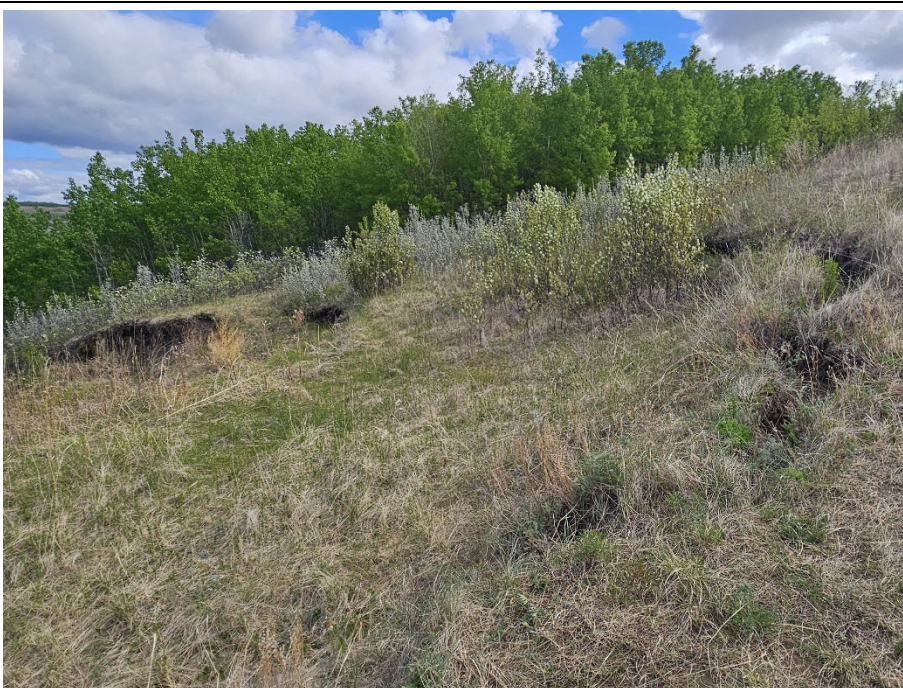
**Photo 6.**

Slide area (first observed in 2019) approximately 120 m NW of the north end of the pile wall. Slide is active with fresh soil exposures in 2025.

- The slide area northwest of the Sunshine pile wall should be monitored during the PH072 annual inspections or alternatively a new site should be created.
- The slope inclinometers should continue to be read manually twice per year and the datalogger installed at the site will continue to take readings of the load cells twice daily as part of the Geohazard Risk Assessment Program.

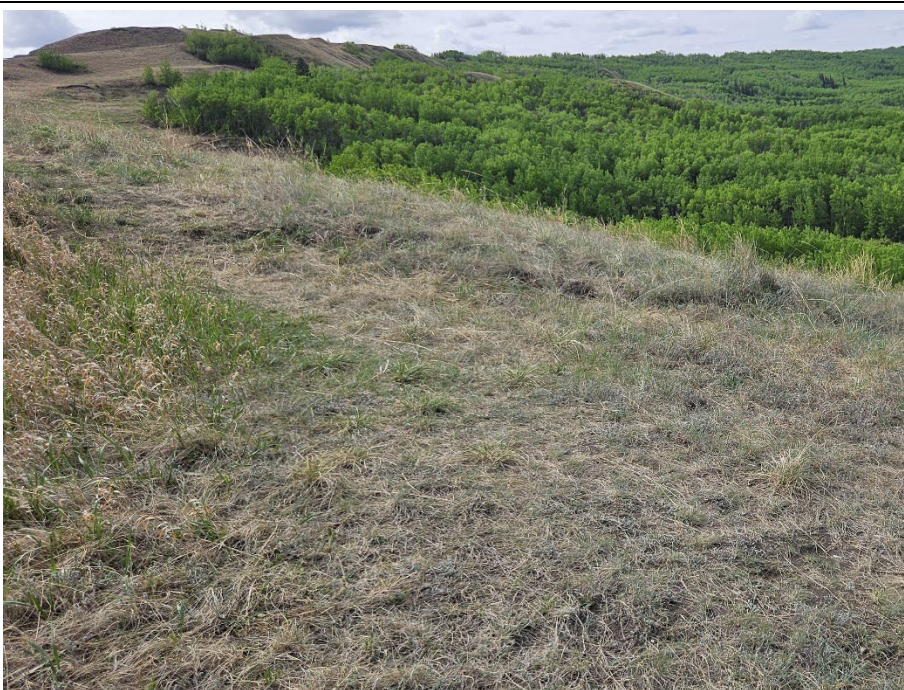
**Photo 7.**

Looking southeast at the uppermost tension crack observed upslope from the slide scarp in Photo 6. Cracks are up to 75 mm wide.

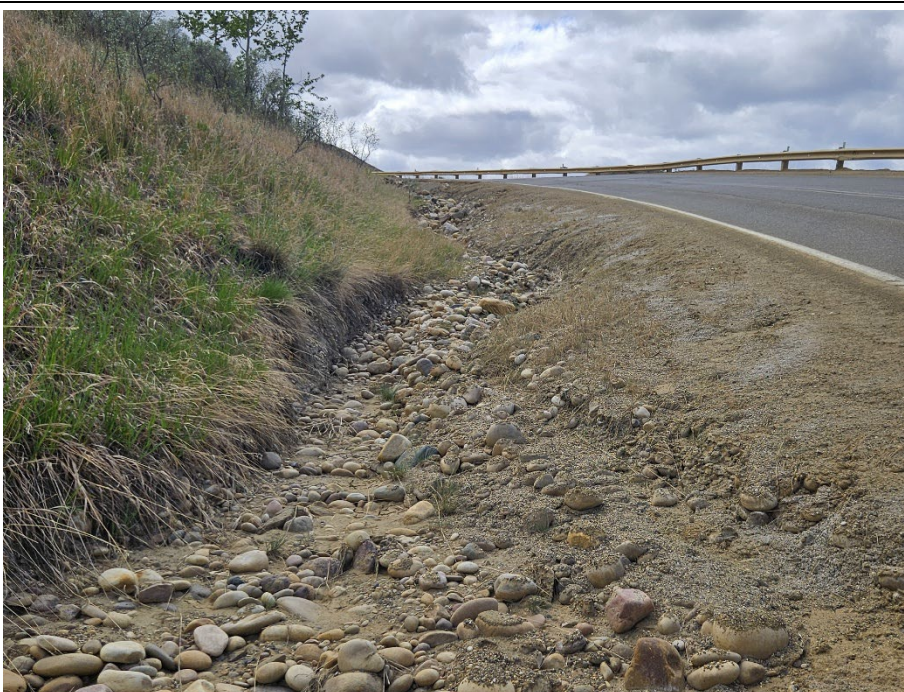
**Photo 8.**

Looking south at erosion in NBL ditch at km 58.43. Scattered 1M riprap visible in ditch bottom.

- The erosion gully forming on the west edge of the road near the north end of the pile wall (km 58.35) should be backfilled with granular fill to provide support and minimize further undermining and damage to the ACP.
- The erosion in the NBL ditch north of the pile wall and reconstructed highway embankment should be addressed by placing additional Class 1M riprap over non-woven geotextile.
- A small ditch should be dug to drain the ponded water from the soil bench downslope of the wall. This will help slow down the movements in the bench area.
- The damaged anchor caps should be replaced and repacked with grease.
